SR 14 Marble Rd. Vic. To Belle Center Rd. Safety Improvements (Homestead Lake) Mitigation Site

USACE NWS-2011-544

2015 MONITORING REPORT

Issued March 2016

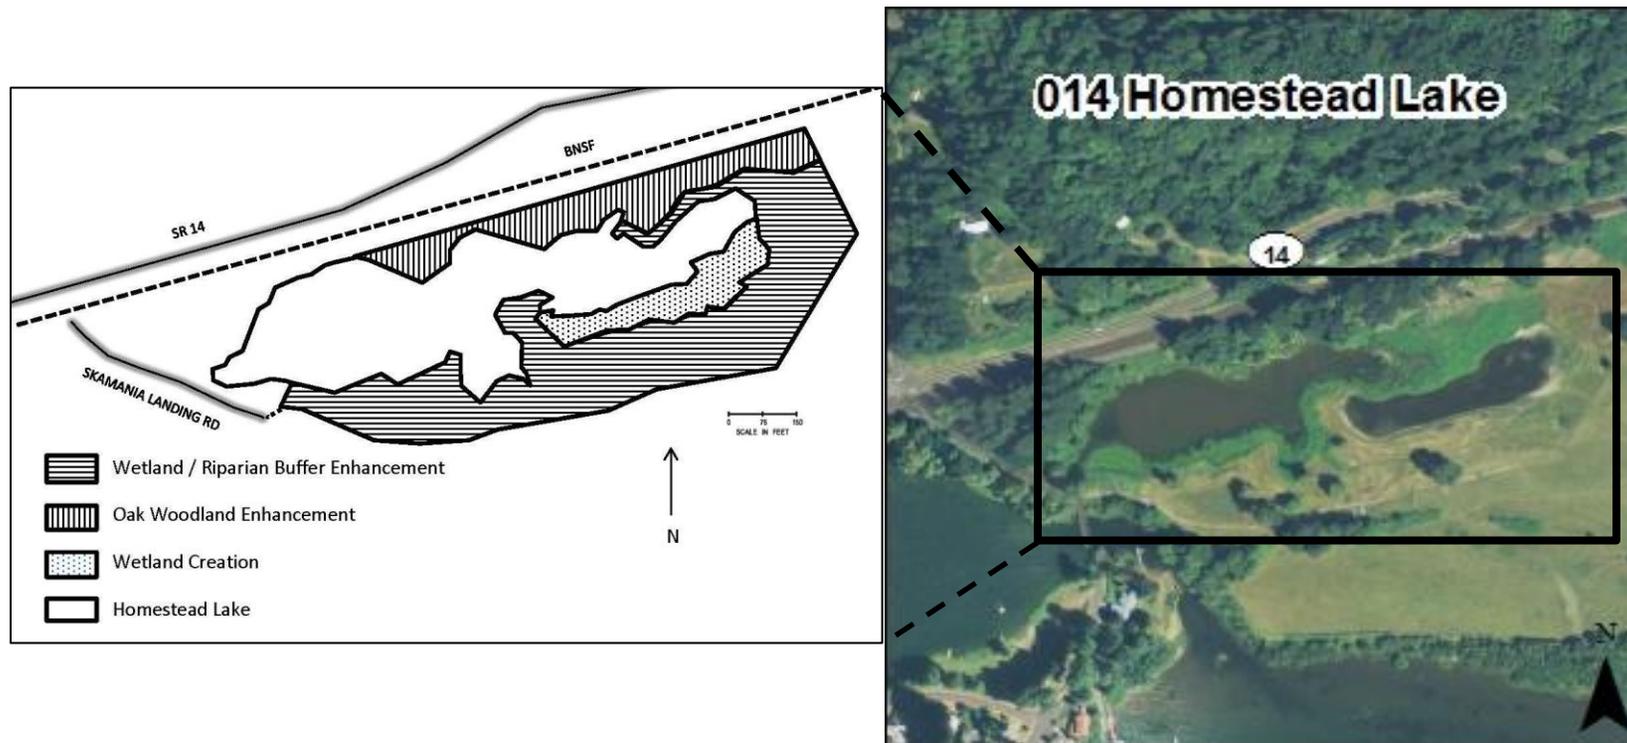
Figure 1 Site Sketch

This 10.2-acre mitigation site (Figure 1) is a new wetland created on the western edge of Beacon Rock State Park. This site was created to compensate for the loss of 0.16 acre of wetlands and 2.25 acres of oak woodland due to road improvements along SR 14. The wetland establishment area expands a wapato-dominated shelf on the perimeter of Homestead Lake and enhances habitat for the endangered western pond turtle. This mitigation site is designed to improve water quality and provide hydrologic and habitat functions.

The previous buffer of grazed and mowed grasslands has been replaced with a native transitional wet prairie. The wet prairie is screened by wetland buffer planted with a mix of native trees and shrubs. The oak woodlands have had non-native invasive blackberry removed and have been under planted with native woody species associated with an undisturbed understory. Appendix 2 includes site directions.

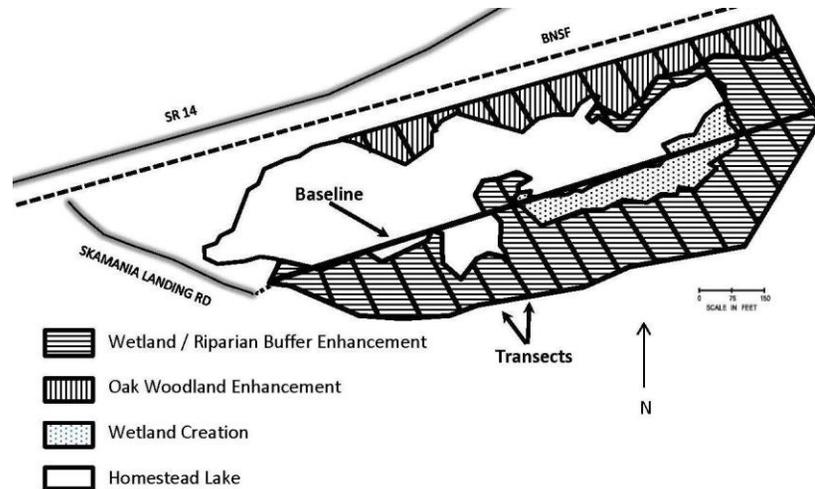
Figure 2 Site Sampling Design (2015)

Placement of Baseline: Mainly through the center of the site with two jogs: one to avoid the lake and one to ensure the entire site had the potential to be sampled.

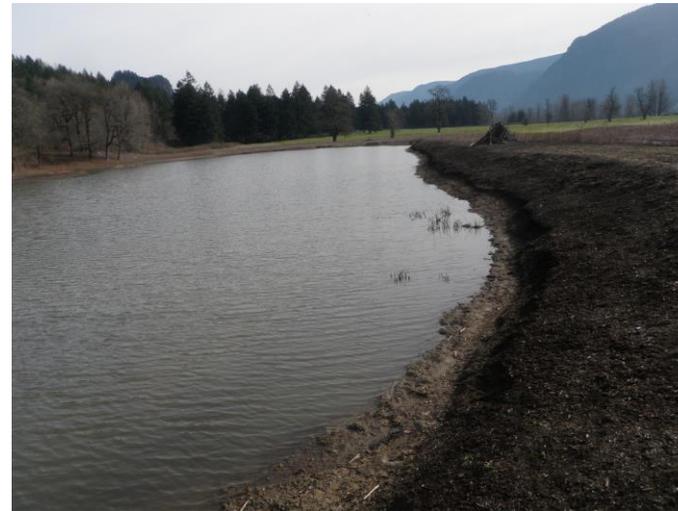
Photo 1
Inundation in the created wetland (July 2015)

On each of the three hydrology visits the created wetland was inundated from approximately 9 inches at the shoreline to up to greater than 20 inches at the outer edge of the zone (Photo 1). Due to the continual inundation on each visit no ground monitoring wells were installed.

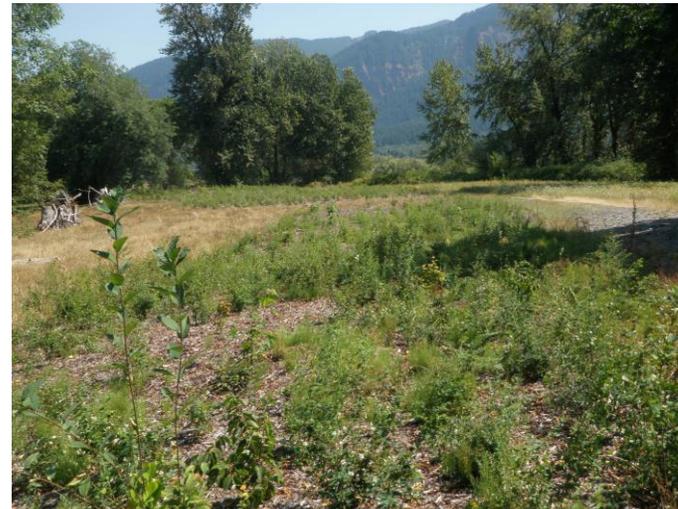
Photo 2
Native woody survival in the wetland buffer (July 2015)

Survival of woody species across the site is estimated at 94% (CI_{80%} = 92-95%). There is an abundance of volunteer black cottonwood (*Populus balsamifera*) in the southeast corner of the site. Other dominant species include snowberry (*Symphoricarpos albus*) and beaked hazelnut (*Corylus cornuta*) (Photo 2 and 3).

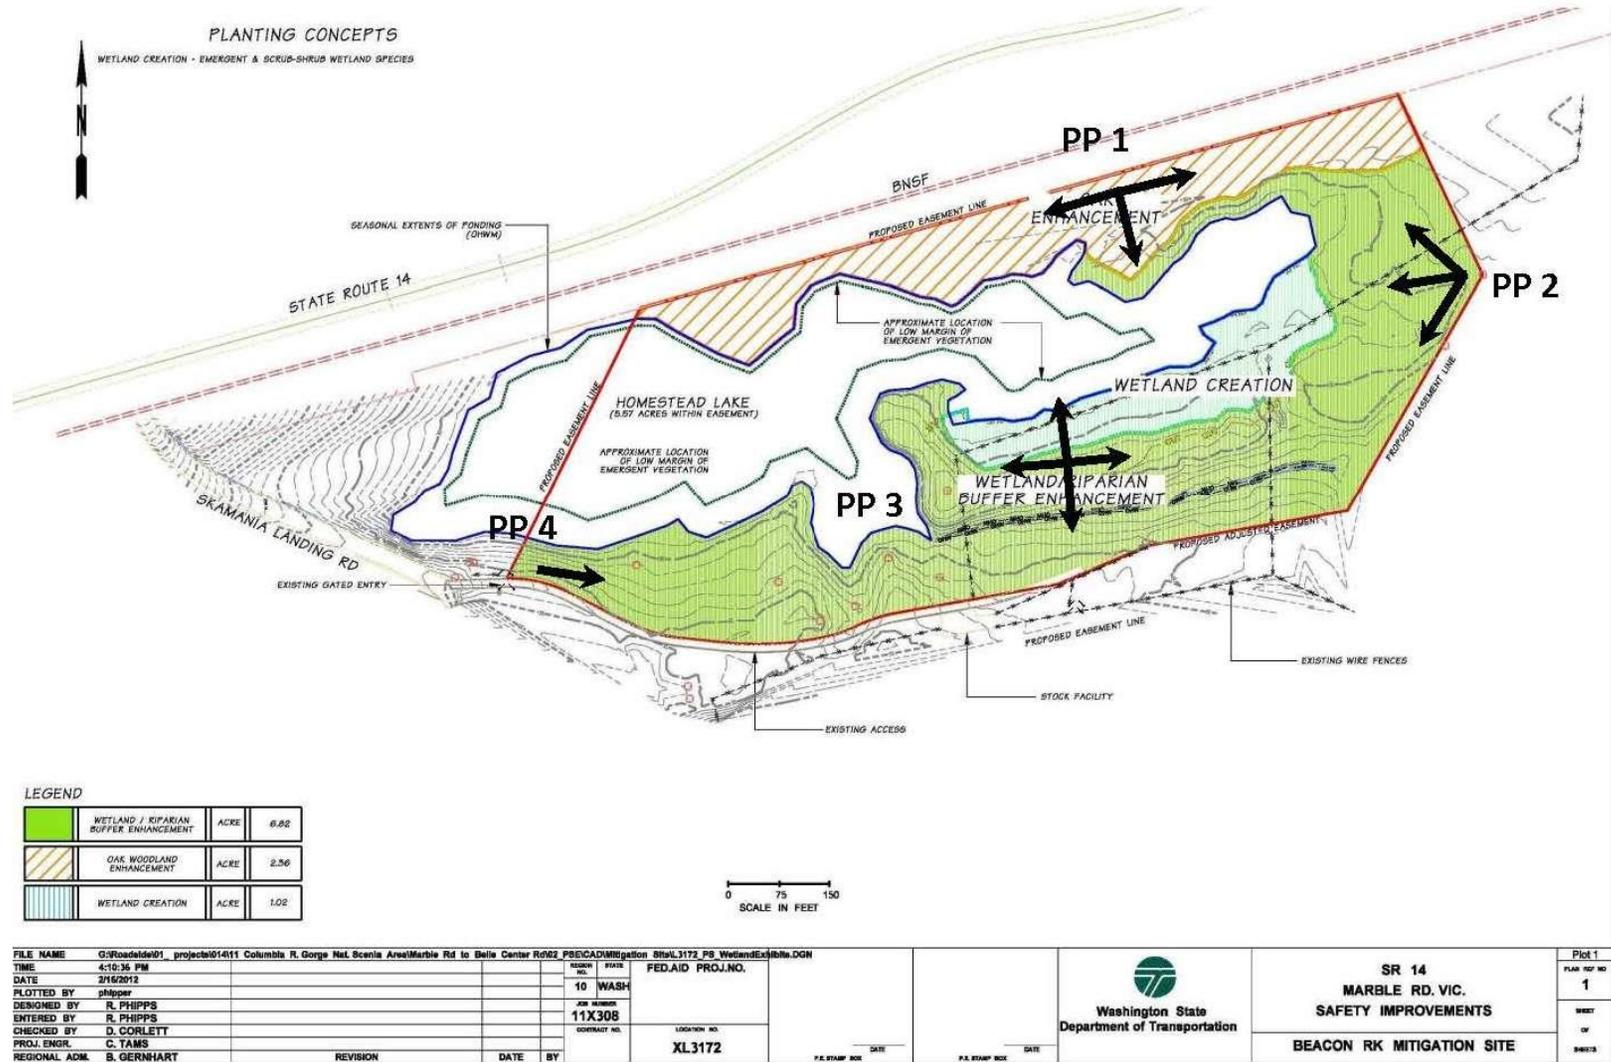
Appendix 1 – Planting Plan with Photo Point Locations

Appendix 1 shows the planting plan (WSDOT 2011).
