Hello everyone. First, the good news – we learned late this afternoon that crews will be wrapping up their work tomorrow (Friday, Feb. 27), one day early, on the State Route 305 Agate Pass bridge. Motorists can still expect single-lane alternating traffic tomorrow from 8:45 a.m. to 3 p.m., and then everyone can breathe a sigh of relief as equipment gets packed up and the bridge maintenance crews head home.

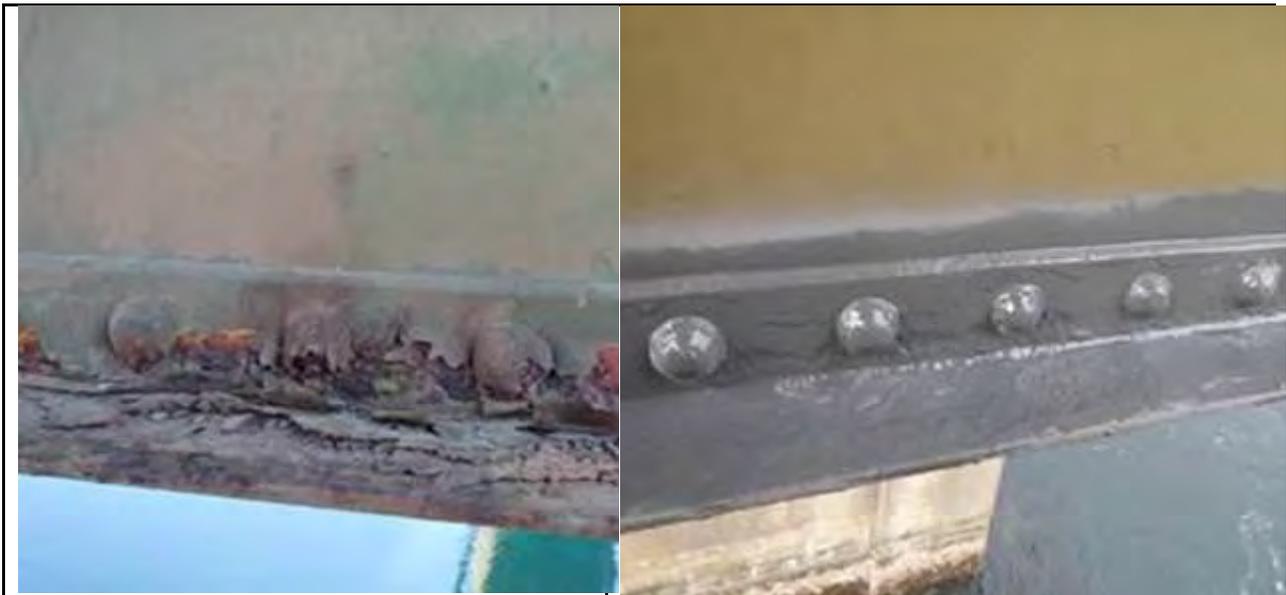
This ‘before’ photo shows rust eating away at rivets and a beam flange. Crews are removing rust from the most critical areas of the bridge, a time- and labor-intensive but necessary job.

This ‘after’ photo shows the rivets and beam cleaned and coated with a zinc-based coating to protect the steel from future rust.

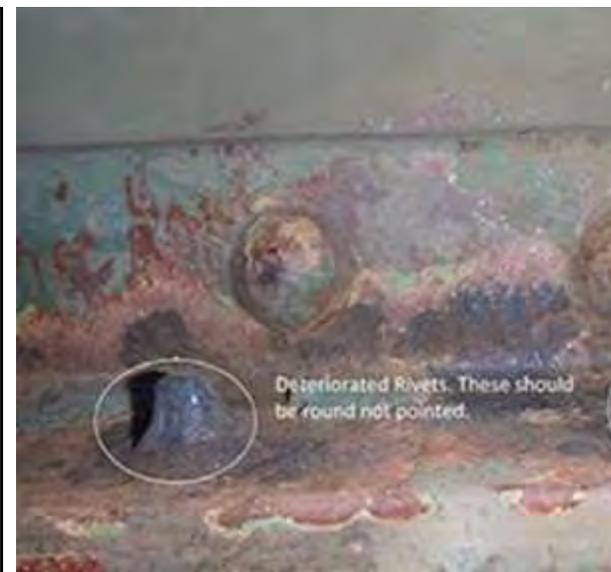
Other rivets are rusted to the point that they must be replaced. Rust has eroded the dome heads of these rivets into points.

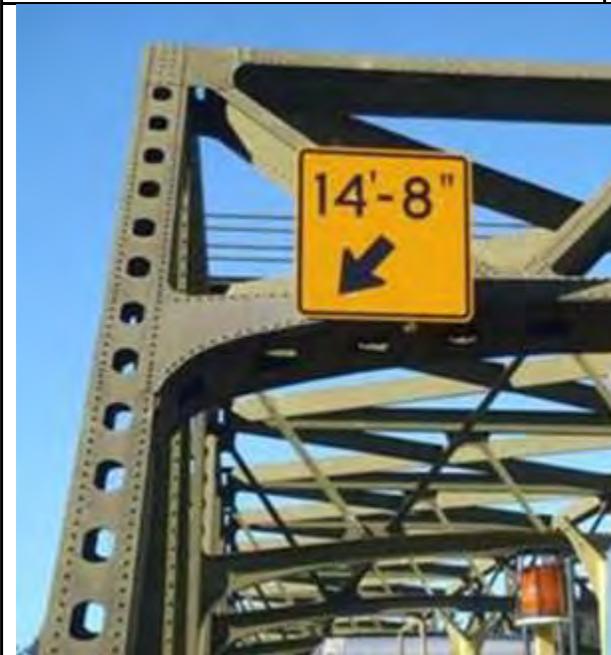
To reduce the potential of bridge strikes by over-sized trucks, crews also installed signs stating the vertical clearance under the bridge.

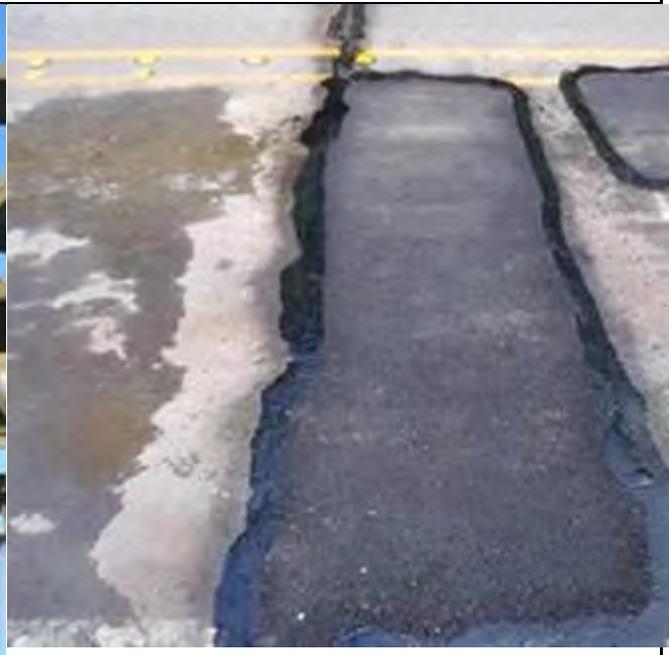
The dry weather allowed crews to grind and patch a bump in the pavement at the bridge abutment to smooth the ride for motorists.

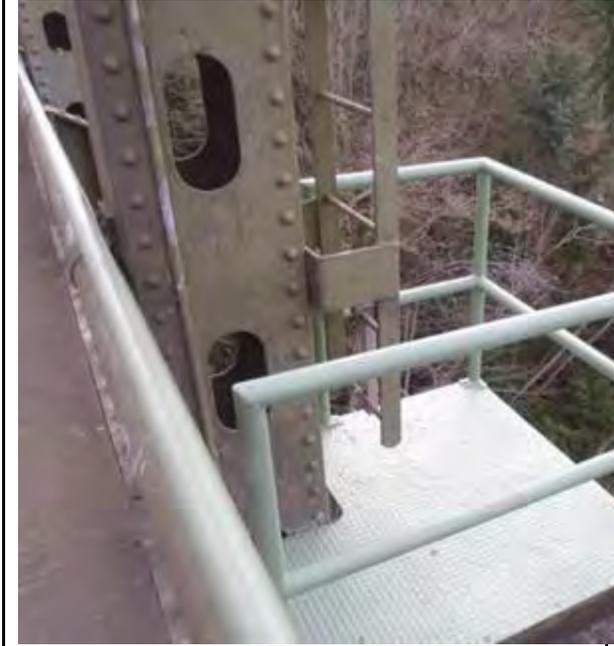
Another task crews were able to complete was to repair the work platform under the bridge. Not visible to the traveling public, this platform is a key safety component for crews working on the bridge.

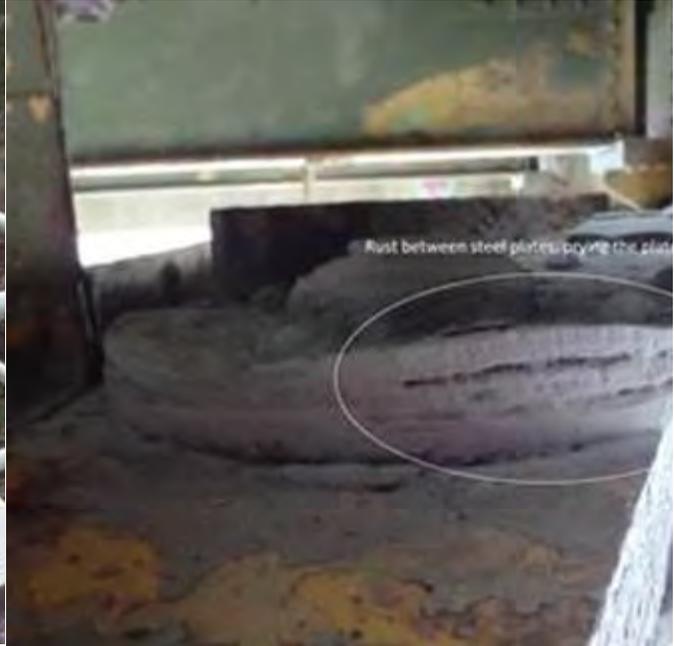
Not all repairs were completed in this three-week period. This photo shows an area affected with “pack rust,” a thick layer of rust that has exerted so much force that it has bent the steel plates it inhabits. Crews will monitor the area and a future repair will be scheduled. In the interim, a zinc coating will slow rust progression.
