US 12 Tieton River Bridges Replacement Mitigation Site

USACE NWP (23) NWS-2008-080-SOD

2015 MONITORING REPORT

Issued March 2016

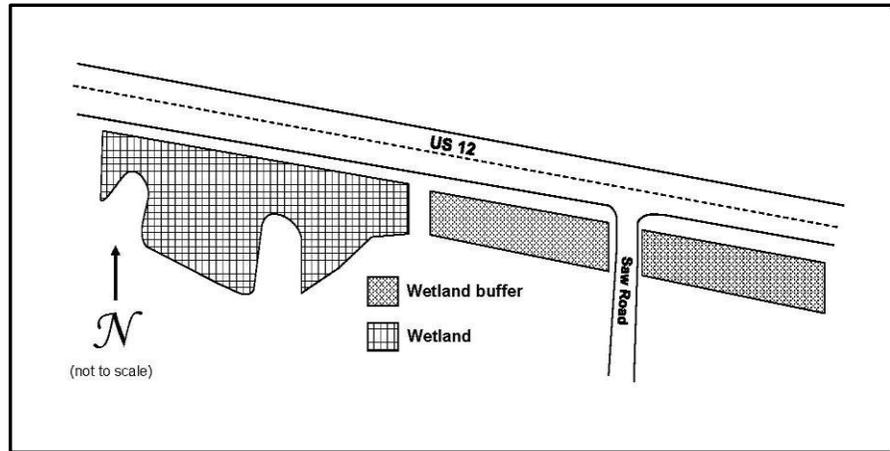
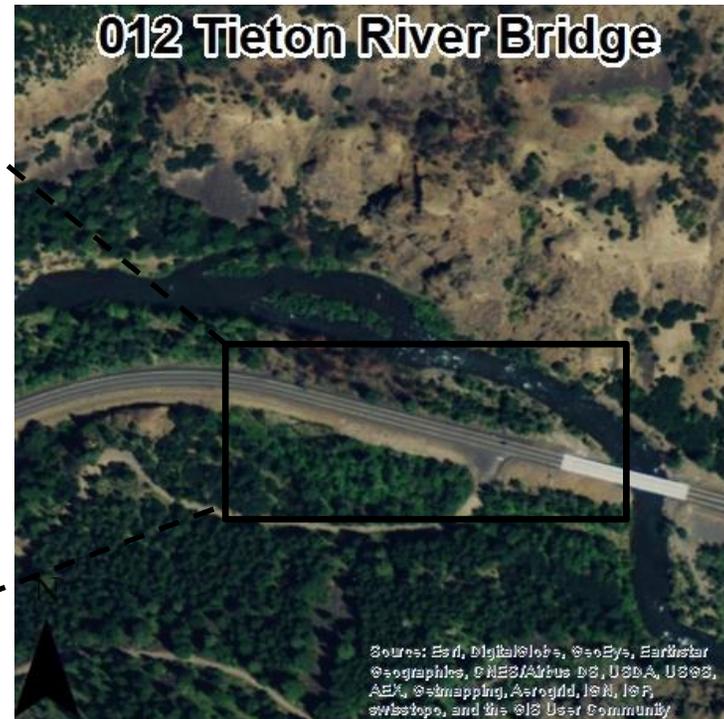
Figure 1 Site Sketch

The US 12 Tieton River Bridges Mitigation Site consists of an established wetland and associated upland buffer. Appendix 1 includes site directions.

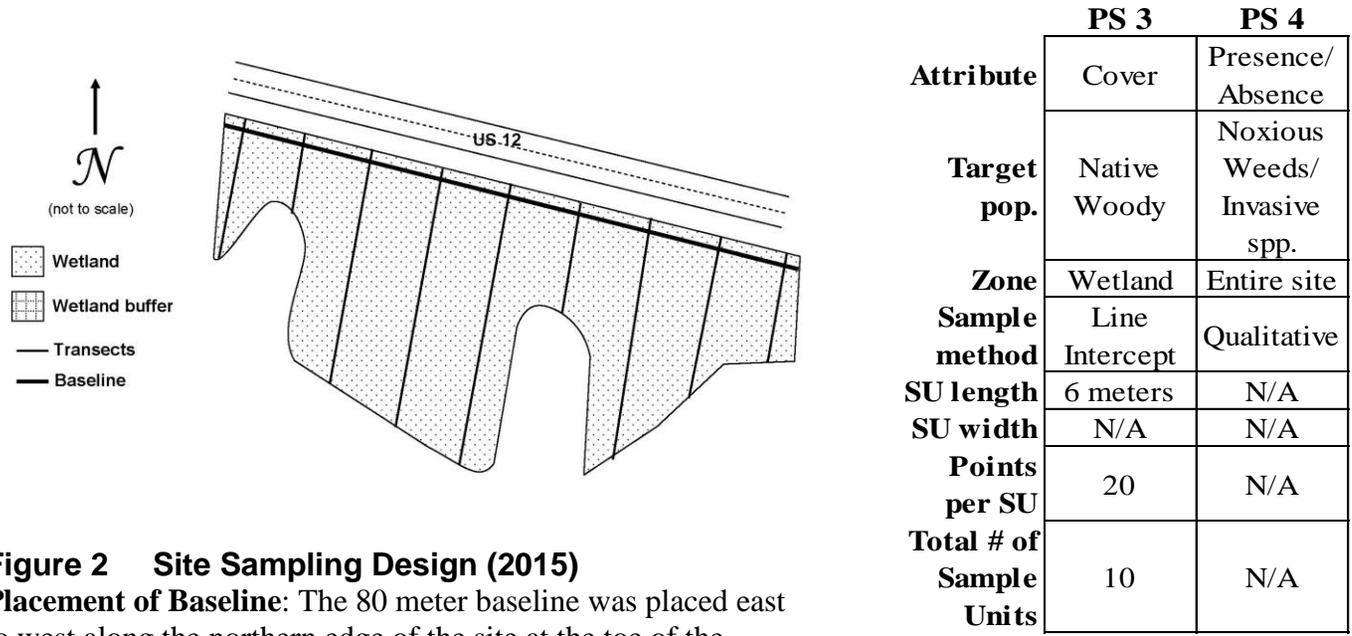
Figure 2 Site Sampling Design (2015)
Placement of Baseline: The 80 meter baseline was placed east to west along the northern edge of the site at the toe of the slope.

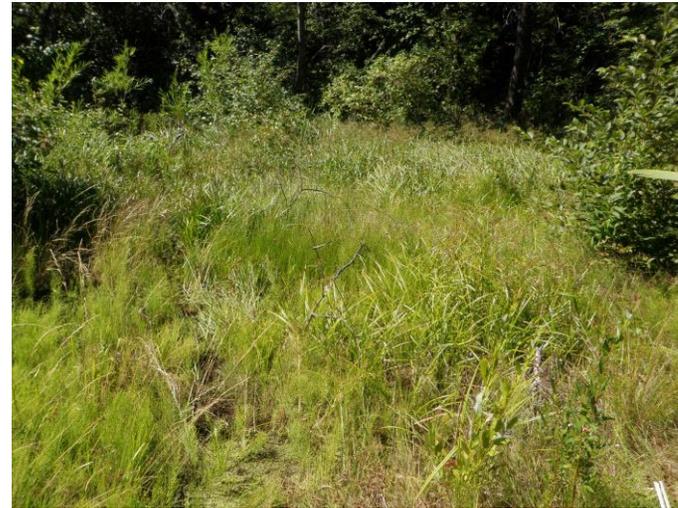
Cover in the wetland is 80% ($CI_{80\%} = 72-87\%$). Cover in the zone is made up of both emergent and woody species. The community has a diverse and thriving herb understory with a native woody overstory forming along the edges (Photo 1). The dominant species include swordleaf rush (*Juncus ensifolius*), small-fruited bulrush (*Scirpus microcarpus*), and gray alder (*Alnus incana*) (Photo 2).

Photo 1
Herb cover in the Wetland (July 2015)

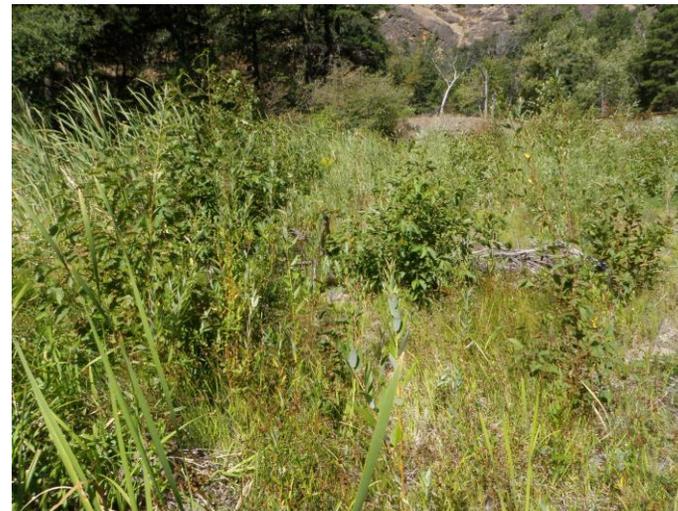
Photo 2
Vegetation Community in the Wetland (July 2015)

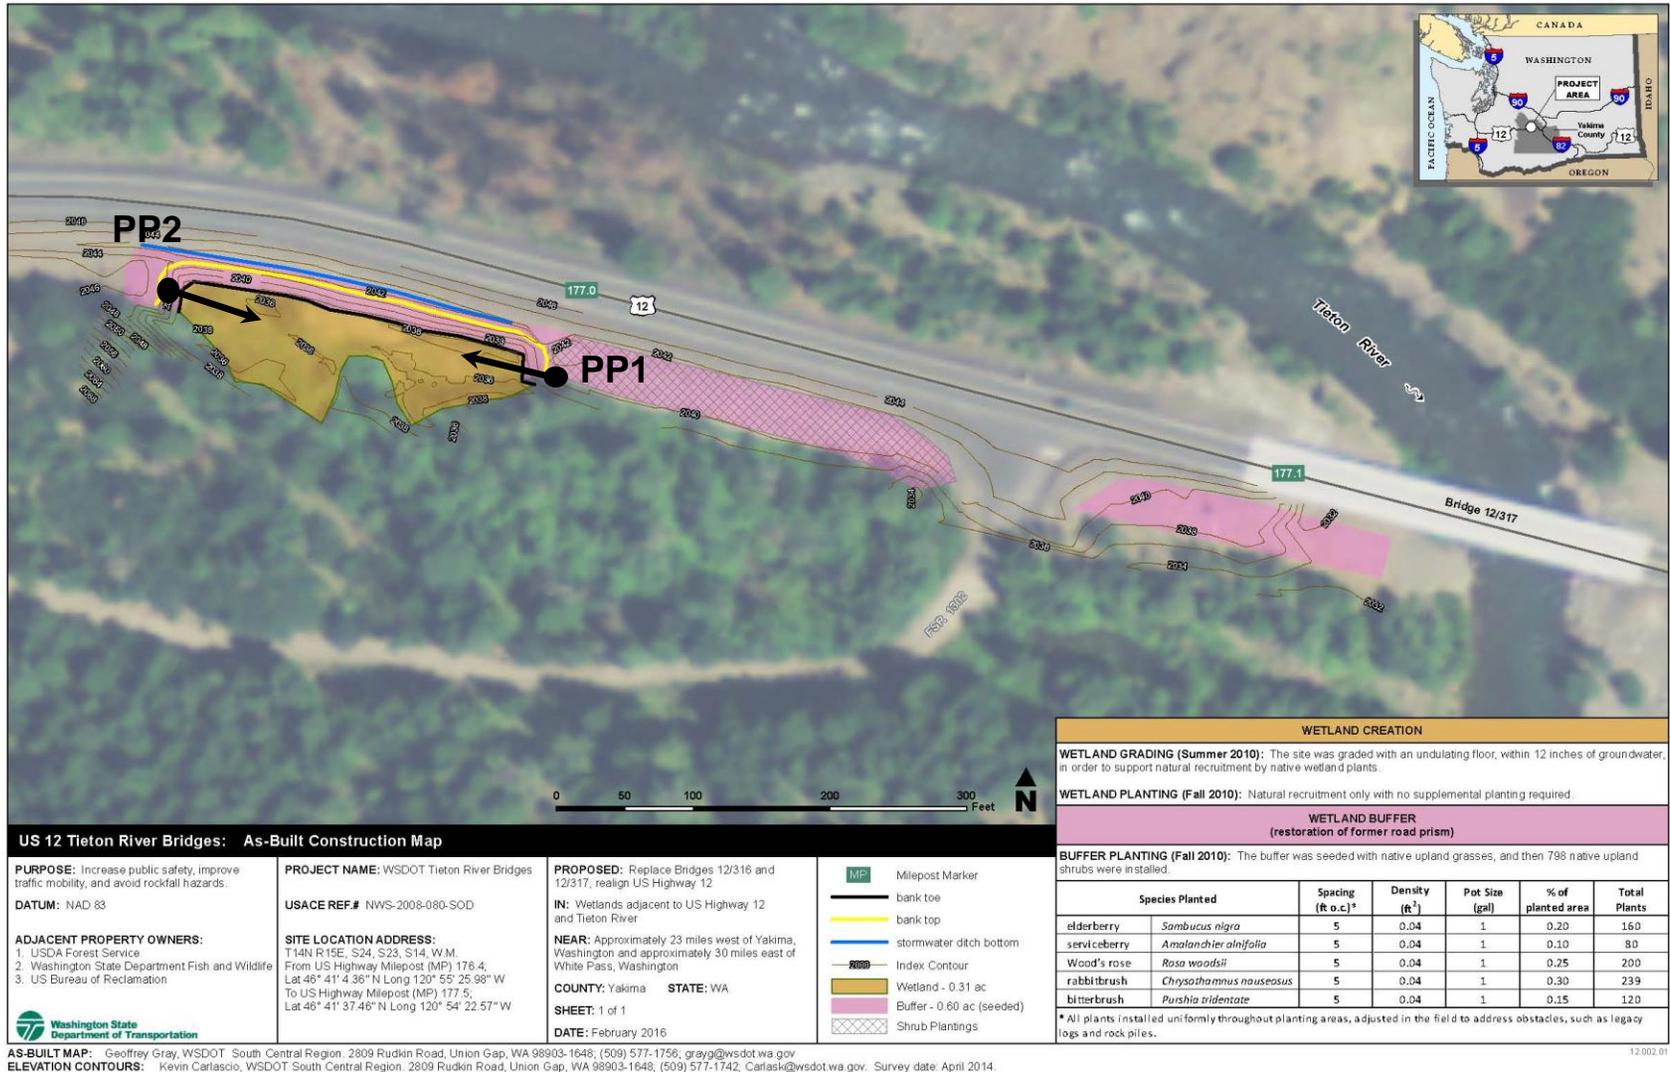
US 12 Tieton River Bridges: As-Built Construction Map

WETLAND CREATION						
WETLAND GRADING (Summer 2010): The site was graded with an undulating floor, within 12 inches of groundwater, in order to support natural recruitment by native wetland plants.						
WETLAND PLANTING (Fall 2010): Natural recruitment only with no supplemental planting required.						
WETLAND BUFFER (restoration of former road prism)						
BUFFER PLANTING (Fall 2010): The buffer was seeded with native upland grasses, and then 798 native upland shrubs were installed.						
Species Planted		Spacing (ft o.c.) ²	Density (ft. ²)	Pot Size (gal)	% of planted area	Total Plants
elderberry	<i>Sambucus nigra</i>	5	0.04	1	0.20	160
serviceberry	<i>Amelanchier alnifolia</i>	5	0.04	1	0.10	80
Wood's rose	<i>Rosa woodsii</i>	5	0.04	1	0.25	200
rabbitbrush	<i>Chrysothamnus nauseosus</i>	5	0.04	1	0.30	239
bitterbrush	<i>Purshia tridentate</i>	5	0.04	1	0.15	120

* All plants installed uniformly throughout planting areas, adjusted in the field to address obstacles, such as legacy logs and rock piles.

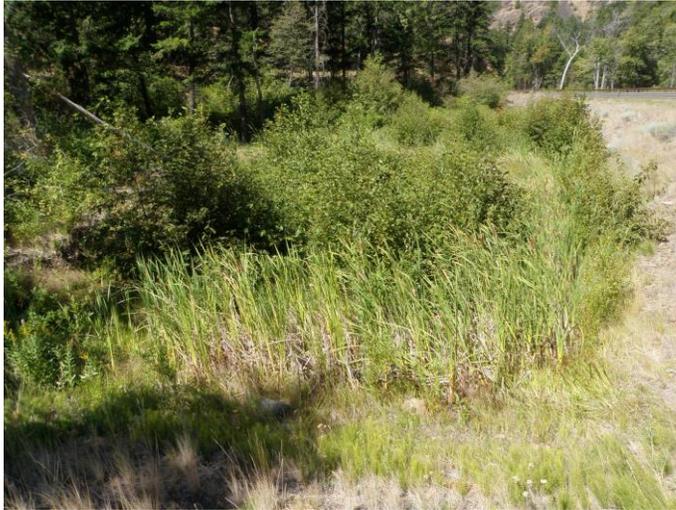
Photo Point 1

The photographs below were taken from permanent photo-points on July 28, 2015 and document current site development.

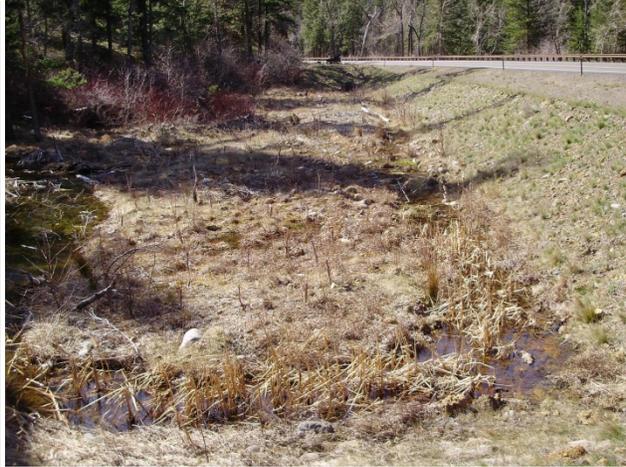
Figure 1. Vicinity Map

General Information for the Us 12 Tieton River Bridges mitigation site		
Location:	S14, T14N, R15E. Yakima County. (Vicinity map, Figure 1)

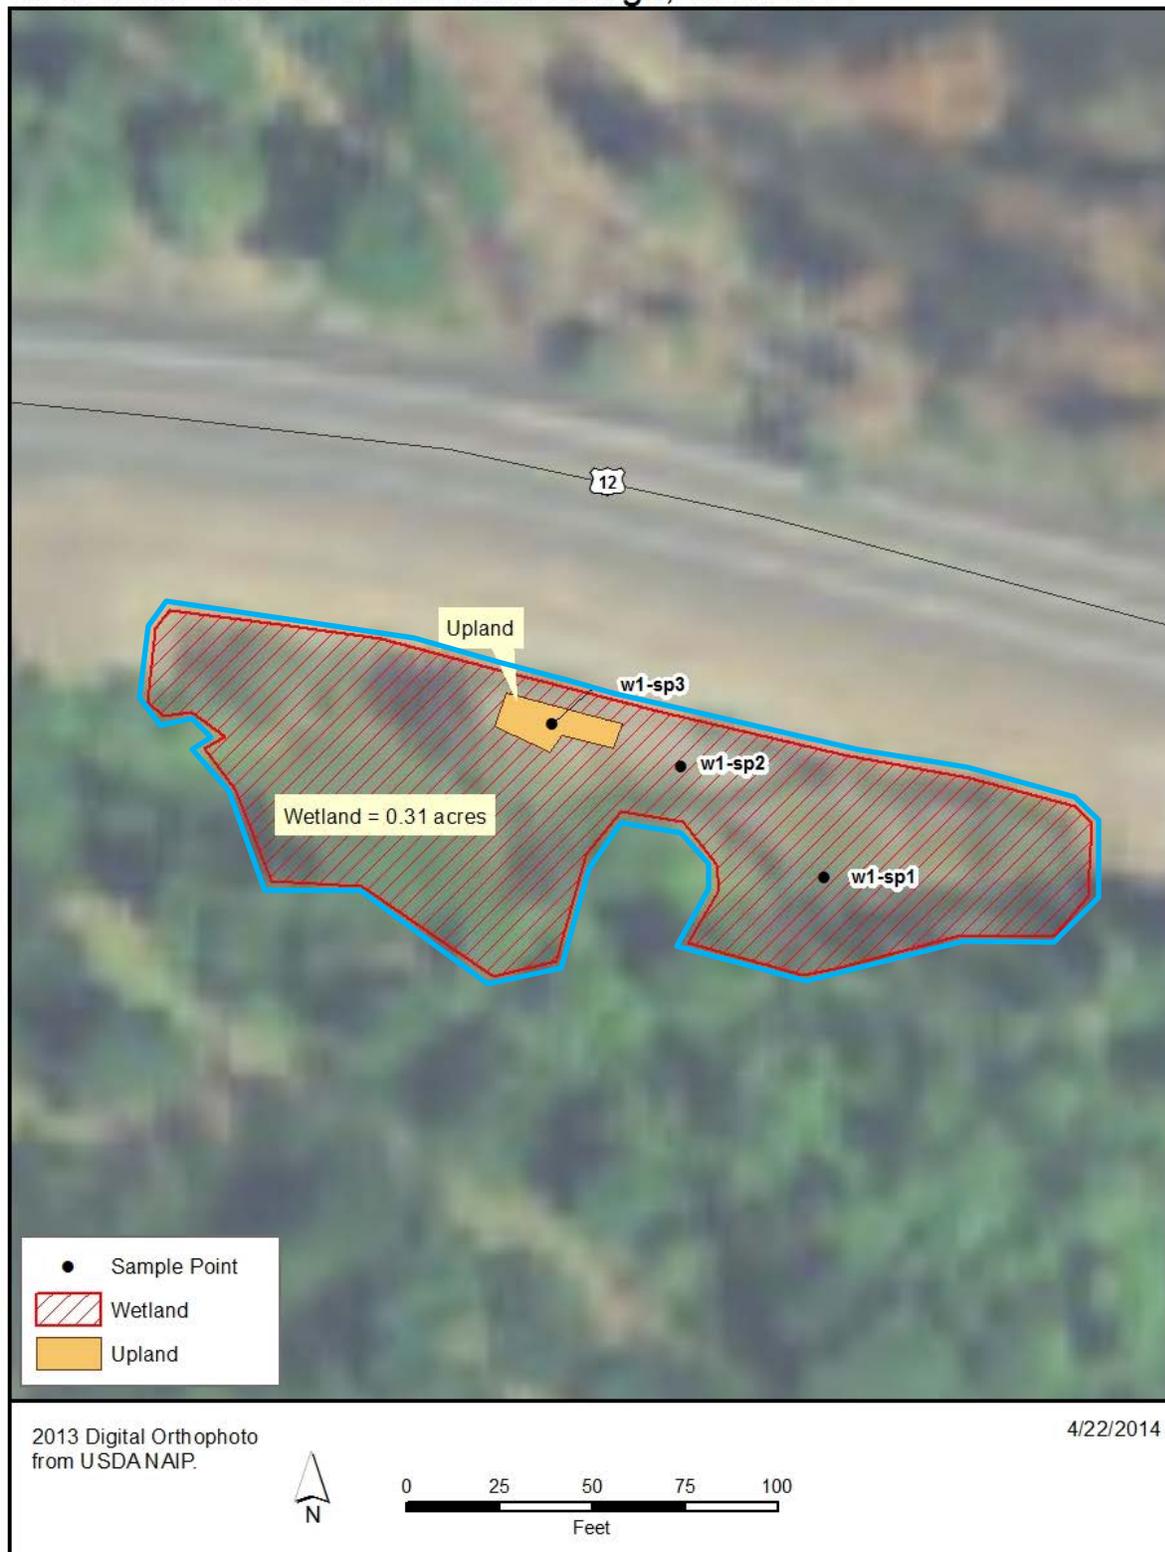
A Global Positioning System (GPS) Trimble GeoXT mapping grade unit was used to record the wetland boundaries and sampling point locations (Figure 2). Wetland boundary points were recorded at regular intervals and at any change in direction along the boundary.

Wetlands described in this report were assessed only within the wetland mitigation site boundary (Figure 2). Wetland preservation areas are present beyond the mitigation area to the south. These preservation areas were not included in this delineation.

The delineation determined 0.31 acre of wetland were present within the US 12 Tieton River Bridges mitigation site. The small upland area within the delineated wetland boundary (Figure 2) was not included in calculating the wetland area. Delineation data were collected at three sampling points and recorded on wetland determination data forms (Appendix A). Paired wetland and upland sample points were used to define the wetland edge. Additional wetland sample points characterize various wetland vegetation communities. Data recorded on wetland determination data forms characterize typical wetland and upland conditions observed on site. Vegetation, soils, and hydrology were examined in many additional sampling locations to determine the wetland boundary.

Figure 2. Study area in blue, wetland boundary in red, and sampling point locations in black.

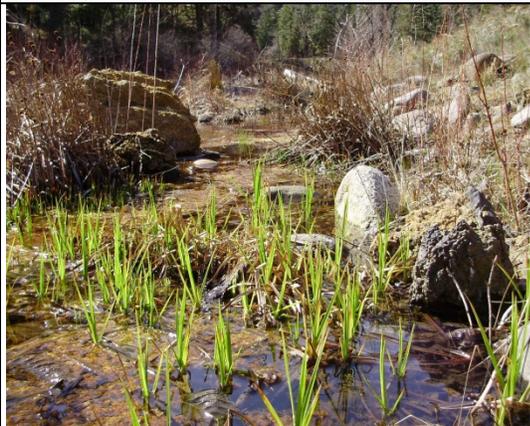
US 12 Tieton River Mitigation Site – Wetland Delineation Summary		
Total Delineated Wetland Area	0.31 acre

Wetland Determination Data Form(s)	Appendix A; Sampling Points W1-SP1 and W1-SP2
	Upland Determination Data Form(s)	Appendix A; Sampling Point W1-SP3
	Delineator(s)	Tatiana Dreisbach Sean Patrick
	Delineation Date	April 21, 2014
Vegetation	Trees – none Shrubs – sandbar willow (<i>Salix exigua</i>), willows (<i>Salix spp.</i>), black cottonwood (<i>Populus balsamifera</i>) Herbs – broadleaf cattail (<i>Typha latifolia</i>), swordleaf rush (<i>Juncus ensifolius</i>), Idaho fescue (<i>Festuca idahoensis</i>), field horsetail (<i>Equisetum arvense</i>), common yarrow (<i>Achillea millefolium</i>),	
Soils	Soils examined to a depth of 10 inches exhibited hydric characteristics. Cobbles were present below 10 inches. Matrix colors of 5Y 2.5/1 and 5Y 3/2 were observed. Redoximorphic concentrations and depletions were observed in the 5 to 10 inch layer. Indicator Redox Dark Surface (F6) met.

Hydrology	Water in the observation pits ranged from 1 inch below the soil surface to 8 inches below the surface. Surface water up to 6 inches deep was observed in some areas of the wetland with lower elevations. Groundwater appears to be the main source of hydrology. Precipitation and snow melt also contribute to the hydrologic regime of this wetland.	
Rationale for Delineation	Positive indicators of all three wetland criteria are present. Placement of boundary determined by presence/absence of hydric soils and hydrology indicators. Topographic break along the road prism to the north and along wetland preservation areas beyond the mitigation area to the south also helped inform placement of the wetland boundary.
