**I-5 SR 501 Ridgefield Interchange  
McCormick Creek Mitigation Site**

**USACE NWP (23) NWS-2008-1303**

**2014 MONITORING REPORT**

**Washington State  
Department of Transportation**

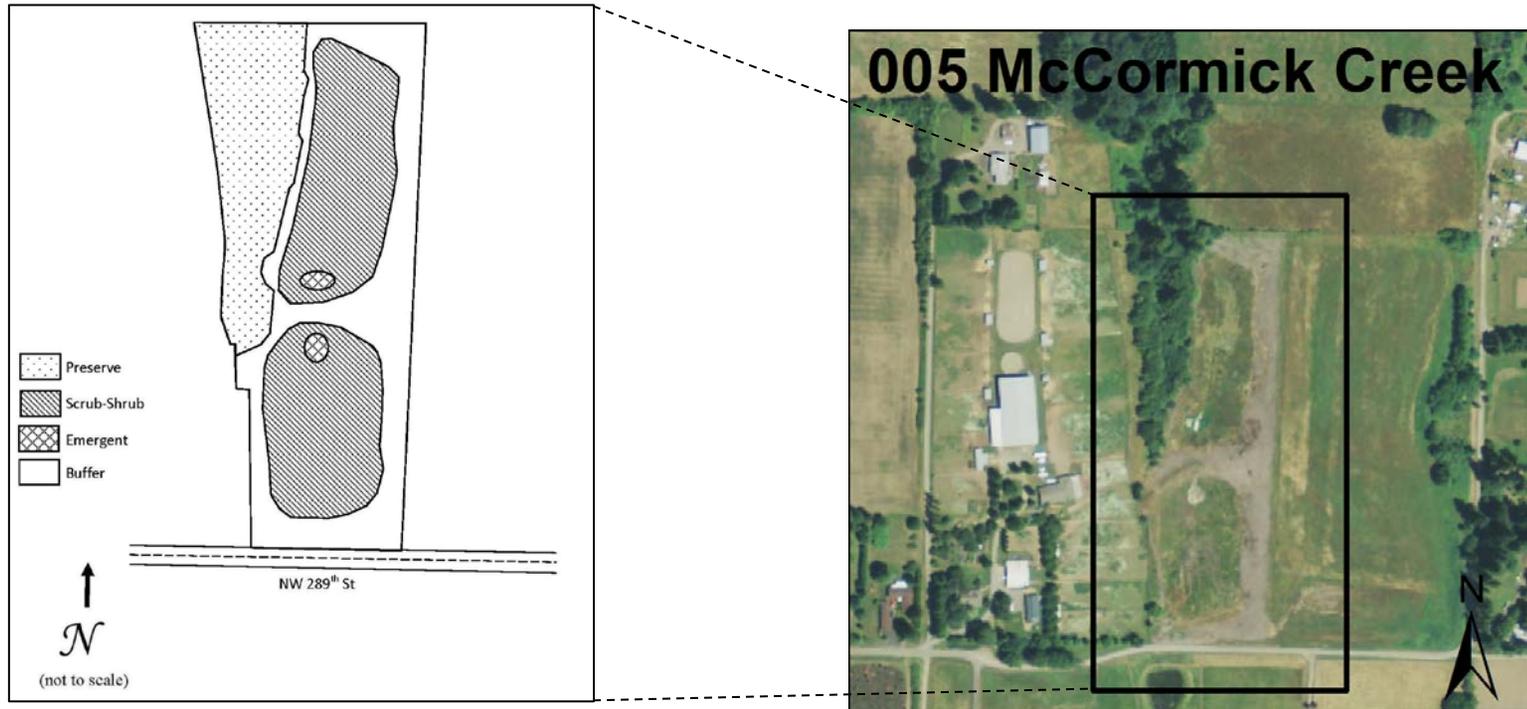
**Figure 1 Site Sketch**

This 7.8-acre mitigation site (Figure 1) comprises new wetlands, enhanced riparian areas, and forested preserve areas created adjacent to the headwaters of McCormick Creek. This site was created to compensate for the loss of 1.78 acres of wetlands due to road improvements to the I-5/SR 501 Interchange. The two seasonally ponded depressions and surrounding scrub-shrub and forested preserve areas are designed to provide mitigation for lost wetland functions including water quality, hydrologic, and habitat functions.

The I-5 McCormick Mitigation Site contains two depressions surrounded by scrub-shrub wetlands, upland buffers and forested preservation areas. Appendix 2 includes site directions.

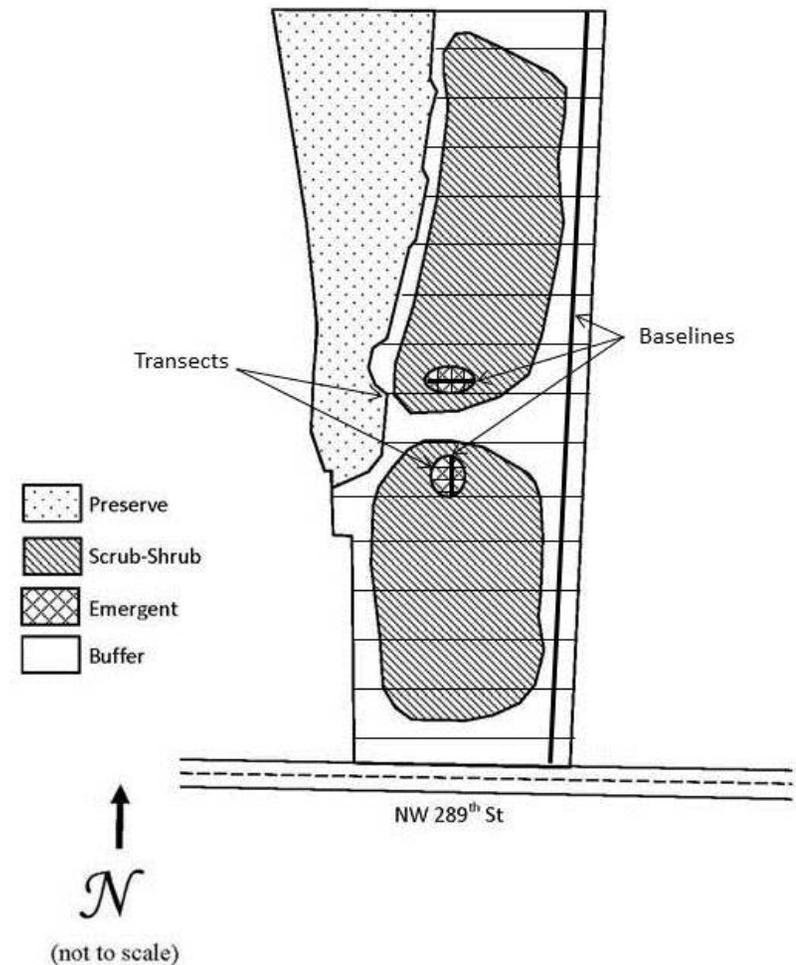
**Figure 2 Site Sampling Design (2014)**

To evaluate standards for vegetative cover, a baseline was established along the eastern site boundary (Figure 2). Twelve sampling transects were randomly placed perpendicular to the baseline. The unequal-area belt transect method was used to estimate the survival of native woody species in the buffer and scrub-shrub wetland (Performance Standard 2). The point intercept method was used to estimate herbaceous cover because accurately estimating the survival of planted herbaceous vegetation is not a meaningful measurement due to the difficulty of this measurement. Two separate baselines were established through the center of both emergent depressions. Seven ten-meter sample units (twenty points per sample unit) were used to sample this zone. The cover of non-native blackberries and Class A noxious weeds (Performance Standard 3), reed canarygrass (Performance Standard 5), and Japanese knotweed (*Reynoutria japonica*) (Performance Standard 4) were estimated qualitatively.

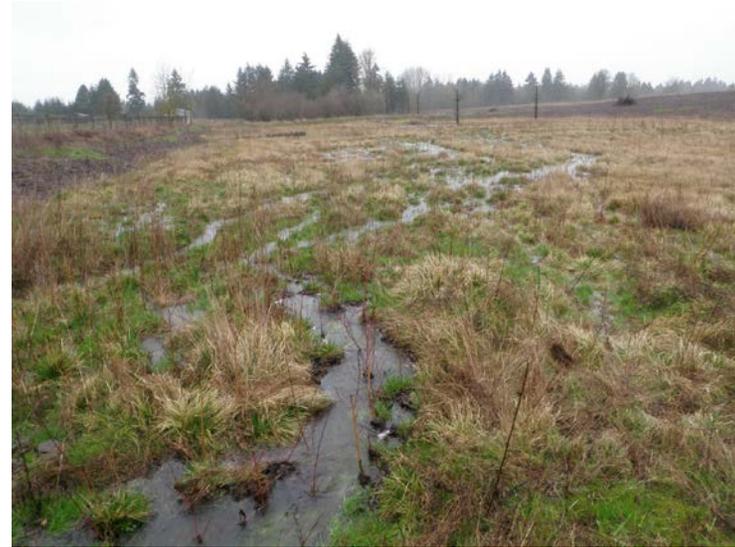
Wetland hydrology was not observed in all intended areas on each visit (Photo 1). Well 1 is installed in an area with very clay rich soils and water was not observed in that well on the second or third visit (wells were installed on the second visit). Well 3 did not meet hydrology criteria on the second visit (Appendix 3, Table 1).

**Photo 1**  
**Shallow inundation in scrub-shrub wetland (March 2014)**

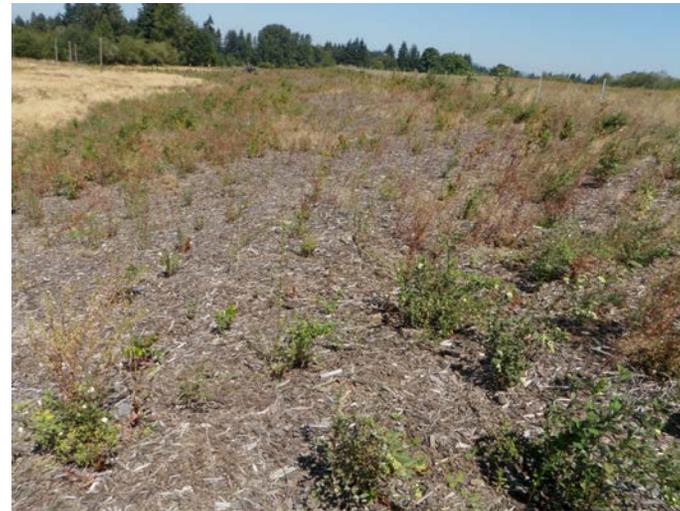
Survival was evaluated in the scrub-shrub wetland and upland buffer. Since it is extremely difficult to determine the survival of planted/seeded herbaceous vegetation, cover was evaluated in the emergent zones. The survival of planted woody vegetation in the scrub-shrub wetland is 87% ( $CI_{80\%} = 81-94\%$ ). The survival of planted woody vegetation in the upland buffer is 87% ( $CI_{80\%} = 83-91\%$ ) (Photo 2). These survival estimates are slightly below the performance standard target. The cover of native emergent vegetation in the emergent wetland is 95% ( $CI_{80\%} = 91-99\%$ ) (Photo 3).

**Photo 2**  
**Woody cover in upland buffer (August 2014)**

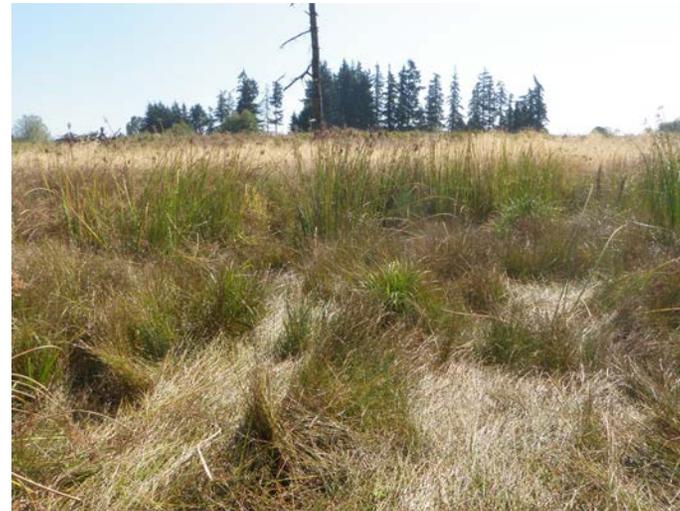
**Photo 3**  
**Herbaceous vegetation in emergent zone (August 2014)**
