SR 500 St Johns Blvd Interchange (Lower Burnt Bridge) Mitigation Site

USACE NWS-2009-1104

2014 MONITORING REPORT

Issued August 2015

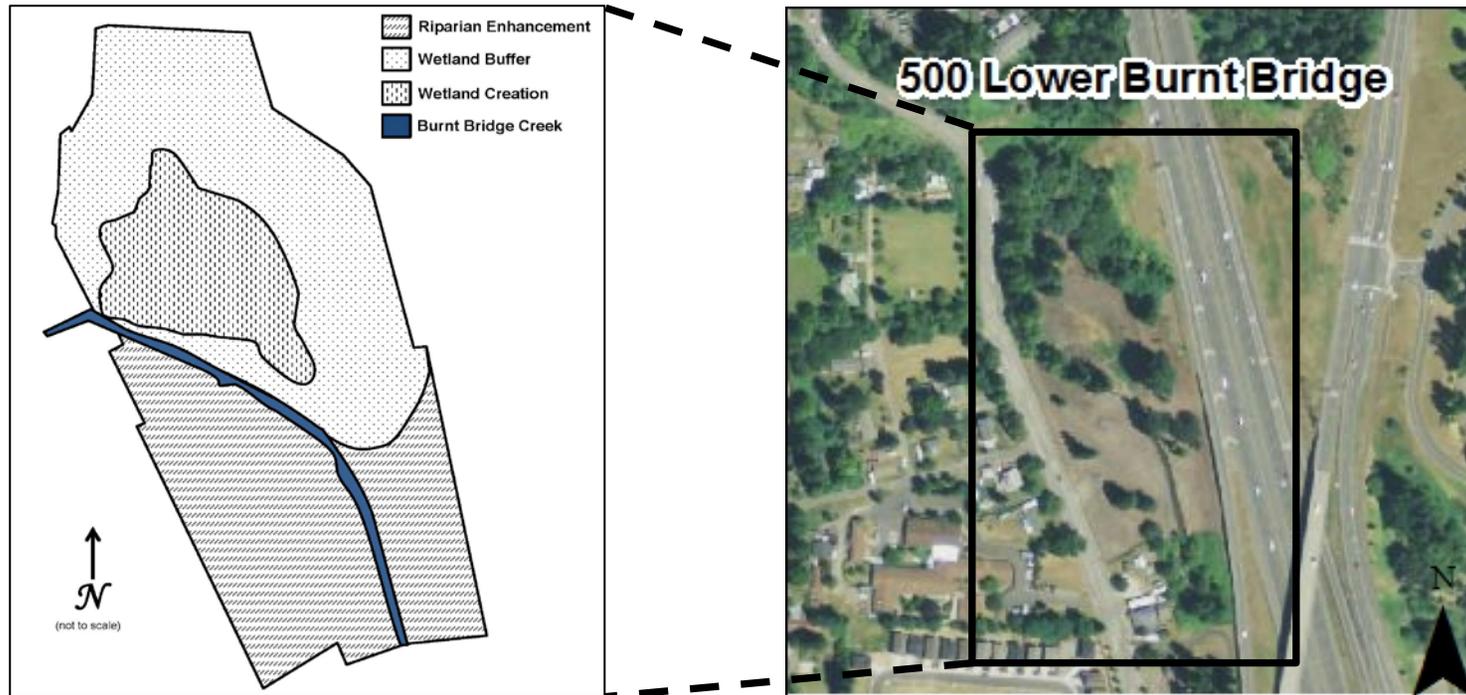
Figure 1 Site Sketch

The SR 500 Lower Burnt Bridge Mitigation Site contains one created low area adjacent to Burnt Bridge Creek upstream of its confluence with Clear Creek. Riparian and wetland buffer areas flank the channel of Burnt Bridge Creek. Appendix 2 includes site directions.

This 9.8-acre mitigation site (Figure 1) is a partly new and partly enhanced wetland created adjacent to Burnt Bridge Creek at the confluence with Cold Creek. This site was created to compensate for the loss of 0.24 acre of wetlands, 1.56 acres of wetland buffer, and 4.3 acres of riparian buffer due to road improvements along SR 500. The 0.86 acres of created wetland, and surrounding 2.27 acres of enhanced wetland buffer and 6.67 acres of riparian buffer enhancement are designed to provide mitigation for lost wetland functions including hydrologic, water quality, and wildlife habitat.

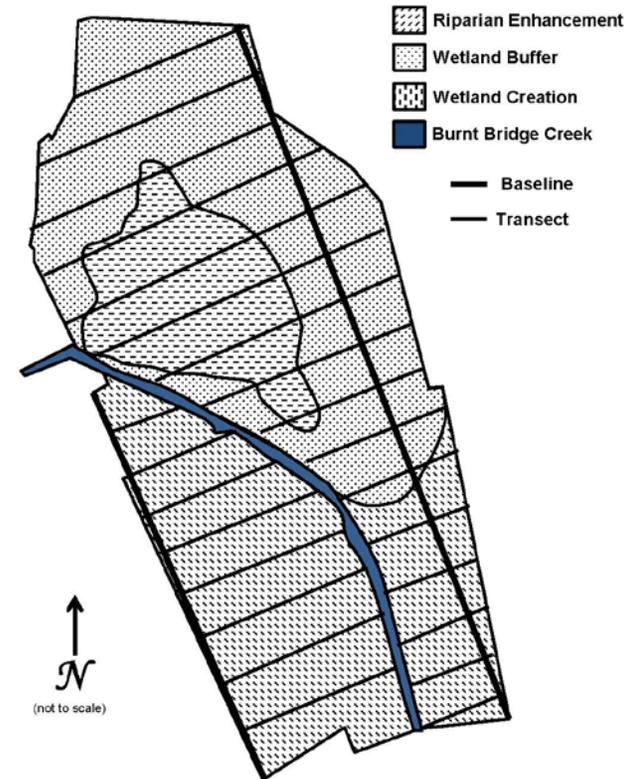
Figure 2 Site Sampling Design (2014)

To evaluate the standard for vegetative survival, a 405-meter segmented baseline was established on the east and west sides of the site and sampled to the creek in the middle (Figure 2). Twenty-five sampling transects were placed perpendicular to the baseline using a systematic random sampling method. The unequal-area belt transect method was used to estimate percent survival of planted vegetation (Performance Standard 2). Twenty-five one-meter-wide belt transect sample units were positioned along the sampling transects. The cover of invasive species on-site was visually estimated (Performance Standards 3-5).

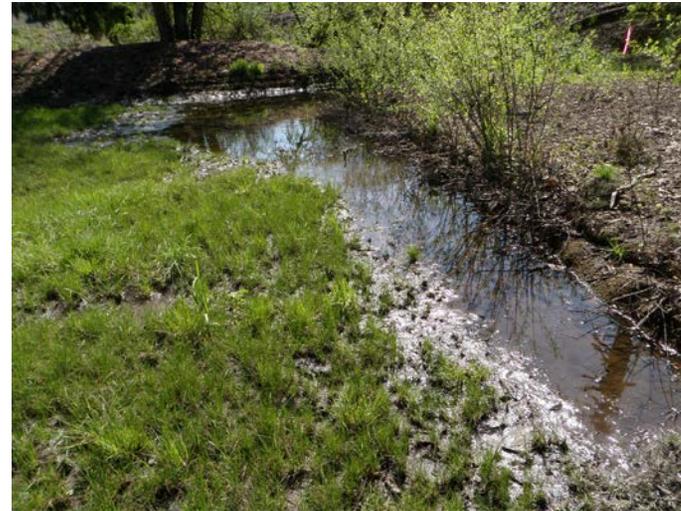
In 2014, soils were saturated to the surface for two consecutive hydrology monitoring visits in the spring. (Appendix 3, Table 1) (Photo 1). At the third visit, soils were saturated in the emergent zone, but not the scrub shrub zone. Hydrology will continue to be monitored and the site will be delineated in year five.

Photo 1
Inundation in the newly created wetland (April 2014)

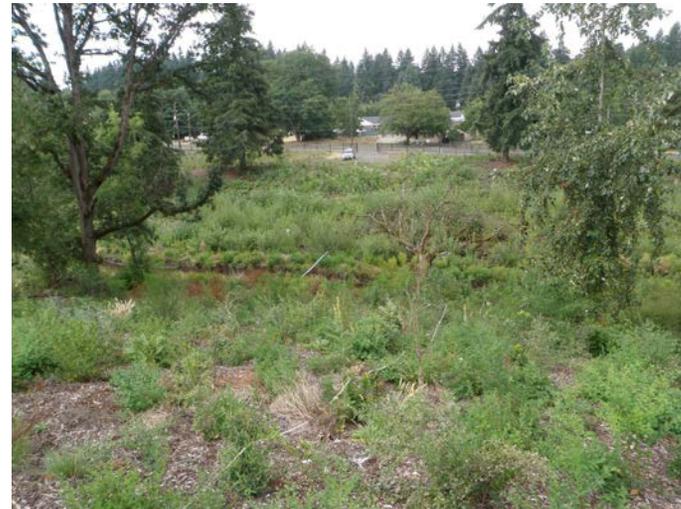
The estimated survival of plants in the scrub-shrub, wetland buffer, and riparian zones combined is 95 percent ($CI_{80\%} = 93-96\%$) (Photo 2). This estimate exceeds the performance standard target.

Photo 2
Survival of planted vegetation in riparian buffer (August 2014)

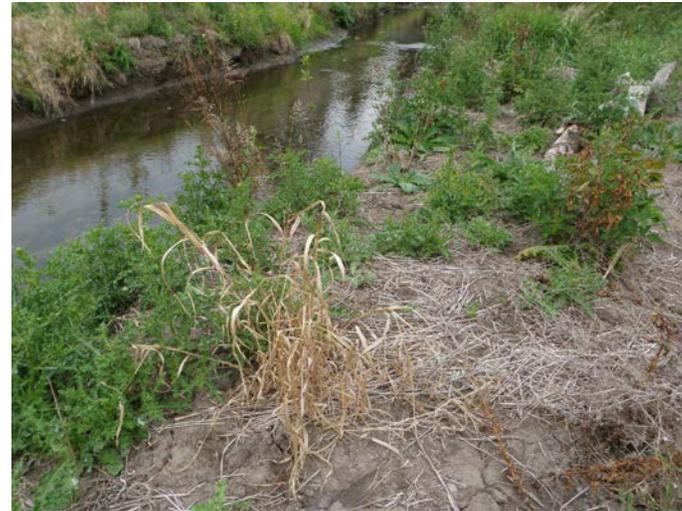
Cover of blackberries and class B noxious weeds is visually estimated at five percent. This value is below the performance standard threshold. Class B species present include scotch broom (*Cytisus scoparius*), poison hemlock (*Conium maculatum*), tansy ragwort (*Jacobaea vulgaris*), and annual bugloss (*Anchusa arvensis*) (Photo 3).

Photo 3
Annual bugloss on creek bank (August 2014)

The region has plans replant and to continue weed control as needed.
