RE: Springbrook Creek Wetland and Habitat Mitigation Bank Unit D
Formal Year-7 Report
USACE 200600100

The Washington State Department of Transportation completed monitoring at Unit D of the Springbrook Creek Wetland and Habitat Mitigation Bank on June 15 and August 5, 2015 to address Year-7 vegetation performance standards. Monitoring activities included vegetation observations and photo documentation. This Year-7 report is being issued to document monitoring results for compliance with the terms and conditions of the Final Mitigation Bank Instrument.

General Site Information	
USACE IP Number	200600100
Mitigation Location	Southwest Renton, King County.
LLID Number	1222395474429
Monitoring Period	2009-2018
Year of Monitoring	7 of 10

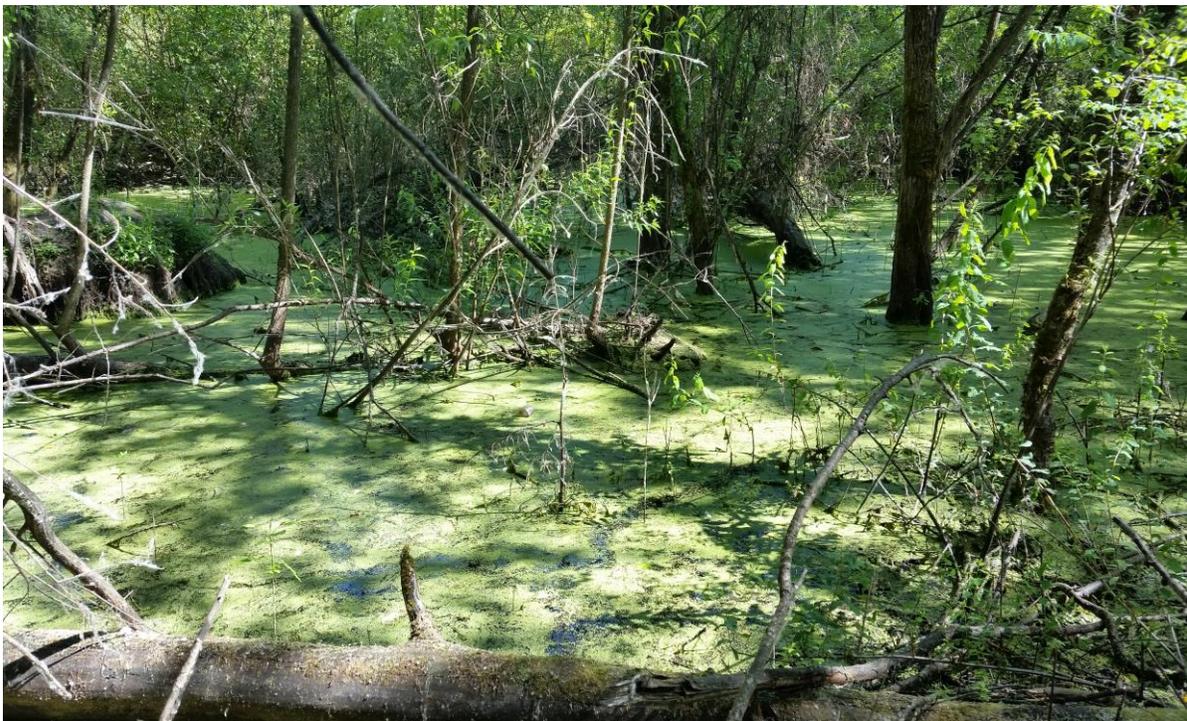
Photo 1 – Inundation in Unit D on June 15, 2015.

Inundation was observed in the northern portion of Unit D on June 15, 2015. (Photo 1)

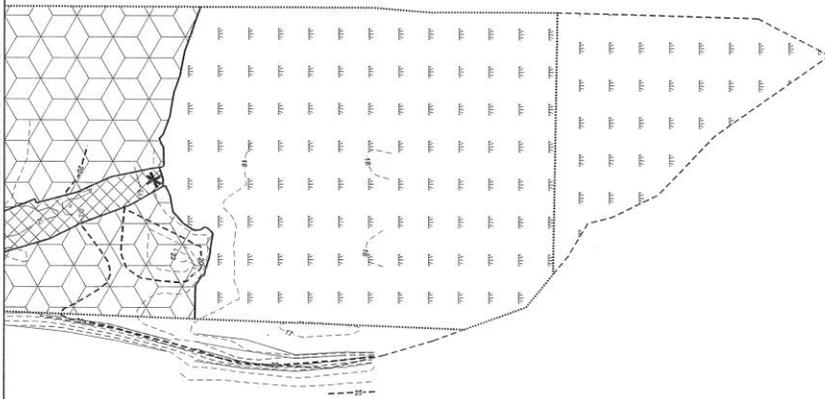
1-408
**SPRINGBROOK CREEK WETLAND AND
 HABITAT MITIGATION BANK**
 WETLAND MITIGATION PLANTING AS-BUILT

WETLAND TREE/SHRUB #2:	QUANTITY	SYMBOL	DESCRIPTION
REDOSIER DOGWOOD	0.09 ACRES	(Grid pattern)	THIS SHEET
SITKA WILLOW	36 C.Y. OF	(Diagonal lines)	THIS SHEET
PACIFIC WILLOW	1.15 ACRES	(Dotted pattern)	THIS SHEET
RED BUD WILLOW		(Cross-hatch)	THIS SHEET
WESTERN RED CEDAR		(Vertical lines)	THIS SHEET

WETLAND FOREST UNDER-PLANTING:	QUANTITY	SYMBOL	DESCRIPTION
SITKA SPRUCE	1.15 ACRES	(Dotted pattern)	THIS SHEET
WESTERN HEMLOCK		(Vertical lines)	THIS SHEET
WESTERN RED CEDAR		(Vertical lines)	THIS SHEET
