Klineline Bridge Scour Monitoring

Presented By: **Carolyn Heniges, P.E., P.L.S.**
Clark County Public Works
Vancouver, WA

Douglas L. Sarkkinen, P.E., S.E.
Kramer Gehlen and Associates, Inc.
Vancouver, WA

2007 Western Bridge Engineers' Seminar – Boise, Idaho

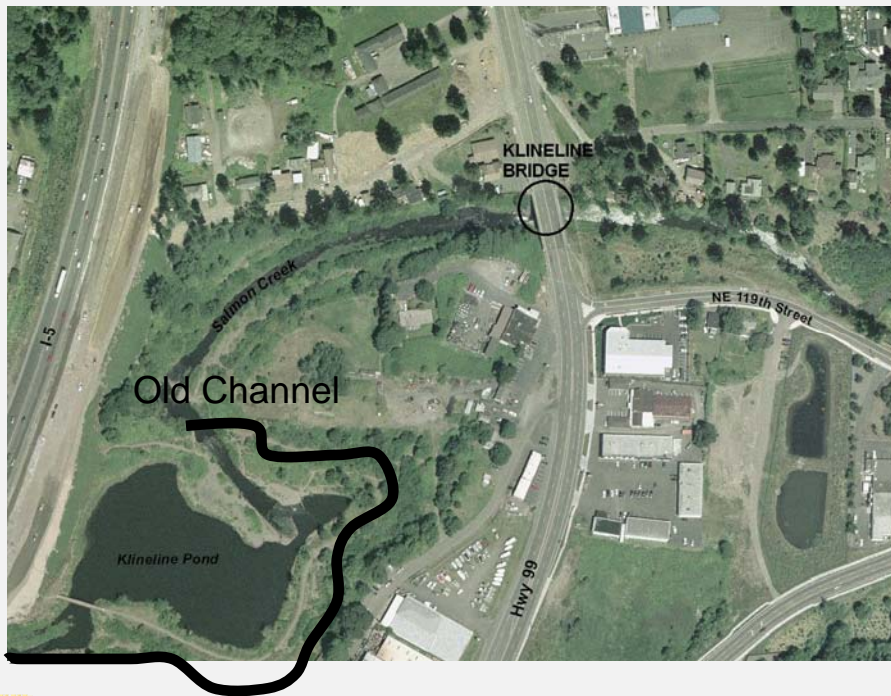
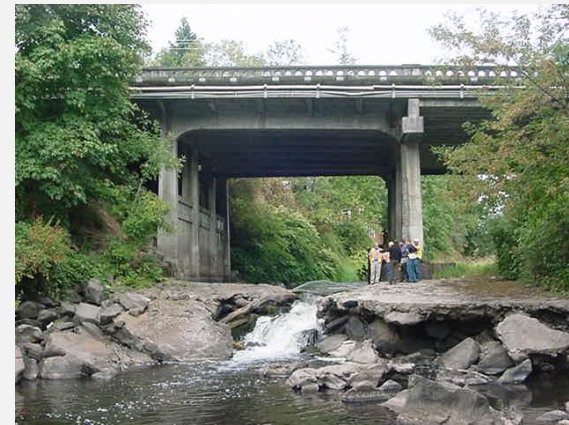
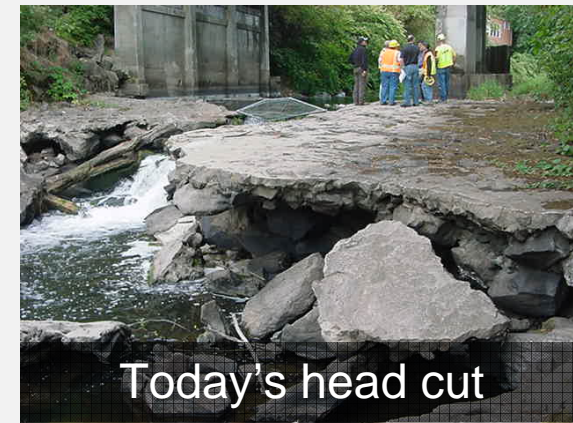
Pond dike breached
– head cut travels toward bridge site

Today's head cut

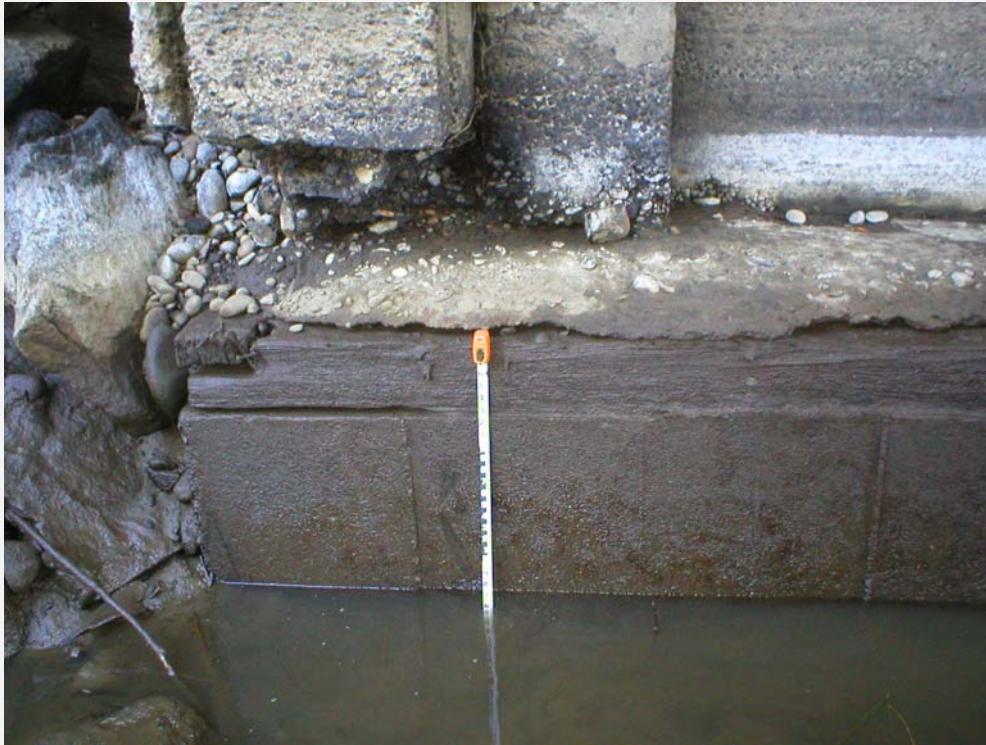
Significantly more scour damage noted during
the 2006 low flow inspection

5 ft deep spread
footing
with 4 ft exposed
and ½:1 slope
behind

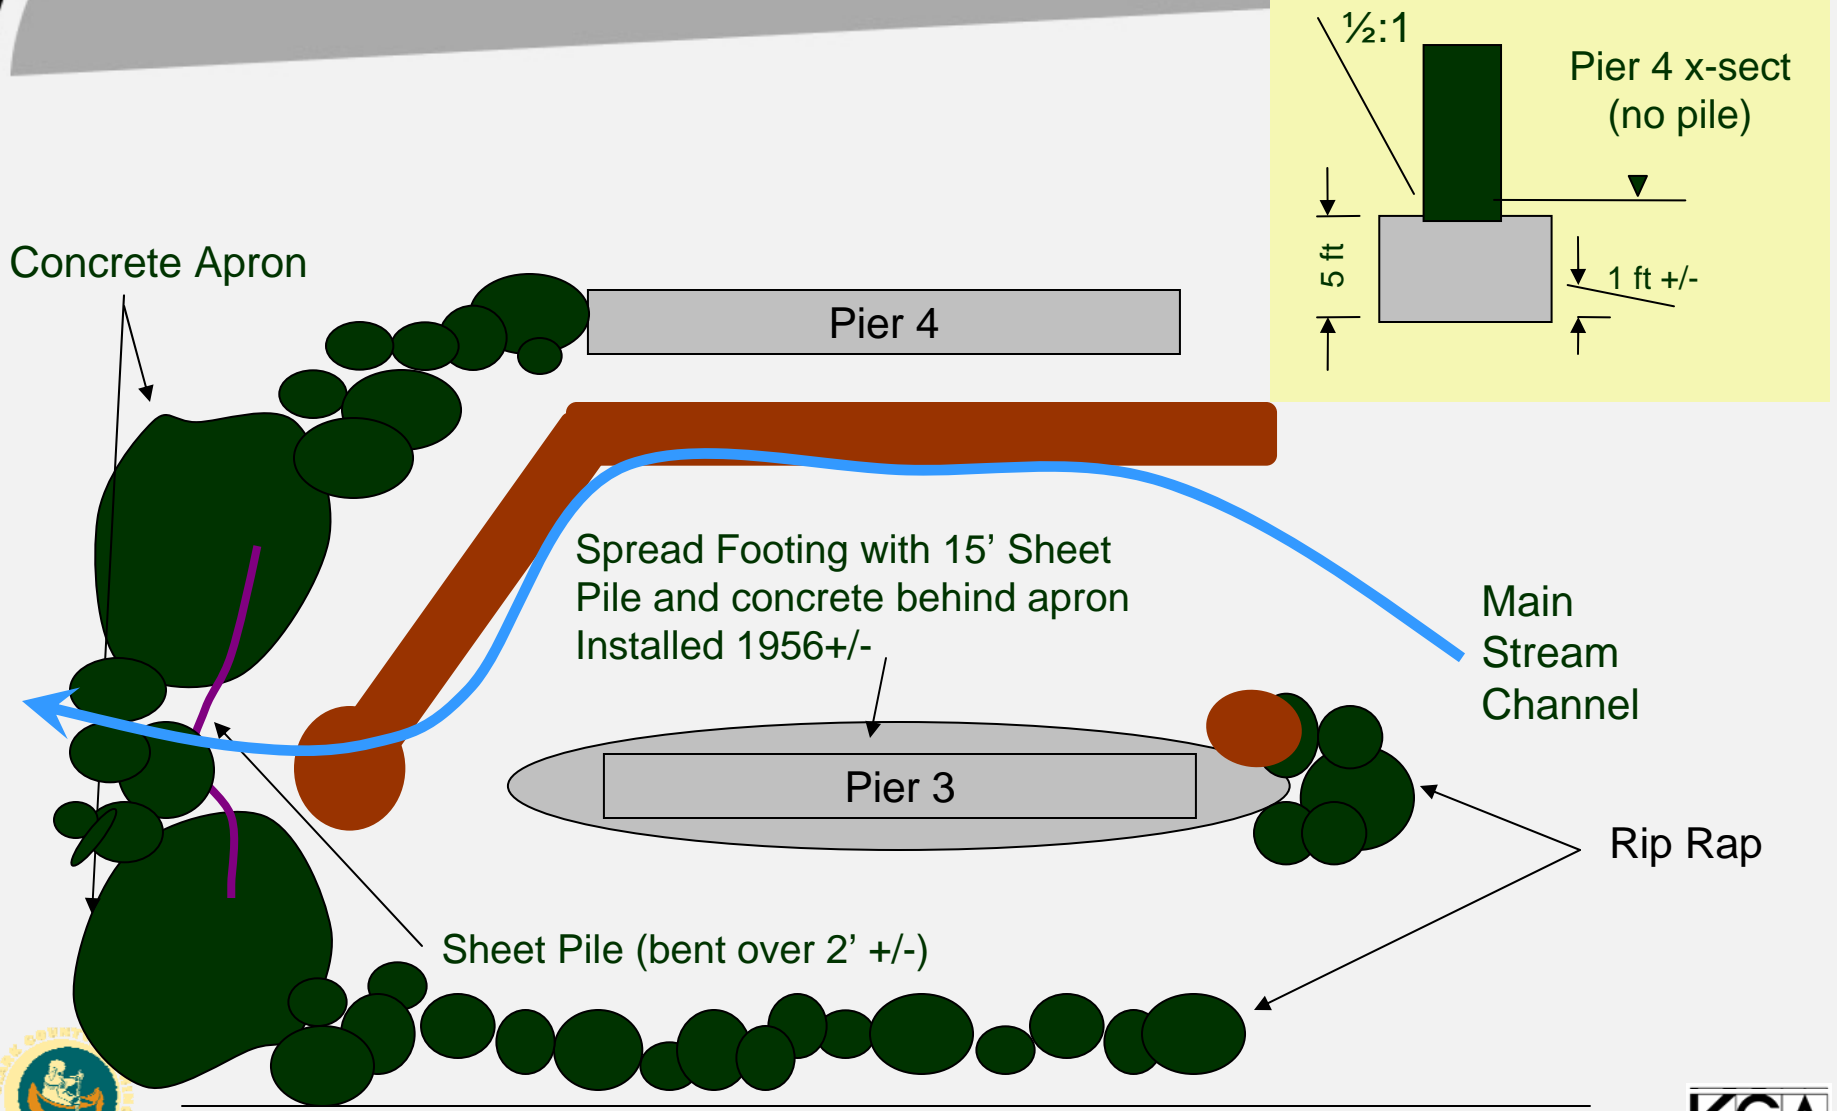
■: Scour Holes: approx. 4' in depth

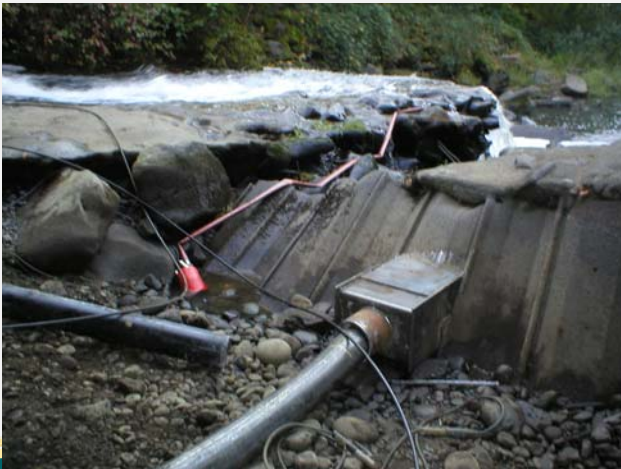
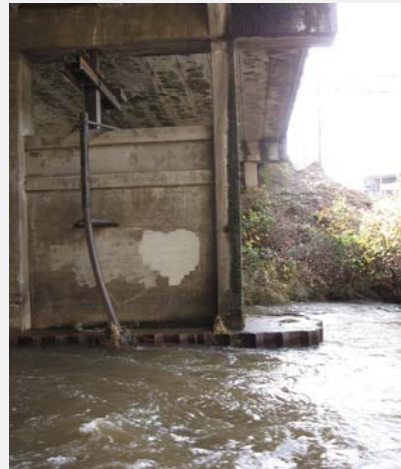
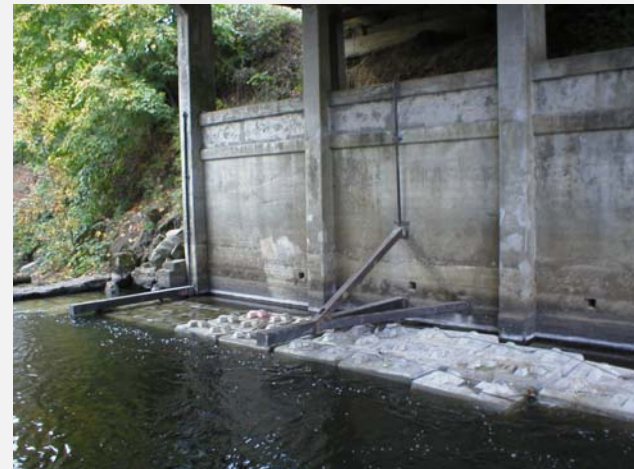
1. Flow gage with background data regarding shear stresses and material displacement forces
2. Sonar for river bed movement
3. Tilt meter for pier and downstream sheet pile

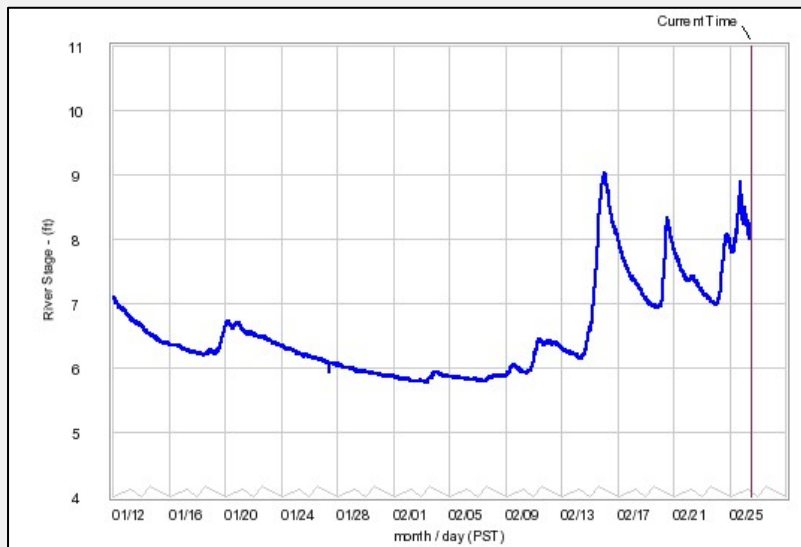
Sutron Data Logger
NOAA River Data
Website

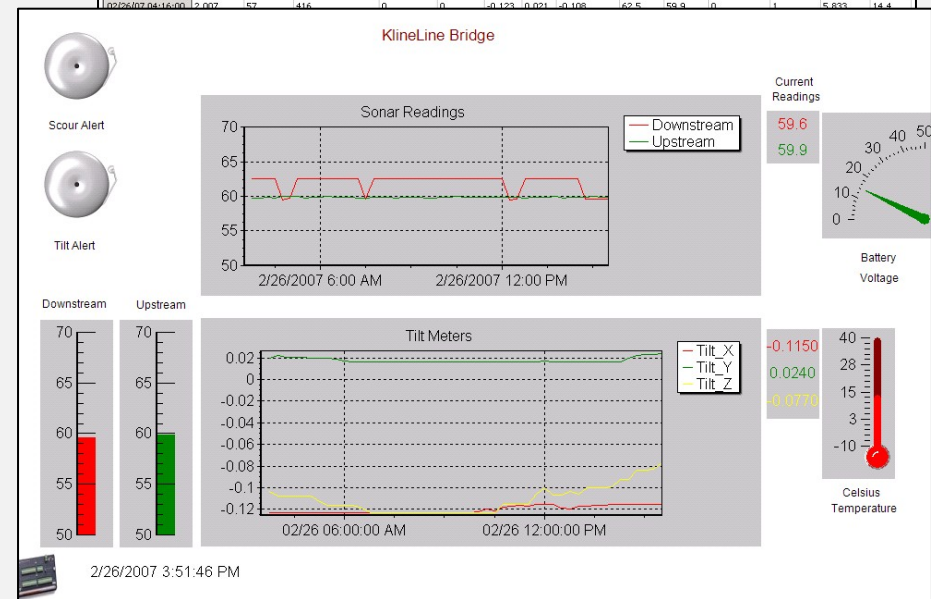
Campbell Data Logger

Timestamp	Year_RTM	Day_RTM	Hour_Minute_RTM	Scour_Alert	Tilt_Alert	Tilt_X	Tilt_Y	Tilt_Z	Sonar_1	Sonar_2	Downstream	UpStream	Temp	Battery
02/26/07 02:01:00	2,007	57	201	0	0	-0.123	0.024	-0.09199999	62.5	62.5	0	0	5.851	14.4
02/26/07 02:16:00	2,007	57	216	0	0	-0.123	0.024	-0.09199999	62.5	59.9	0	1	5.938	14.4
02/26/07 02:31:00	2,007	57	231	0	0	-0.123	0.022	-0.097	62.5	59.9	0	1	5.978	14.4
02/26/07 02:46:00	2,007	57	246	0	0	-0.123	0.024	-0.1	62.5	59.8	0	1	5.999	14.4
02/26/07 03:01:00	2,007	57	301	0	0	-0.123	0.023	-0.1	62.5	59.9	0	1	5.999	14.4
02/26/07 03:16:00	2,007	57	316	0	0	-0.123	0.023	-0.1	62.5	59.9	0	1	5.978	14.4
02/26/07 03:31:00	2,007	57	331	0	0	-0.123	0.022	-0.1	62.5	59.9	0	1	5.935	14.4
02/26/07 03:46:00	2,007	57	346	0	0	-0.123	0.02	-0.103	62.5	59.8	0	1	5.893	14.4
02/26/07 04:01:00	2,007	57	401	0	0	-0.123	0.022	-0.108	62.5	59.8	0	1	5.853	14.4
02/26/07 04:16:00	2,007	57	416	0	0	-0.123	0.021	-0.108	62.5	59.8	0	1	5.833	14.4

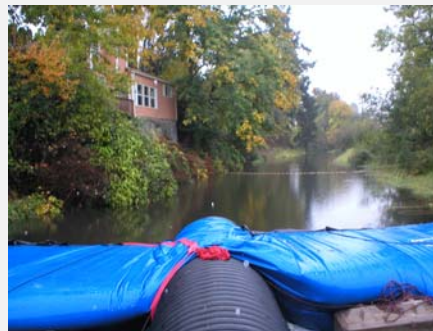
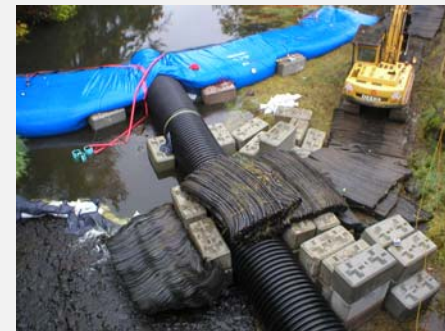
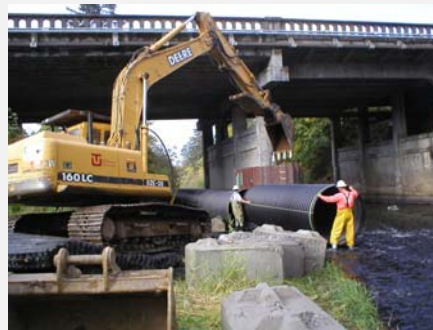
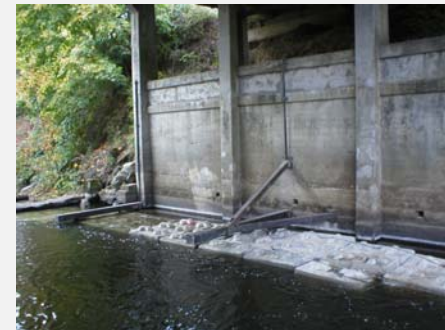
The Repair

Stream Diversion

Track Hoe Access

Block Placement

Tying the Blocks
Together

Install Monitoring
Devices

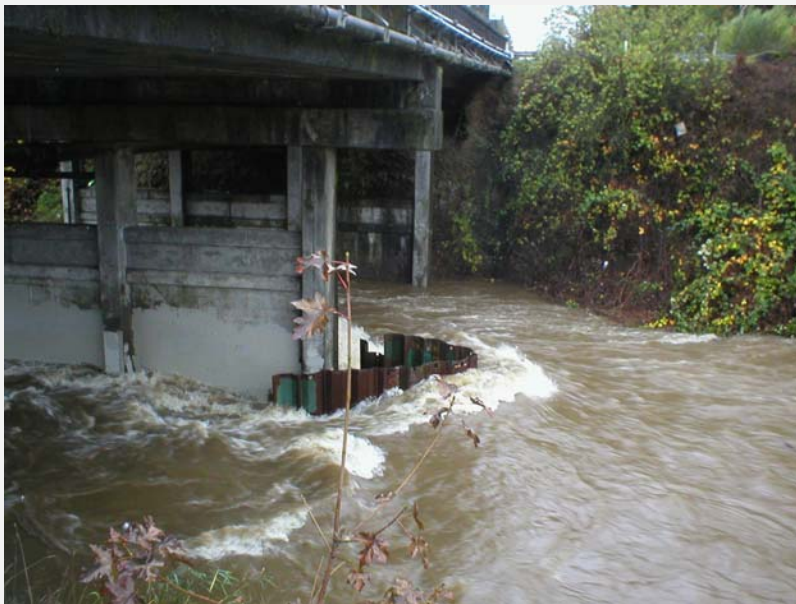
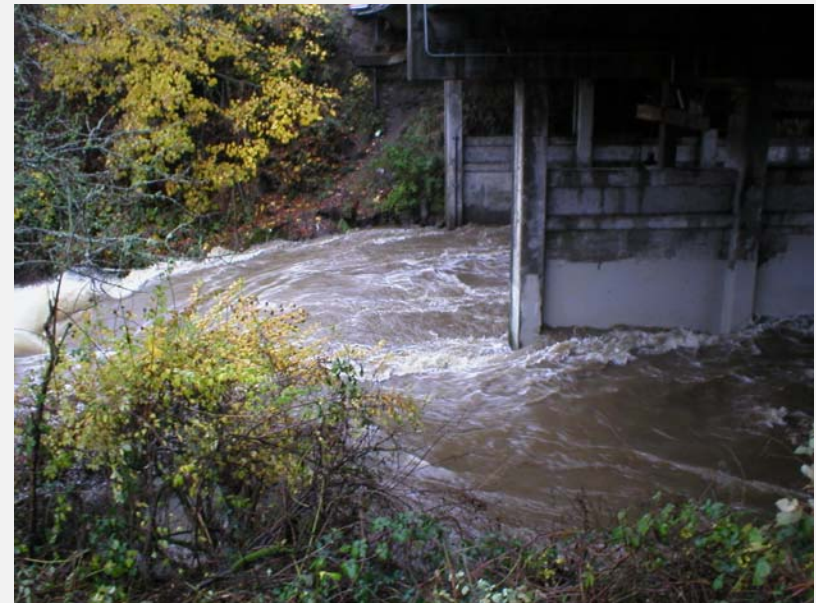
On Nov 7th, 2007

Approximately – 3700 cfs (87 yr storm)

Closure criteria – 1000 cfs

Bridge closed for 8 days

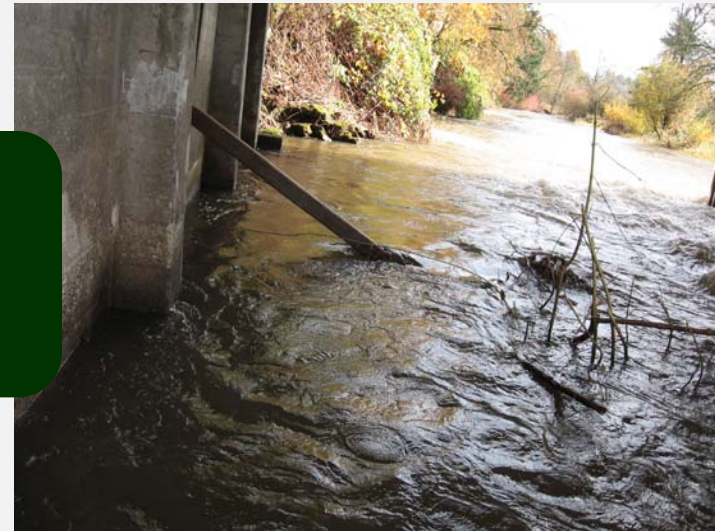
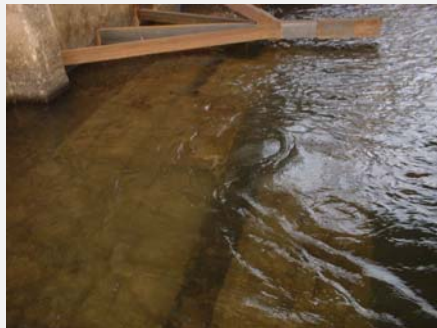
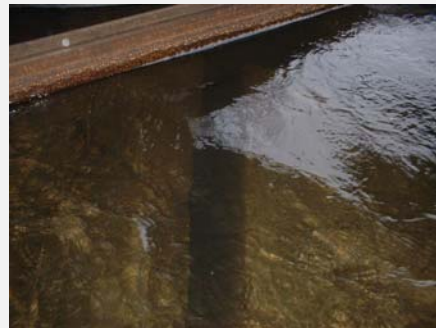
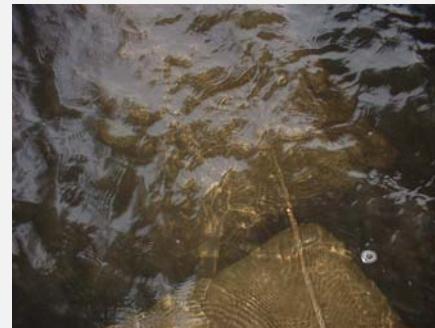
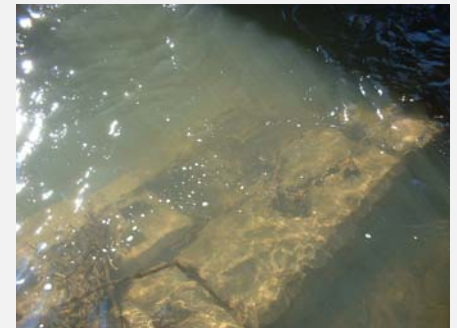
Block rotation from
Continued scour and
debris build-up
