# **Ancillary Structure Inspection Procedures and Findings**

**Michael Garlich, S.E., P.E.  
Collins Engineers, Inc.**

**Western Bridge Engineers' Seminar 2007**

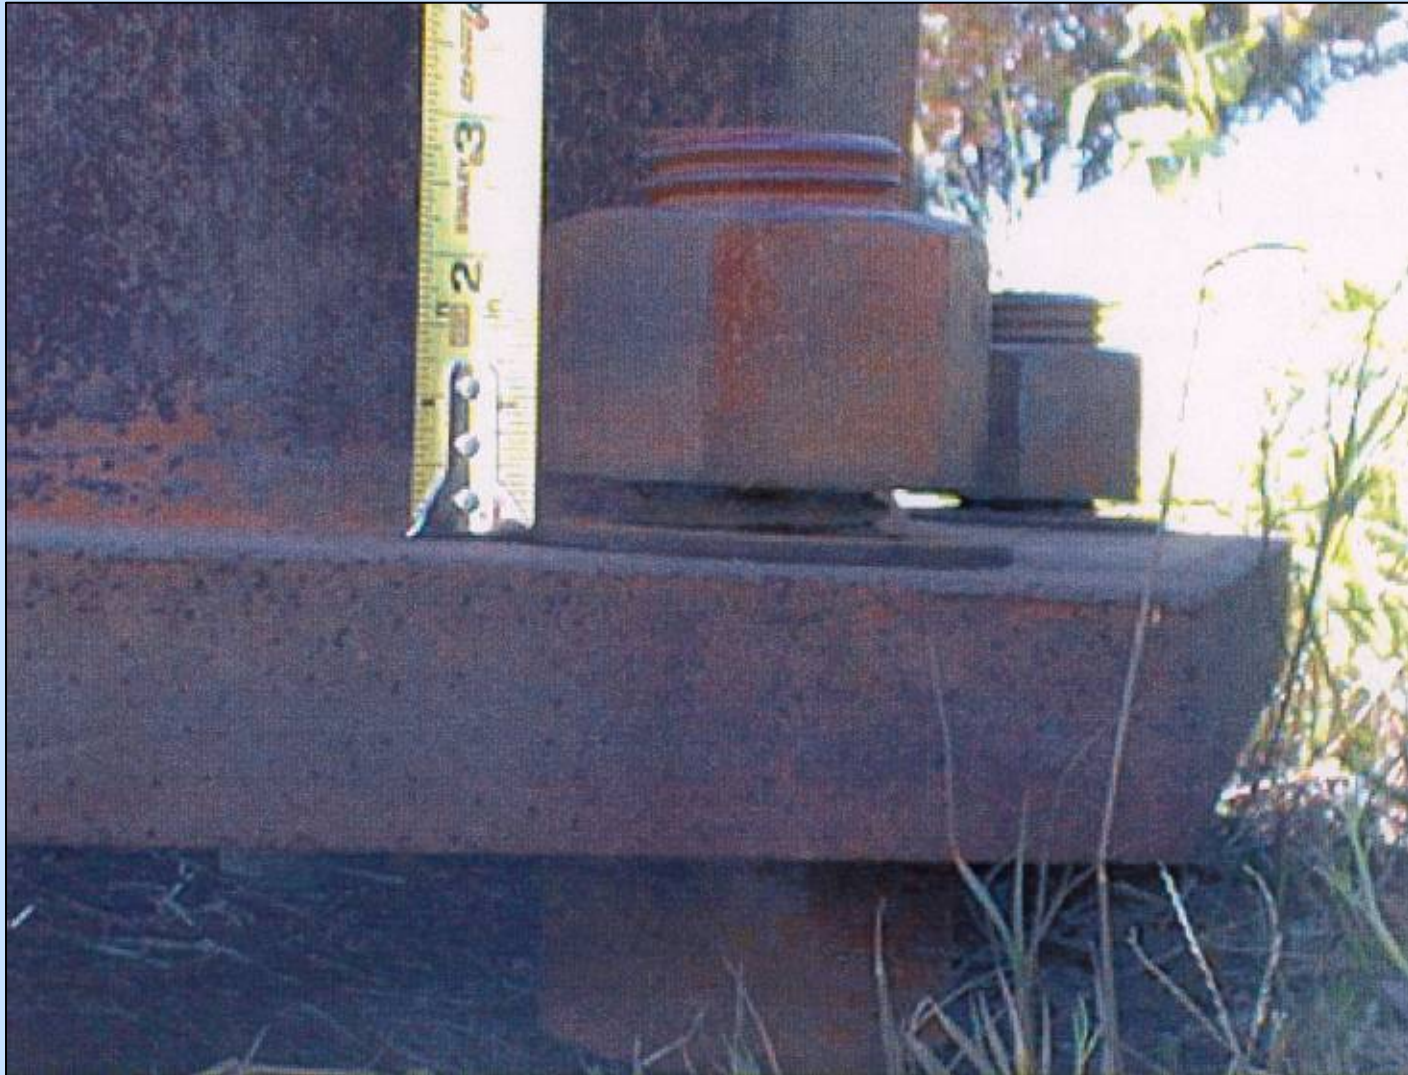
# Anchor Rods Nuts Obviously Loose

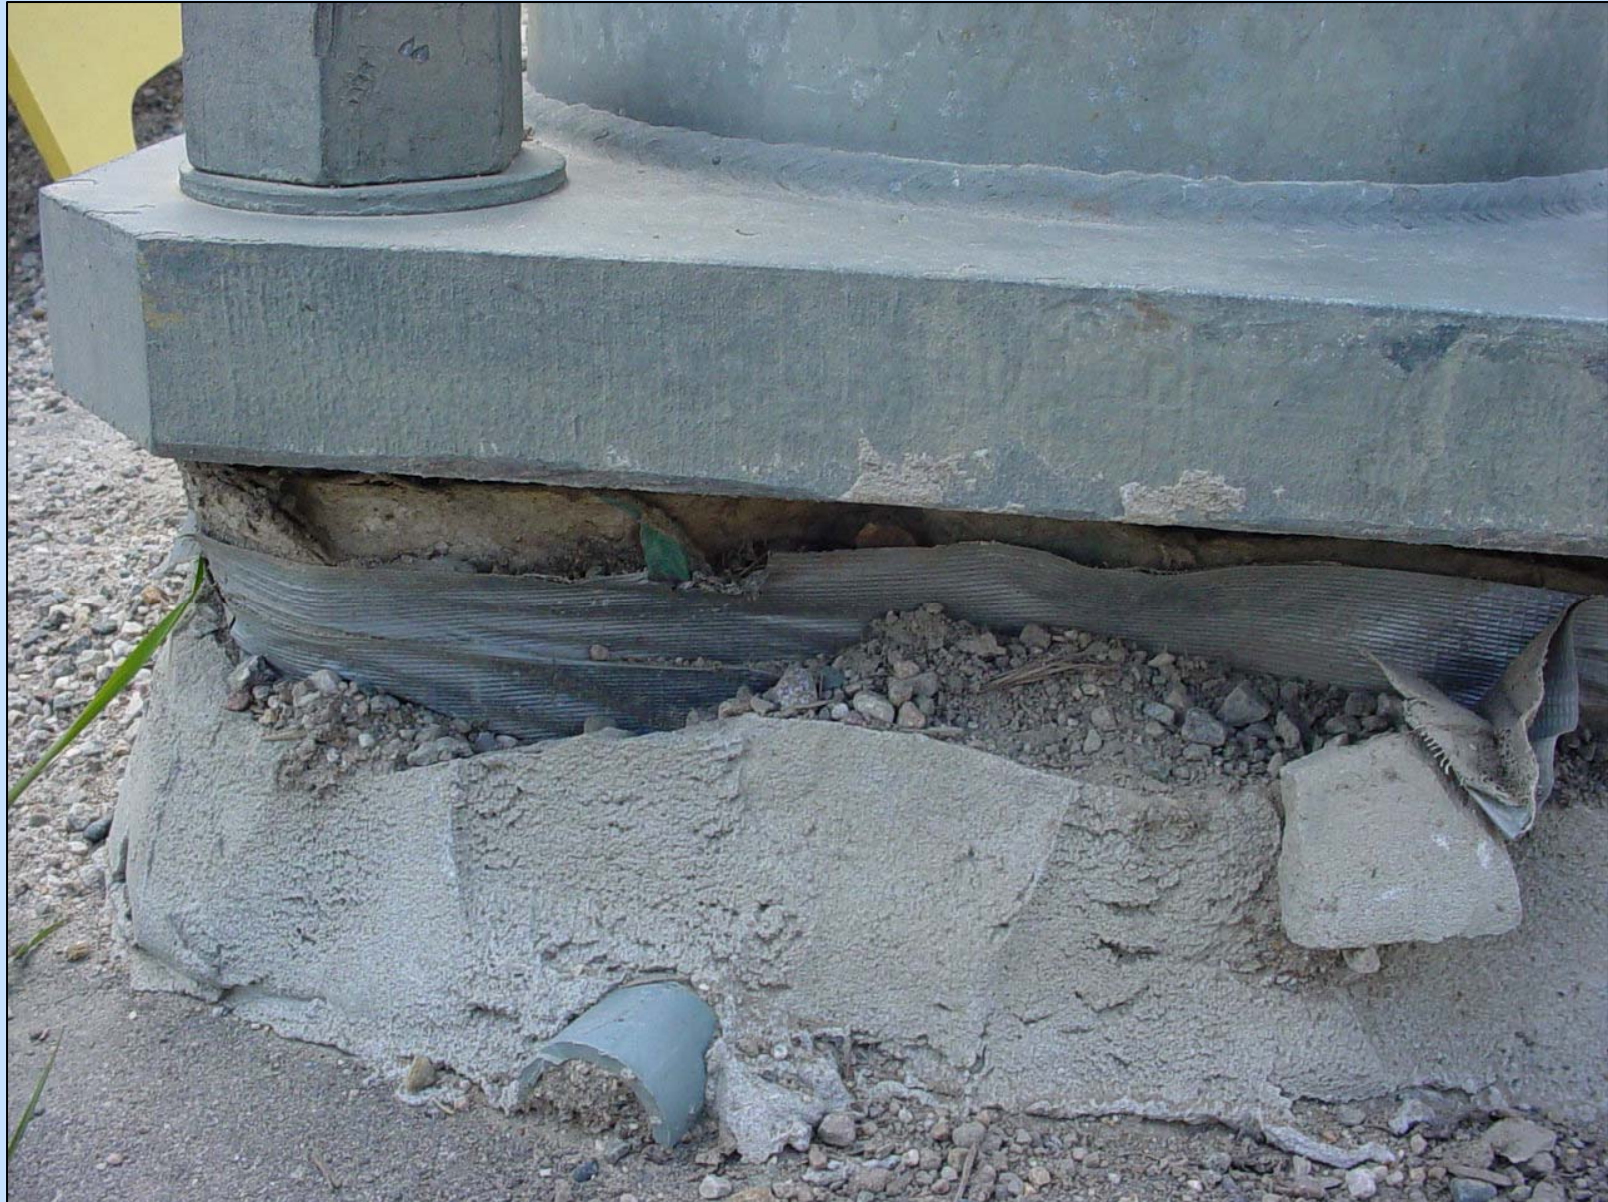
# Deteriorated Grout Pad

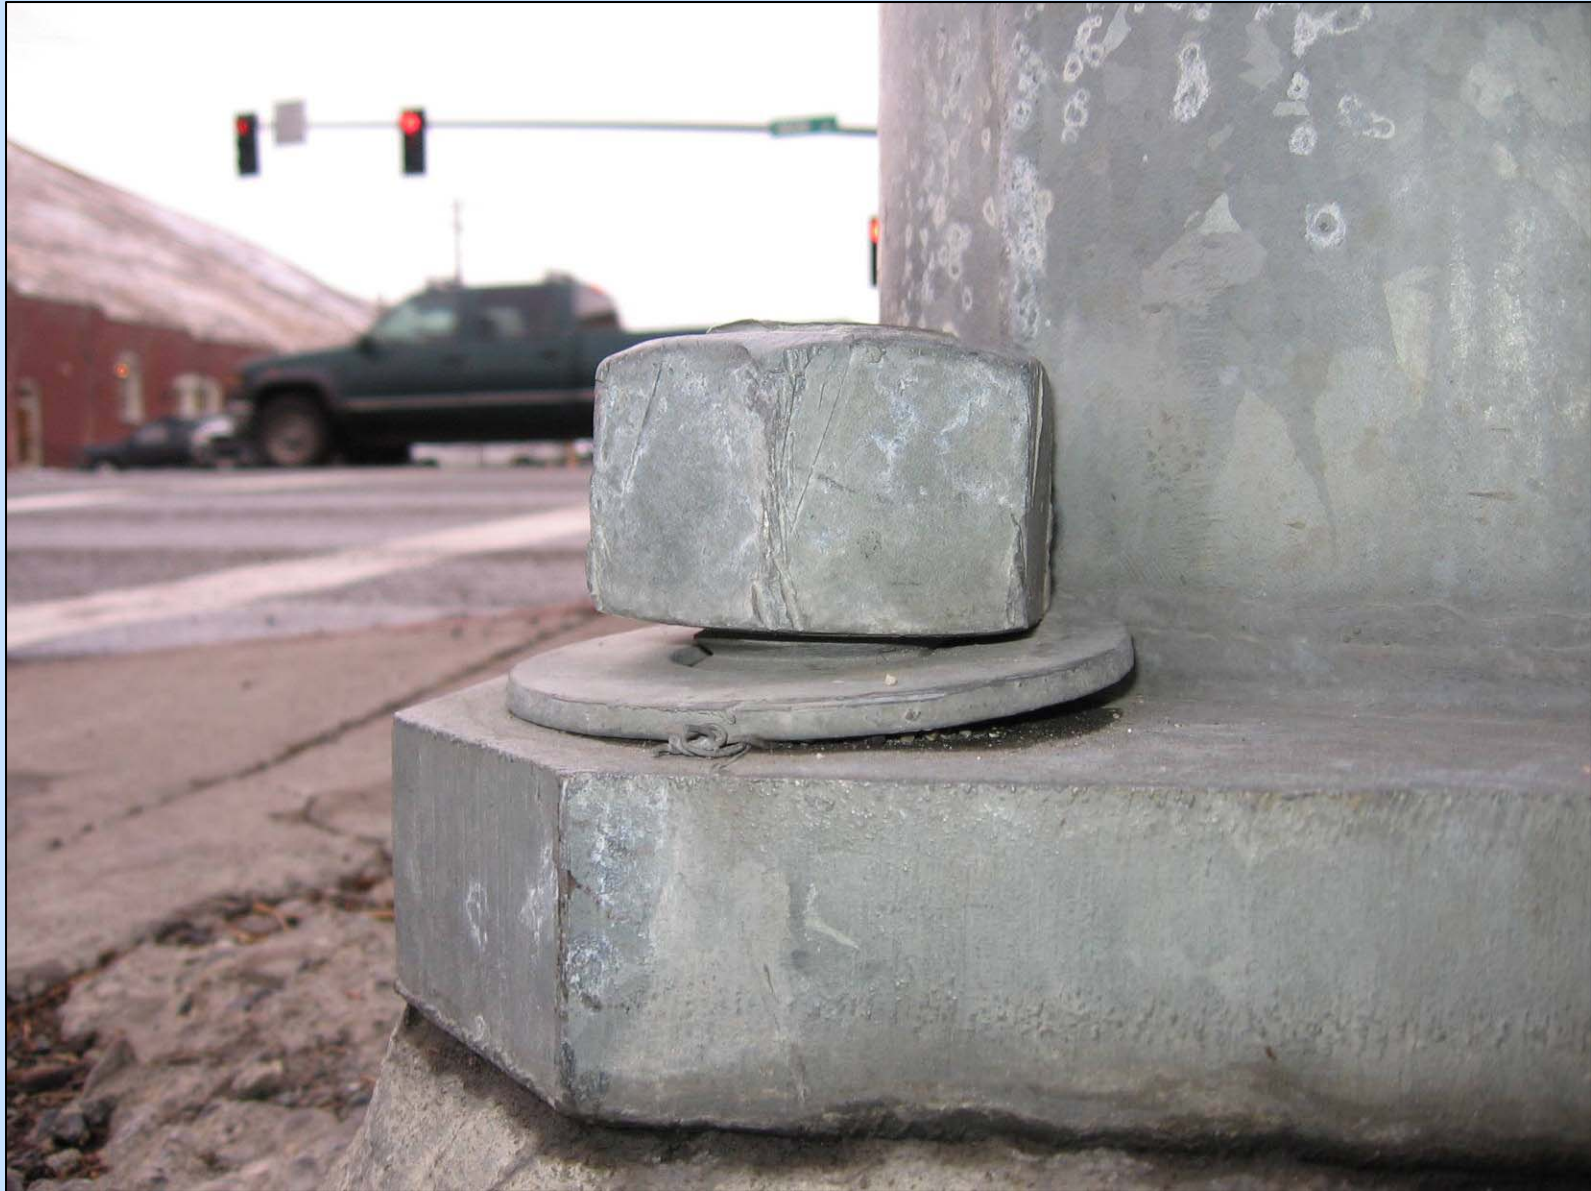
# Anchor Bolt Nut Not Seated Properly

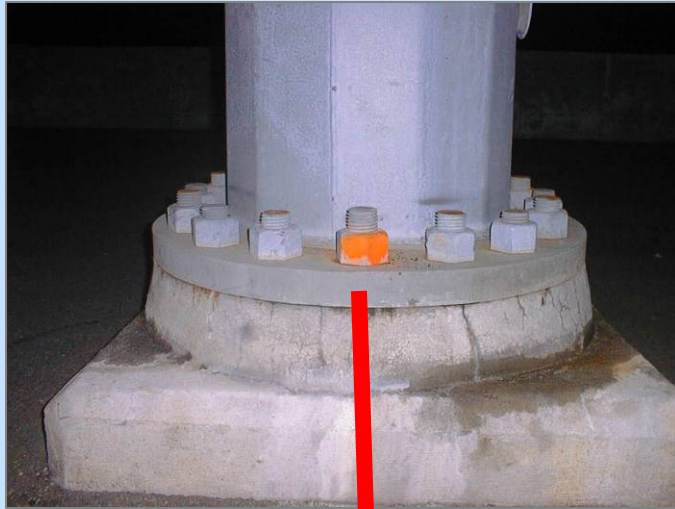
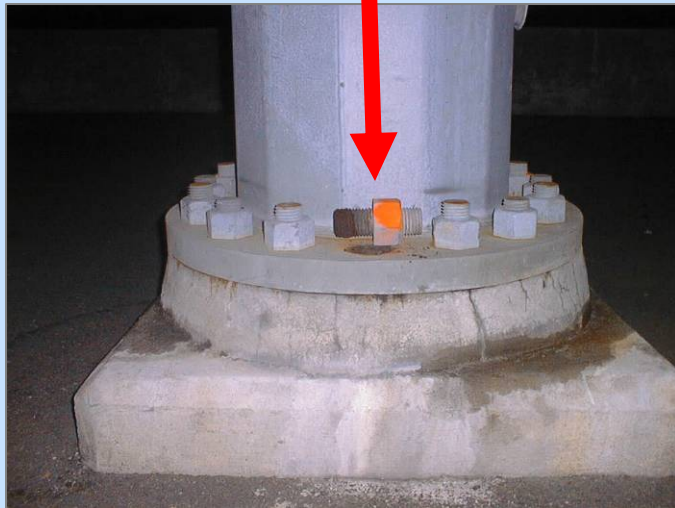
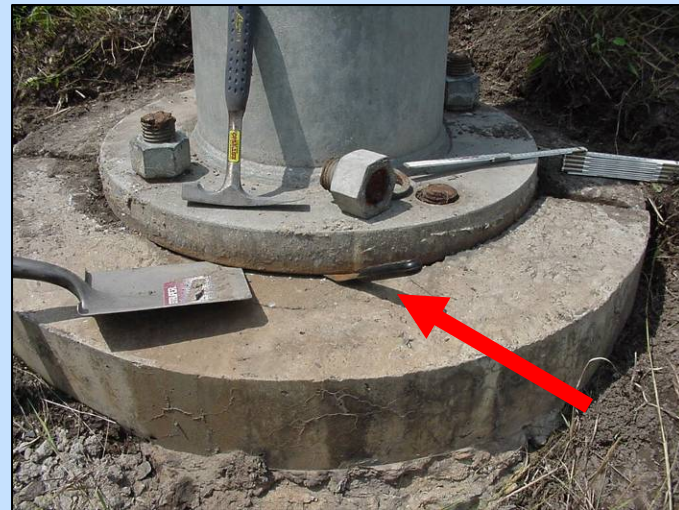
# Anchor Rod Failure

- Broken Due to Corrosion

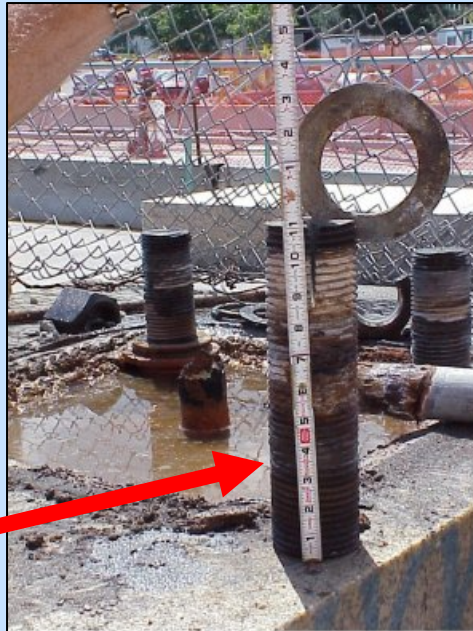
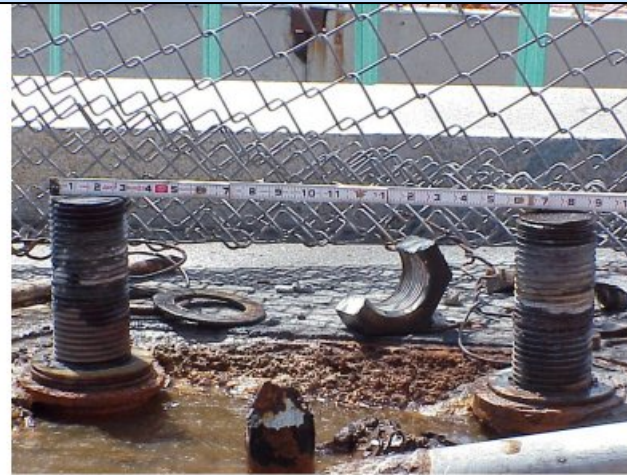
# Construction Deficiencies

Short  
Coupler

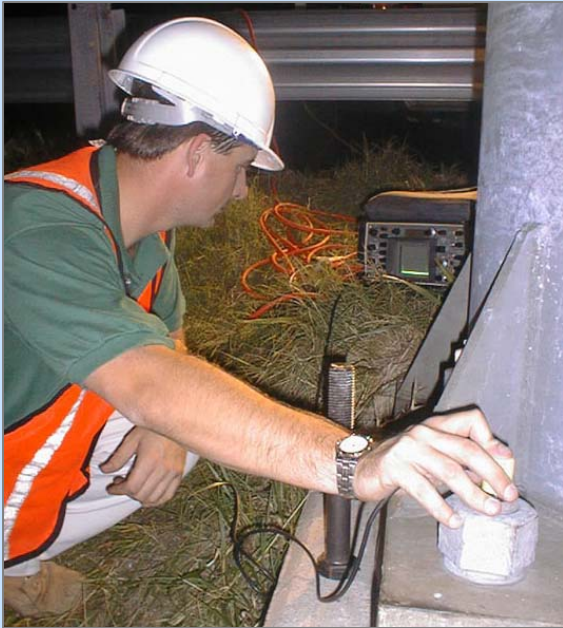
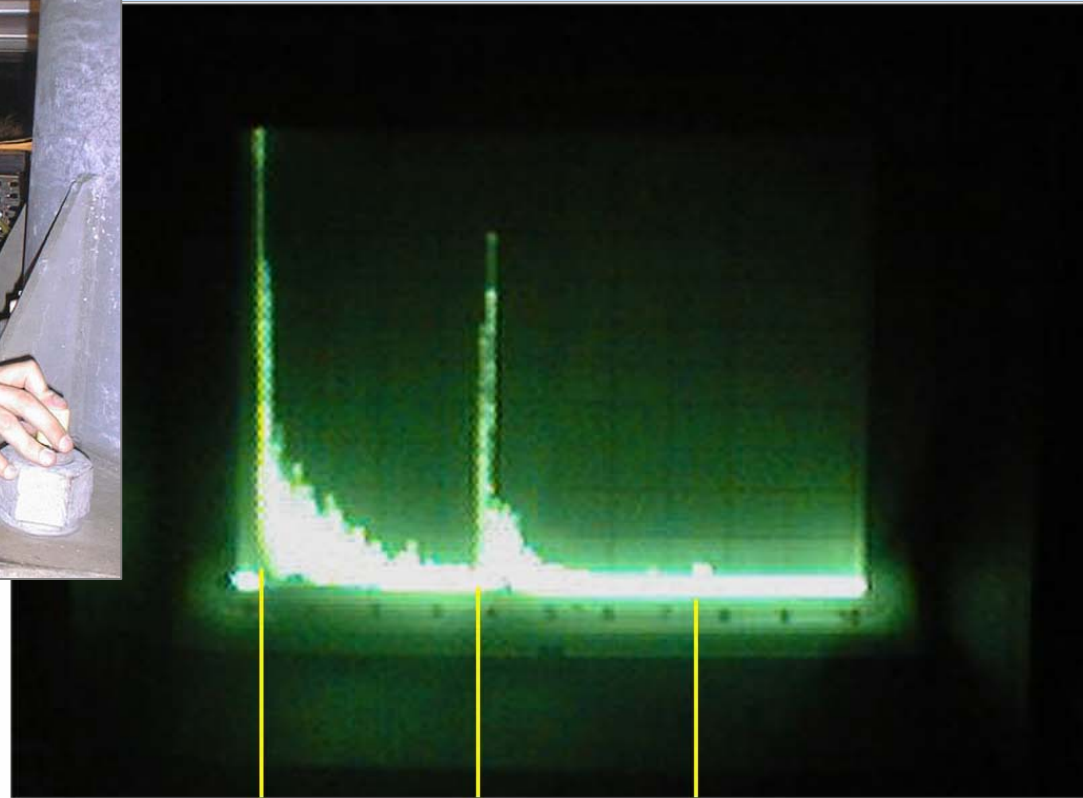
# Ultrasonic Testing

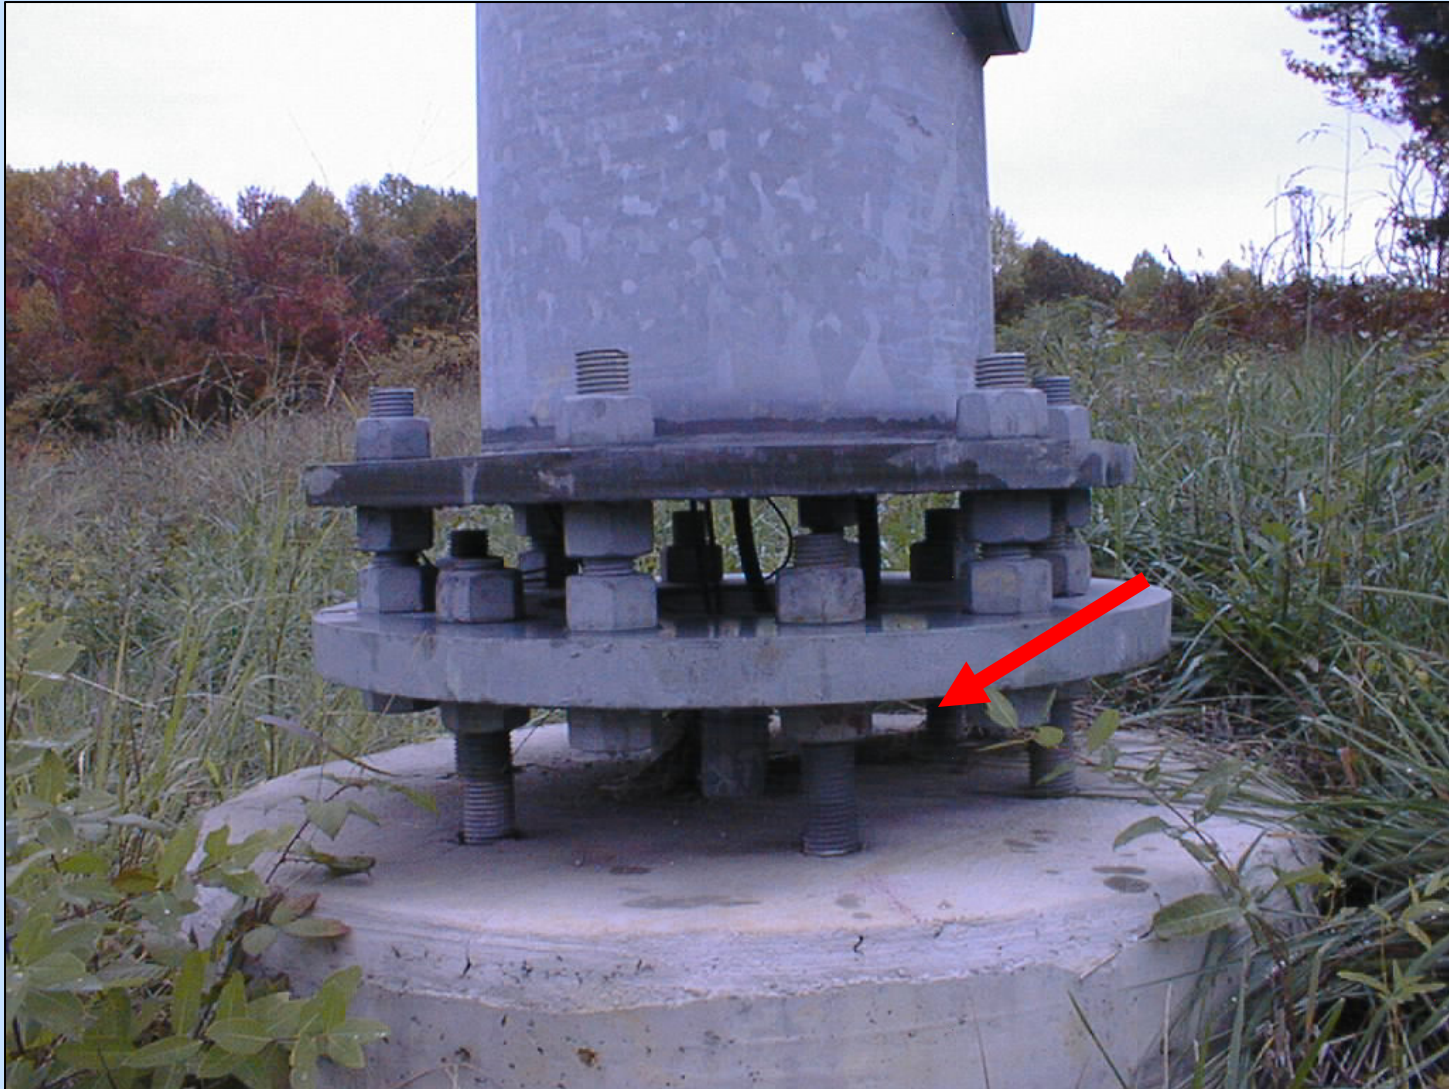
# Inadequate Design

Inadequate Base Plate-to-Pedestal Connection

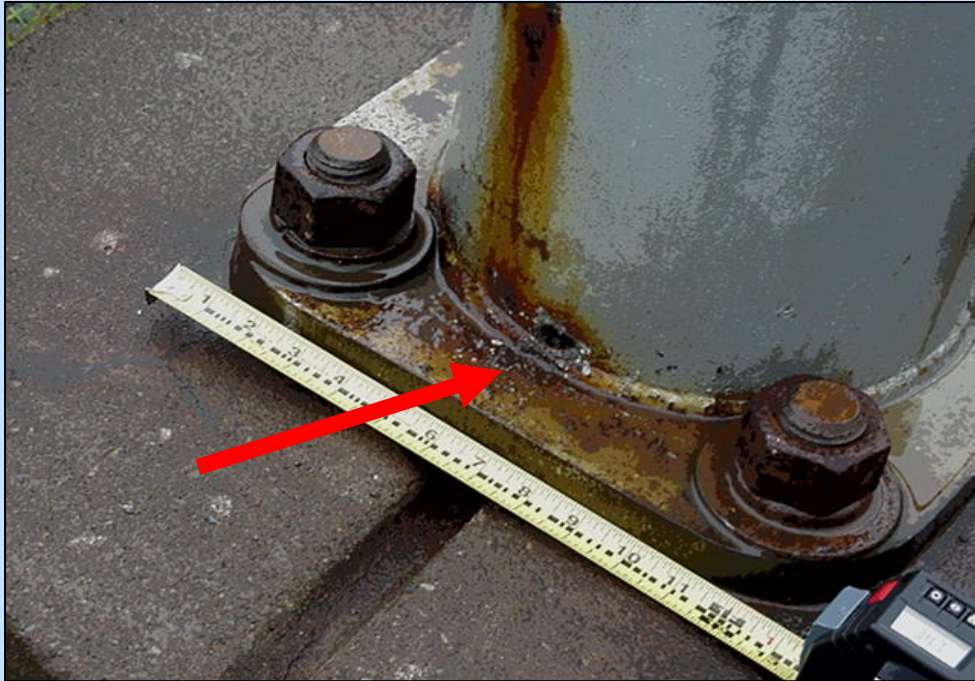
# Post / Tower Corrosion

Base Plate Corrosion  
Note the Hole

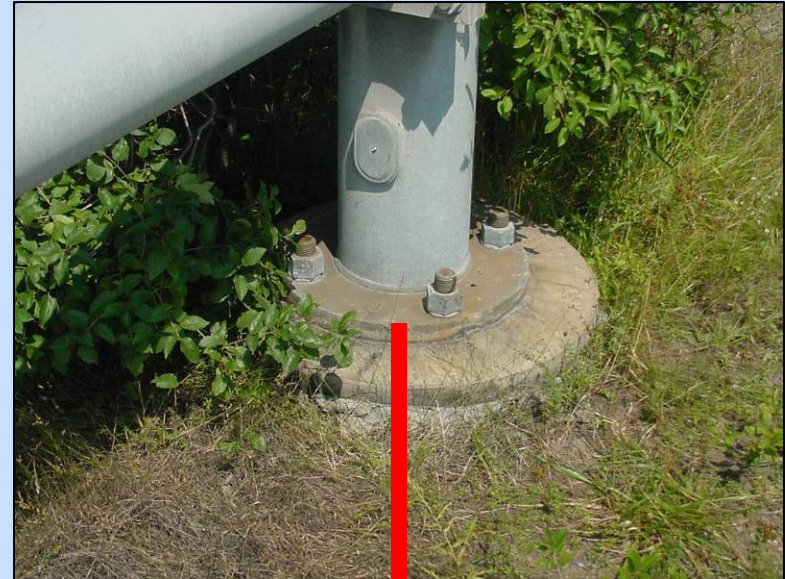
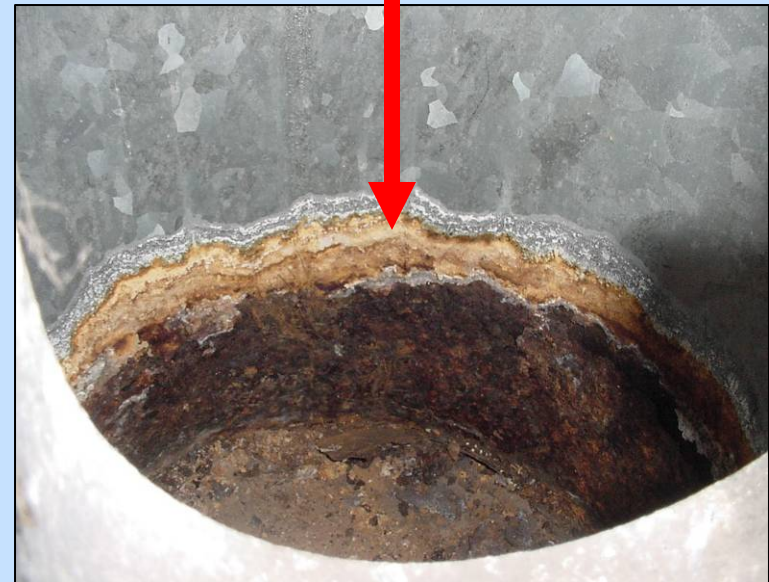
Corrosion Inside Post

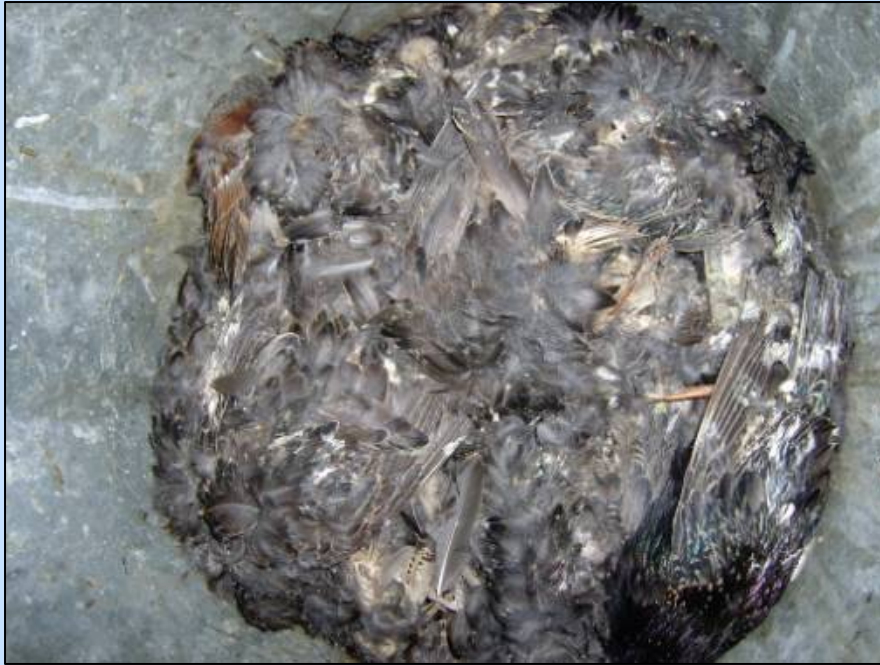
# Tower / Post

Views Inside a Post

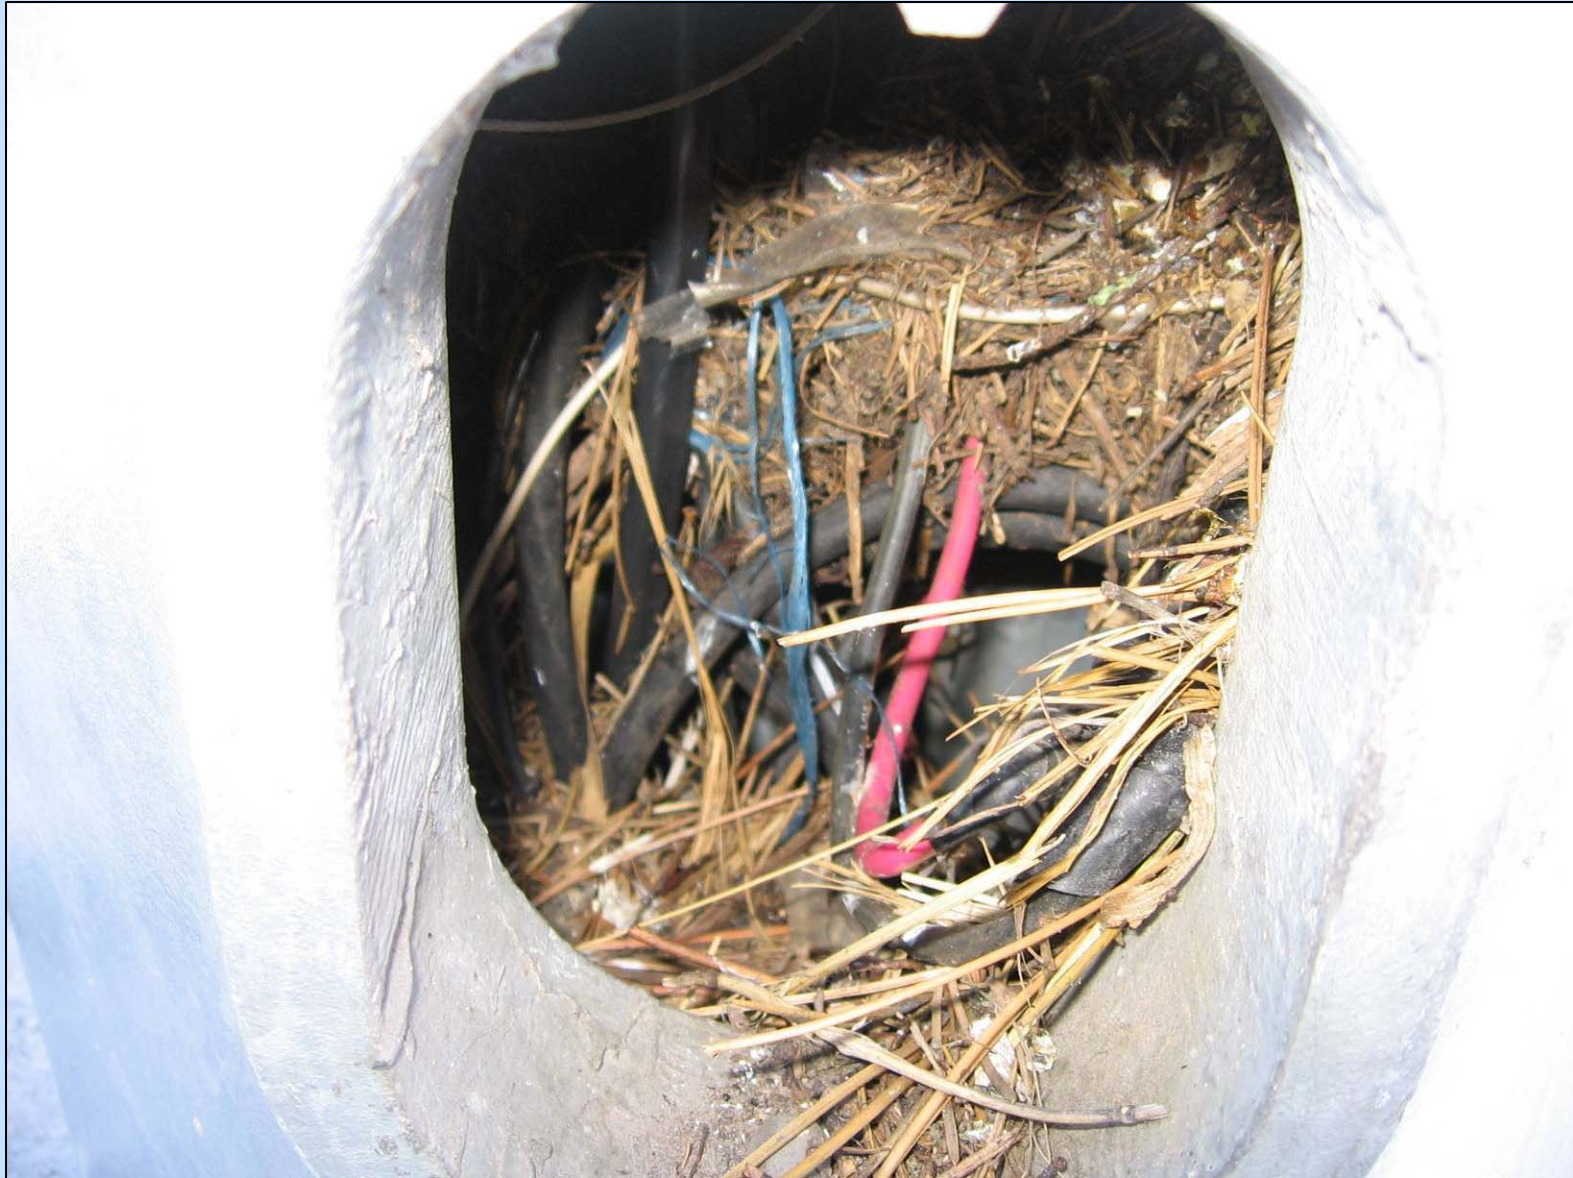
# Debris Inside Column

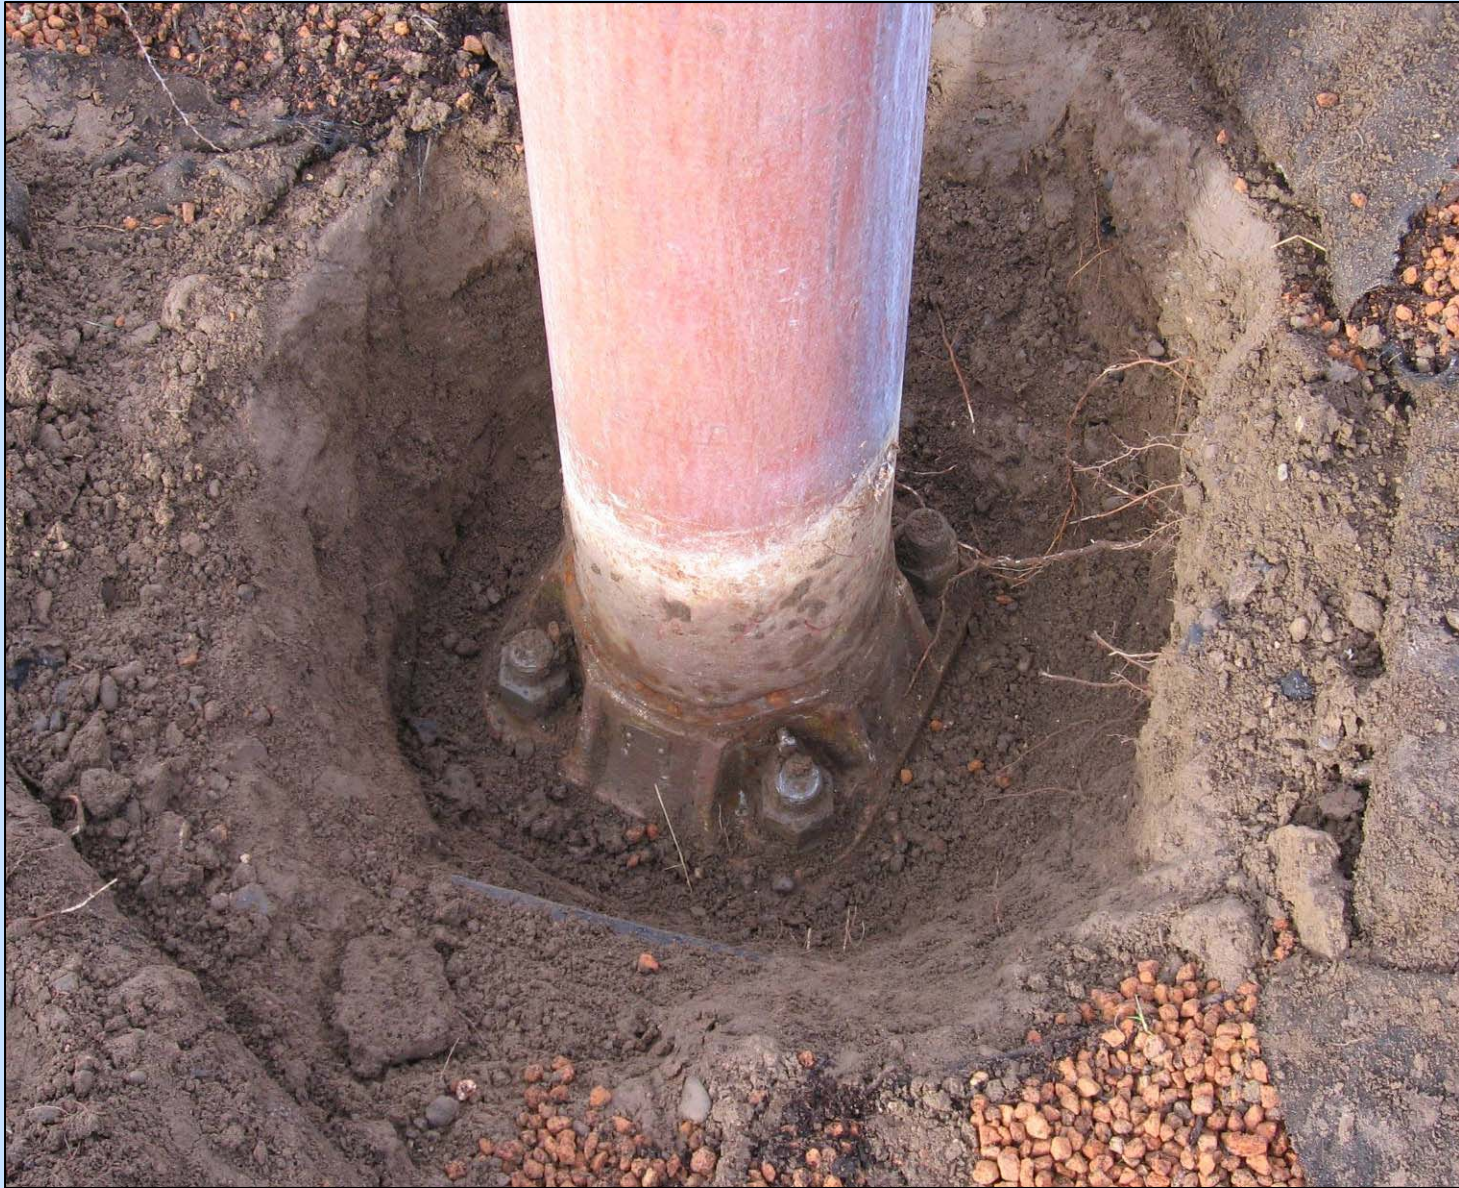
# Buried Base

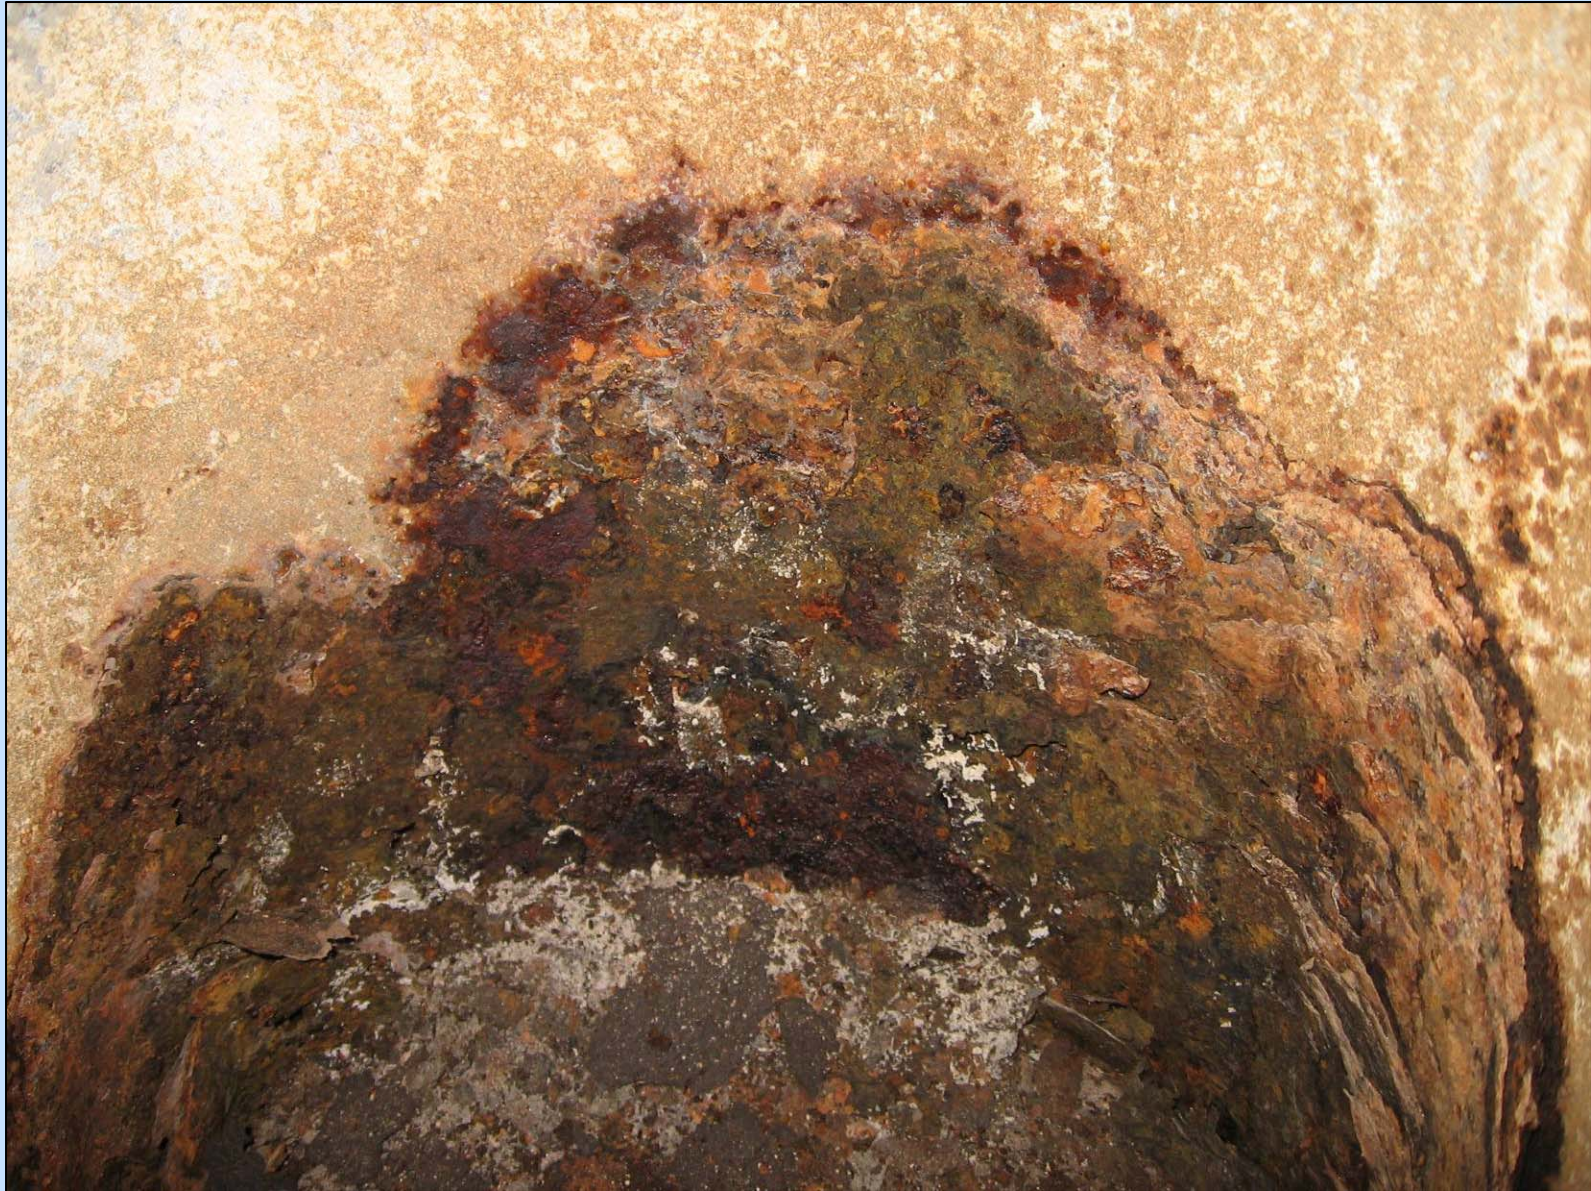
# Interior Column Corrosion

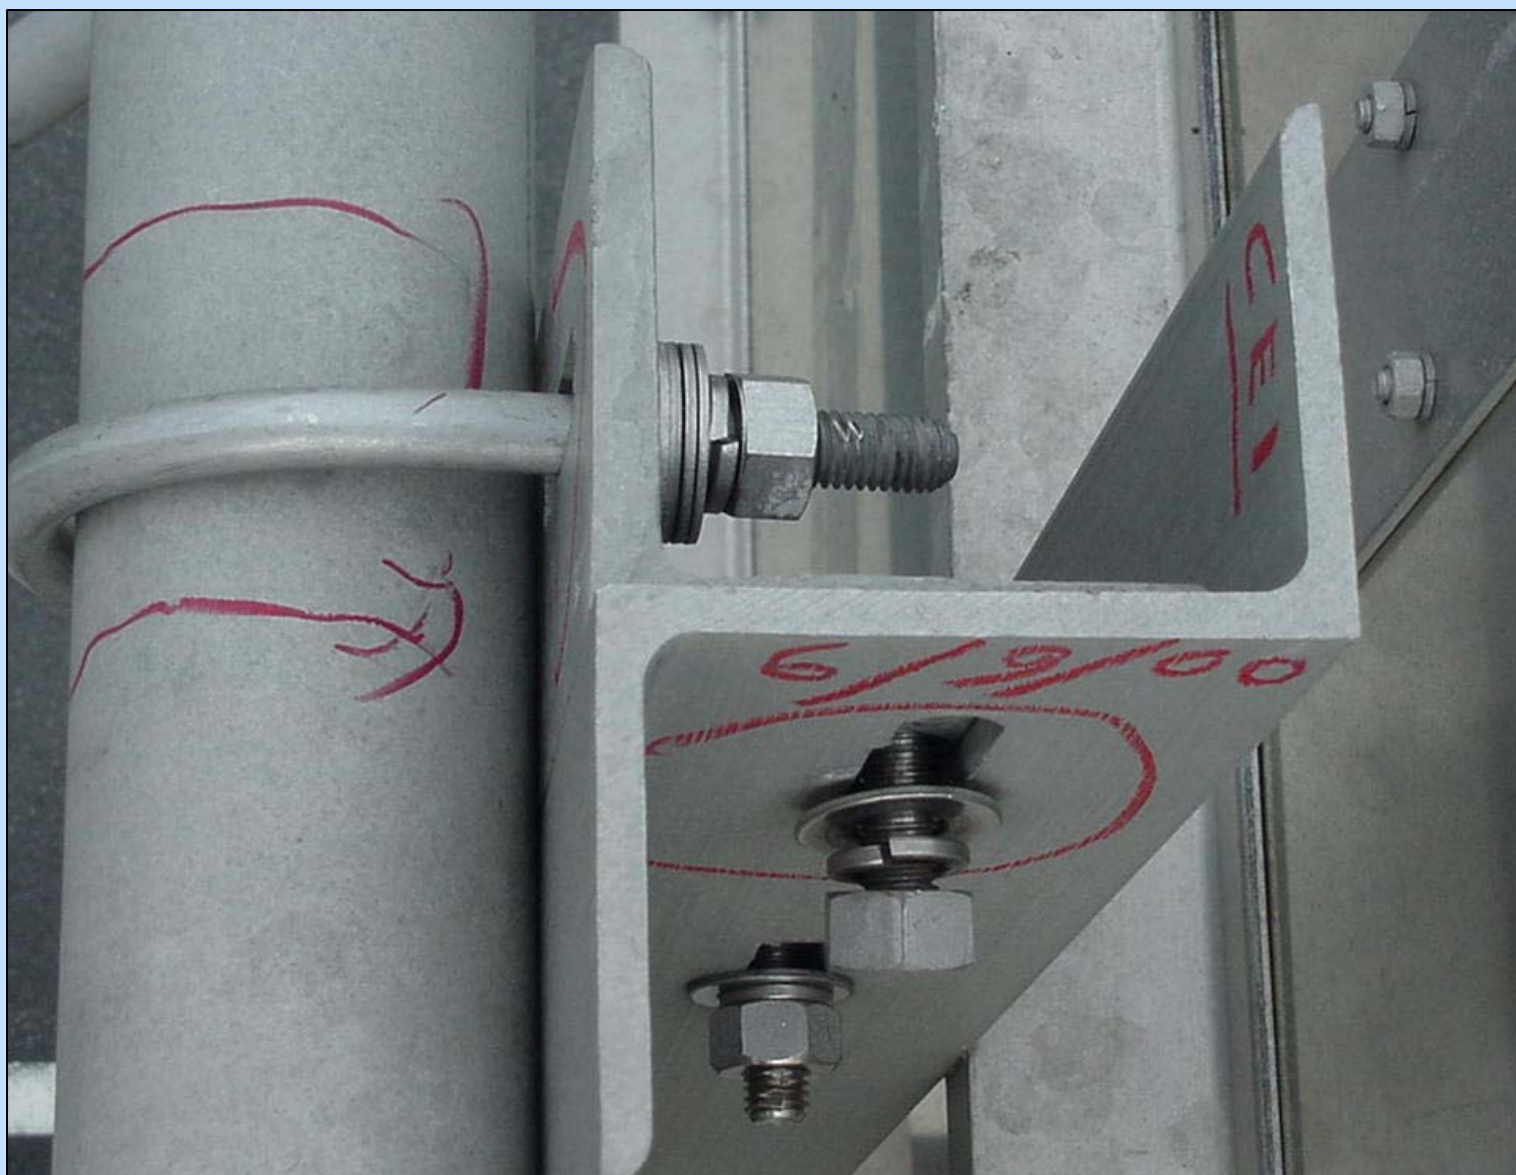
# Loose Bolts on Sign Superstructure

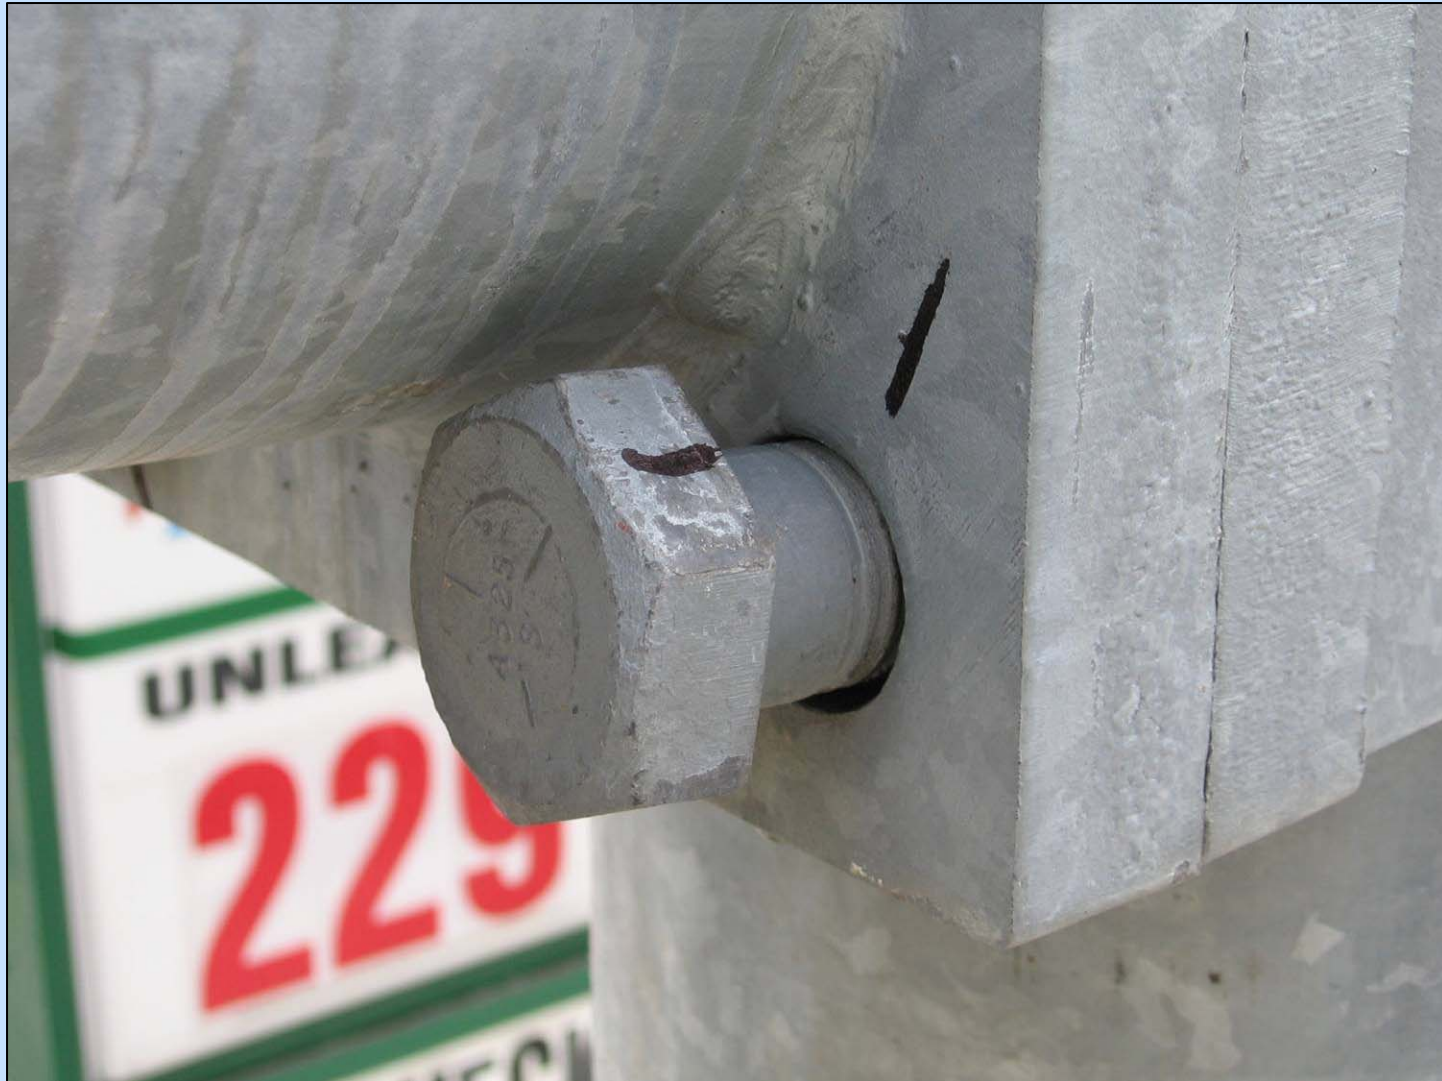
# Connection Bolt Not Seated Properly

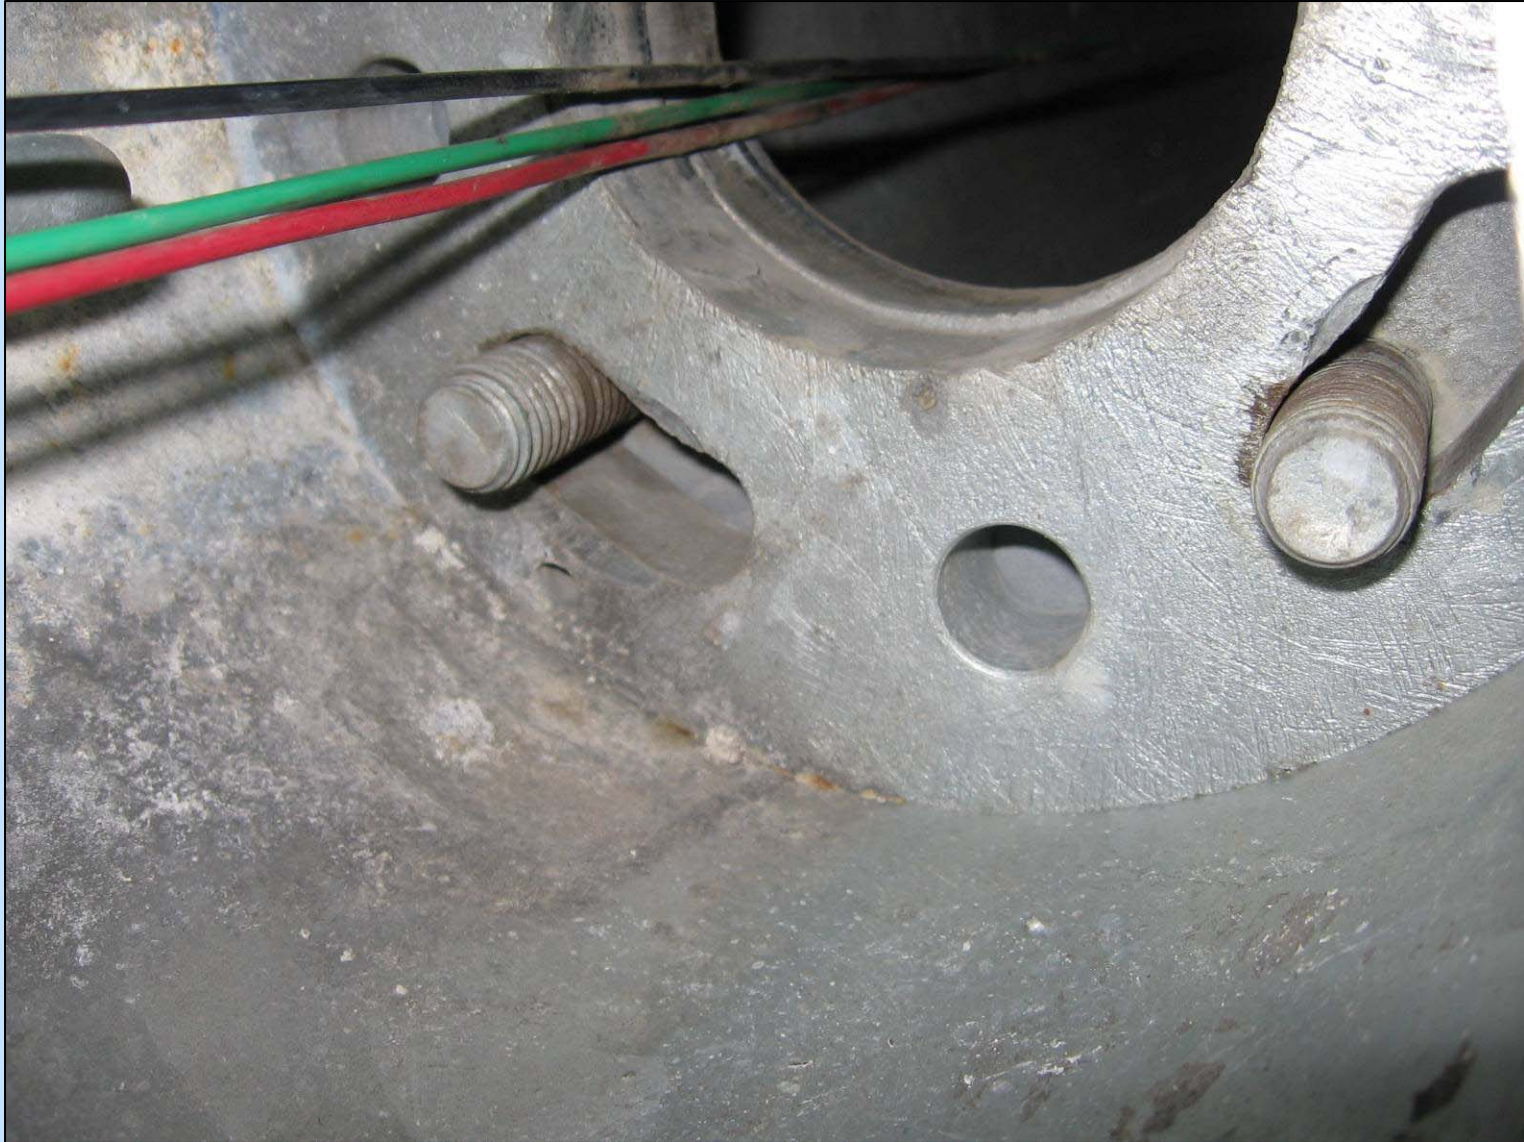
# Missing Column Splice Nuts
