# **Ancillary Structure Inspection Procedures and Findings**

**Michael Garlich, S.E., P.E.  
Collins Engineers, Inc.**

**Western Bridge Engineers' Seminar 2007**

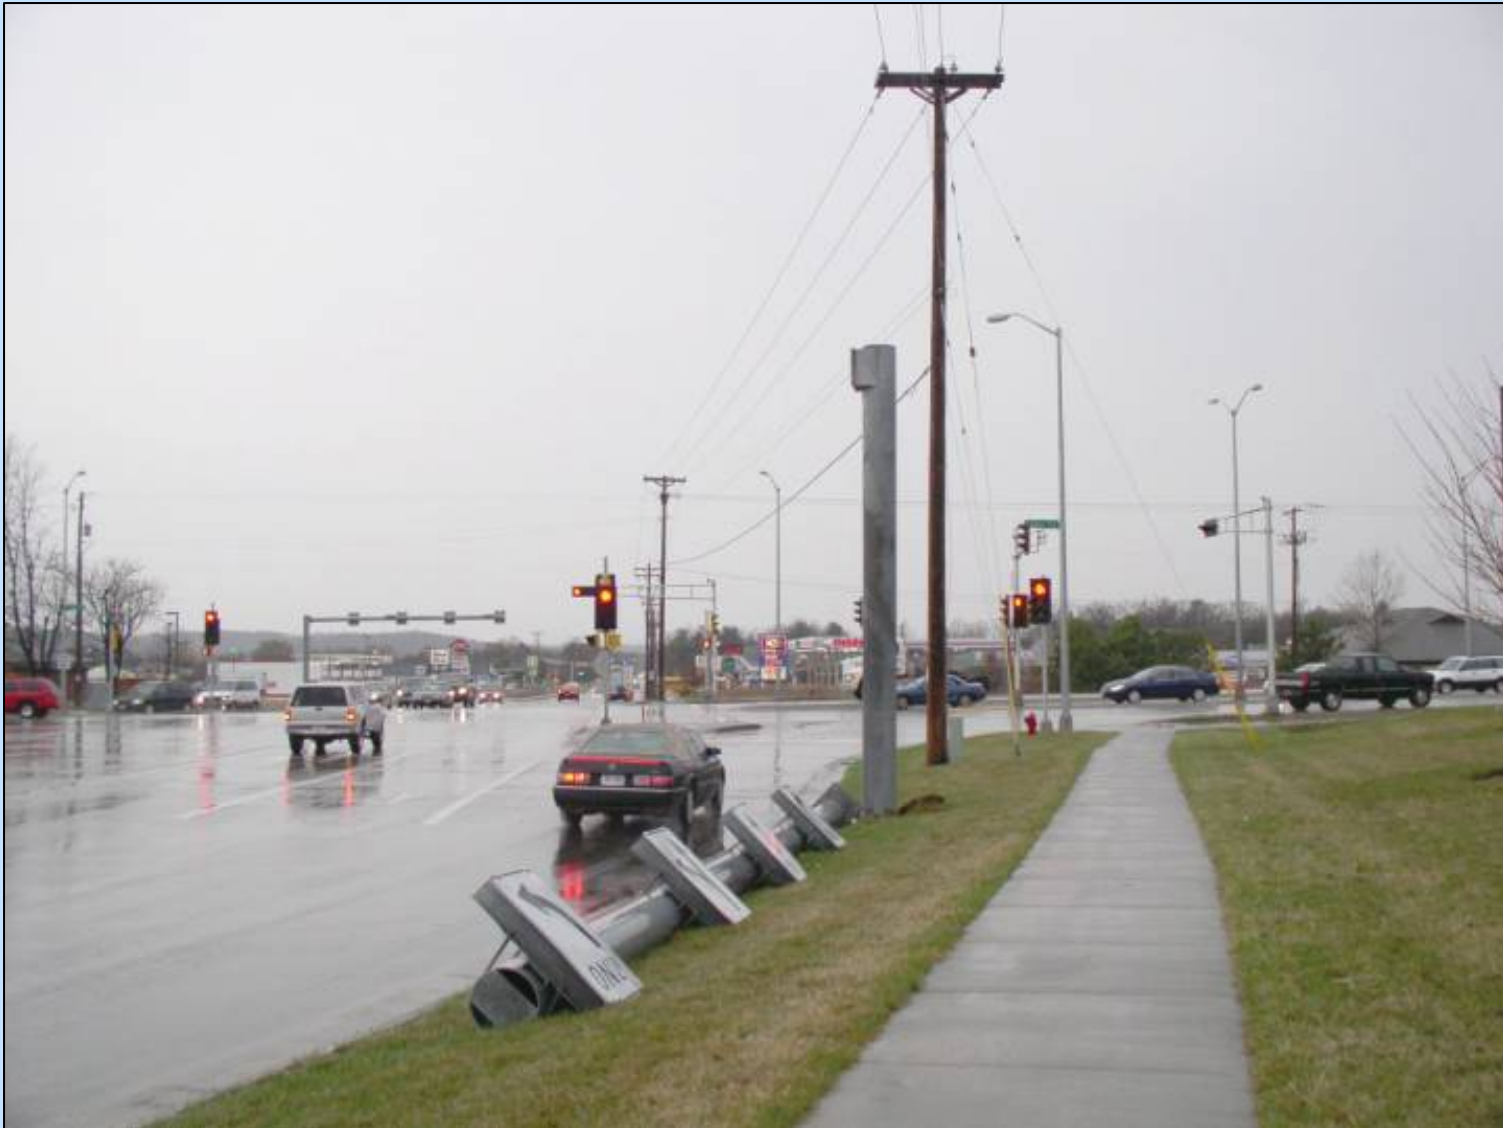
# Failed Mast Arm

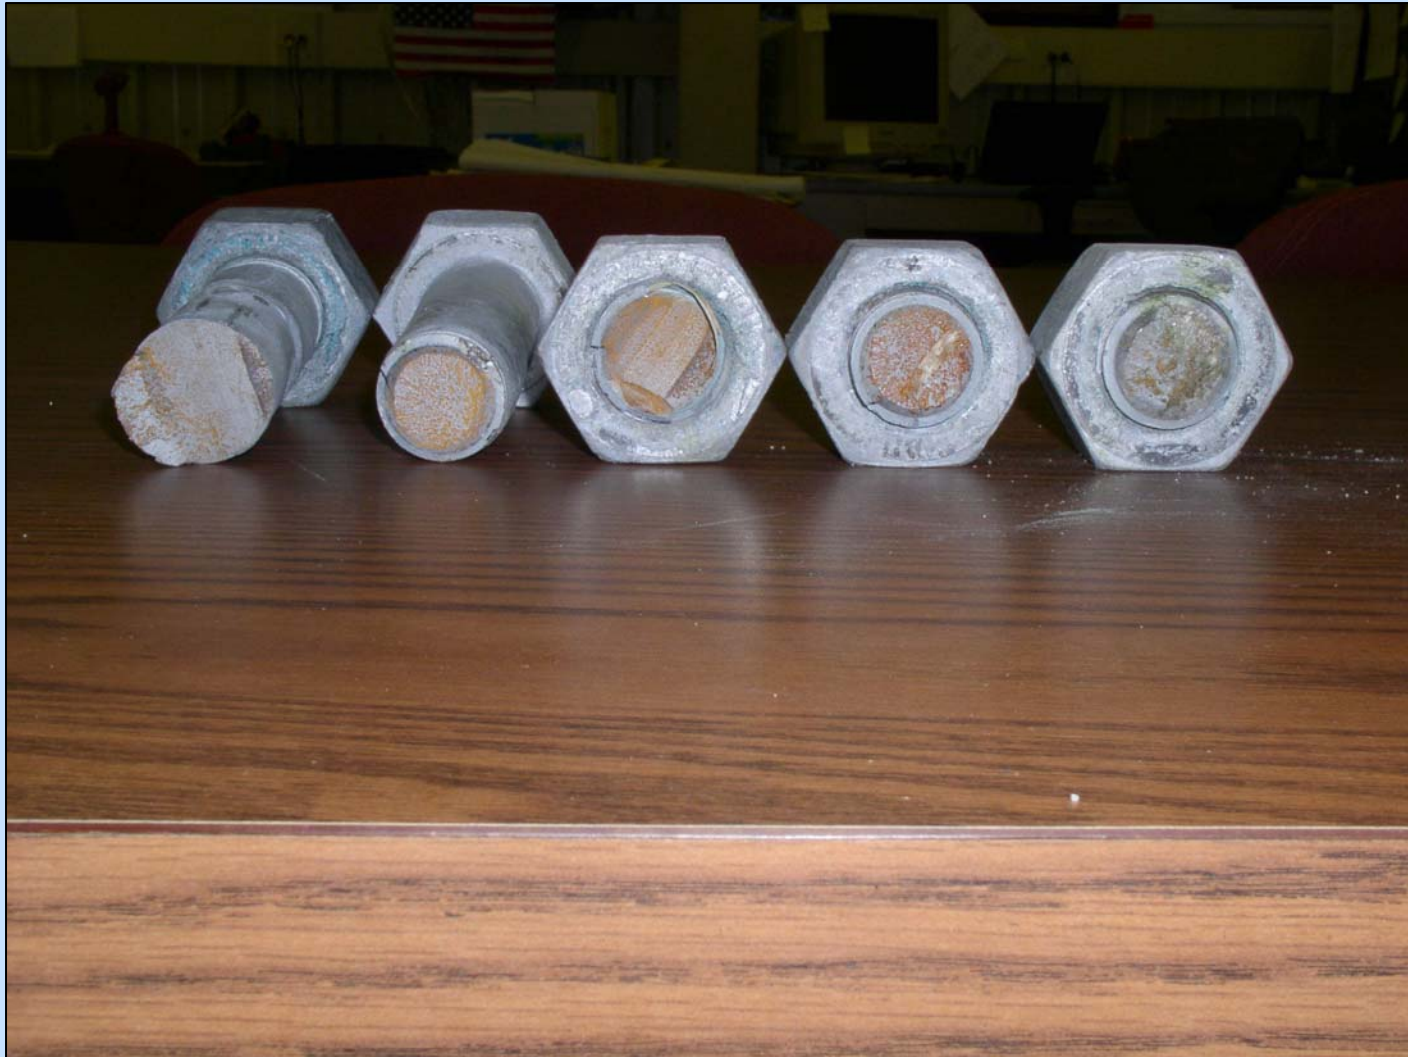
# Broken Connection Bolts

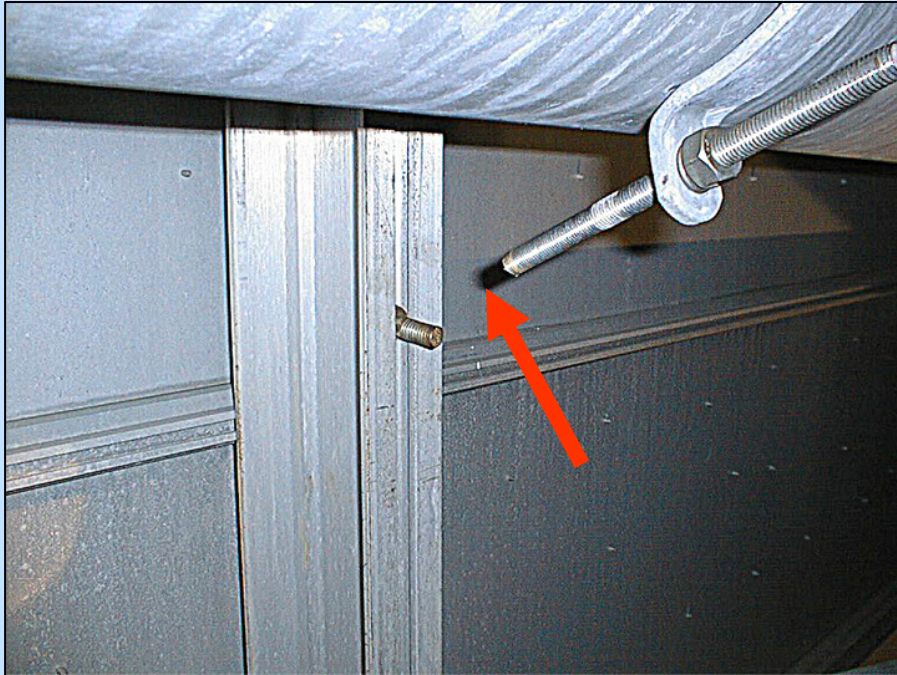
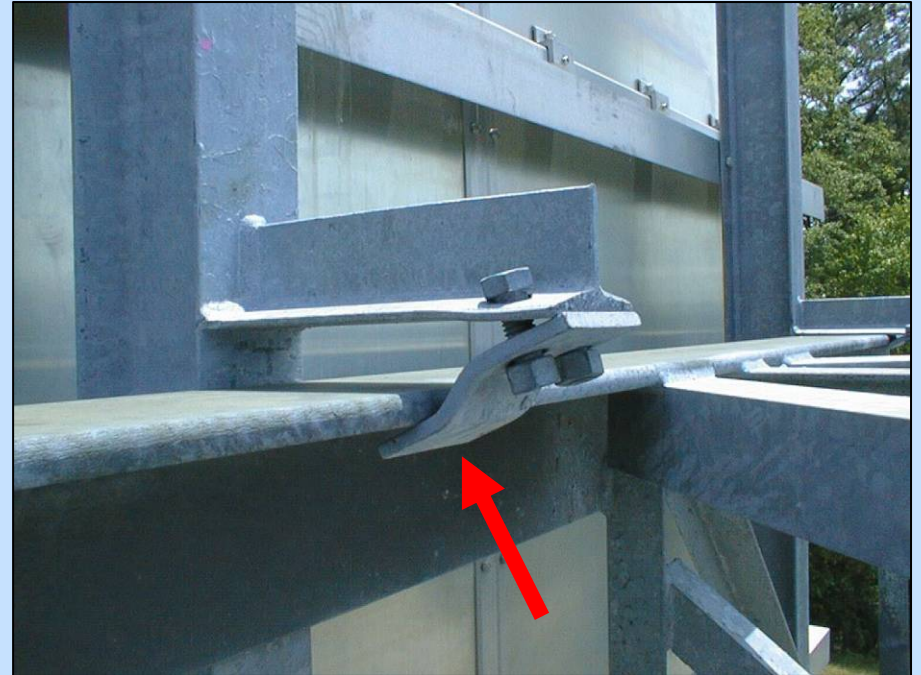
# Sign Panel Connection Deficiencies

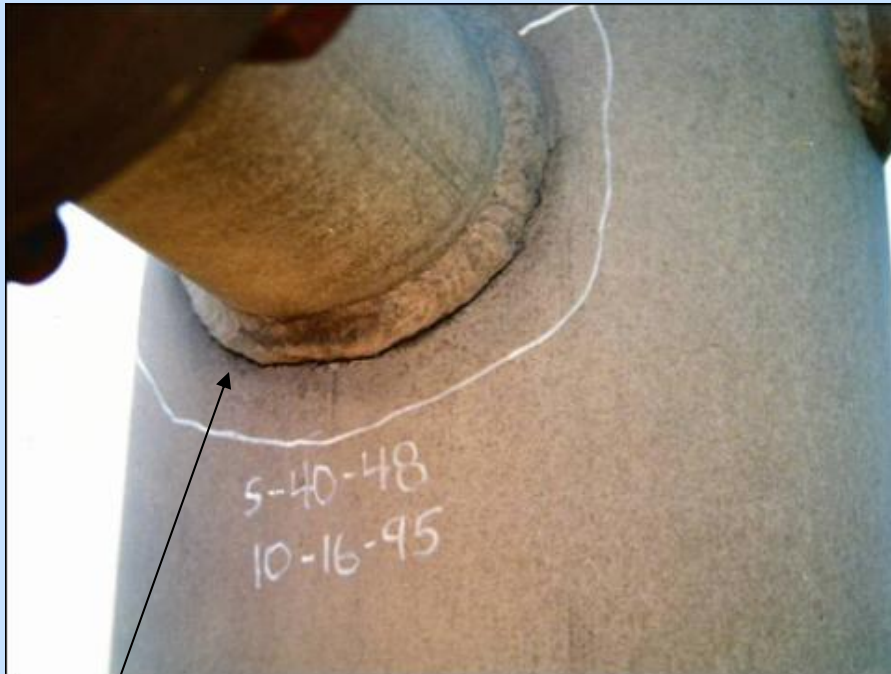
Fatigue Crack From Weld  
Crater Crack

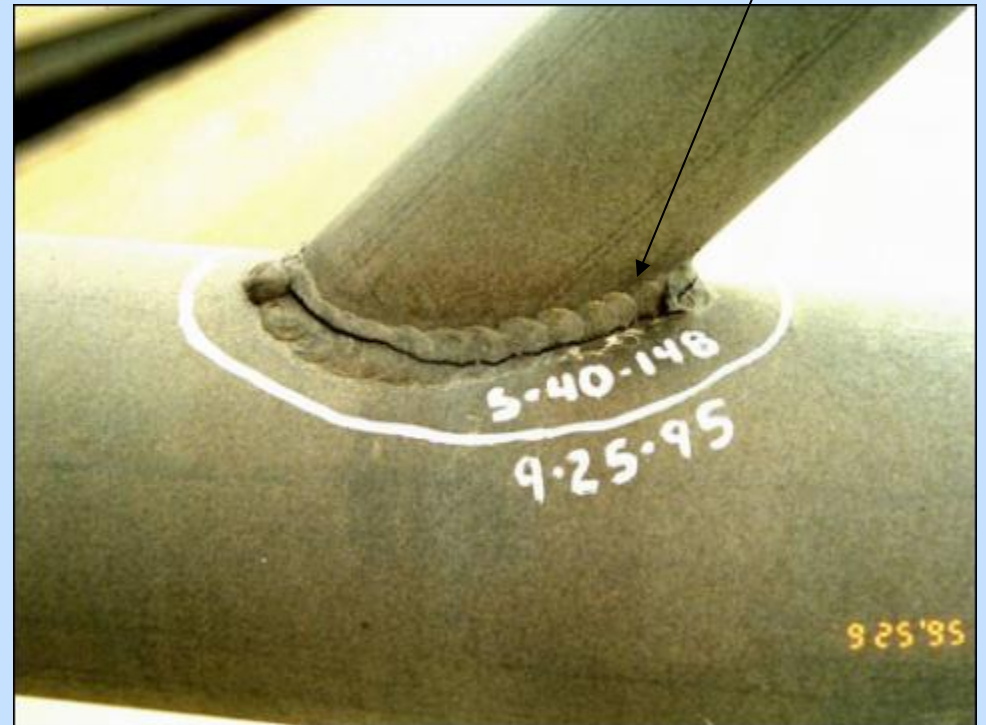
Fatigue Crack in  
Heat Affected Zone

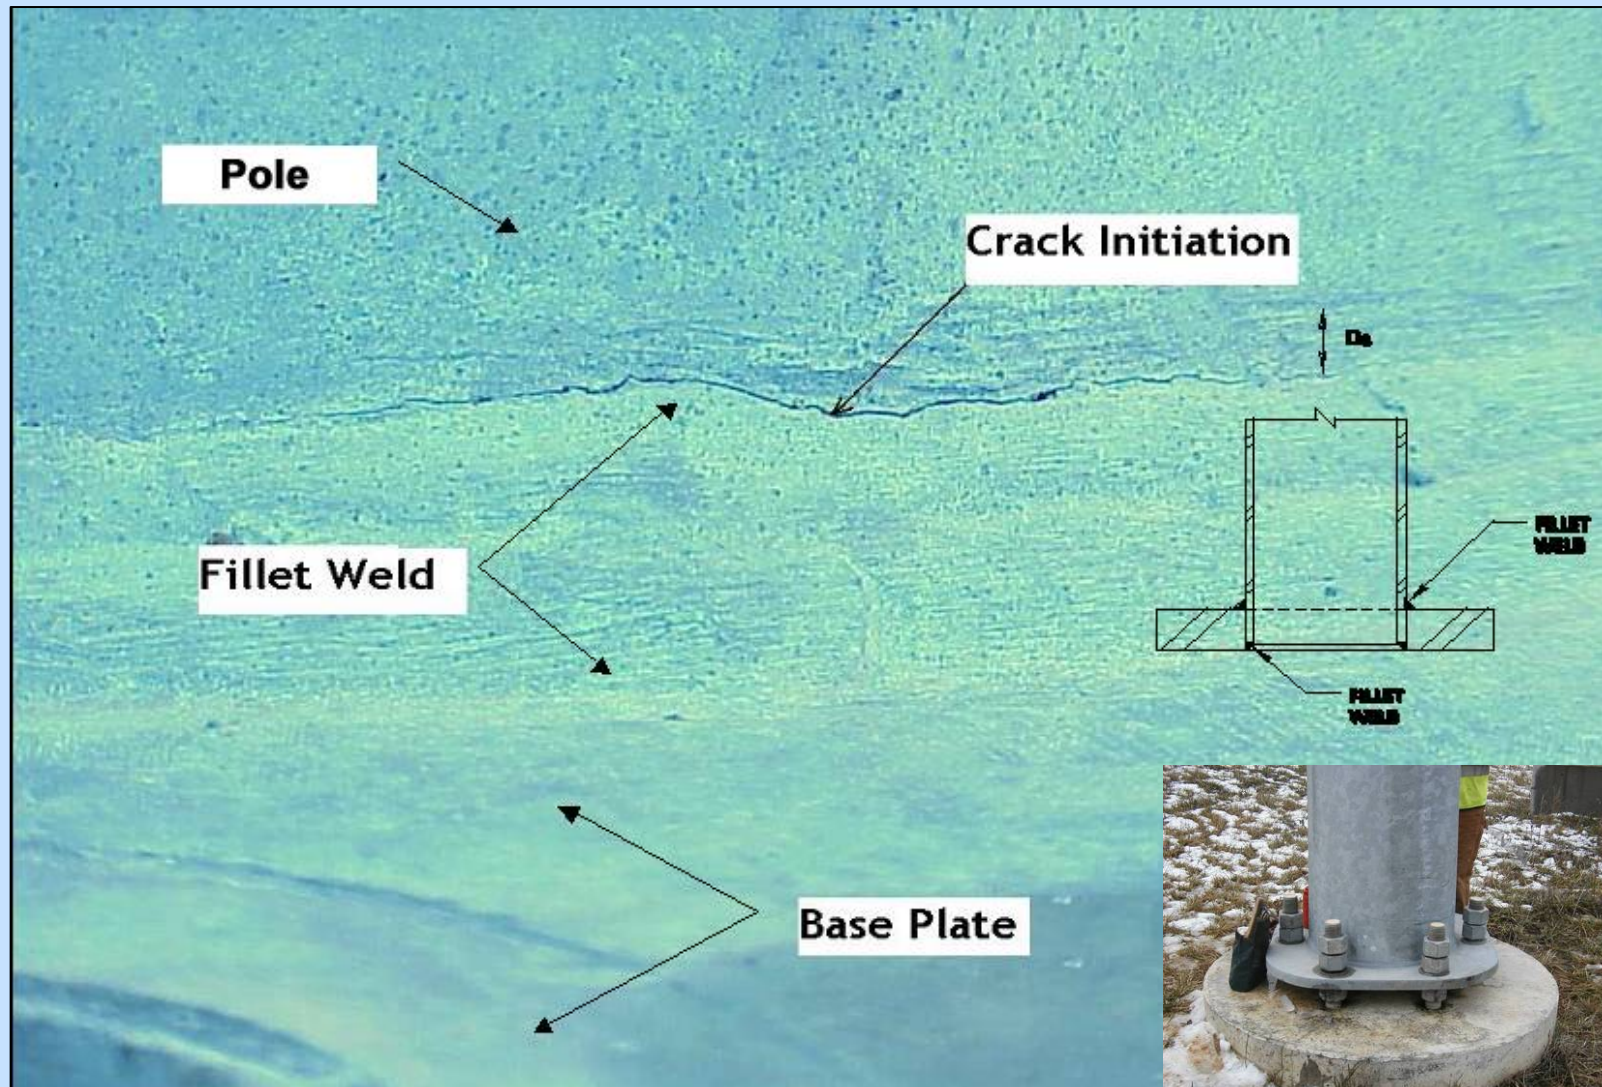
# Fatigue Initiation

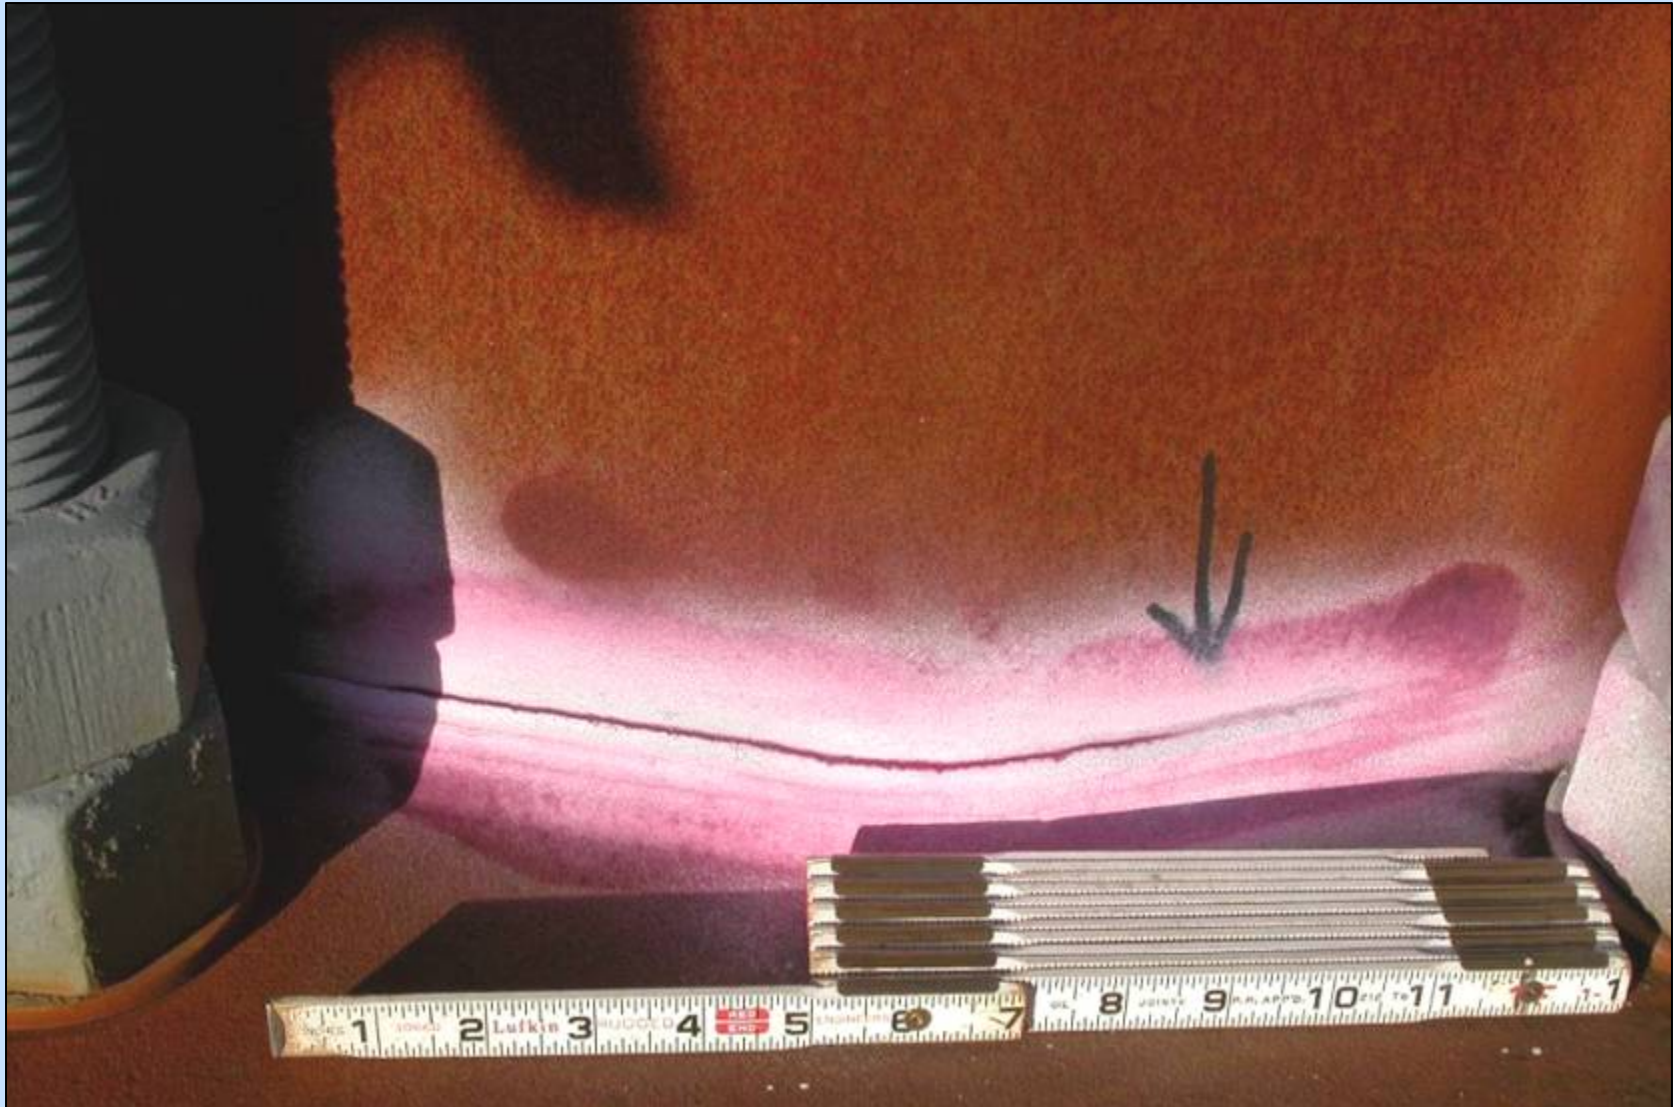
# Fatigue Propagation

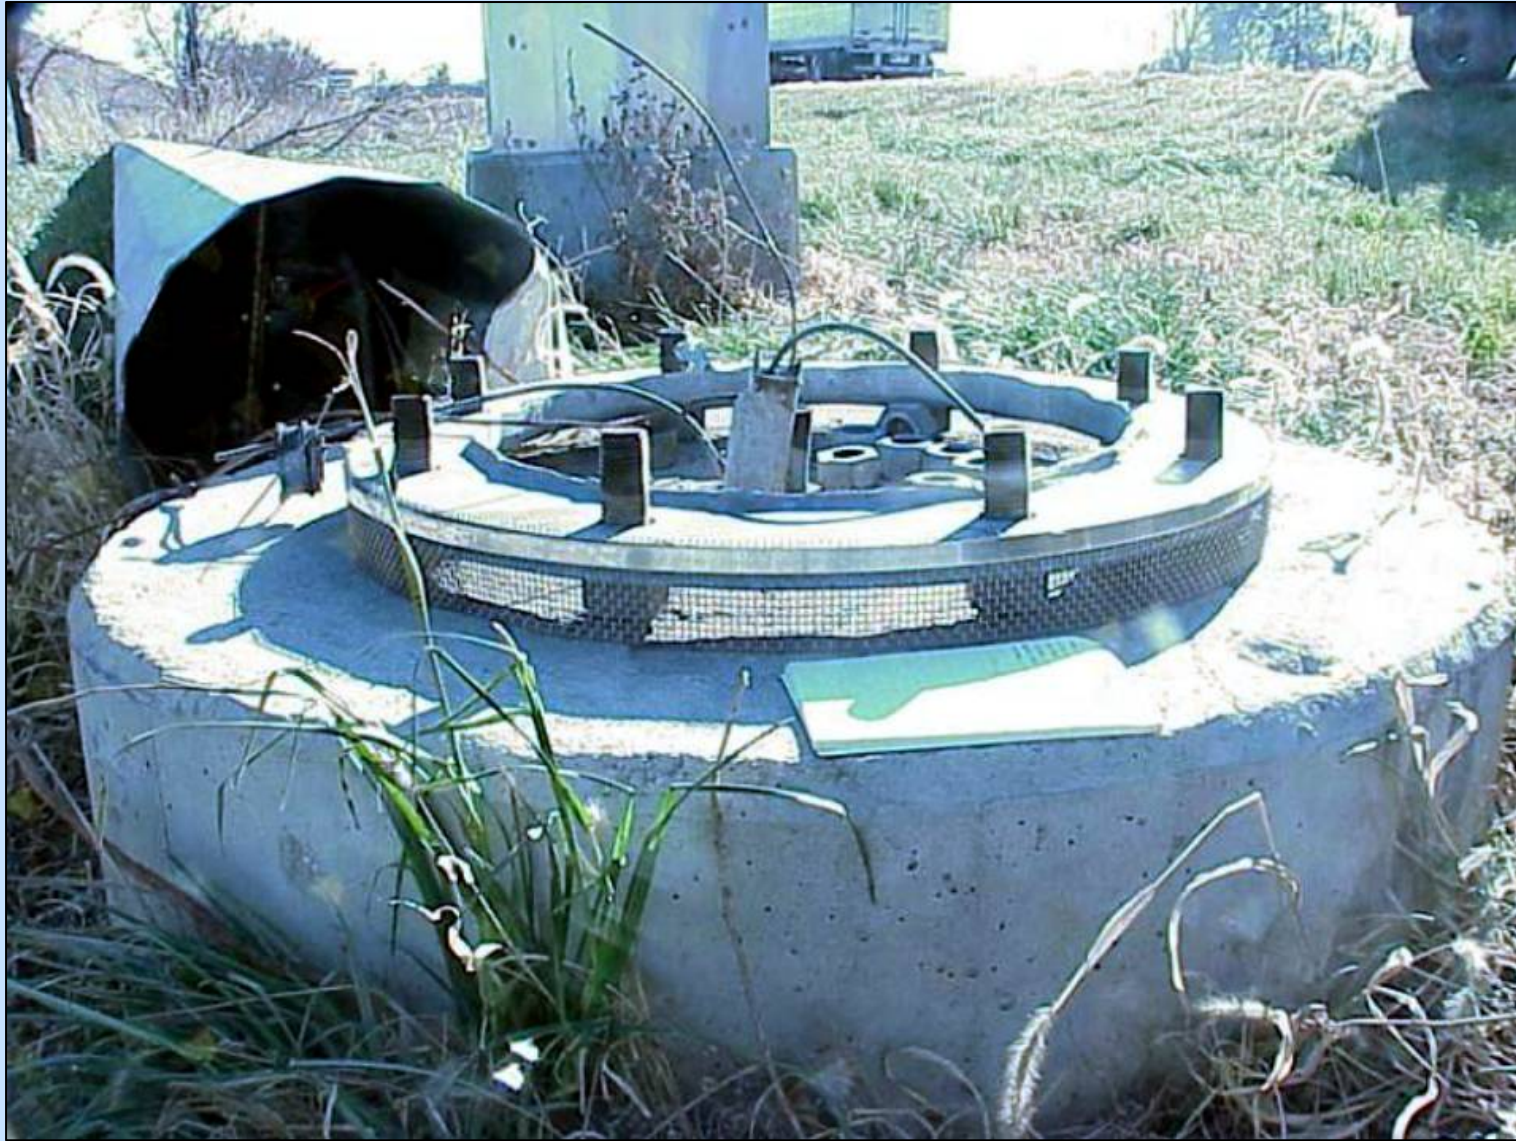
# Fatigue Fracture

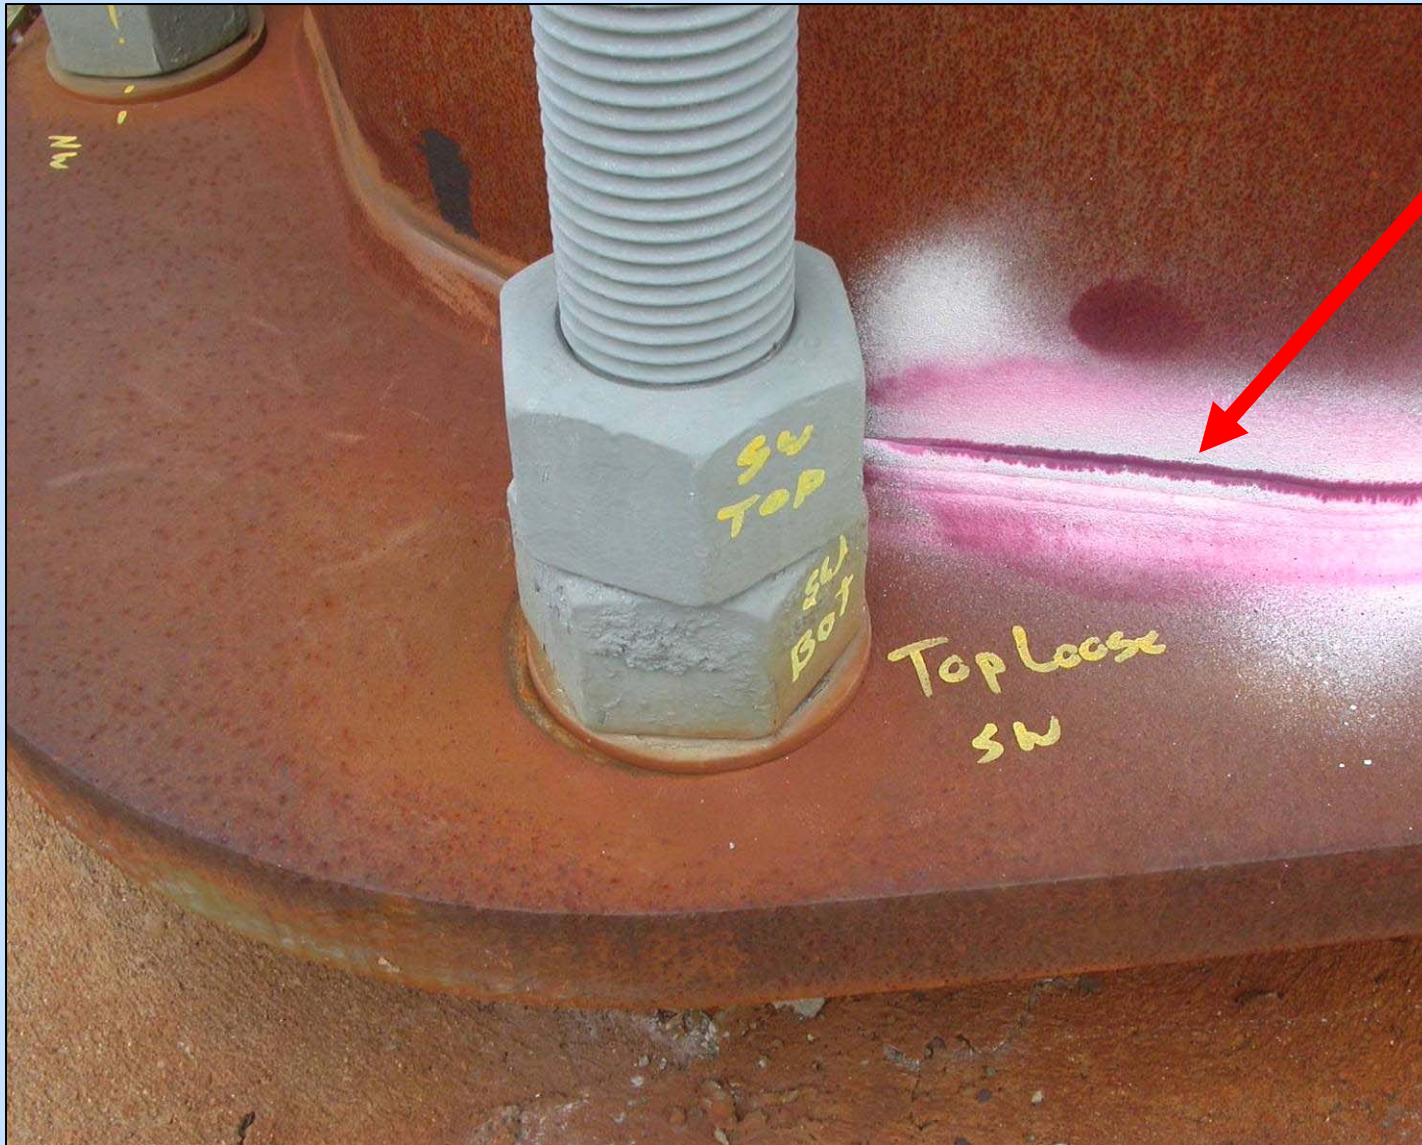
# Dye Penetrant Testing

Crack

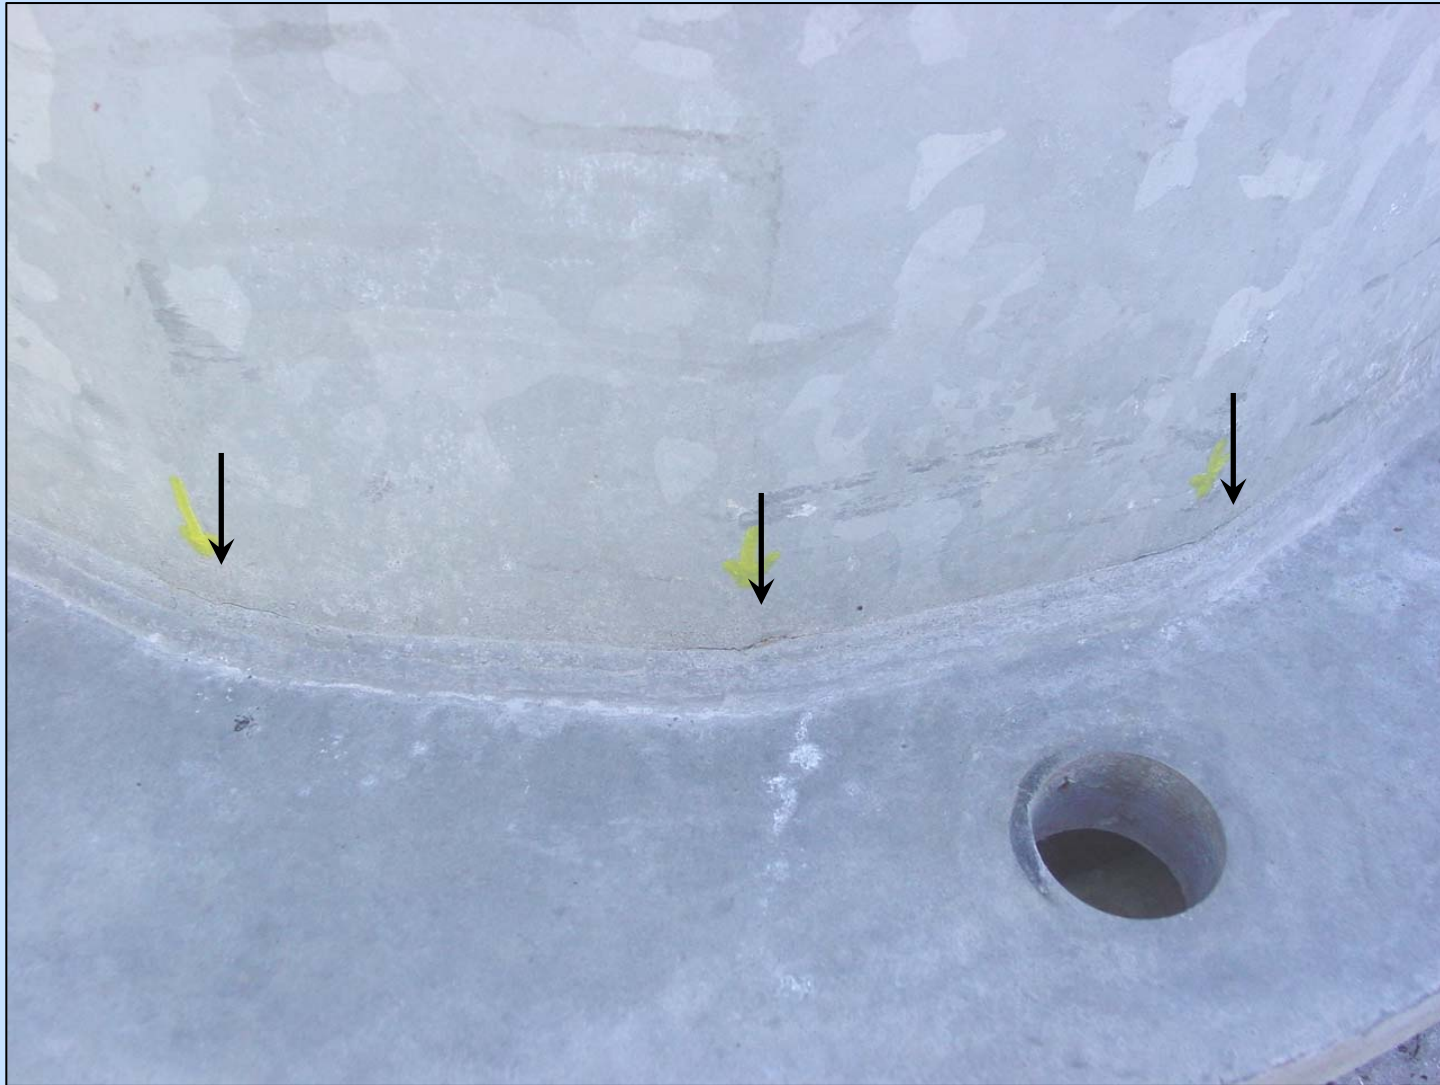
# Cracks at Bend Points

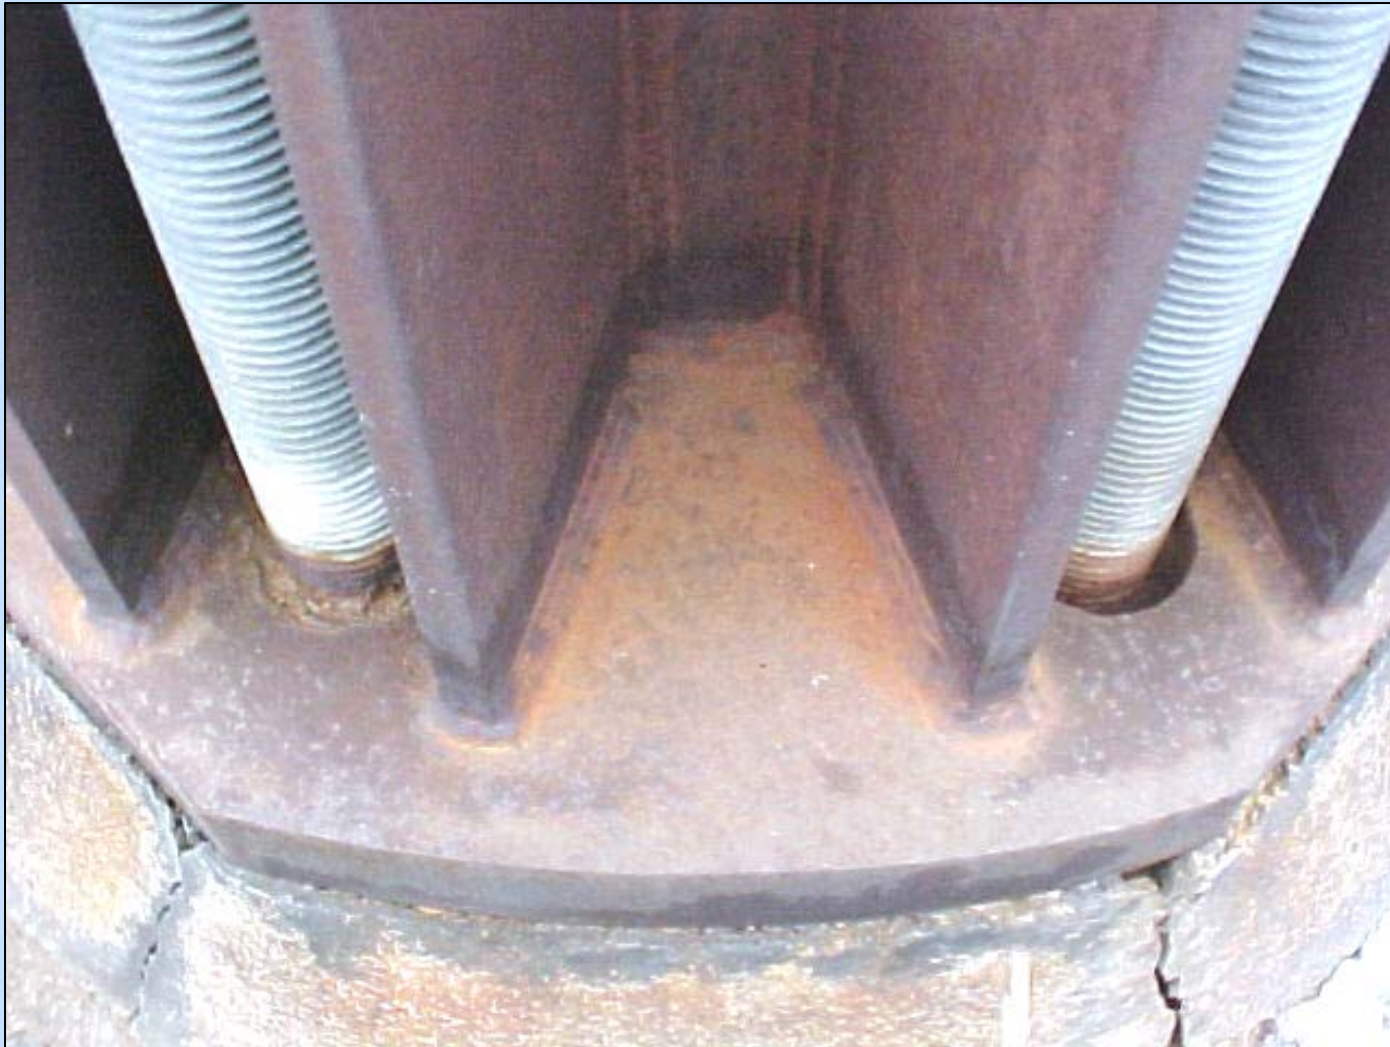
# Tower / Base Plate Welds

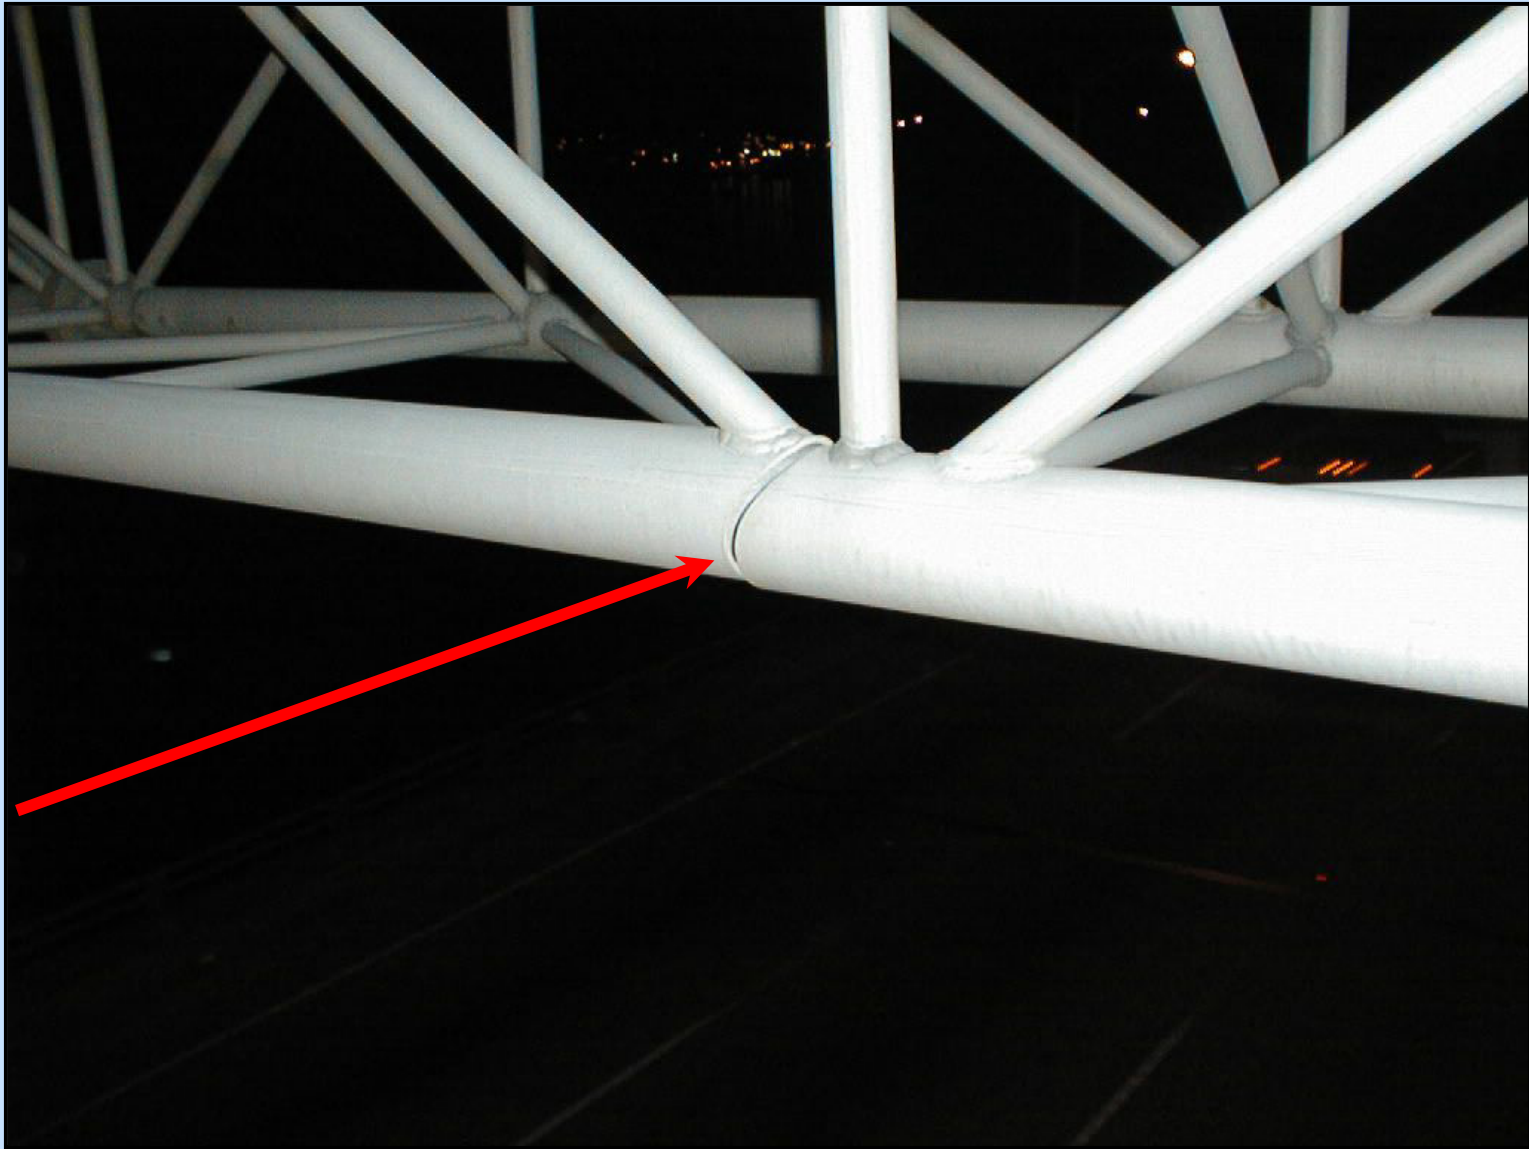
# Fractured Chord

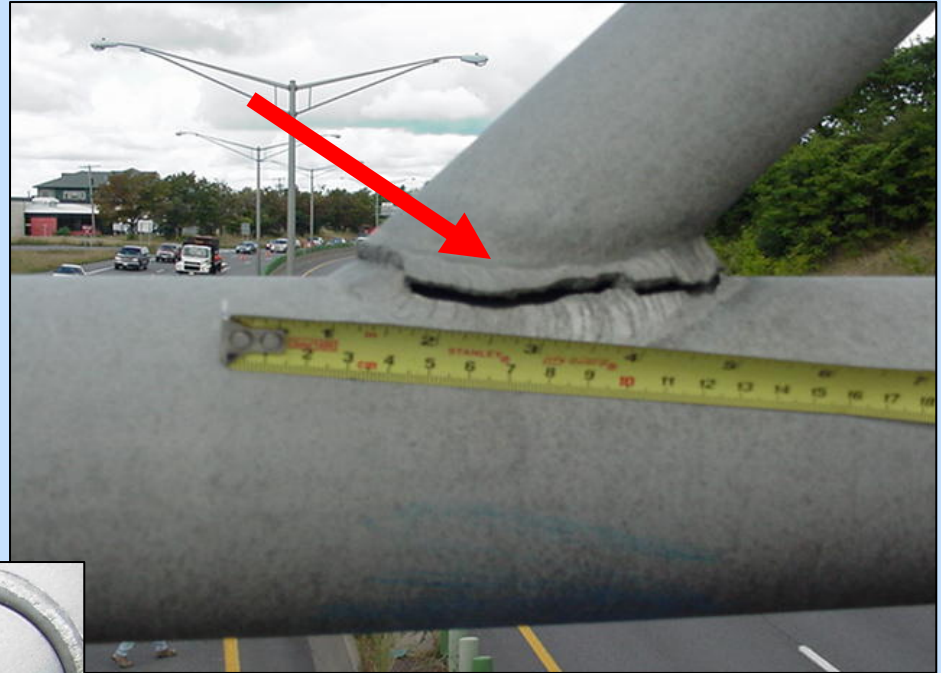
# Weld Defects

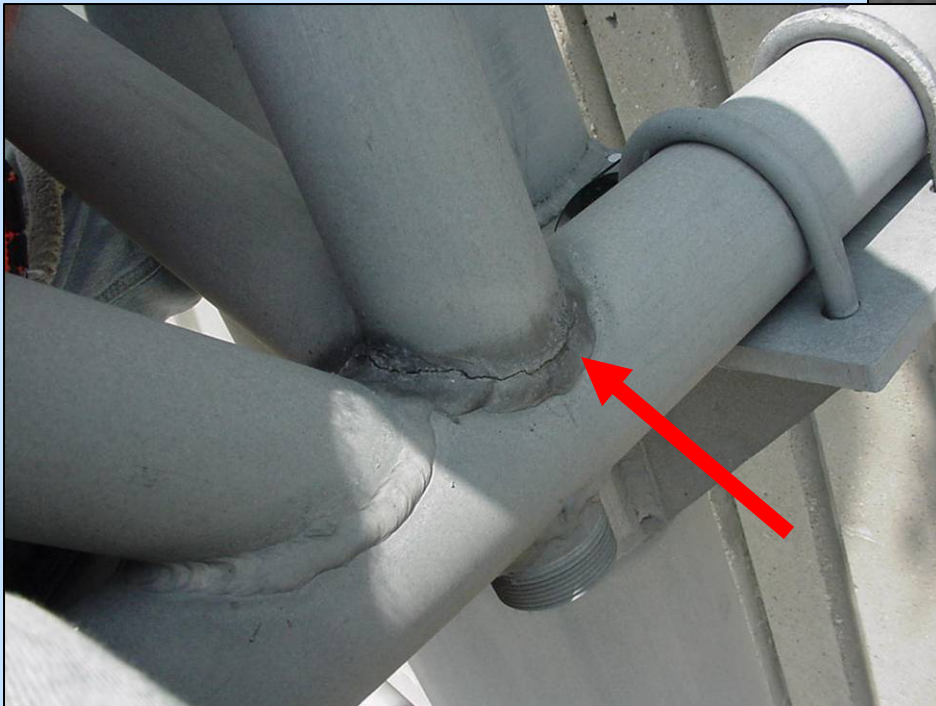
Aluminum Weld Cracks  
in Aluminum Truss

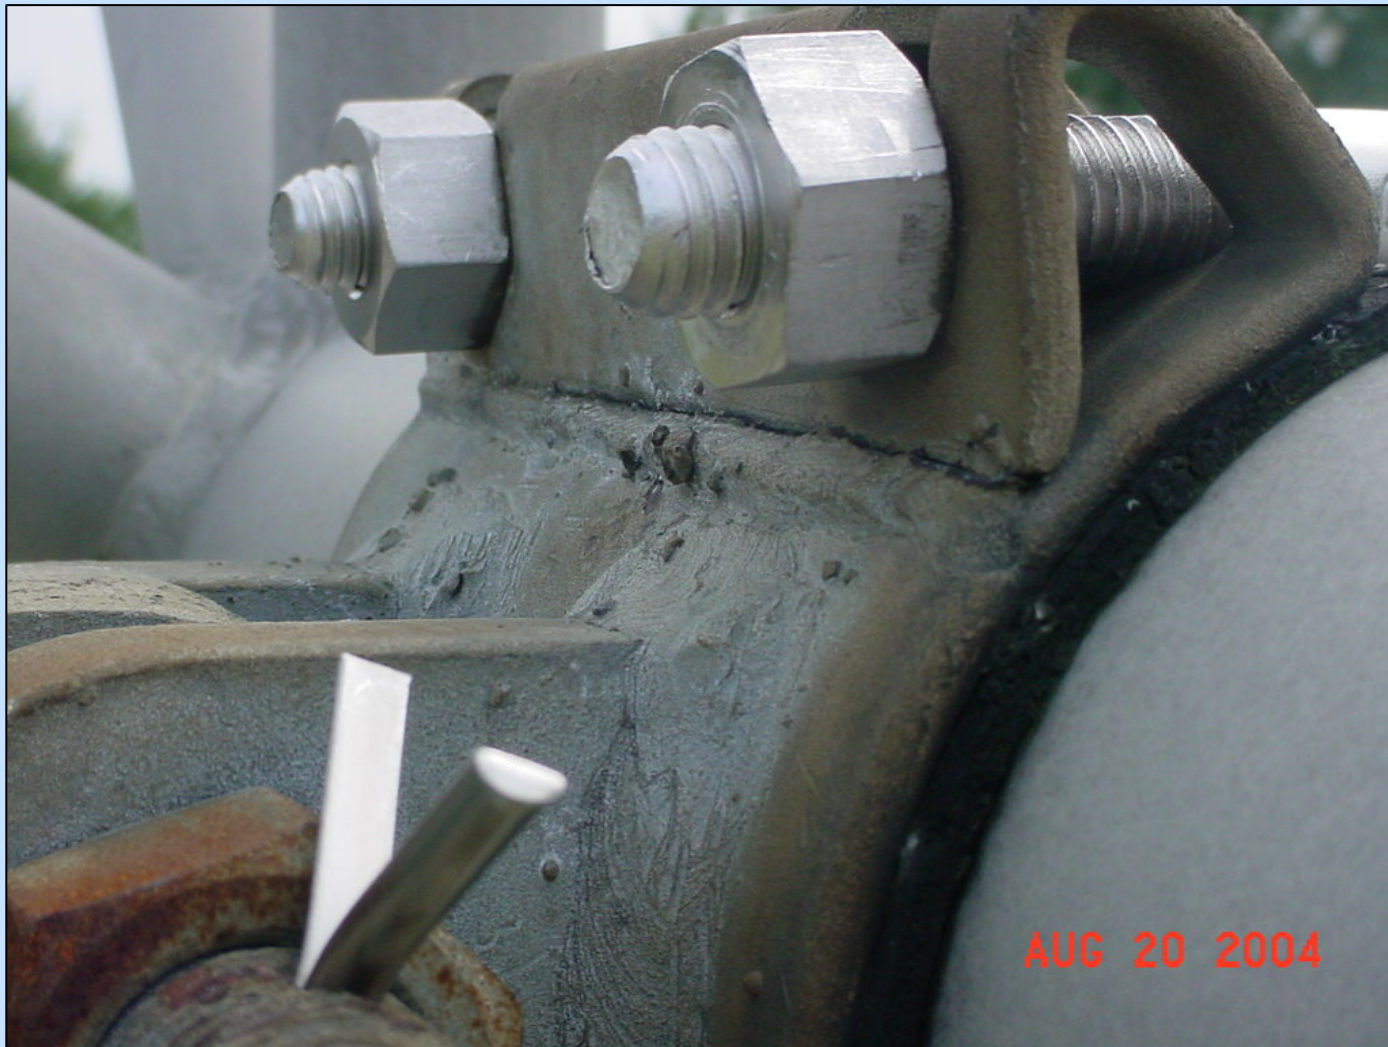
# Crack – Friction Clamp to Post

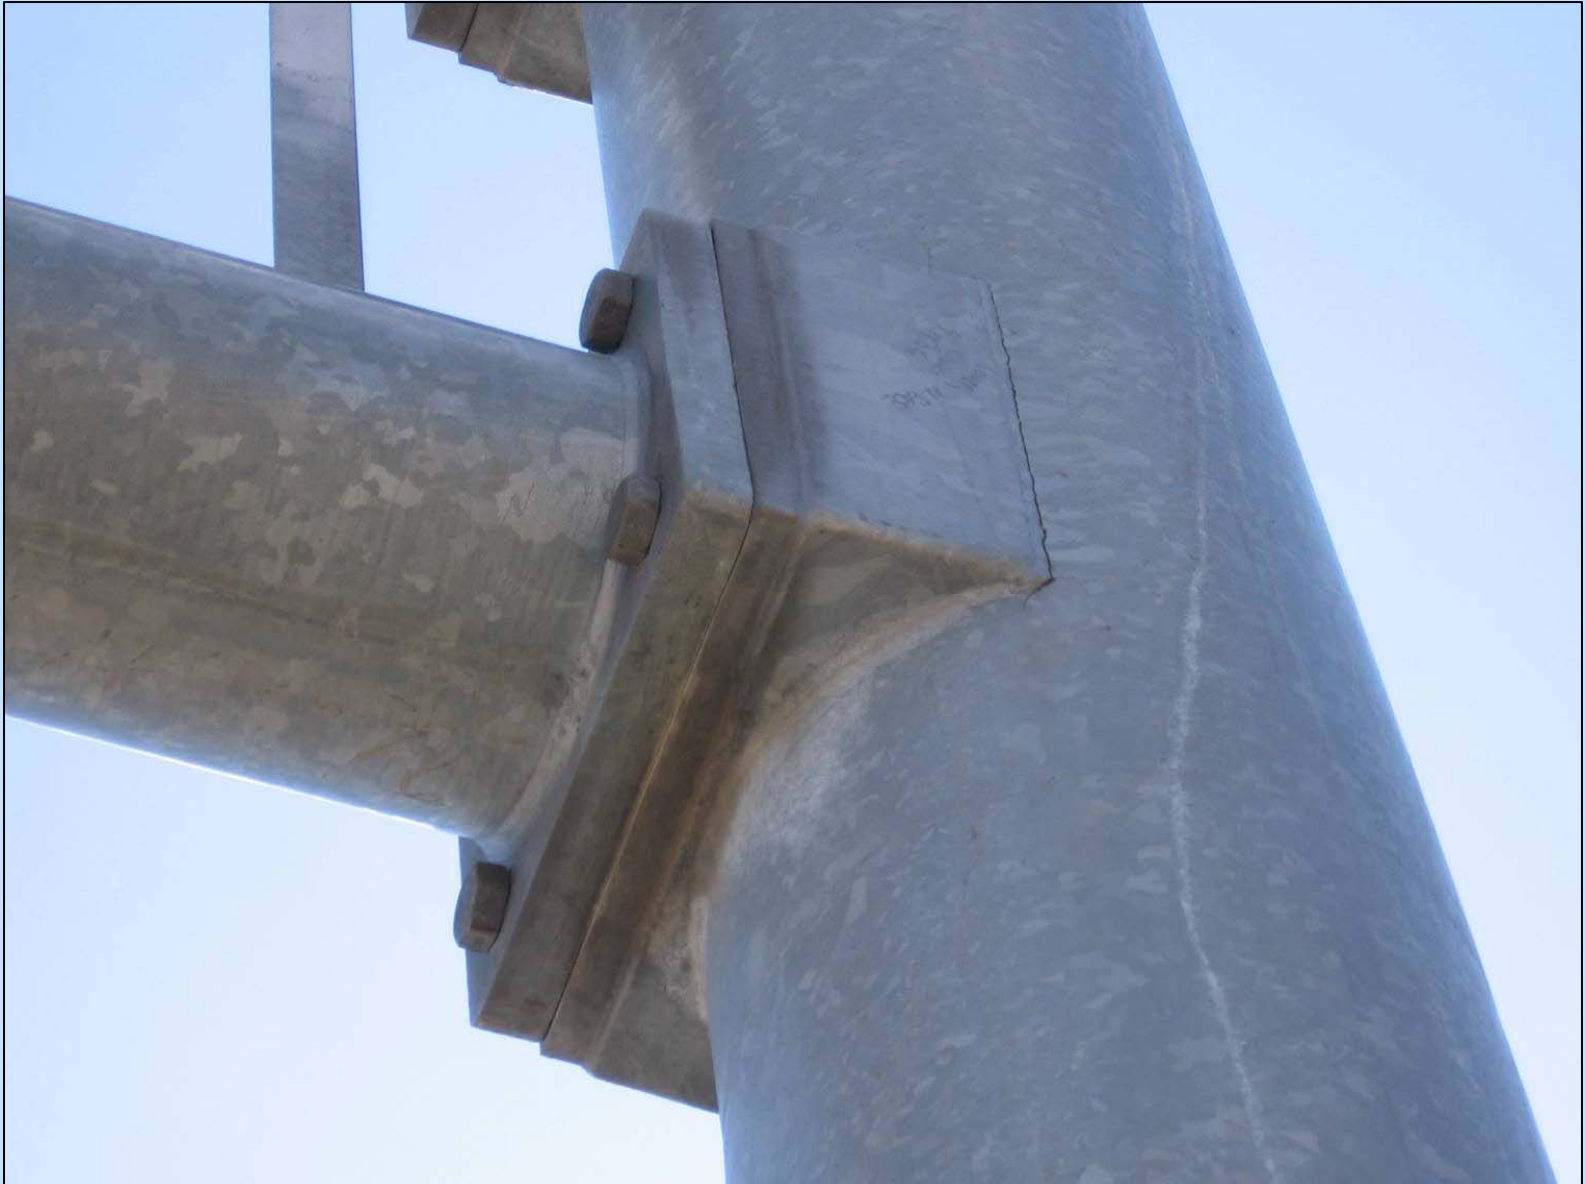
# Cracks in Newer Structure
