# **Ancillary Structure Inspection Procedures and Findings**

**Michael Garlich, S.E., P.E.  
Collins Engineers, Inc.**

**Western Bridge Engineers' Seminar 2007**

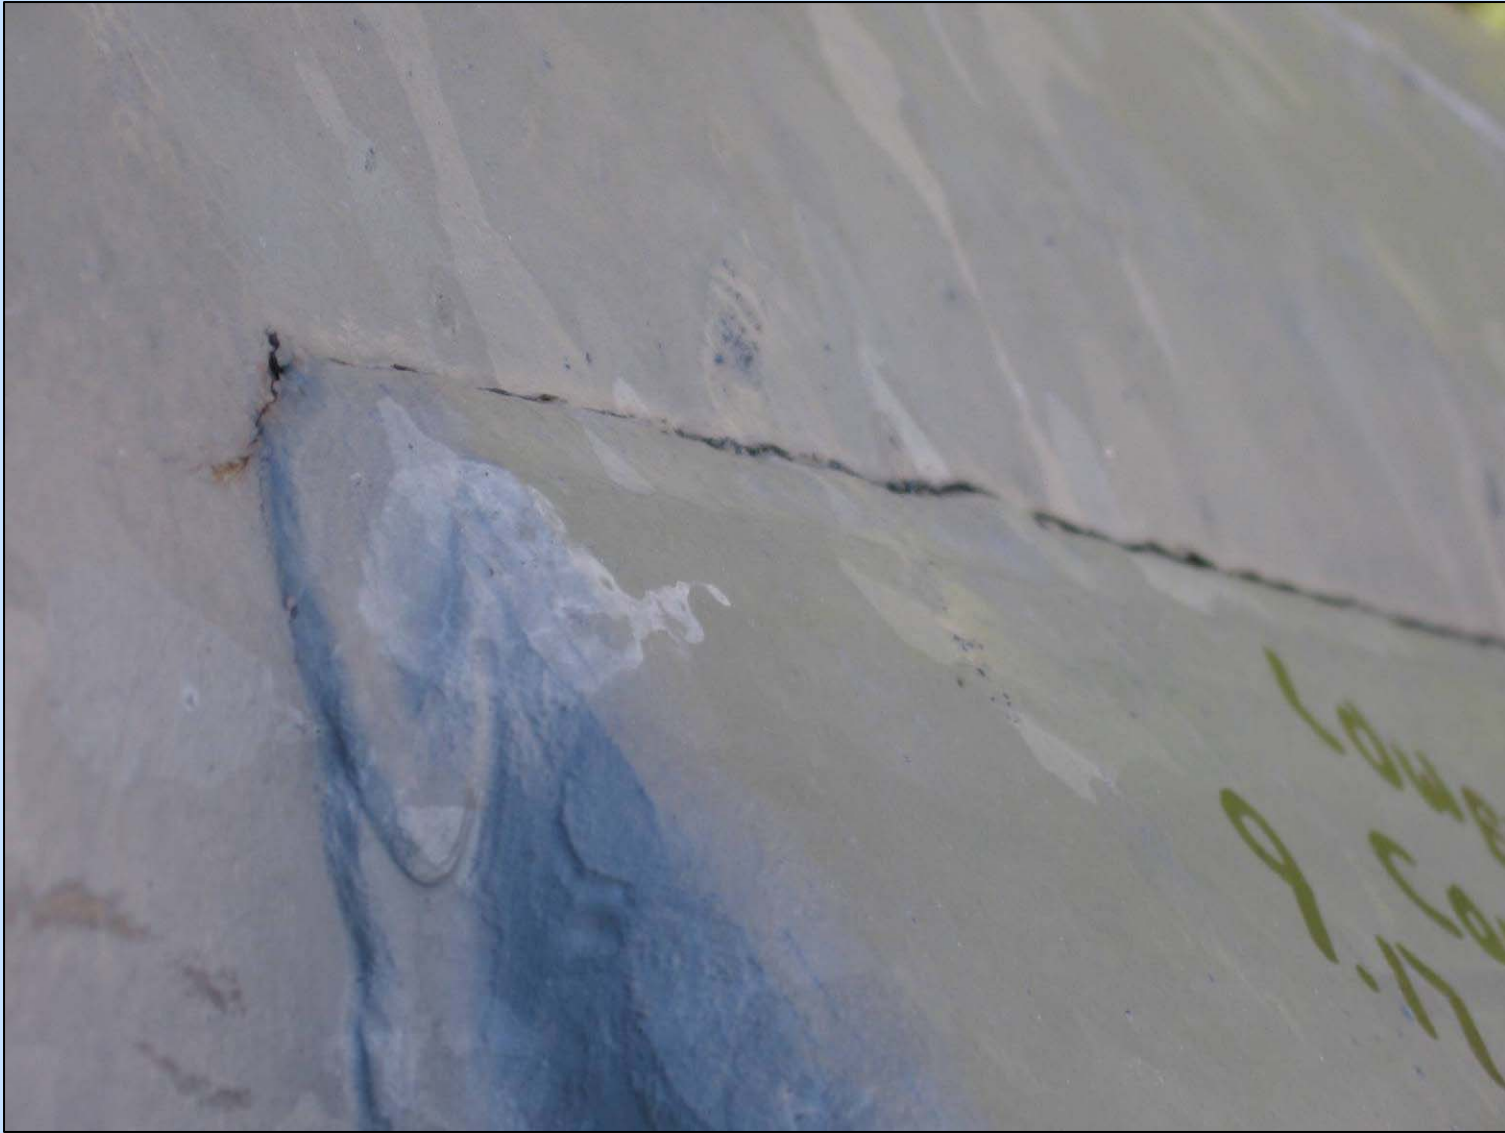
# Cracks in Newer Structure

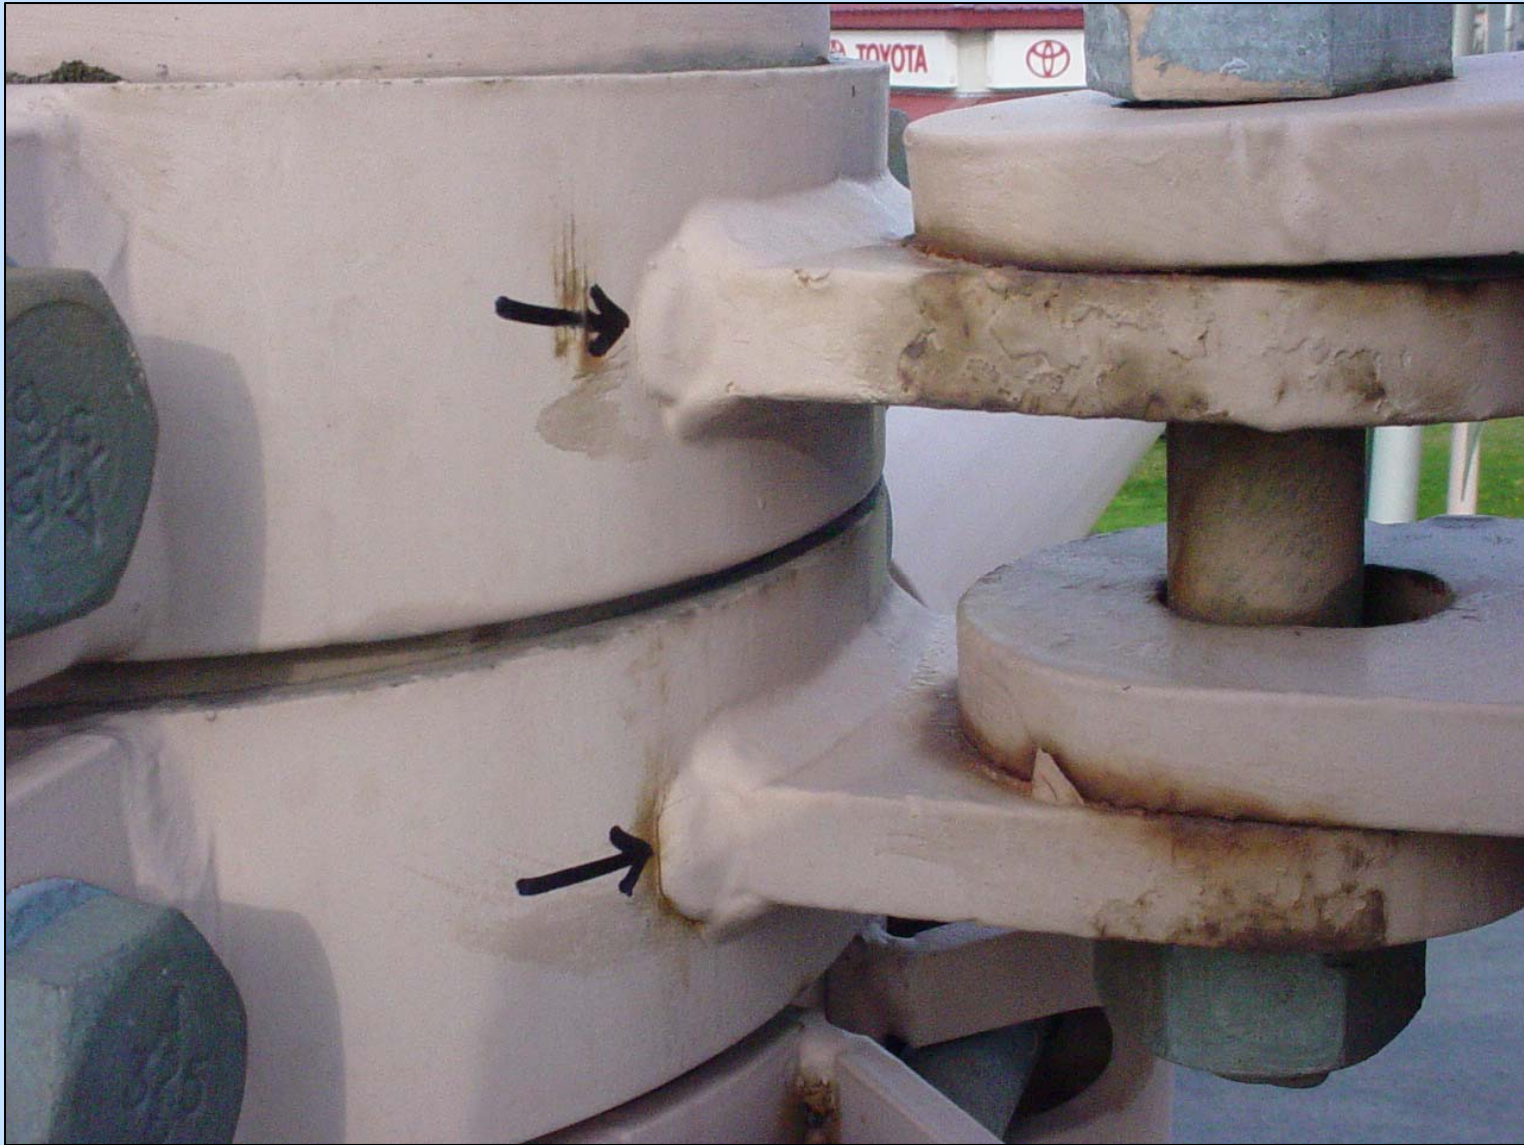
# Weld Cracks on Z-Type Structure

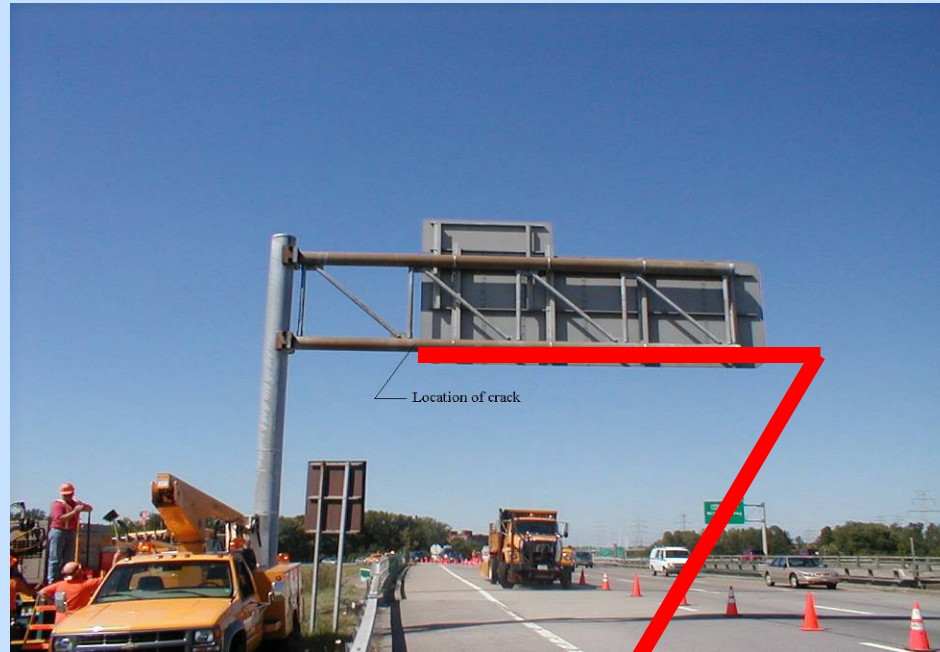
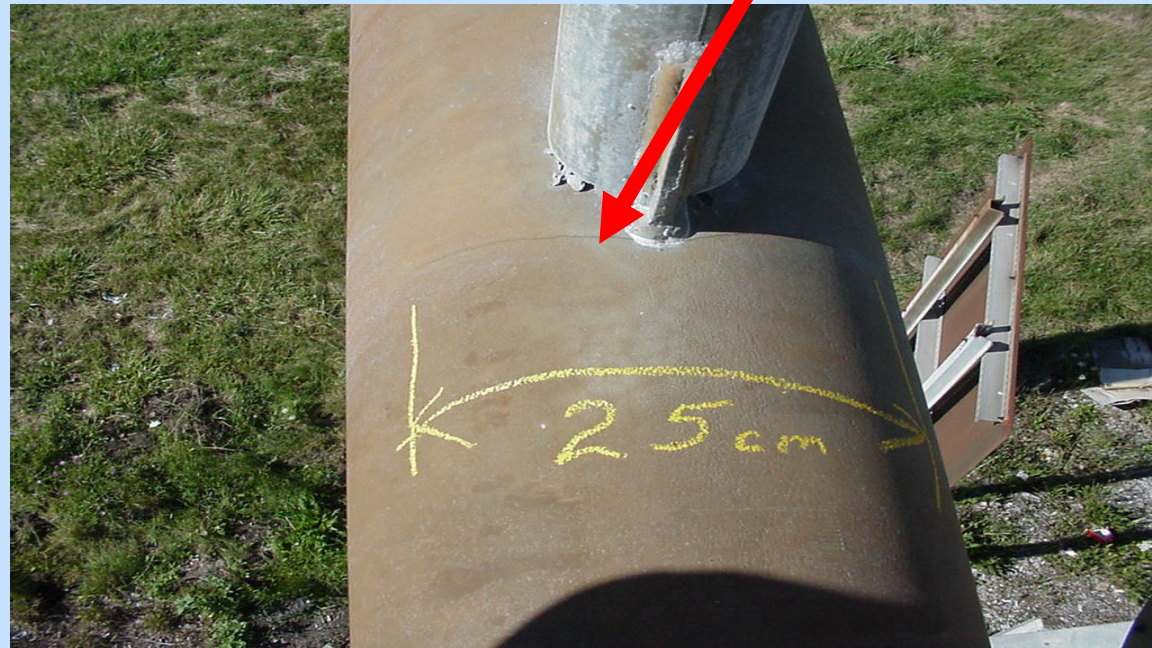
# Chord Crack

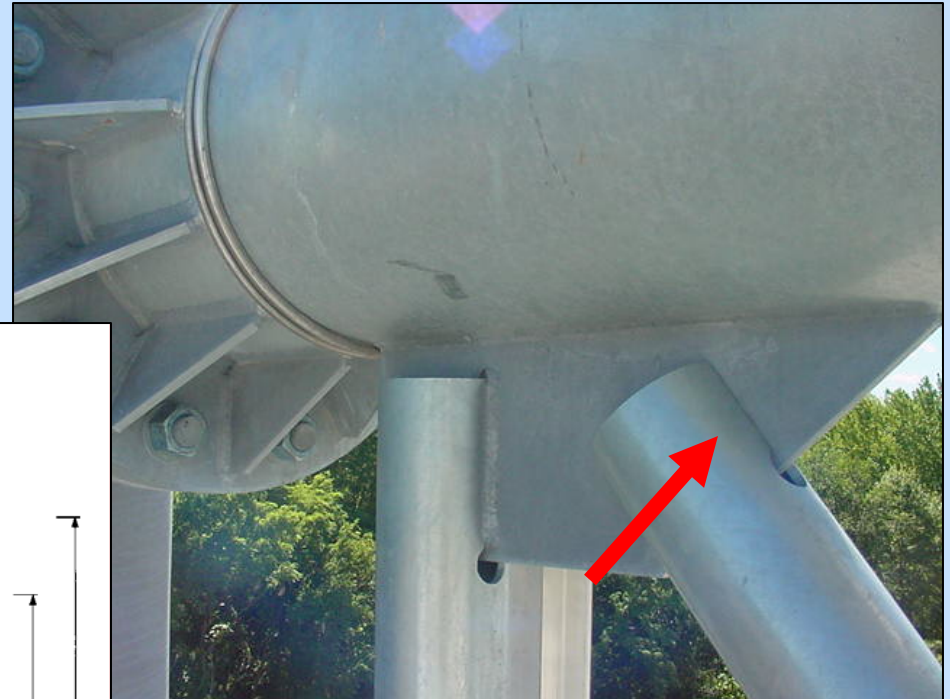
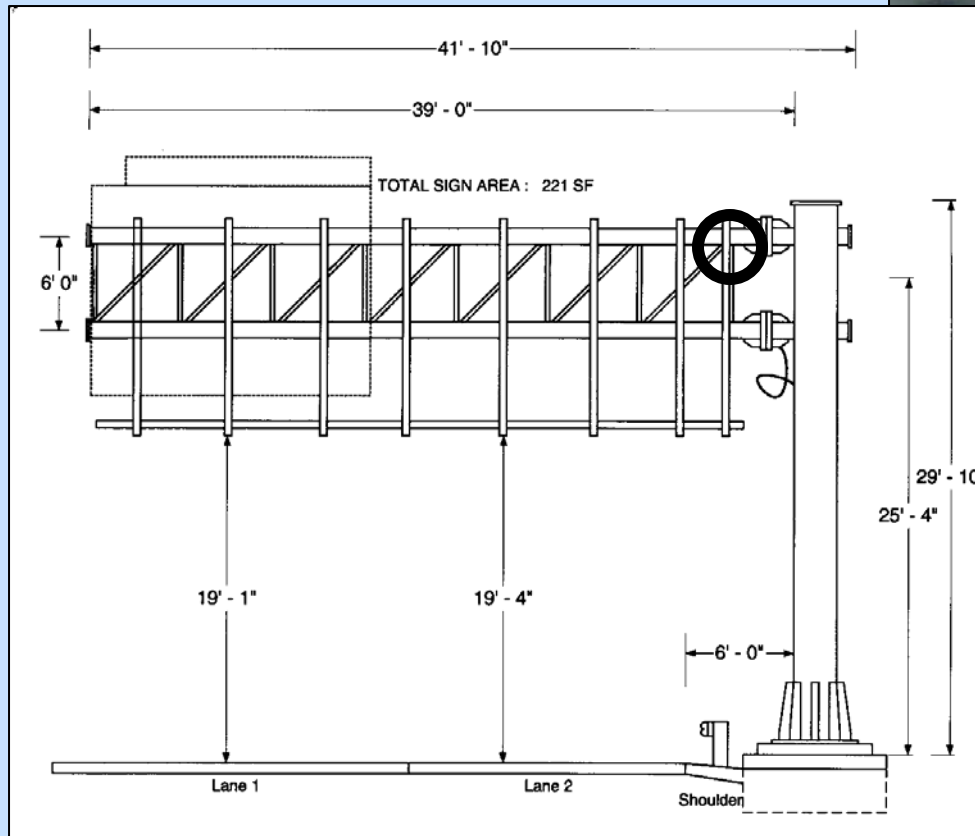
# Immediate Removal of Sign

- Connection  
– Rating?

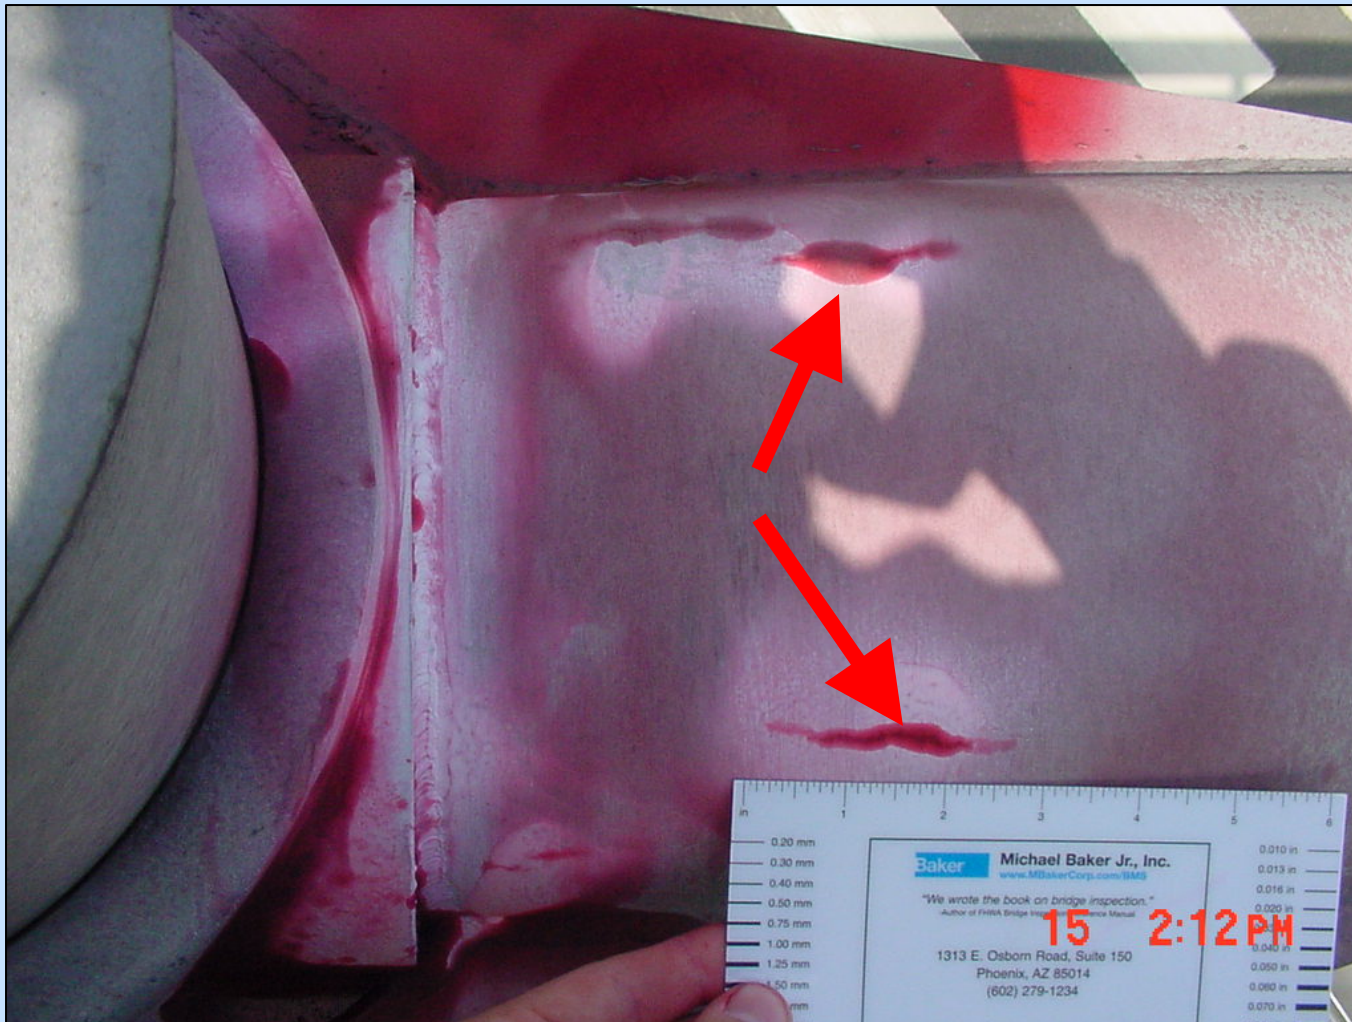
# Cracked Monotubes

- Cracks in Arm Parallel to Tensile Stress

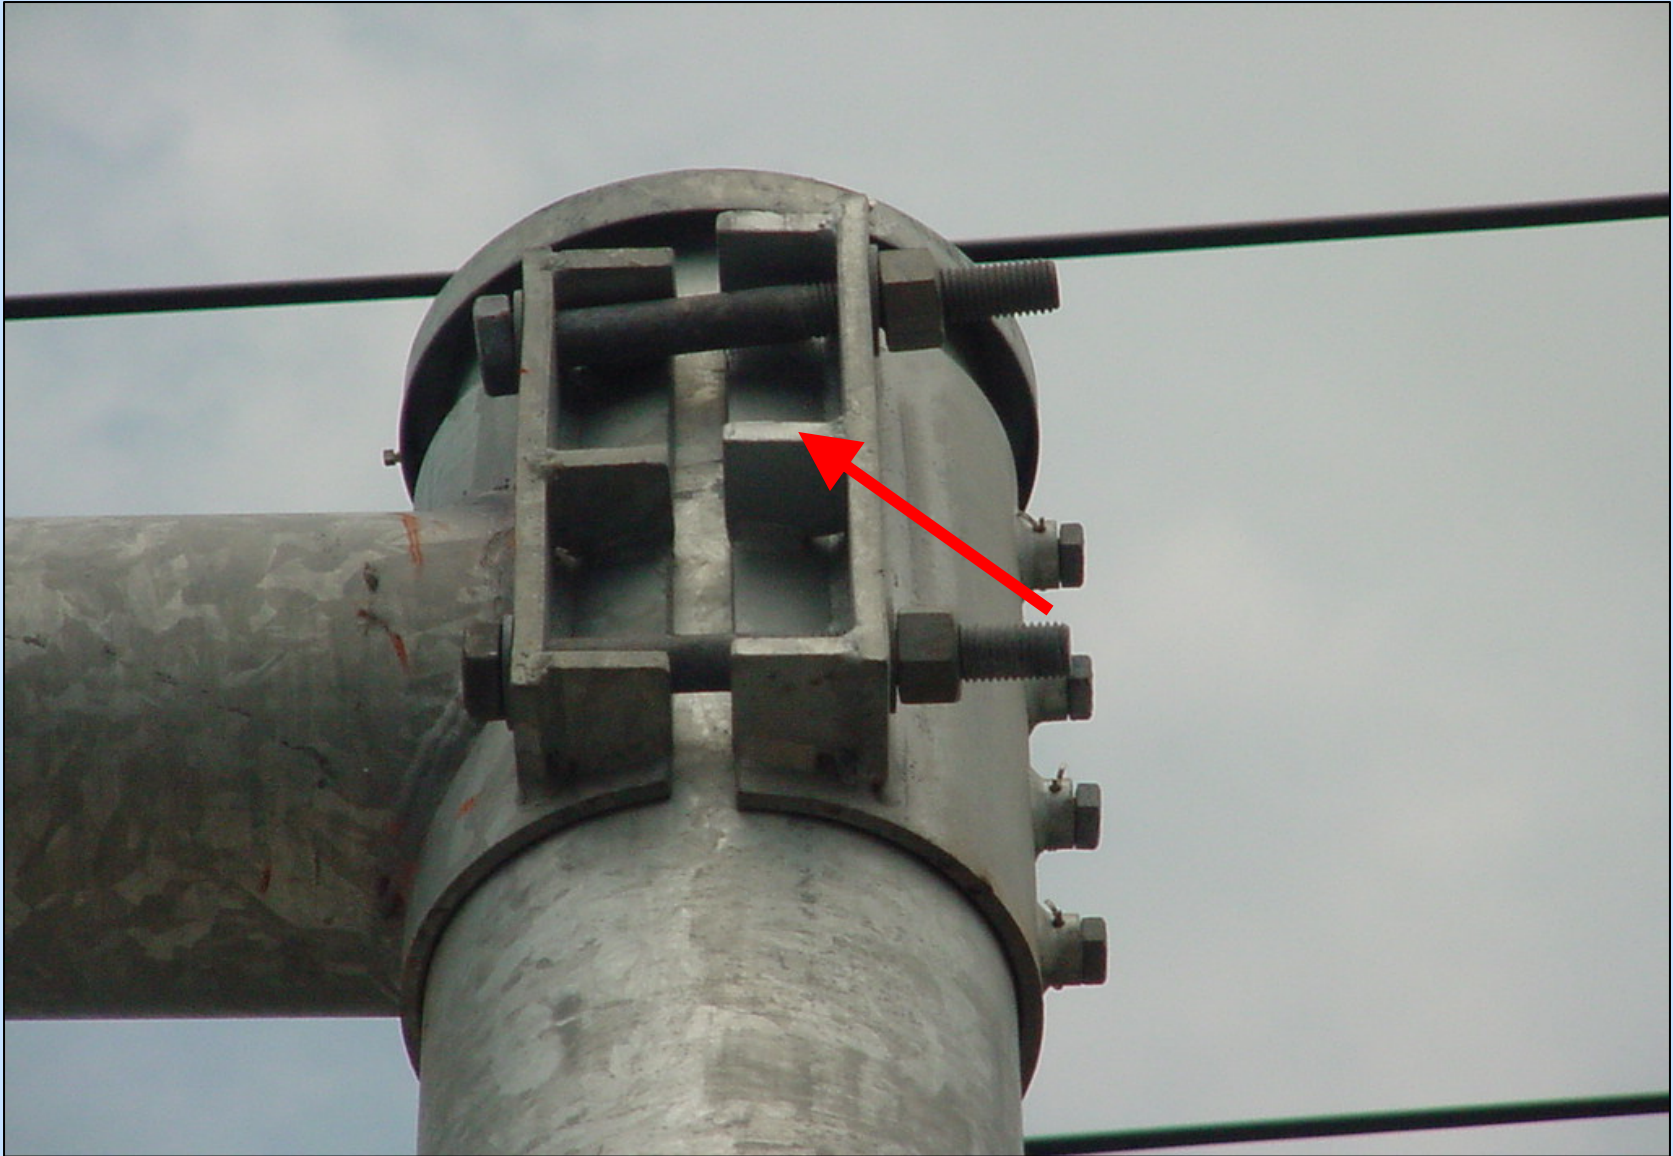
# Mismatched Connections

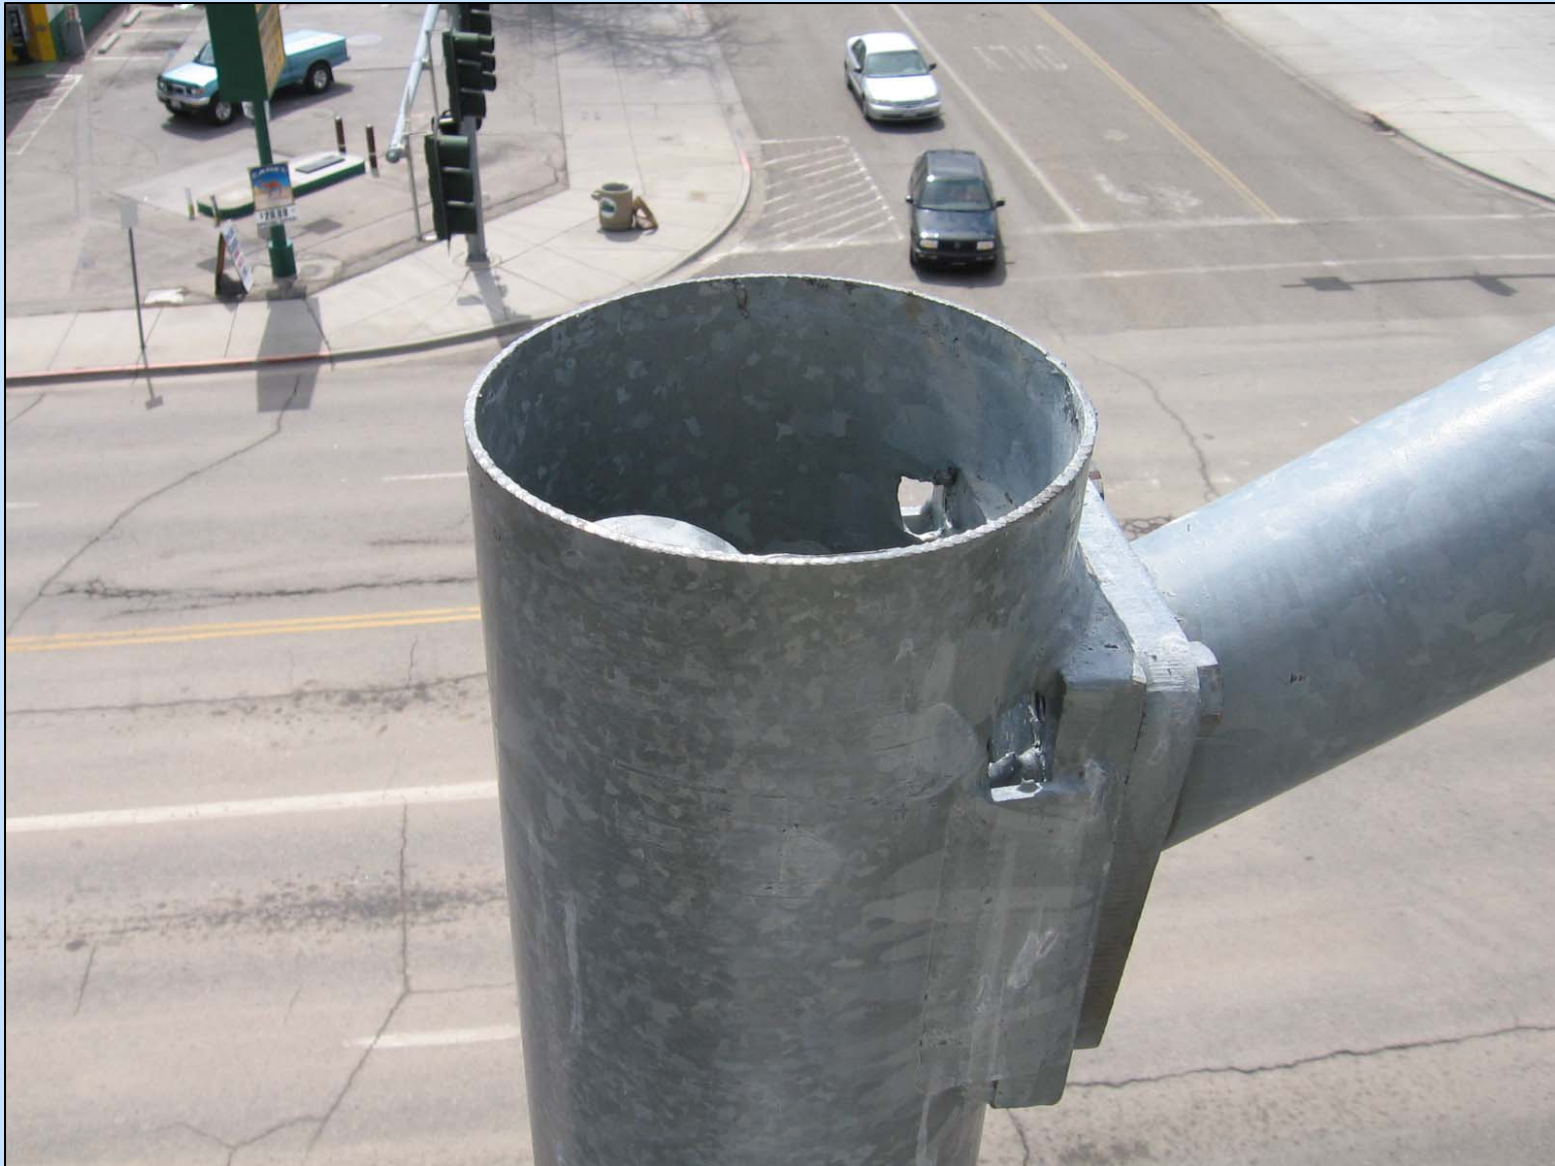
# Missing Column End Cap

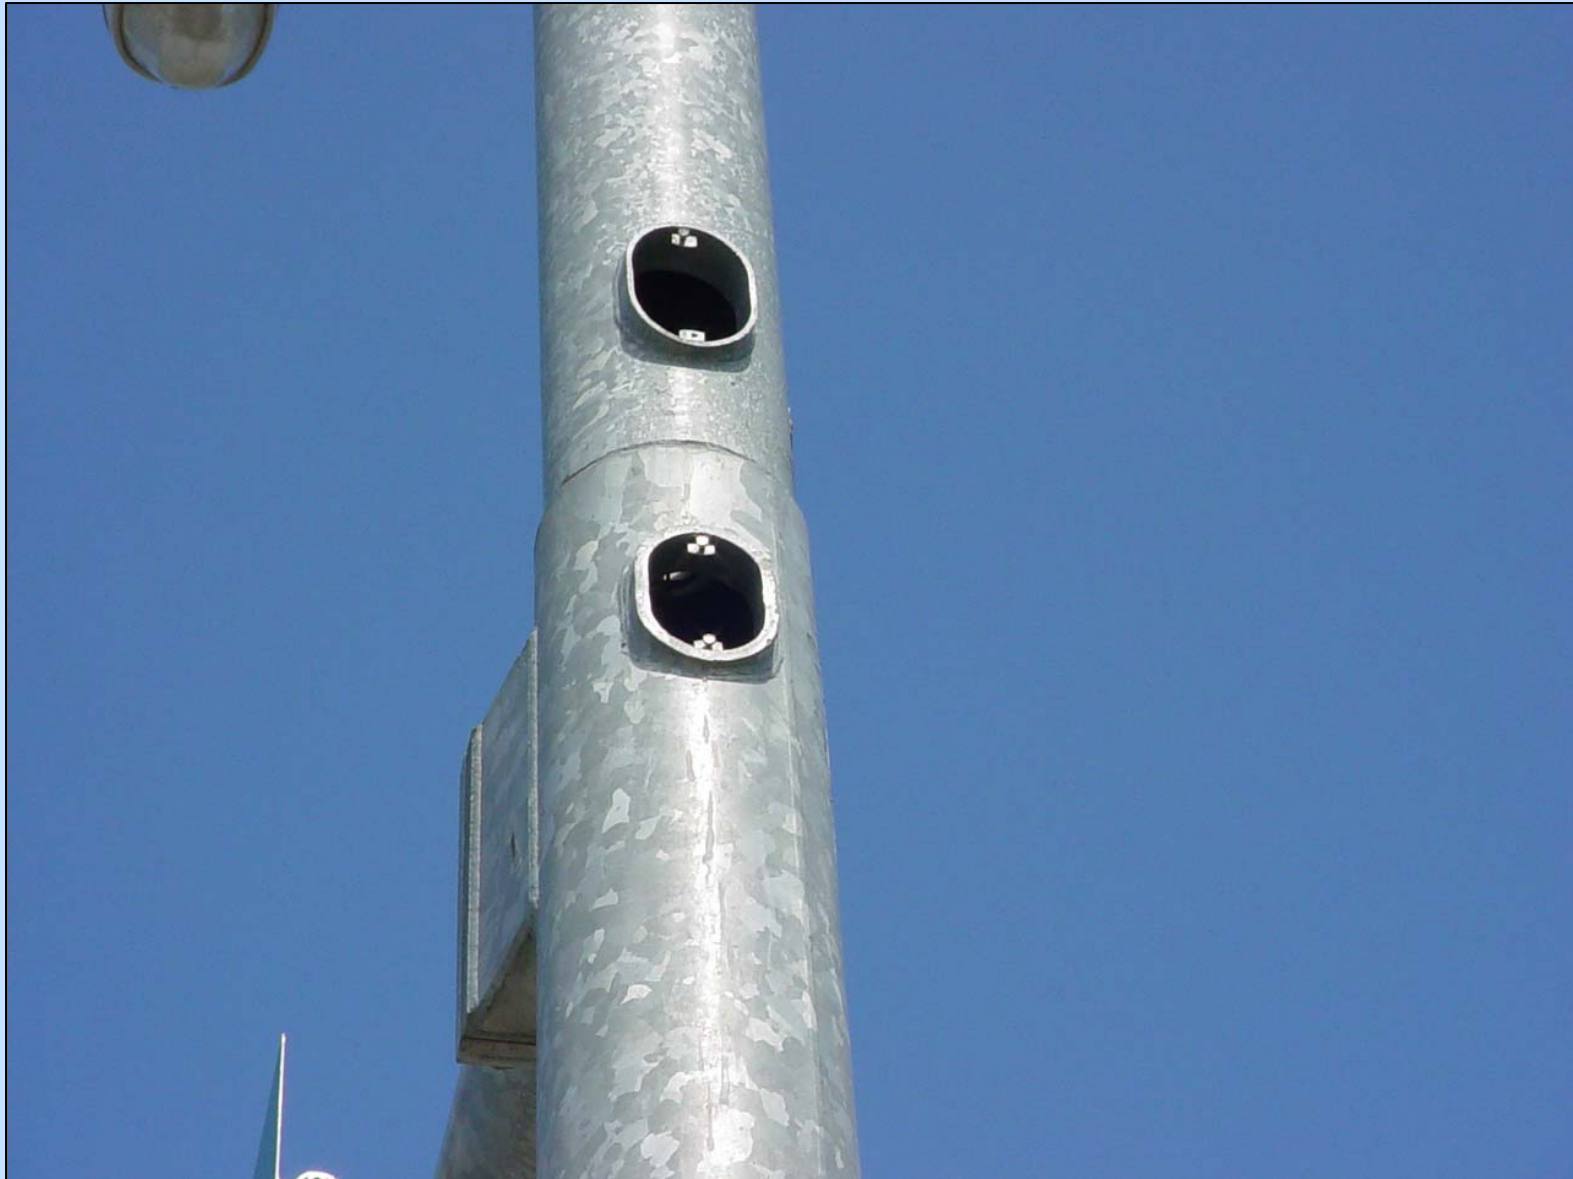
# Missing Hand Hole Covers
