Western Bridge Engineers' Seminar
September 24 – 26, 2007
Boise, Idaho

Emergency Replacement of the Russian River Bridge on Hwy 128 in Geyserville

CALIFORNIA DEPARTMENT OF TRANSPORTATION

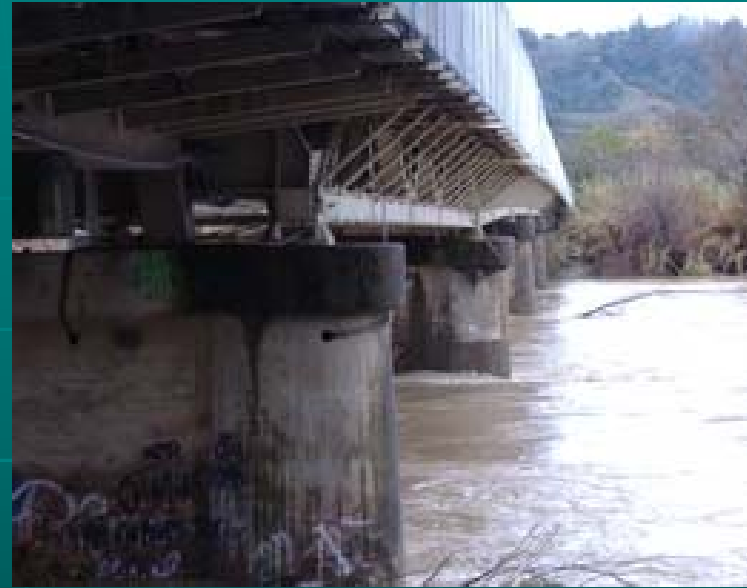
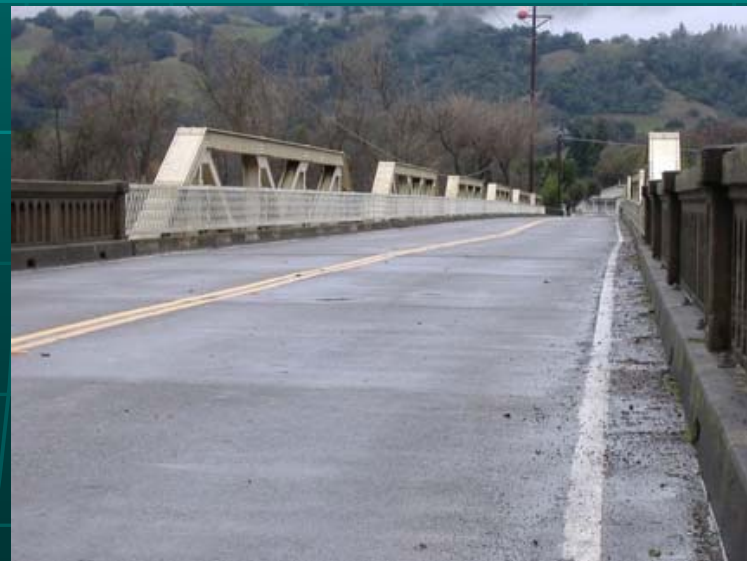
- Major damage resulting from series of storms during last week of December 2005
- Bridge closed to traffic after local authorities observe deck sag and shift
- Structure Maintenance and Investigations on January 2 observes:
 - 0.2-m settlement at right gutter above Pier 6
 - Longitudinal misalignment of superstructure
 - Diagonal break in web wall
 - Tilted rocker bearings
- Closure creates hardship to the community
 - 15 mile detour
 - Public schools, residences and businesses divided by river

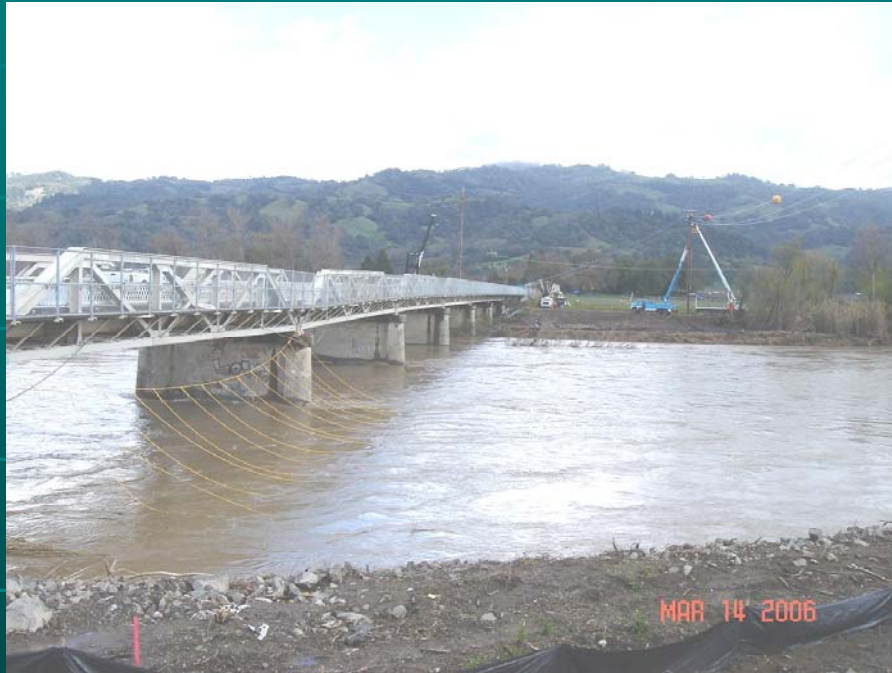
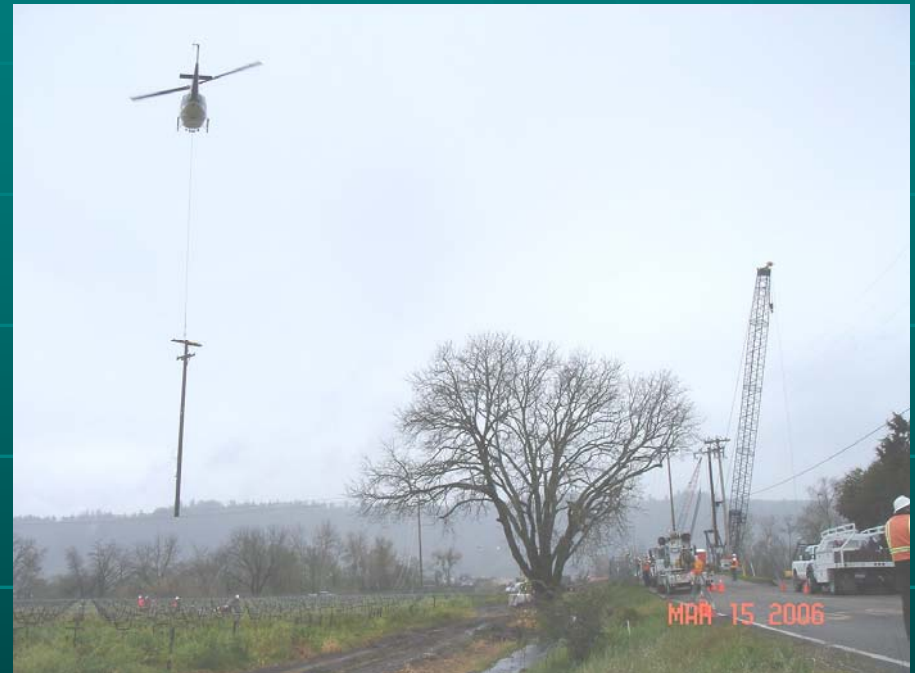
Creating Access Utility Relocation

- Overhead lines relocated from adjacent to upstream EOD to downstream utility easement

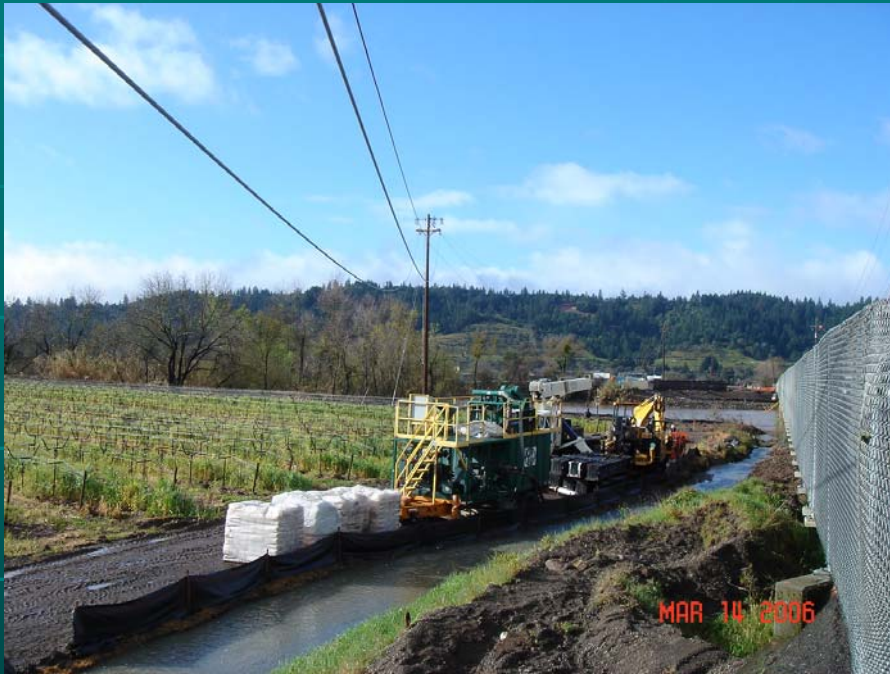
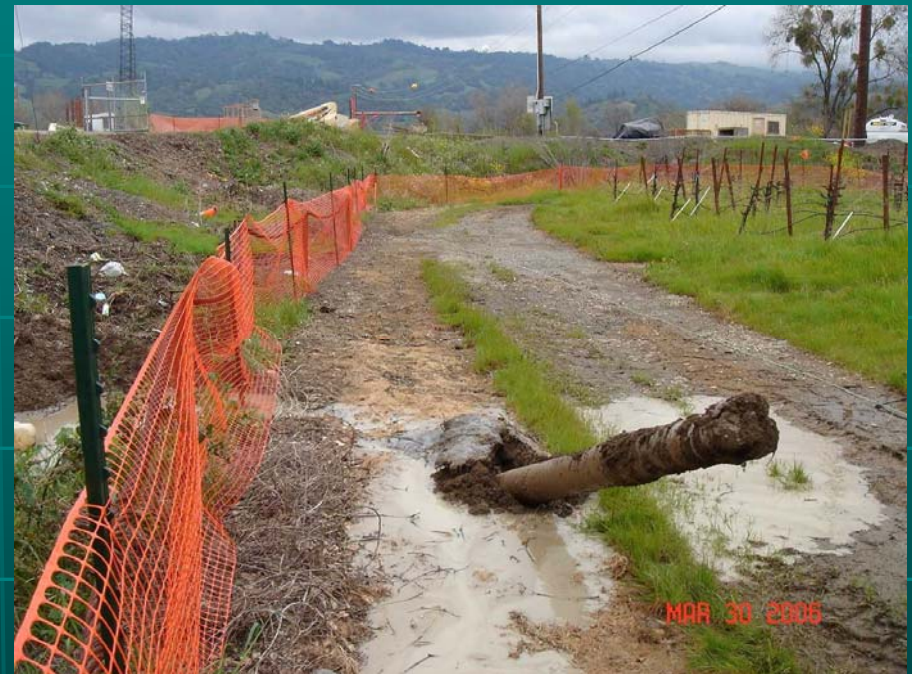
Creating Access Utility Relocation

- PG&E Contractor bored 1000' long 8" dia. hole up to 65' deep under river
- Placed 4" permanent gas line
- Trestle pile work stopped due to vibration while boring pipe

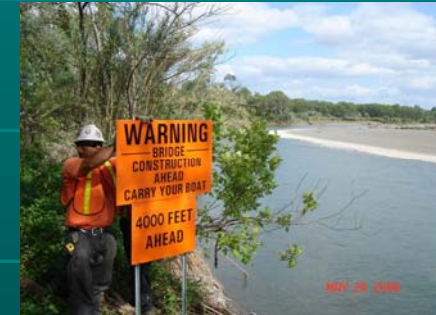
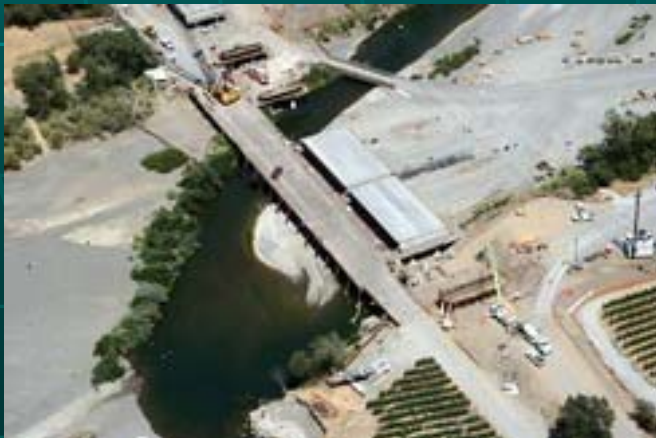
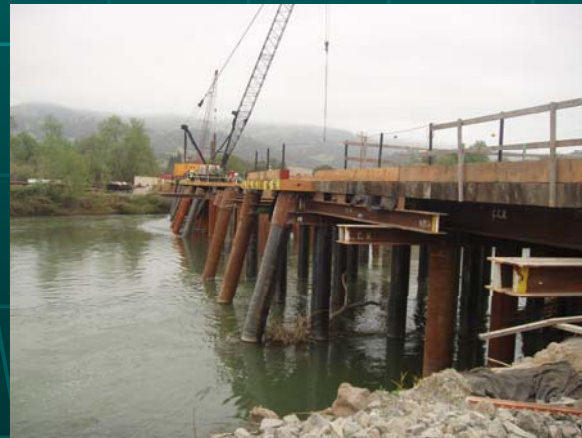
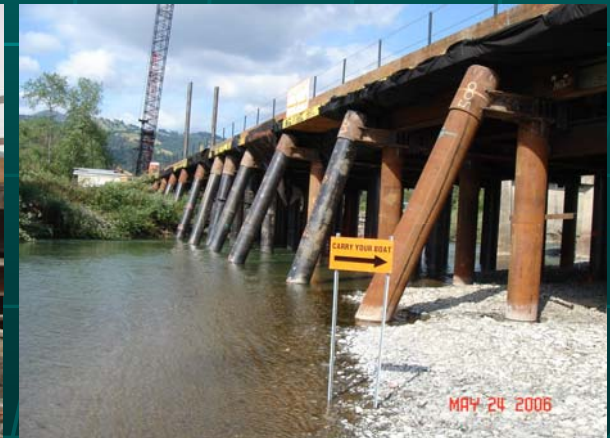
- Provide all weather access & durability
- Width to accommodate bridge repair, removal & meet all future contract needs
- Minimize environmental impacts
- Minimize installation time

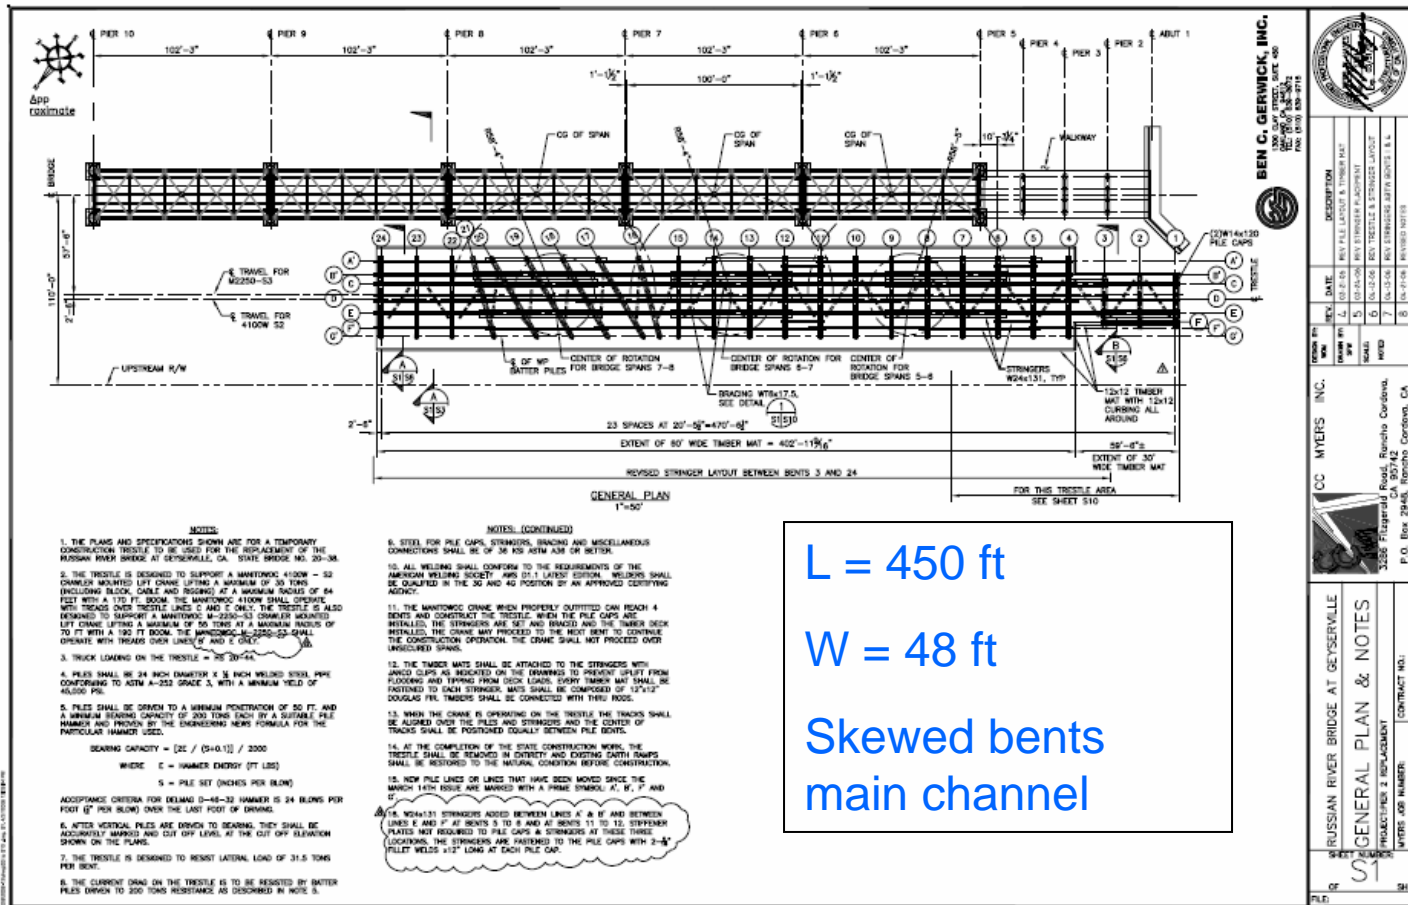
L = 450 ft
W = 48 ft
Skewed bents
main channel

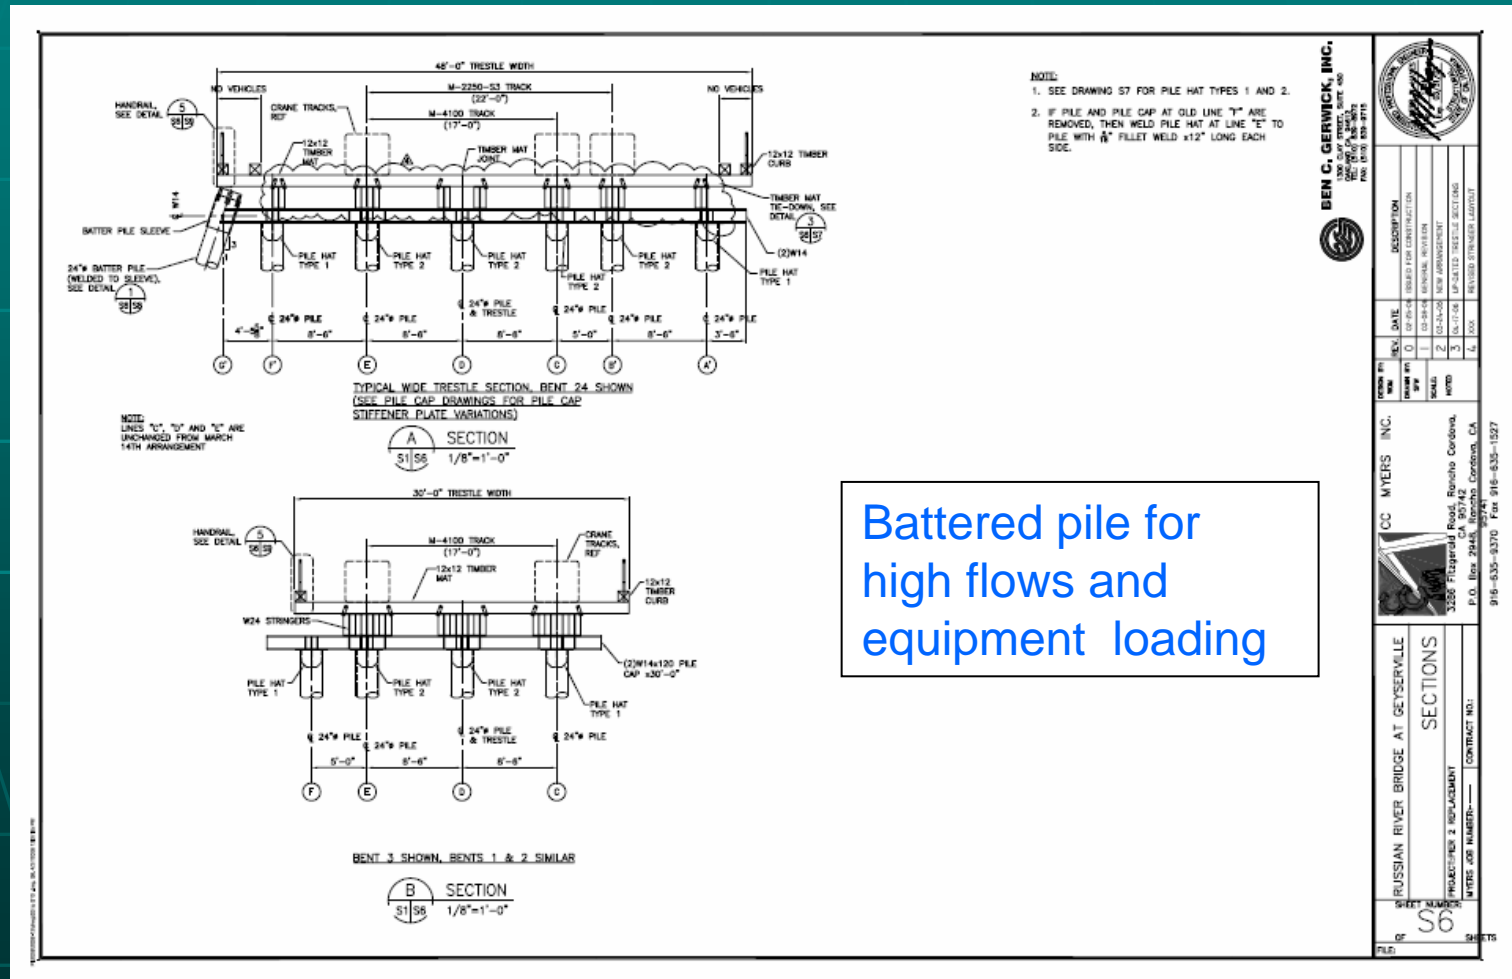
Battered pile for high flows and equipment loading

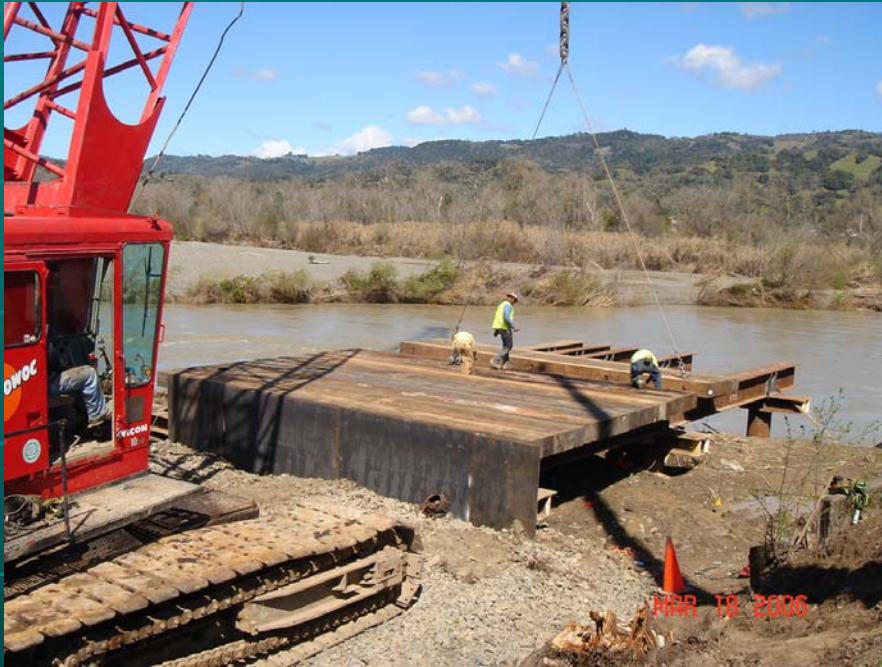
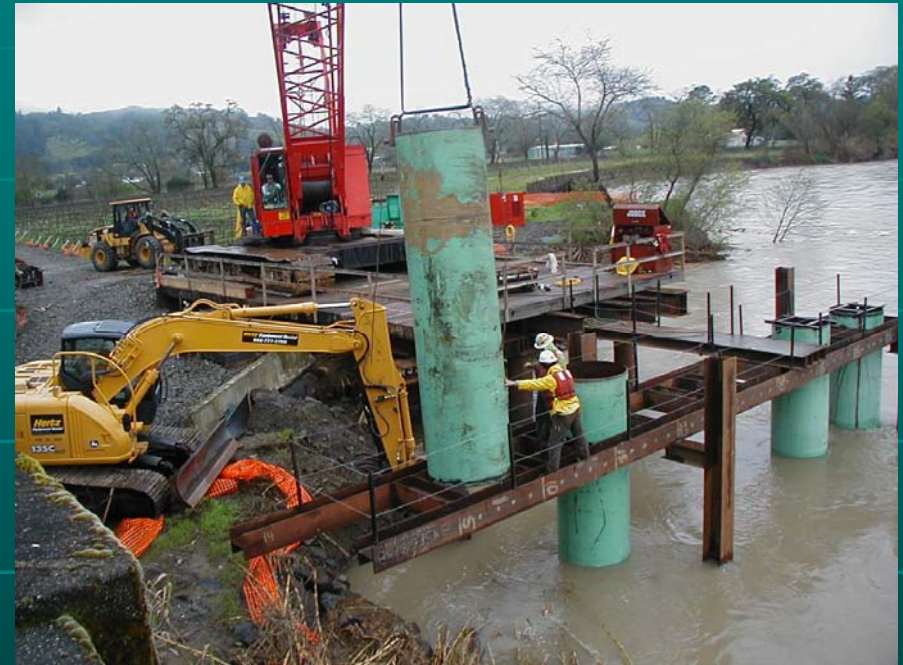
- Trestle installation started from west bank using Manitowoc 4100W
- Template installed to support 48" isolation casings
- Isolation casing required by agencies to minimize sound vibration from driving 24" trestle pipe piles due to presence of endangered Coho Salmon and threatened Coastal Steelhead
- Hydroacoustic monitoring performed

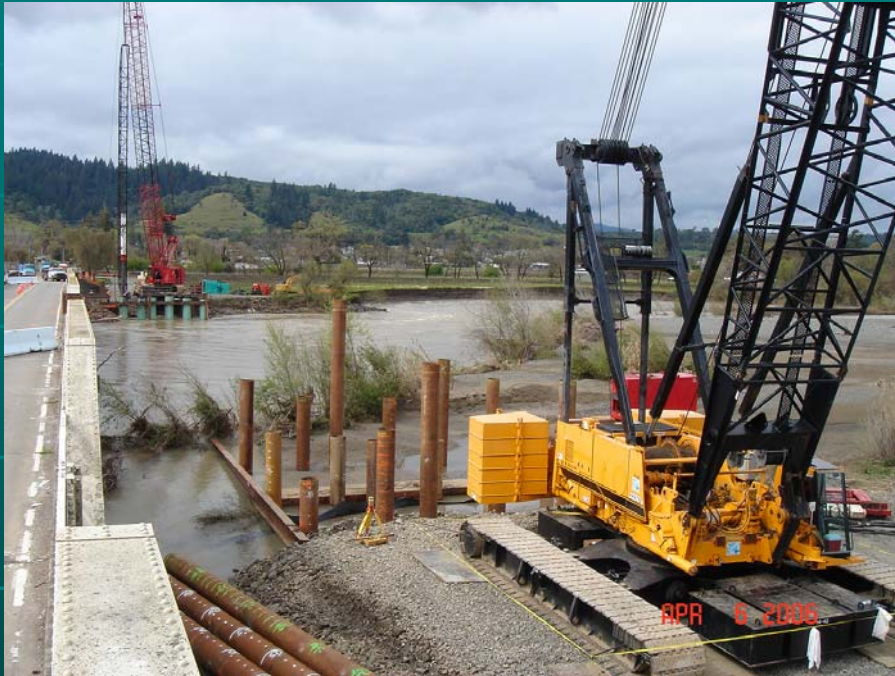
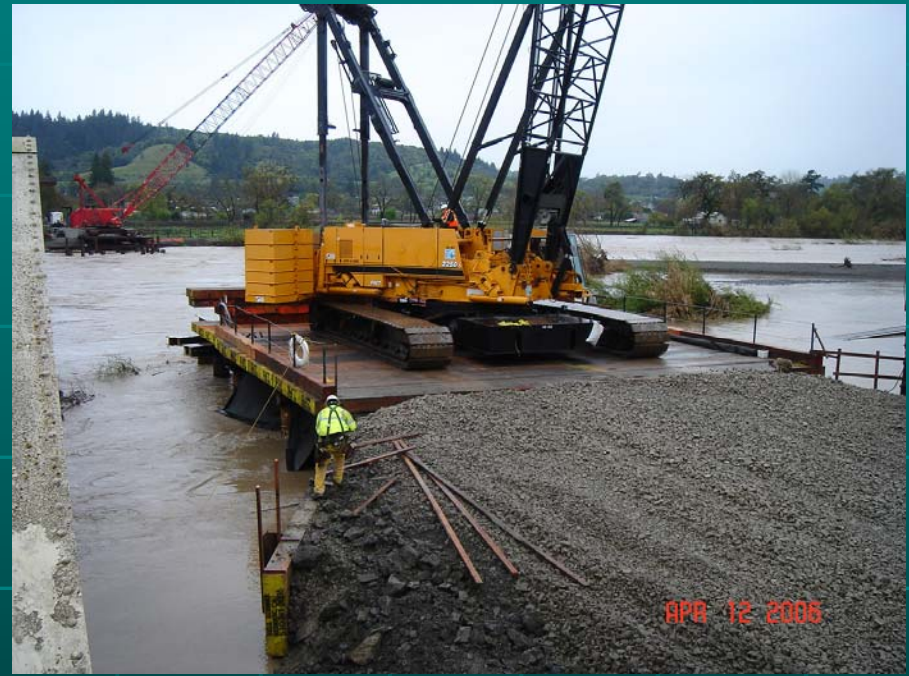
- Trestle started from east bank to accelerate progress using Manitowoc M2250
- East bank crane provided greater reach & all weather production
- High water in mid-April threatens access & slows trestle progress

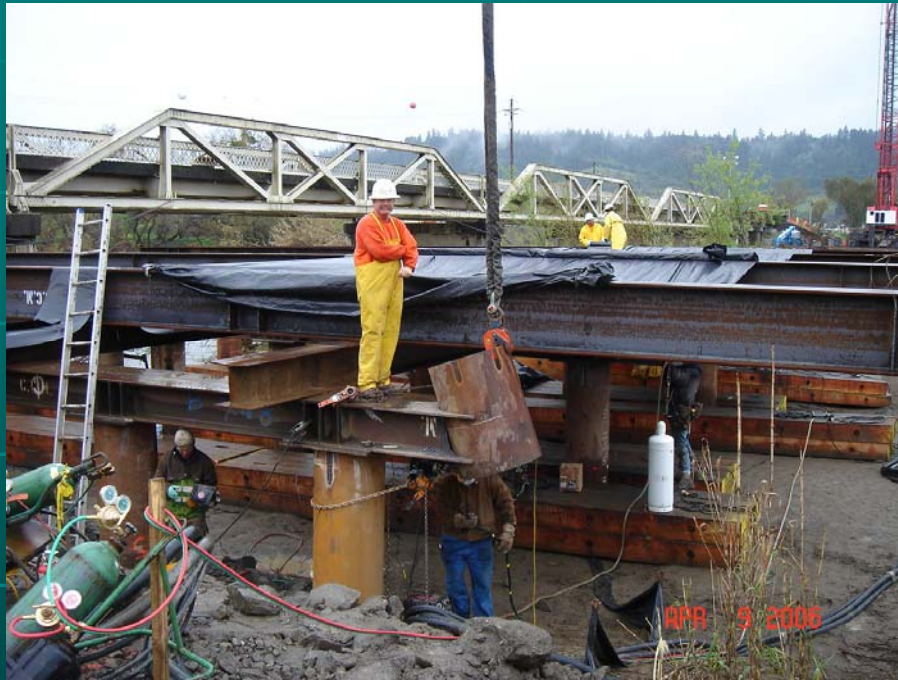
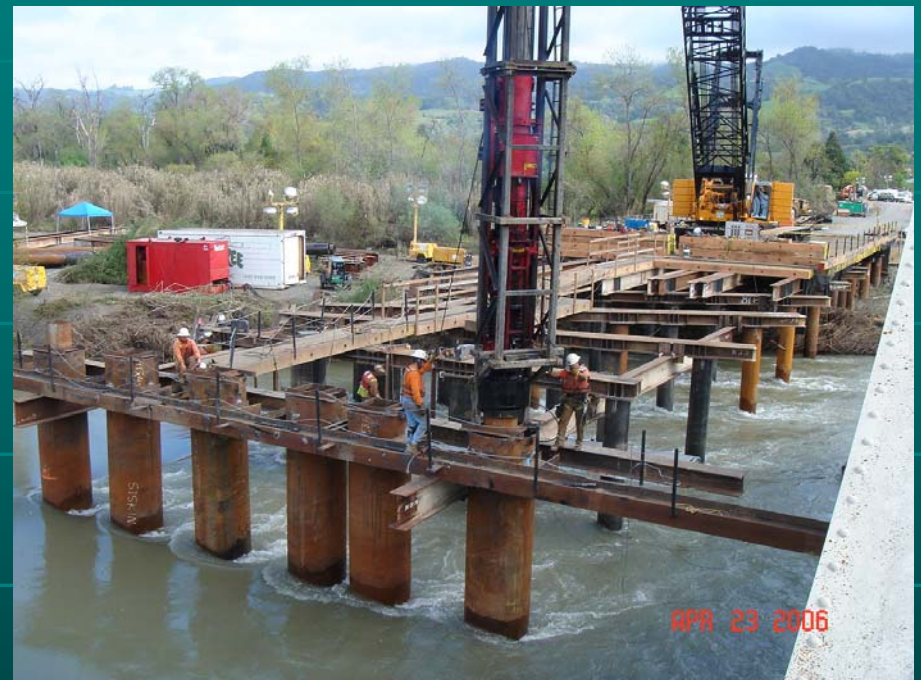
- Setting trestle battered pile collar
- Installing east side trestle piles through isolation casing
- Piles installed using diesel hammer, vibratory hammer & hydraulic hammer
- Pile driving records maintained
- PDA performed to reduce ENR bearing requirement on 200 ton trestle piles

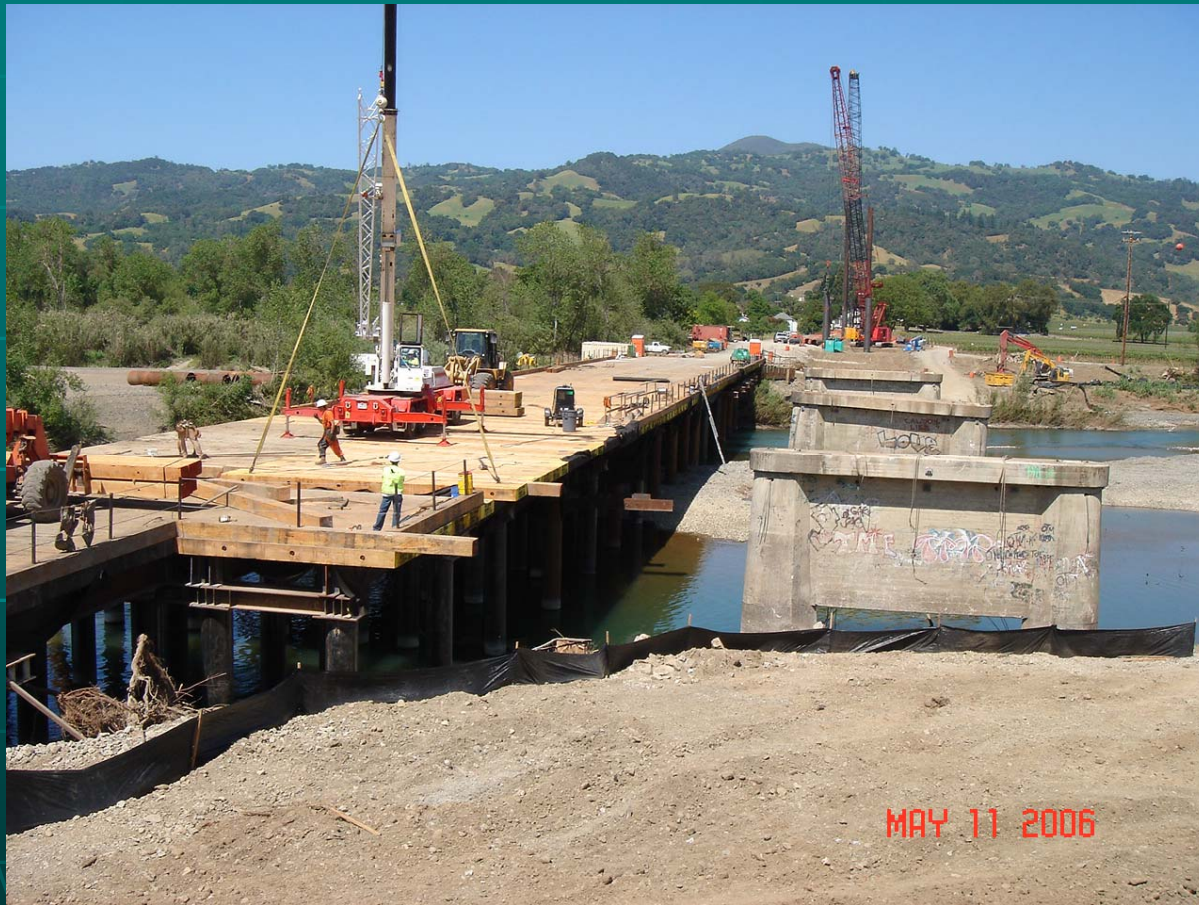
- Trestle construction completed early May after major bridge removal started

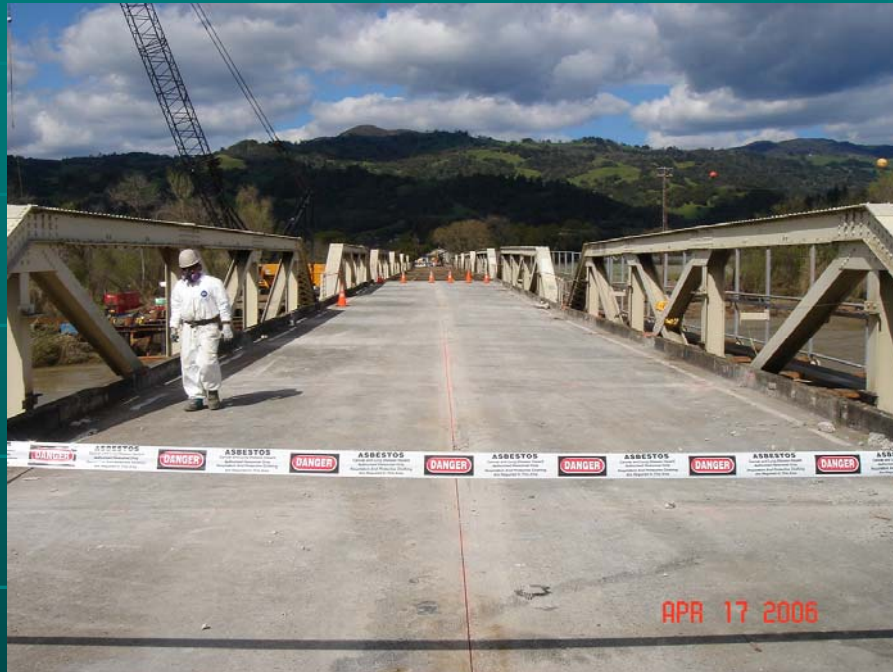
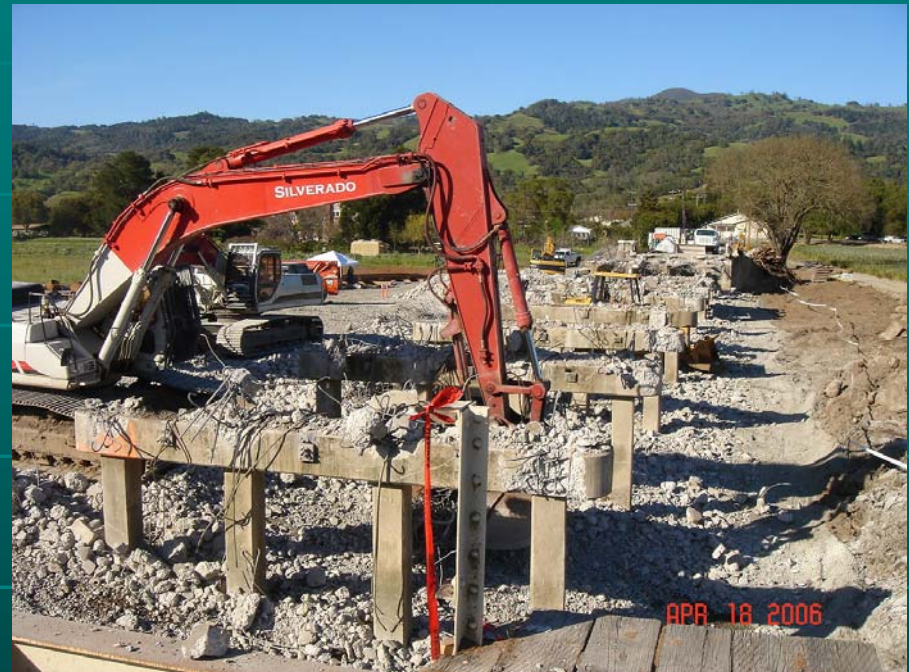
Red Lead & Asbestos

- Trace (<1%) amounts of asbestos found in concrete aggregate
- Required Asbestos Safety and Health Plan and contractor certification
- Required Lead Compliance Plan

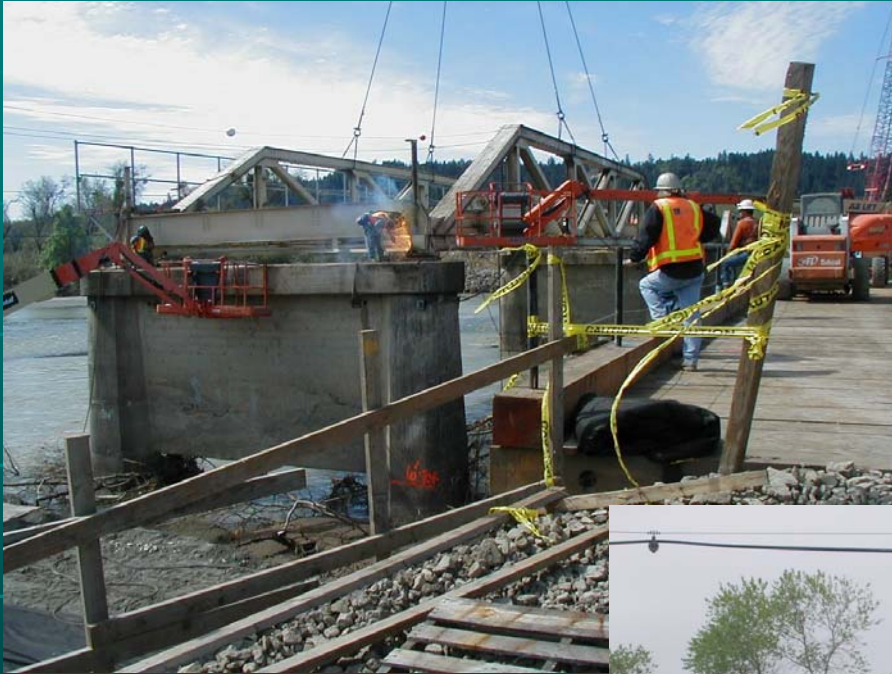
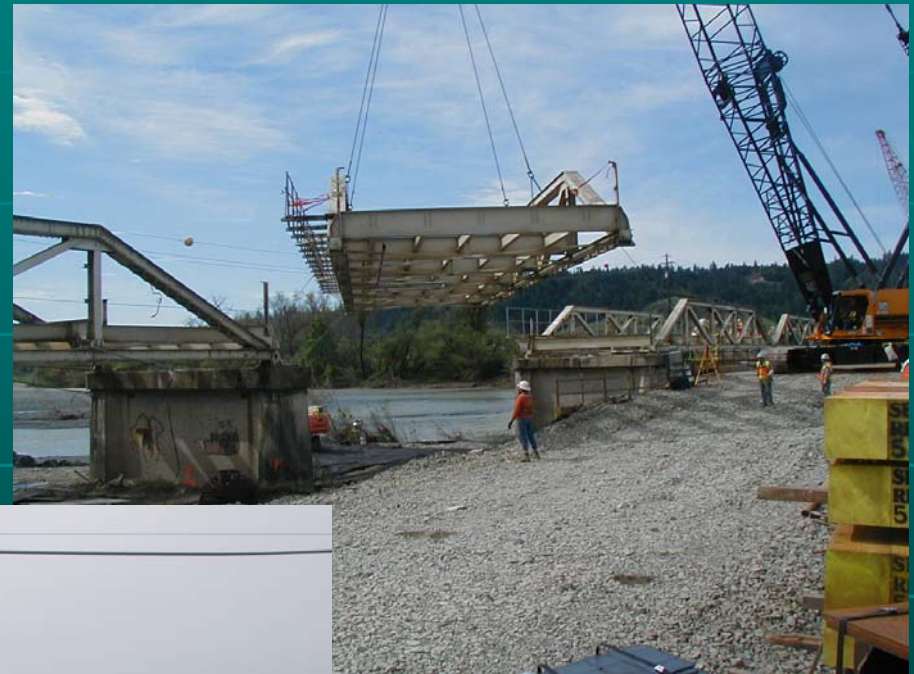
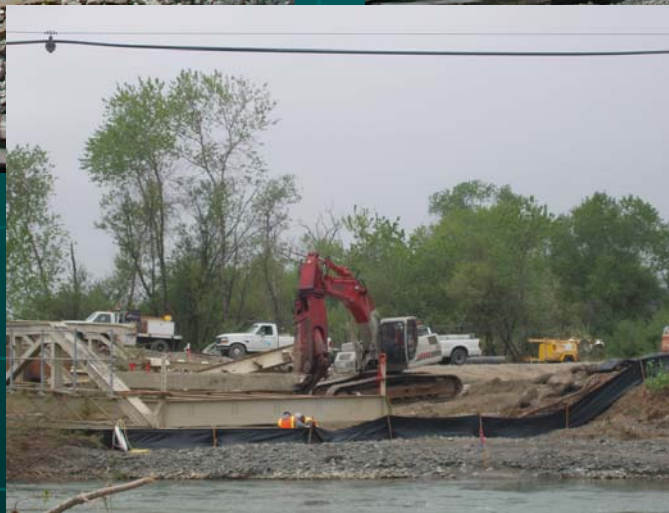
- Hydraulic shears minimize torching

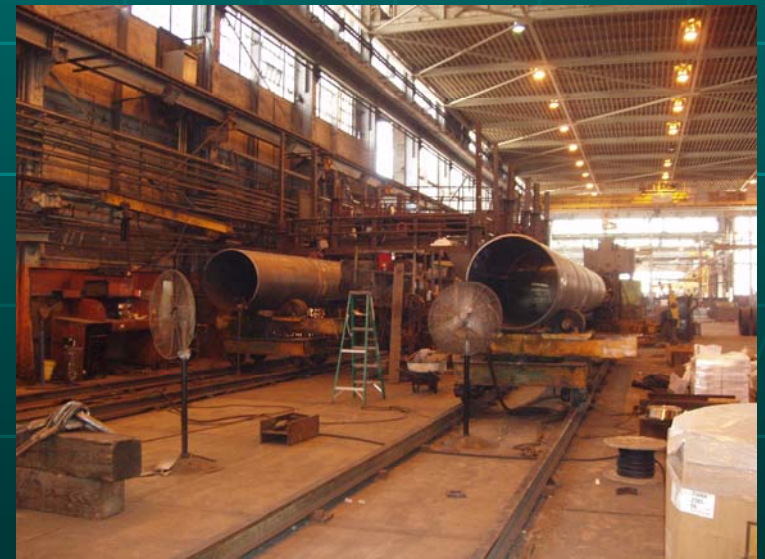
State Furnished Materials

- Per contract SP 1220mm pipe pile to be State furnished
- XKT Engineering, Inc Mare Island
- All pile to be available by June 20th
- 1100m of pile to be provided

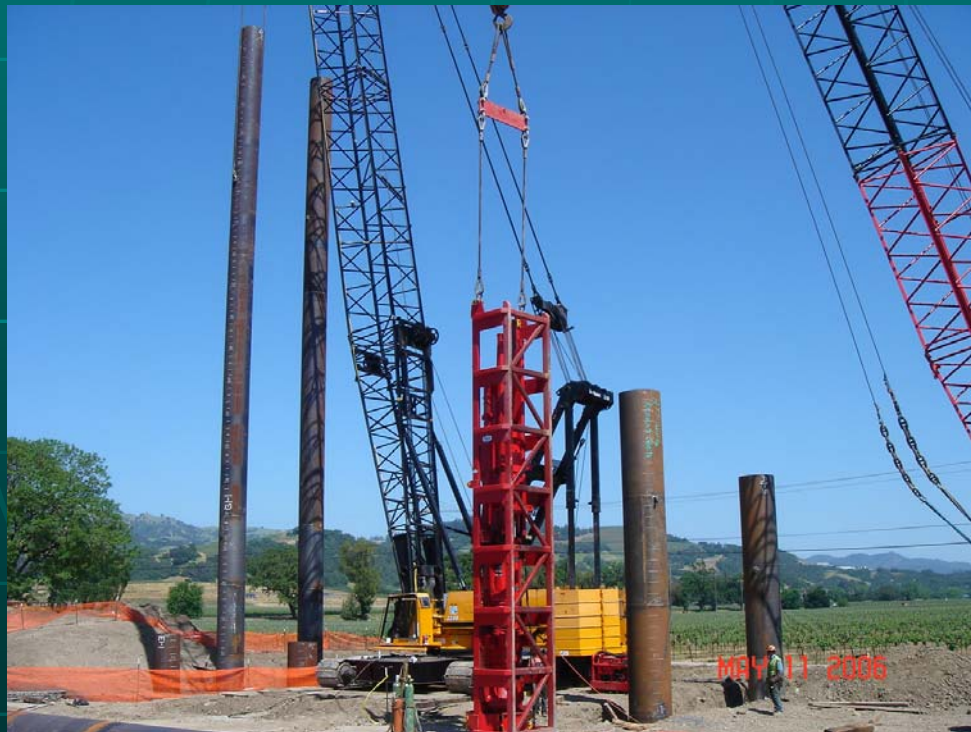
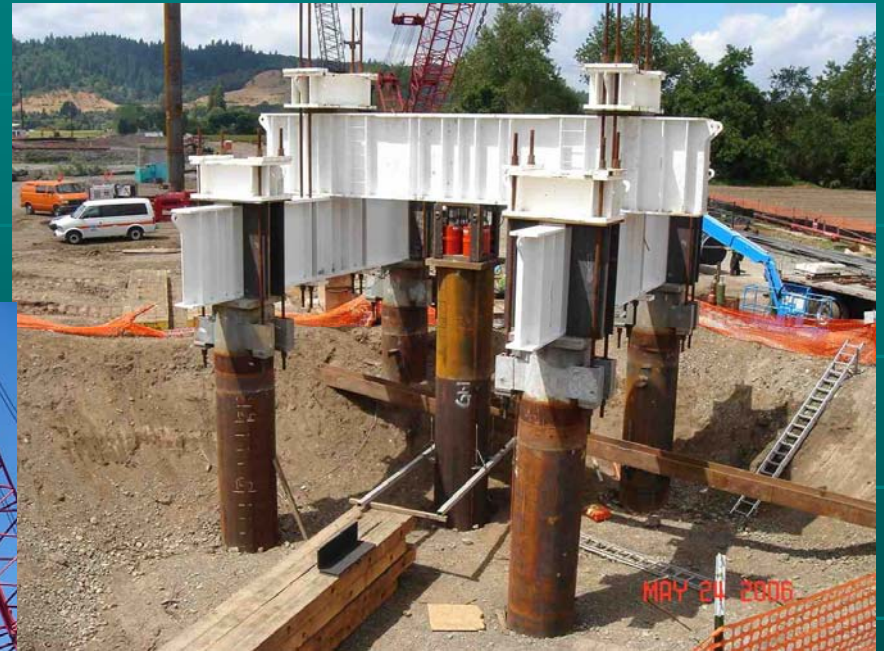
- 13790 kn load test
- Passed with 23mm settlement
- D100 –13 hammer, piston weight = 22.1K

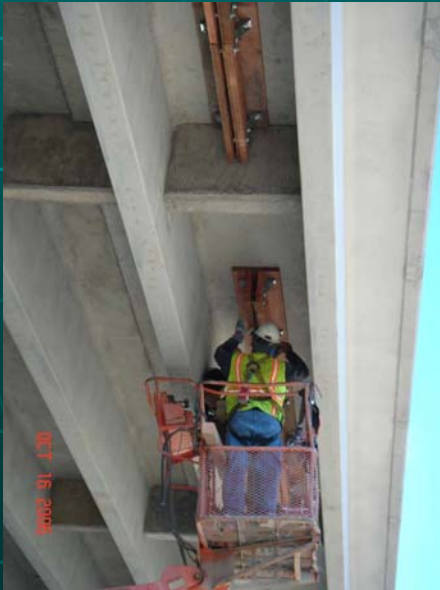
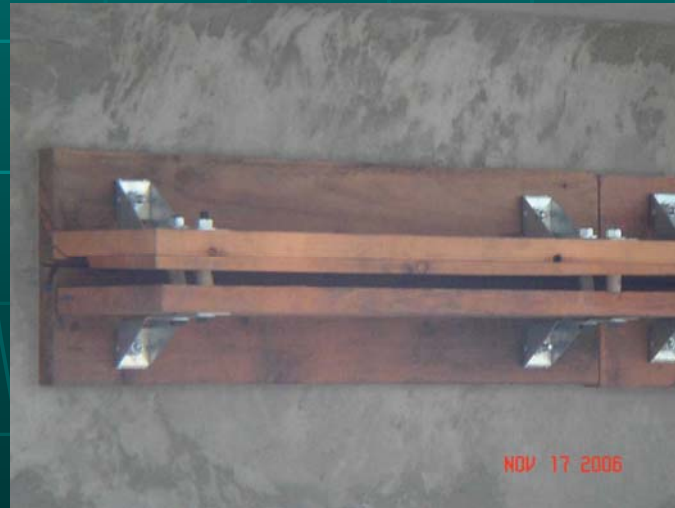
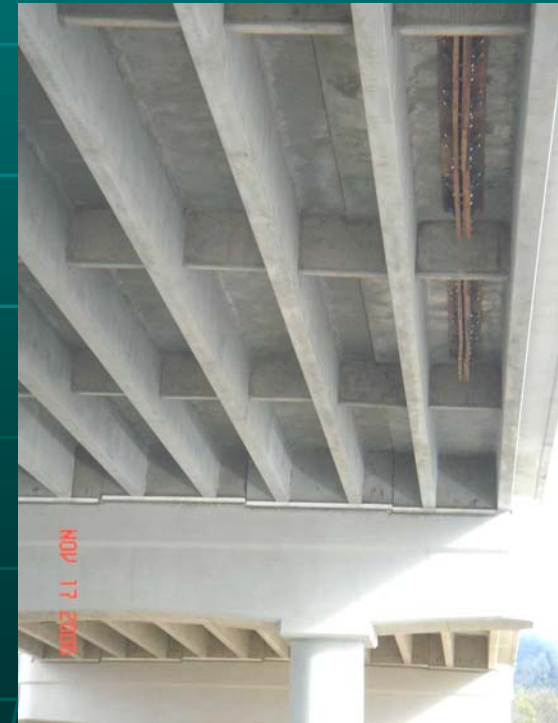
- Offsite stream mitigation for construction impacts
- Re-planting lost vegetation
- 40 redwood bat structures installed

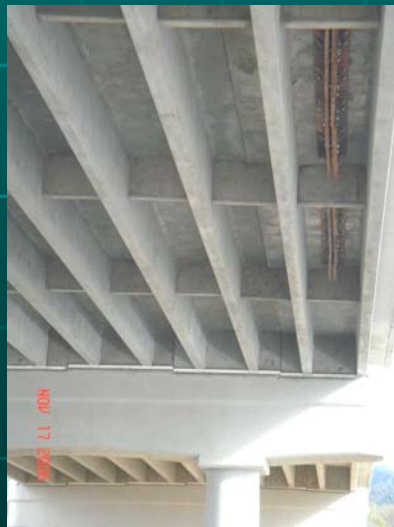
- Bat house design criteria
 - In house, original design
 - Lightweight
 - Placement in areas away from regular inspection zones
 - South side of bridge
 - 4' long / 5 per bay

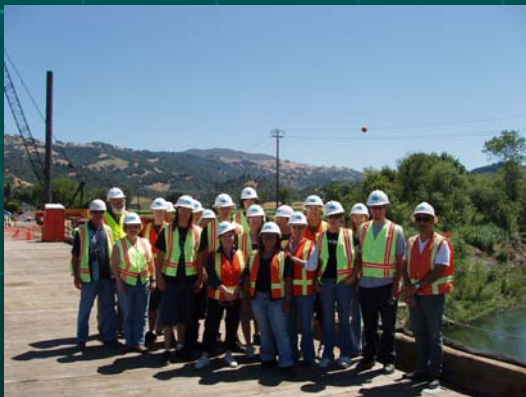
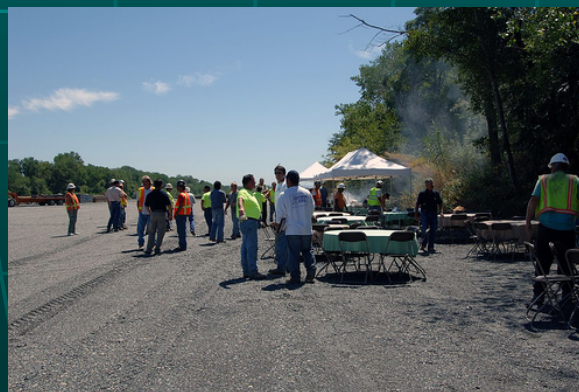
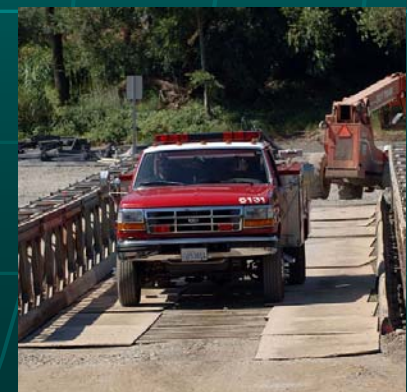
■ CISS piling

- June 15 subcontractor A drills out Pile 6R to depth of 95' leaving 25' soil plug. Bottom of hole appears dry. Water table near top of pile elevation.
- 5' seal course tailgated into hole
- June 23 rebar cage set & pile concrete placed by subcontractor B
- Pile concrete pumped into pile
- Inspector & contractor observe water being displaced from pile top
- subcontractor proceeds until "good" concrete observed being displaced
- Pile acceptance withheld until full length core can prove "good" concrete
- Subcontractor spends 2 weeks trying to verify competent concrete exist
- Competent concrete not found after 20 feet
- All concrete & rebar removed to seal course elevation
- 2nd seal course placed, new pile placed in dry

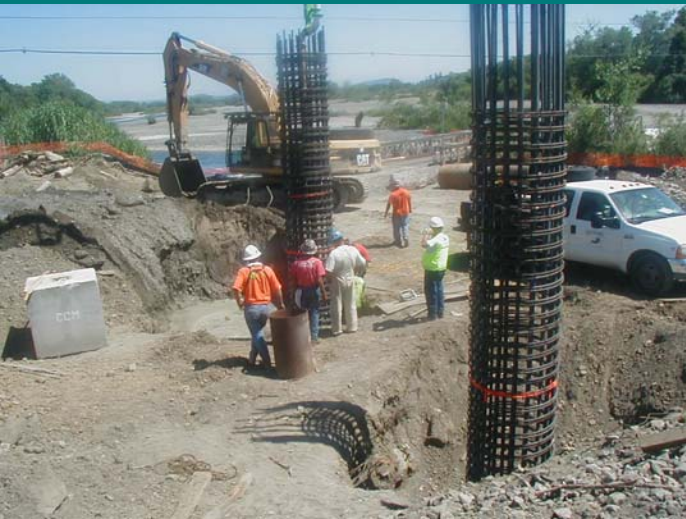
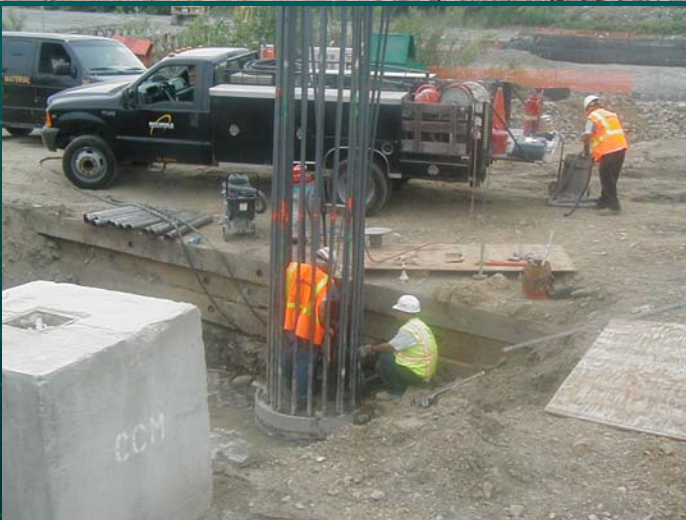
Lessons Learned Pile at Bent 6 R

■ Remaining piles charged with water prior to placing seal course

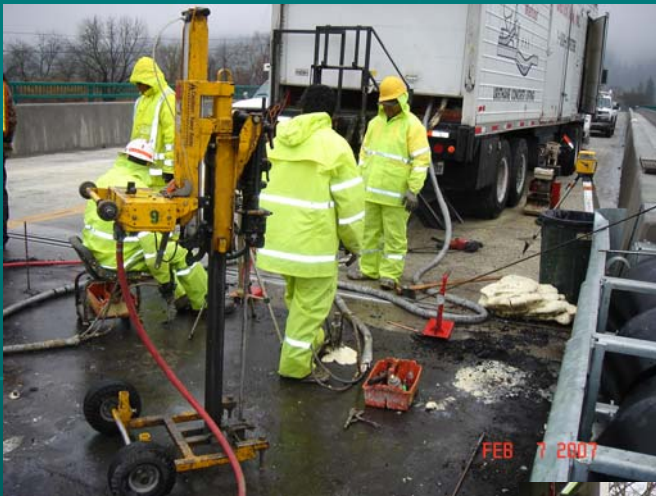
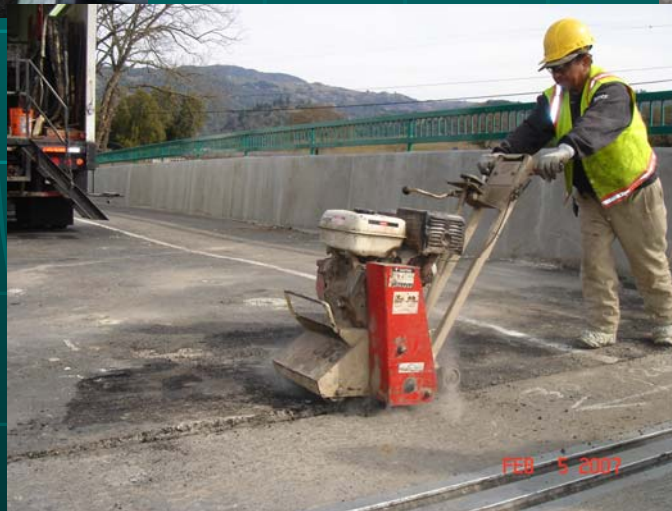
Approach Compaction

- Observe excessive settlement at east approach after first rain in December
- Geotechnical recommends injecting lightweight fill
- Hollow stem auger borings & penetrometer test show area within 10' of abutment & retaining walls have voids & minimal density
- Soil saturated & fines appear to have displaced into permeable material behind walls
- Expanding polyurethane injected into approach fill

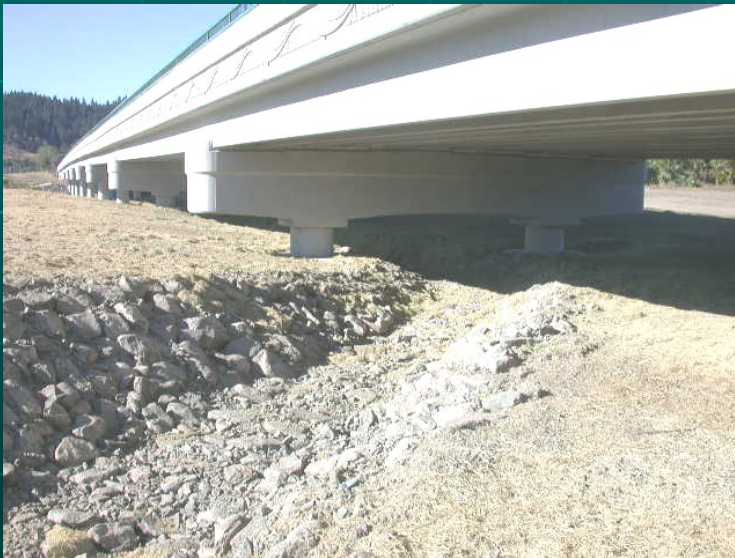
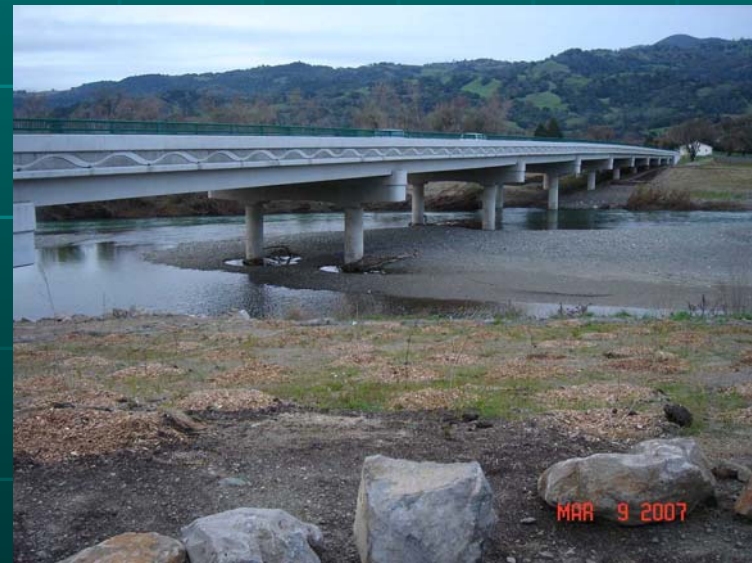
- Pre-cast girder deflection
 - No camber built into girders
 - Negative deflection remains
 - PT force increased after girders at site
