Meadowbrook Bridge Rehabilitation

Technical Session Agenda

Introduction & Program Design (Jessy Jose, King County)

Rehabilitation Design & Construction (Ken Wilson, ISE)

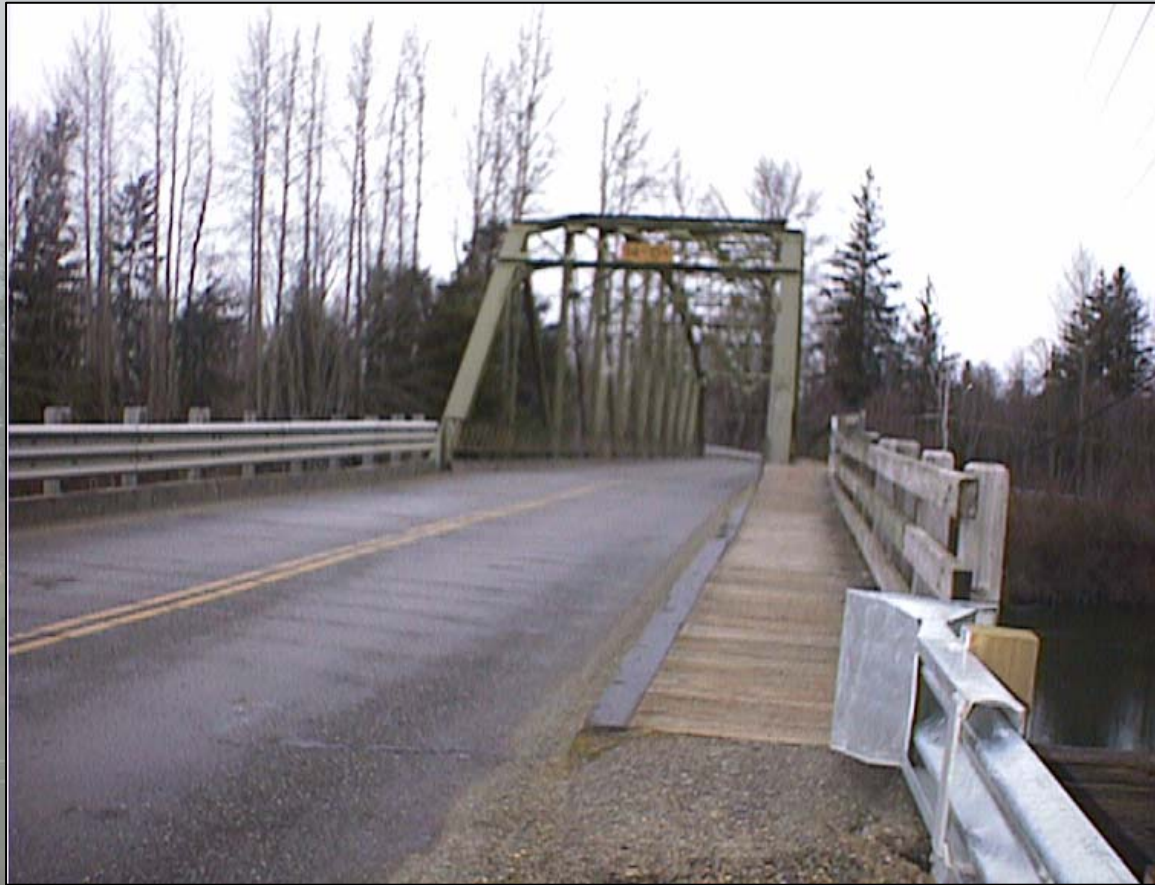
Meadowbrook Bridge looking North

- Built in 1921
- Posted for load limit due to structural deficiencies (16 Ton)
- Narrow bridge width (18'-6").
- Substandard vertical alignment with limited sight distance
- Posted Vertical clearance only 14'
- Very Low sufficiency rating (4.27/SD)

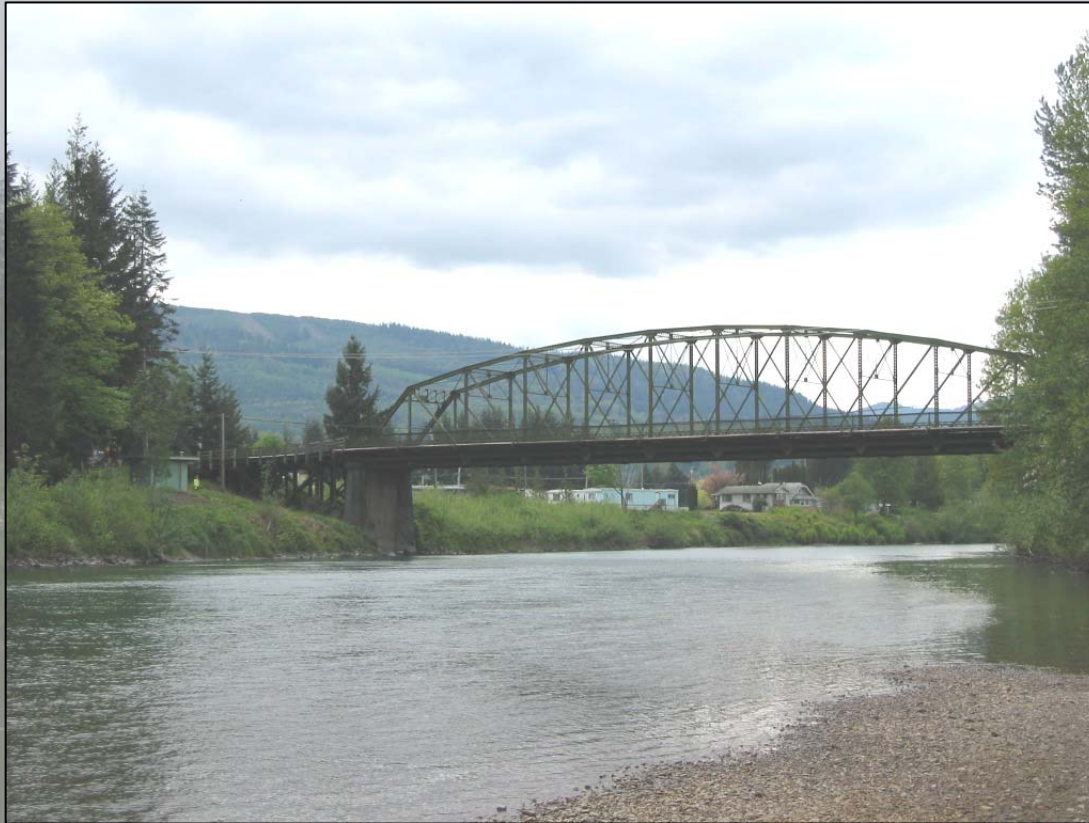
Meadowbrook Bridge looking
West- Down stream

- 9 approach timber trestle spans
- 220' truss main span
- 6" of flood clearance above 100 year flood elevation

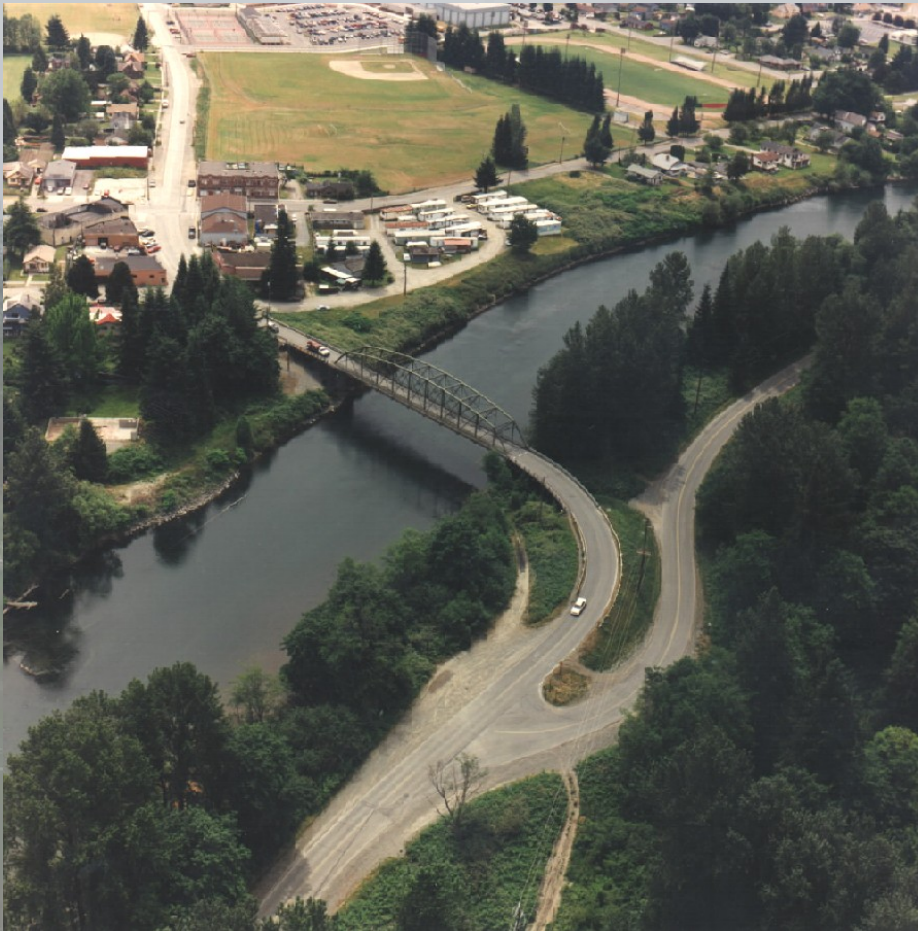
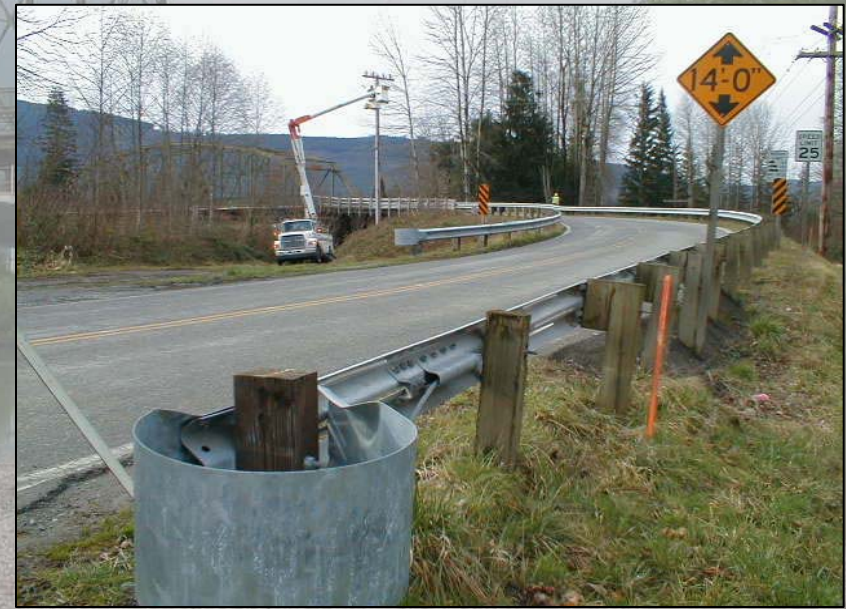
**LOOKING WEST- Poor sight distance
and substandard horizontal curve**

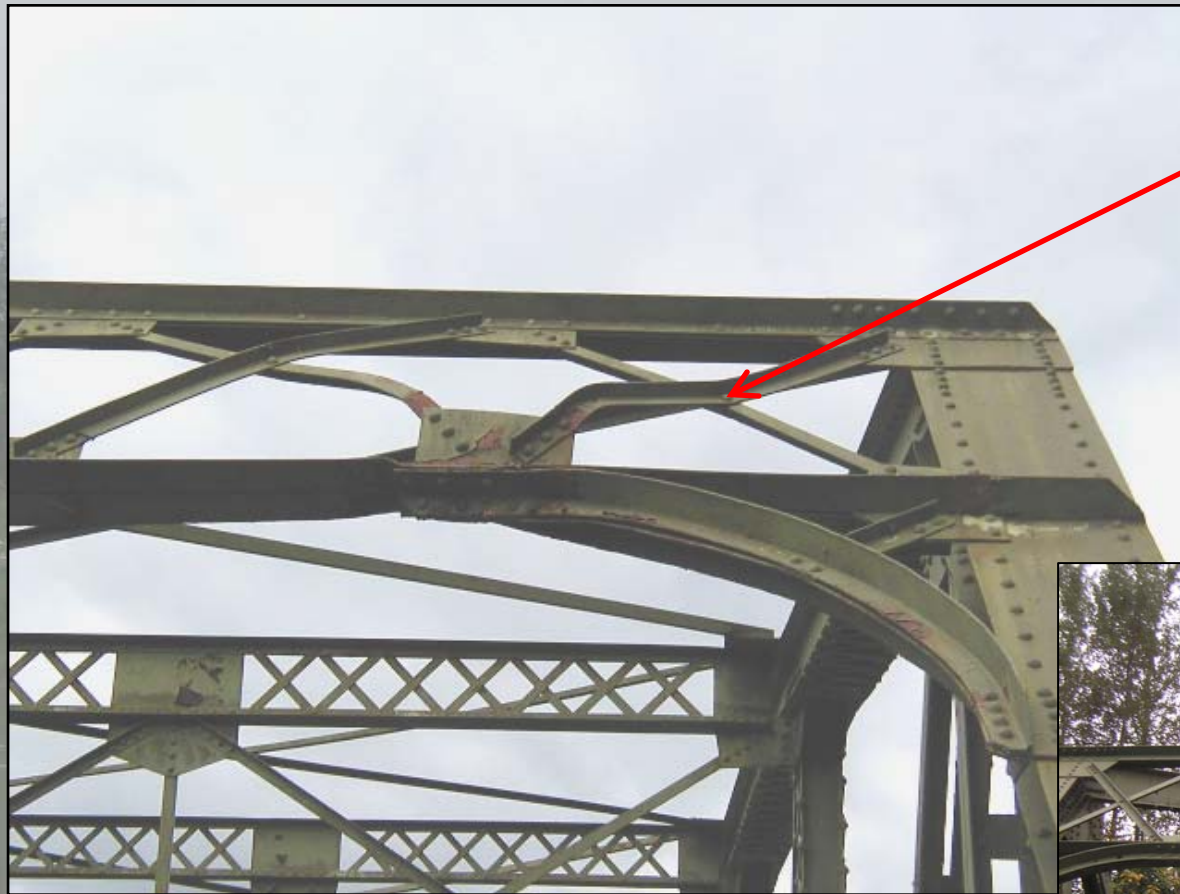
Damaged top lateral
due to high load hit –
14' Vertical clearance

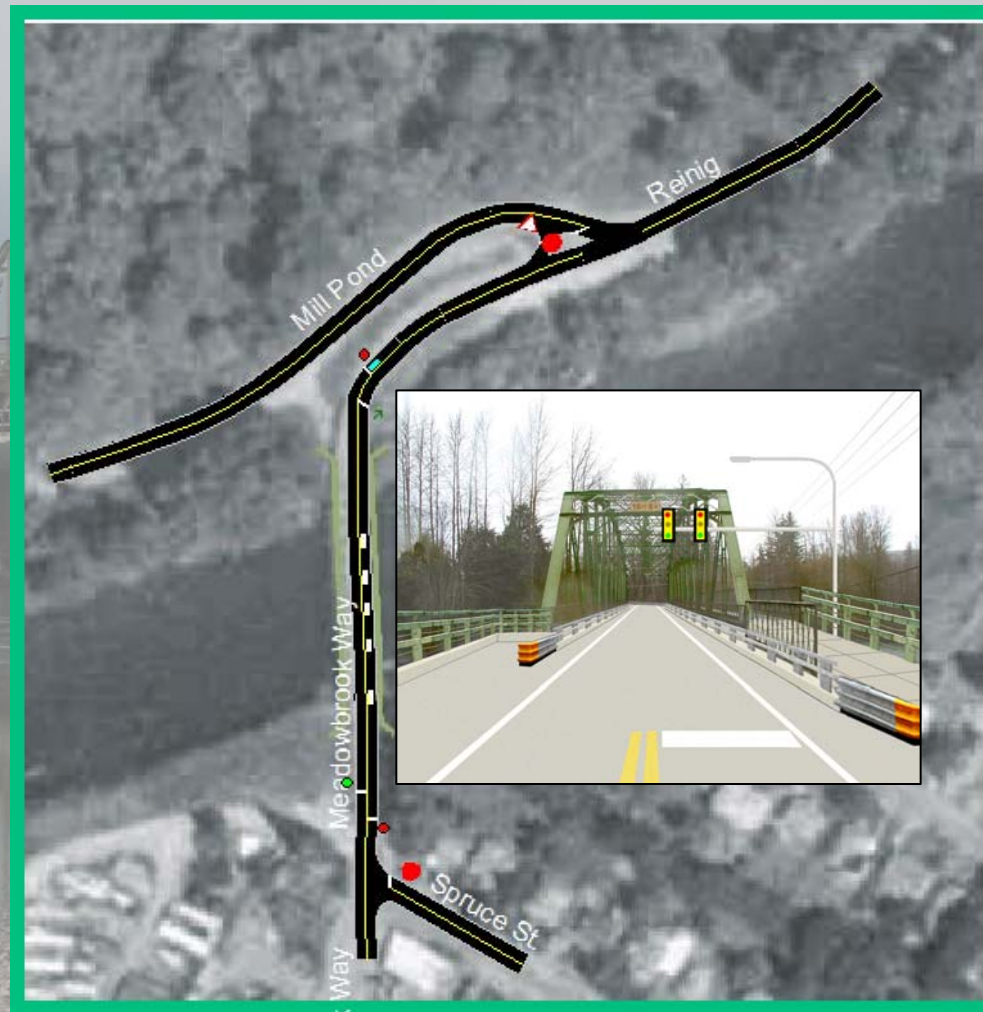
One Lane Traffic Configuration

Current ADT
:1900

20 year
forecasted
ADT :4500

Analysis: 15.1
sec delay
during
peak

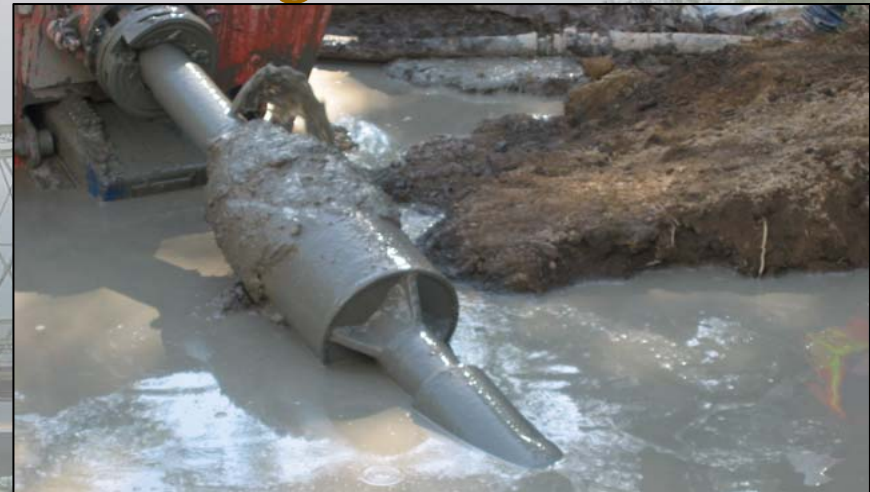
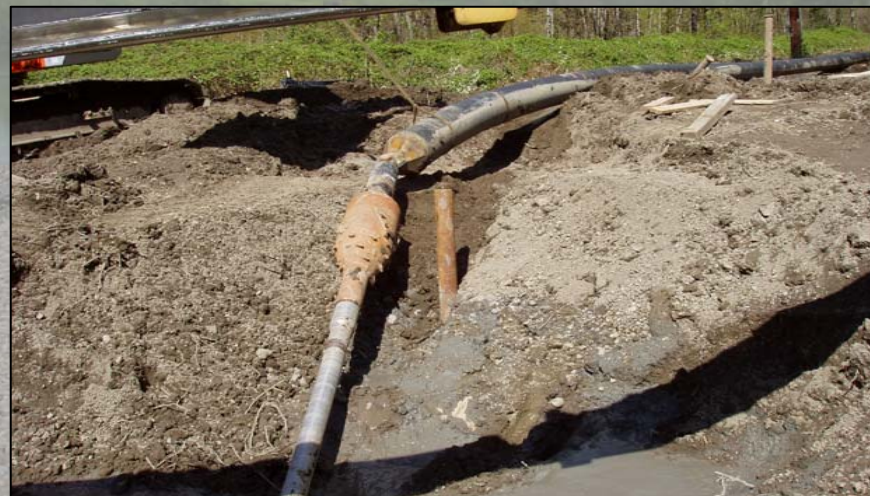
Water Line Directional Boring Relocation

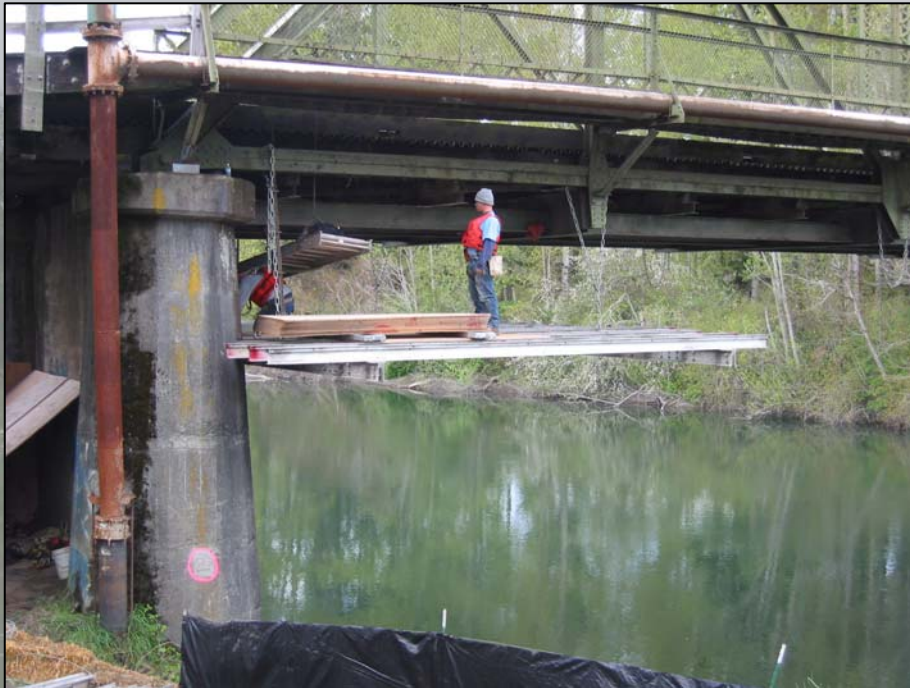
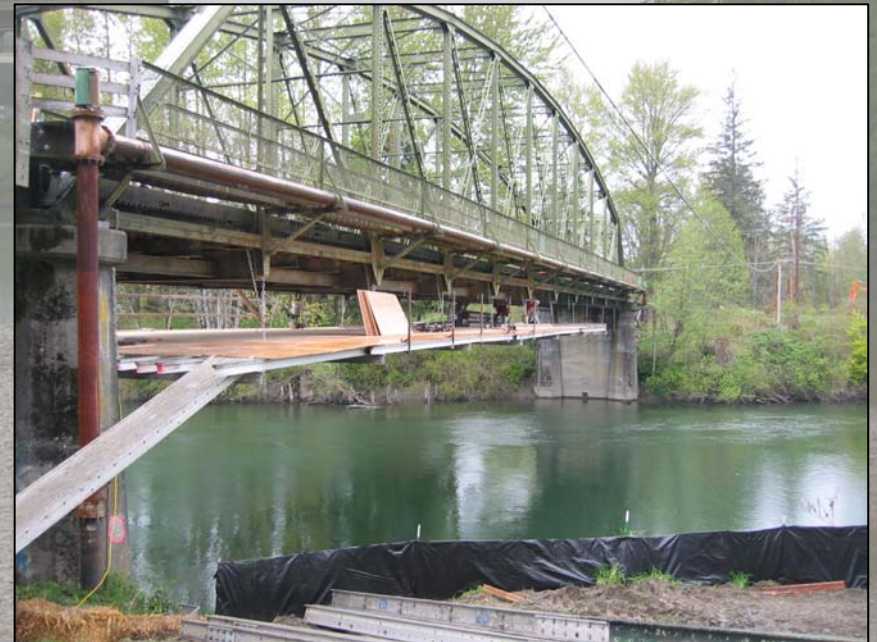
Installing Temporary Work Platforms

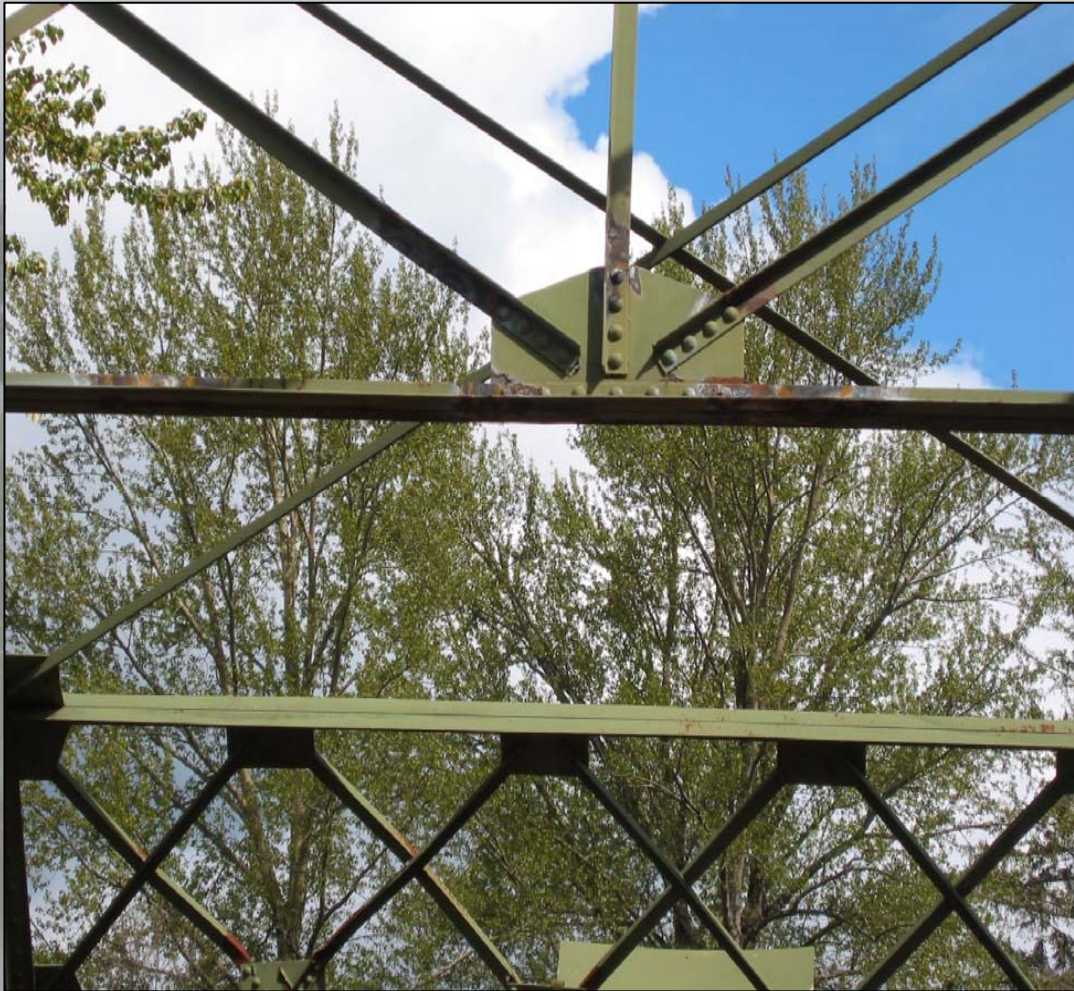
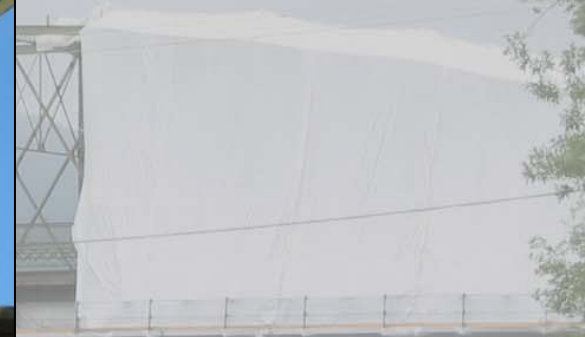
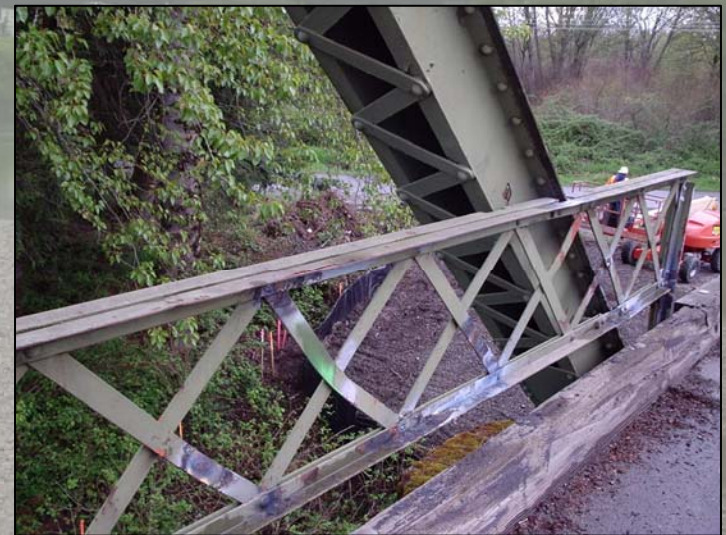
Heat Straightening Truss Repairs

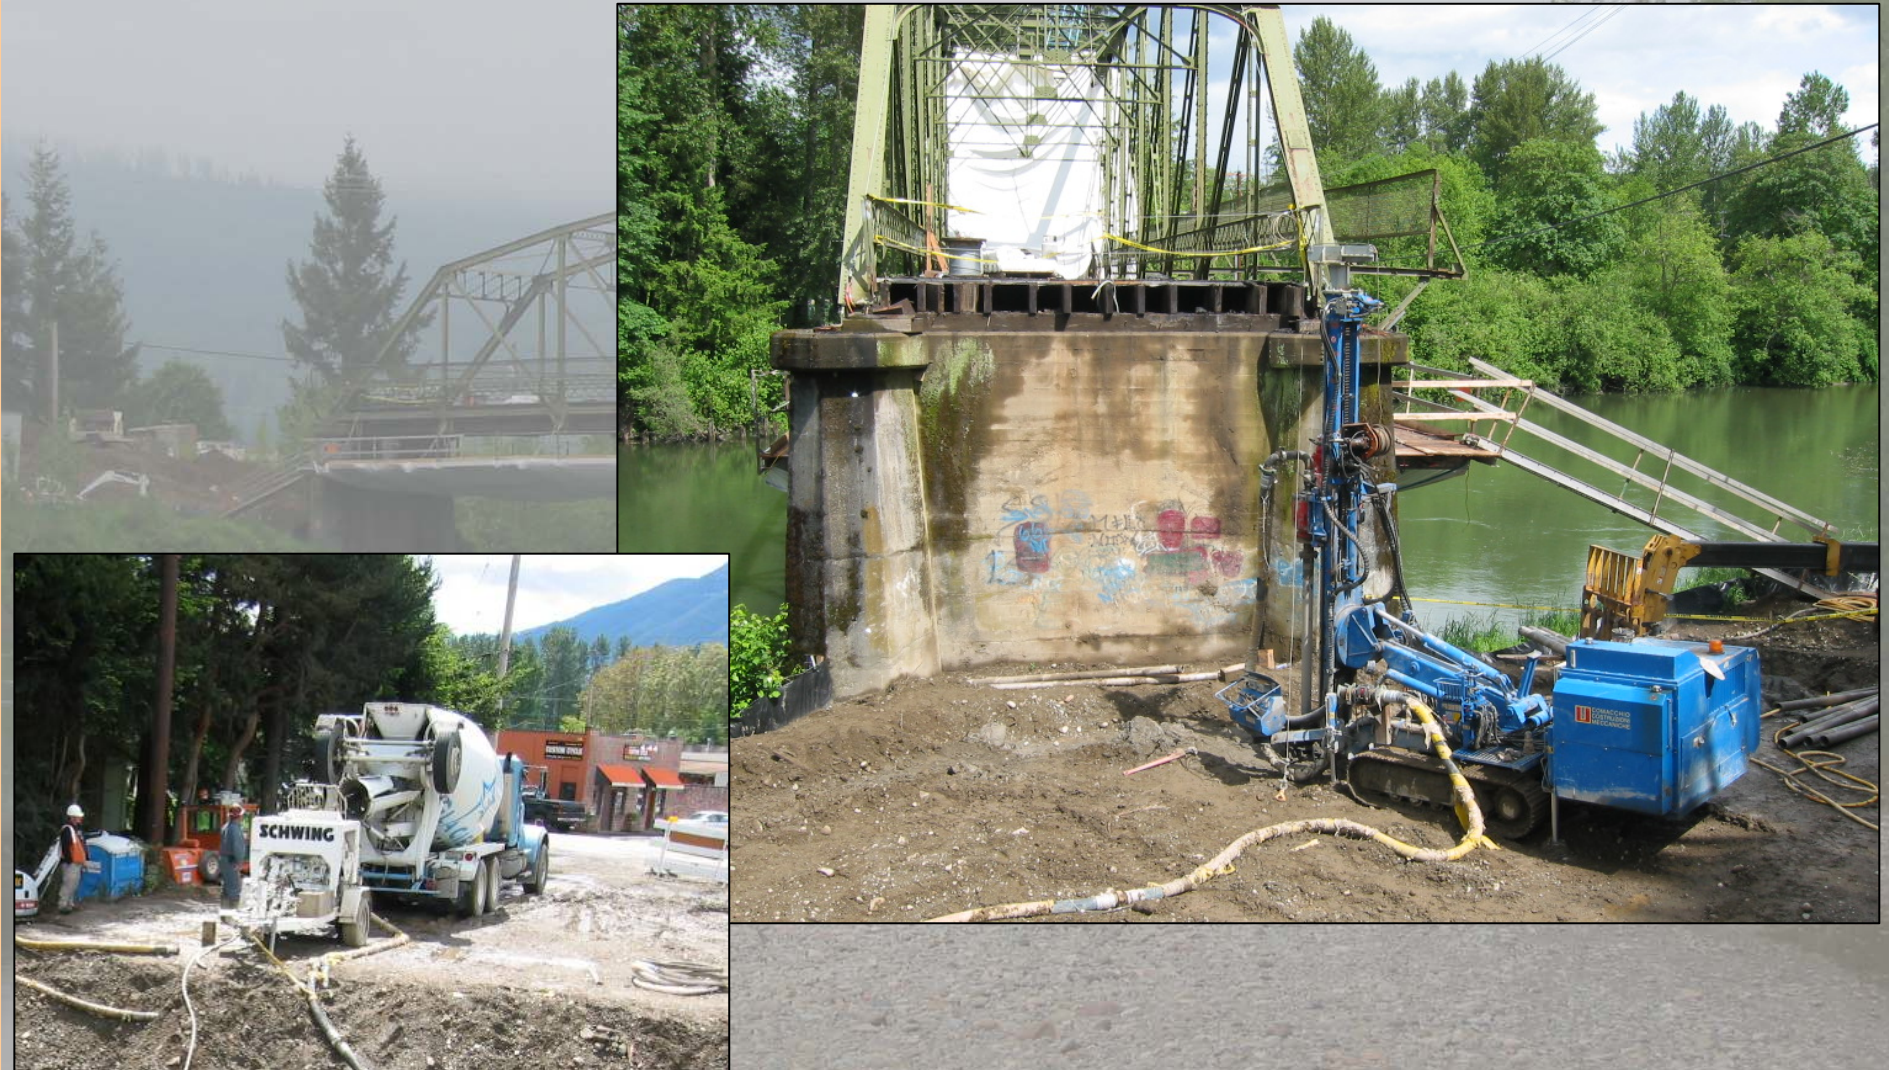
Grout Compaction Soil Densification

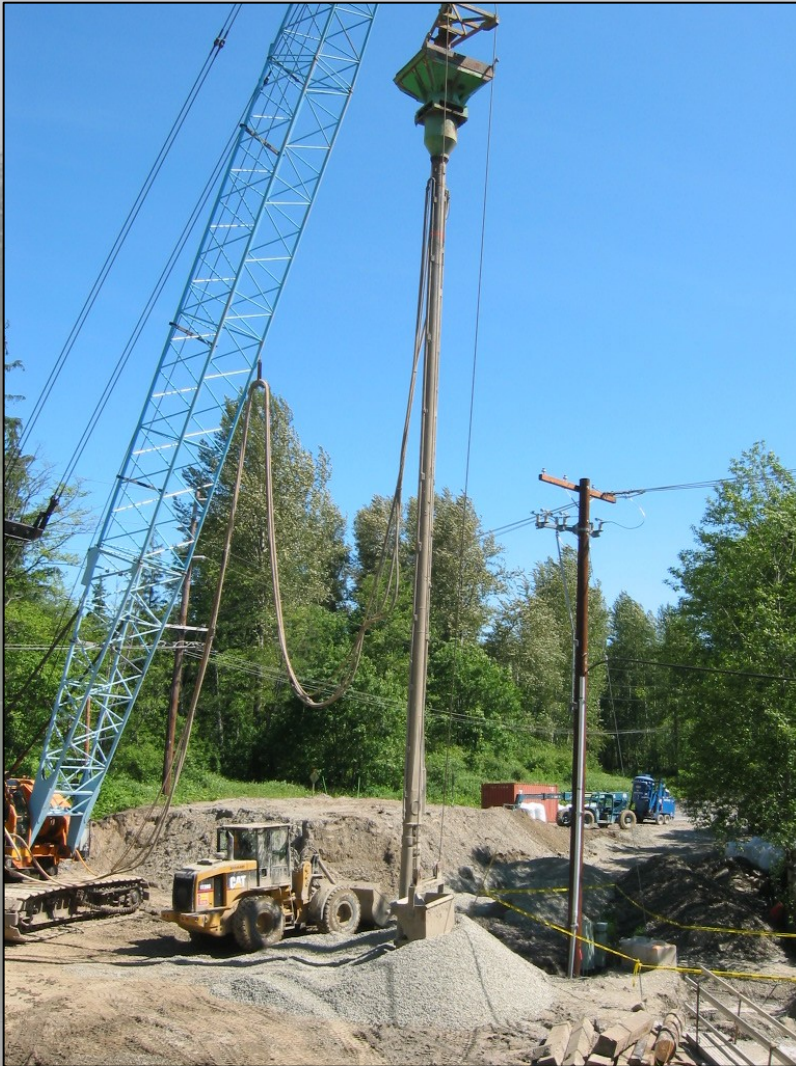
Stone Column Soil Densification & Monitoring

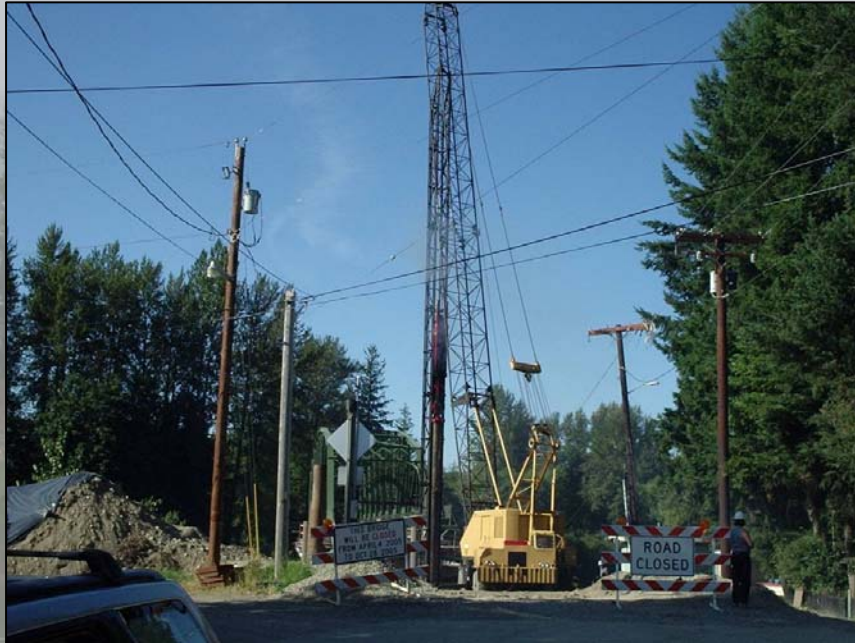
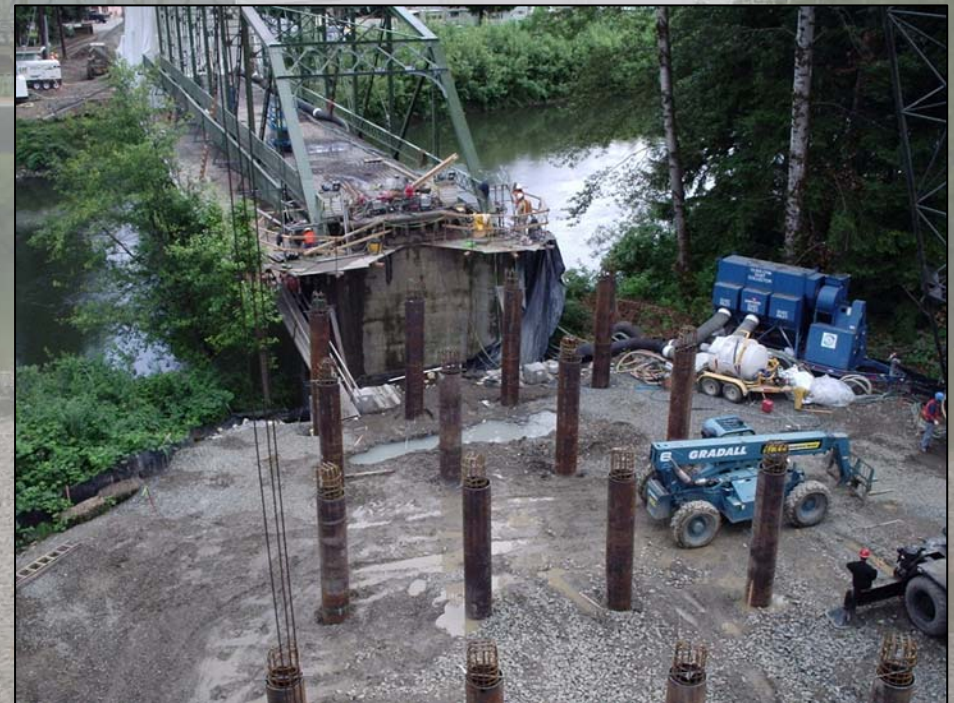
Approach Pile Driving

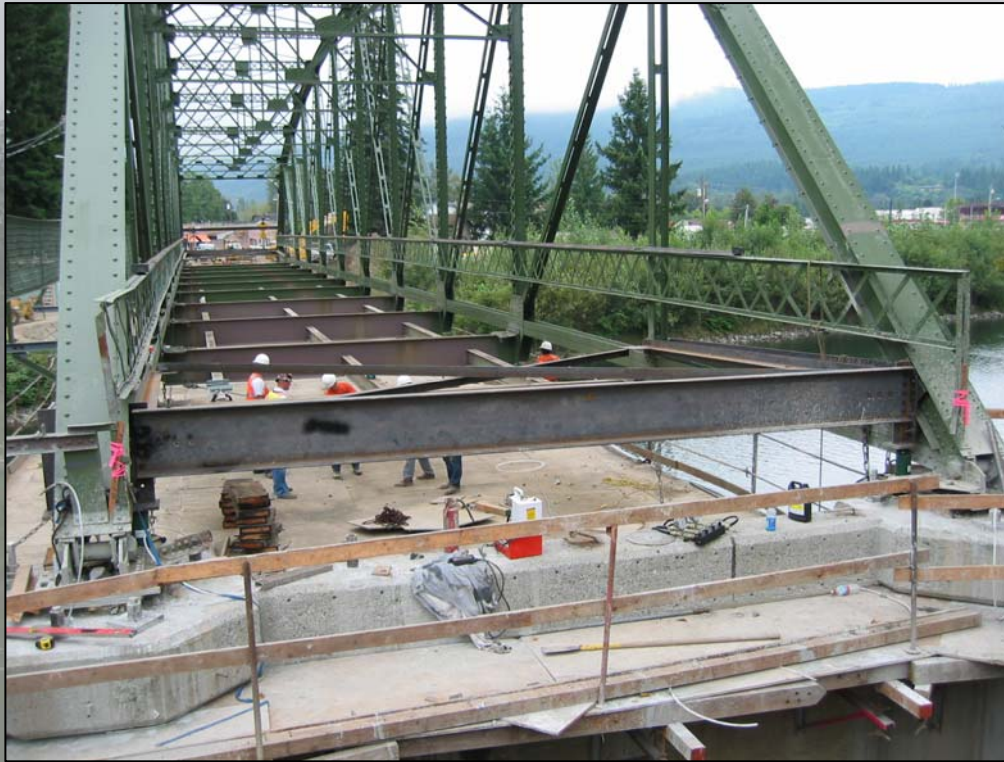
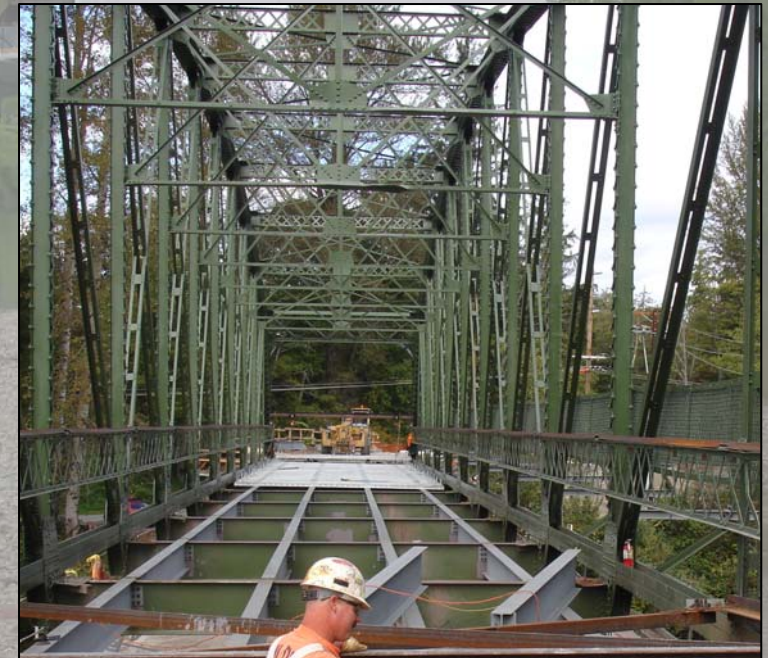
Truss Deck Replacement Work

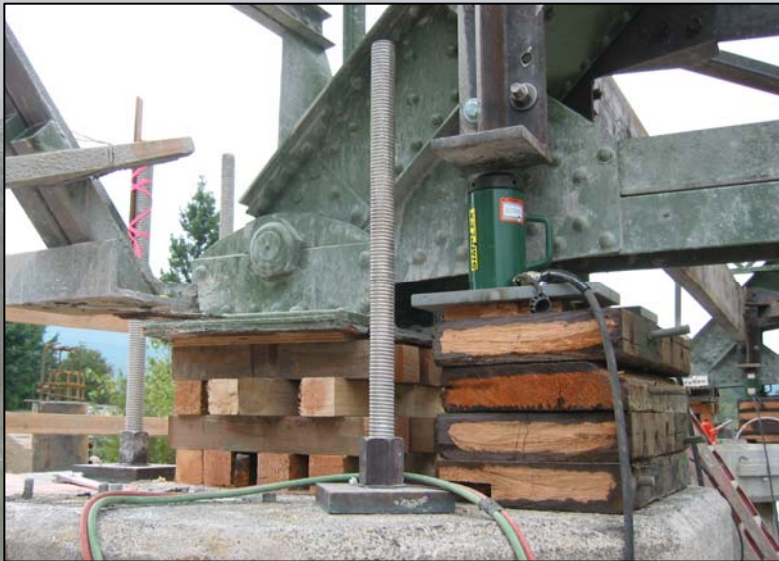
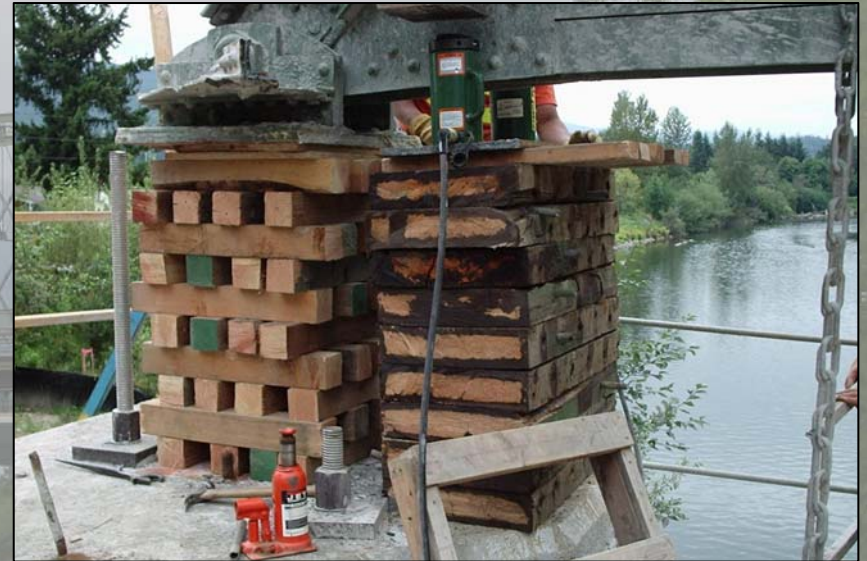
Truss Lifting/Bearing Work

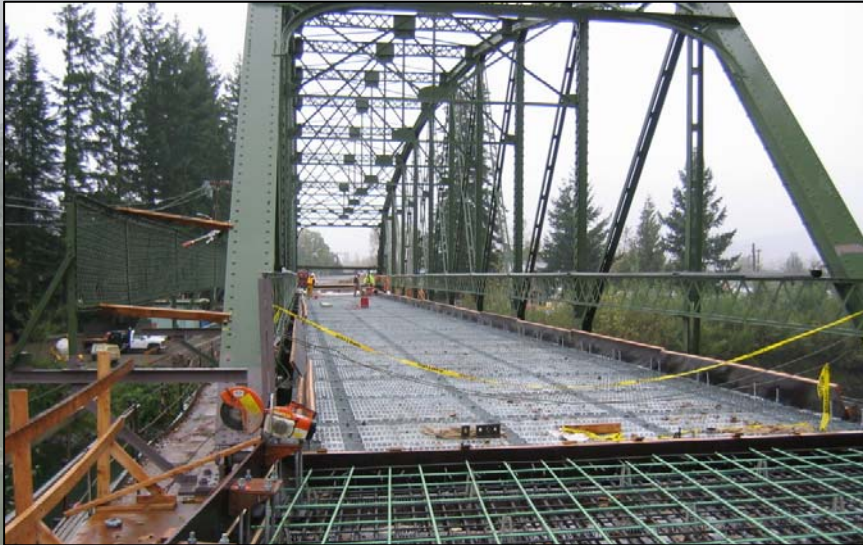
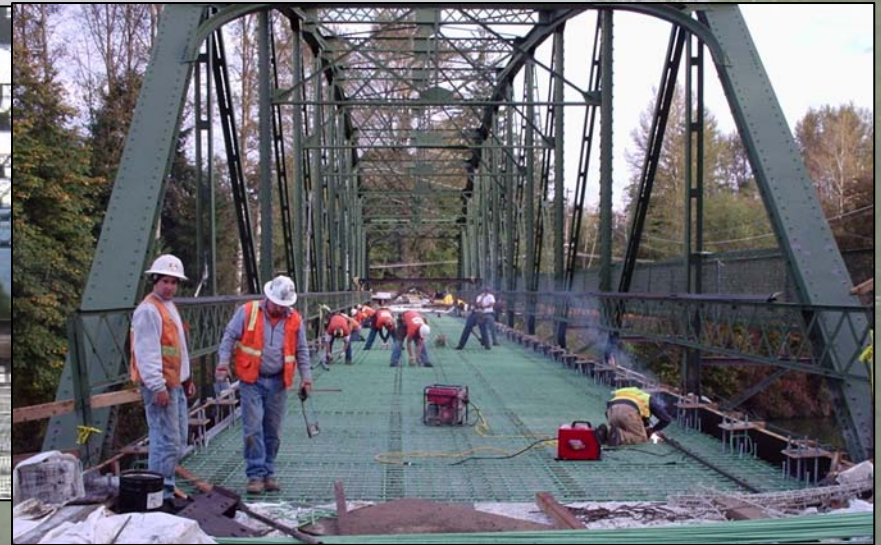
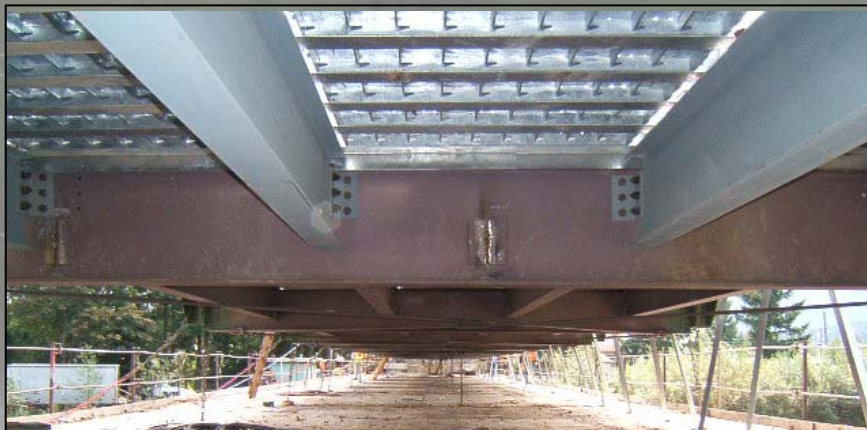
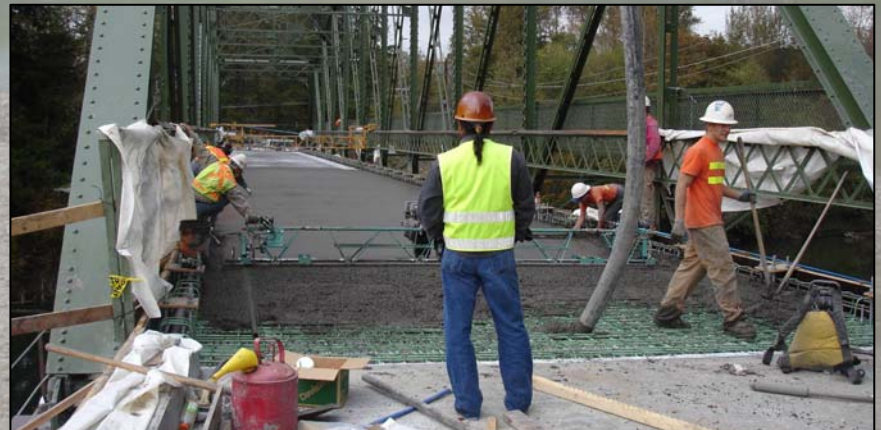
Exodermic Truss Deck Replacement

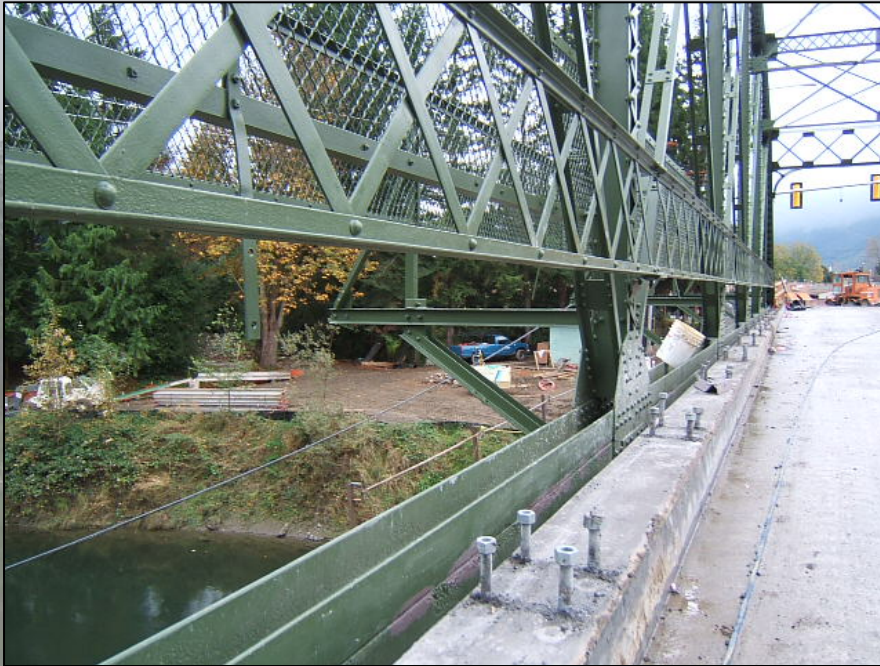
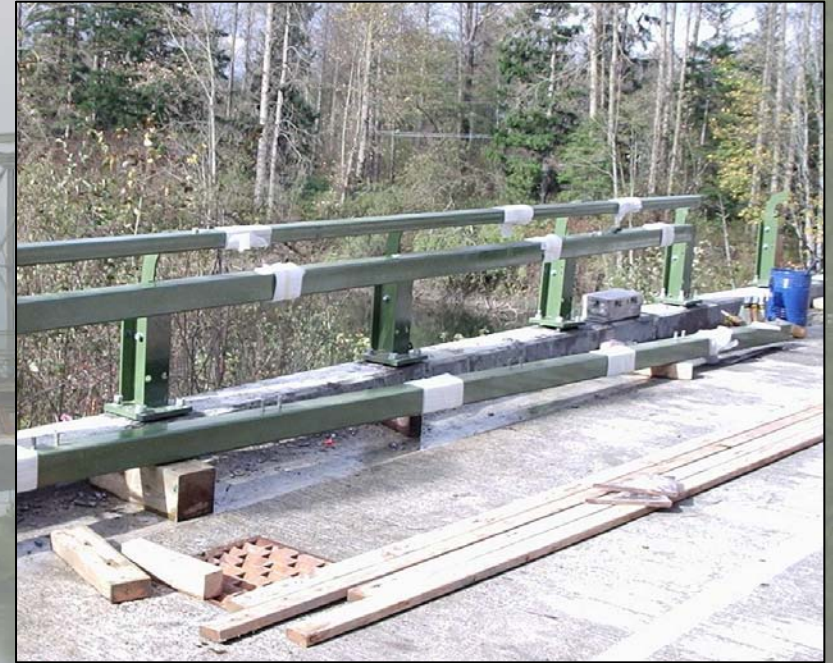
Bridge Rail Installation
