## Overcoming Oregon Design-Build Challenges Rapid Bridge Replacement at Hancock Mountain

#### Scott M. Nettleton P.E., Associate

## **Elk Creek to Hardscrabble Creek**

## Elk Creek Crossing #3 and #4

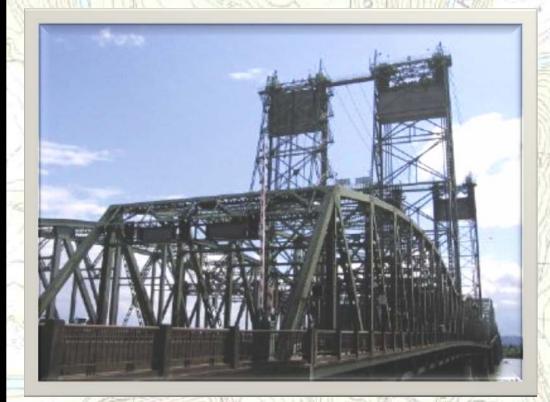
I-5 Columbia River (Interstate) Bridge Trunnion Replacement (1997)

TYLI offered services in analysis of construction options and assistance during construction.

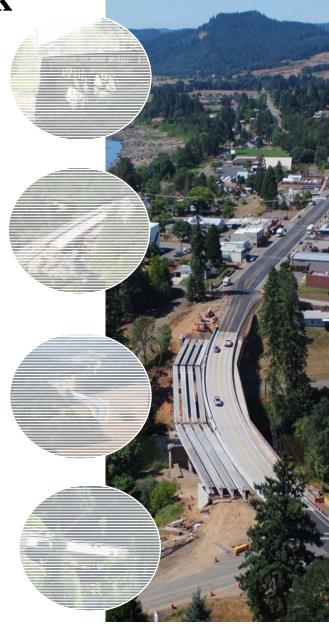
- Elkton to Drain, Oregon
- 5 Bridge Replacements
  - Elk Creek Crossings 1, 2, 3 and 4
  - Hardscrabble Creek
- Cost \$52 Million, Design, Construction and Program Management
- Unique Features
  - Schools Program Student designed
    Bridge Pylons
  - Rapid Replacement
  - Aesthetic components (Bridge rail and Features at Bridge #1)
- http://www.obdp.org/files/dashboard/proj ects/bundles/401.pdf

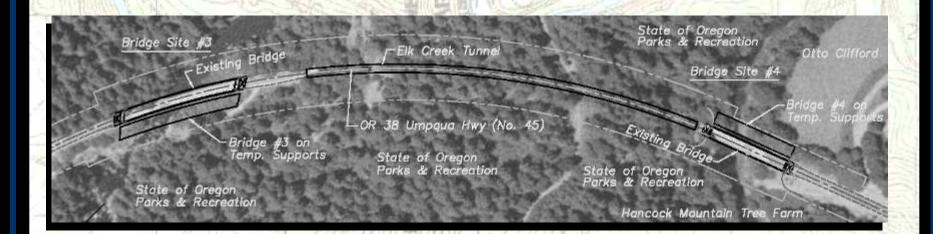
Location of Bridges in Proximity to the Elk Creek Tunnel

Bridge #3 approximately 100 ft from tunnel portal Bridge #4 approximately 50 ft from tunnel portal

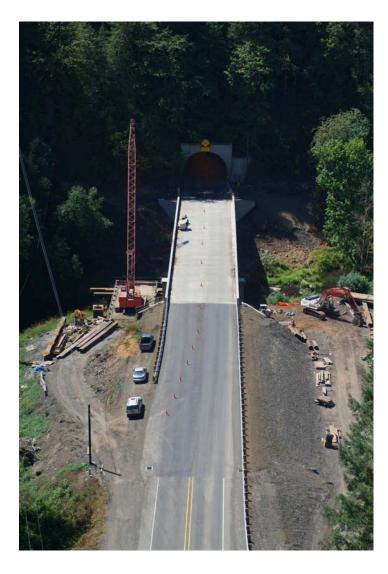
- Straight Alignment (Superelevation transition)
- 2 Span w/ 90 degree bents
- Prestressed concrete simple spans

- Tailings from the tunnel construction in the area
- Pre-bored piling required at West abutment

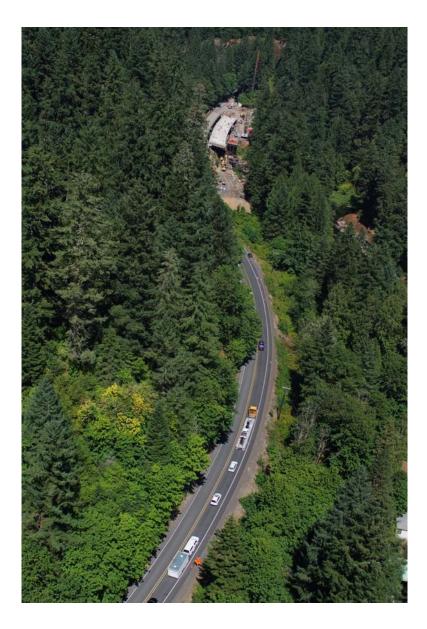
- Longer span
- Curved alignment
- Super elevated
- High skew angle
- Steel plate girder bridge with short end spans
- Extreme topography

- Produces uplift
- Code requires restraint
  - Difficult to install complex restraint system in short time period
- Solution
  - Construct bridge with "low" ends to *elastically* deform upon placement and "pre-stress" a downward force onto the abutments
  - Not sufficient to offset all code required loads, but it will cover the Service loading.
  - Originally based no the concept of Alternate Load Factor Design. Plastic deformation to establish an "Auto-moment". Abandoned because criteria do not support bottom flange plastic deformation, contract also disallows untried techniques.
