Rehabilitation of the Fremont Bridge in Seattle, Washington

John R. Williams, P.E.

2009 Western Bridge Engineers' Seminar Sacramento, CA September 21-23, 2009

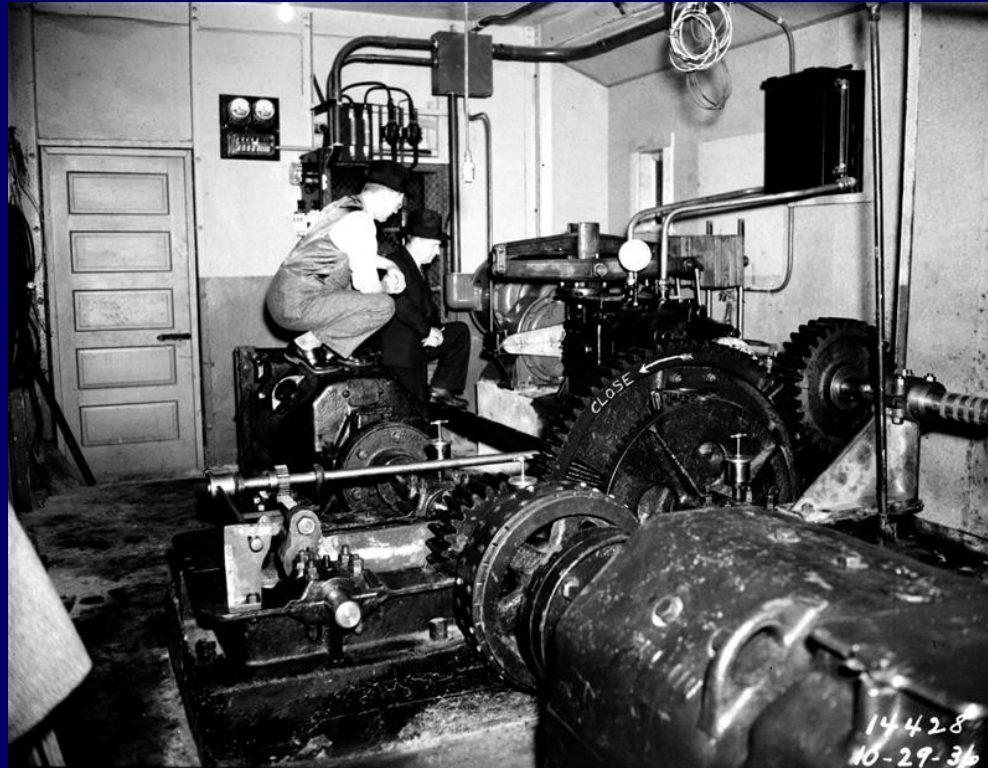
**Fremont Bridge,
Original Span
Drive Machinery
Circa 1936**
Seattle Municipal
Archives
Photograph
Collection

- The Fremont Bridge currently opens an average of 35 times per day or almost 13,000 times per year
- When the Fremont Bridge celebrated its' 566,000th opening in January, nearly all of the span drive machinery was original.

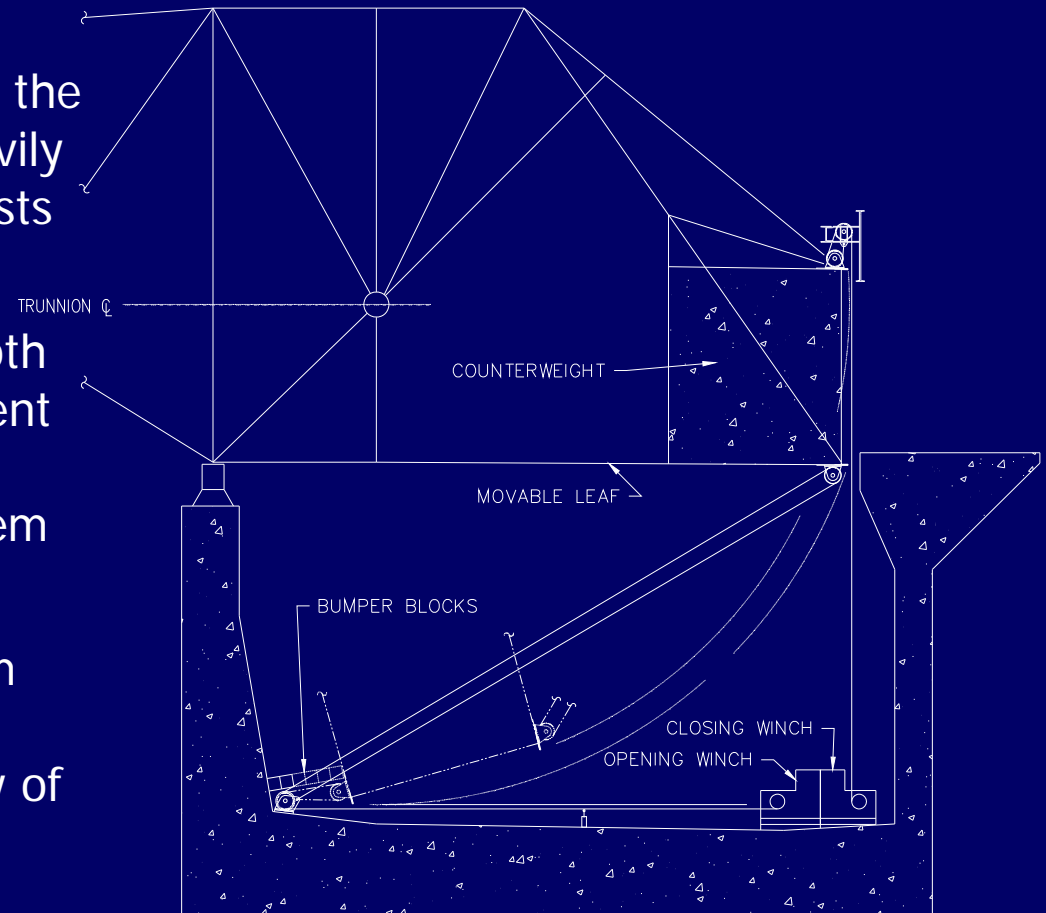
- All three of the movable bridges over the Lake Washington Ship Canal are heavily used by vehicles, pedestrians, bicyclists and marine vessels.
- In order to maintain operation of both movable leaves during the replacement of the span drive machinery, a temporary span drive operating system was required.
- A temporary winch operating system was selected for use on the basis of simplicity, low cost, and the flexibility of the system to be used during the rehabilitation all three of the City's bascule bridges.

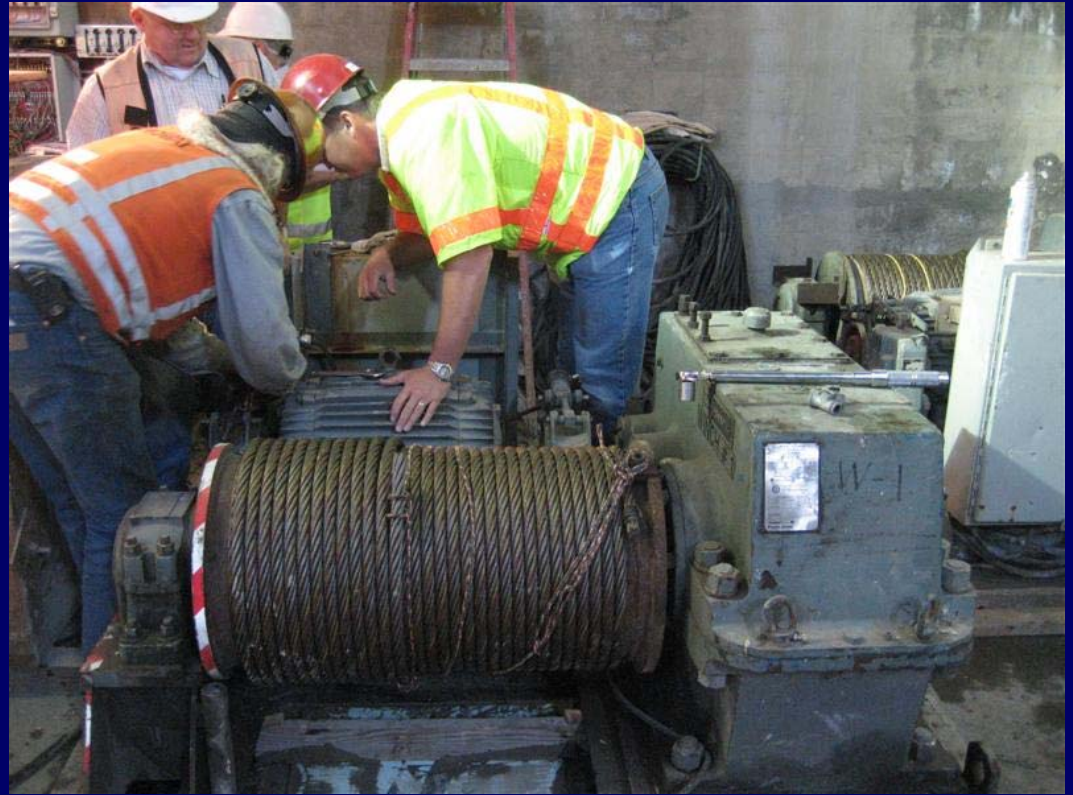
- A temporary winch system designed by SBE was built for use on the University Bridge rehabilitation.
- The winch system was loaned to Multnomah County, Oregon for use during a rehabilitation of the Broadway Bridge in the 90's.
- The winch system was returned to Seattle and used at the Ballard Bridge rehabilitation before utilizing it for the Fremont rehabilitation project.
- The time of opening for the temporary winch system is approximately 3 ½ minutes.

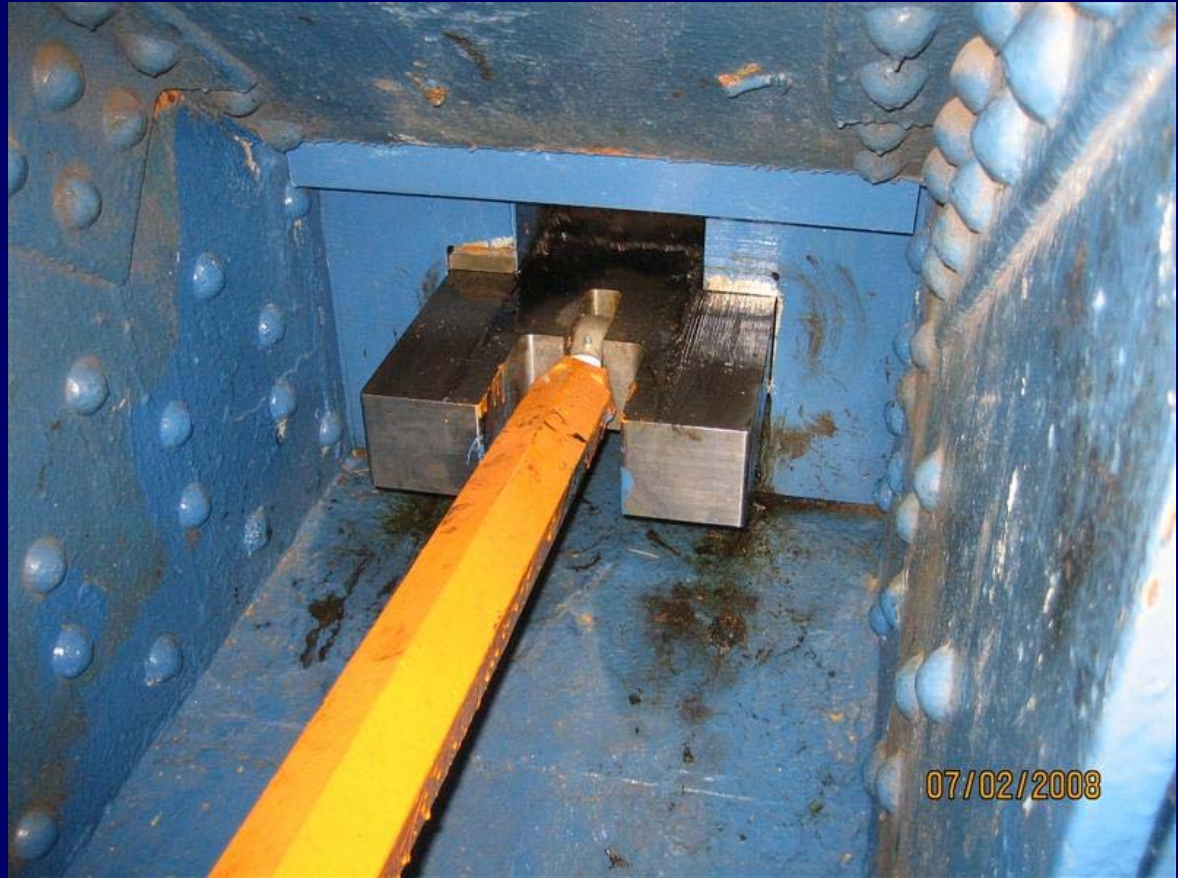
- The original design had no provision to adjust the clearances in the jaw and guides.
- During the current rehabilitation, the guides and jaws were replaced with a new design that included bronze wear shoes.
- A similar design was used at the retrofit of the University Bridge and the feedback from the City after 20 years of service was that that design was performing well.

New Span Lock Connecting Rod, Lock Key And Guide With Bronze Wear Shoes, Shown Disengaged

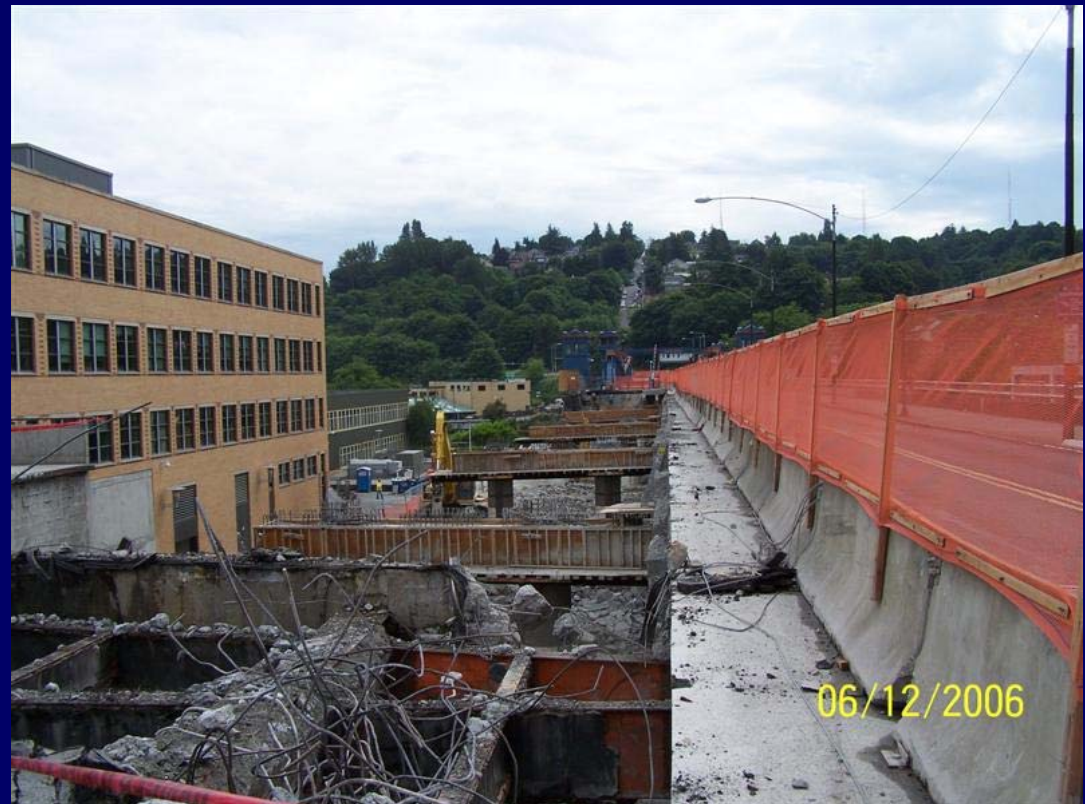
North Approach Replacement Under Construction

- The rehabilitation contract was awarded in September, 2005.
- The project was staged so that the approach span replacement work was started immediately.

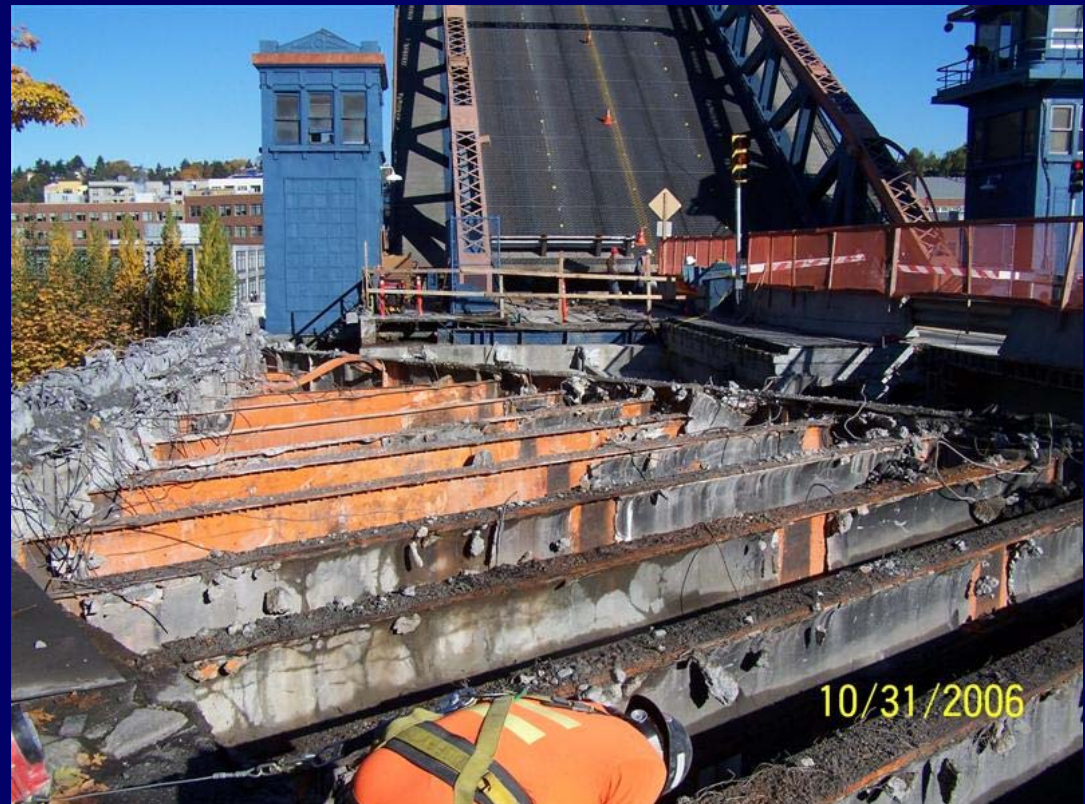
South Approach Replacement Under Construction

- While the approach replacement work was underway, the shop drawings were developed and fabrication, testing and shop inspection of the machinery was completed. The replacement of the approaches was completed in May 2007.
- Pedestrian, vehicle and bicycle traffic was maintained throughout construction.

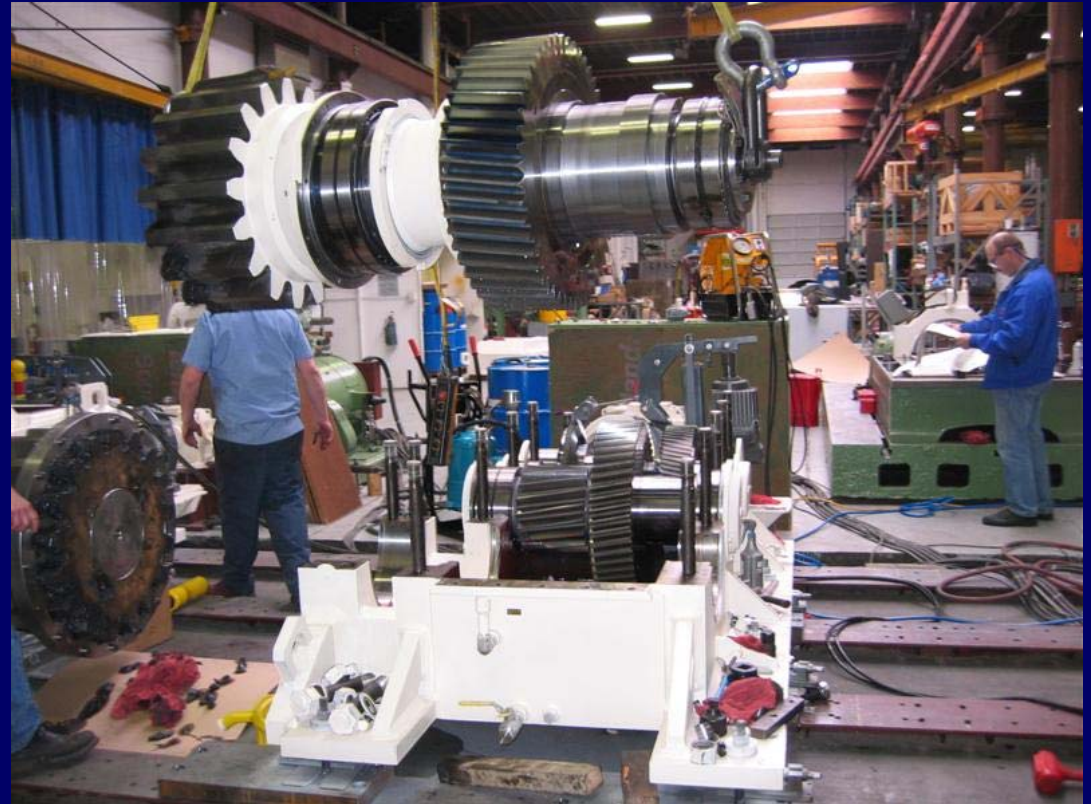
- Based on the “slinky” measurements, each pinion was custom manufactured with a special modified tooth form to optimize the strength of the teeth and ensure that the desired backlash could be achieved without the risk of tip interference.

**Assembly Of The Output Pinion Shaft Into The Reducer At
The Gear Works, Seattle**

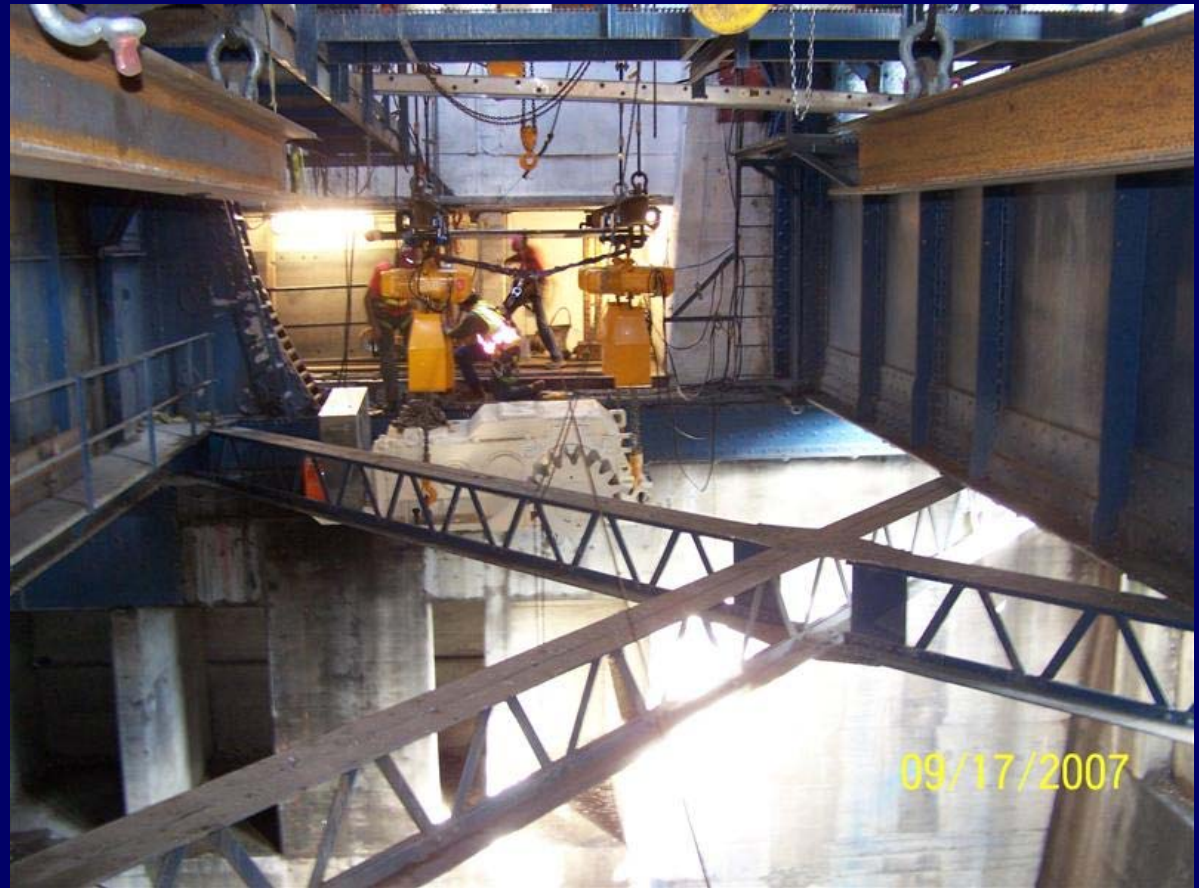
- Rigging was then installed to lift the reducers and machinery support assemblies up to the machinery level

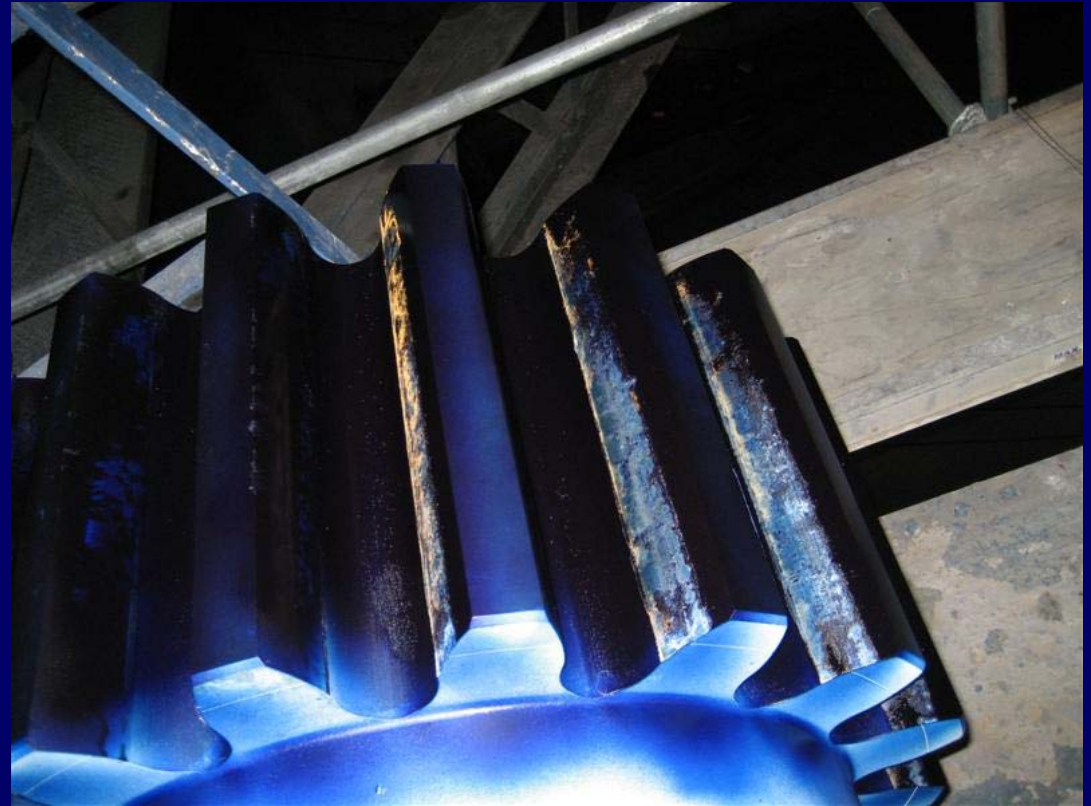
- The secondary reducers were lowered into position so that the rack pinion engaged the rack during a nighttime closure to vehicular traffic.
- The leaf position corresponding to the minimum backlash had been previously established based on the “slinky” measurements.
- The leaf was opened using the winch to establish the contact pattern on the new pinion and existing rack.

Evaluating Rack Pinion Tooth Contact During Installation Of The Secondary Reducers

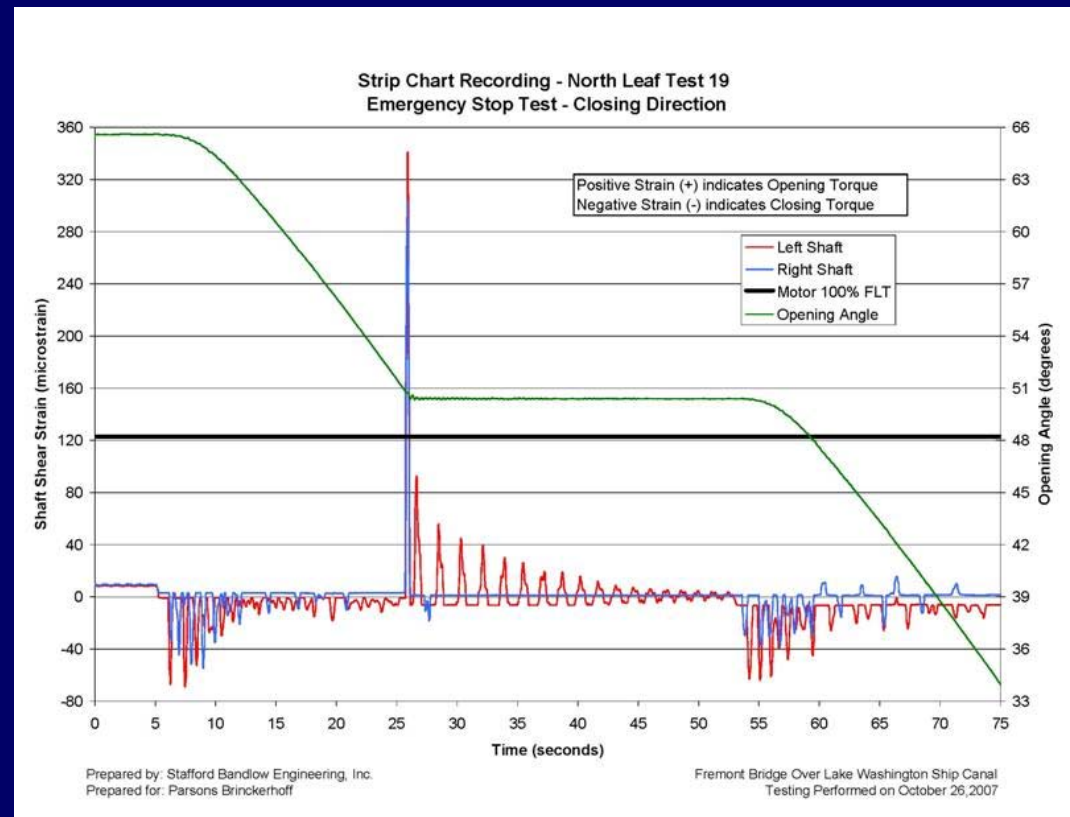
- Emergency stop tests were performed during commissioning
- Brake torque was verified with a torque wrench (equivalent to ~95% FLT of the motor) using the breakaway method
- With the motor brakes set for no time delay the peak braking torque was nearly 300% FLT of the motor.
- With a 2 second time delay for the motor brakes, peak braking torque was reduced by 50%.

Emergency Stop Testing Of New Span Drive Machinery With No Motor Brake Time Delay

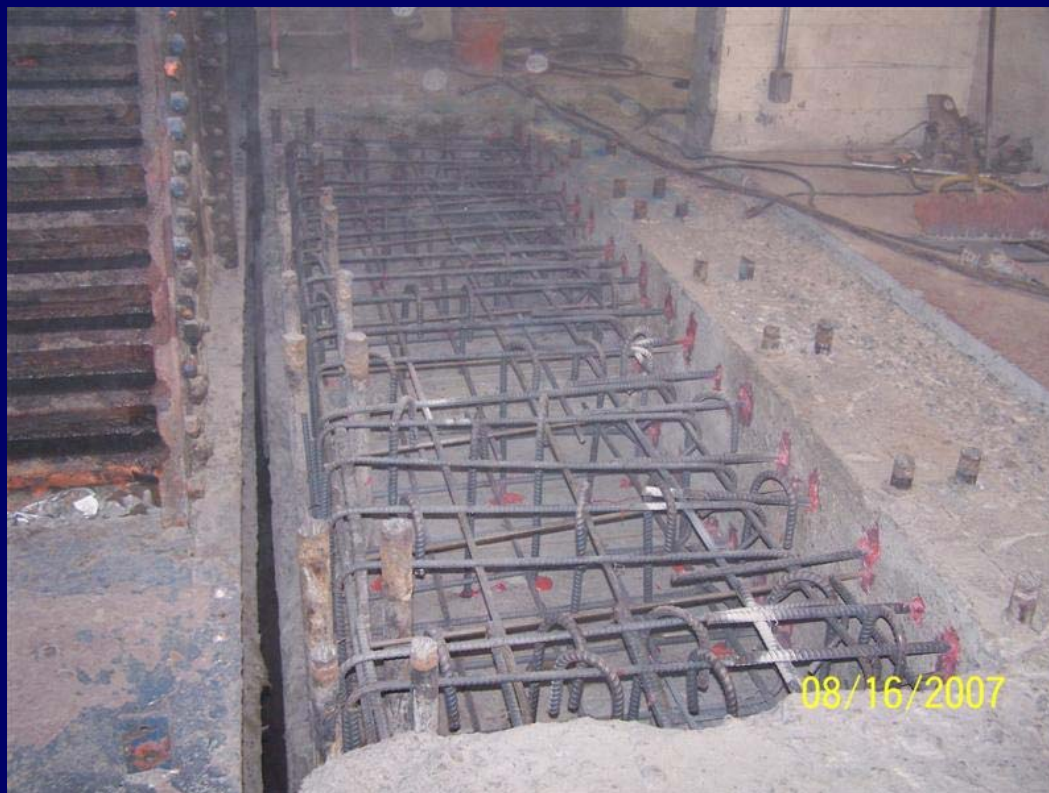
- Large voids and poor quality concrete were discovered within the counterweight. It was not possible to anchor the winch sheave brackets and it was necessary to weld them to the counterweight box.
- Unsound concrete was also discovered during modifications to the machinery floor that the secondary reducers were anchored to. In order to ensure the integrity of the reducer anchorage, the unsound concrete was chipped out and reinforcing was added.

Machinery Anchorage Modifications

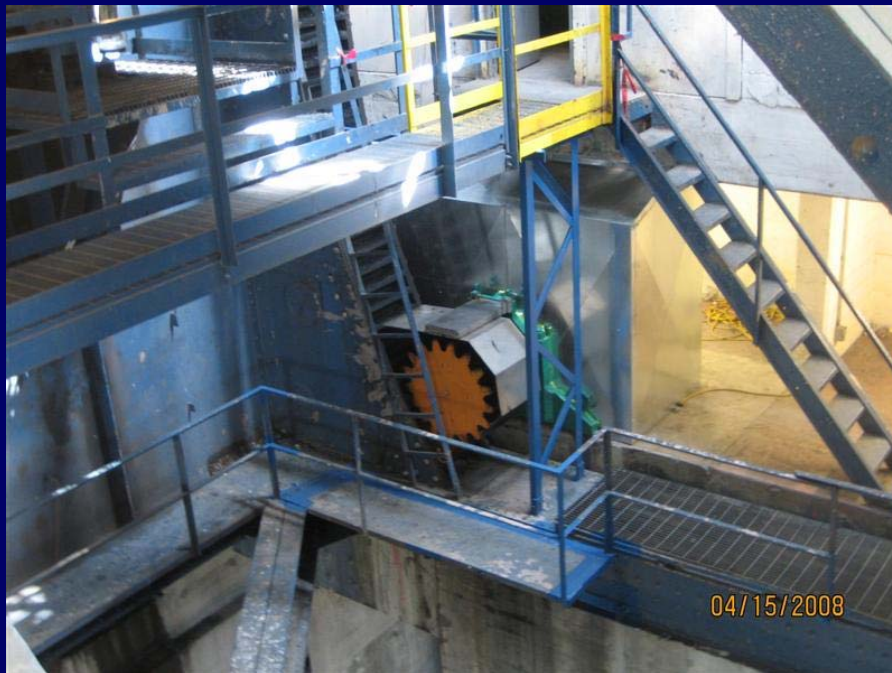
The Rack, New Pinion And Machinery Shield Viewed From Inside The Bascule Leaf

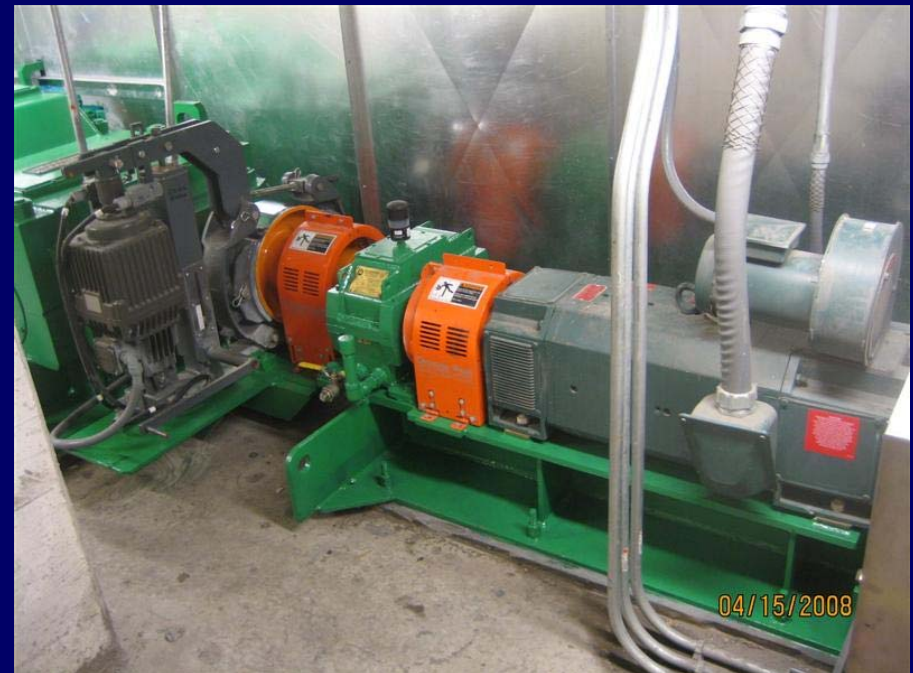
New Span Drive Motor, Primary Reducer, Motor And Machinery Brakes Viewed From The Machinery Room
