Green River Gorge Bridge Seismic Retrofit

Zhengjie Zhou, Ph.D., PE

King County DOT, Seattle, WA

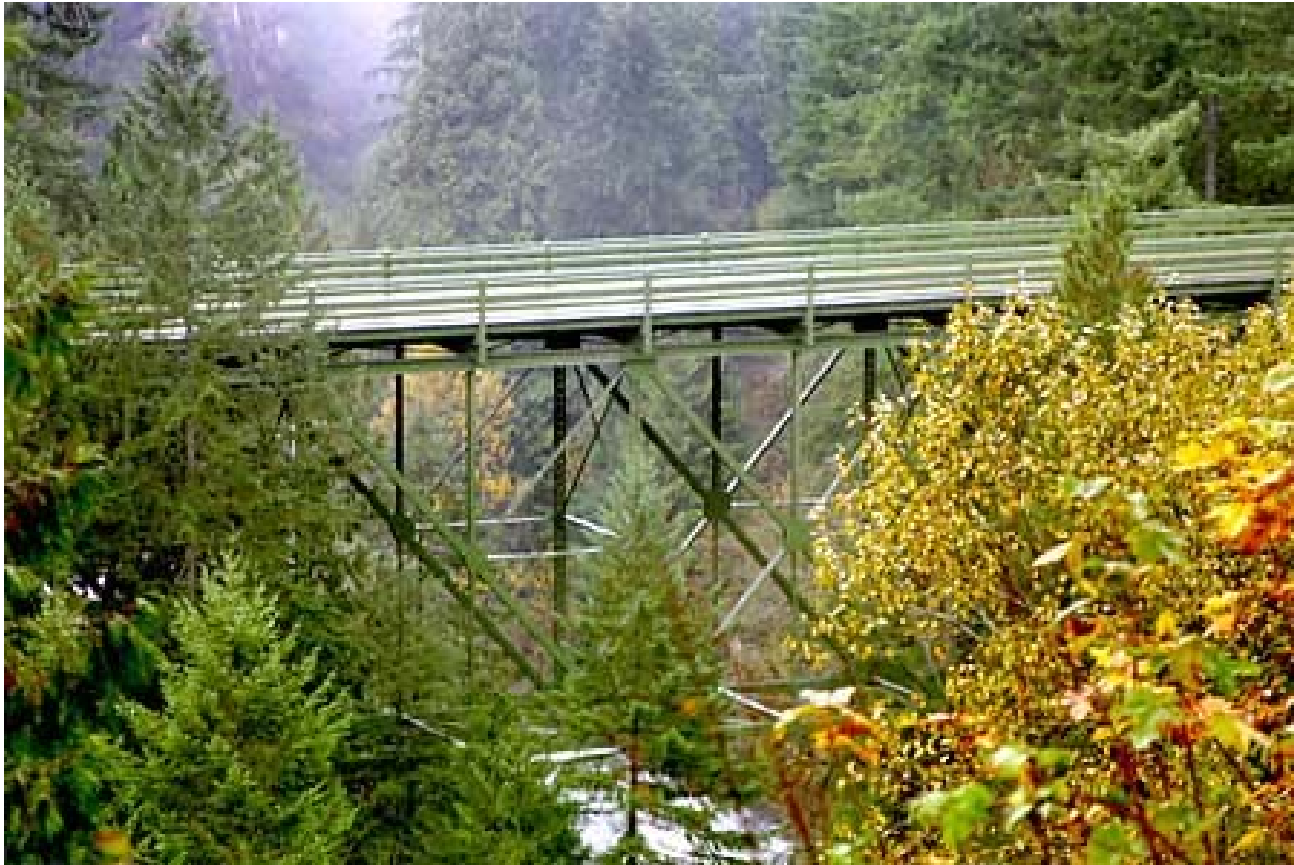
Main span truss of the bridge

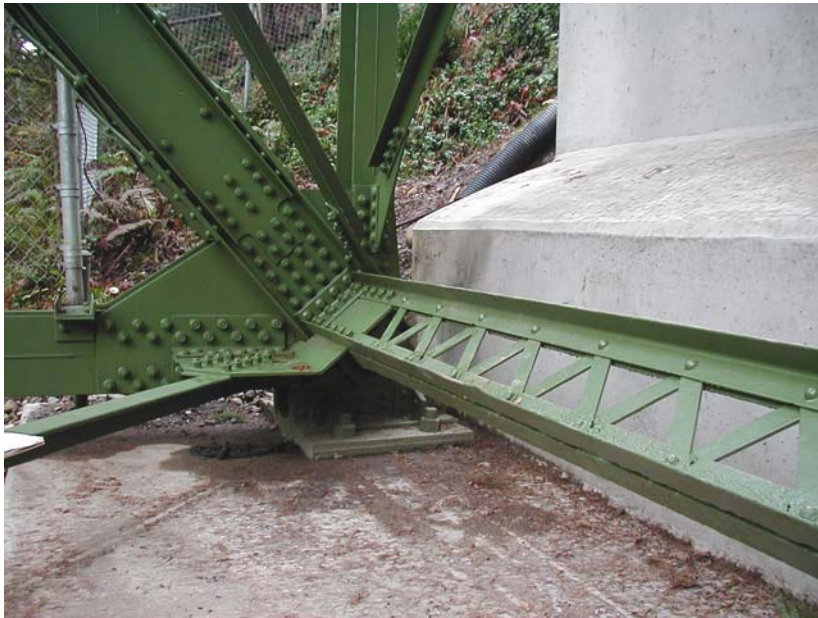
Sliding bearing support
at West End of Bridge

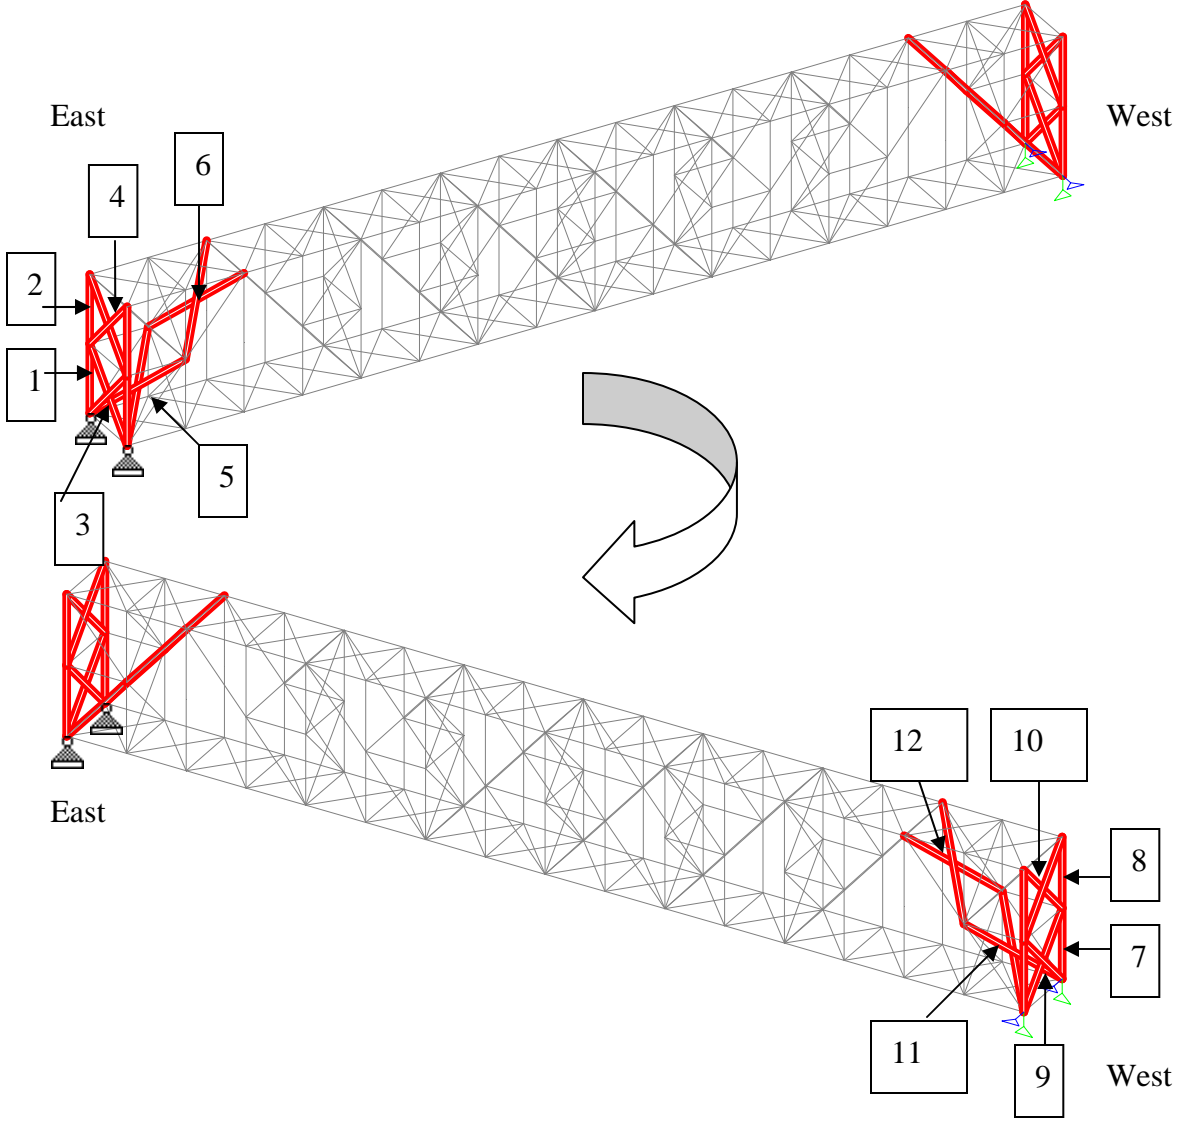
Deficient Components of the Truss

- Strengthening/replacing deficient truss members
 - Replacing deficient braces by larger section and higher strength steel angle
 - Welding steel plate on the vertical columns
- Strengthening deficient connections
 - Thicker and higher strength steel plates
 - Stronger bolts
 - Weld connection
- Reinforcing bearing anchor connection at east bridge abutment

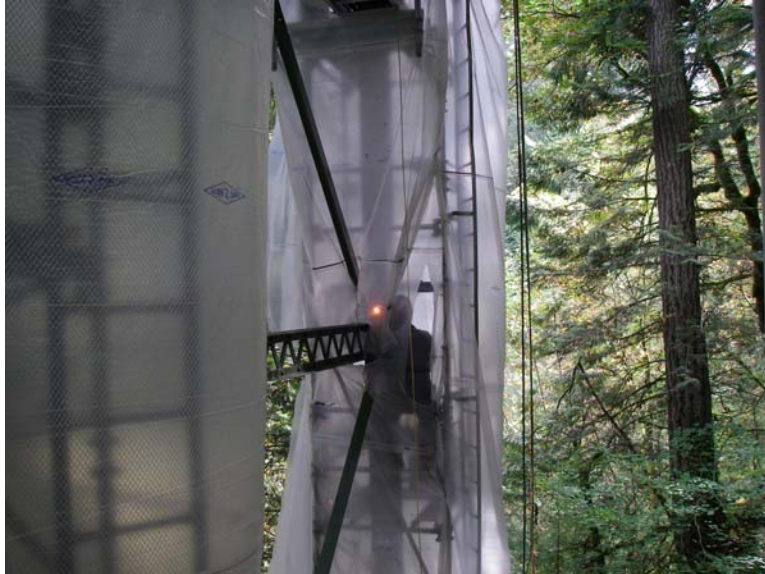
Steel Plate Welded on Vertical Column

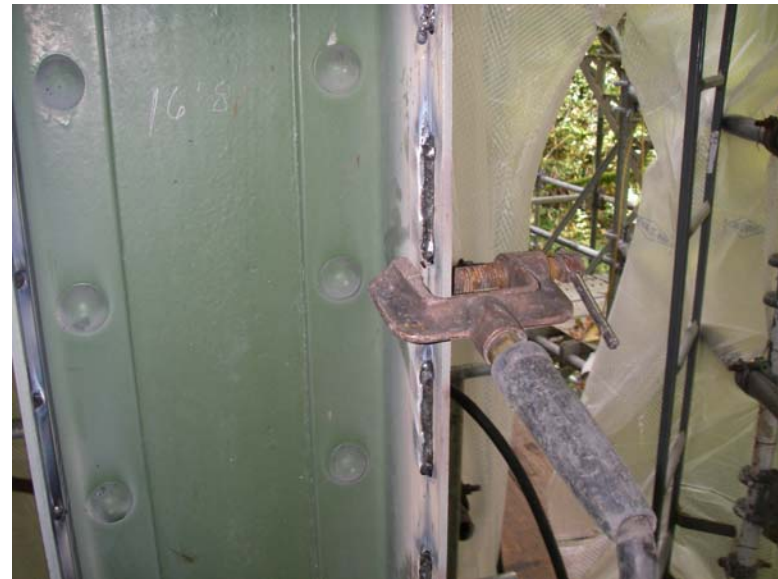
Replacement of deficient braces

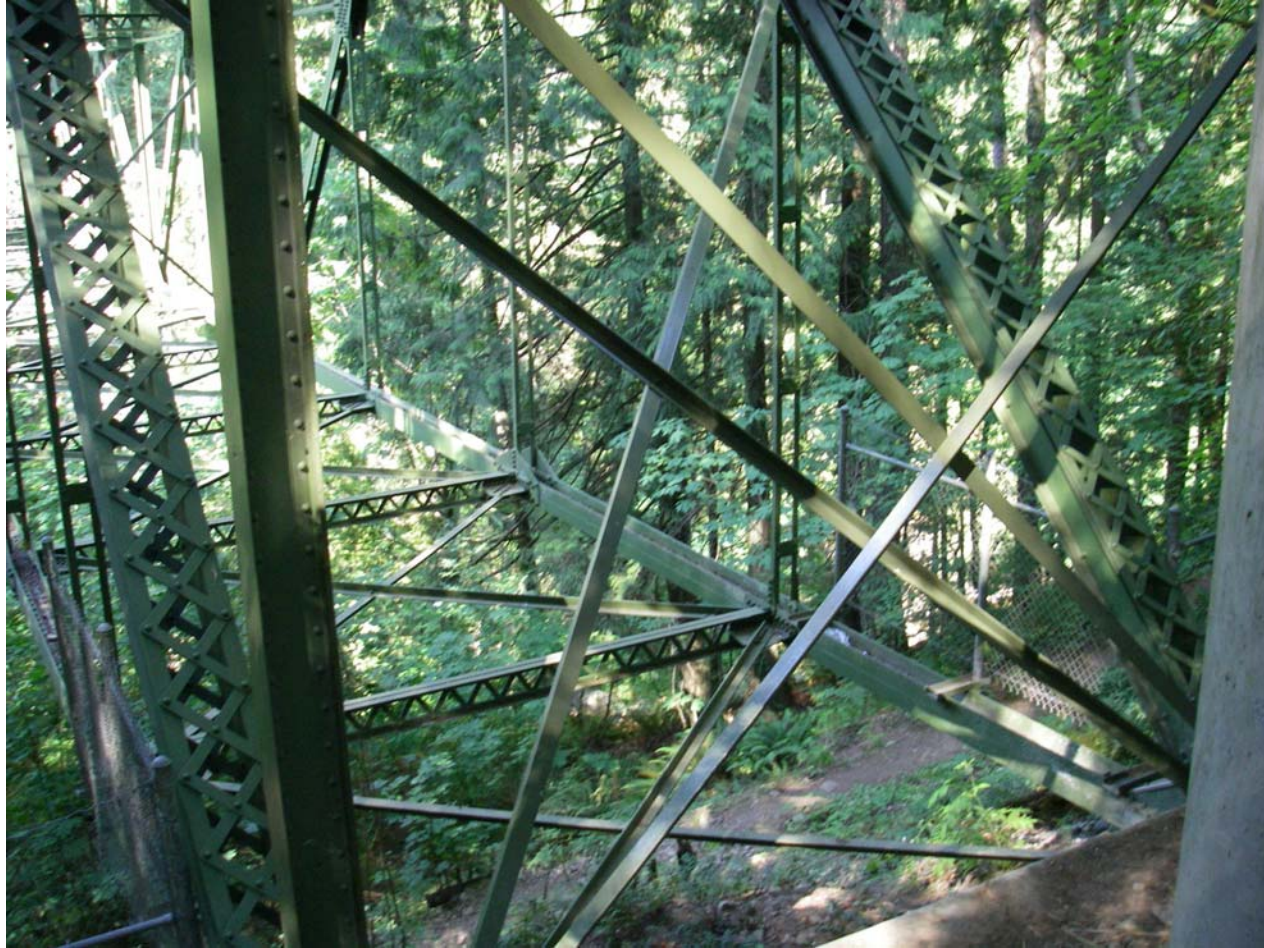
Existing Connection
Plate: $t=3/8$ ", Grade 36
Bolt: $4-3/4$ " Φ , A304
2L3.5x3x1/4, Grade 36

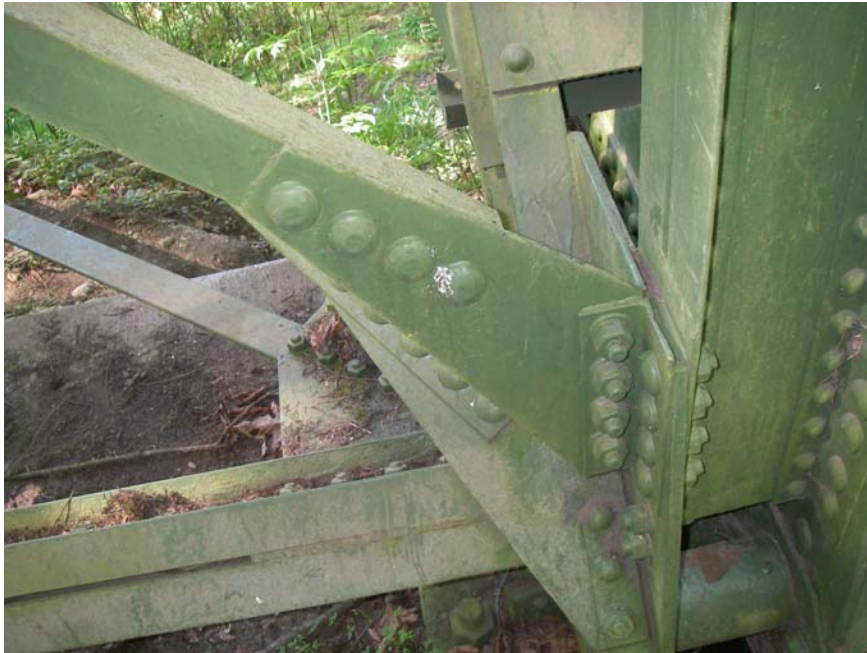
New Connection (before painting)
Plate: $t=1/2$ ", Grade 50
Bolt: $5-7/8$ " Φ , or $4-1$ " Φ , A325
2L4x3x3/8, Grade 50
