Seismic Retrofit and Rehabilitation of the North Torrey Pines Road Bridge

Keith J. Gazaway, P.E.

Simon Wong Engineering

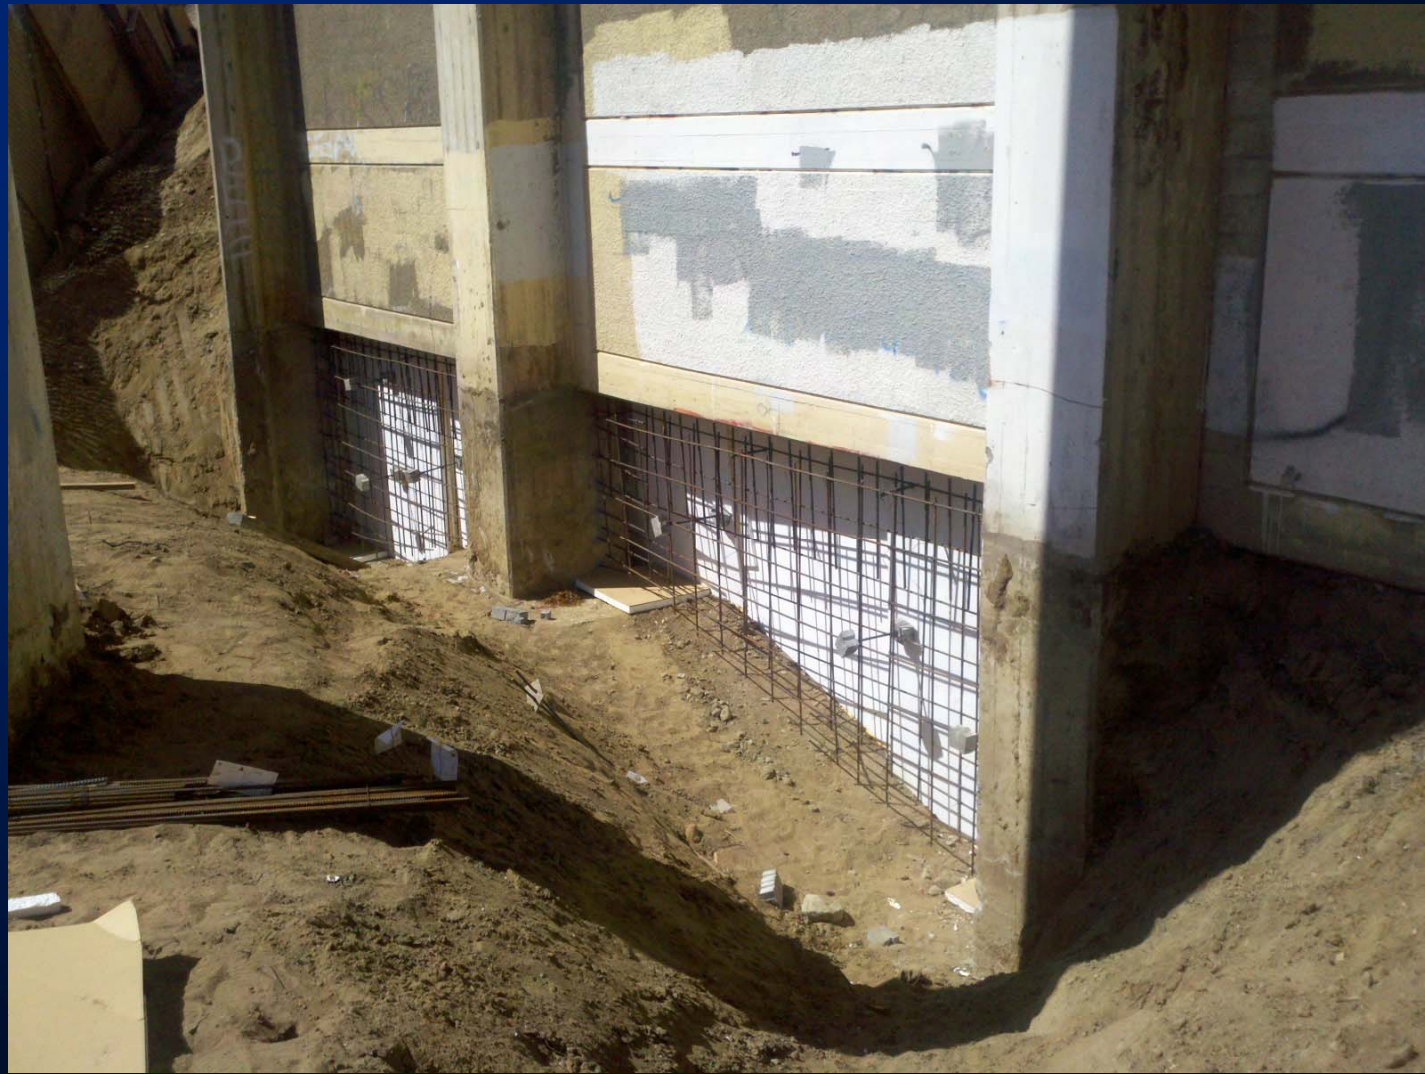
Shear Wall Infill Panels

- ❑ Oct 2010: Winning Bidder: Flatiron West, Inc.
- ❑ Dec 2010: Notice to Proceed
- ❑ Mar-Apr 2011: Compaction Grouting
- ❑ Jun 2011: Shear Wall Retrofit
