MILLPORT SLOUGH BRIDGE

Coastal Bridge Construction Incorporating Ground Improvement

Matthew Stucker, P.E. Structural Design Engineer Oregon DOT Region 2 Tech Center – Bridge/Geo/Hydro Unit

Michael Zimmerman, P.E., G.E., C.E.G. Senior Engineer/Geologist GRI of Beaverton, Oregon Oregon Department Of Transportation

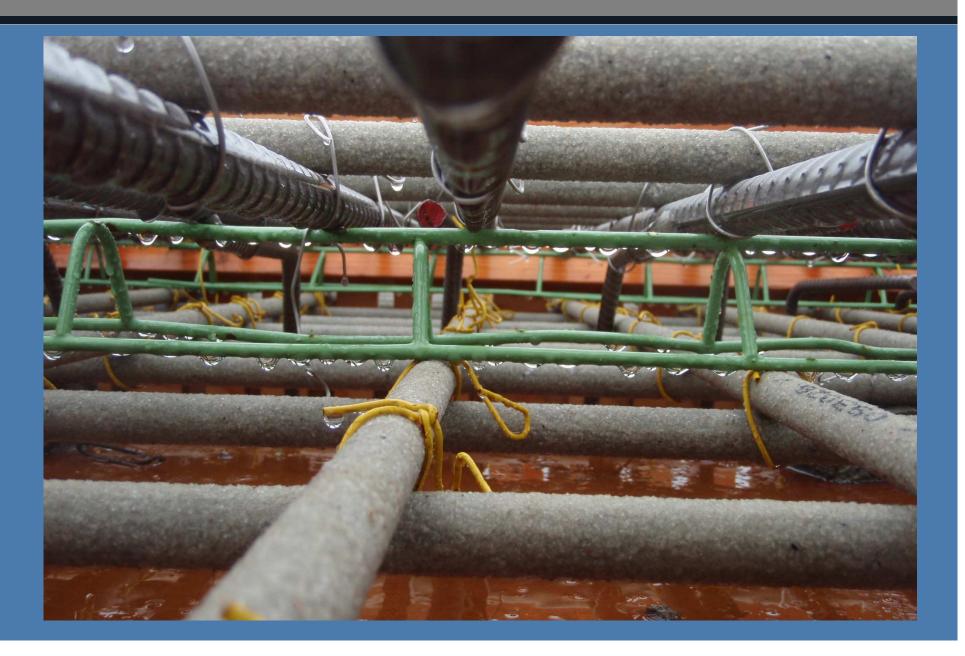
Deck Corrosion Protection

Deck Design Reinforcement Alternatives Considered		
	#4 Black Bar	#5 & #6 GFRP Bar	#4 Stainless Steel (75ksi)
Unit Cost	\$1.10/lb (assumed)	\$1.36/ft (wgt. avg.)	\$4.25/lb
Total Length	L	1.07*L	0.91*L
Total Cost	С	1.97*C	3.53*C

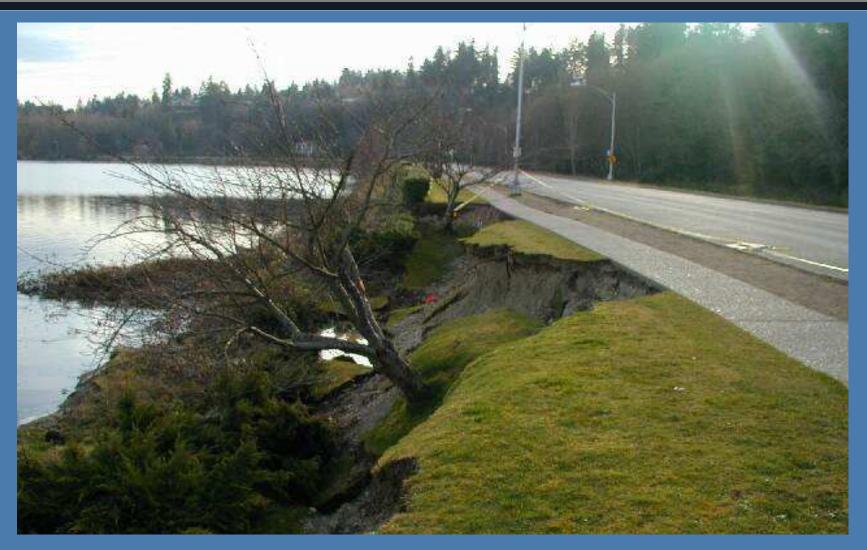
Lateral Spreading Due to Liquefaction

Capital Lake, Olympia, Washington (Nisqually event, 2001) Lateral spreading from magnitude 6.8 earthquake

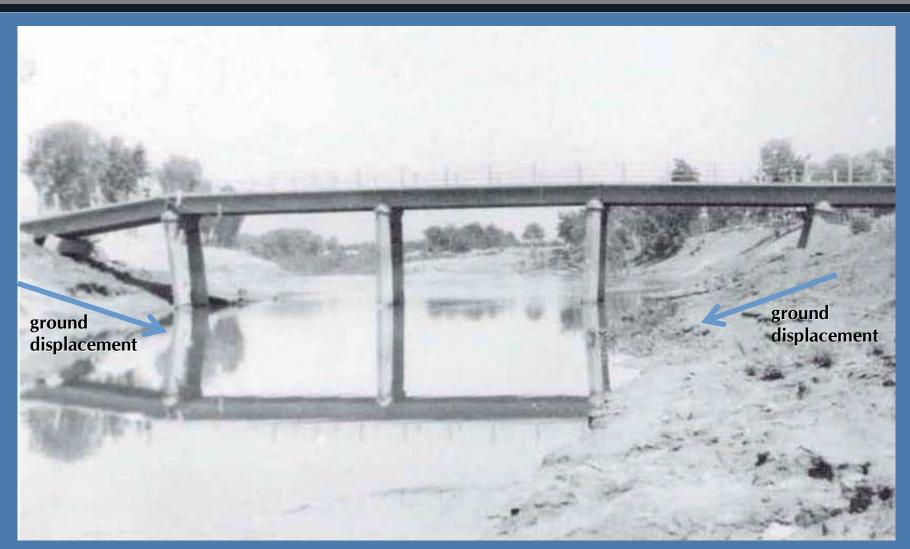
Damage From Lateral Spreading

1976 Tangshan Earthquake - Yuehe Bridge near Tangshan, China (M7.8 earthquake)

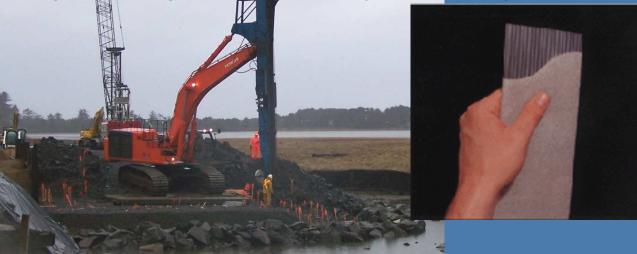
Prefabricated Vertical Drains, "Wick Drains"

- Installed before driving PCPS concrete pile and placed 4 ft oncenter between PCPS concrete pile locations
- □ Wick drains driver to 50 60 ft depth
- Improves densification during pile driving
- □ Soil iquefaction may still occur
- Documented reduction in liquefaction for stone column ground improvement and dynamic compaction
