In Span Hinge Replacement and Seismic Retrofit of the Flamingo Viaduct

Nathan Johnson, Ph.D., PE

Sami Megally, Ph.D., PE

- ▣ Las Vegas, NV, I-515 over Flamingo
- ▣ Owner: Nevada DOT
- ▣ Constructed in 1982
- ▣ 10-span continuous PT box girder
- ▣ Twin 72ft wide 1400ft structures with 2 ISH
- ▣ Scope: Repair hinges, seismic retrofit/rehab
- ▣ \$3.5M Retrofit/Rehab (small cost difficult task)

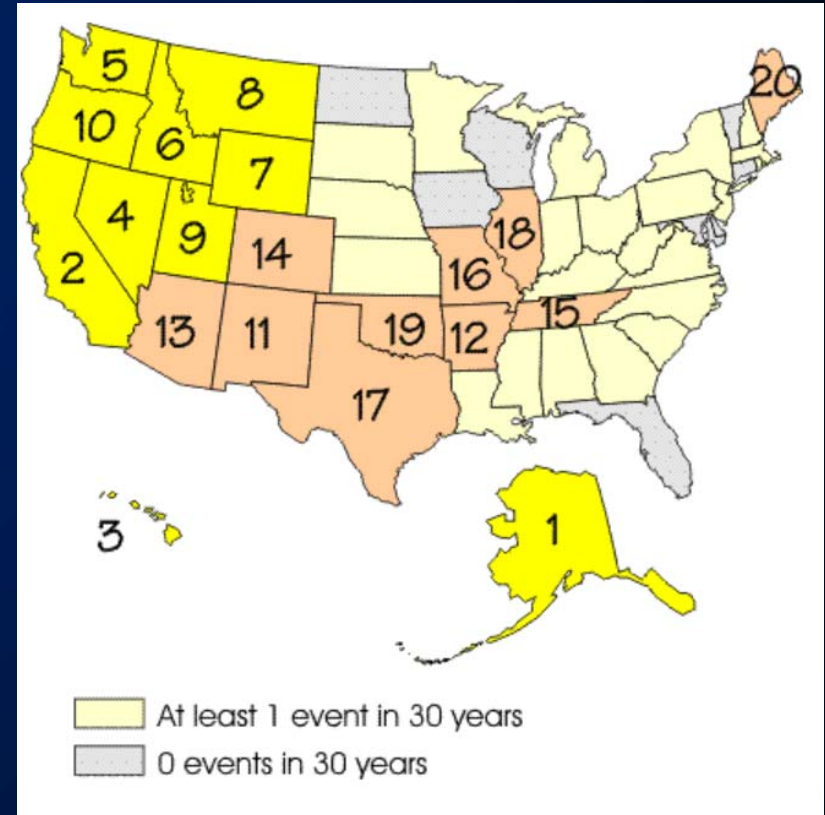
Nevada Seismicity??

Mag >= 7.0	Mag >= 6.0	Mag >= 5.0	Mag >= 3.5
1st	Alaska	Alaska	Alaska	Alaska
	59	370	2050	14914
2nd	California	California	California	California
	16	114	675	10965
3rd	Nevada	Hawaii	Nevada	Hawaii
	4	29	159	2247
4th	Hawaii	Nevada	Hawaii	Nevada
	4	21	80	1586
5th	Missouri	Montana	Washington	Washington
	2	6	41	898
6th	Arkansas	Washington	Montana	Idaho
	2	5	25	613
7th	Washington	Wyoming	Wyoming	Wyoming
	1	5	22	392
8th	Montana	Idaho	Idaho	Montana
	1	4	18	321
9th	South Carolina	Oregon	Utah	Utah
	1	3	15	193
10th		Arkansas	Oregon	Oregon
		3	14	148

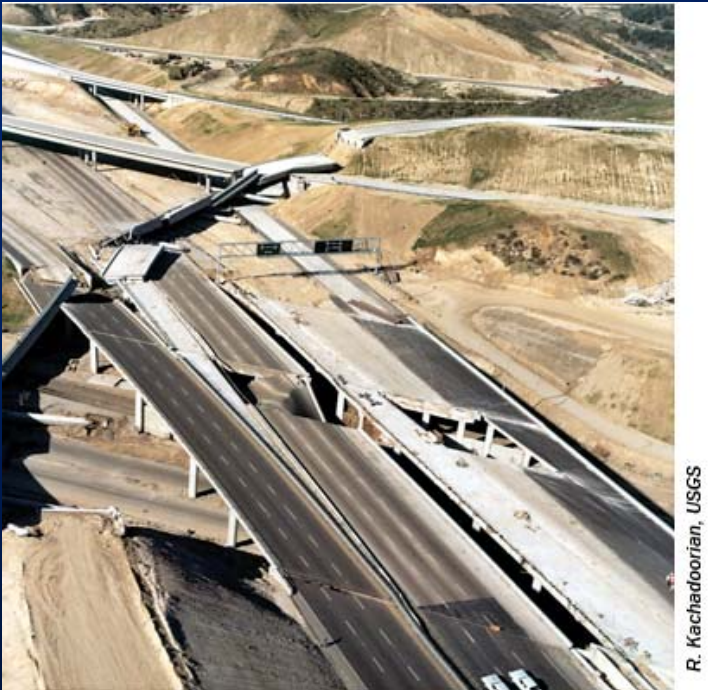
1971 San Fernando

In-Span Hinge Failures

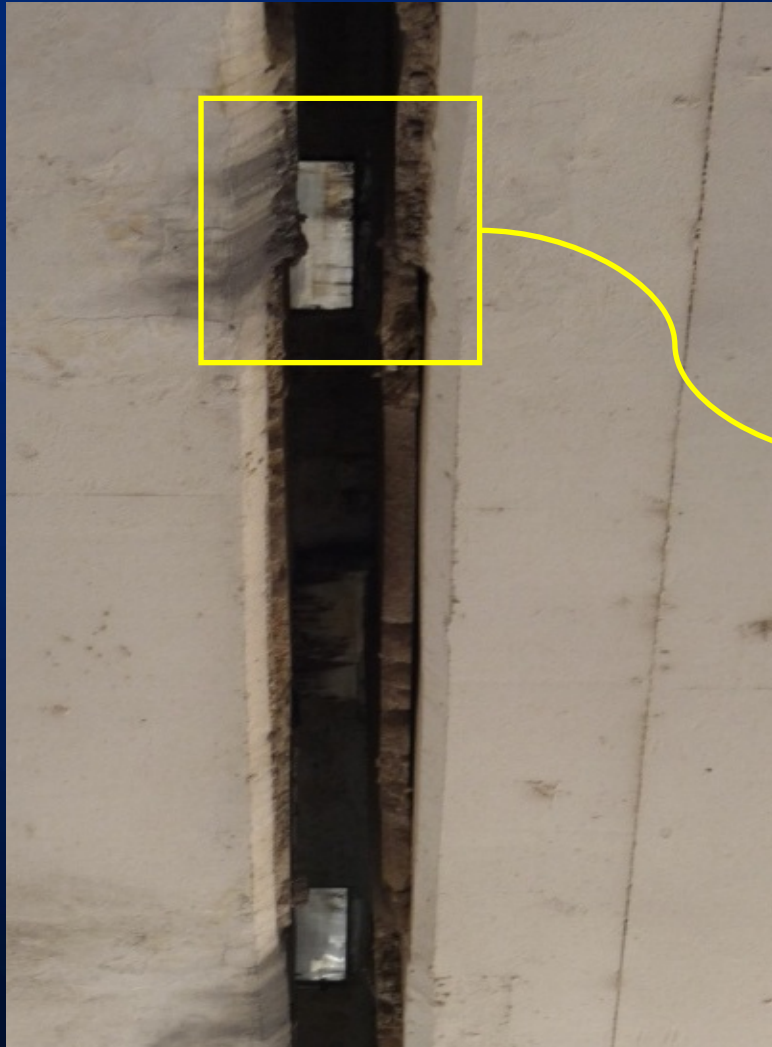
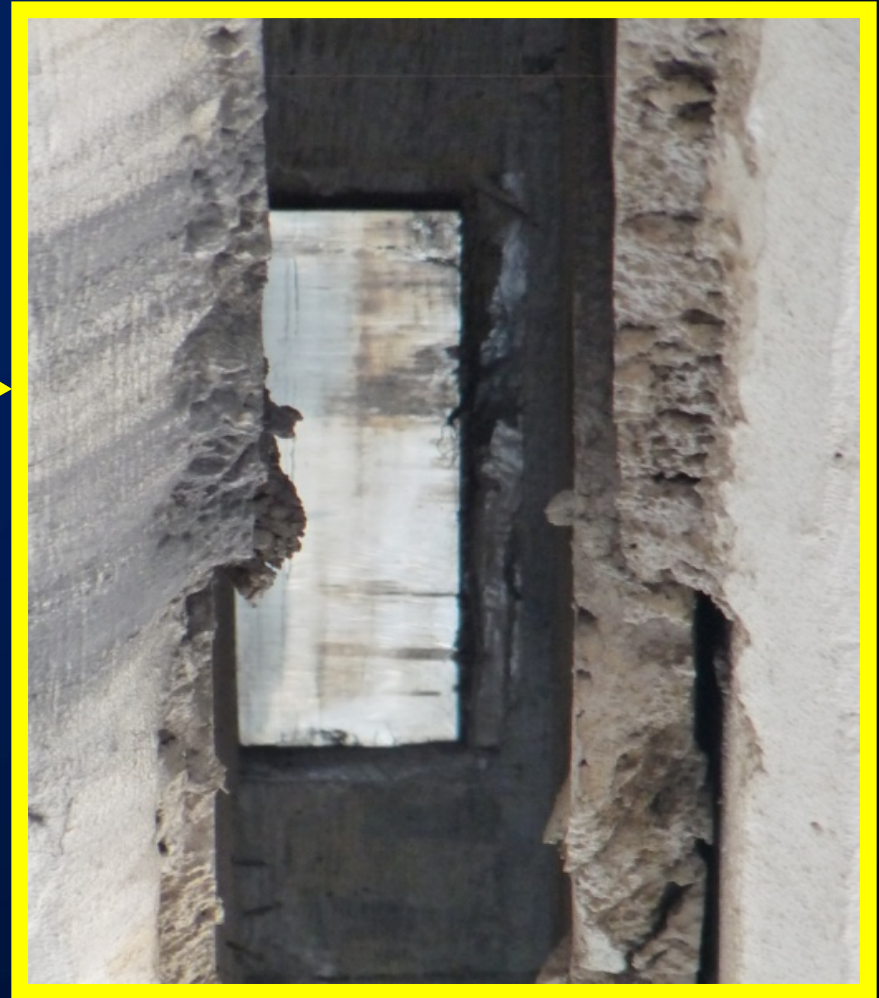
In-Span Hinge

- Excessive hinge movement (18" seat)
 - Designed for 2in, measured 8-10 in
 - Restrainers failed
 - Hinge seats
 - Columns hinged
 - Cap beam T & V

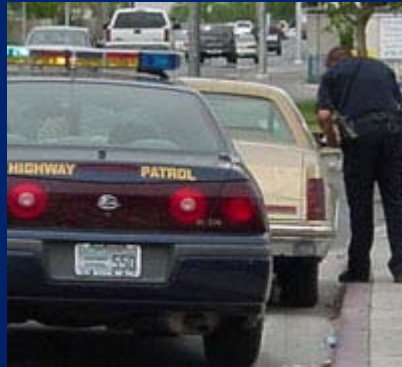
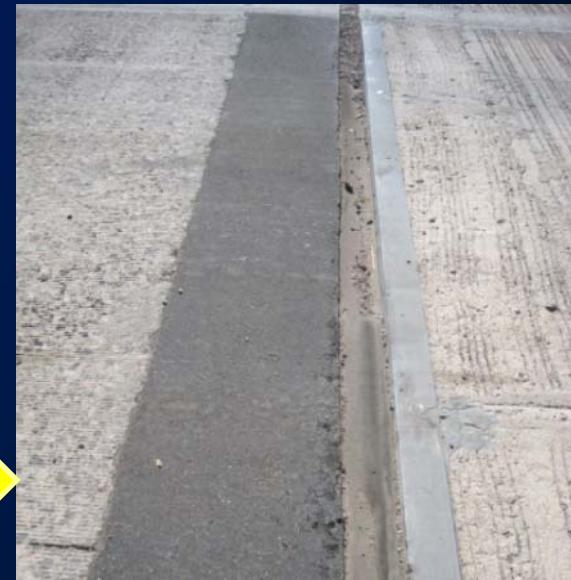
1992 Expansion Joint Reconstruction

- ▣ 1985 inspection reports noted excessive ISH movement
- ▣ 1992 expansion joints reconstructed
- ▣ 2003 Initial rehabilitation study (PB)
- ▣ 2007 Second Rehabilitation study (PBSJ)
- ▣ 2010 Retrofit/Rehabilitation Type Selection and Final Design
- ▣ (9 year project)

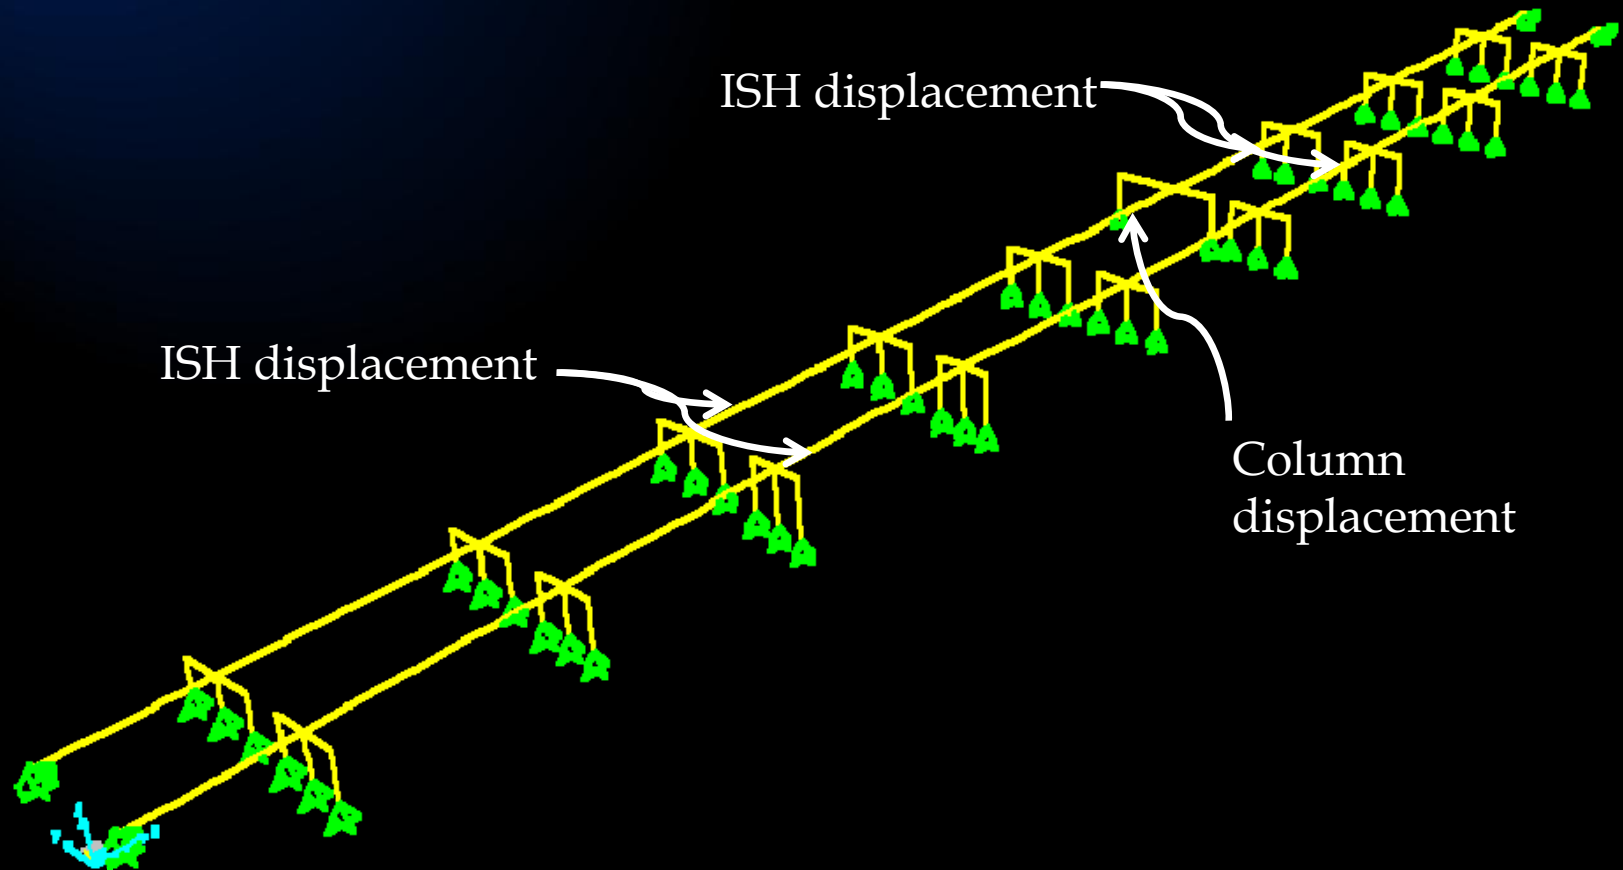
Linear RSA System

- ▣ Criteria is Life Safety
- ▣ Columns already experienced displacement
- ▣ NDOT standard is FHWA manual
 - Method B, C, D
- ▣ Caltrans standard (FHWA D) makes sense
 - “Linear” RSA displacement demands (ATC6)
 - NL pushover disp. capacities & force demands
- ▣ Add shortening deformations to 100/30 seismic demand, $\Delta_c > \Delta_d$

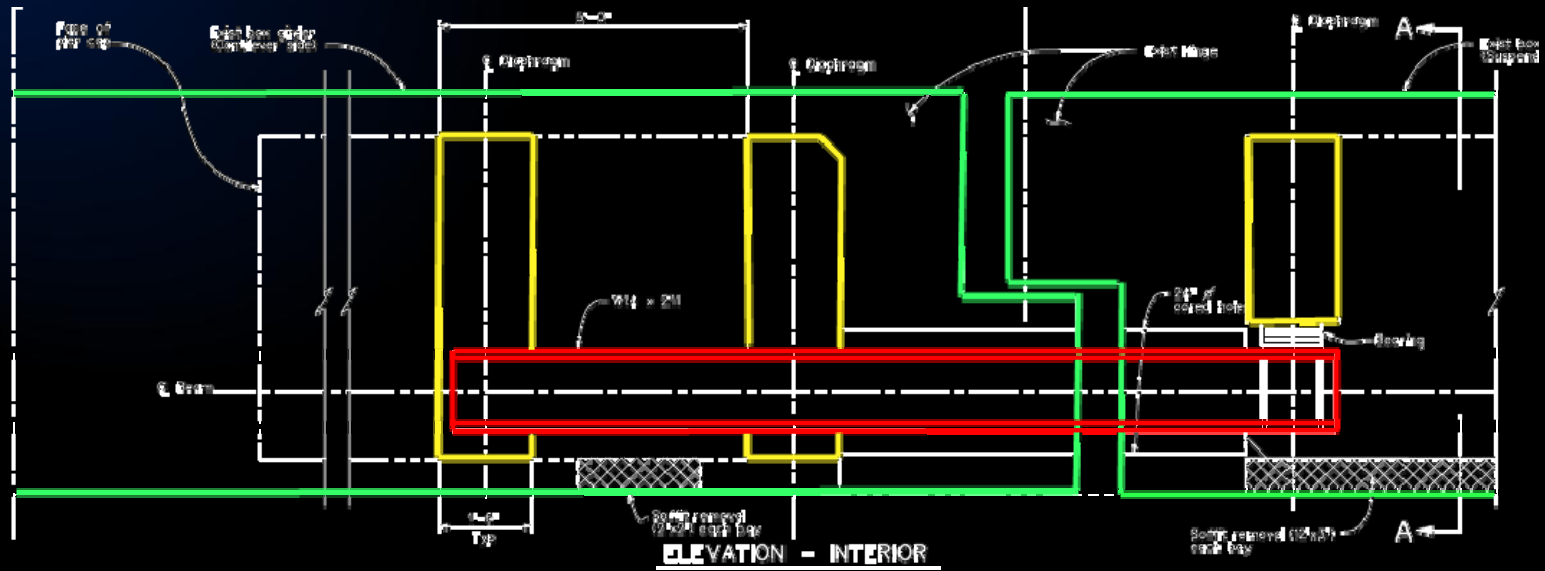
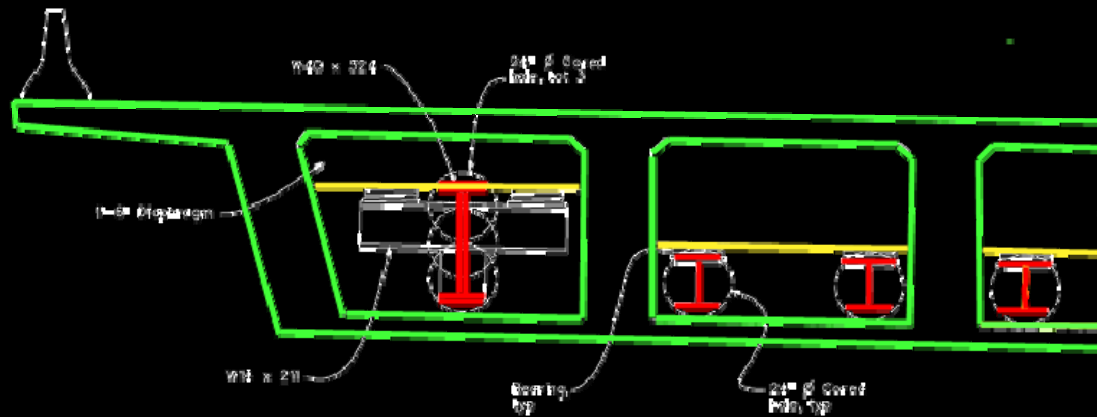
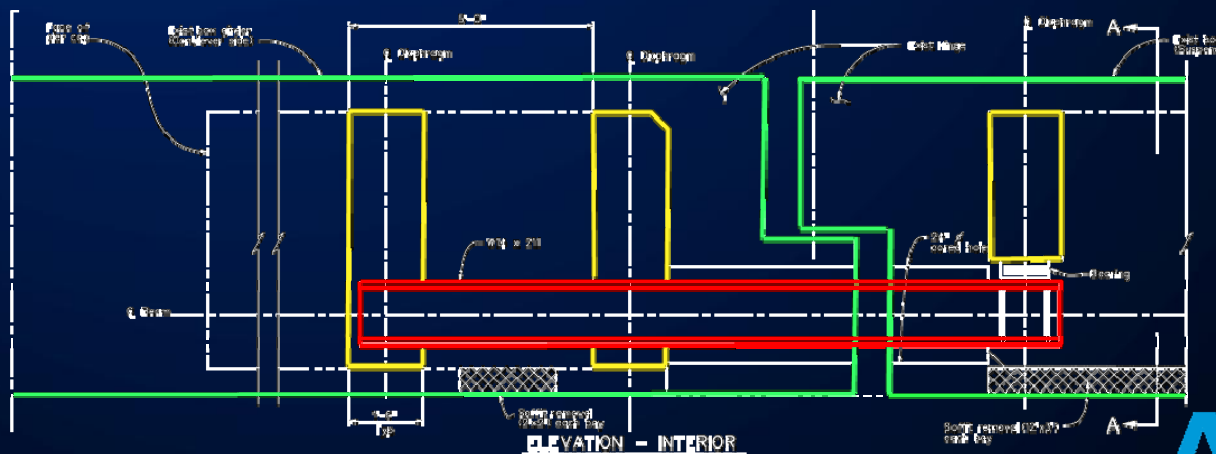
Internal Strong Back

- ✓ Minor Traffic Impact
- ✓ No Future Maintenance
- ✓ No Impact on Bridge Aesthetics
- ✓ Bearing Pads Accessible for Inspection

- × Complex Structural Modification

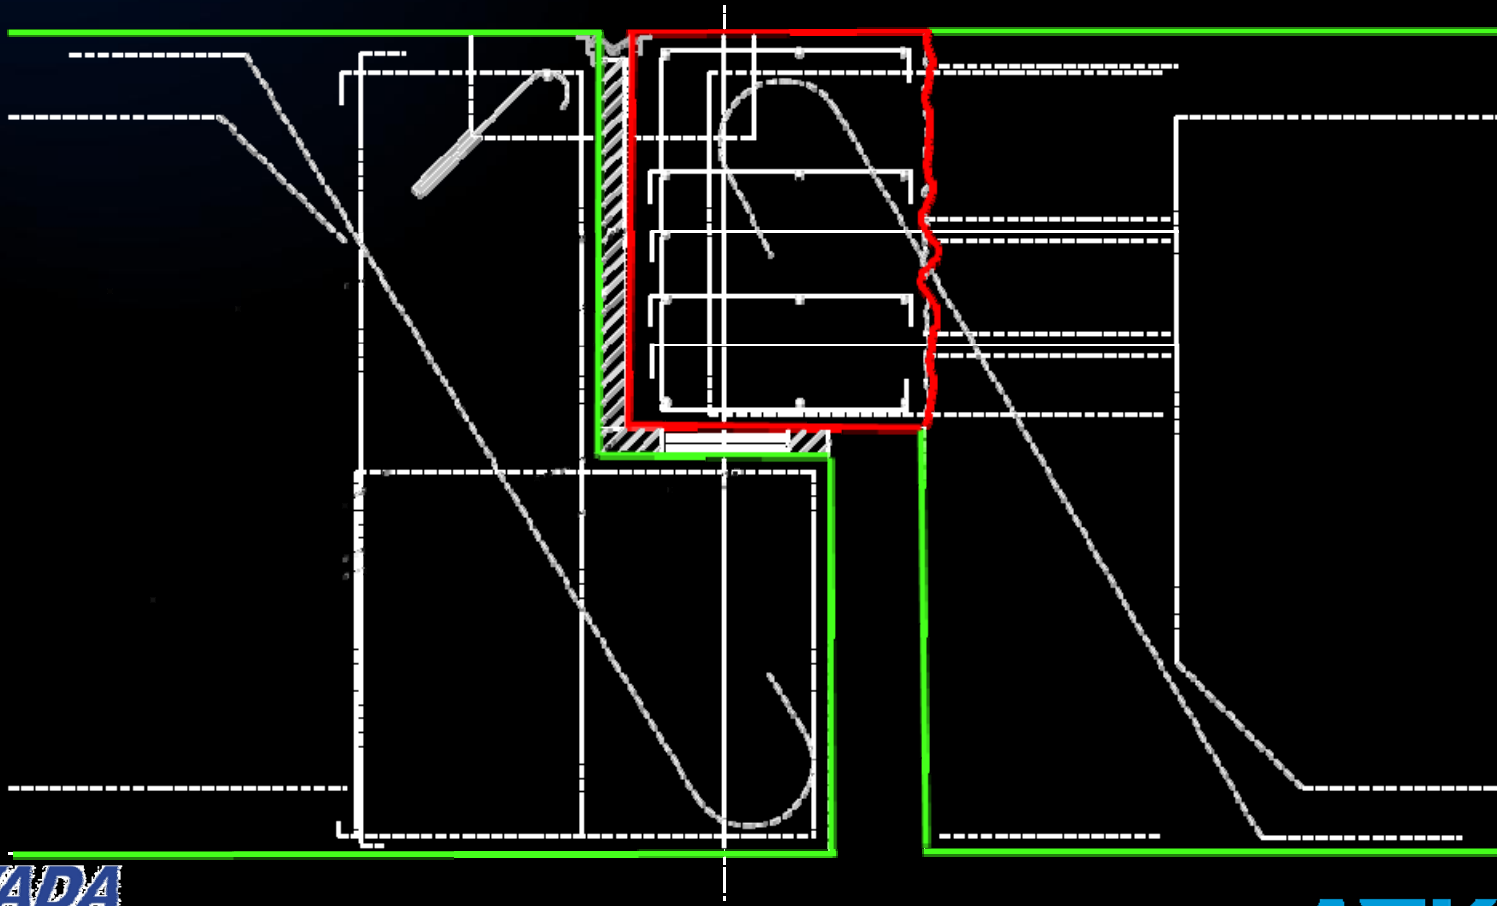
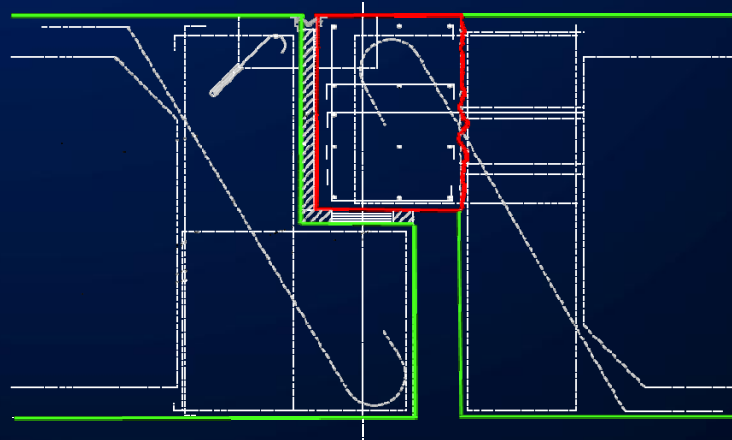
Hinge Replacement

- ✓ No Future Maintenance
- ✓ No Aesthetic Impact

- × Complex Structural Modification
- × Significant Impact to Traffic
- × High Cost
- × Bearing Pads Inaccessible

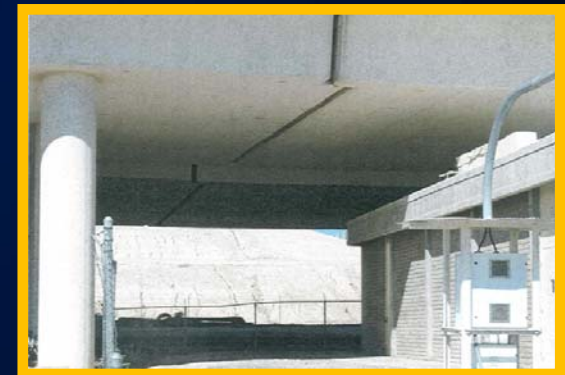
- ✓ Ease of Construction
- ✓ Low Cost
- ✓ Minor Traffic Impact
- ✓ Bearing Pads Accessible for Inspection

- × Aesthetics
- × Future Maintenance

- ▣ Multiple Alternatives Available for Replacement of ISH (staging, aesthetics)
- ▣ External Strong Back Proved Best Alternative for This Case
- ▣ In-Depth Analysis Necessary for Force Transfer
- ▣ Scheduled Completion end of 2011

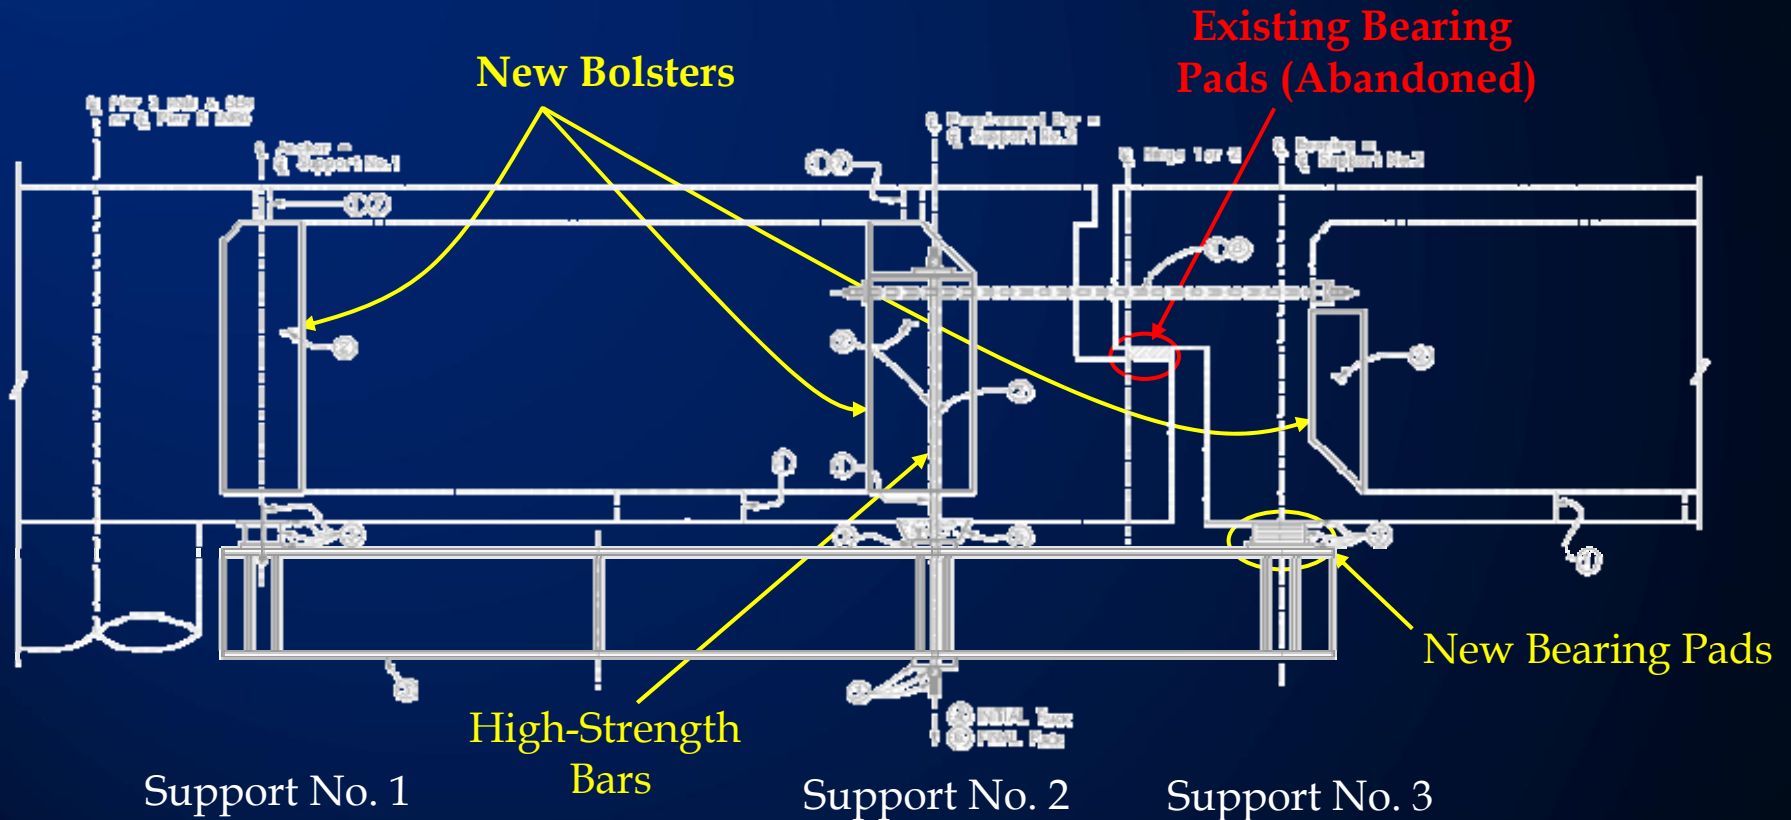
Hinge Rehabilitation

- New bearing pads are active for permanent loads reactions
- New bearing pads designed to take full live load reactions

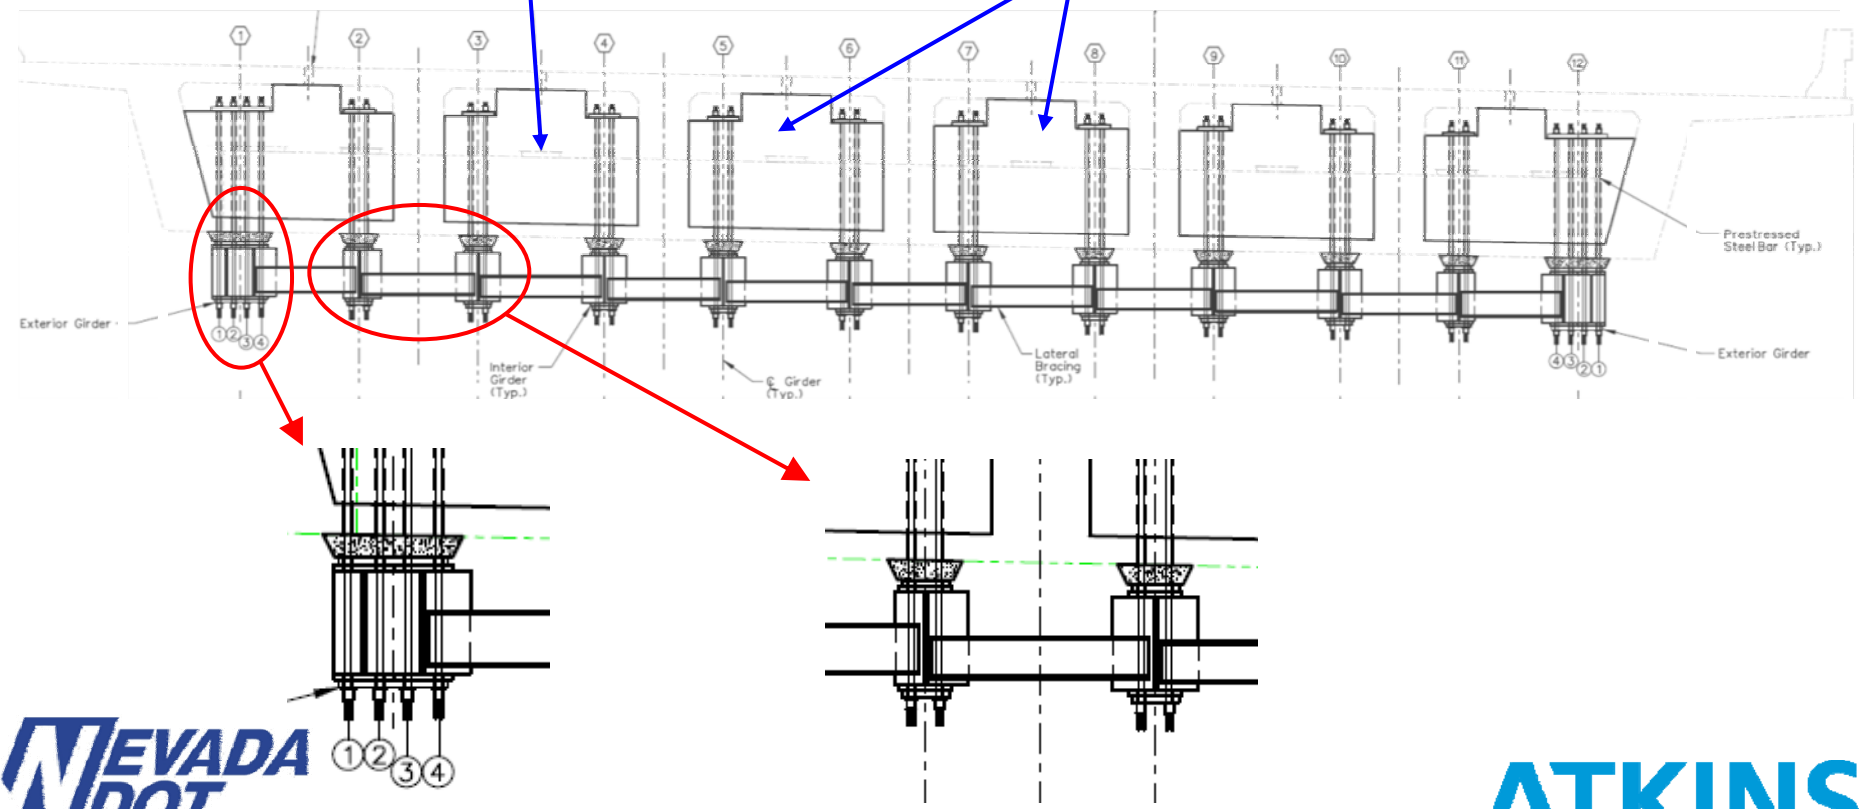
PT Bars Stressing Sequence

- PT bars are NOT stressed simultaneously at all new steel beam locations
- Effect of stressing sequence of PT Bars at different beam locations is investigated by nonlinear analysis (SAP2000)

Exist Bearing Pads New Bolsters

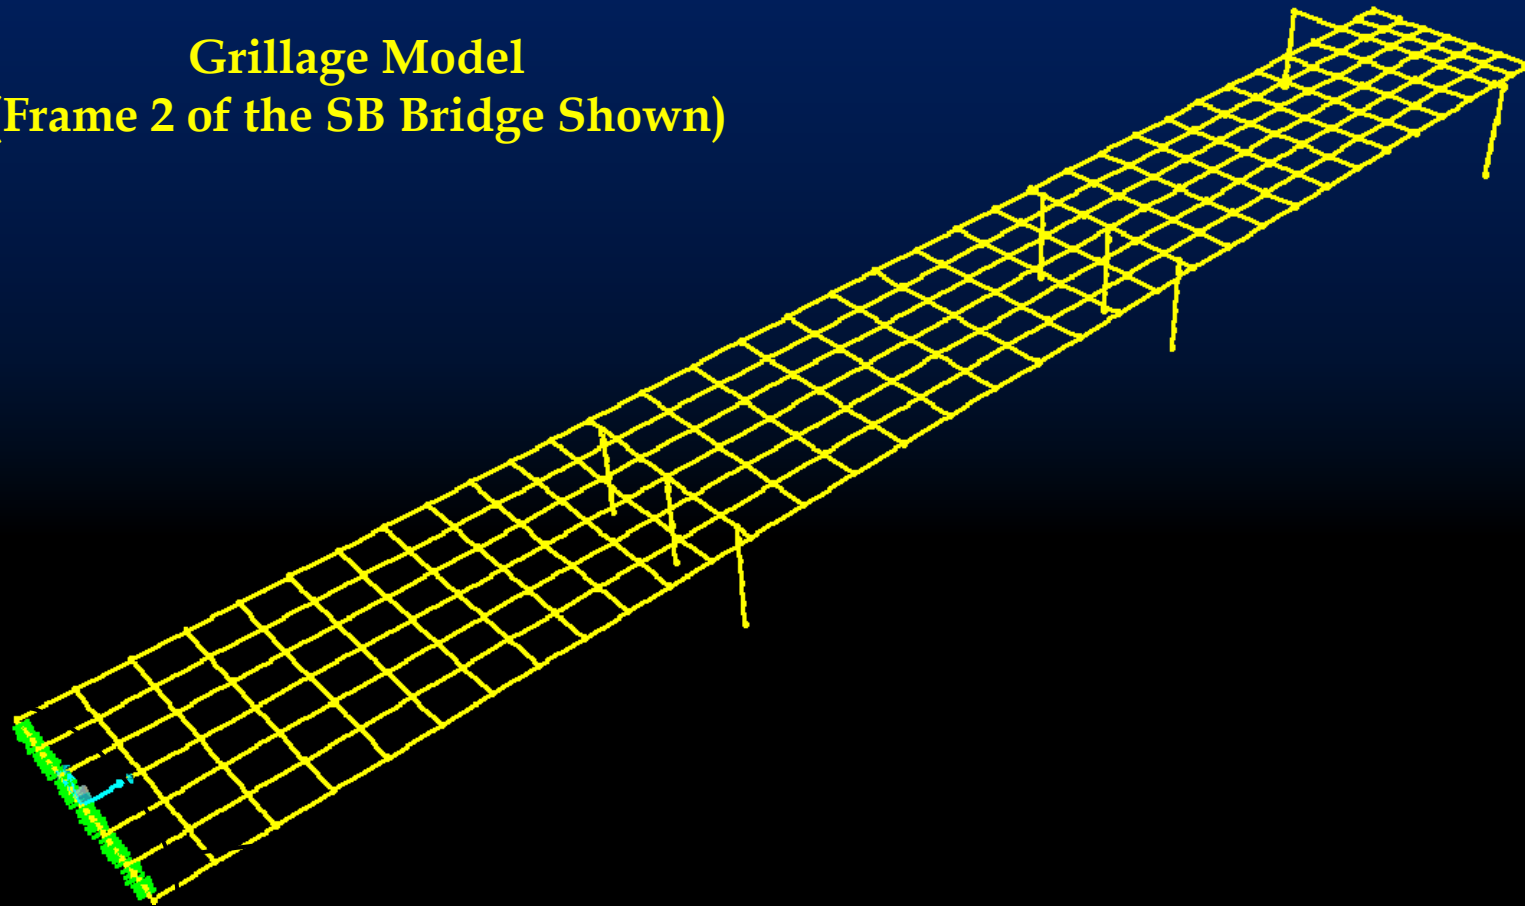
Grillage Model
(Frame 2 of the SB Bridge Shown)

- Nonlinear spring (compression-only) elements used to model existing bearing pads and new steel beams/bearing pads
- Initial load case is permanent loads (reactions on existing pads only)
- Model loaded in the same sequence specified for stressing of PT bars

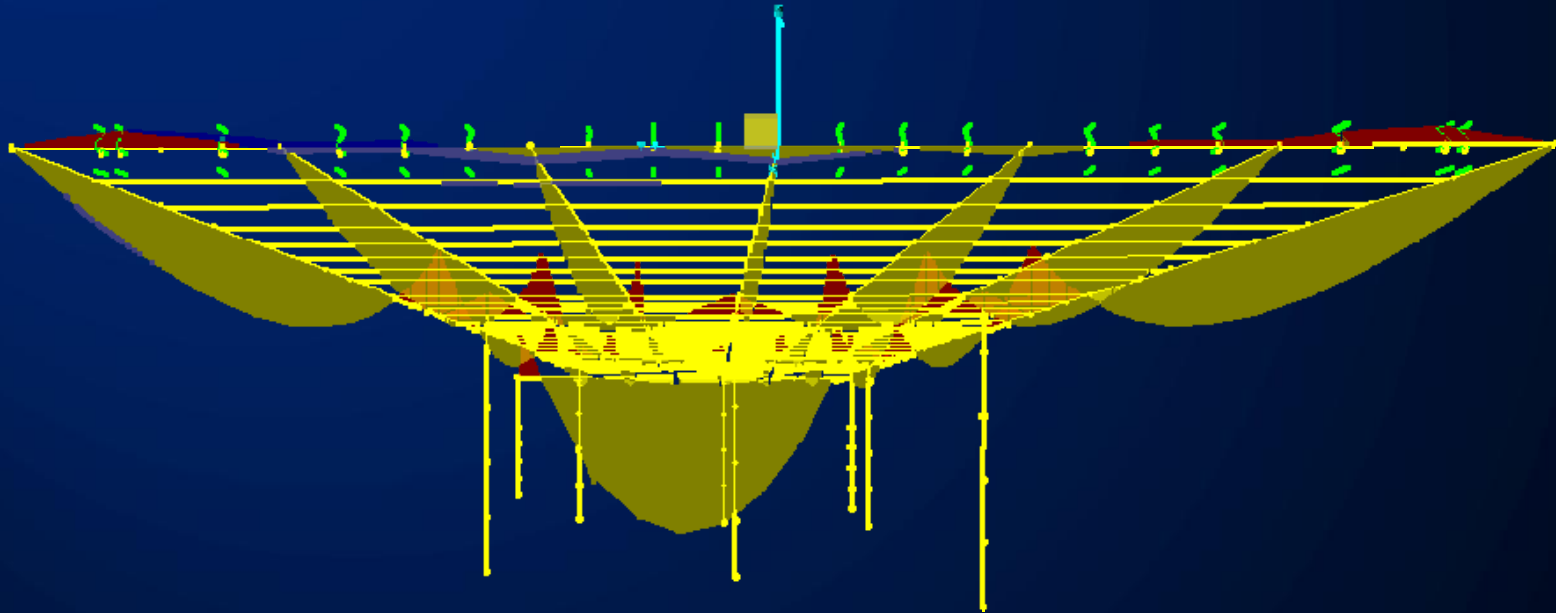
**Bending Moment Due to Jacking of PT Bars
at the Exterior Steel Beams (Left Side)**

- Hinge diaphragms checked for forces due to PT bars stressing
- Bending moment is less than cracking moment and flexural capacity

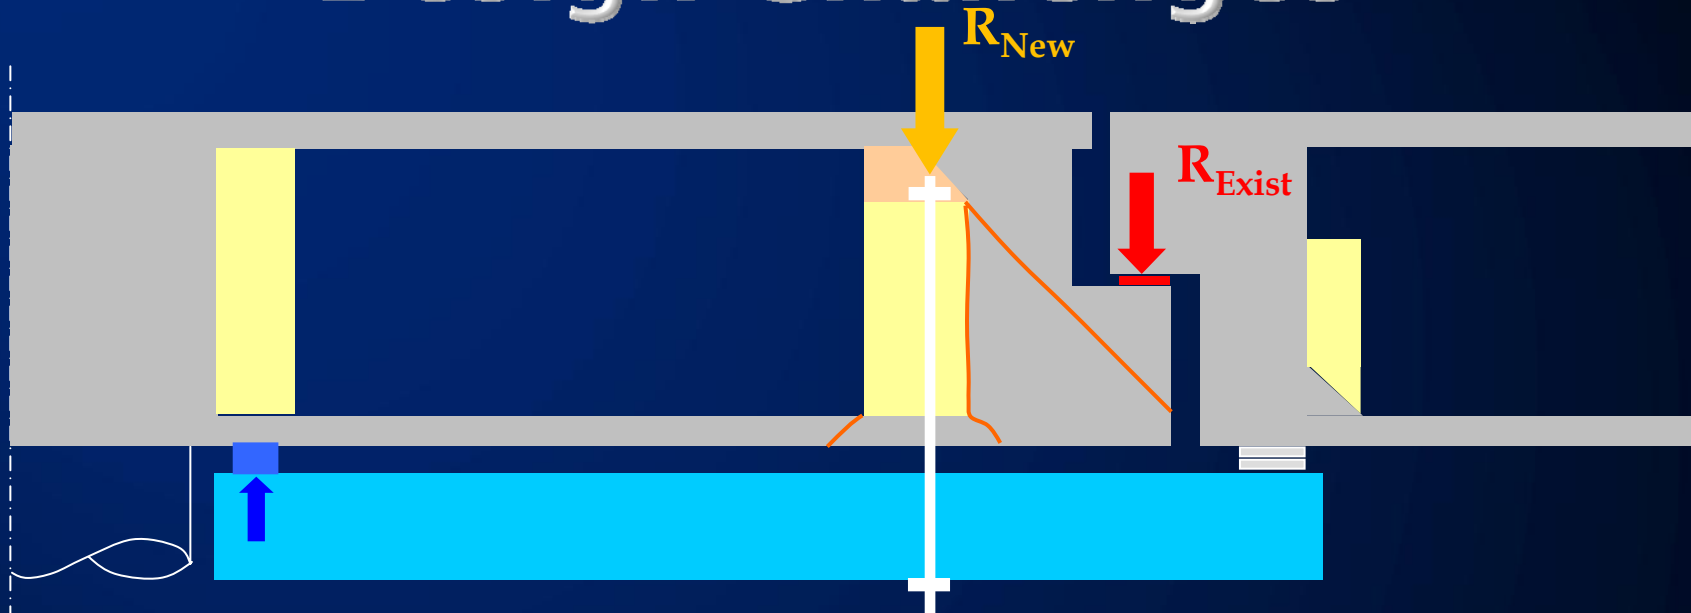
Design Challenges

- New reactions on hinge diaphragm are about 50% higher than reactions in the existing condition
- Transverse analysis and check of hinge diaphragms and bolster
- Diaphragm is modelled as a beam supported on springs
- Possible failure modes of the bolster have been checked
- Special attention to design of PT Bars

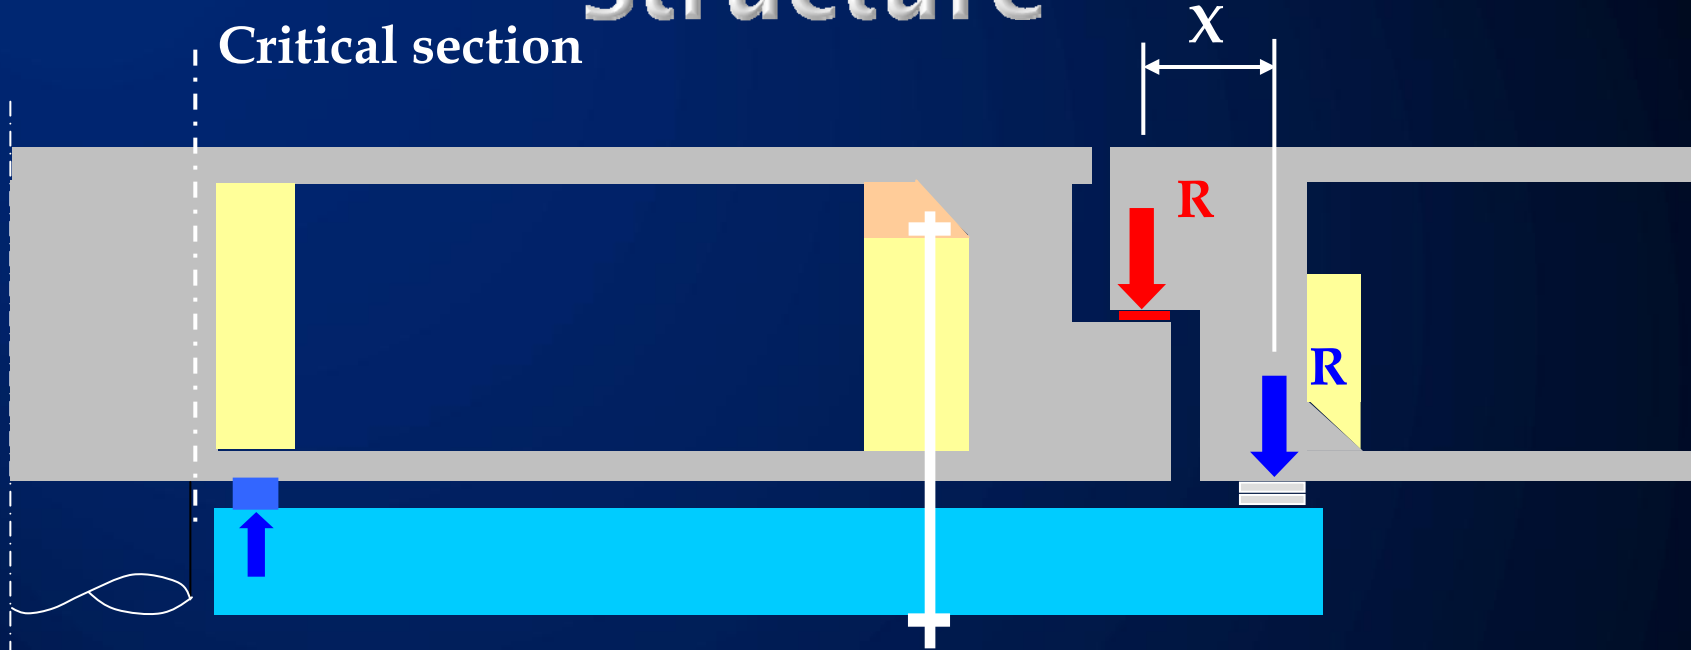
Check of the Existing Structure

- Additional eccentricity of load on the short side of the hinge results in higher moments and tensile stresses at top of the superstructure
- Additional moment = $R \cdot X$ (X is approximately 3 ft)
- Additional moments and shears due to weight of bolsters and steel beams

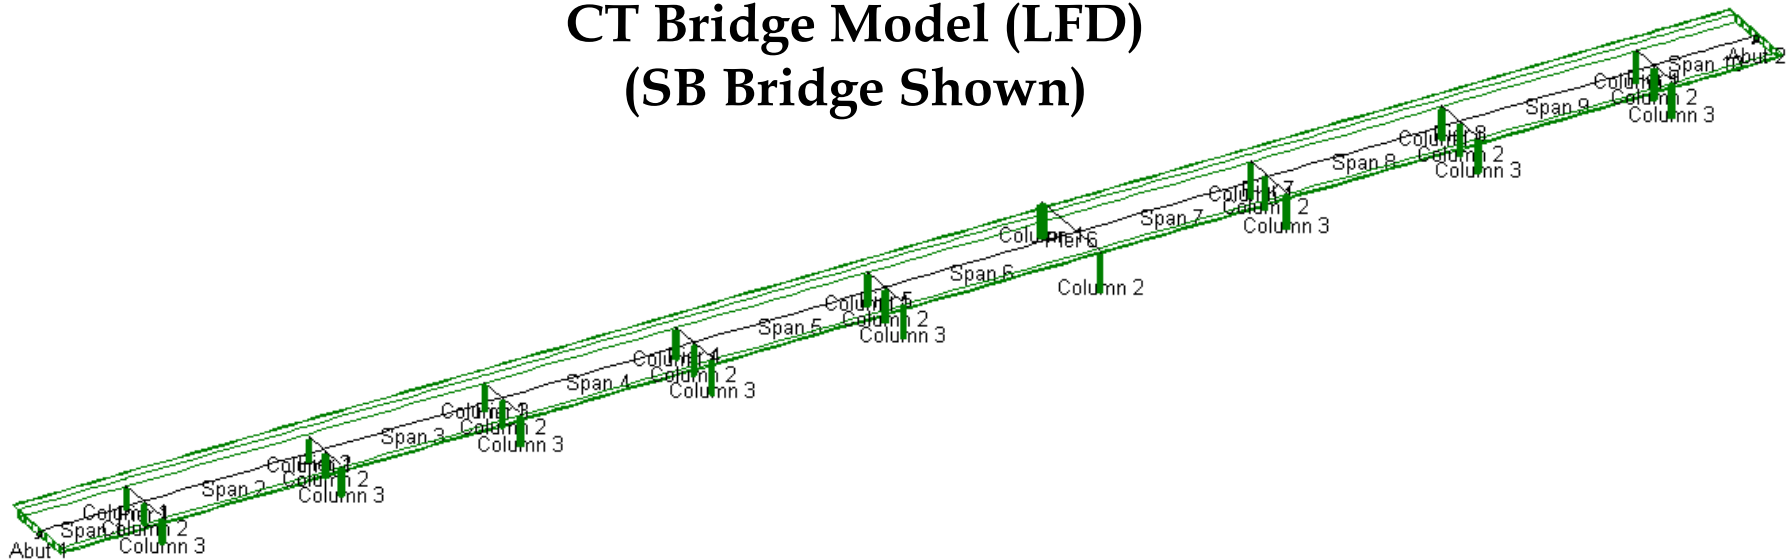
CT Bridge Model (LFD) (SB Bridge Shown)

- Concrete stresses under service loads are within the acceptable limits
- Flexural and shear capacities are adequate

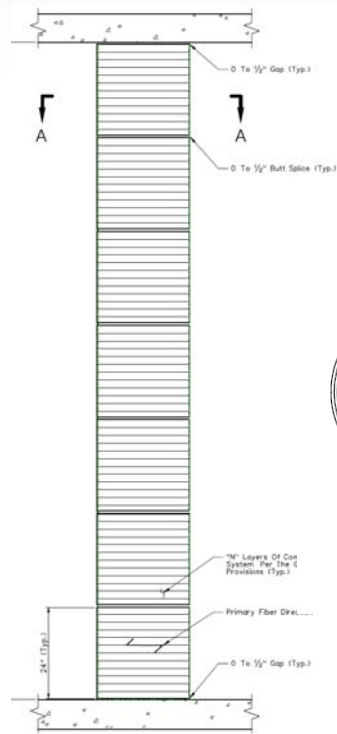
SECTION "A-A"

- Elastic dynamic & pushover analyses
- Displacement demand exceeds capacity for one column
- Shear demand exceeds capacity for 4 columns
- Column retrofit & outrigger bent cap retrofit by fiberwrap composite system

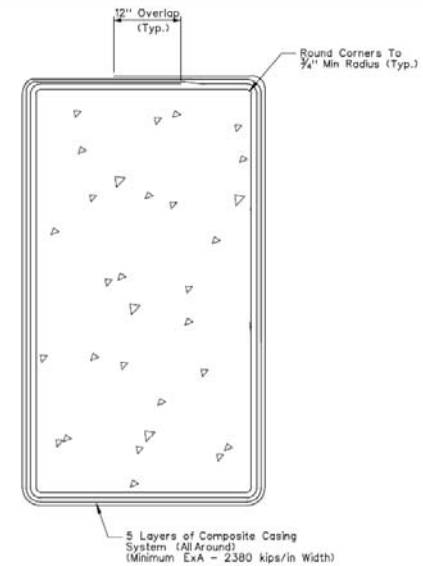
SECTION "A-A"

NOTE: NOT ALL LAYERS SHOWN FOR CLARITY
