# Analysis and Evaluation of Reinforced Concrete Bridges with Flexural Cutoffs at Diagonal Crack Locations

Joshua K. Goodall  
Western Bridge Engineer's Seminar  
9/27/2011

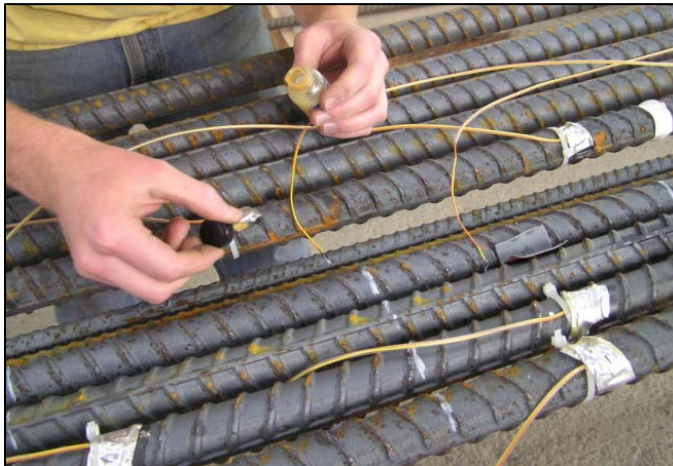
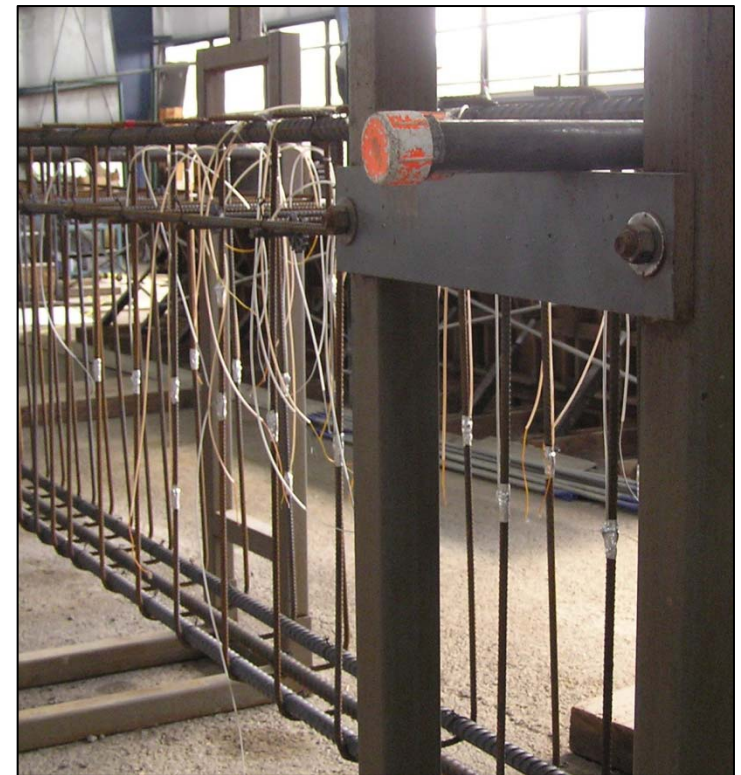
- Midspan Displacement
- Reinforcing Bar Strain
- Cutoff Bar Slip

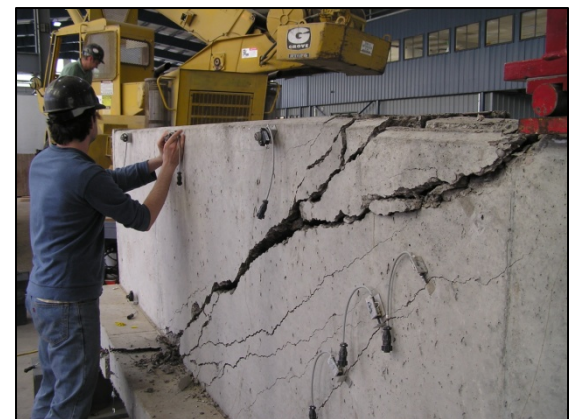
- Failure Type

Specimen	Failure Mode	Failure Crack Angle (degrees)	Midspan Deflection [in]
IT.45.Ld2(6)	Shear-Compression	32	[0.97]
IT.60.Ld2(6)	Shear-Compression	60	[0.69]
IT.45.Ld2(5)	Shear-Anchorage	44	[0.98]
IT.60.Ld2(5+19)	Shear-Anchorage	45	[1.05]

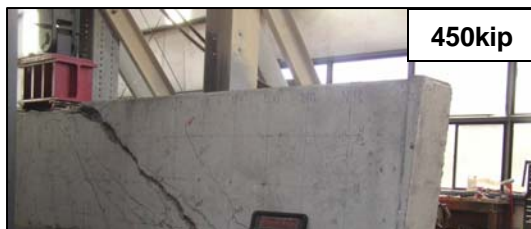
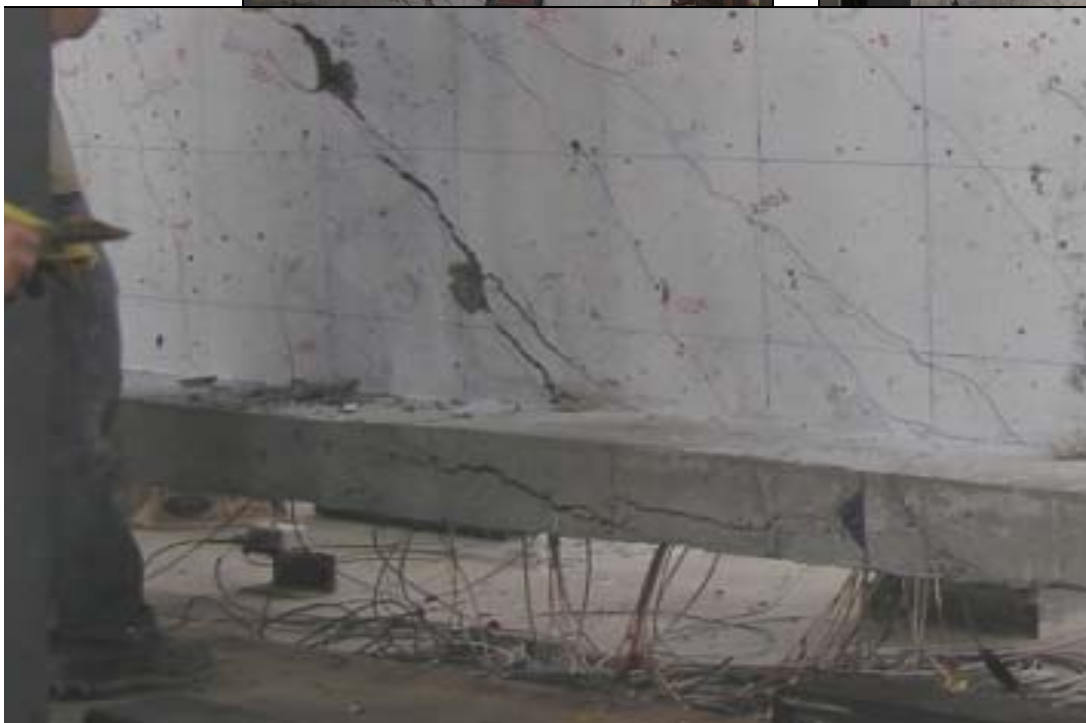
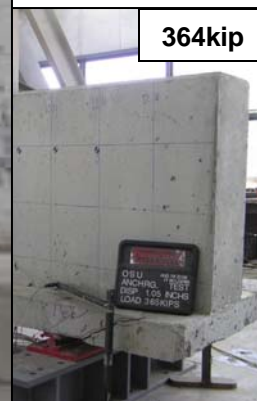
- Failure Photos

- Shear-Compression

- Shear-Anchorage

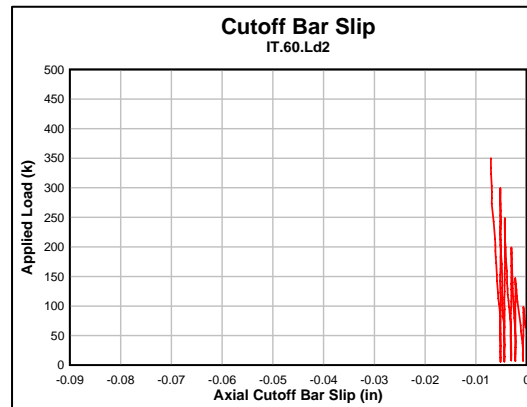
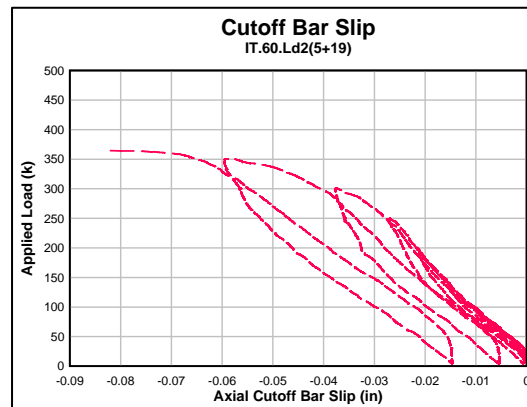
- Average Cutoff Bar Slip

- Shear-compression failures: negligible bar slip

- Shear-anchorage failures: noticeable, permanent bar slip

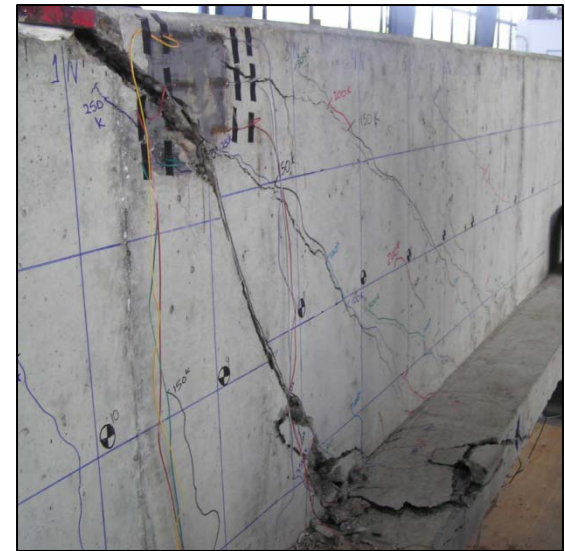
- Relationship between test results and AASHTO-LRFD equation 5.8.3.5-1

$$T = \frac{M_u}{d_v} + \cancel{C} T_u + (V_u - 0.5V_s - \cancel{C}) \cot \theta$$

- Tensile demand at failure

Specimen	AAHSTO-LRFD Prediction [k]	Measured Tensile Demand [k]	% Difference
IT.45.Ld2(6)	[638.7]	N/A	N/A
IT.60.Ld2(6)	[473.9]	[461.4]	2.70%
IT.45.Ld2(5)	[446.6]	[437.4]	2.09%
IT.60.Ld2(5+19)	[470.1]	[461.0]	1.96%

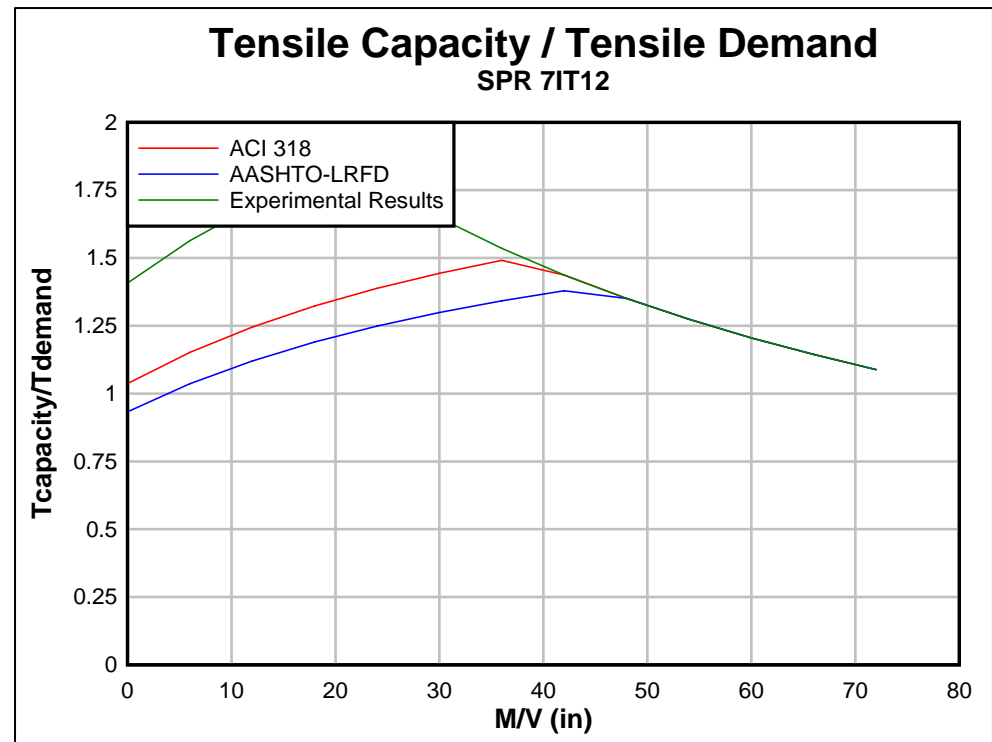
- Use described analysis procedure to predict failure mode for sample SPR 350 specimens
  - AASHTO-LRFD tensile demand prediction
  - Tensile capacity predicted using specifications and test results
  - All straight longitudinal anchorage details

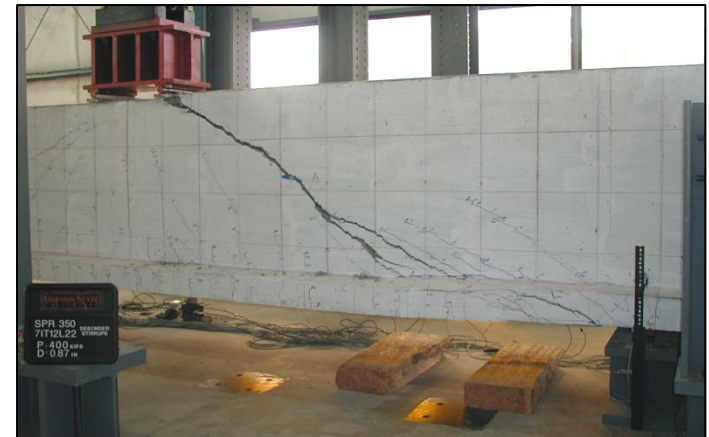
SPR 7IT12 Failure  
-SPR 350, Higgins et.al-

Specimen	Actual Failure Mode	Failure Mode Prediction		
		ACI 318	AASHTO-LRFD	Experimental Results
SPR 2IT10	Shear-Anchorage	Correct	Correct	Correct
SPR 2IT12	Shear-Anchorage	Correct	Correct	Correct
SPR 5IT12-B4	Shear-Compression	Correct	Incorrect	Correct
SPR 7IT12	Shear-Compression	Correct	Incorrect	Correct
SPR 8IT12	Shear-Compression	Incorrect	Incorrect	Correct

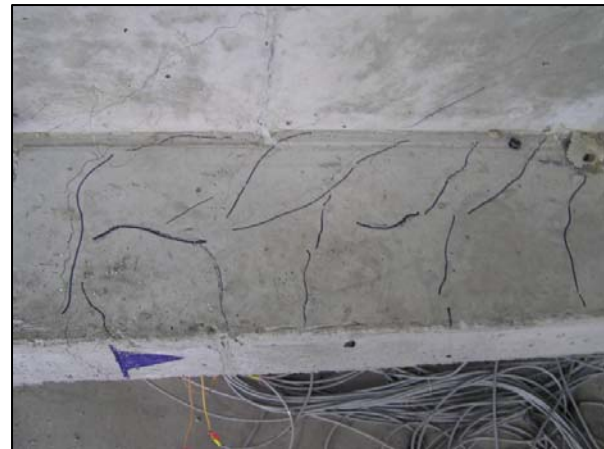
- Initial observed diagonal cracking not necessarily indicative of failure angle
- Development lengths predicted by specifications are conservative compared to experimental results
- Design development lengths may mistakenly identify anchorage failures
- Anchorage failures predicated by wedge cracking near slip location
