Managing Nevada's Scour-Critical Bridges

John Hunt, PE
Manager-Water
Resources
Ayres Associates

NEVADA DEPARTMENT OF
TRANSPORTATION

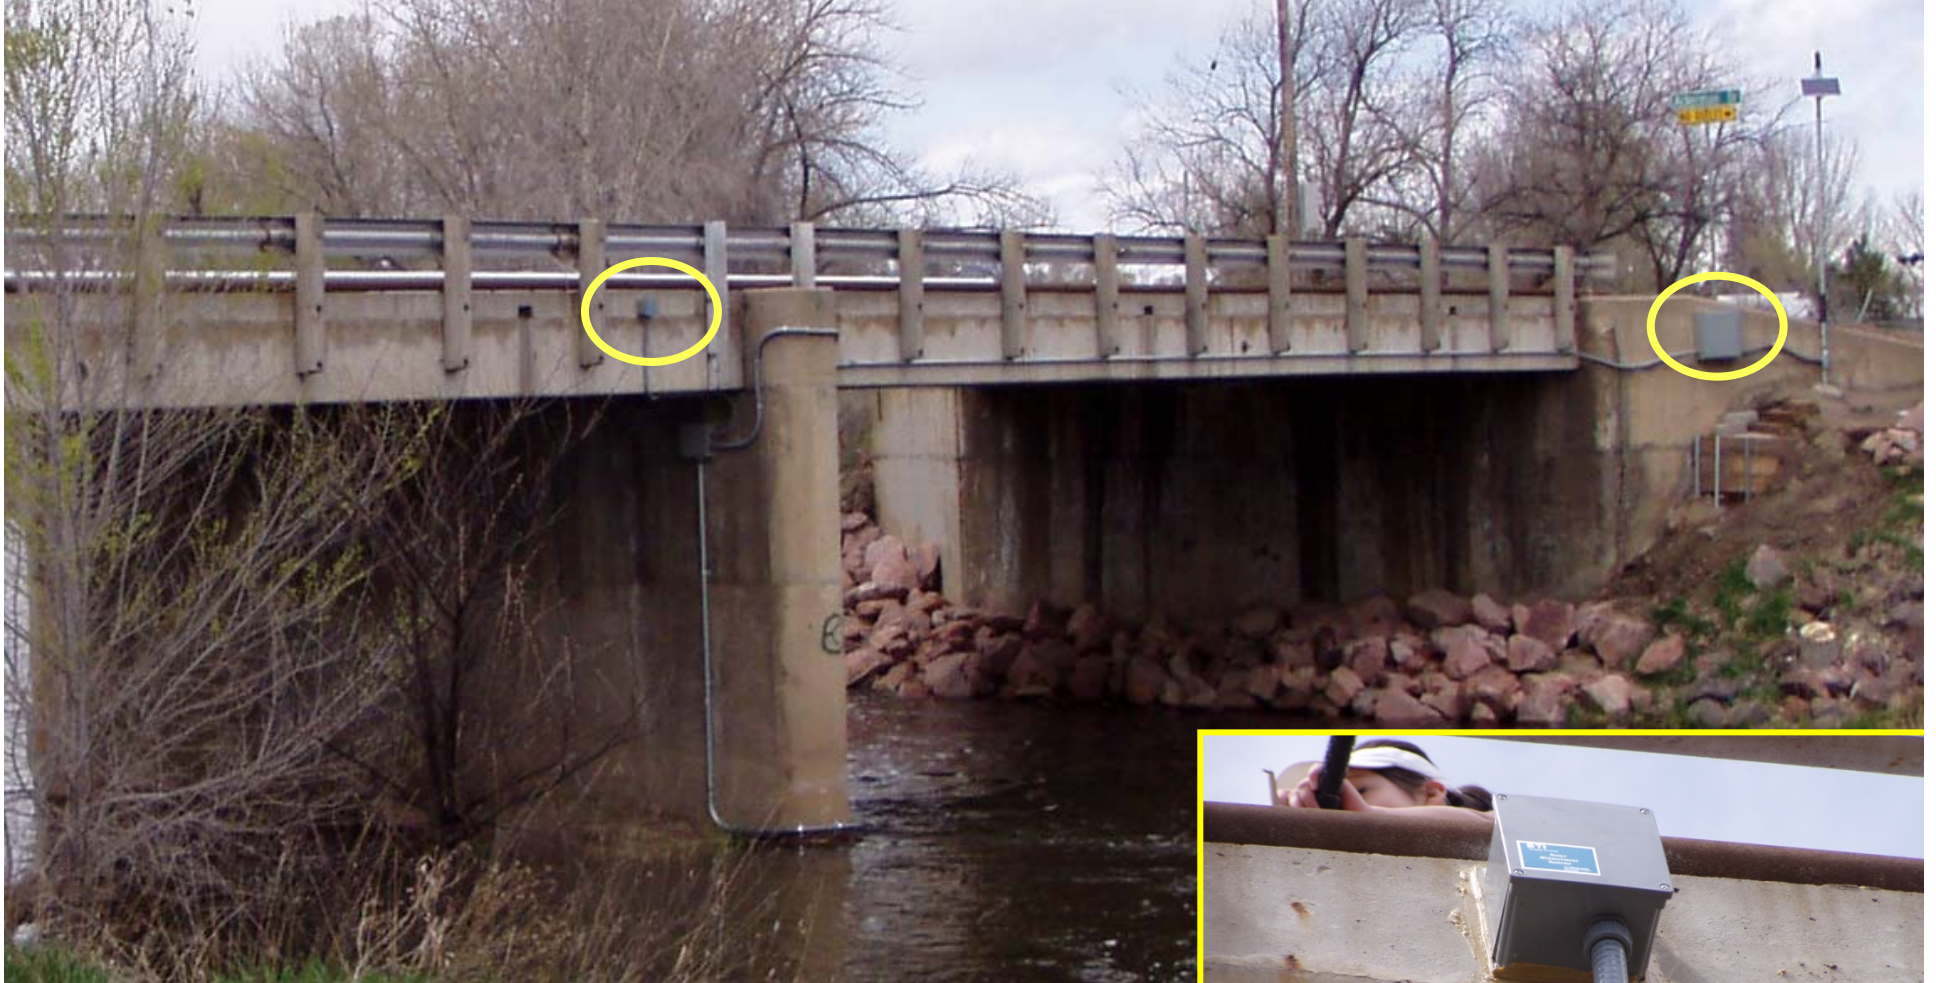
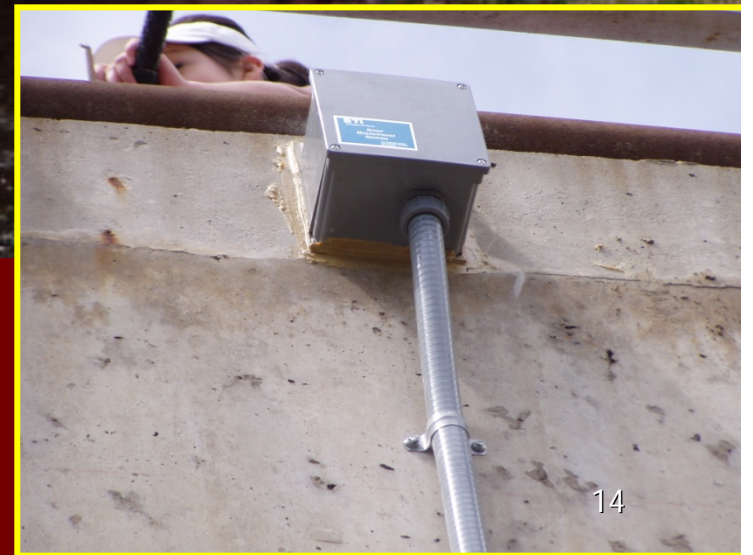
Tilt Sensor Installation Example (Colorado)

2.2.1 Observe Bridge Structure for Distress Triggers for Bridge Closure:	
<input checked="" type="checkbox"/> Joint deflection <input checked="" type="checkbox"/> Excessive debris buildup on pier <input type="checkbox"/> Pressure flow (low chord of bridge submerged) <input checked="" type="checkbox"/> Settlement at one or more piers or abutments (sight along bridge rail to discern) <input type="checkbox"/> Sinkholes in road surface behind abutments <input checked="" type="checkbox"/> Bridge movement under load <input type="checkbox"/> Bridge or approach embankment overtopping <input type="checkbox"/> High-velocity flow impinging directly on abutments or unarmored embankments <input checked="" type="checkbox"/> Abutment armor failure <input checked="" type="checkbox"/> Other: One or more tilt sensors indicating out-of-range inclination of pier
