# Oregon's First ASTM A 1010 Plate Girder Bridge

**Hormoz Seradj, P.E.**  
**Steel Bridge Standards Engineer**

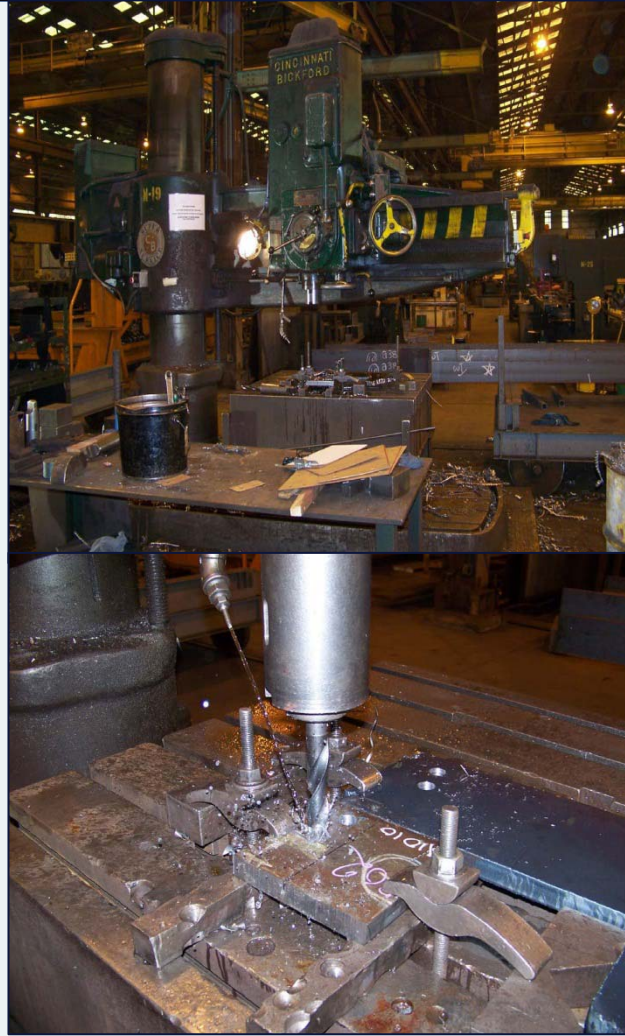
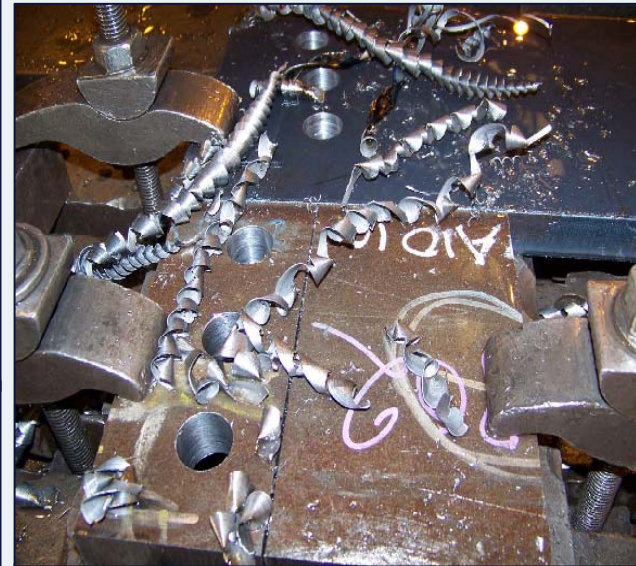
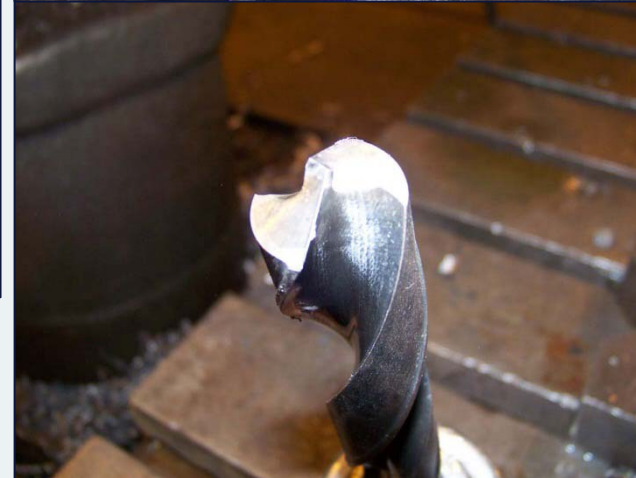
# Drilling 15/16" dia. twist drill

- 15/16" dia. twist drill
- Cut using band saw
- Thermal Cut

- **1998 ASTM recognized A 1010 with maximum plate thickness of 1”.**
- **A 1010 is Machinable**
  - Drilling
  - Saw cut
  - Thermal Cut.
- **A 1010 is weldable”**
  - ER309L, 3/32” consumable
  - Blue Max 2000 Flux
  - Distortion is almost twice of regular steel but can be controlled.

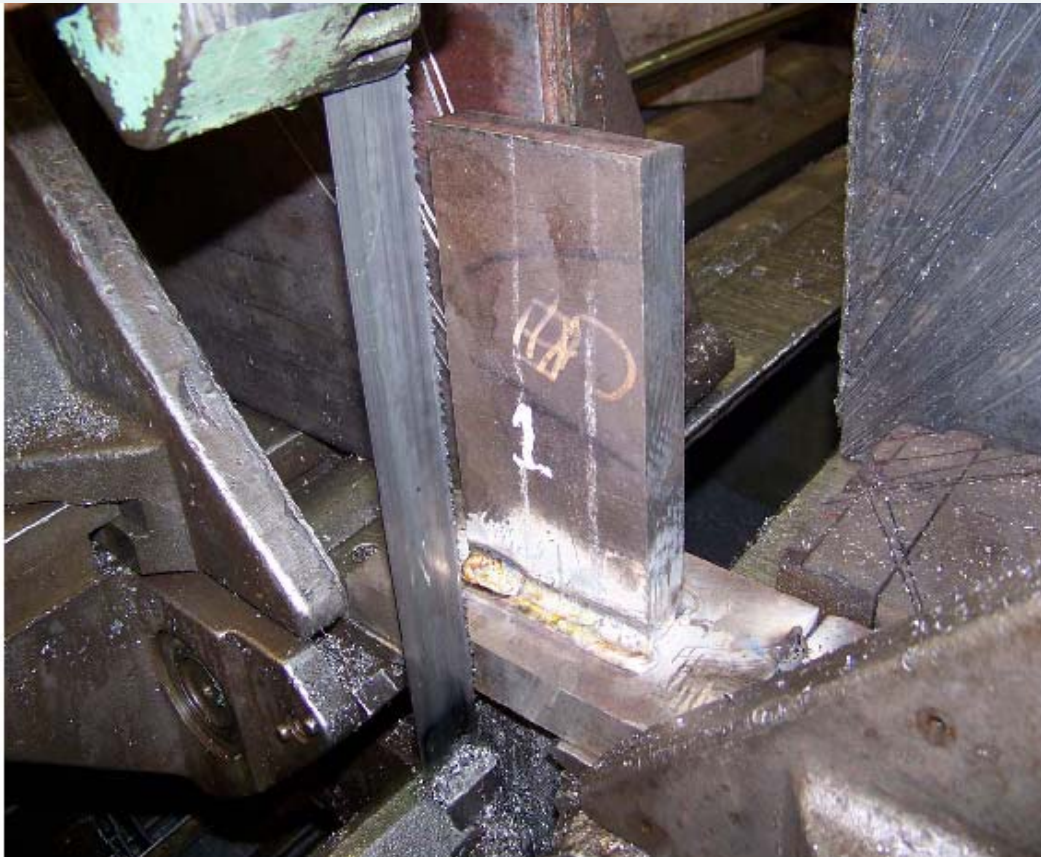
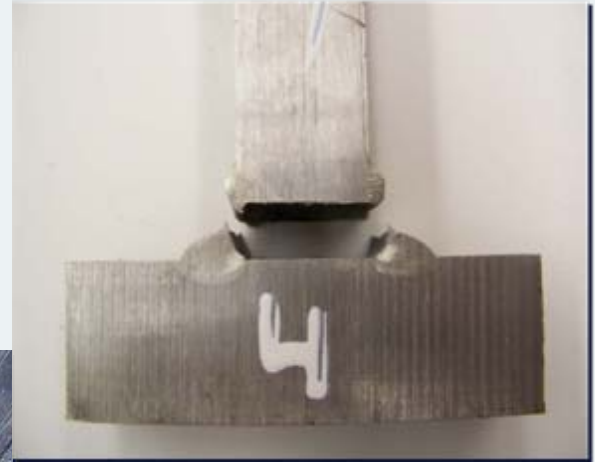
# Filet Weld

- FCAW single pass 5/16"
- SAW two pass weld 3/8"

- **single and two pass fillet weld (automatic submerged arc and a semi-automatic flux core welding process) had ductile failure and fractured in the weld and the fracture path was through the weld metal as expected.**
- **\$/lb (of A 1010) = (2 to 3) x \$/lb (of A 709 steel).**
- **Our study supported using ASTM A 1010 steel for bridge construction in mildly salty and humid environments. It has shown to have more resistance to corrosion than weathering steel or high performance steel.**
