SELLWOOD BRIDGE

The Shoo Fly

Sliding the Sellwood Bridge

September 2013

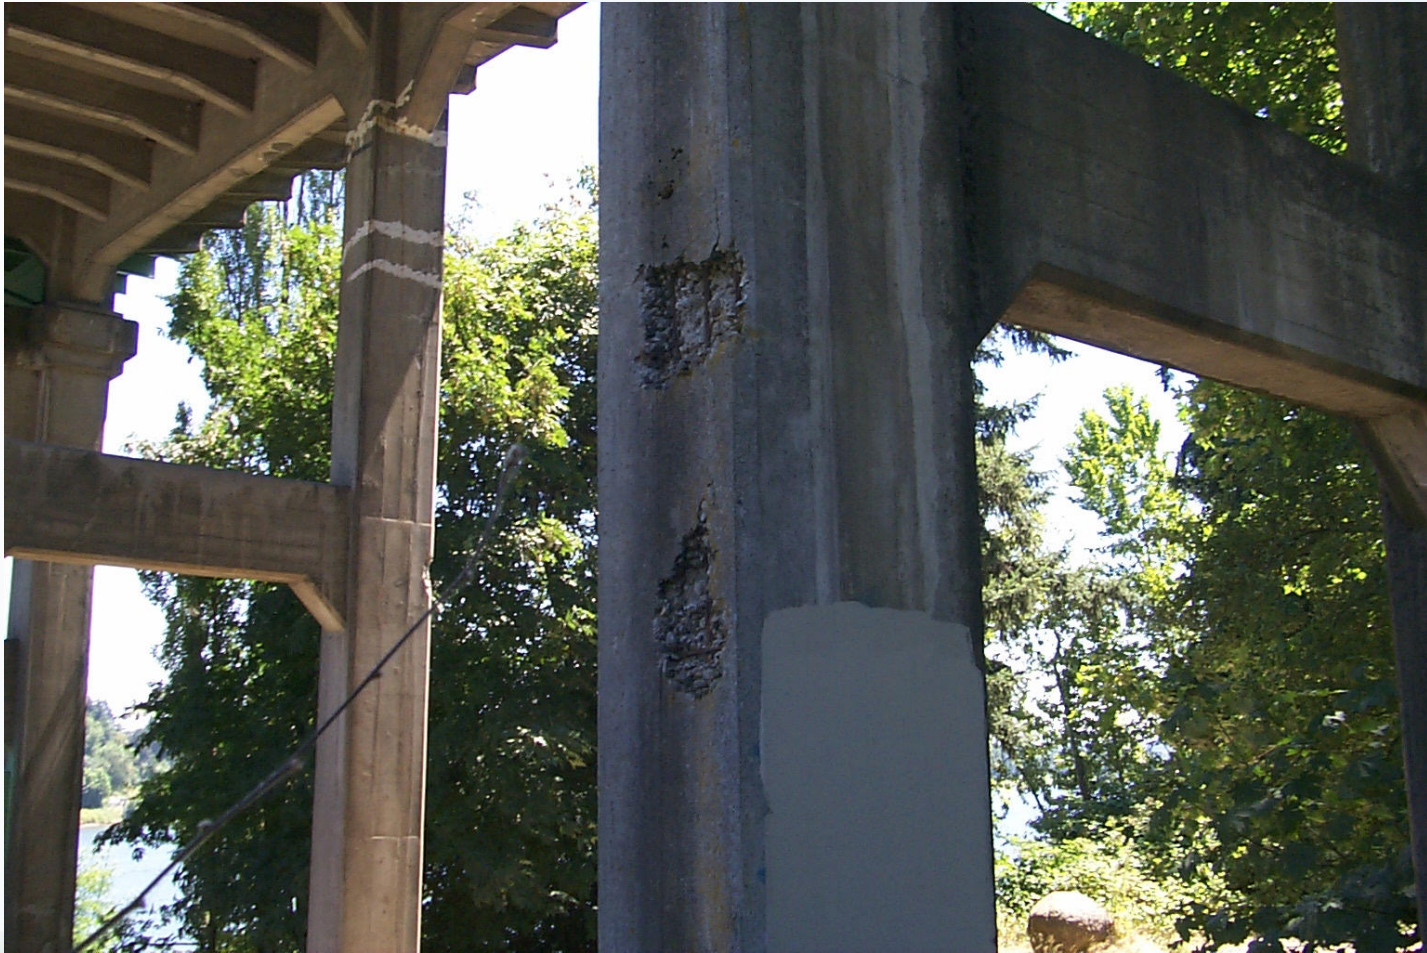
Heavy Cracking & Spalling

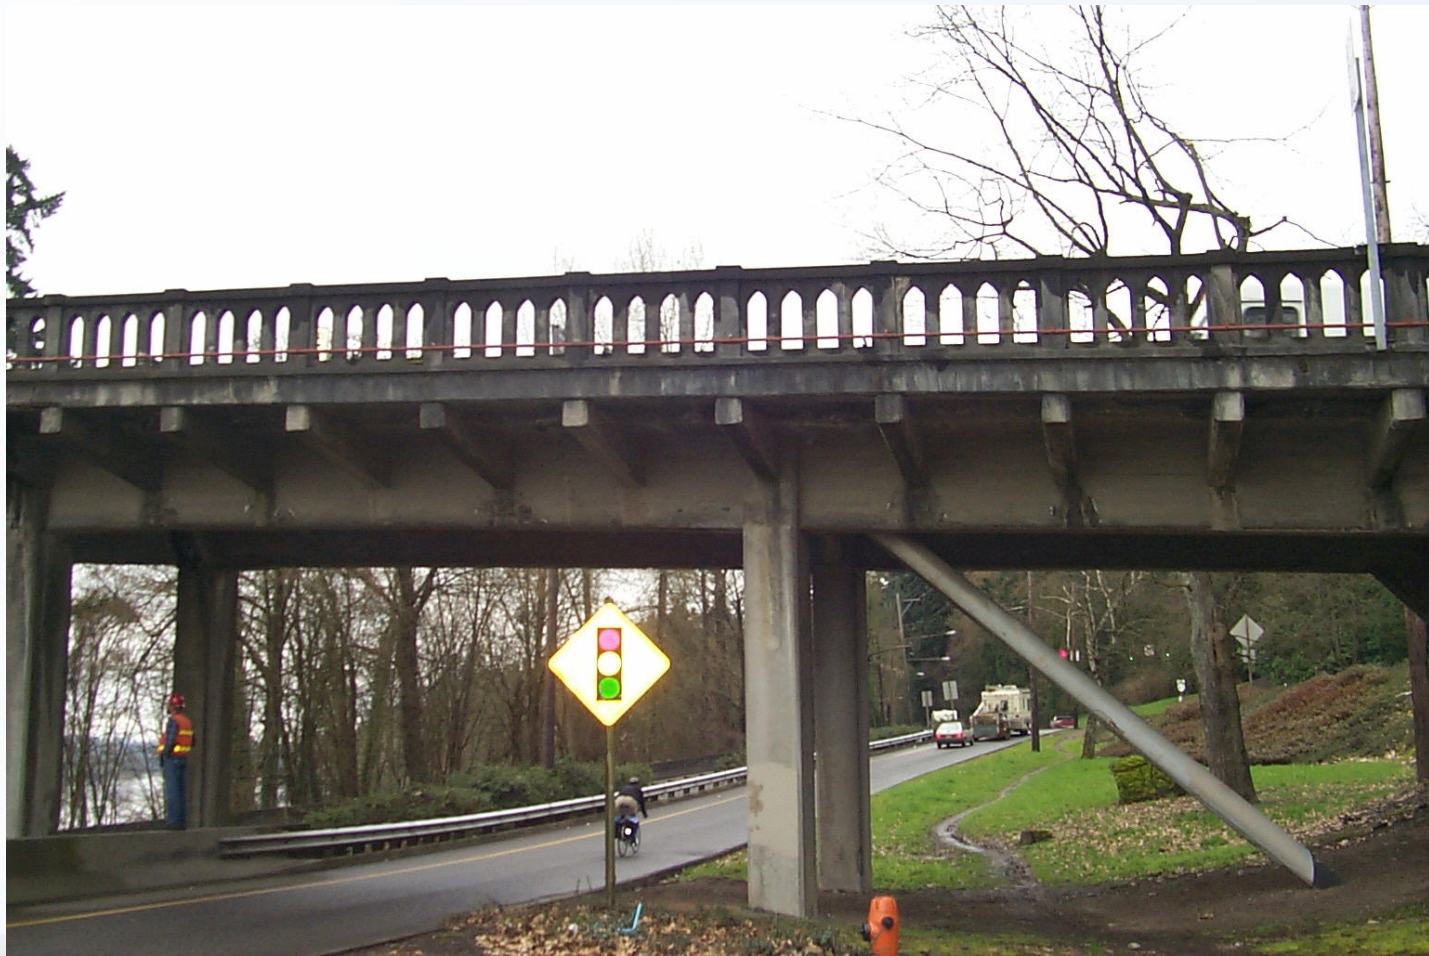
West End Anchors added in the 60's

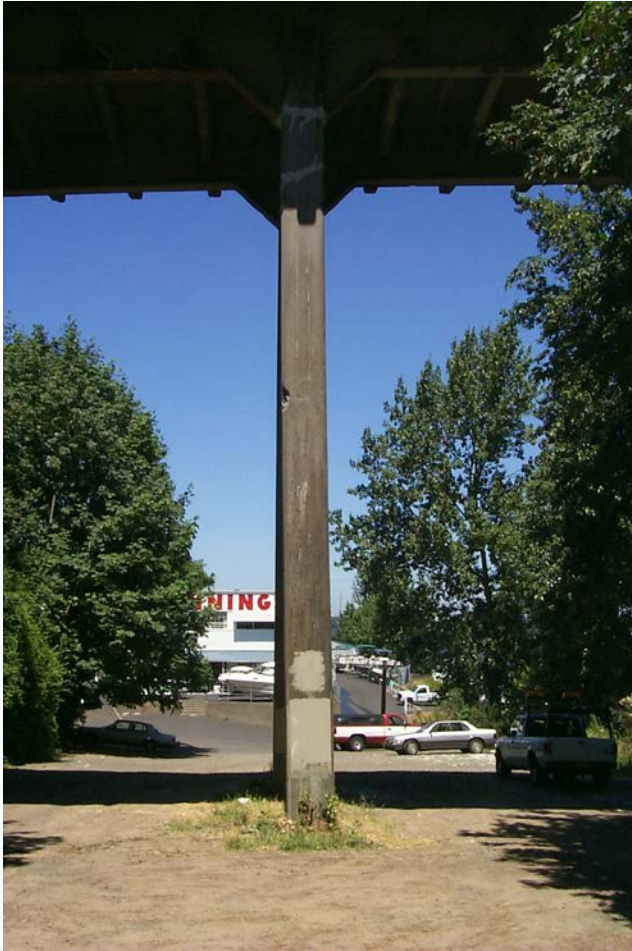
Column Twist

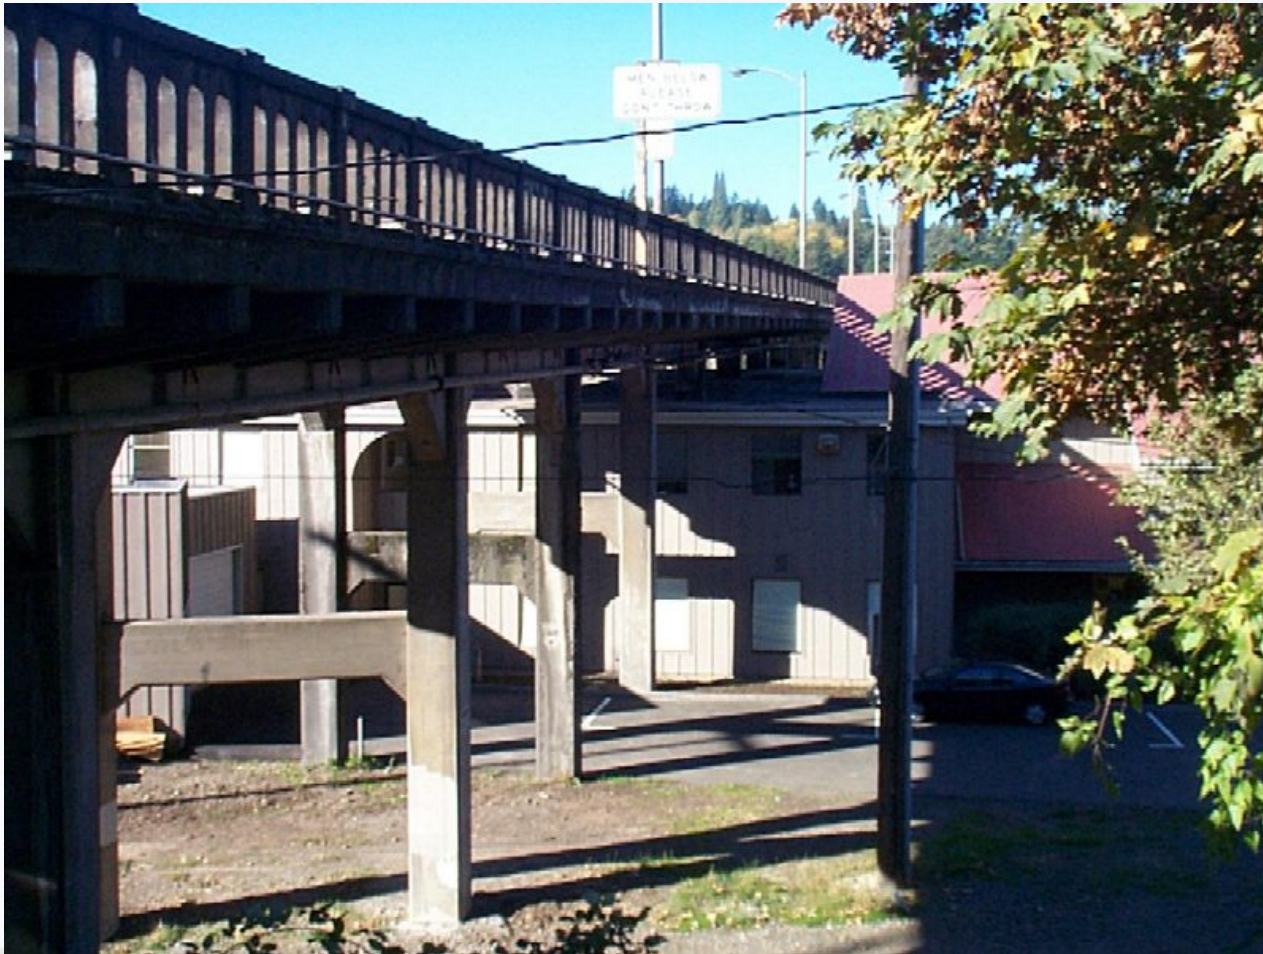
Building Encroaches on Bridge

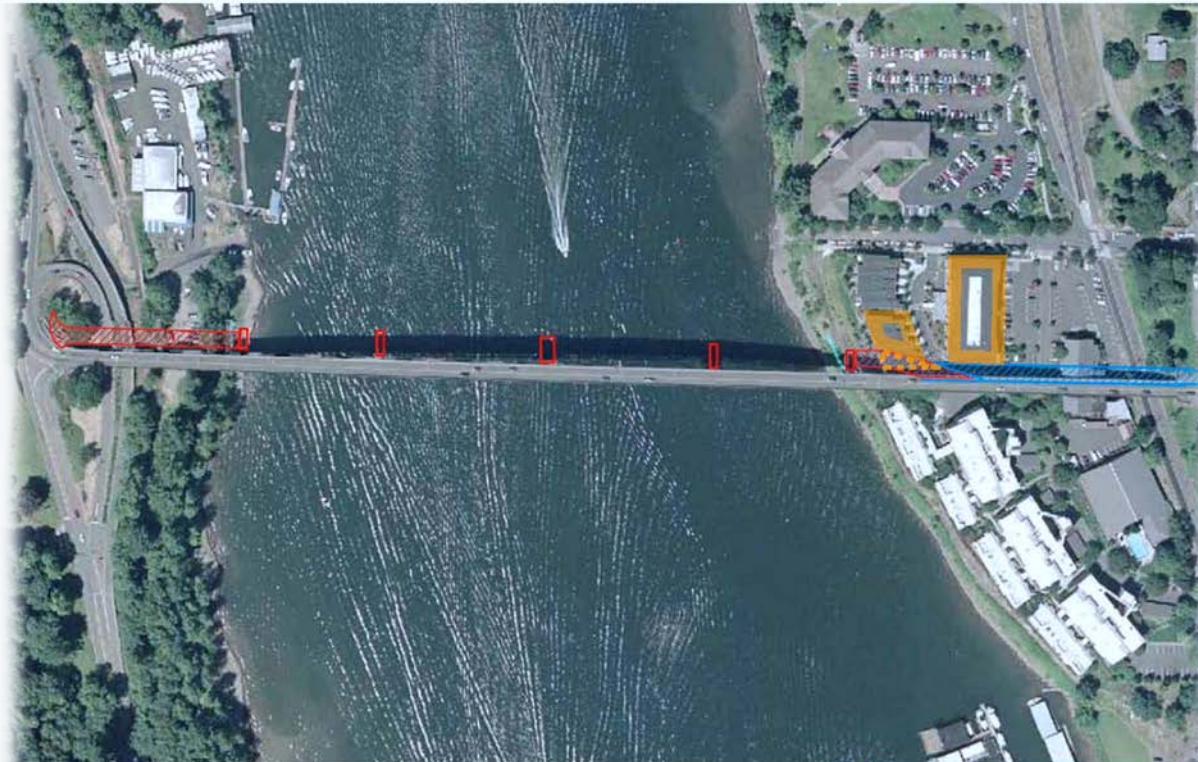
- Shoo-fly alignment options 1 and 2
- Shoo-fly alignment option 2 only

Approaches in Place Translated Truss

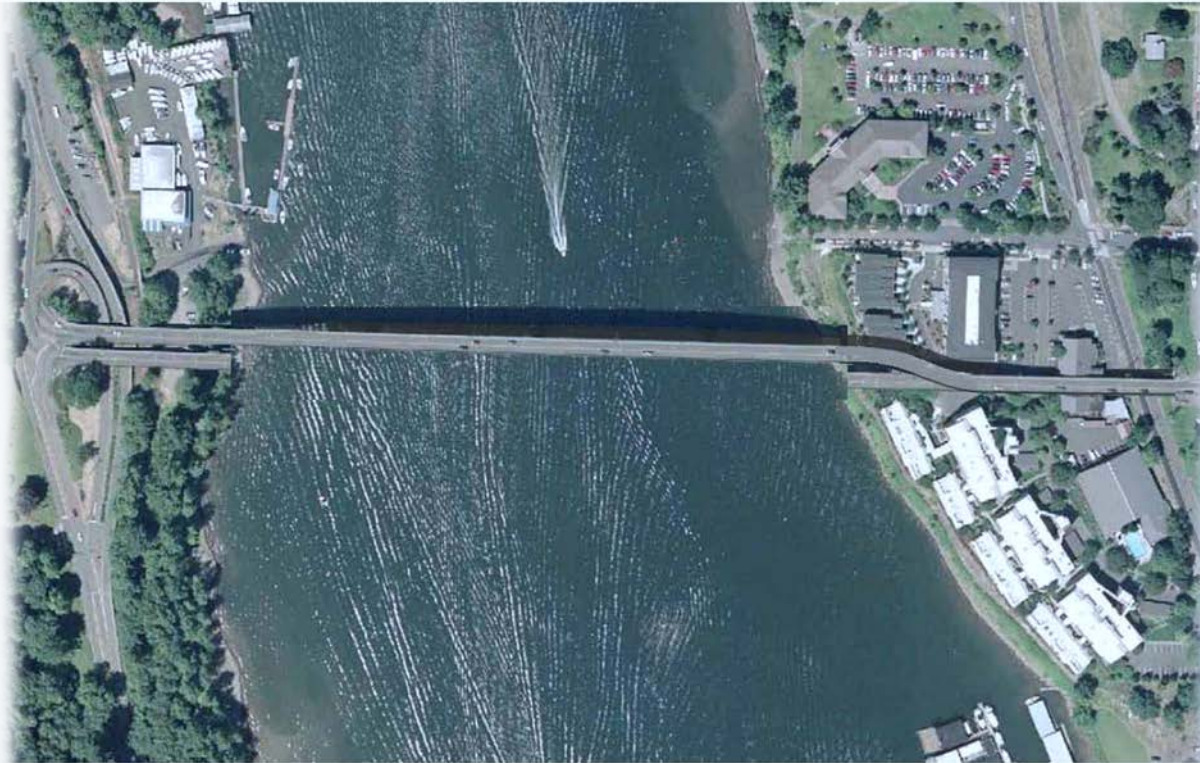
Option 1 Stage 1

Construct Main Span

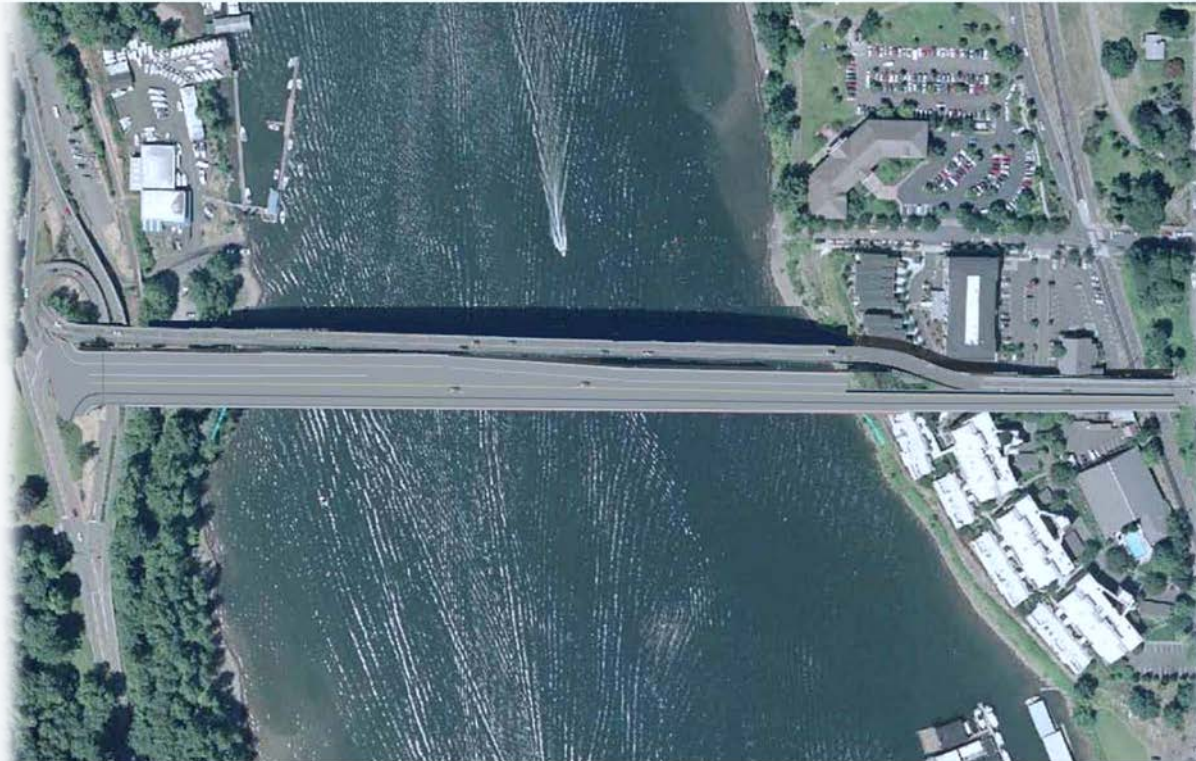
Option 1 - Stage 2, East approach first stage Construction

Complete East Approach

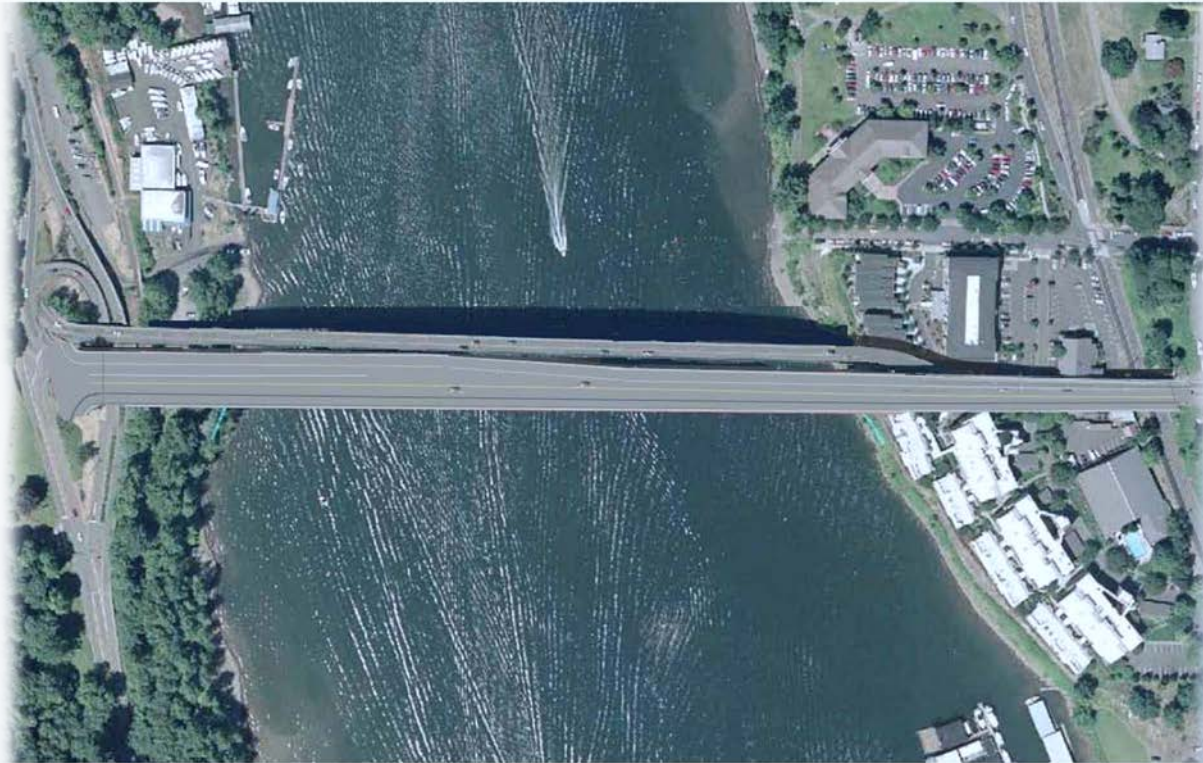
Option 1 - Stage 3, East approach
second stage construction

Finish Demolition

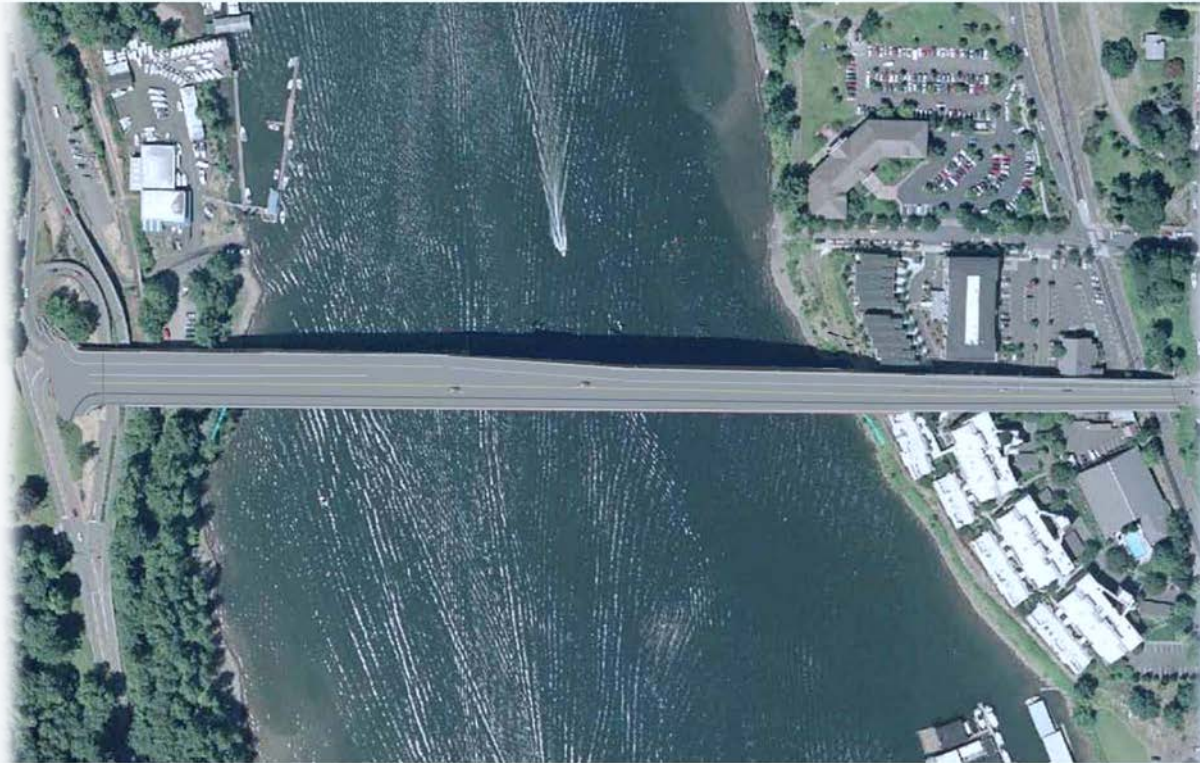
Finished Bridge,
Options 1 and 2

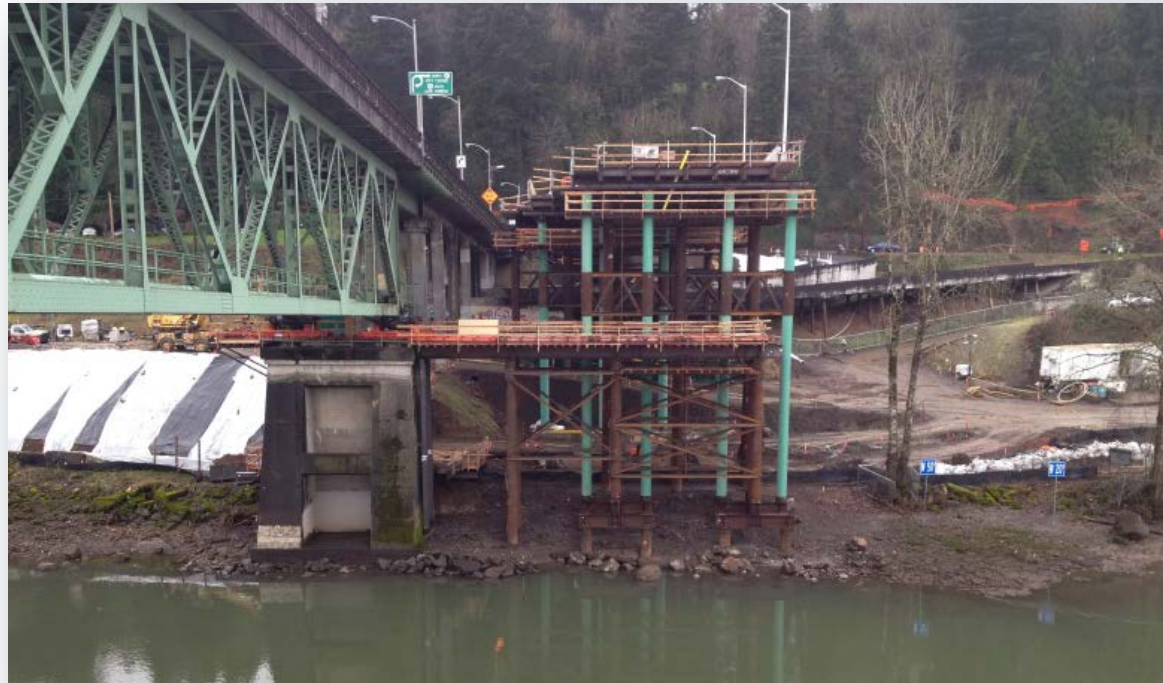
Working Around Landslide Mitigation

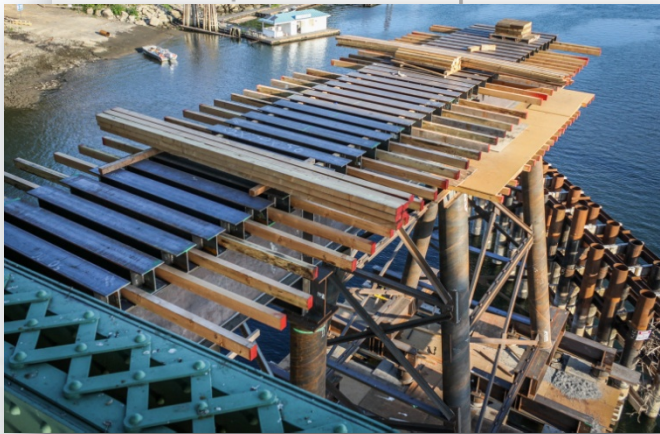
Truss Translation Layout

Layout of translation path was critical

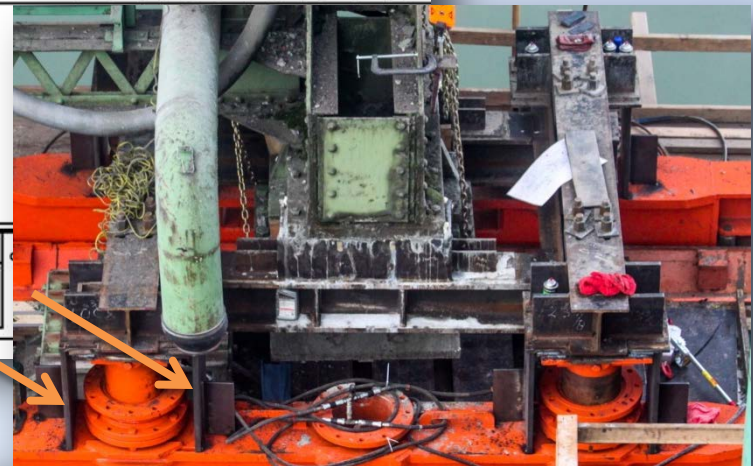
Truss Cradle Design

Support Bearing Across Skid Beams

Vertical plates in case of jack failure

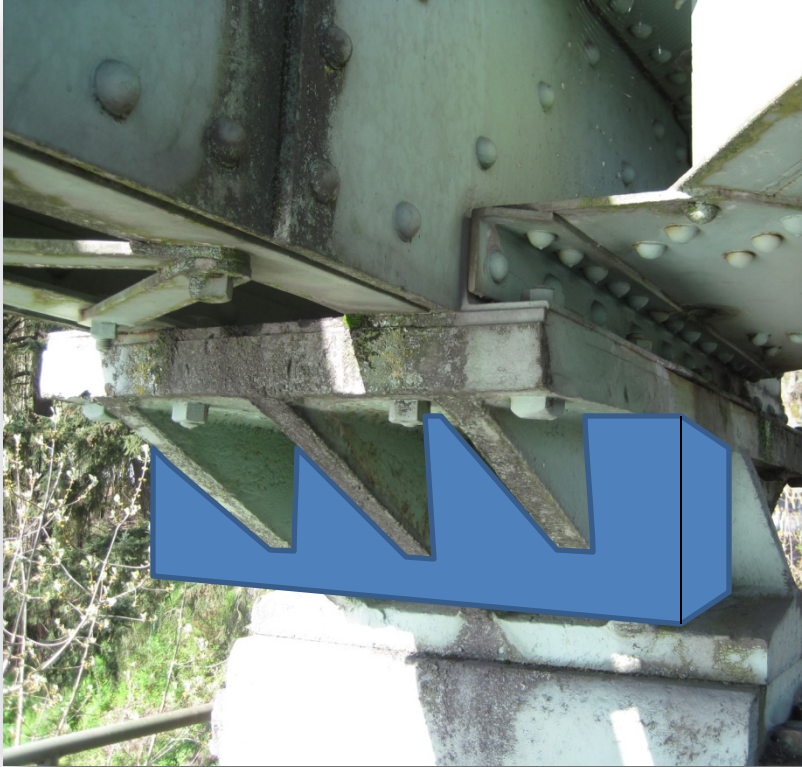
Temporary Bearing

Steel Box Filled with Grout

Sides cut to fit irregular shape of the bearing casting
