2013 WESTERN BRIDGE ENGINEERS' SEMINAR

# STAY-CABLE REPLACEMENT DESIGN

MISSISSIPPI RIVER BRIDGE

LULING, LOUISIANA

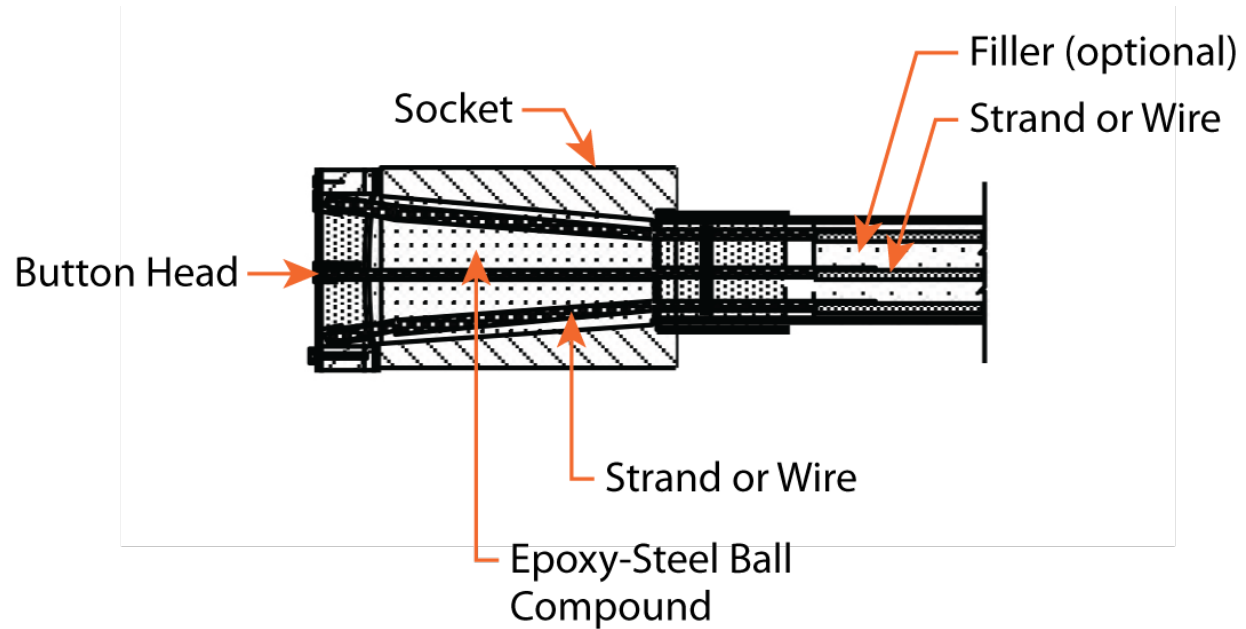
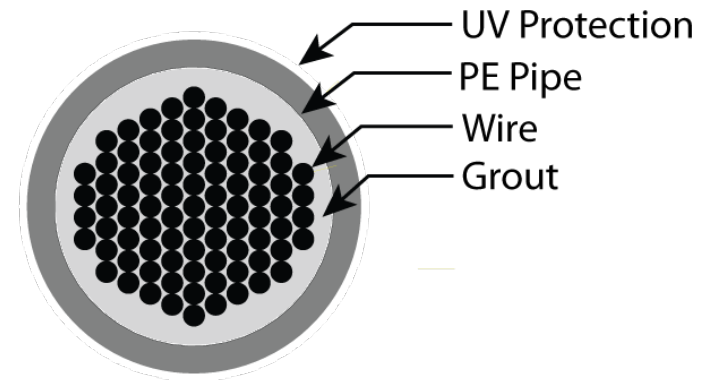
# Original Cable System

- Parallel 7-mm Wires
- Hi-Am Anchors
- HDPE Sheathing
- Grout Filled
- UV Protection Tape

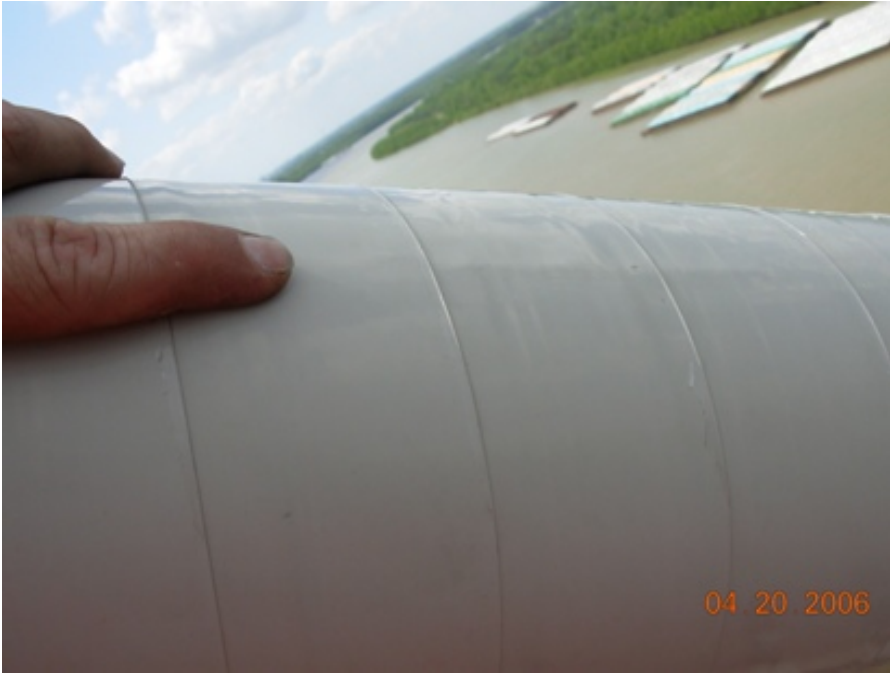
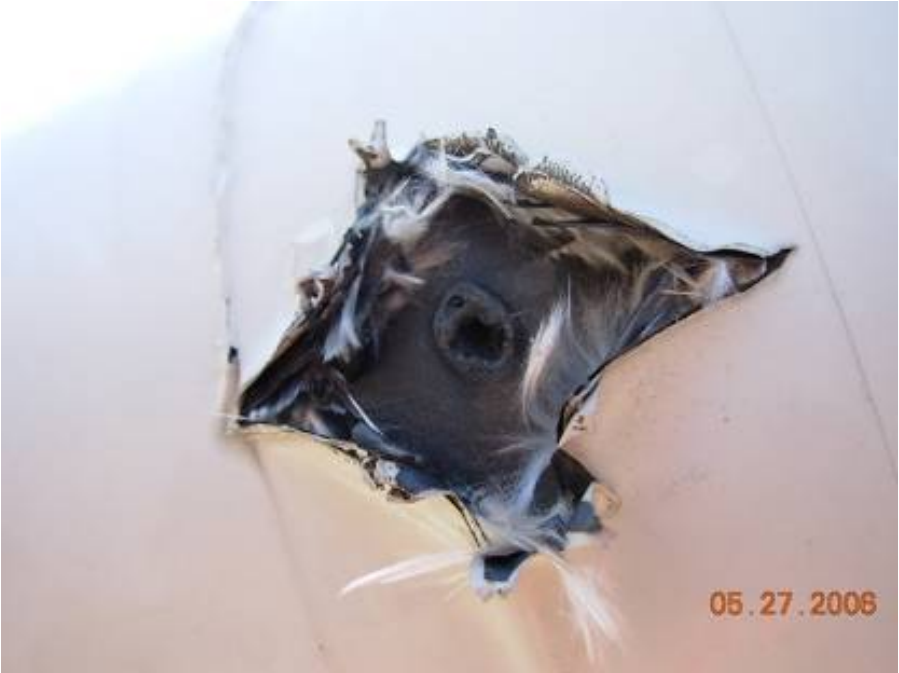
# Cable Damage

Longitudinal Split in PE

PE Damage

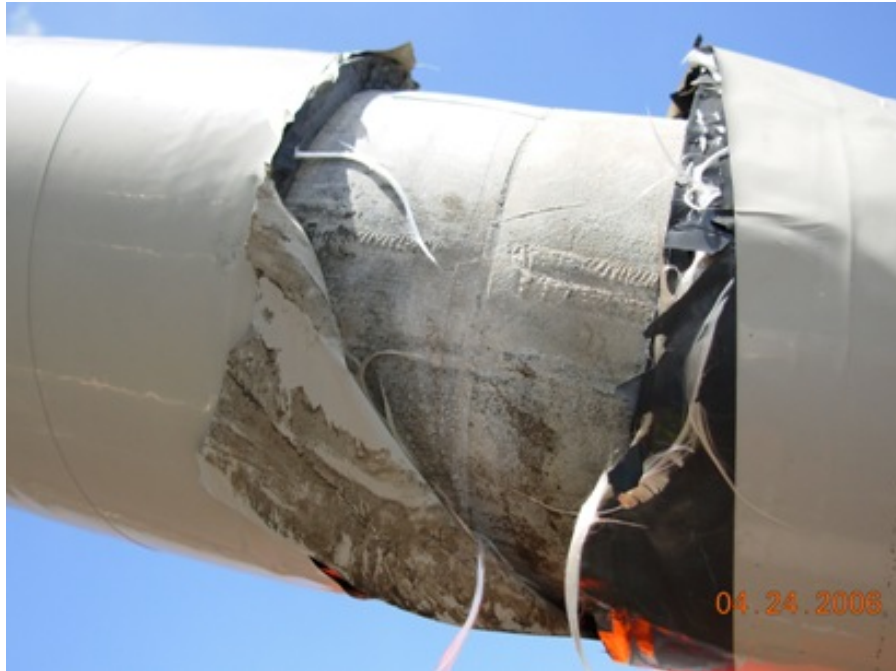
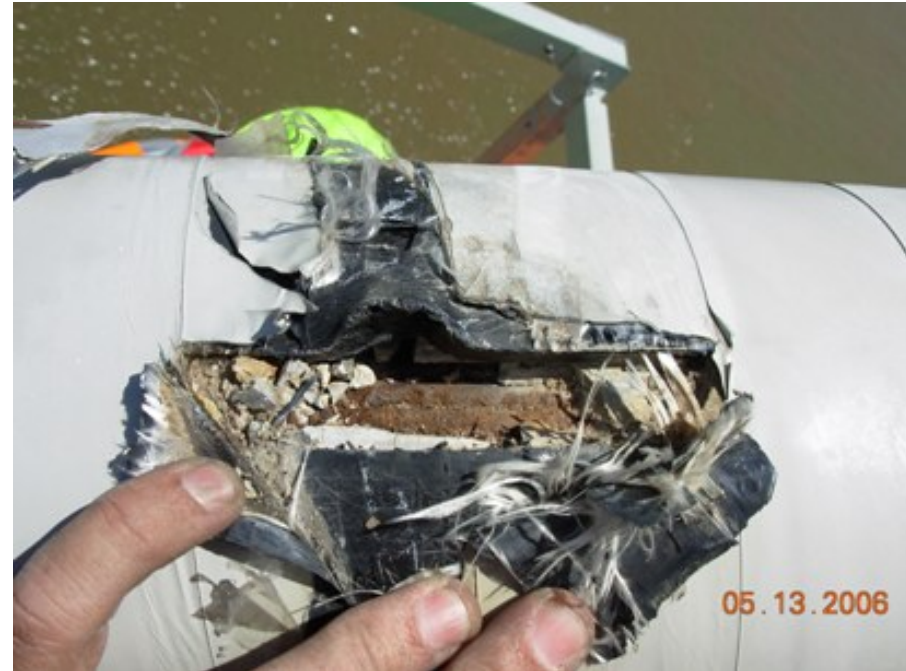
# Critical Damages

PE Damage / Exposed Grout

Exposed / Corroded MTE

- 40 out of 72 cables were rated critical
- Remaining cables had less severe damages
- Increasing rate of deterioration evident
- Timely corrective action was needed
- Cable replacement selected over repair based on LCCA

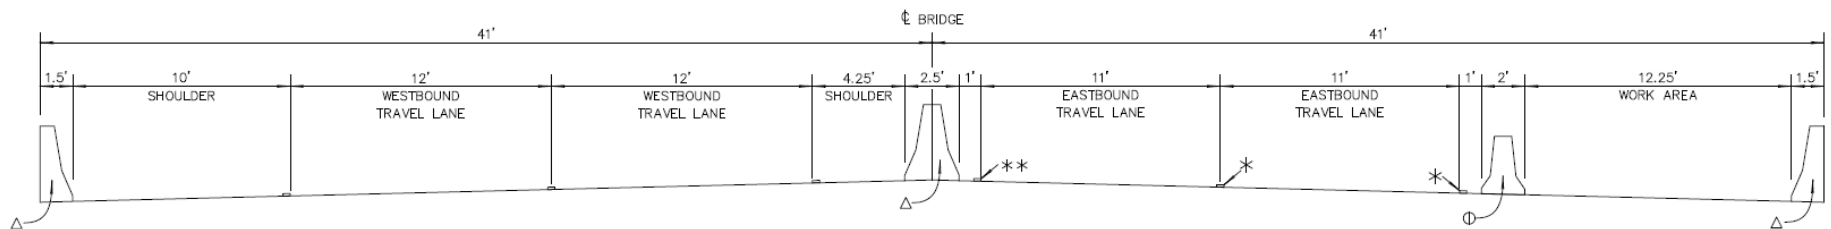
PEAK TRAFFIC OPERATION

- Two traffic lanes maintained during peak traffic times
- Work Area: 12.25 ft width

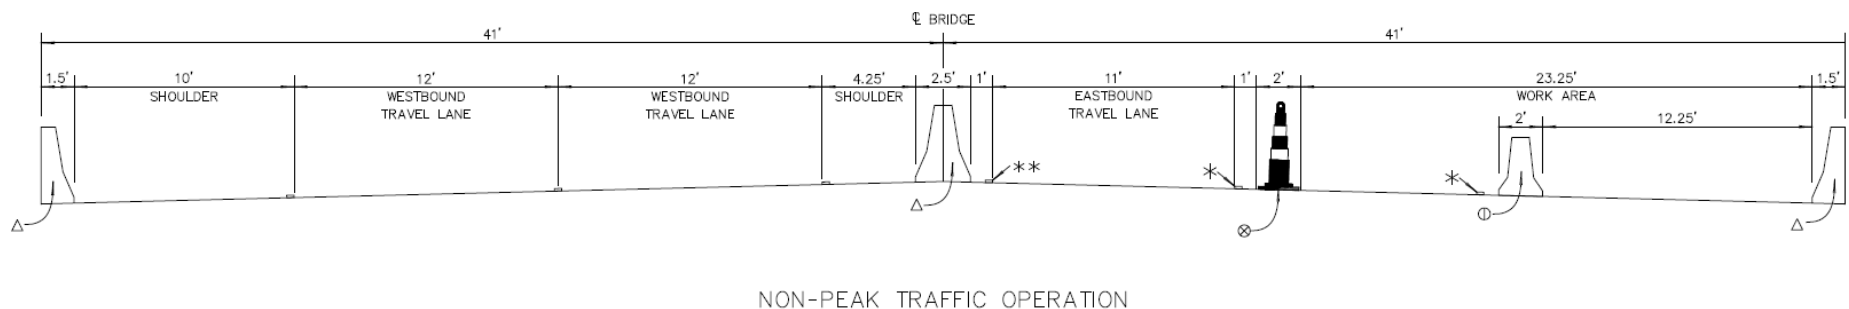
# Maintenance of Traffic

- Single lane provided during non-peak traffic
- Work Area:
  - 12.25 ft width behind barrier
  - Additional 9 ft width adjacent to barrier

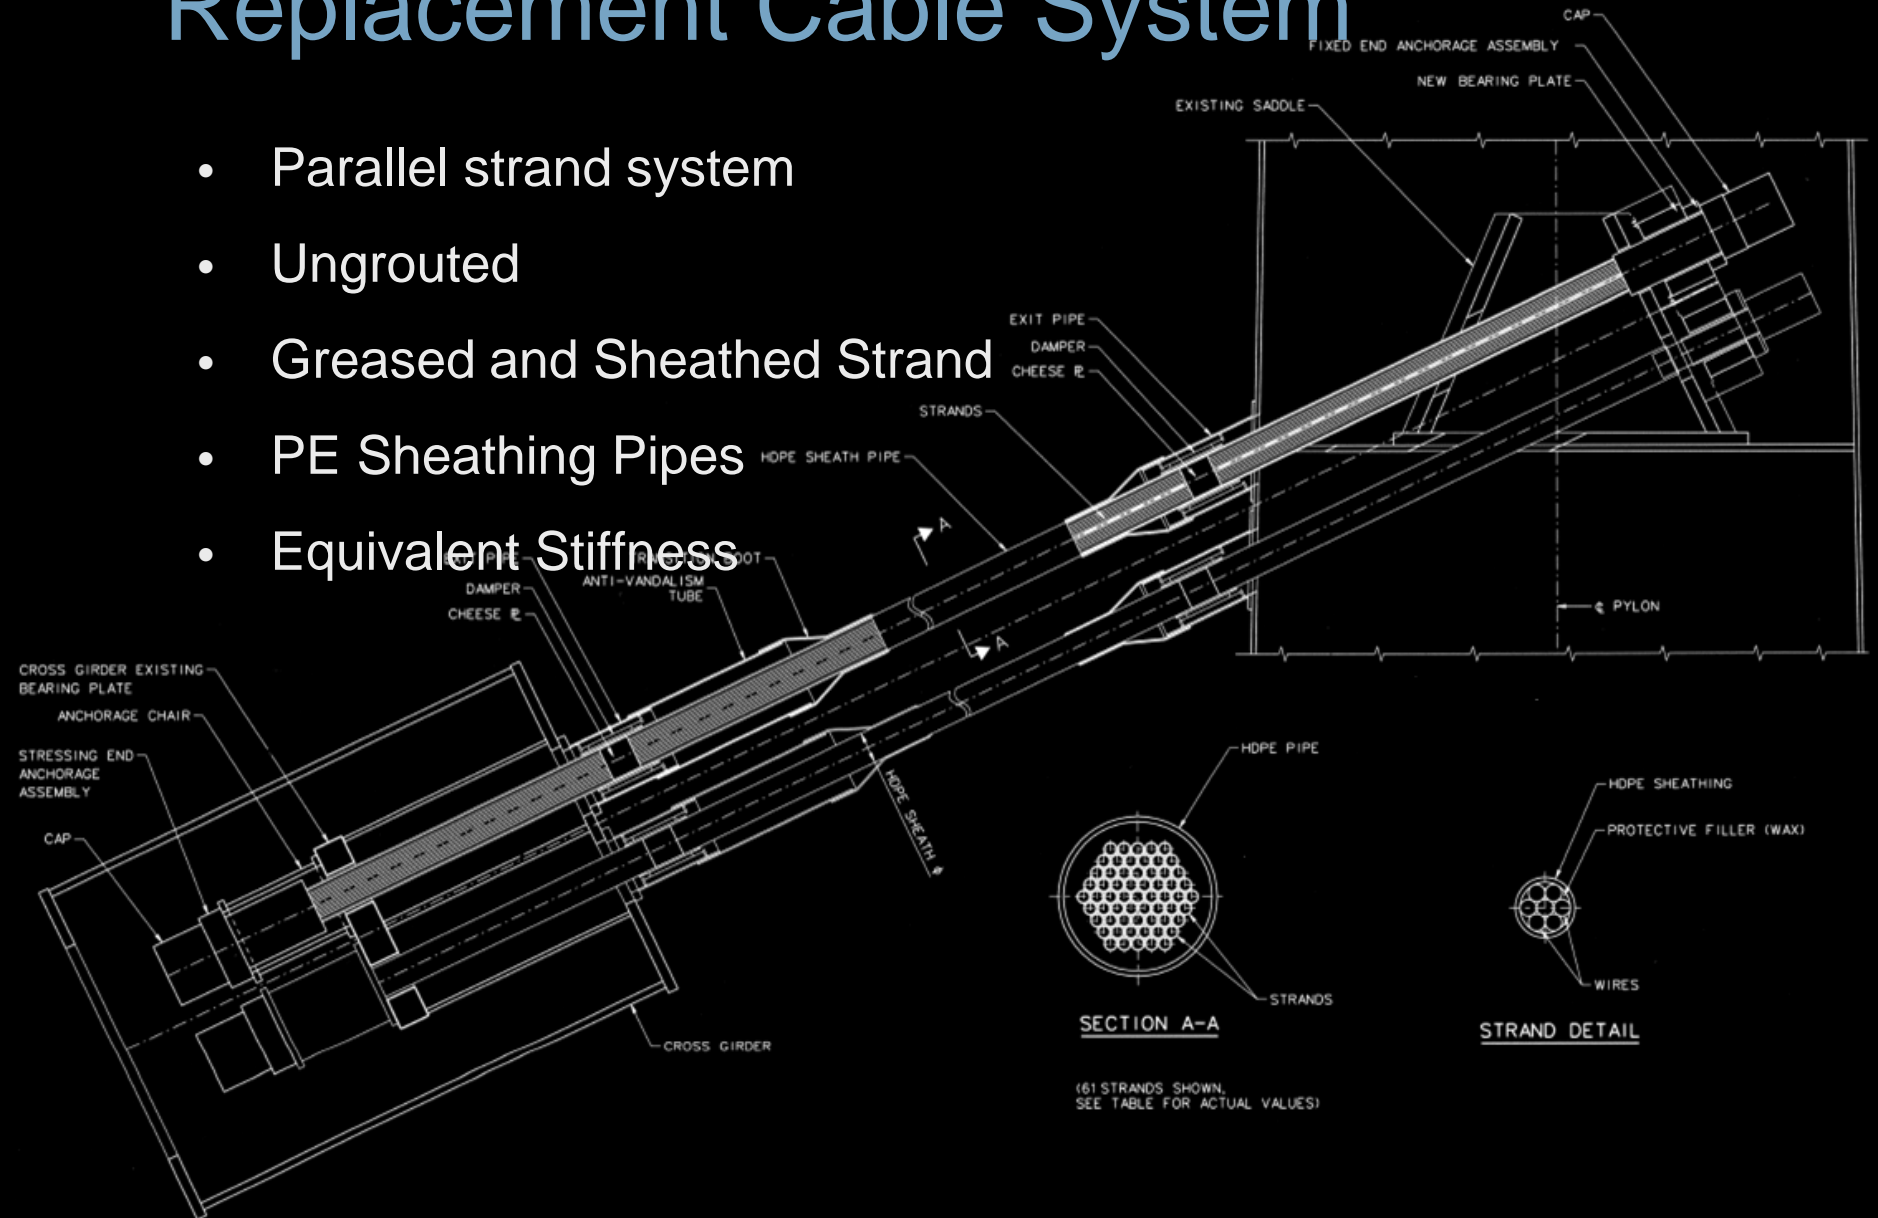
# Replacement Cable System

- Parallel strand system
- UngROUTED
- Greased and Sheathed Strand
- PE Sheathing Pipes
- Equivalent Stiffness

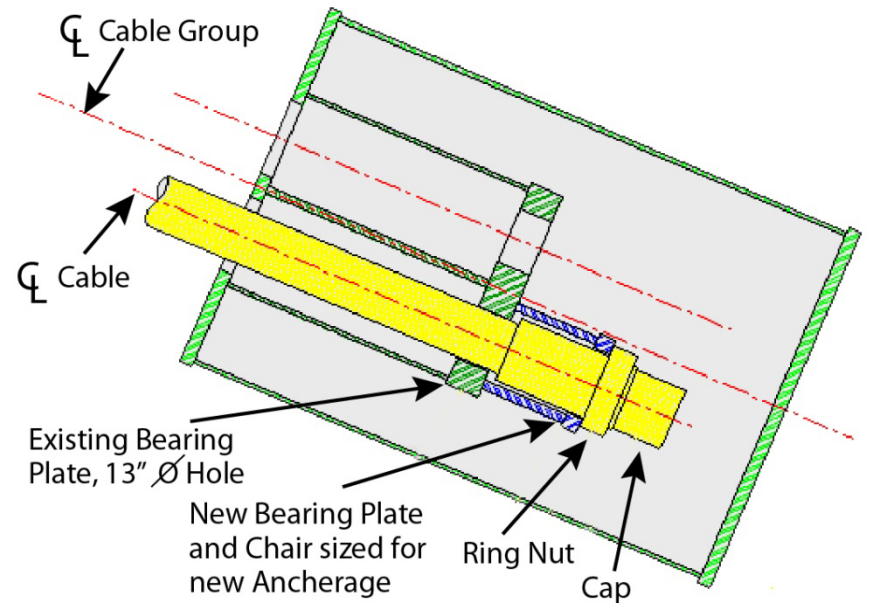
# Anchorage Zone Modifications

- Result of increased Cable Anchorage Sizes
- Designed to accommodate cables from several suppliers

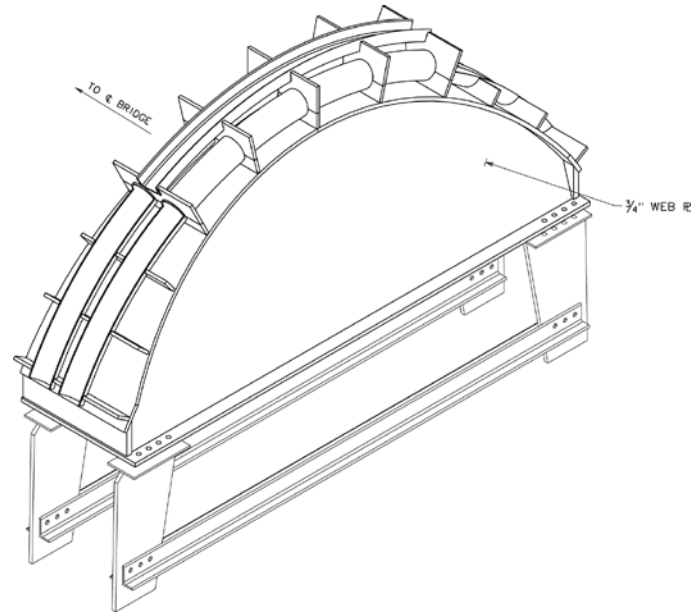
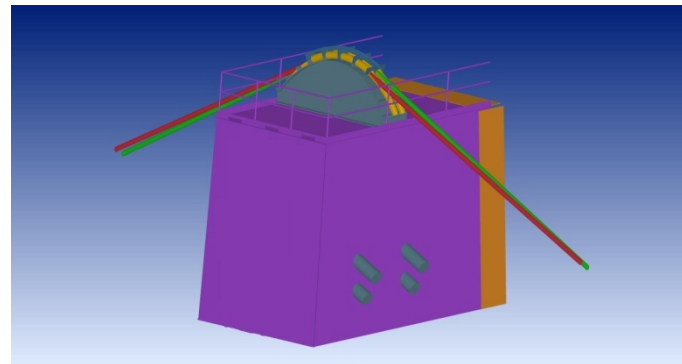
# Temporary Cables - Saddle

- Top of Pylon
- Light weight
- Geometry Fits all Cable Groups
- Limited tower strengthening

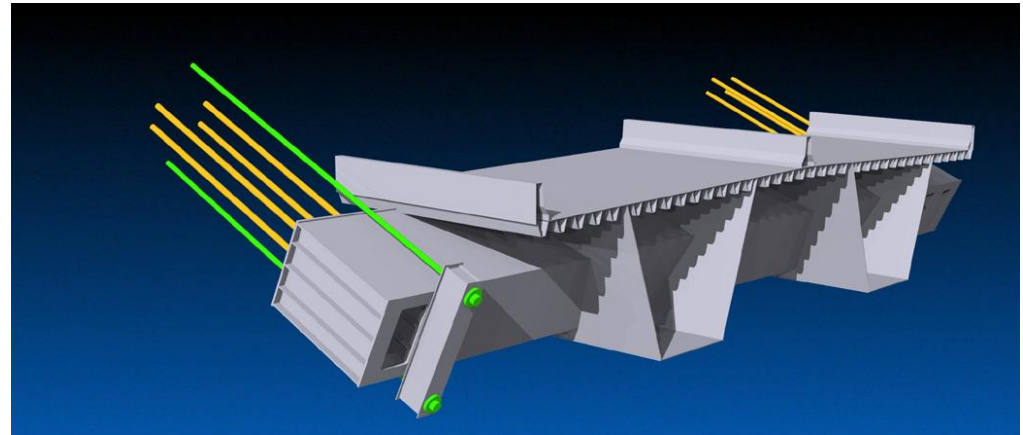
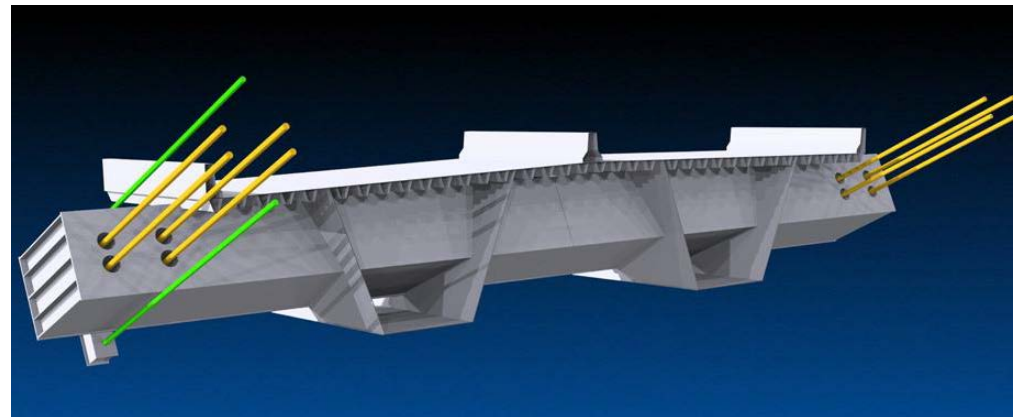
# Temporary Cables - Waler

- Lower Cross Beam
- Set from Deck
- Limit stresses in Cross beam ends

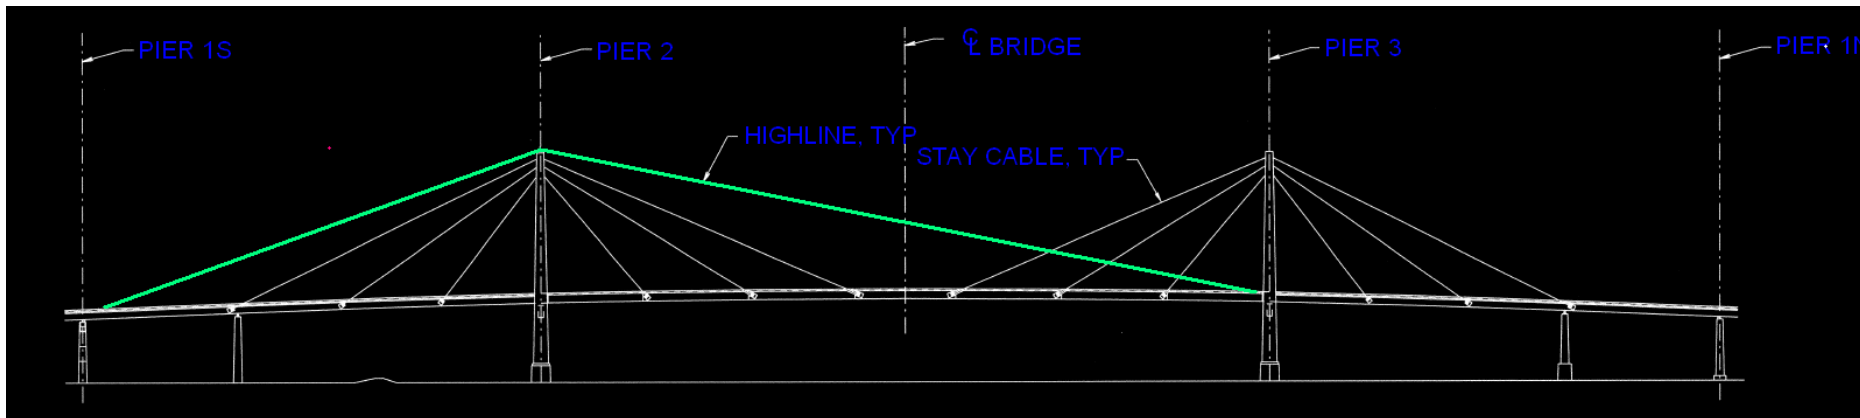
# Schematic Highline Design

- Supported by Saddle at Tower

- Lower Anchorage tied to Superstructure

- Provide means of supporting stay cables during removal and installation operations
- Design developed assuming Highline or cable way to Limits Work zone requirements
- Schematic Design of Highline Provided
- Final Design by Contractor

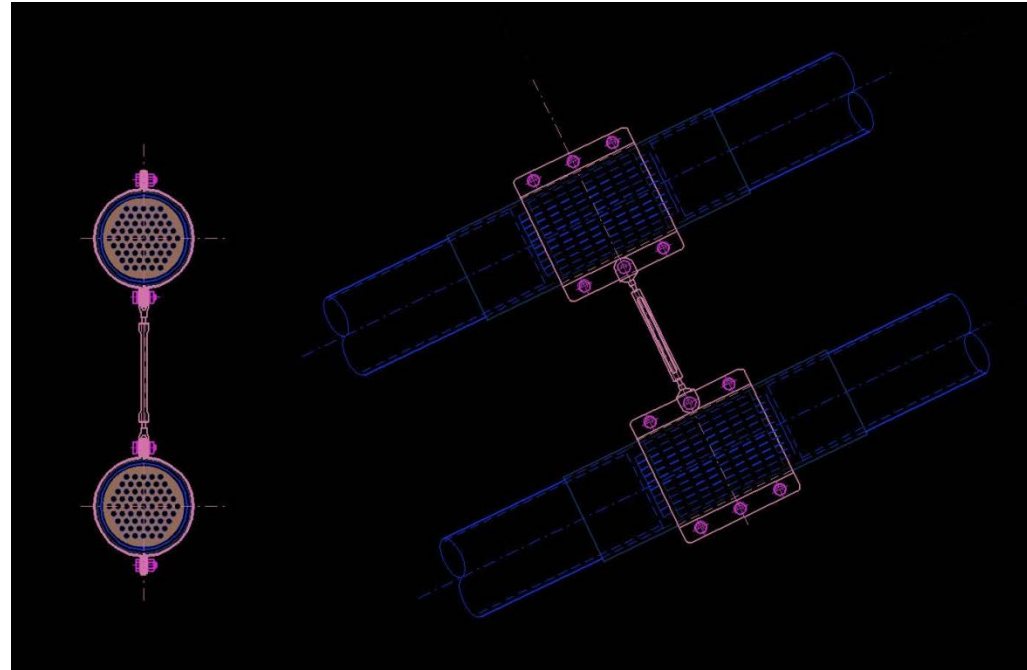
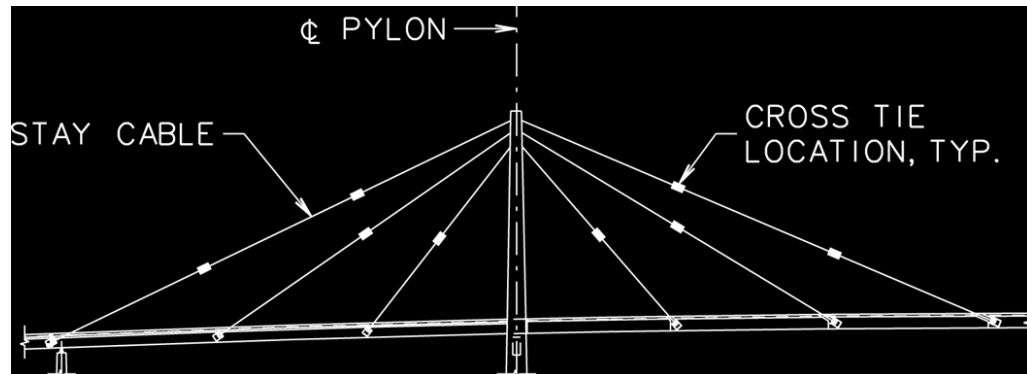
# Cable Cross Ties

- Mitigate potential wake galloping
- Ties between vertical cables
- Detailed to preserve strand replaceability
