**Western Bridge Engineers' Seminar
September 4-6, 2013**

**Seismic Retrofit of the Dumbarton
Toll Bridge**

California Department of Transportation, Sacramento, CA

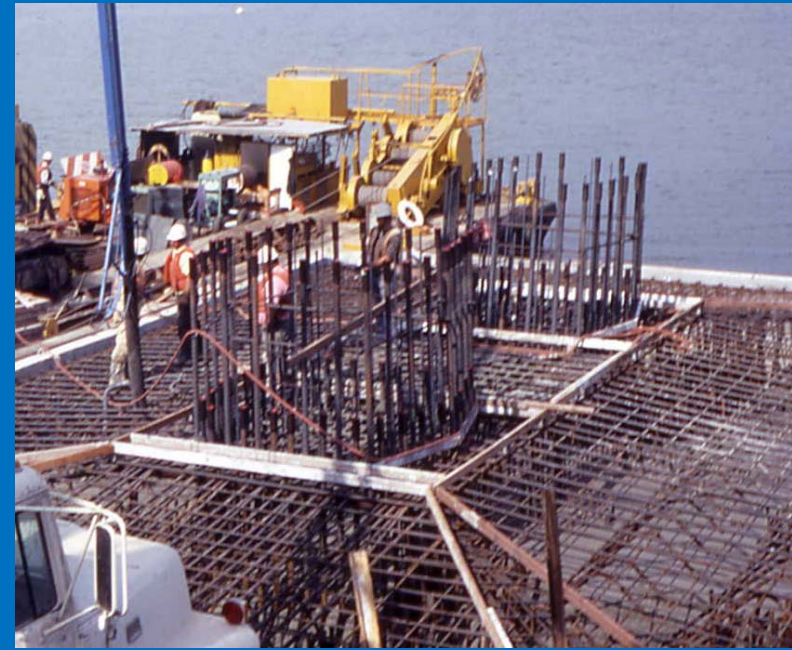
The presence of couplers at the bottom of the columns was investigated:

- Seismic displacement demands computed assuming half of the column couplers are ineffective
- Column ductility demands were compared with the displacement capacities for half of the column main bars

Displ. Capacity > Displ. Demand

Column main bar couplers at the base

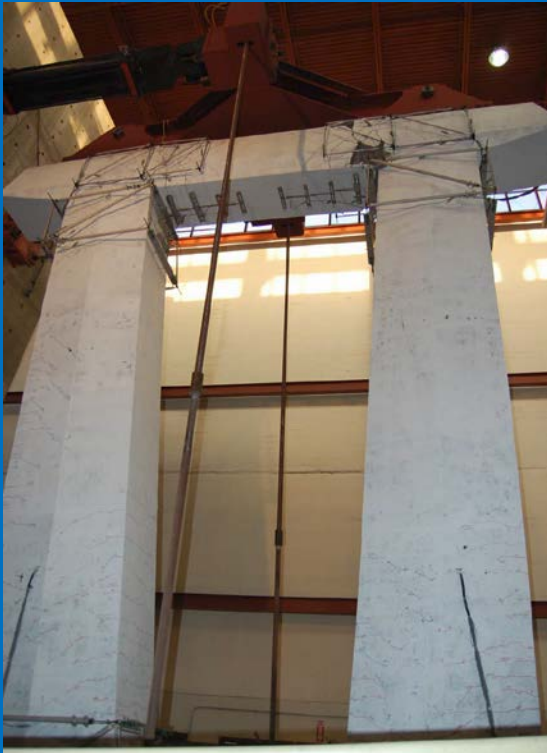
Pier 37 and Pier 23

- Flexural capacity of hollow columns, and joint shear capacity of column-pier cap joint and column-pedestal joint verified by
- 1/3 scale Pier 23 and Pier 37 tested at UCSD
- Test showed reliable ductile behavior of hollow columns with a ductility of 5
- Bent cap-column and column to pedestal joints remained essentially elastic

Test Specimen and Cracks $\mu = 2$

Results of testing at UCSD, Caltrans further rigorous analyses and independent analyses by Dr. Nigel Priestly confirmed that retrofit for column and pier cap joint was not needed.

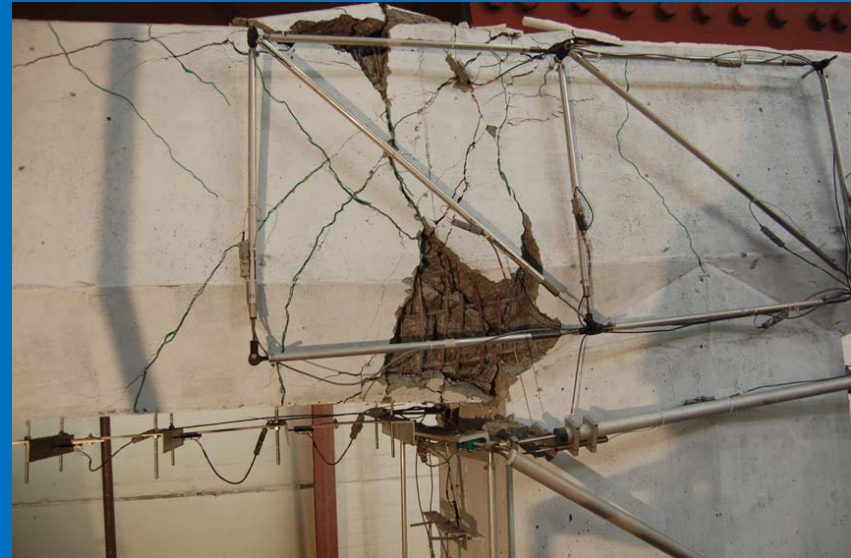
South Column to Cap Beam Joint @ -15" Disp $\mu 5$

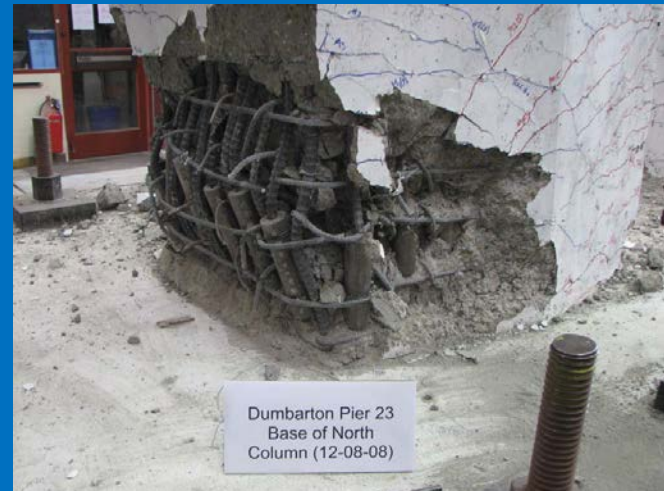
Post Test, West Side, Broken #3
Tie North Column Base @
 ± 18 " Displacement $\pm \mu 6$

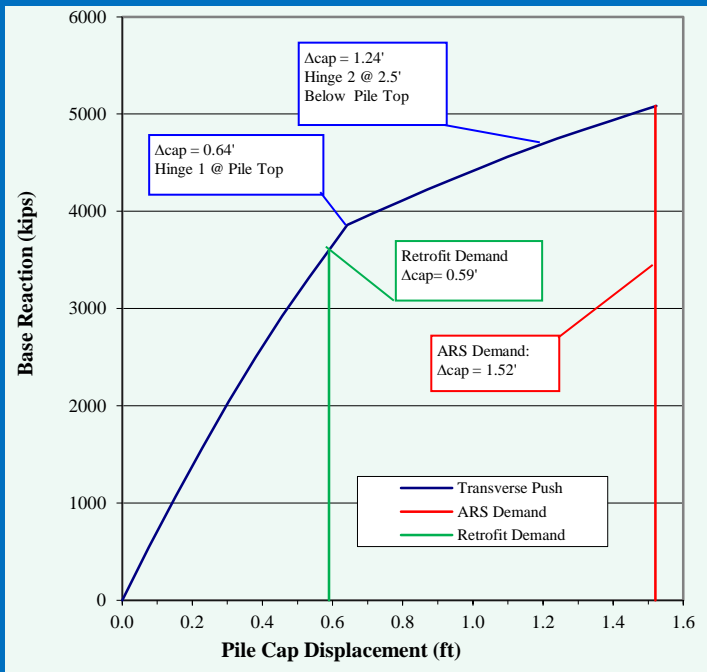
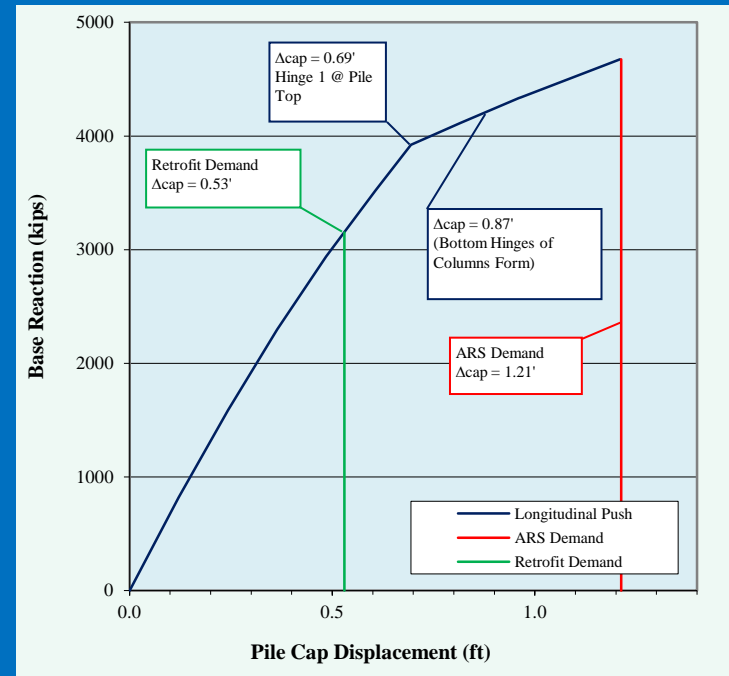
Pier 23- Transverse and Longitudinal Pushover Curve

- Pushover curves Pier 23 - tallest pier supporting the longest 340 ft span
- This curve shows typical foundation behavior for most of the Main Channel piers

- Plastic hinging of the 54" dia. concrete filled P/S hollow concrete pile
- Plastic hinging of columns at the bottom. These columns have couplers at the base
- Retrofit reduced the foundation/pile cap demands significantly

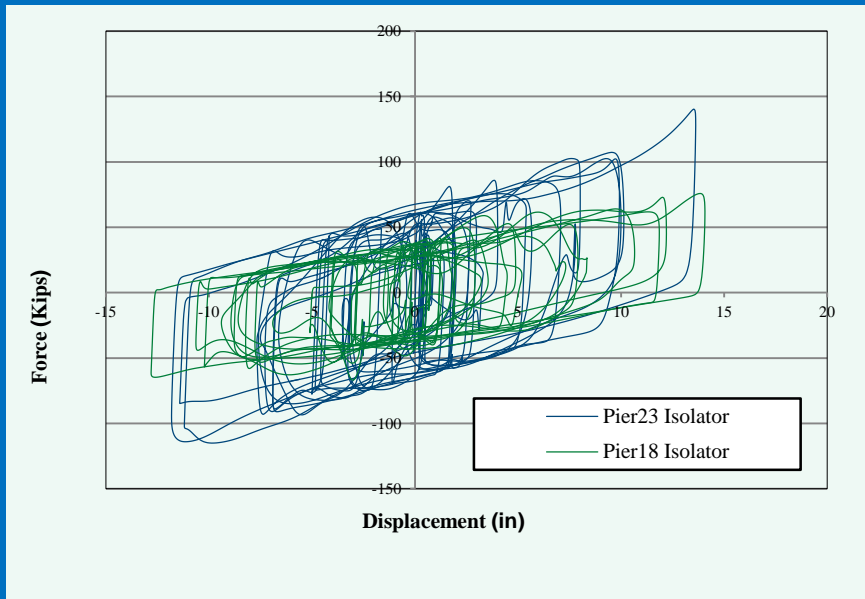
Hysteretic Response of Isolator Bearing

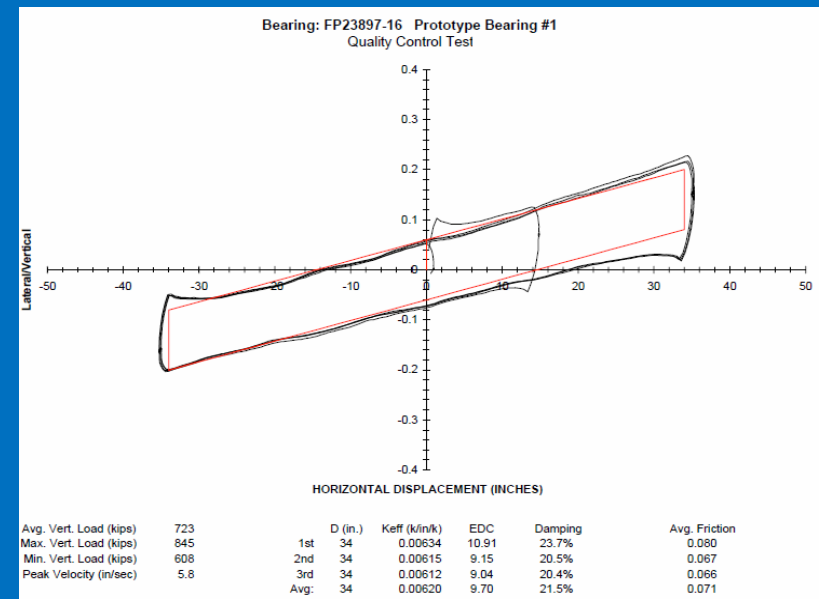
Isolation Bearing Quality Control Test at EPS

- Isolator Bearings design parameters matched by EPS Inc. during design phase
- Isolation Bearing manufactured at Earth quake Protection System and quality assurance testing at UCSD
- Procured and Tested to save time during construction

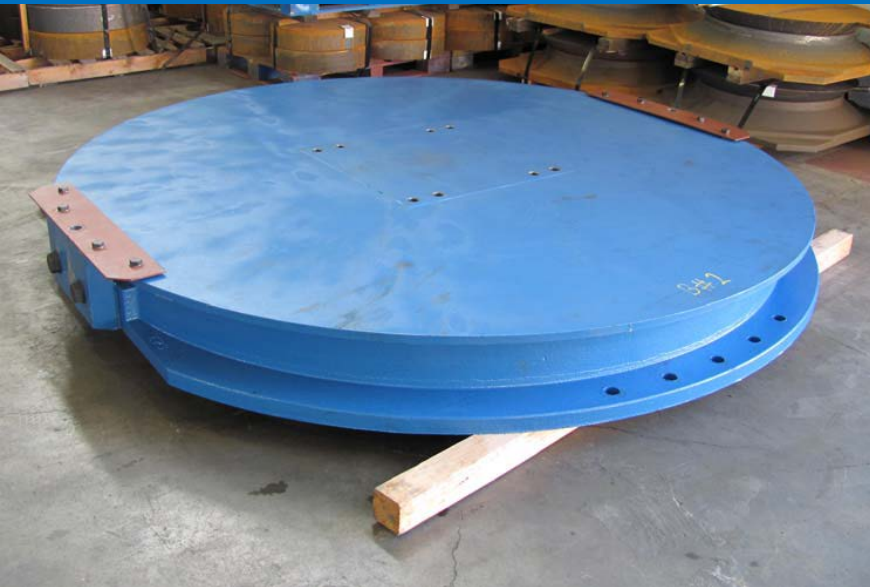
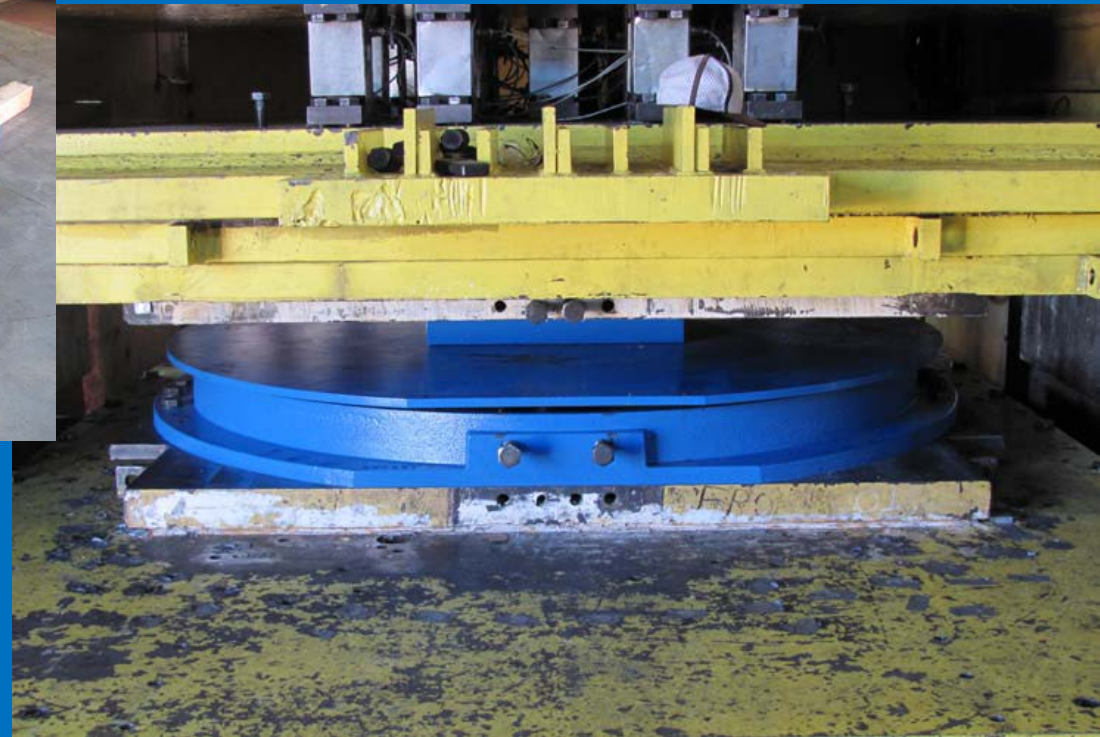
Friction Pendulum Isolation Bearings

Fabrication and testing of all 96 Isolation Bearings was Done at EPS Inc.

The QA testing of 9 bearings at University of San Diego (UCSD).

Isolation Bearing Data:
width : 9' - 4"
Height : 9.5" and 10"
Weight: 15000 lb
Rated loads : 1,100,000 lb
Max Displacement: 42"

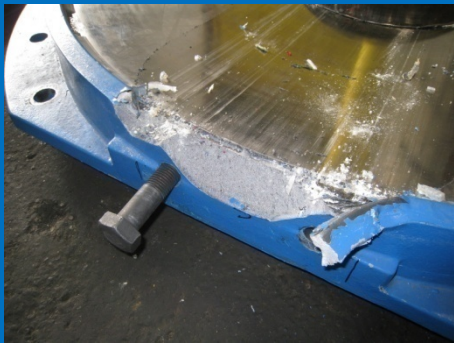
Shear Ring Failure

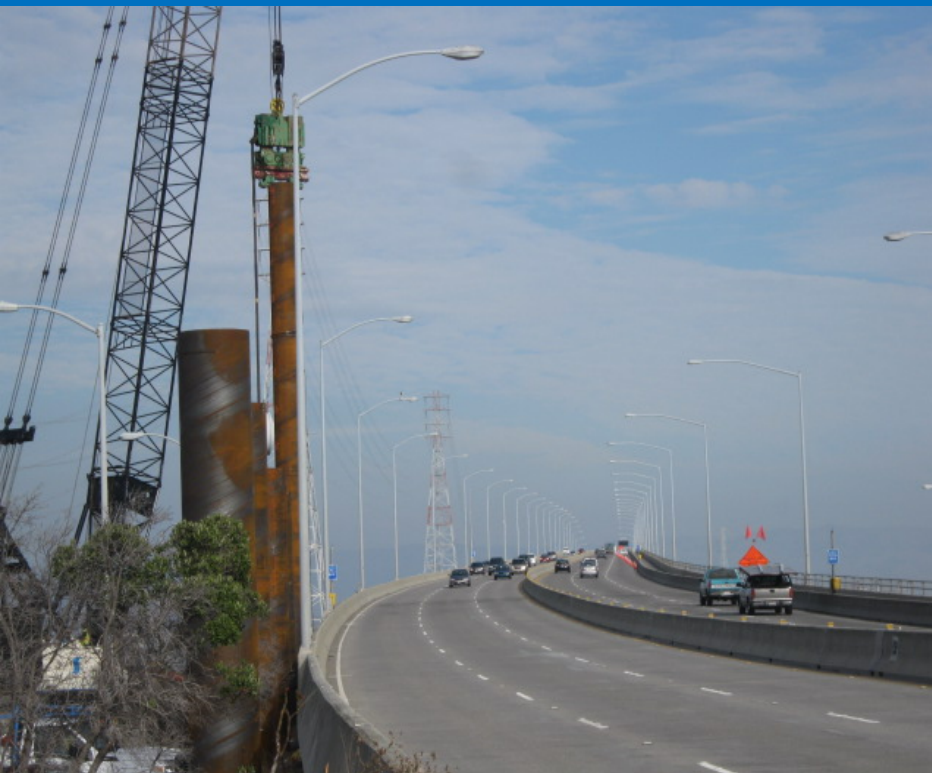
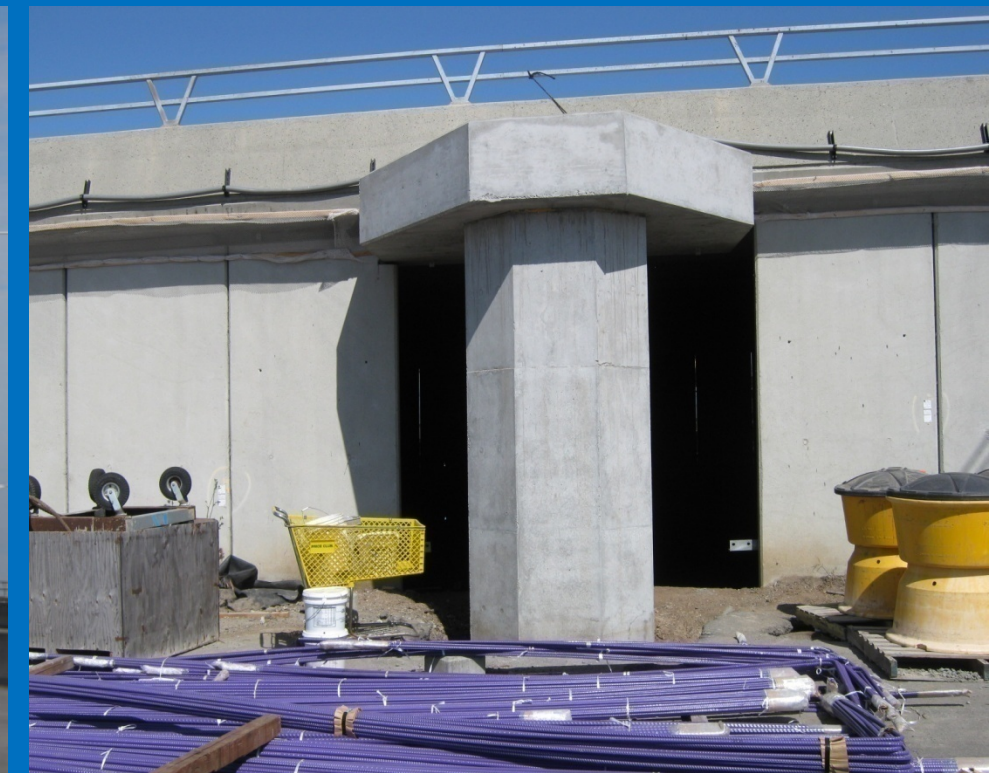
Trestle retrofit work consisted of installing CISS piles, column and pier caps

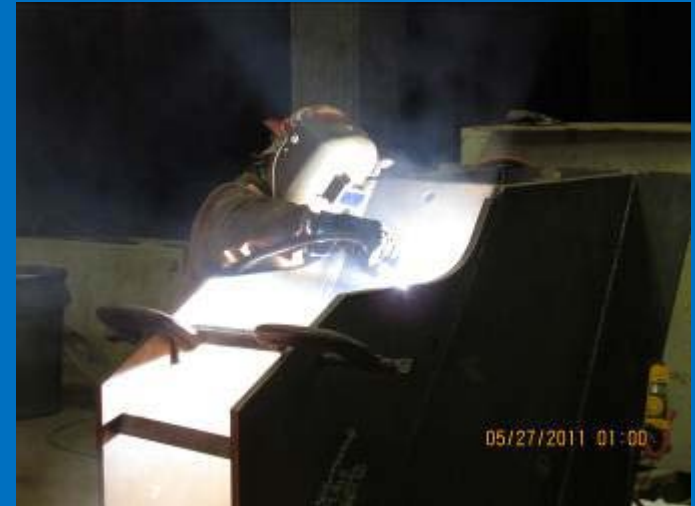
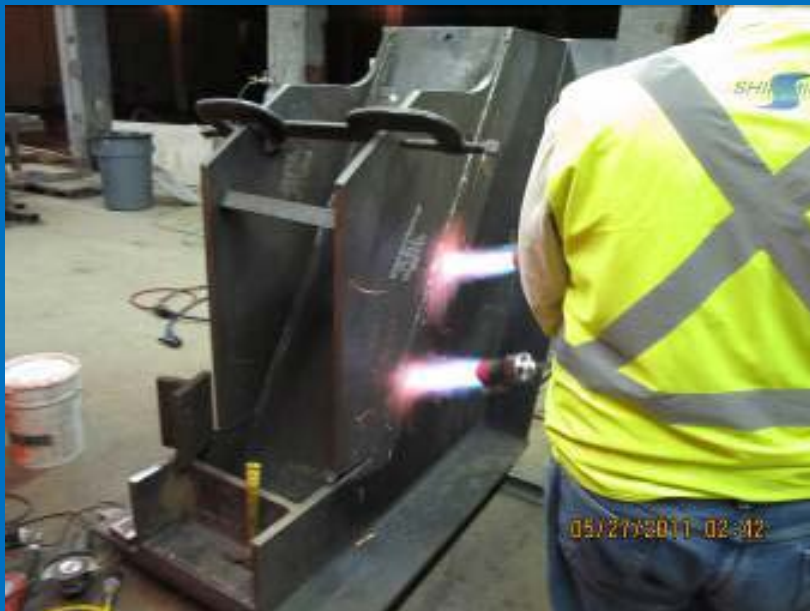
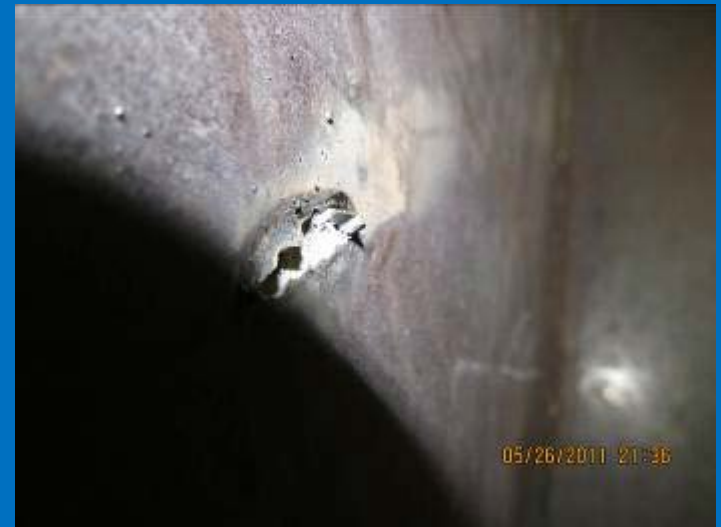
Construction of Main Channel - Mock up 1

Bearing to Steel box connection

Complicated welding inside the box with 100%UT

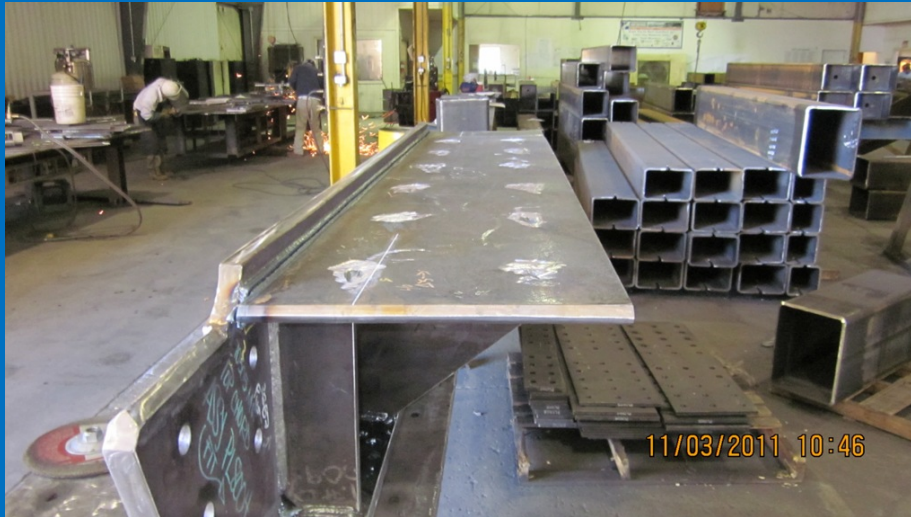
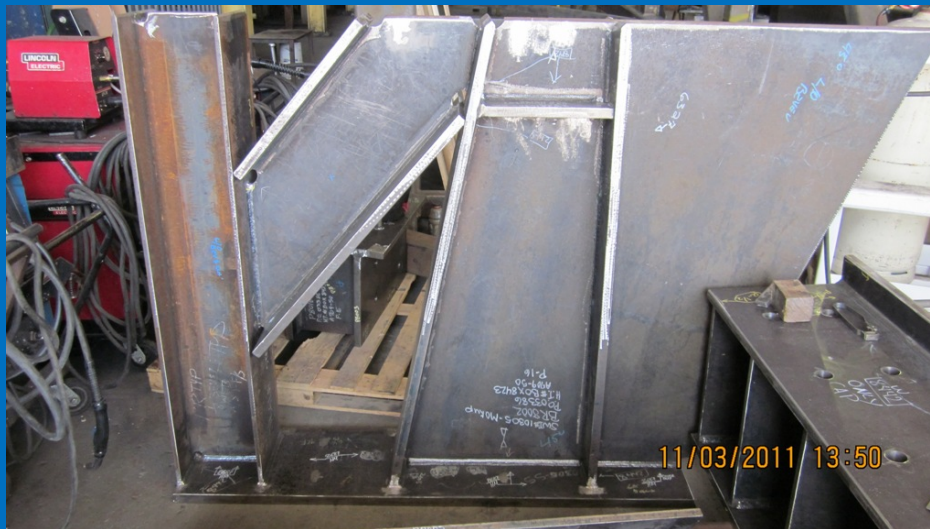
Construction of Main Channel - Mock Up 2

New Steel Cross Frame and Seismic Isolation Joint

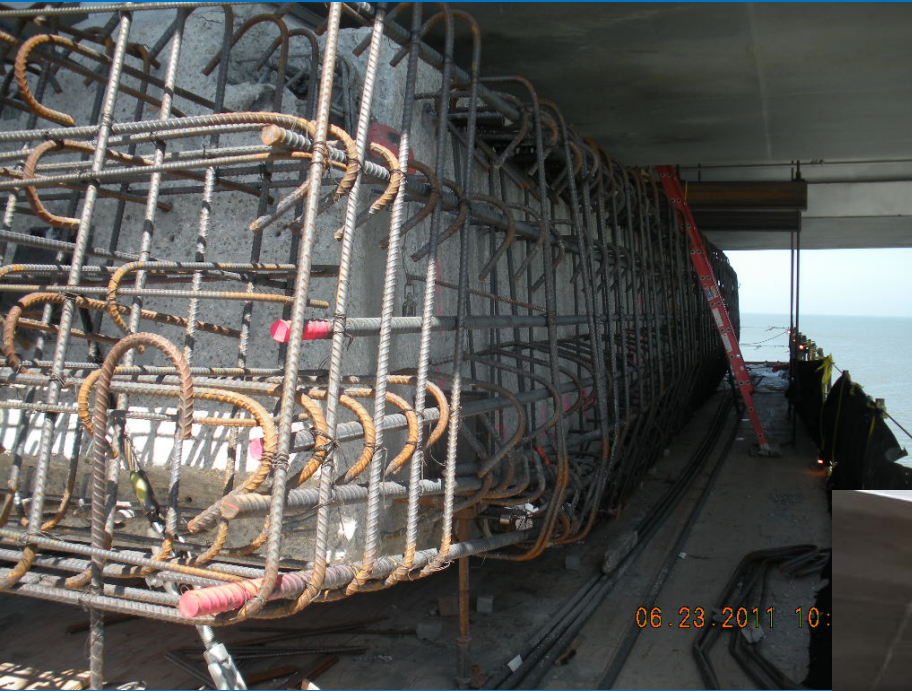
Widen pier caps to allow for the new
Isolation Bearings

Pier cap strengthening on the Main
Channel from pier 16 to 31

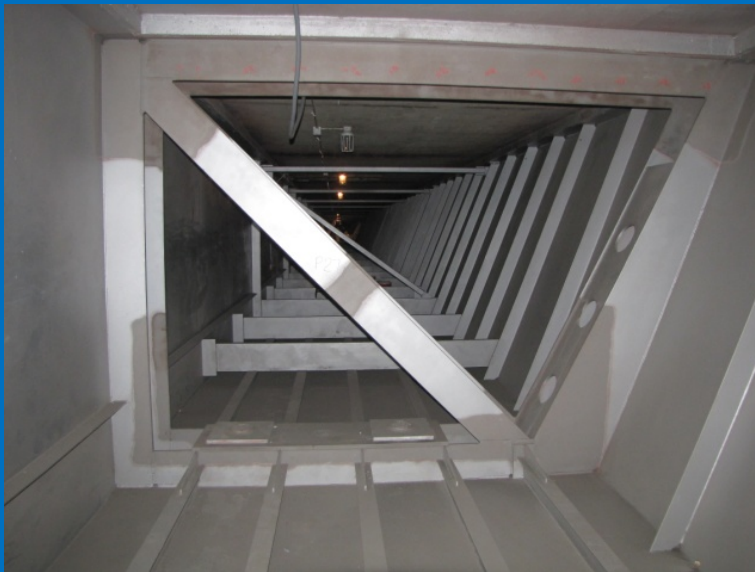
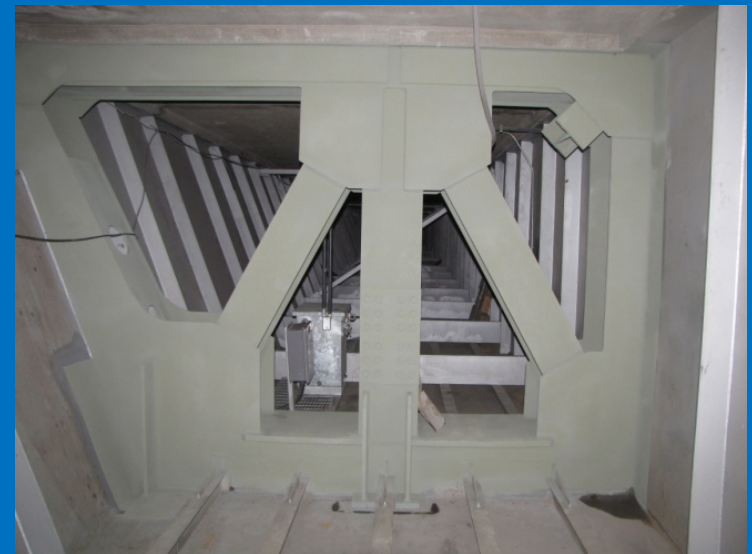
Stresses in Cross Frame Members during Steel Box Girder Jacking

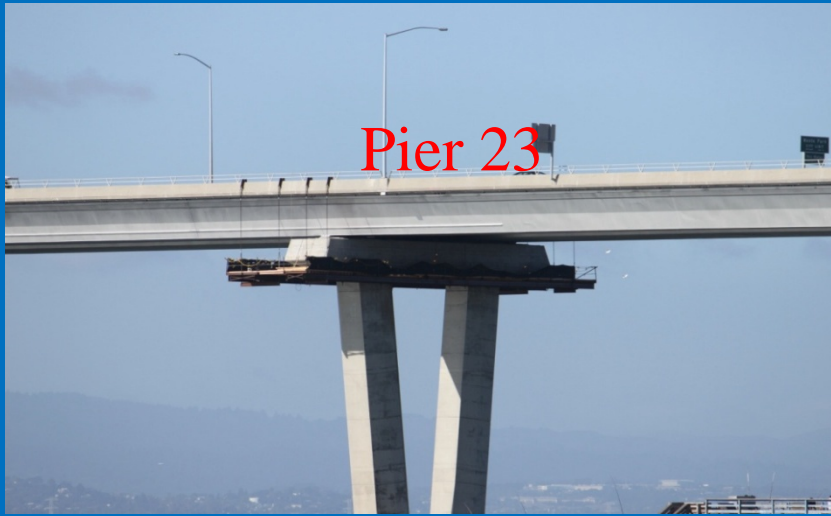
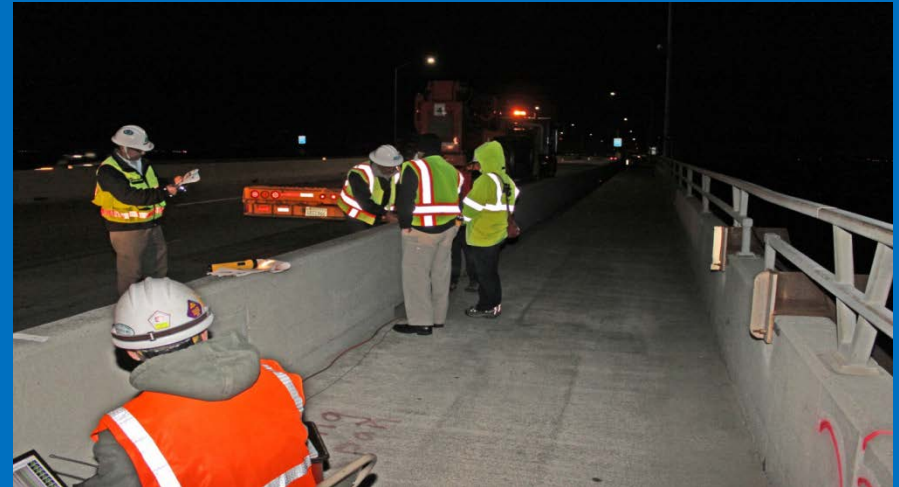
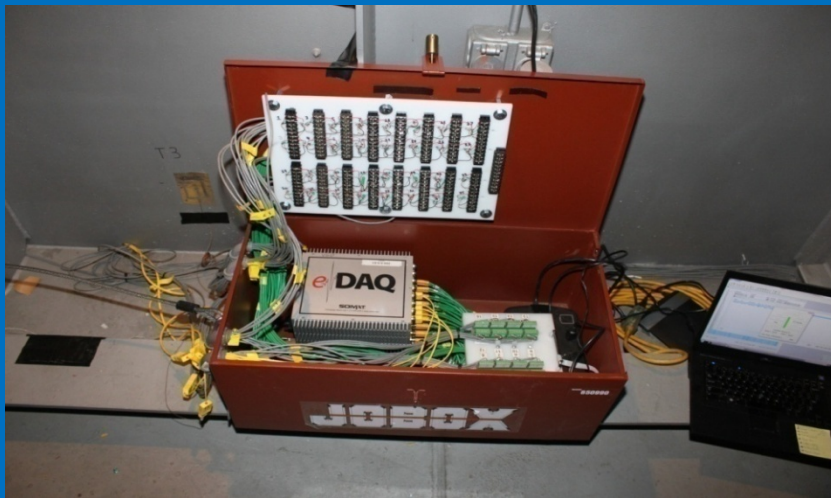
Stress-Strain Monitoring

Strain gauges were installed at pier 23

Trial lift conducted to verify the design stress calculation with Contractor Jacking operations

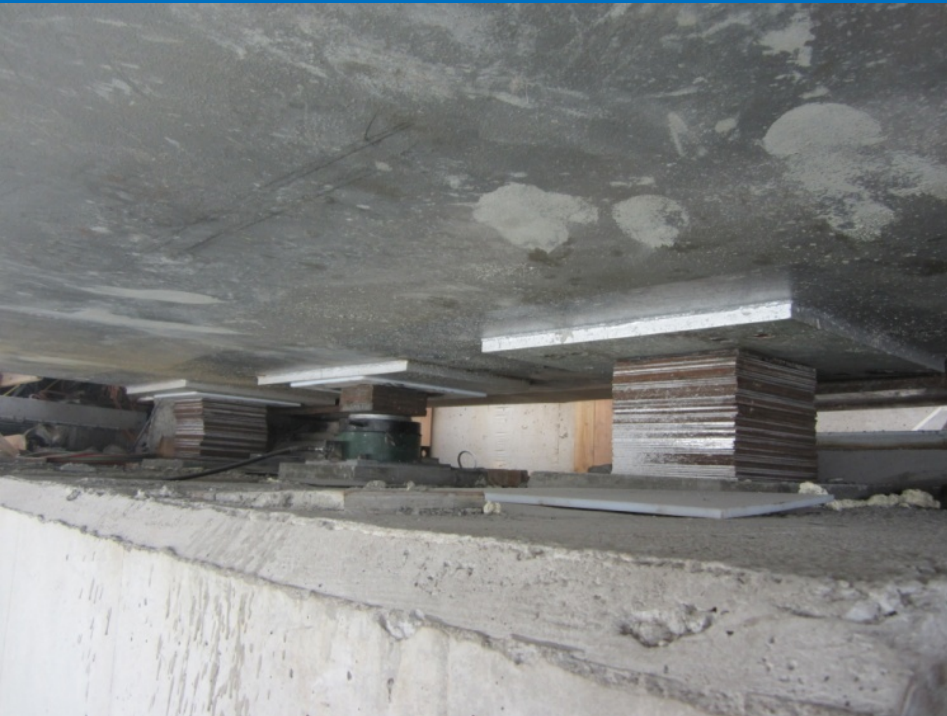
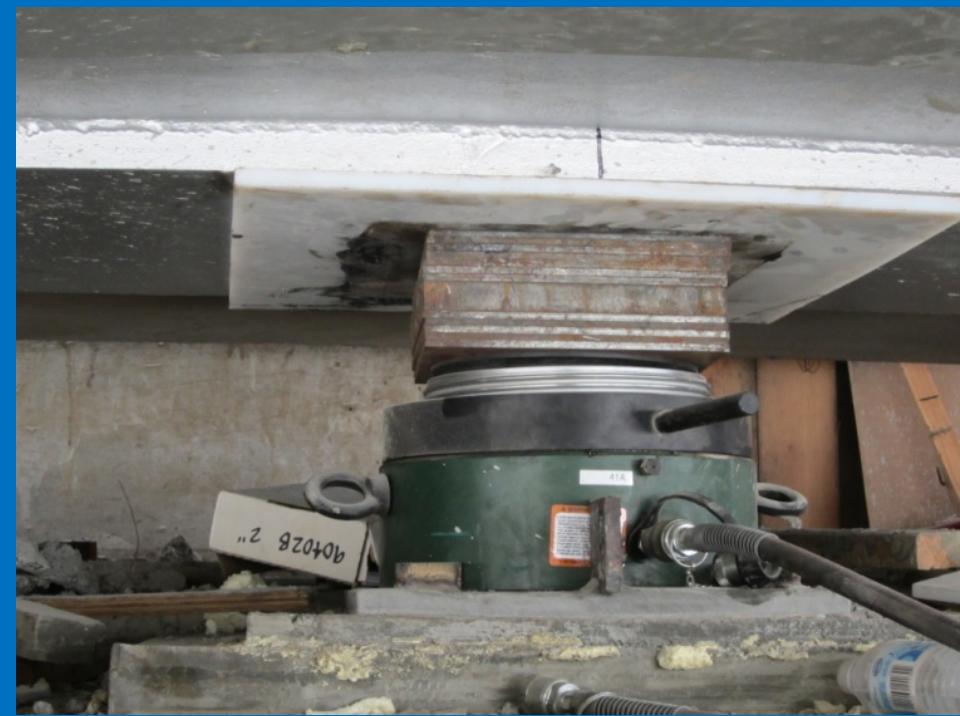
Bridge Jacking

Main Spans permanently raised by 5" at piers 16 through 31.

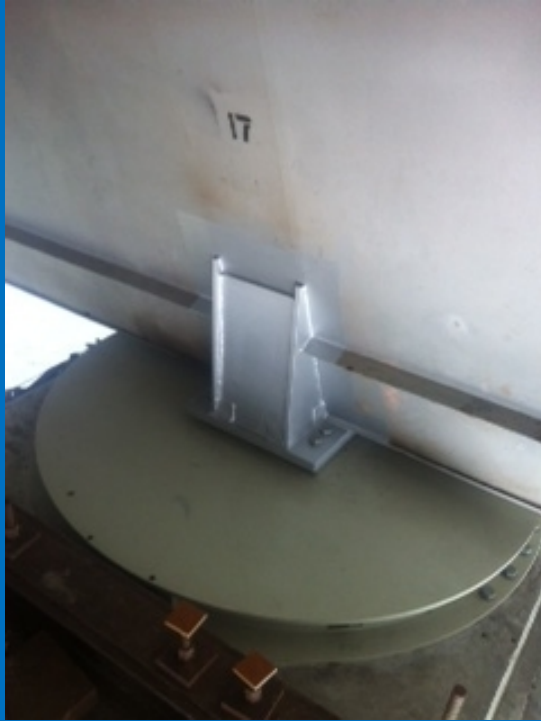
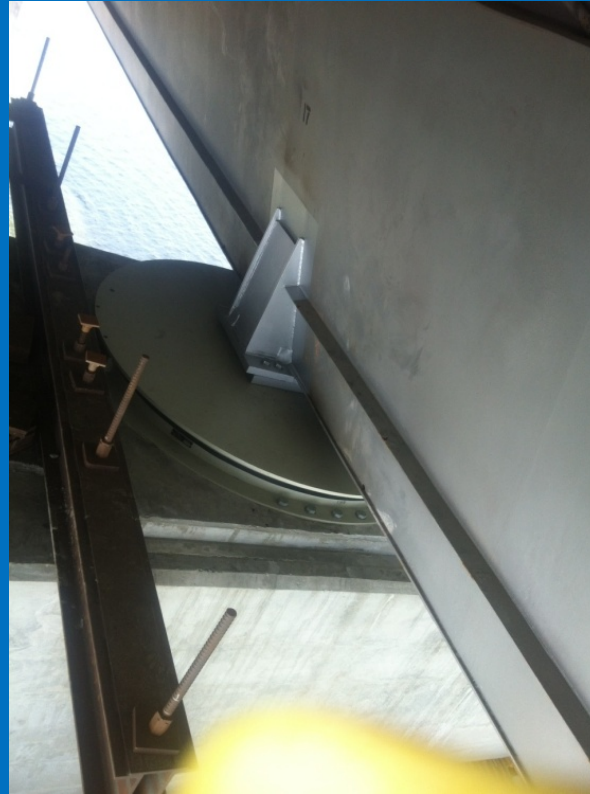
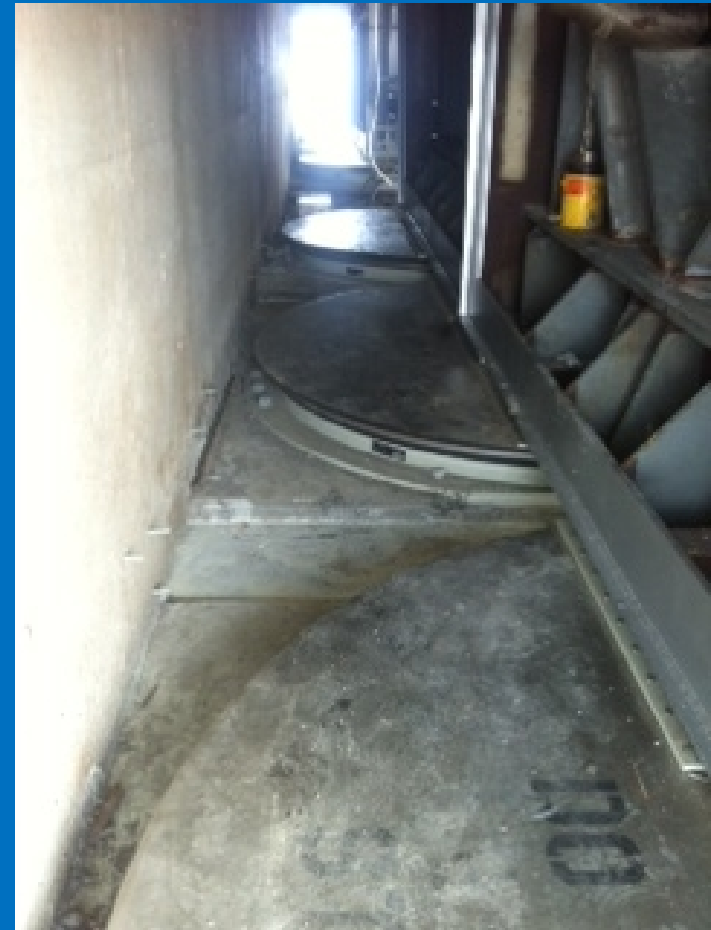
Isolation Bearings Installation

The installation of the 96 Isolation Bearings for Main Channel Pier 16 to 31
6 Isolation Bearing per Pier

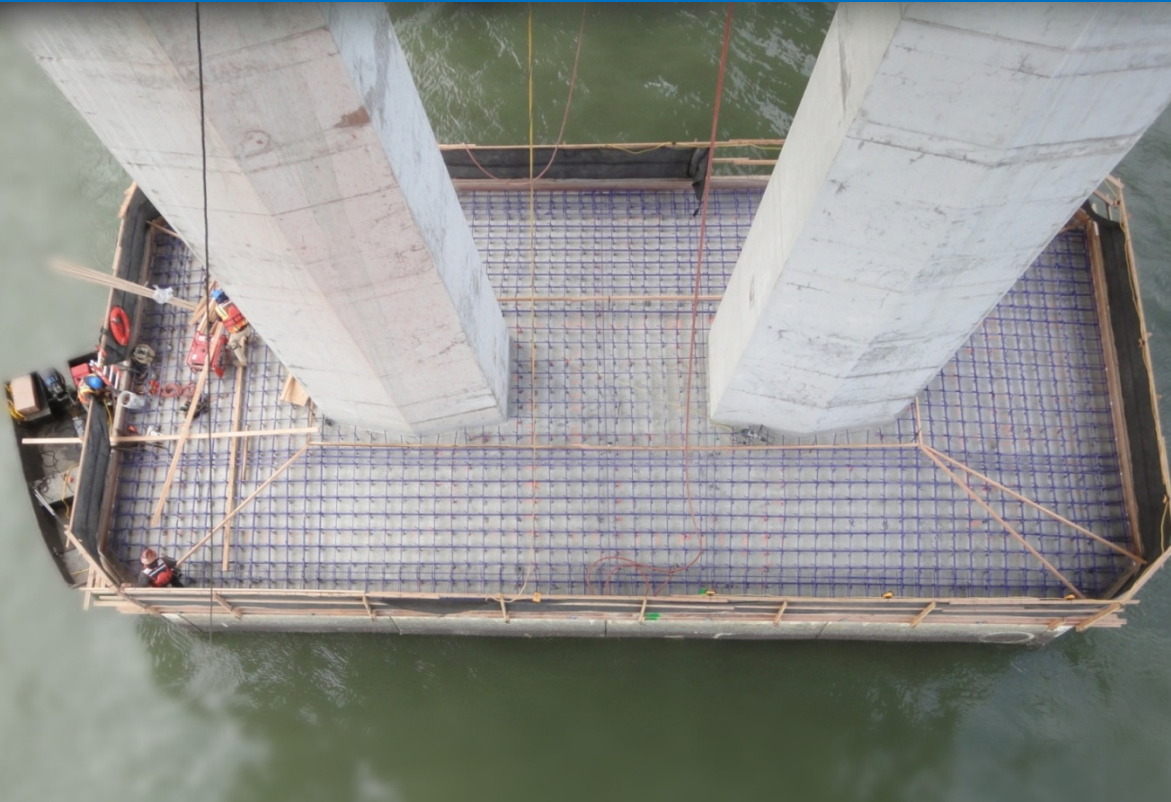
Retrofit the footing pile cap at Pier 17 through 30 and Fender retrofit at pier 23 & 24

Footing pile cap strengthening

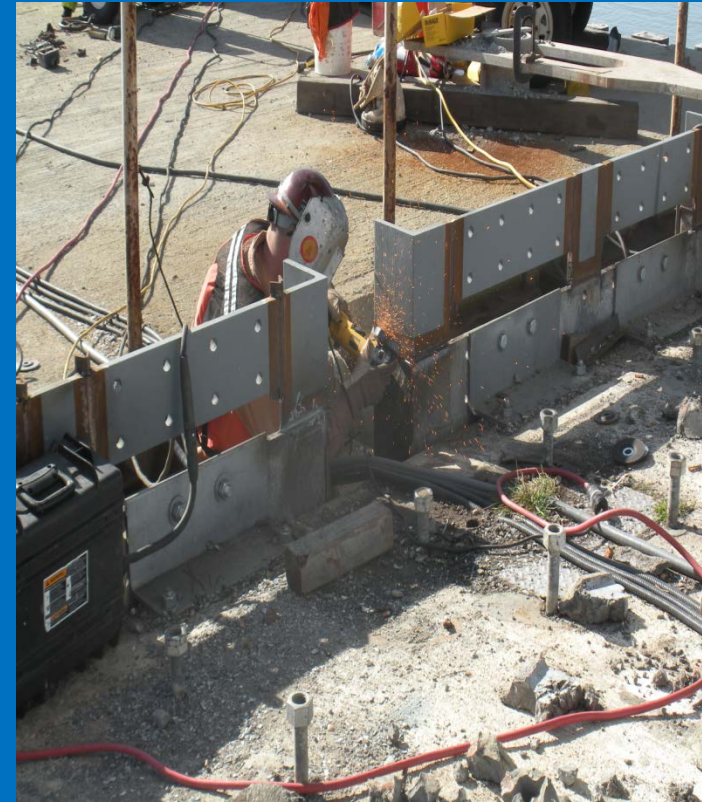
Fender at pier 23 and 24
