US 65 Oak Street Bridge

DESIGN, CONSTRUCTION & STRUCTURAL HEALTH
MONITORING OF A STEEL ARCH BRIDGE

Iowa Falls, Iowa

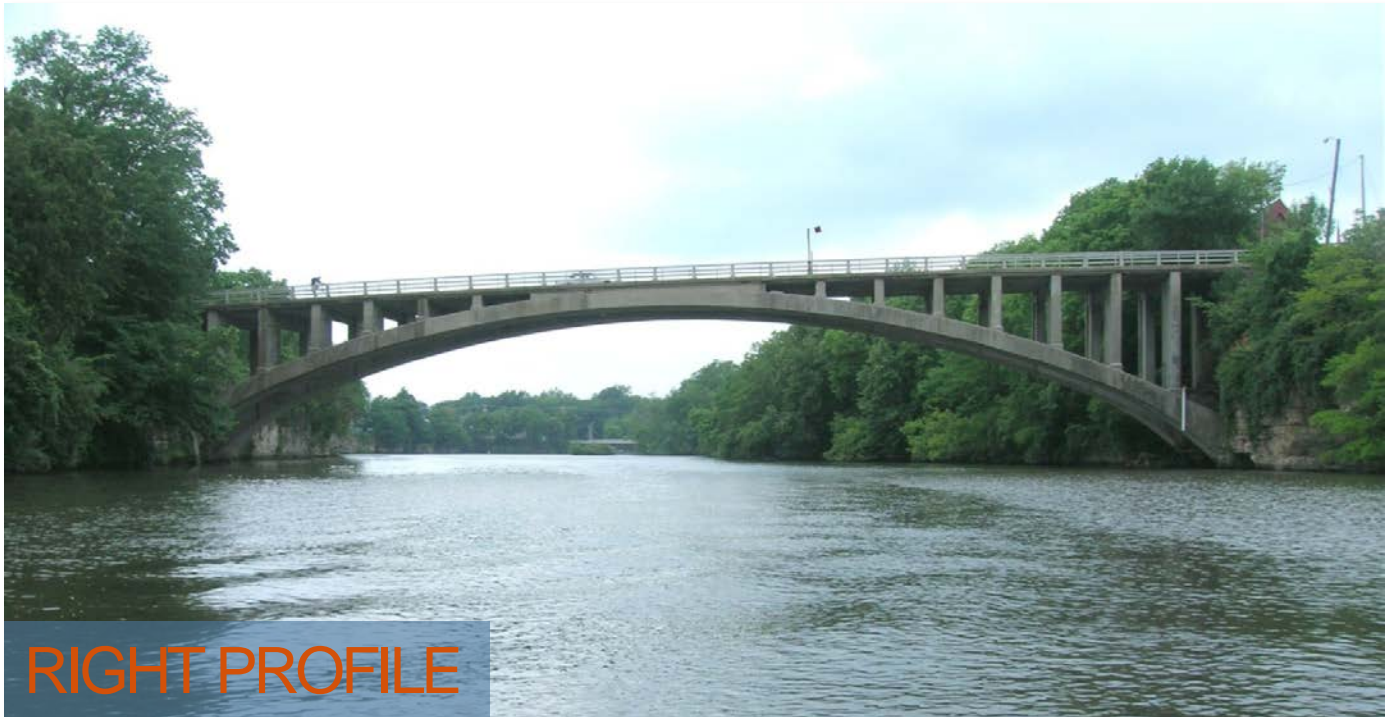
Existing Bridge

- » Built in 1928
- » 255-foot Open Spandrel Concrete Arch Bridge
- » 24-foot Roadway and Two Sidewalks
- » Deck Supported by R/C Floor Beams

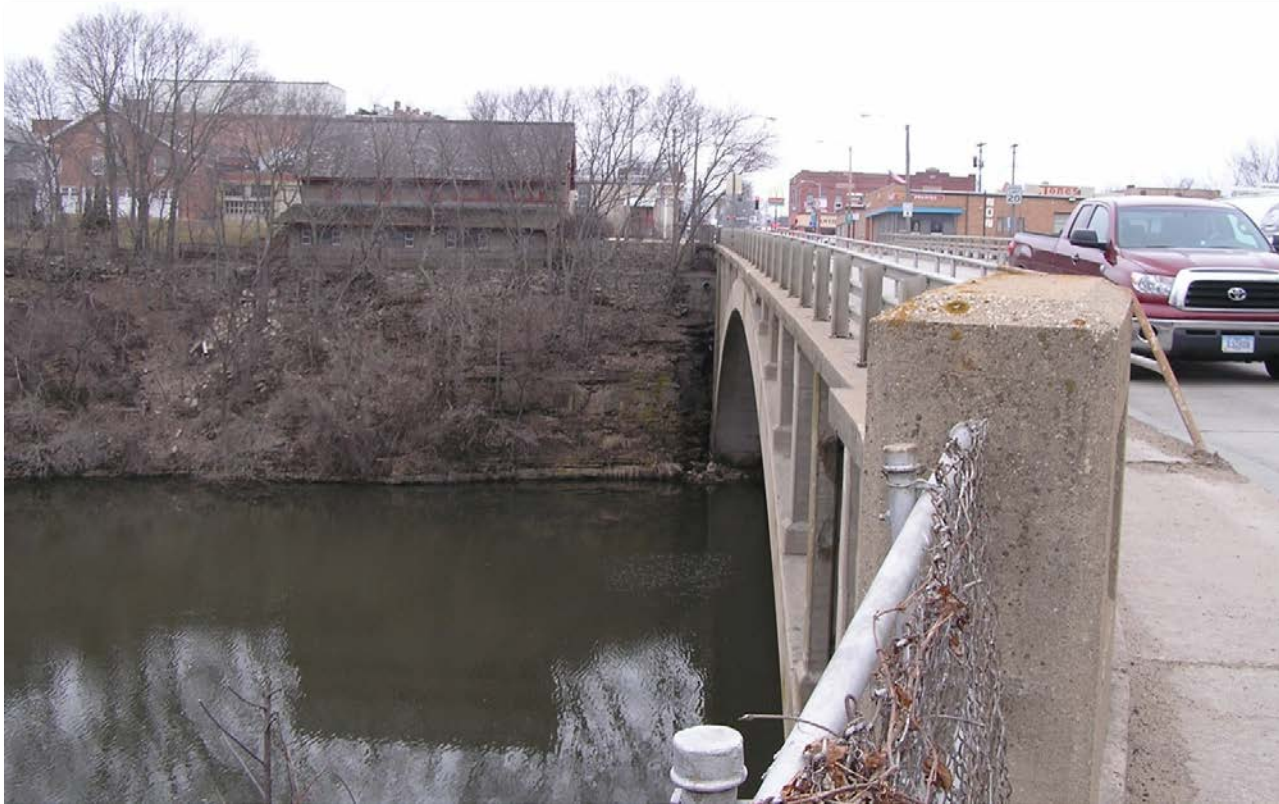
Existing Bridge

- » Rehabilitated 7 Different Occasions
- » Needed Widening and Strengthening
- » Replace Rather than Rehabilitate

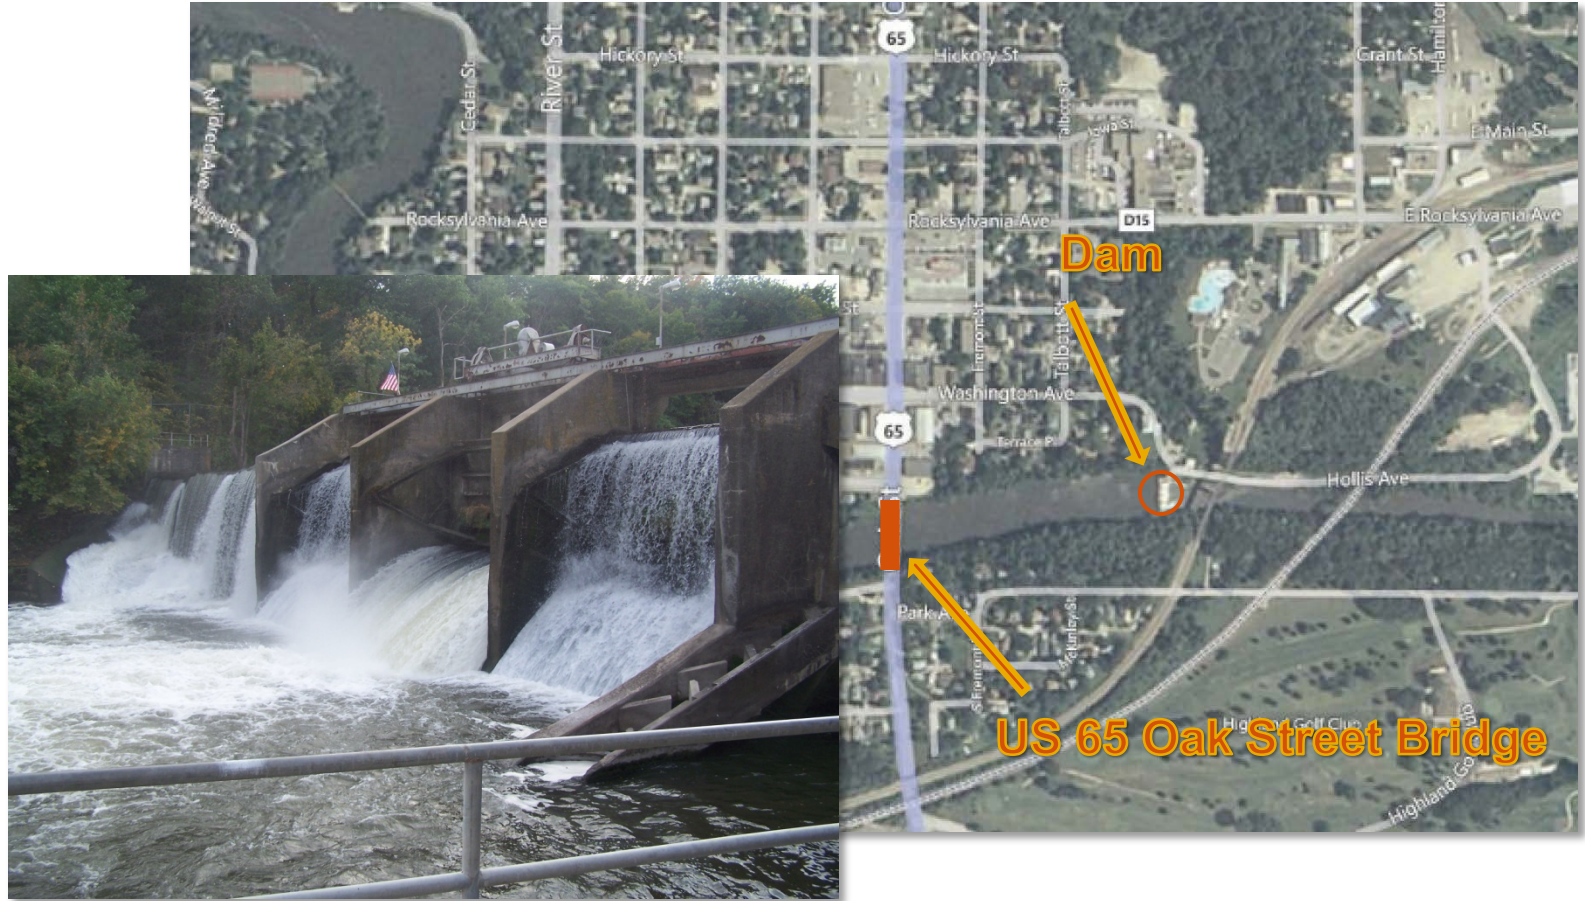
Constraints and Constructability Issues

- » Dam
 - Maintain Water Level

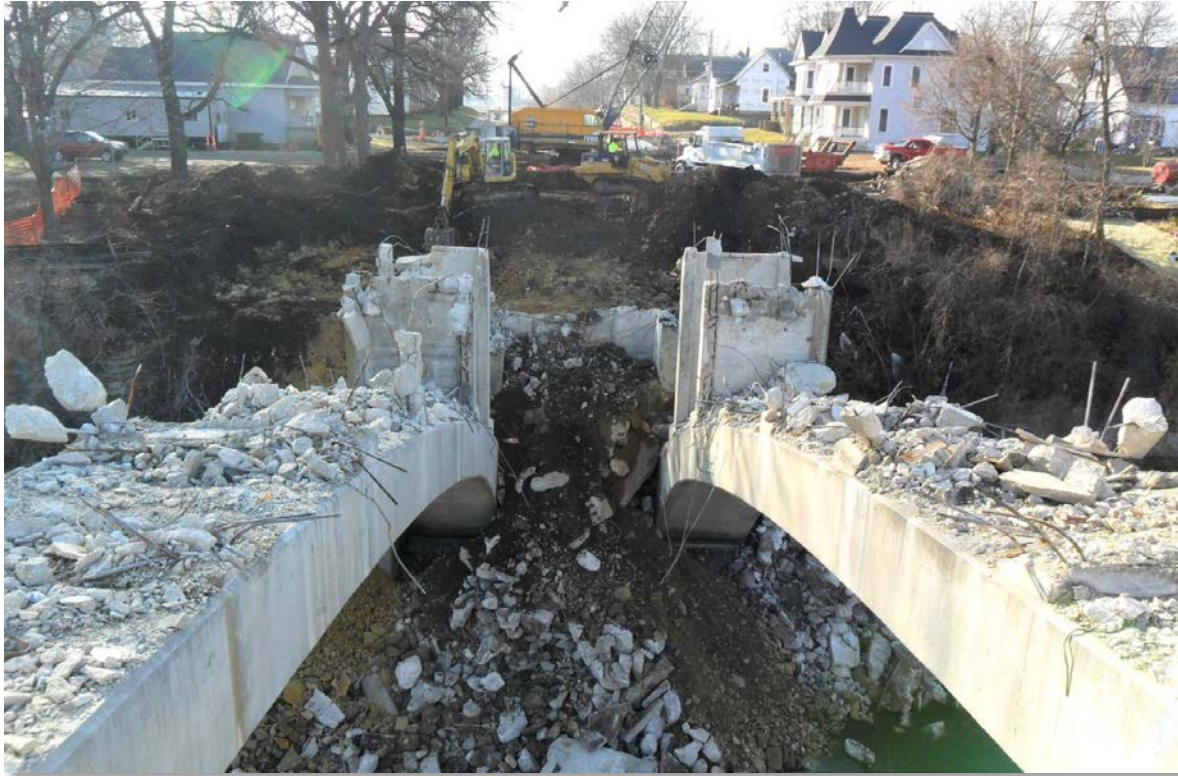
Actual Demolition

- » Started mid October 2010 and Finished mid December 2010.
- » Lowered the Iowa River with Cooperation of the Downstream Dam
- » Constructed an Access Road and Causeway Utilizing a System of Steel Bridge Beams and Crane Mats over the Open Water

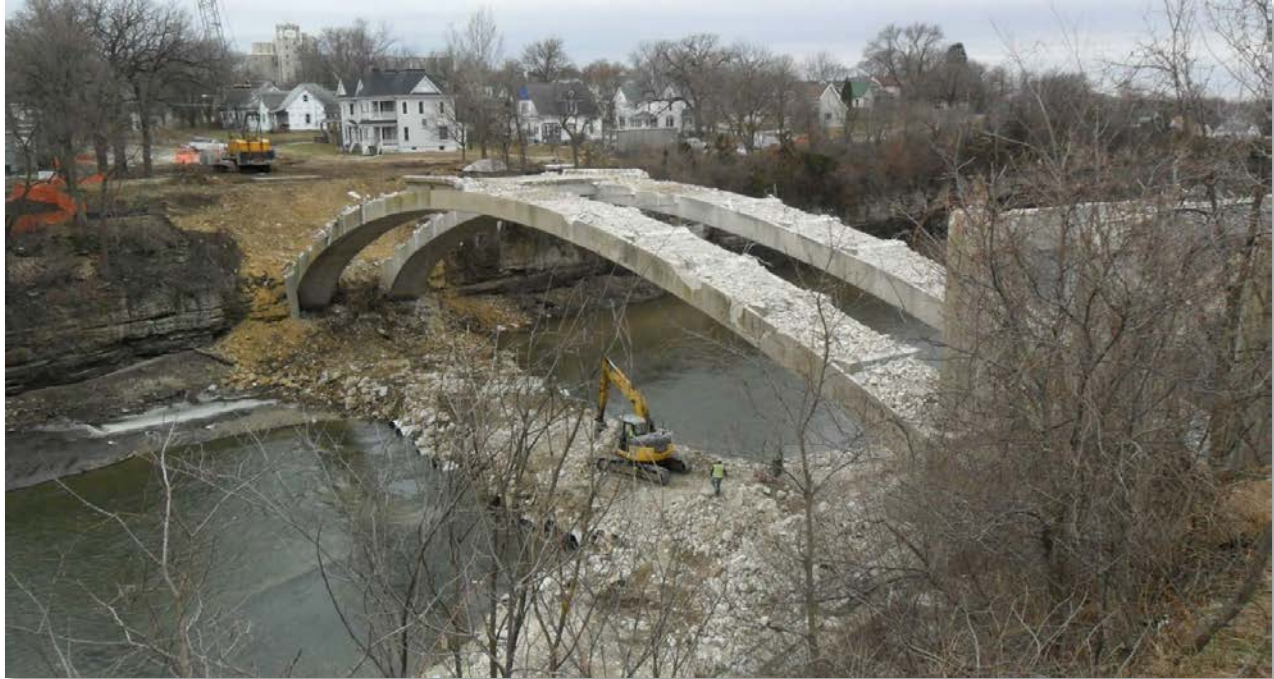
Actual Demolition

- » Constructed a System to Protect the Sanitary Sewer Lines
- » Demolished the Bridge using the Causeway
- » Deck and Columns were Demolished using two Excavators with Hydraulic Breakers
- » Each excavator started at the Center of the Bridge

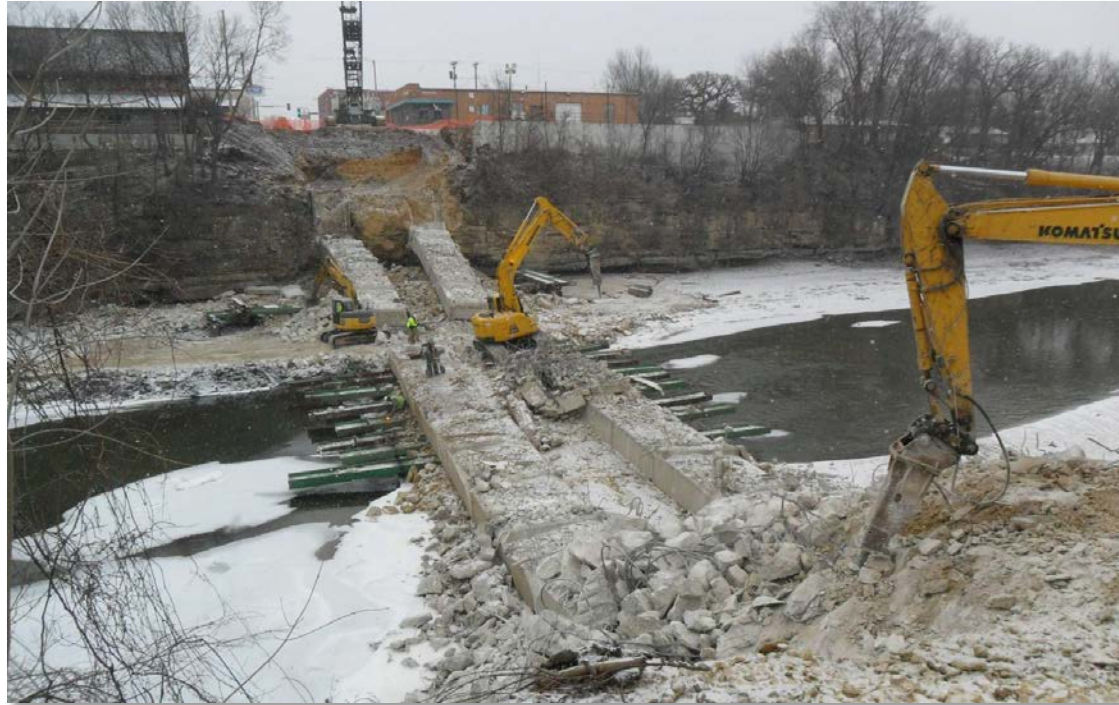
Actual Demolition

- » Demolished the Arches Using the same Excavators with a Mounted Hammer
- » Arch Pieces were Broken Down and Hauled Off-Site by Truck
- » Vibration Monitoring was Provided at the Adjacent Church and Residences

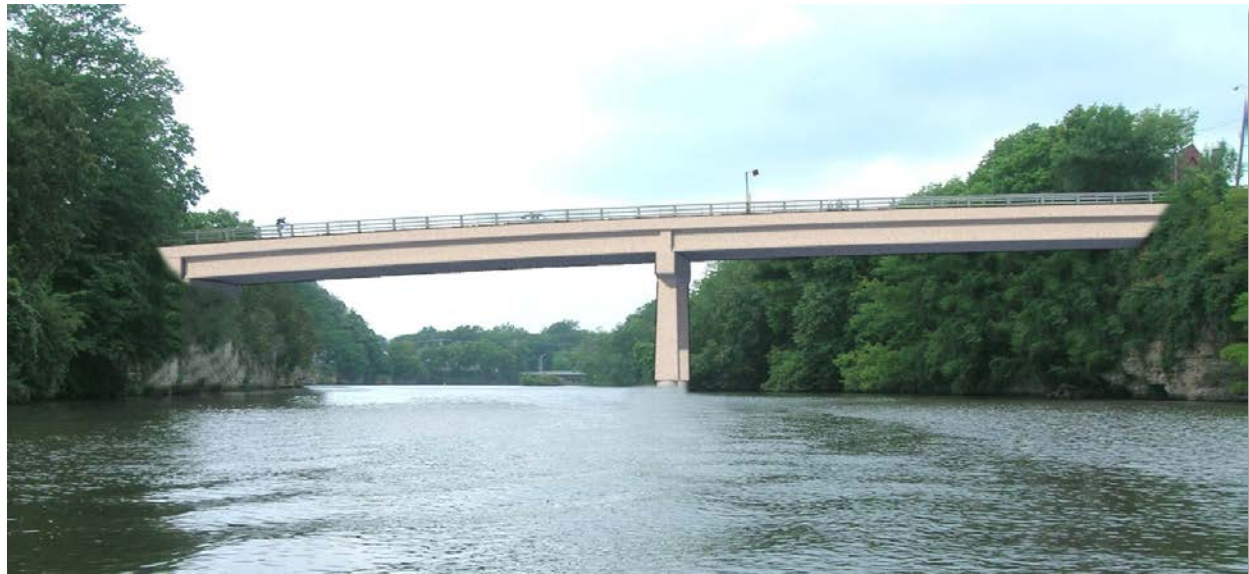
Two Span Prestressed Concrete Alternative

- » Easiest to Construct
- » Drilled Shaft at Pier Eliminates Need for Cofferdam
- » Drilled Shaft at Abutments Reduces Vibration Impacts
- » Less Rock Excavation than other Alternatives
- » Most Economical Option

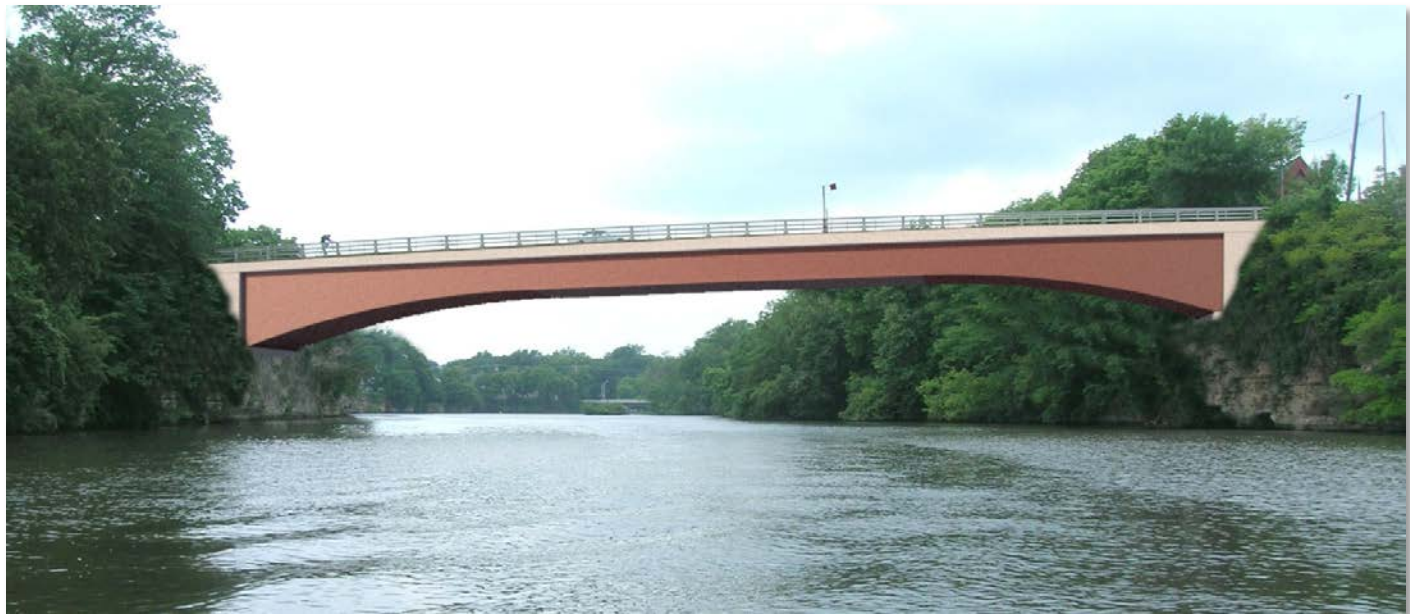
Simple Span Haunched Girder Alternative

- » Non-conventional Super Type
- » Heavy Girder Pieces
- » Require Temporary Bents or Falsework
- » Substantial Rock Excavation
- » Require Lead Time for Fabrication

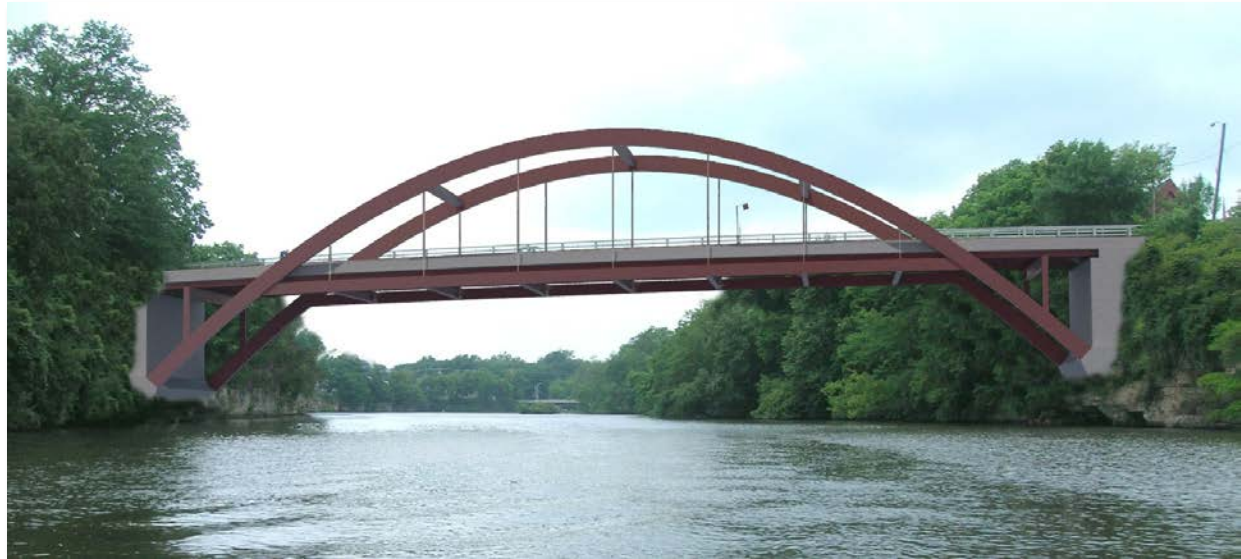
Partial Thru Steel Arch Alternative

- » Easier to Construct Relative to Concrete Arch
- » Shorter Construction Period than Concrete Arch
- » Require Temporary Bents, Falsework or Tied-Back Systems to Construct
- » Additional Inspection and Maintenance of Suspenders
- » Requires Construction Engineering

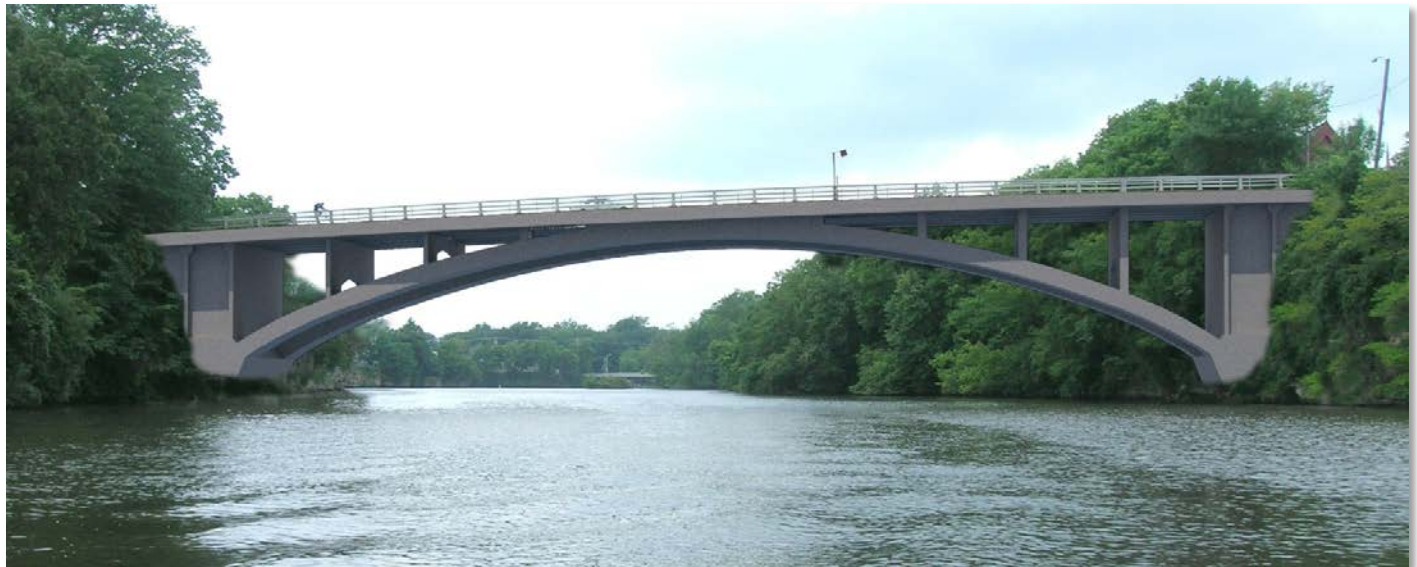
Concrete Deck Arch Alternative

- » Most Difficult/Complex to Construct
- » Rib Shortening Issues
- » Requires Temporary Bents or Falsework or Tied- Back Systems
- » Longest Construction Period
- » Requires Construction Engineering

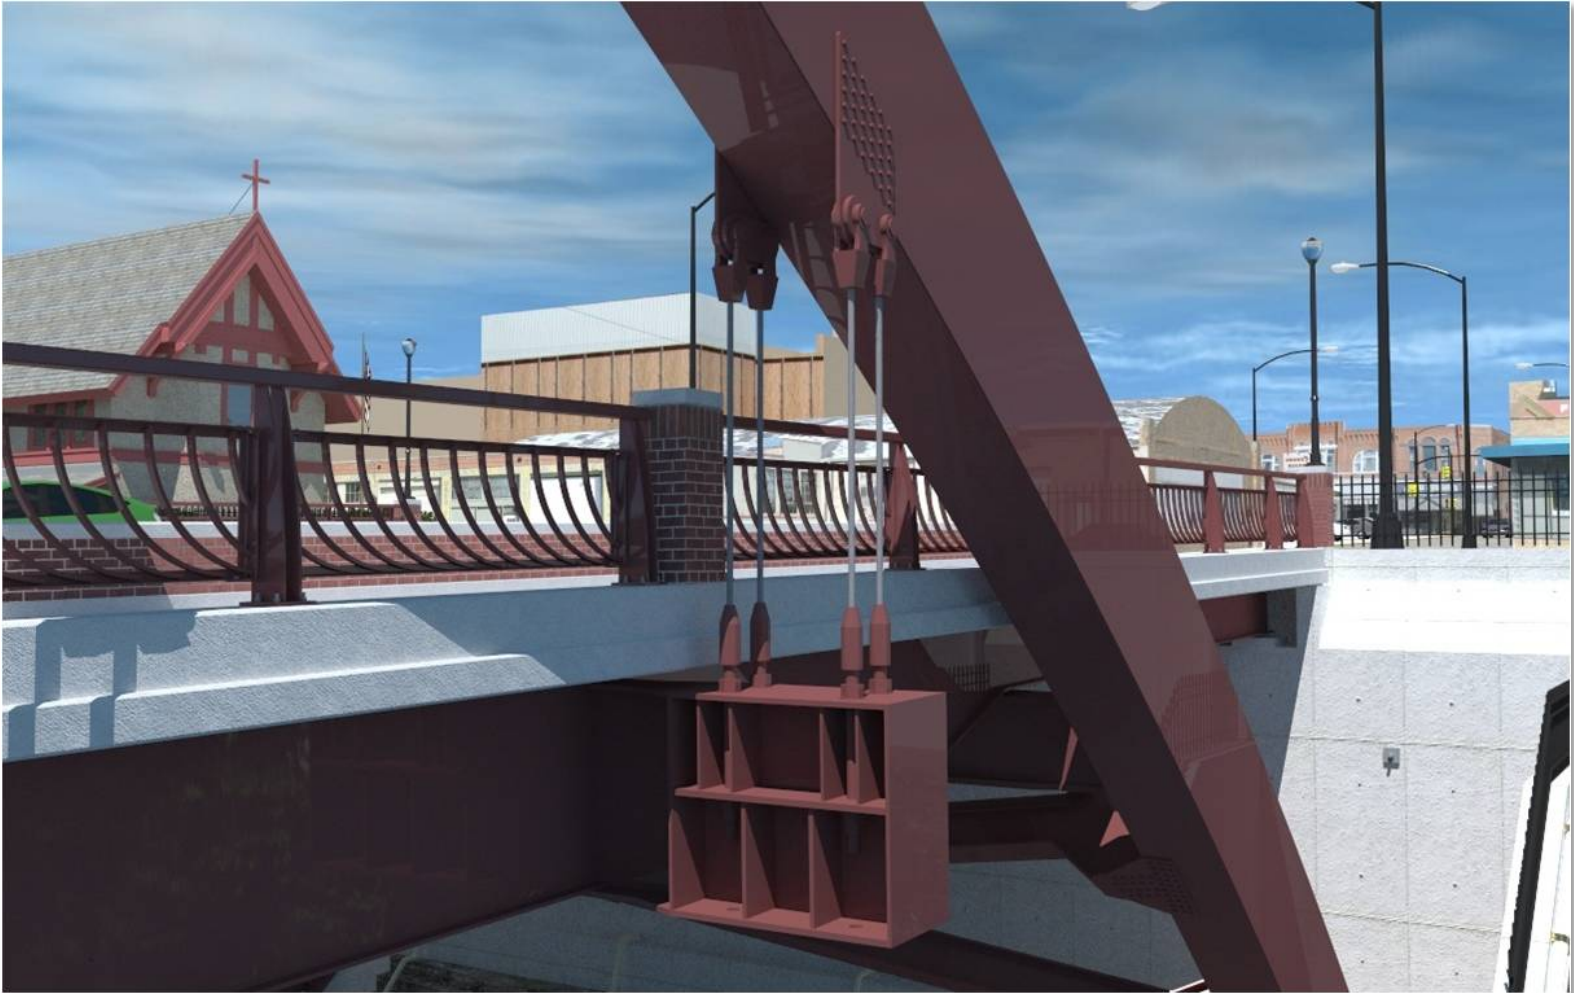
Interior Floor Beam and Hangers

- » Floor Beam and Stinger system suspended from the Arch Rib
- » End Floor Beams frame directly into the Arch Rib
- » Deepened Exterior Stringer / Stiffening Girder
 - Distributes vehicular loads from deck to multiple hanger cables
 - Minimize local live load deflections

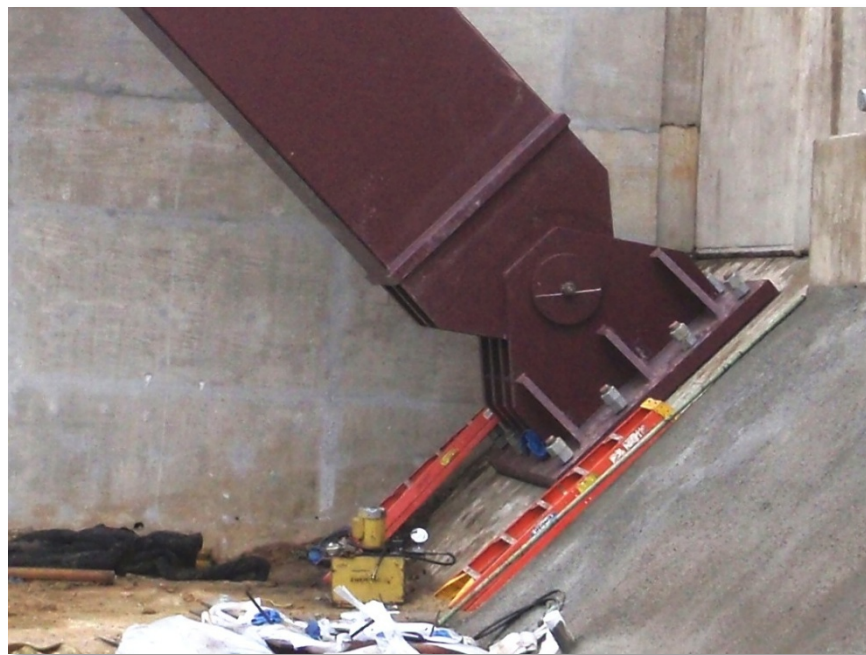
Pinned Bearings

- » Net Zero Change in Steel Weight from a Fixed Connection
- » Reduced Footing Size
- » Minimized Impacts to Surrounding Properties

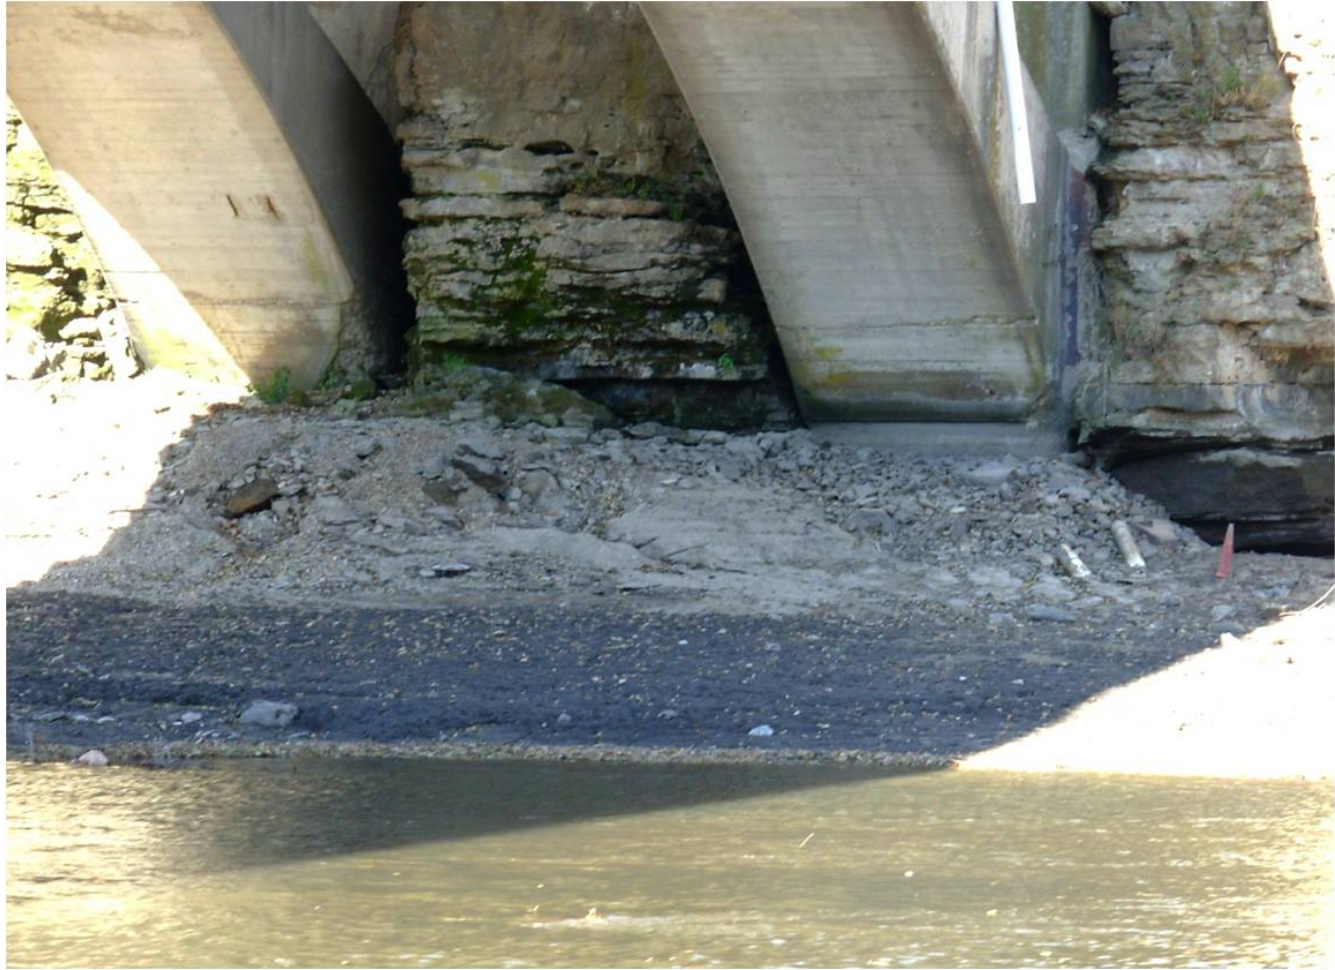
» Existing Bridge Undermining

- » Issues:
 - Existing Bridge Showed Signs of Undermining
 - Arch Skew Back Behave Differently than the Retaining Wall Abutment.

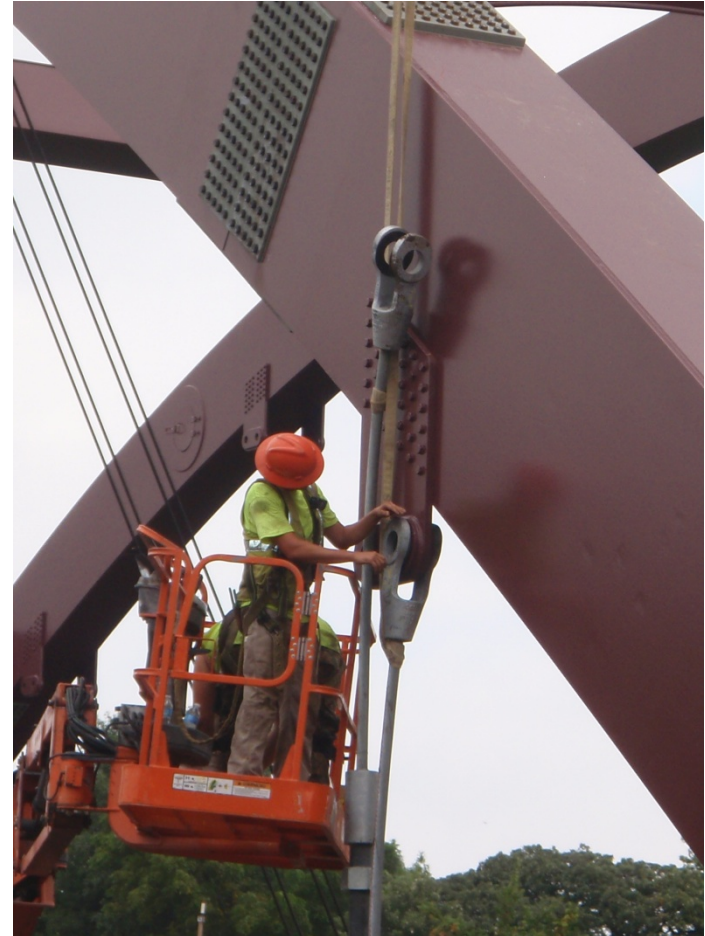
Pin and Hanger Steel Tolerances

- » Construction tolerance issues during fabrication of the Pins and Hangers:
 - ASHTO 6.8.7.3
 - Requirement: 0.031”
- » Maximum Difference
- » As Fabricated
- » Pin to Pin Plate: 0.04”
- » Pin to Socket: 0.14”

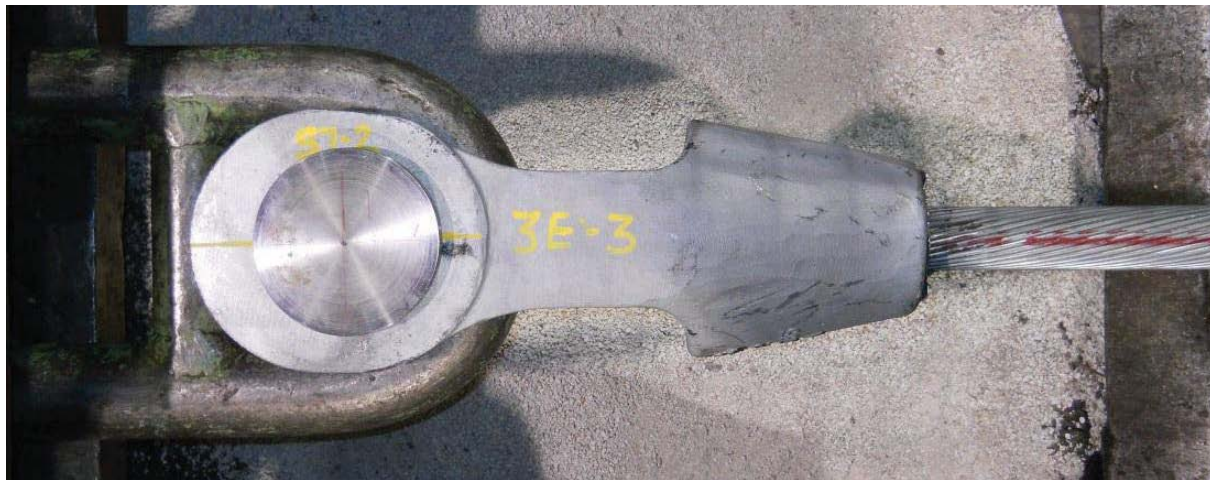
Pin and Hanger Steel Tolerances

- » Resolution – Perform additional tests on the Pin to Socket connection to quantify permanent deformation under load.
 - 55% Proof load – No permanent deformation allowed as measured to nearest 0.001”
 - Contractor also tested two connections to 100% load

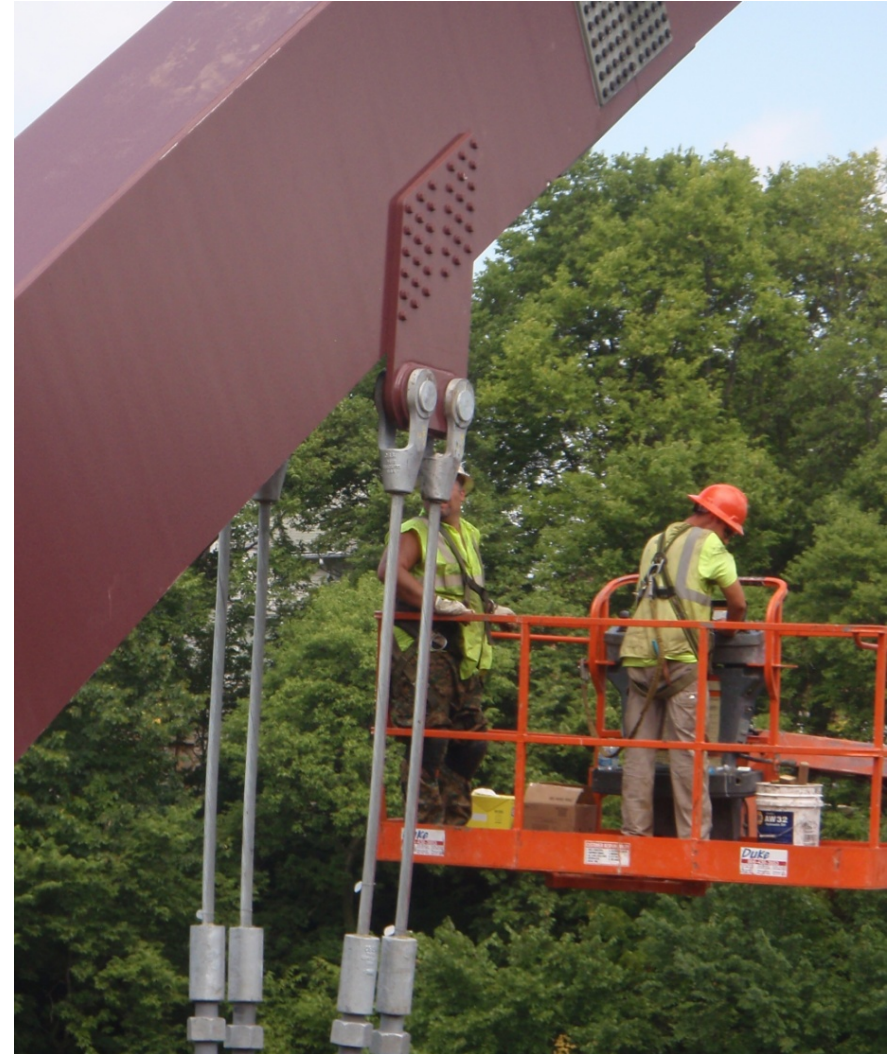
Pin and Hanger Steel Tolerances

- » Observed Deformations
 - Proof load = 0.00"
 - 100% load = 0.04"

- » Contractor was allowed to use the pins and sockets as fabricated.

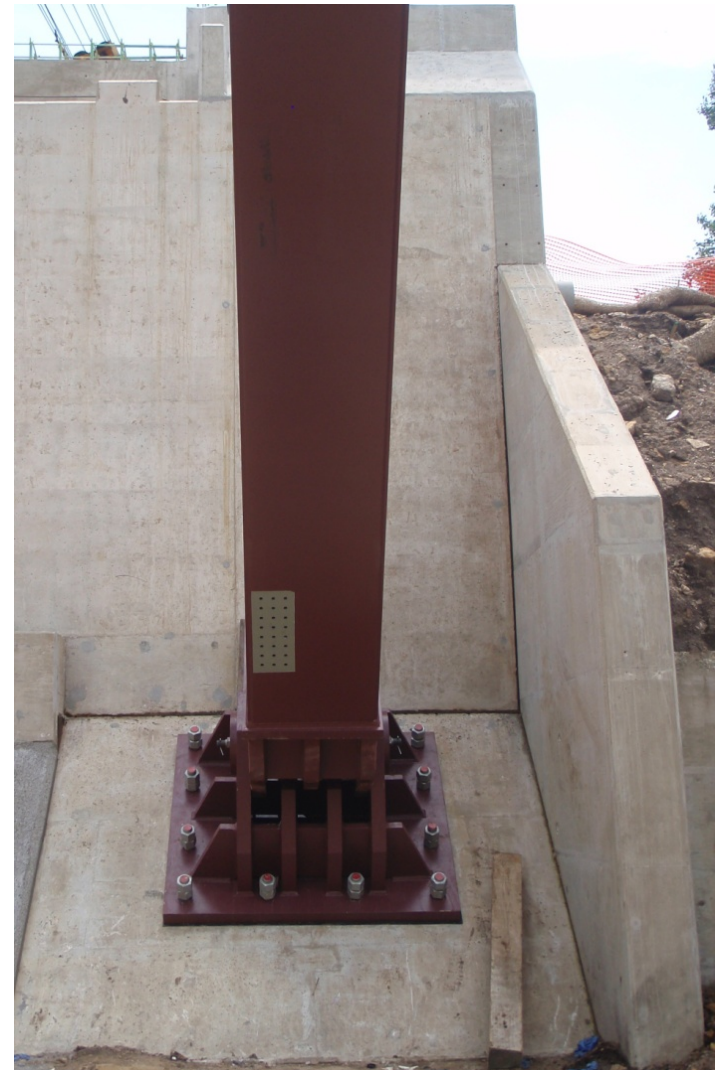
Fabricated Bearing Tolerances

- » Bearing Side Plates
 - Warped out of tolerance
 - Would not allow upper unit to fit with the lower unit
- » Masonry Plate
 - Curved upward on the edges
 - Would not allow full bearing on the concrete skew back

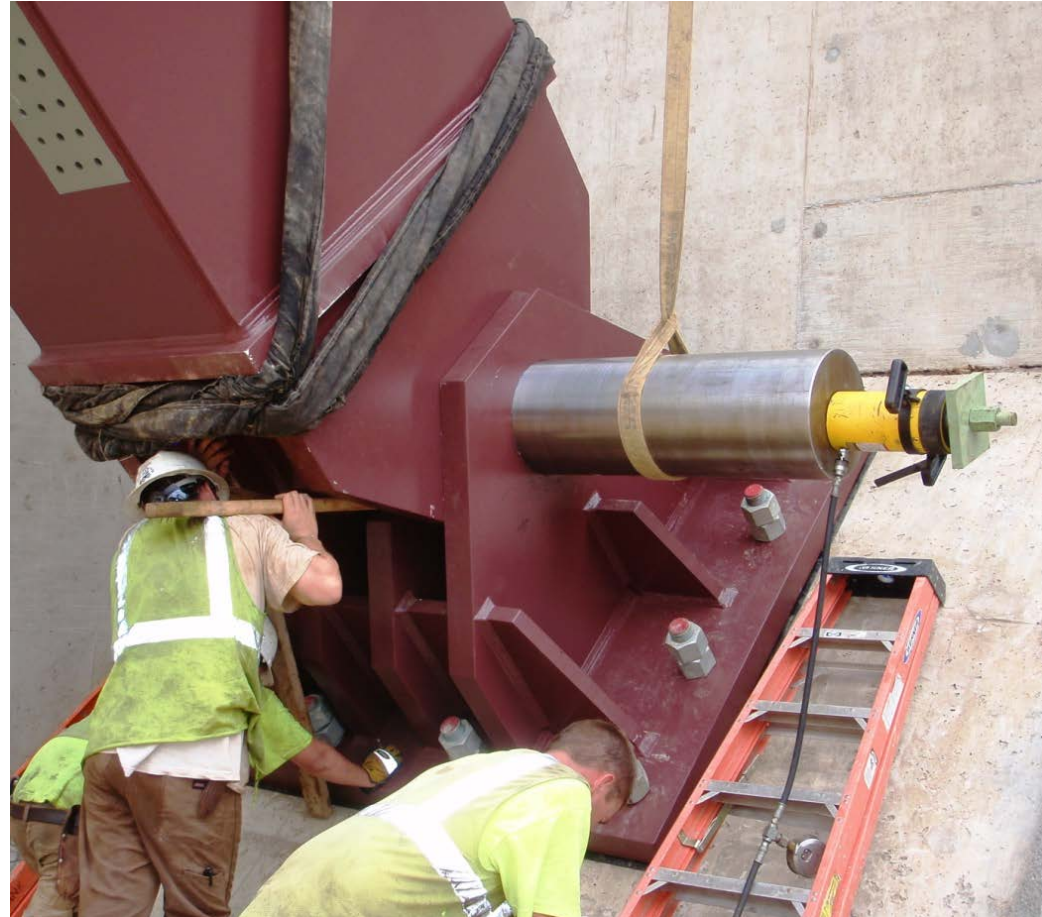
Fabricated Bearing Tolerances

- » Bearing Side Plates
 - Total conflict 1/4"
 - Fabricator milled 1/8" from upper and lower units
 - Difference was evaluated and deemed acceptable
 - Complicated fit

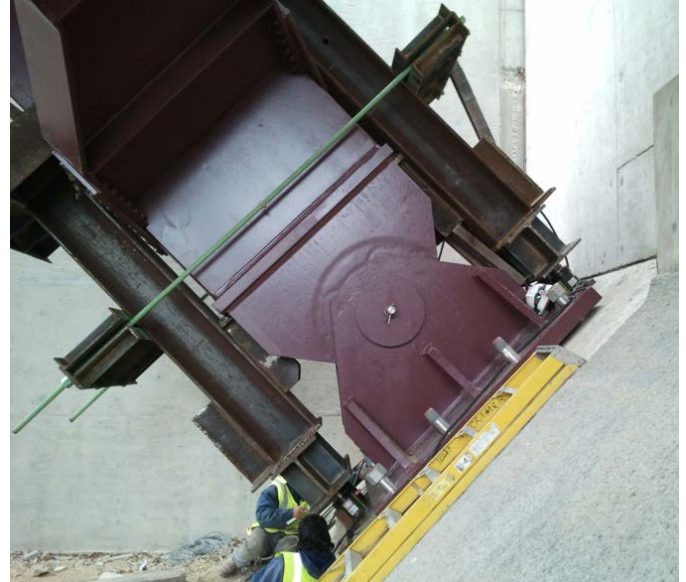
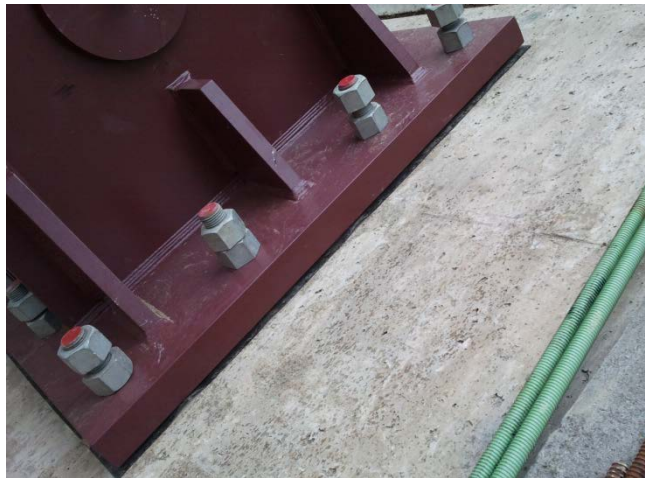
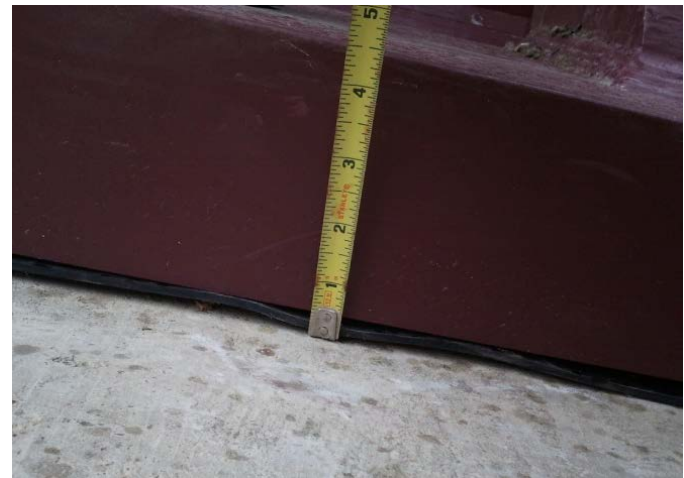
Fabricated Bearing Tolerances

- » Masonry Plate
 - Maximum gap of 3/4" at the edge
 - Steel erection allowed to proceed
 - Jacked and grouted prior to pouring the concrete deck
