2013 WESTERN BRIDGE ENGINEERS' SEMINAR

Innovative Methods for Inspection of Cable-Stayed Highway Bridges, Old and New

Introduction

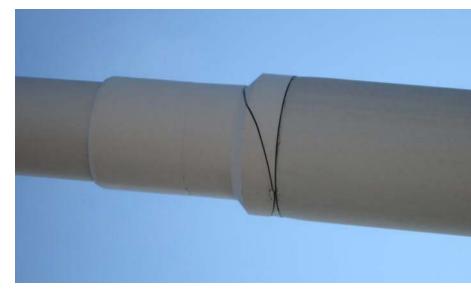
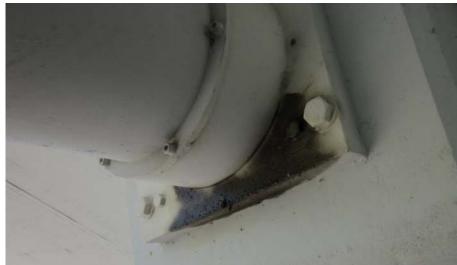
Preliminary Inspection

- Overall visual inspection
 - Anchorages
 - Limited Cable Free Length
 - Other potential Problem Areas
- Limited special access
- IDENTIFY PROBLEM AREAS

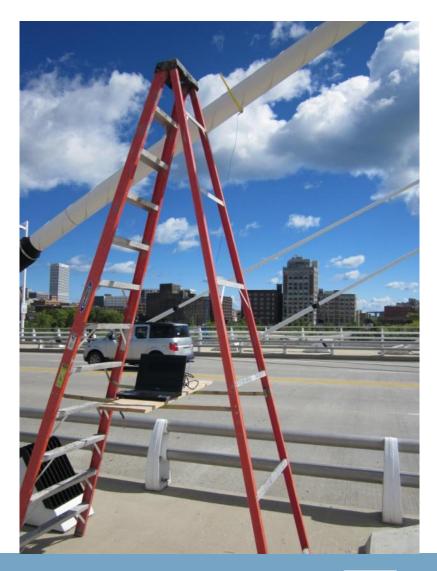
Force and Damping Measurements

- Background
 - Measure Transverse Vibrations
 - Accelerometer
 - Laser Vibrometer
 - Calculate
 Force/Damping
 - Compare to previous measurement / theoretical data

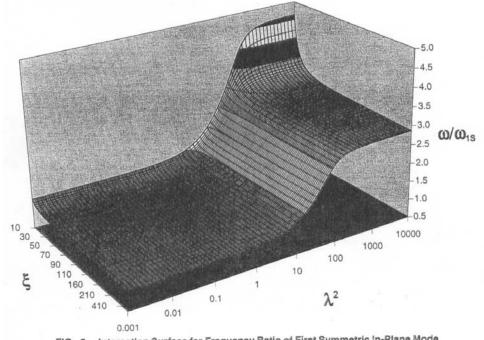
FIG. 5. Interaction Surface for Frequency Ratio of First Symmetric In-Plane Mode

Parametric Study

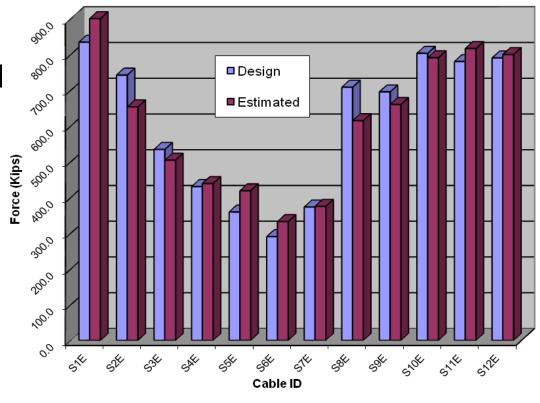
Comparison of Measured Forces

Original Design Forces

- Forces from Analytical Model
- Historical or Baseline Data

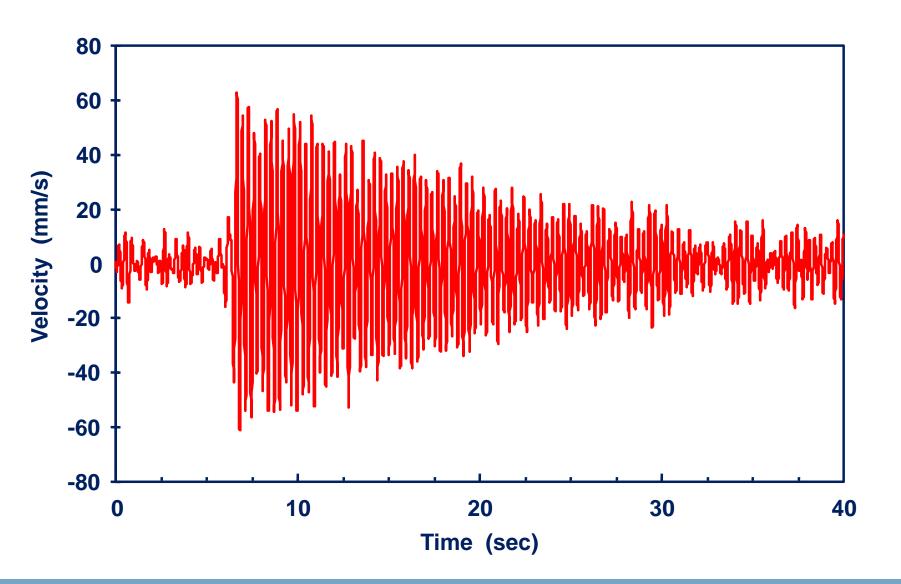
Damping Measurements

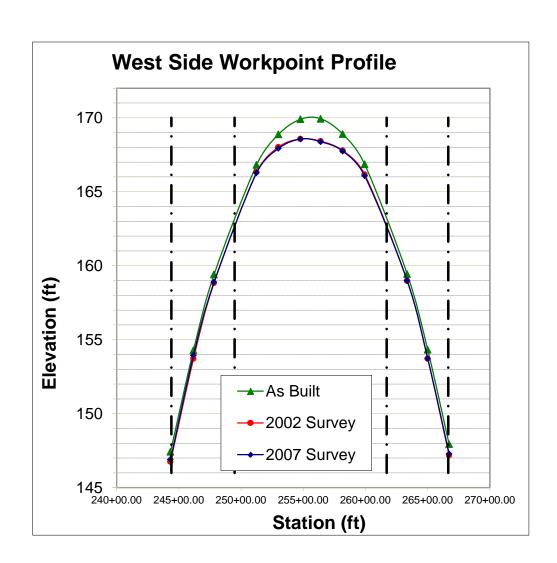
Geometry Measurements

- Survey Data
 - Profile Survey
 - Compare to baseline or as-built data
 - Account for
 - Thermal
 - Prestress Losses
 - Creep

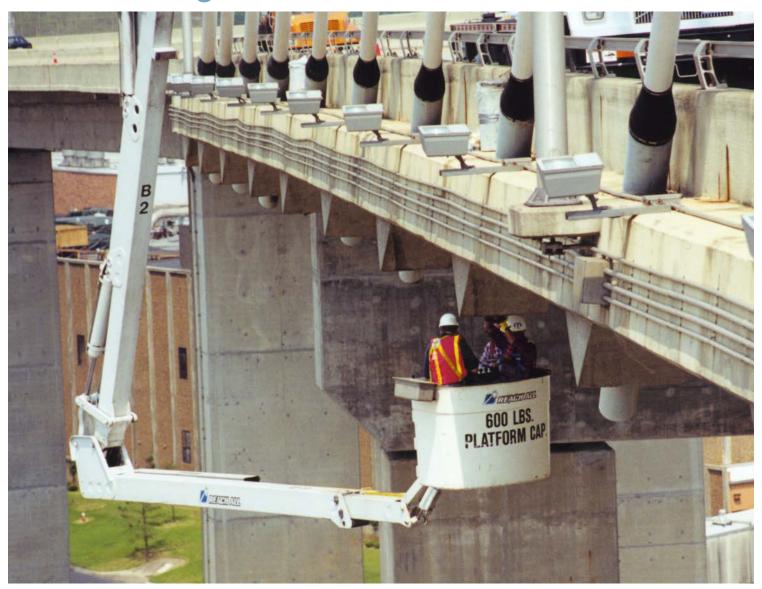
- Visual
 - Grease / Grout Fill
 - Excessive leakage

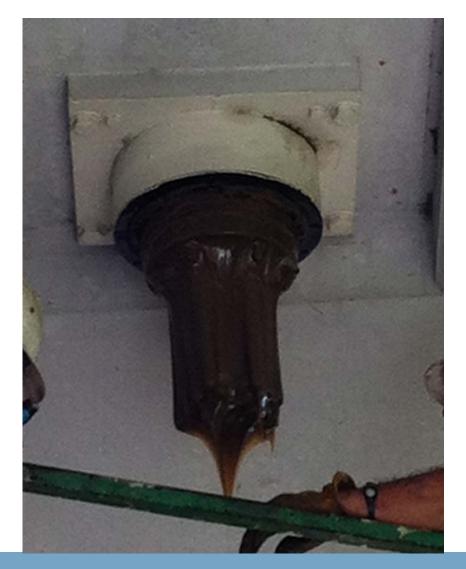
- Visual
 - Water Leakage,
 Internal and External

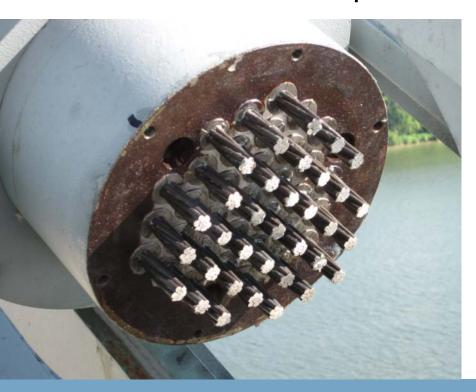
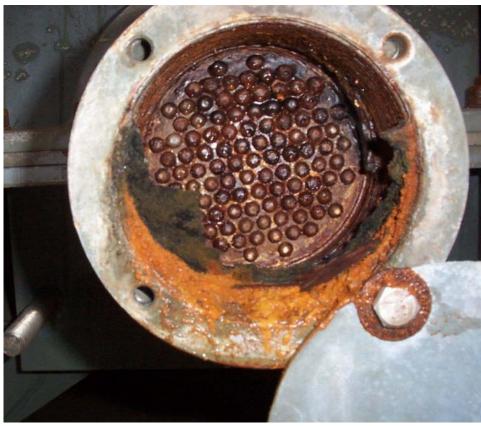
- Visual
 - Corrosion within Anchorage sockets or beneath Caps

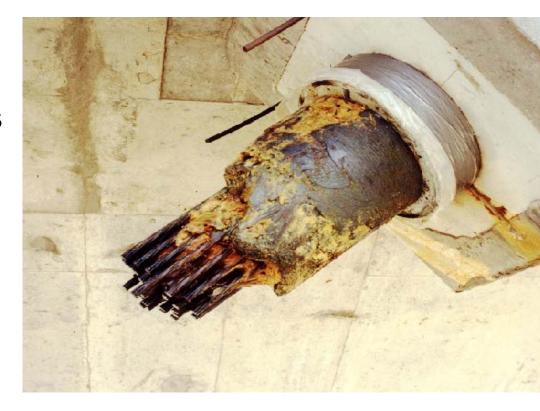
- Visual
 - Corrosion within Anchorage sockets or beneath Caps

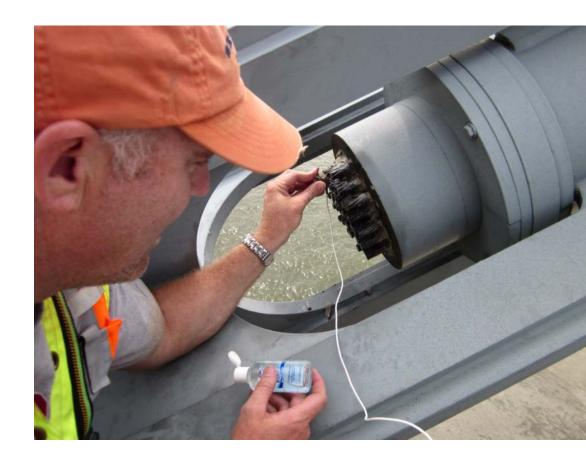
- NDT
 - Ultrasonic
 Pulse-Echo
 (UTPE)
 - Strand damage in Anchorage Zone

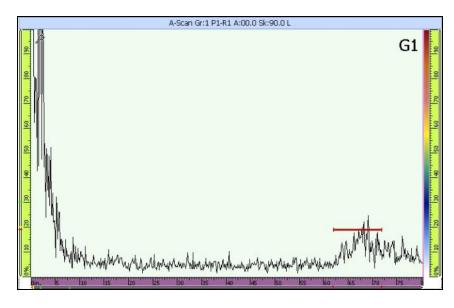
UTPE Typical Results

Field

Calibration

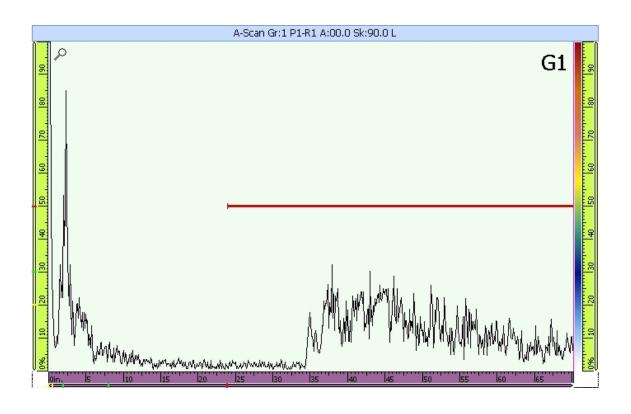
UTPE Fractures

Calibration Strand with Fracture at 37-in

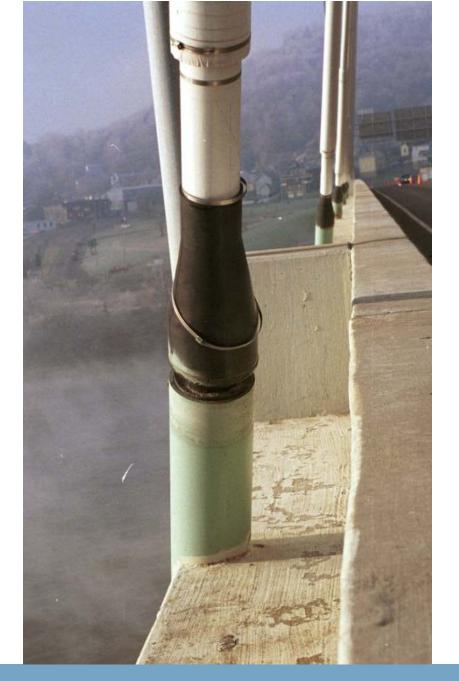
- Visual
 - Damaged Guide Pipes
 - Missing Clamps

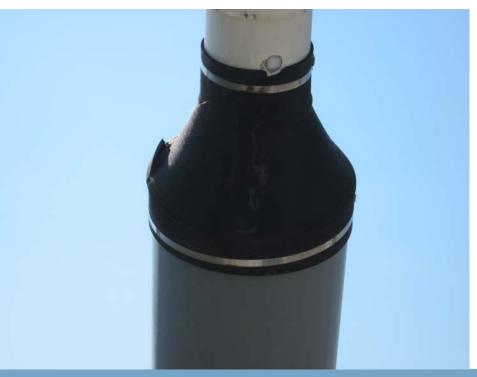
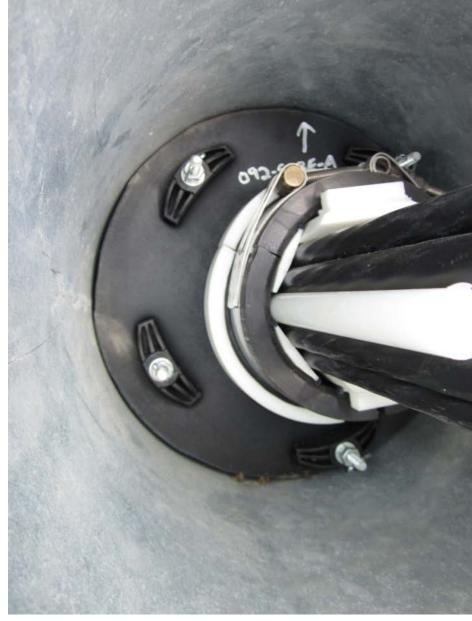
- Visual
 - Damaged Boots
 - Misaligned cables

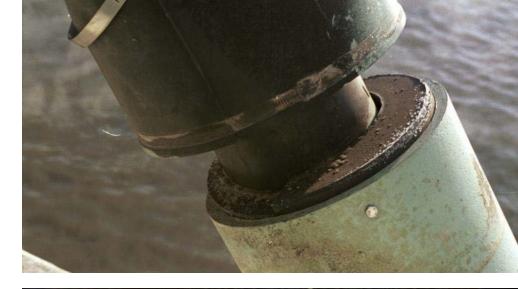
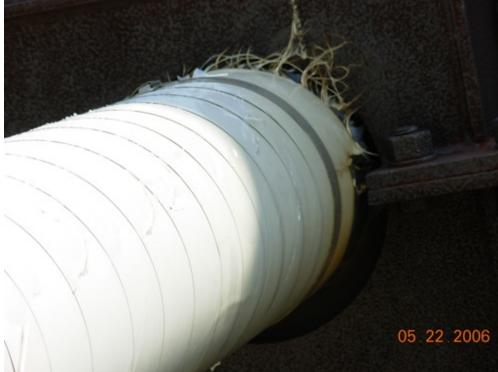
- Visual
 - Damage to
 Neoprene rings
 - Damage to cable sheathing
 - Vibration damage

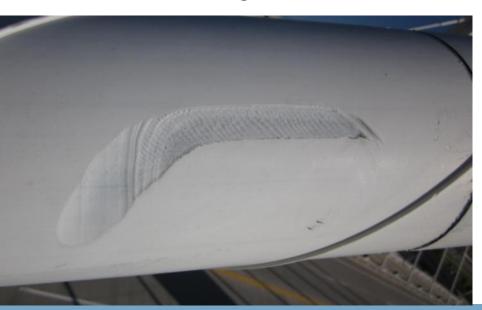
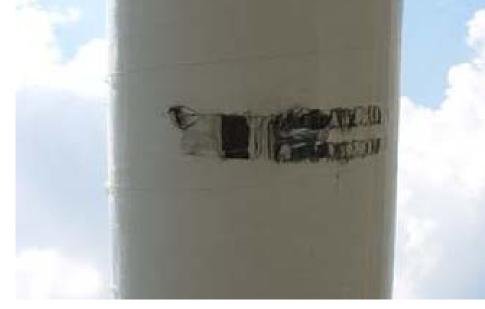
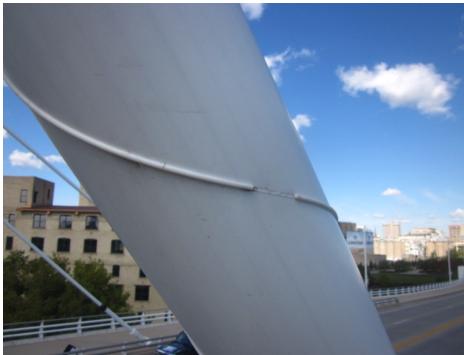
- Visual
 - Damage to UV
 Protection Layer
 - Damage to Helical Spiral
 - Damage to HDPE

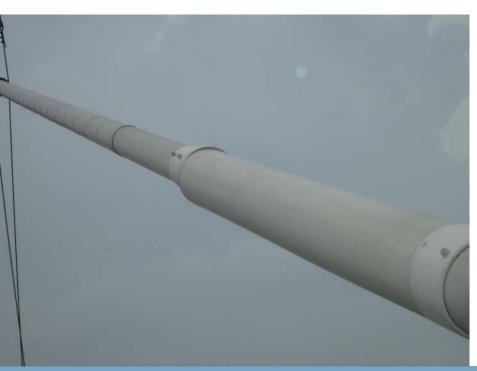
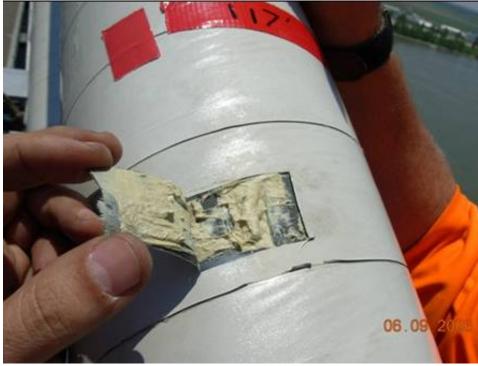
- Visual
 - Cracks / Splits in Sheathing Pipes

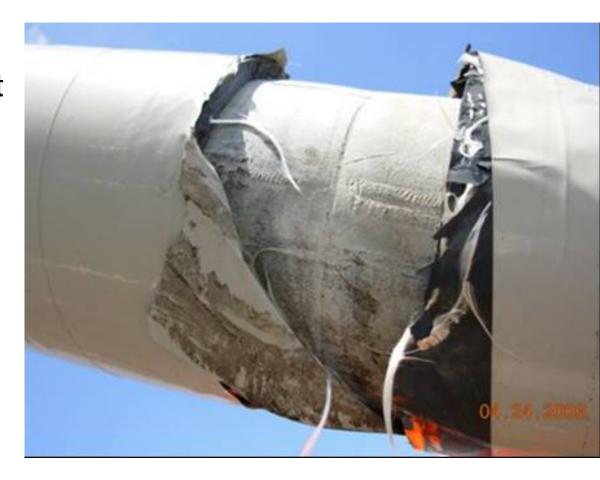
- Visual
 - Exposed Grout

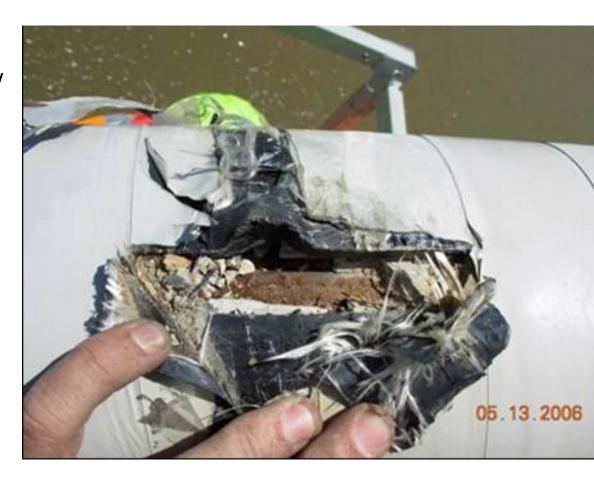
- Visual
 - MTE Exposed / Corroded

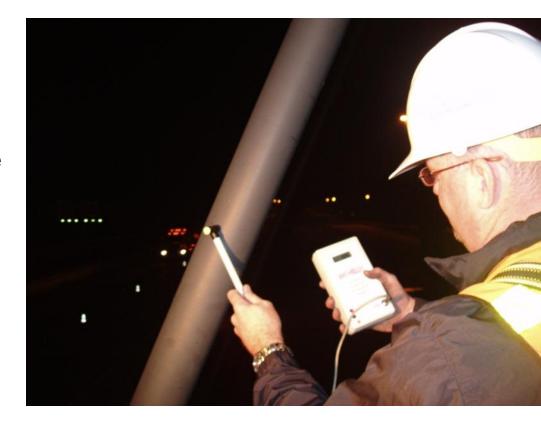
- NDT
 - Sounding / Tap Testing
 - Sheathing Damage
 - Grout Voids

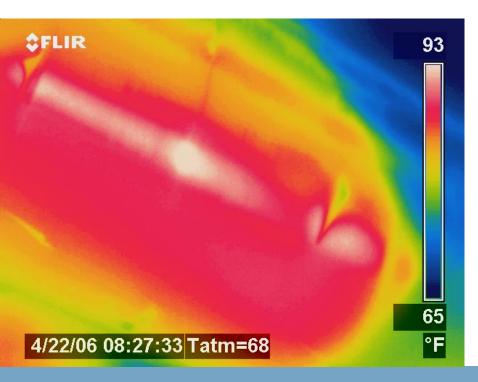
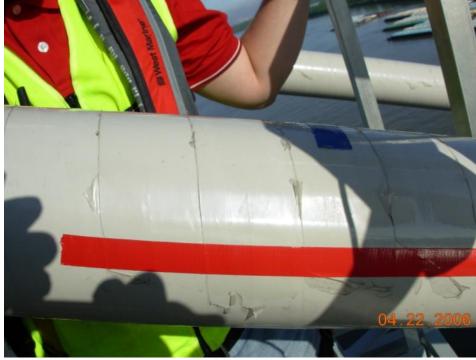
- NDT
 - Infrared Thermography

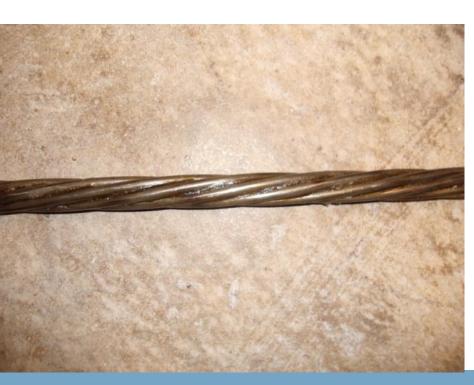
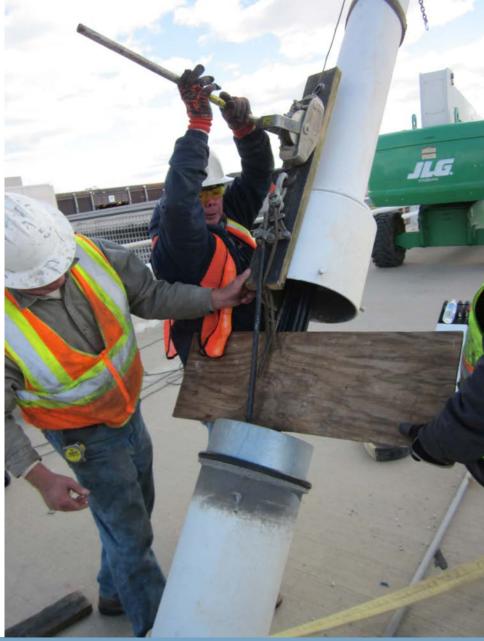
- Material Sampling and Testing
 - Reference Strands

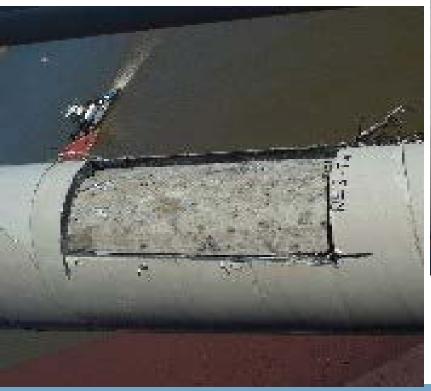
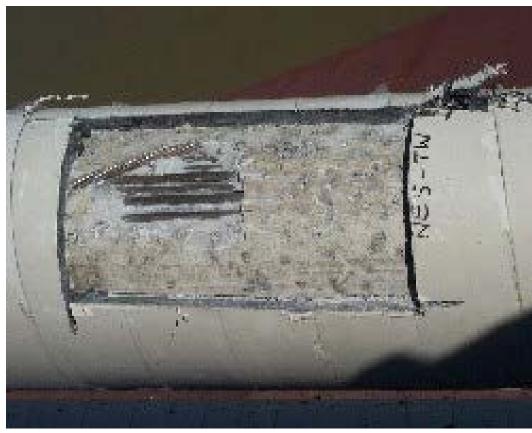
- Material Sampling and Testing
 - Grout windows

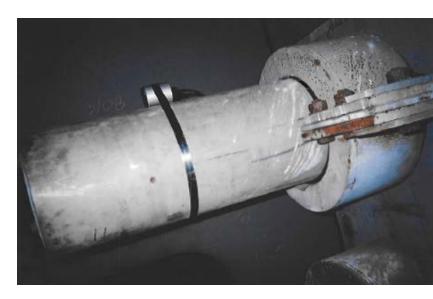
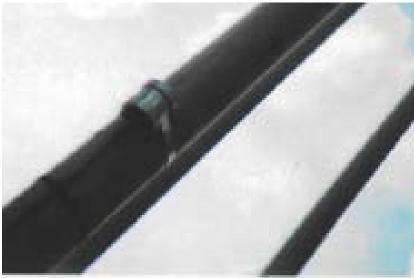
Health Monitoring

- Wire Break Detection
 - Permanent acoustic sensor
 - Real time detection of wire breaks
 - Web interface
