Boeing North Bridge in Washington State

Western Bridge Engineers Seminar September 2015

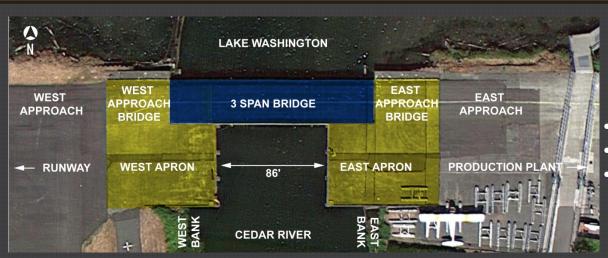
1940 Construction
1969 Construction

- Bridge Seismically Deficient
- Bridge is on critical path for production
- Damage or loss poses economic risk

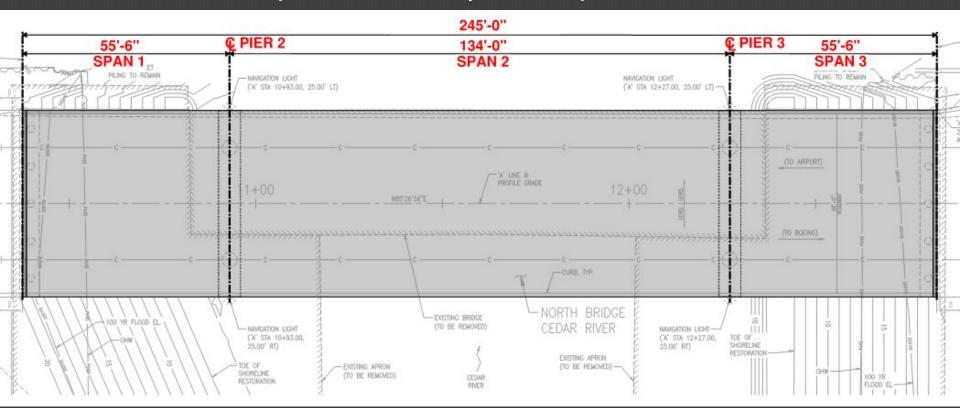
- 3-Span Continuous (245-feet total length)
 - Main Span: 134'-0" | End Spans: 55'-6"

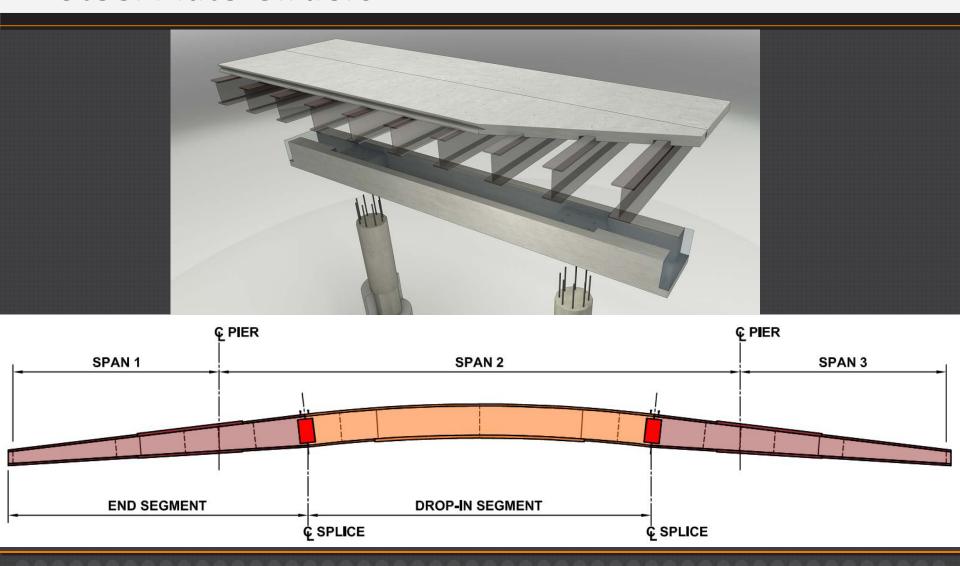
Project Overview – Replacement Bridge Steel Plate Girders

- Prefabricated Bridge Elements
 - Steel Plate Girders
 - Full depth precast deck panels
 - Columns and Crossbeams

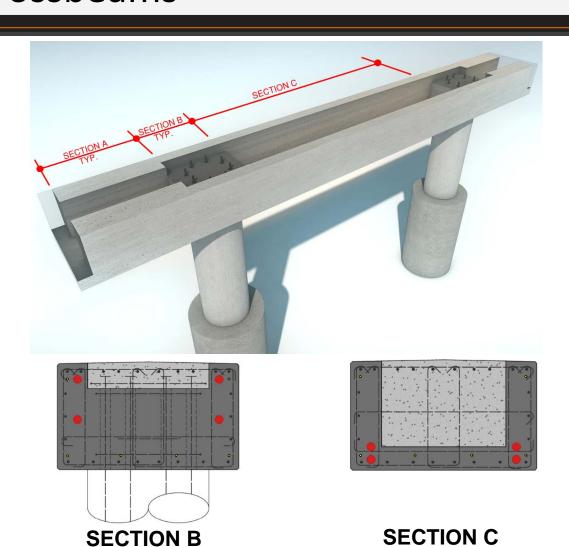
SECTION A

- -Straight
 Pre-tensioning
- -Draped
 Post-tensioning

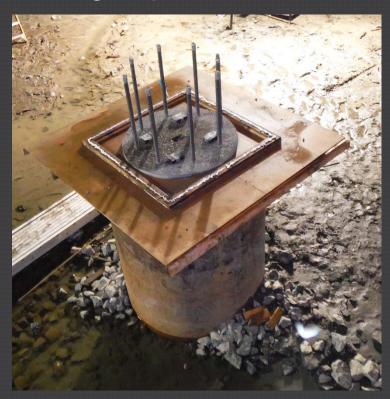
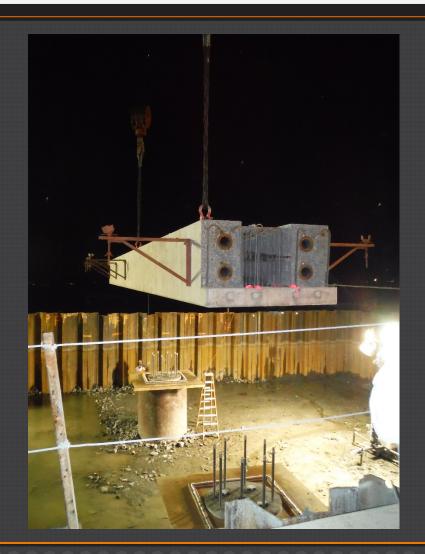
Safety Concern:
 Setting of precast crossbeam

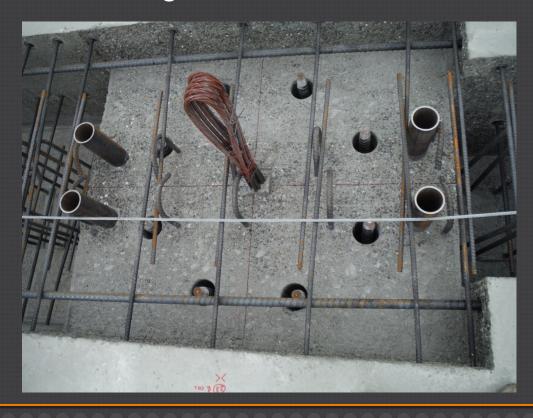
Quality Concern:
 Grouting, # Joints, Tolerances

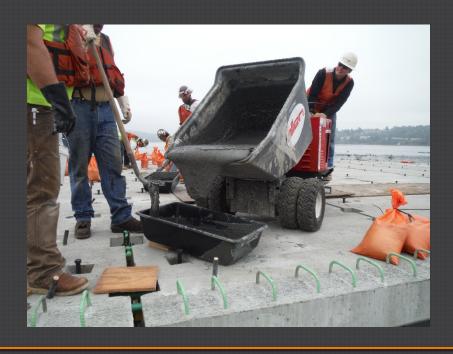
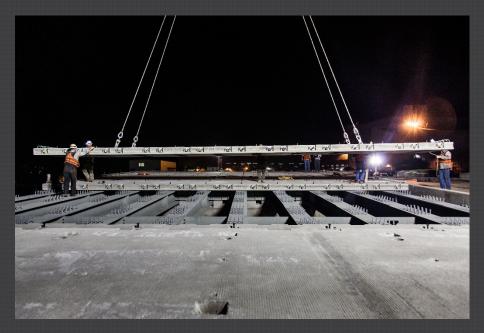
- Precast Deck Construction Details
 - UHPC (Ultra High Performance Concrete)
 - Girder Fabrication and Panel Erection
