Alexander Avenue Bridge Seismic Retrofit & Rehabilitation Project

CARLOS E RAMIREZ, P.E.
WSP | PARSONS BRINCKERHOFF

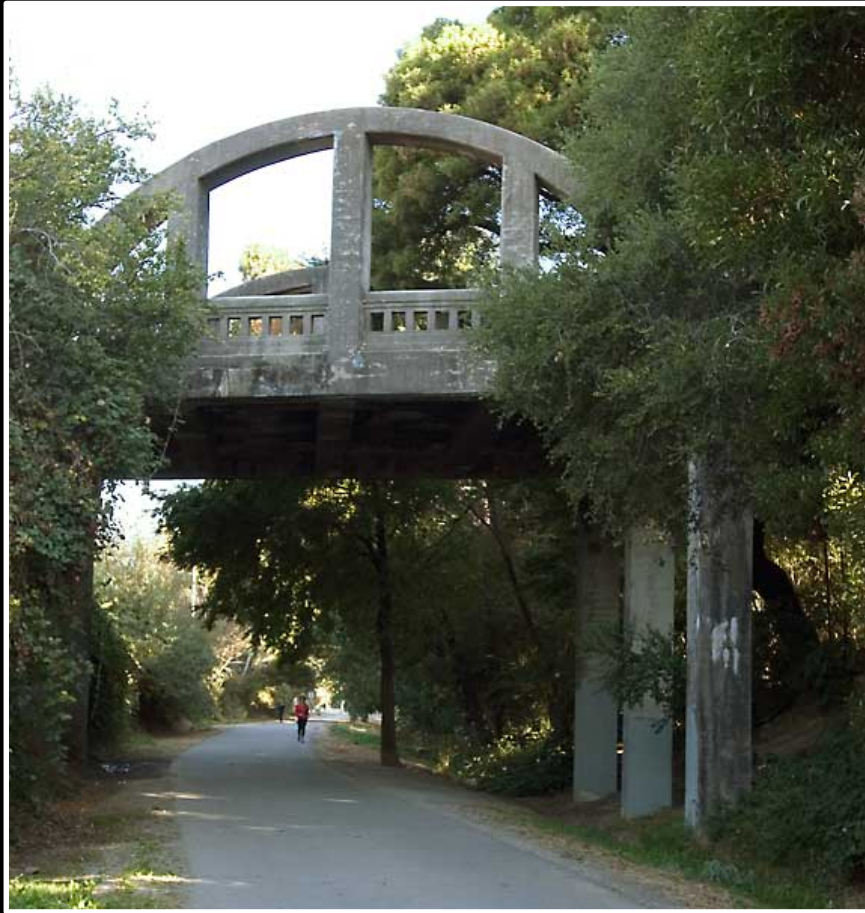
View of north side of arch span taken from bike path

- Built in 1925
- Designed to span the Railroad right-of-way
- Listed in National Registry of Historic Places in 1984
- Structurally & seismically deficient structure

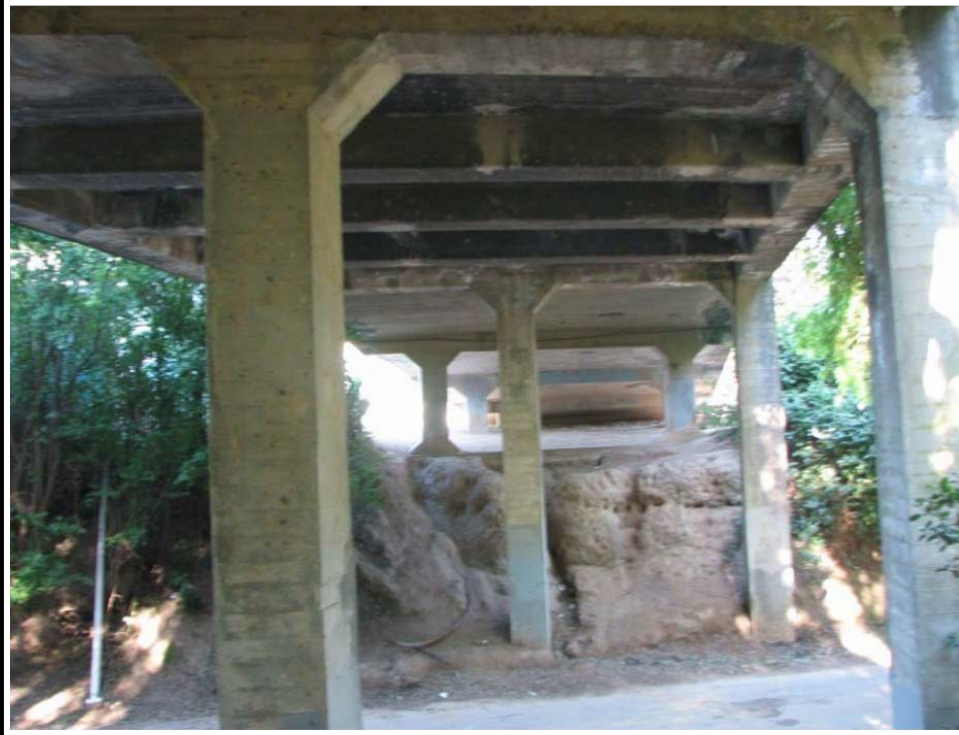
Underside of bridge taken from east side

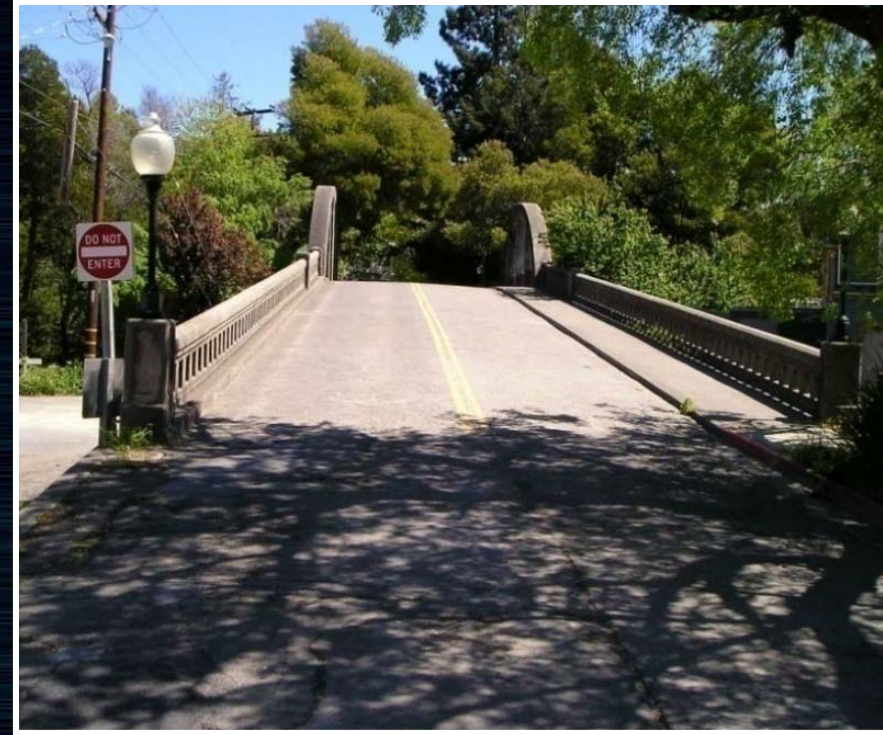
View of bridge approach deck taken from west side

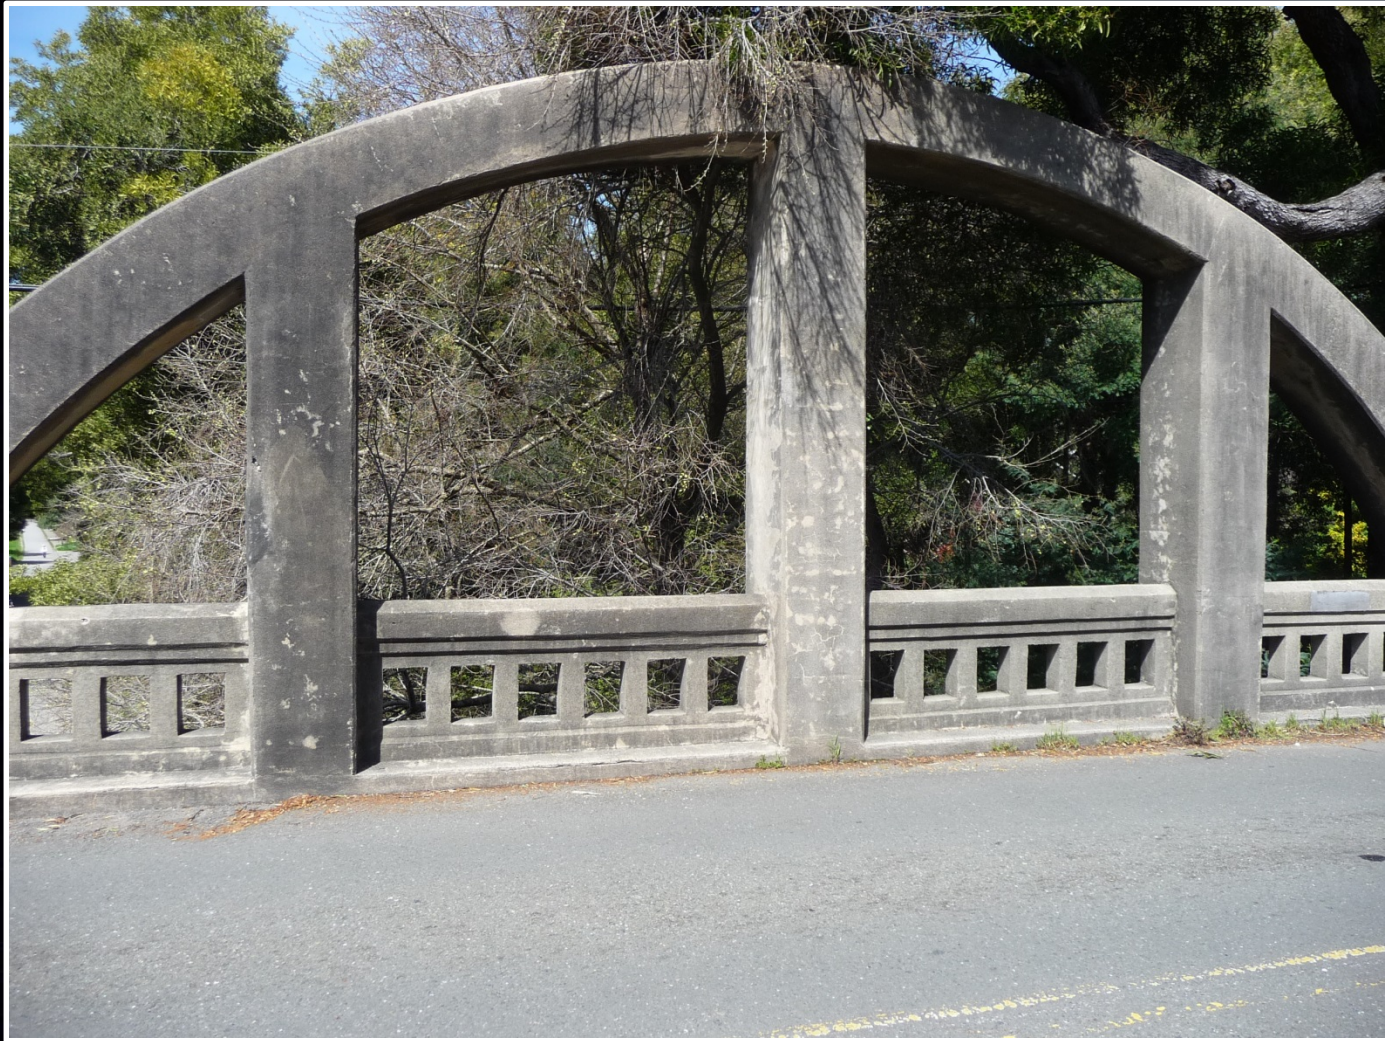
View of the south arch span taken from the westbound lane

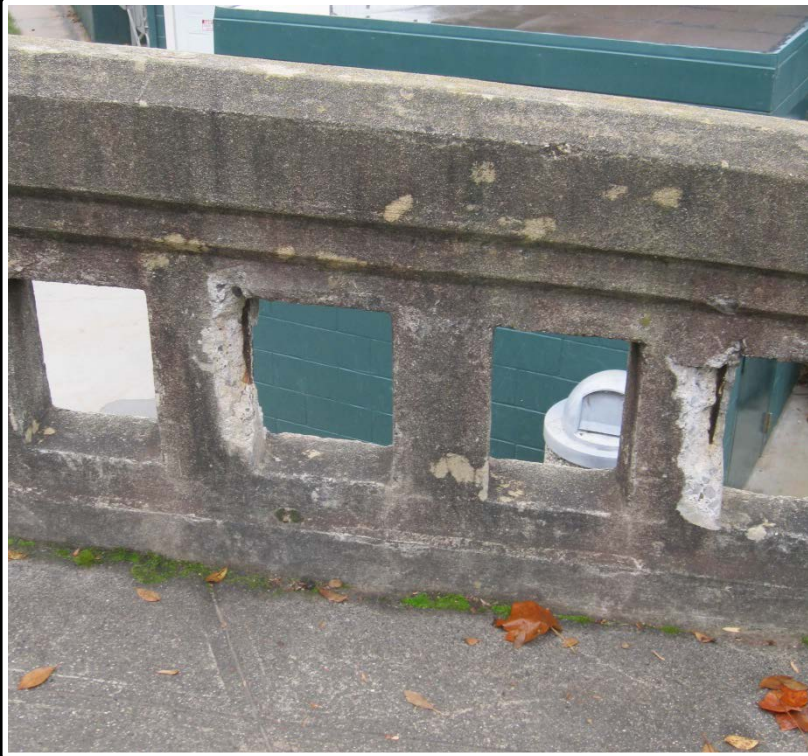
View the south railing

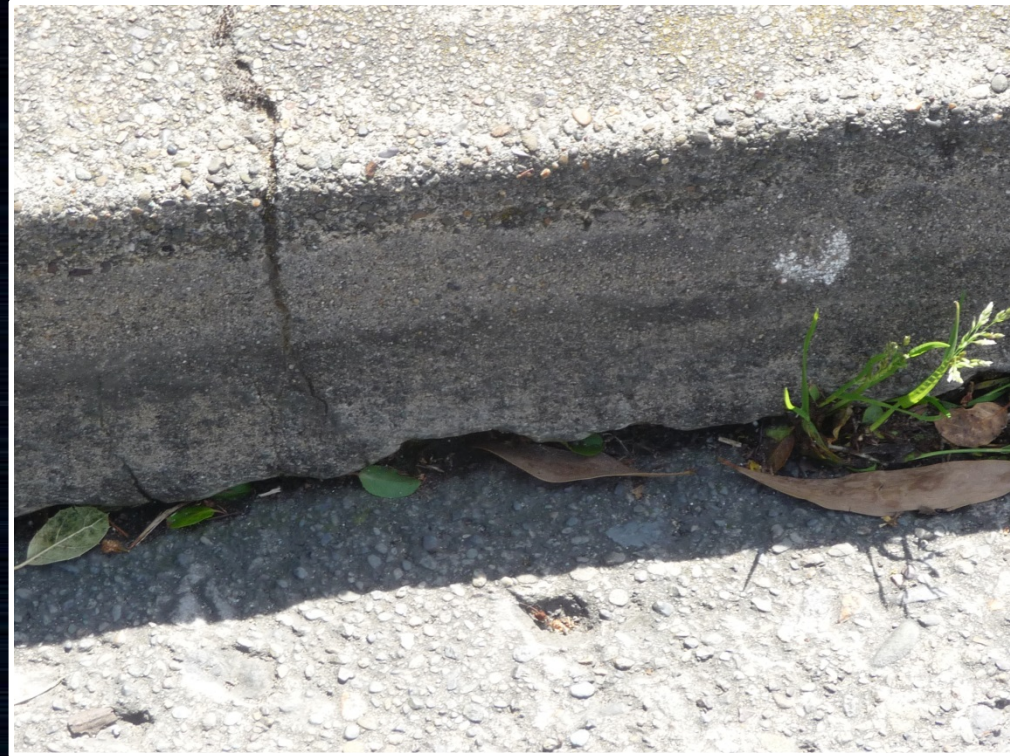
View sidewalk and deck

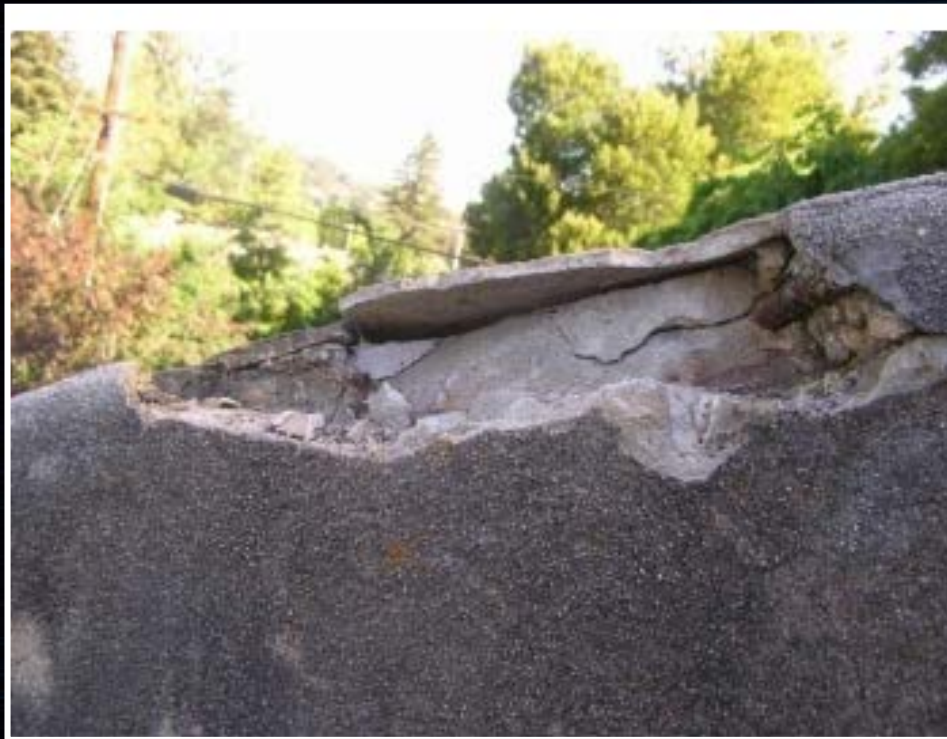
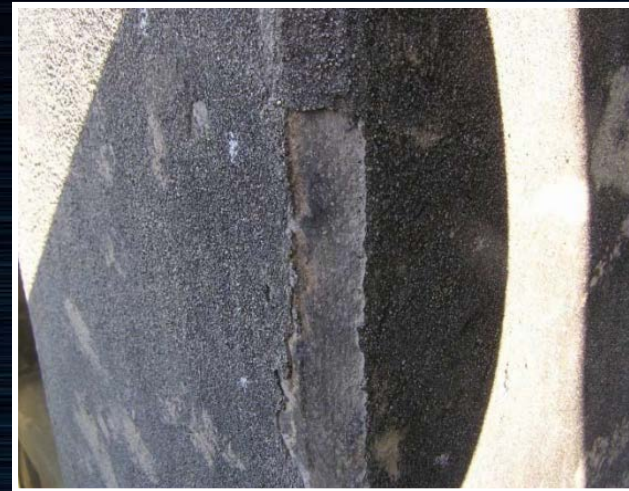
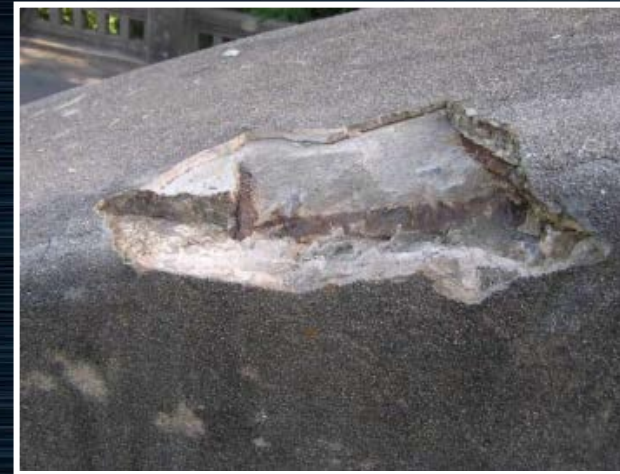
Delaminated Parge

1. Remove and repair delaminated concrete

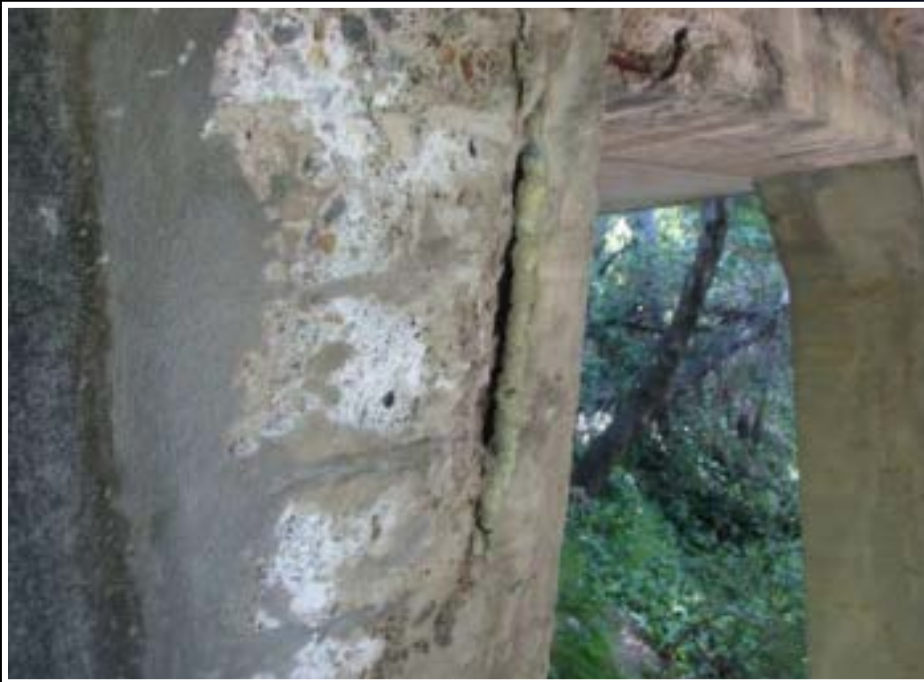
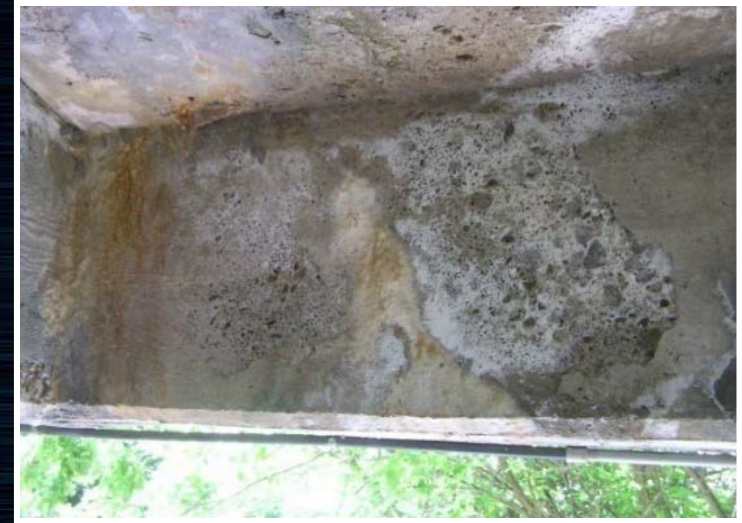
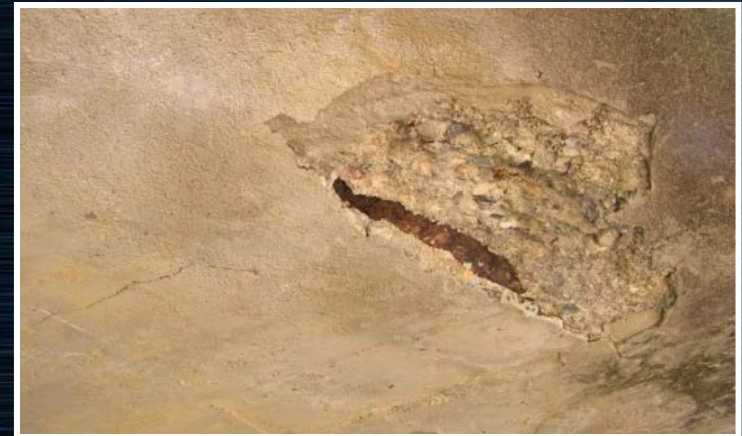
Concrete Spalls

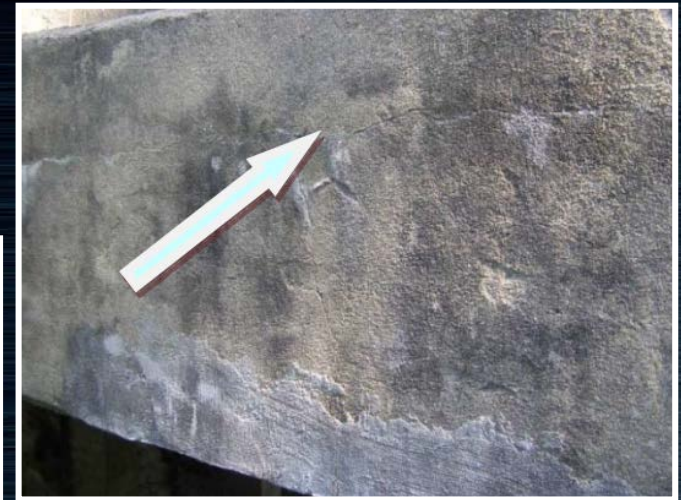
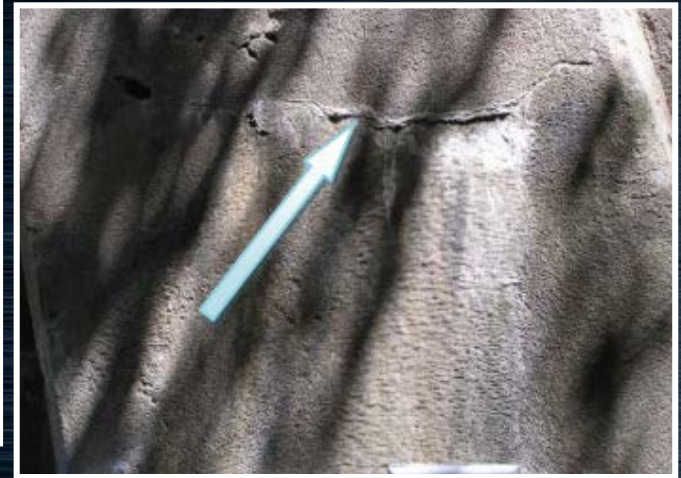
Cracking

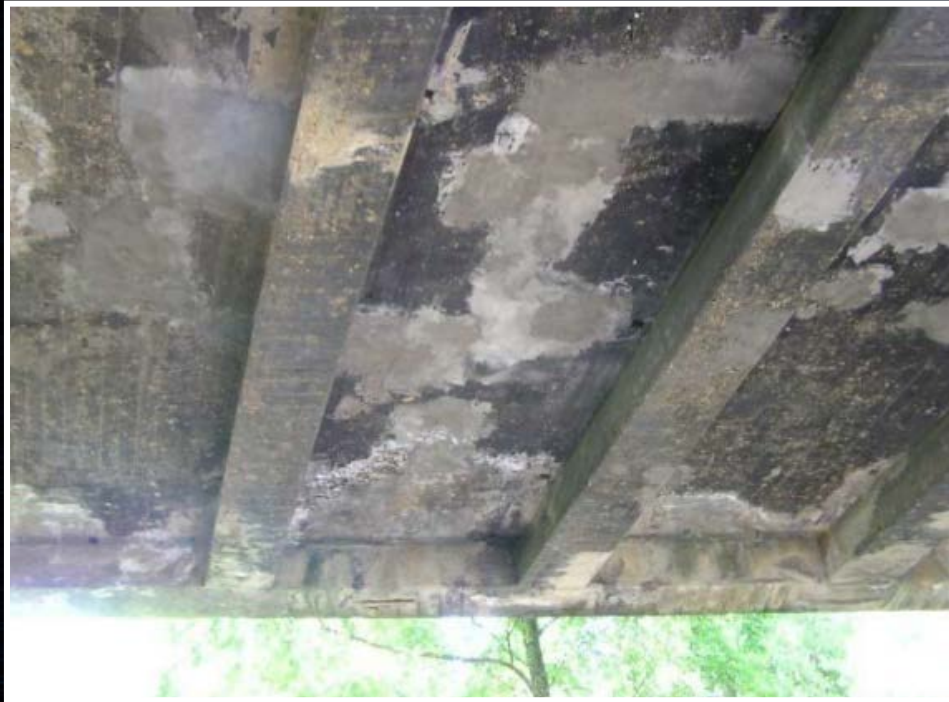
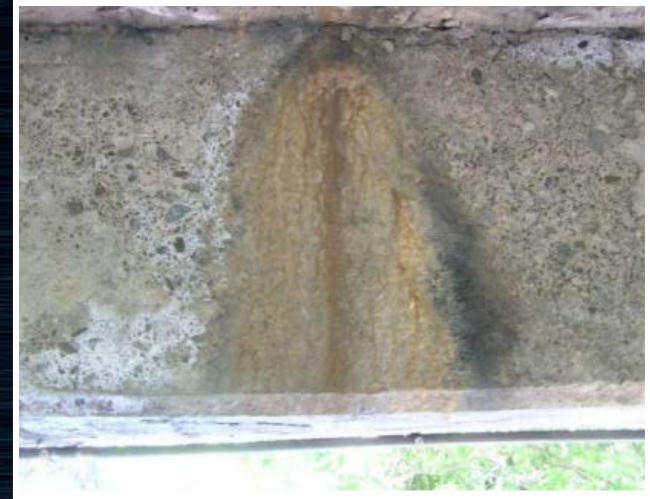
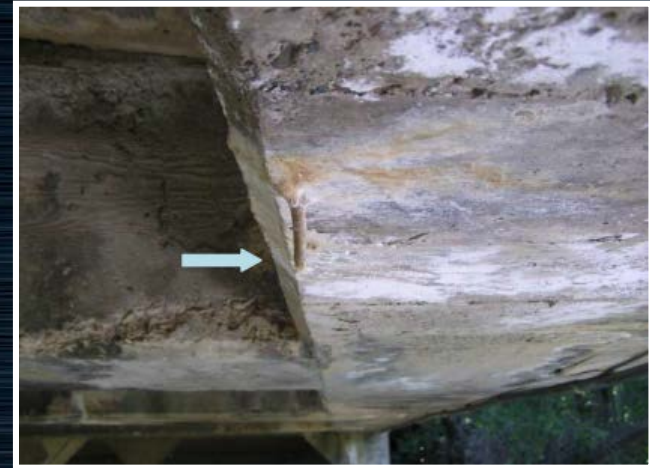
Surface Staining

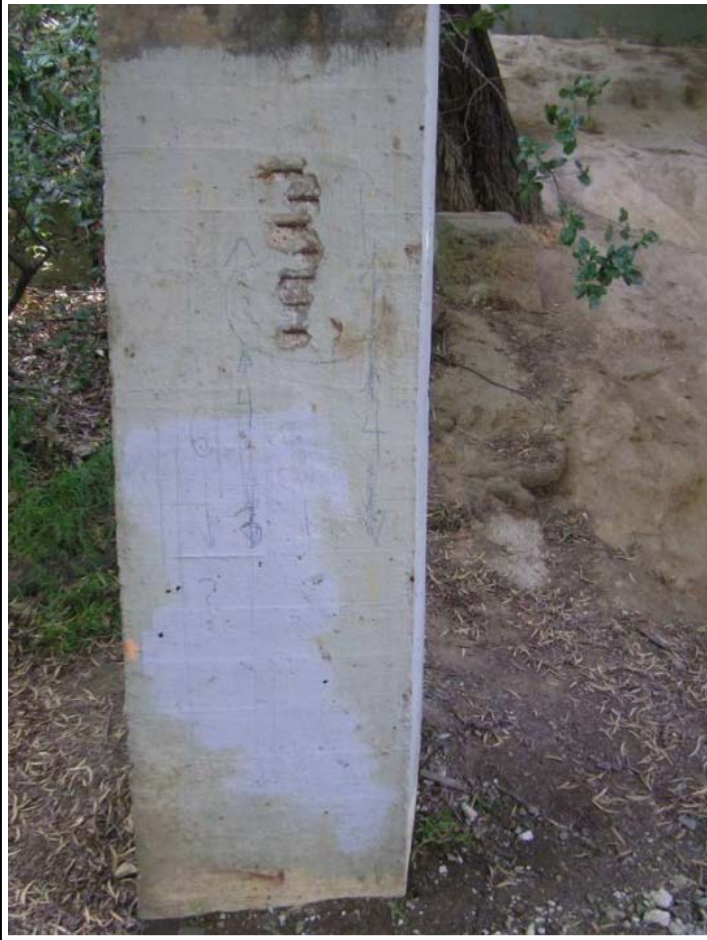
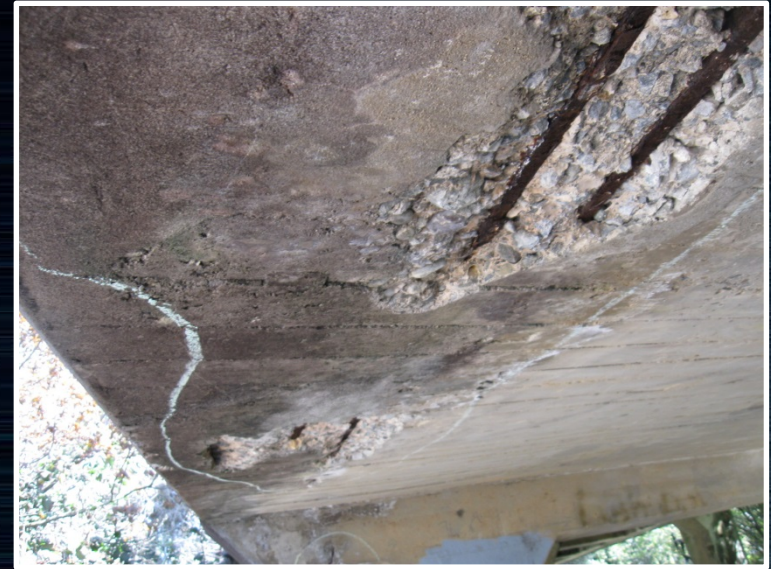
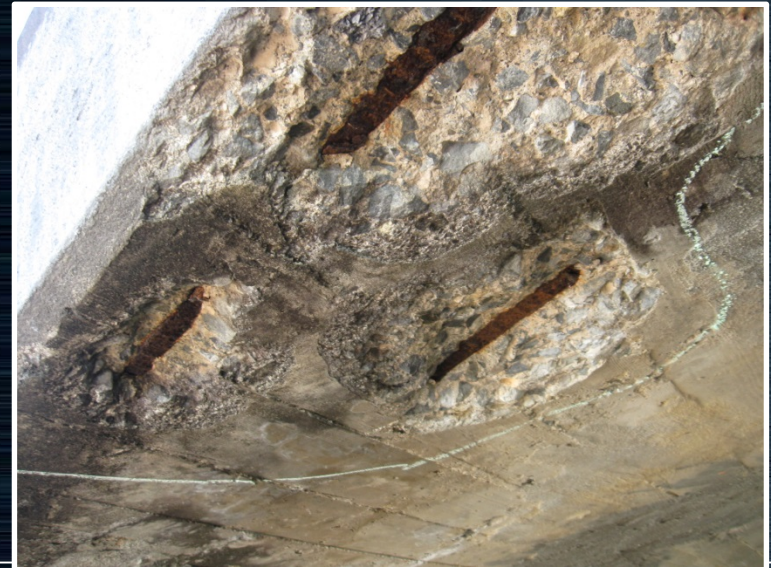
Exposed Rebar

- Extensive repairable concrete surface deterioration
- Concrete in fair to good conditions
- Carbonation to the depth of the steel reinforcement leaving rebar susceptible to corrosion
- Footing condition not determined

2. Add rebar when lost or corroded

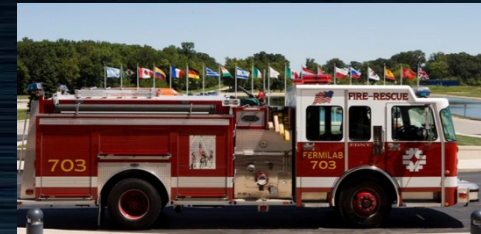
- Existing bridge service & seismic analysis
- Firetruck analysis
- LARSA Finite Element Analysis Model

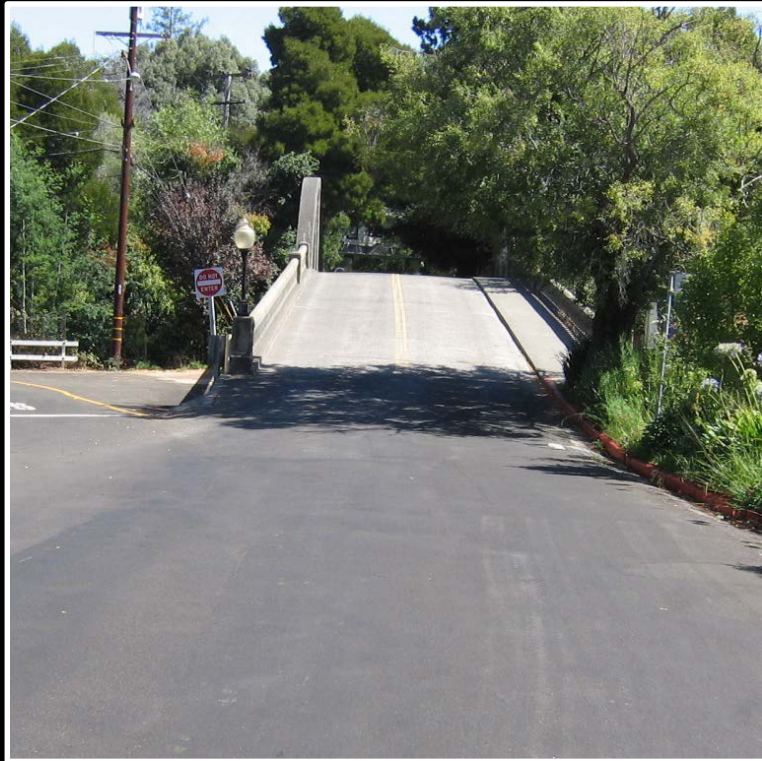
- BEFORE

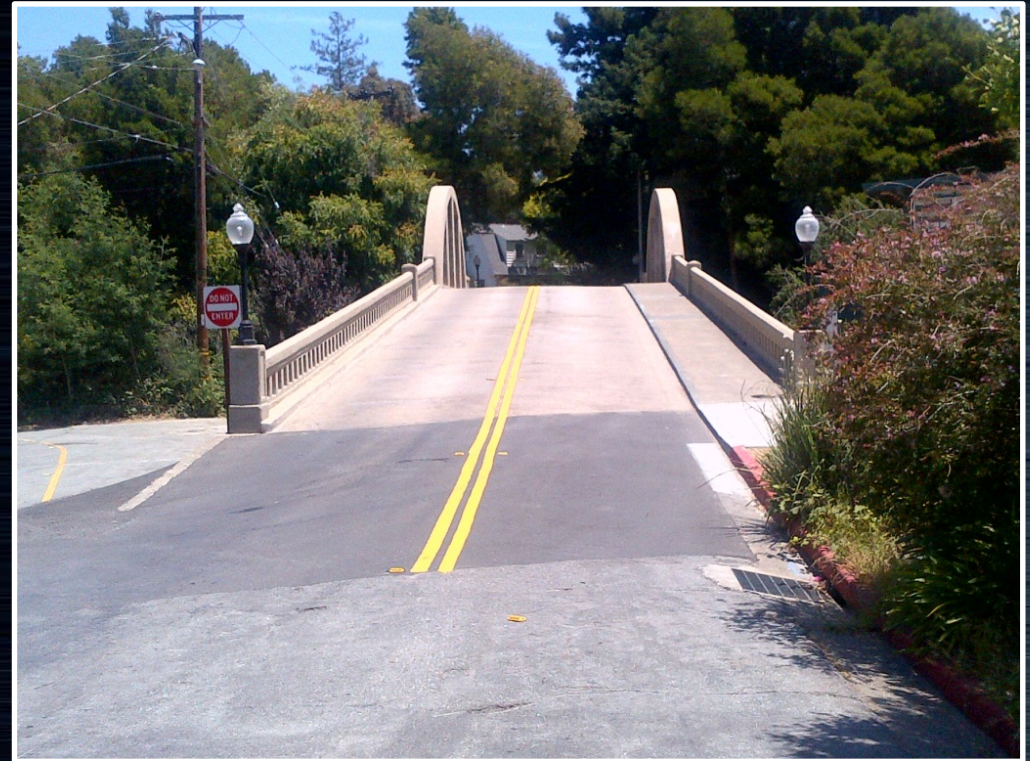
- AFTER

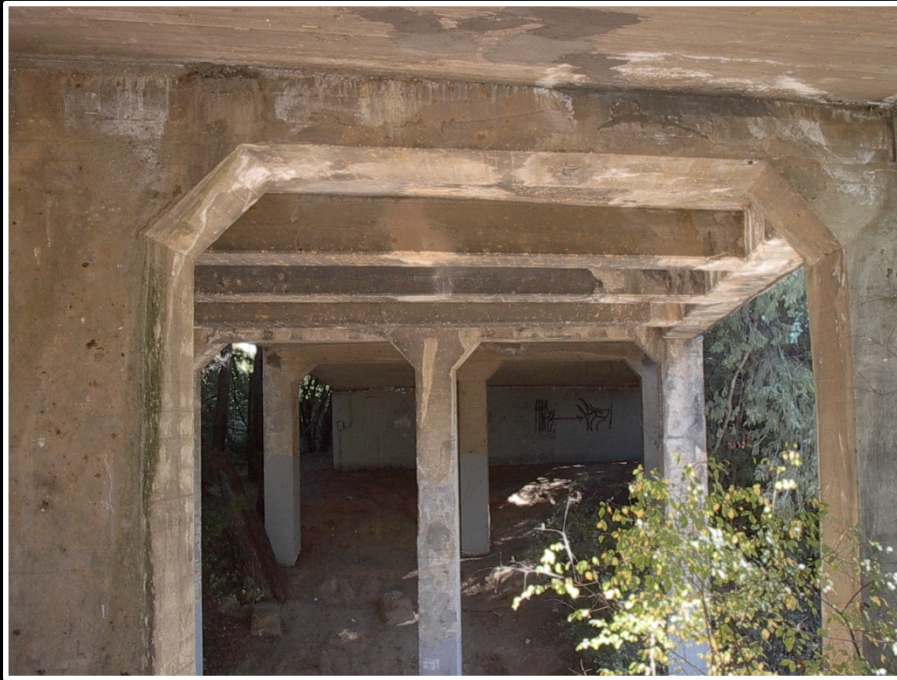
- BEFORE

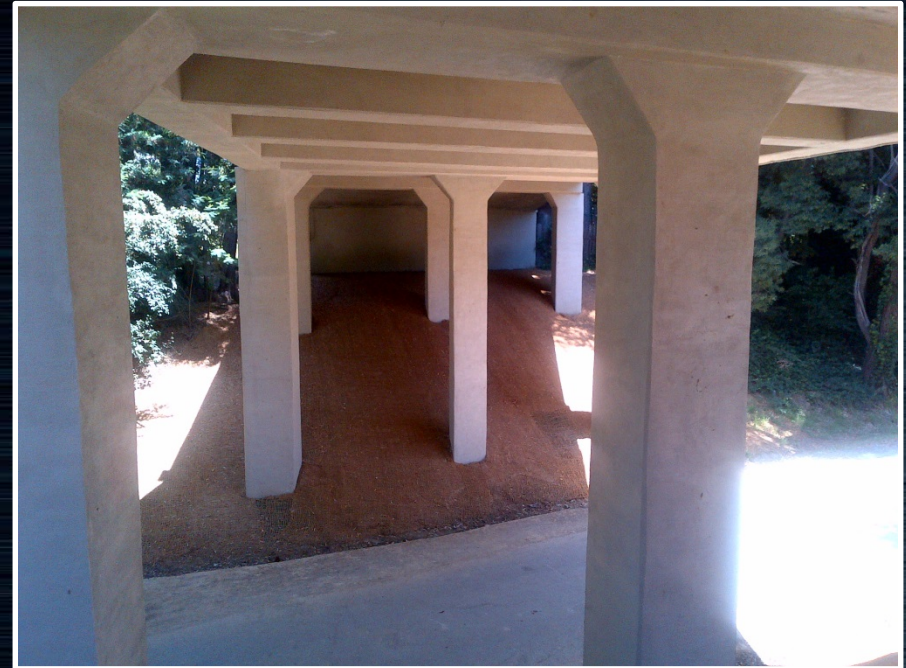
- AFTER

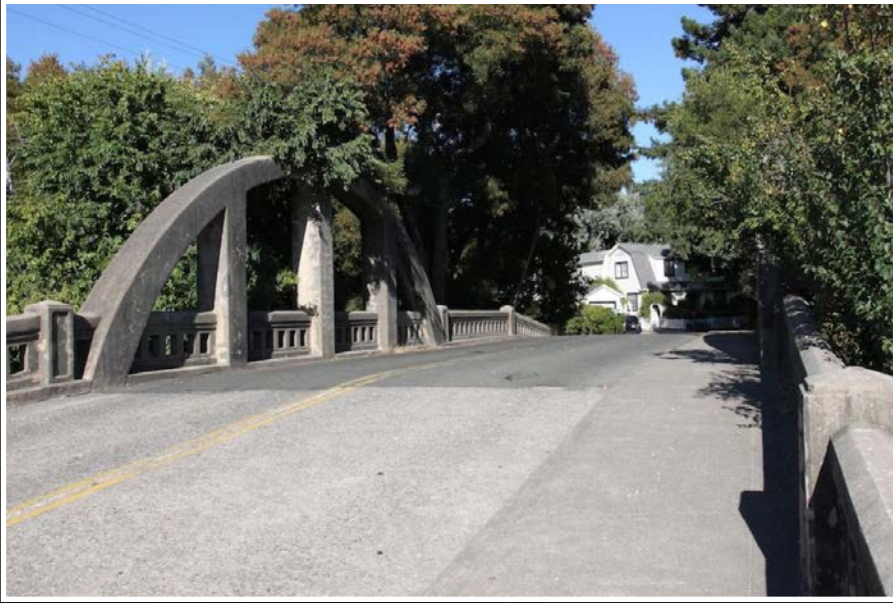
- BEFORE

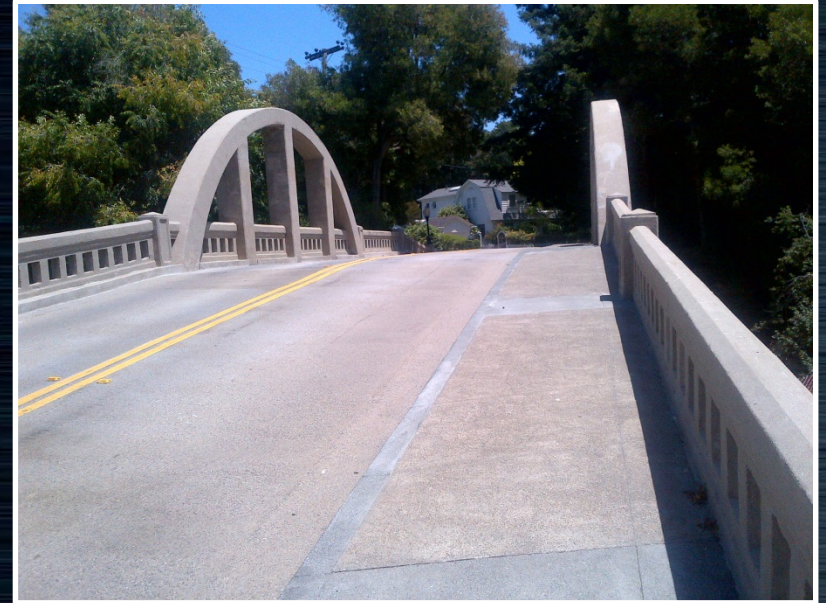
- AFTER
