Structural Response of Bent Caps in Reinforced Concrete Box-Girder Bridges

Mohamed A. Moustafa, PhD, PE

Khalid M. Mosalam, PhD, PE

Western Bridge Engineers Seminar, Reno, NV, Sep. 9-11, 2015

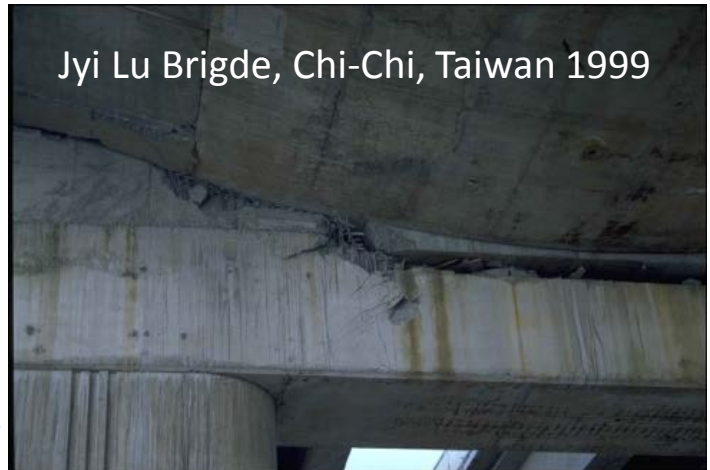
❑ Bent caps damage in past events

- *e.g. San Fernando 1971, Whittier 1987, Chi-Chi 1999*

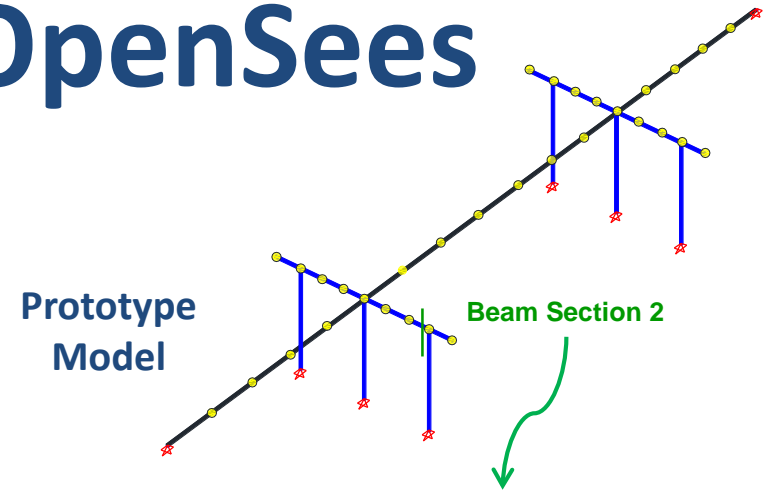
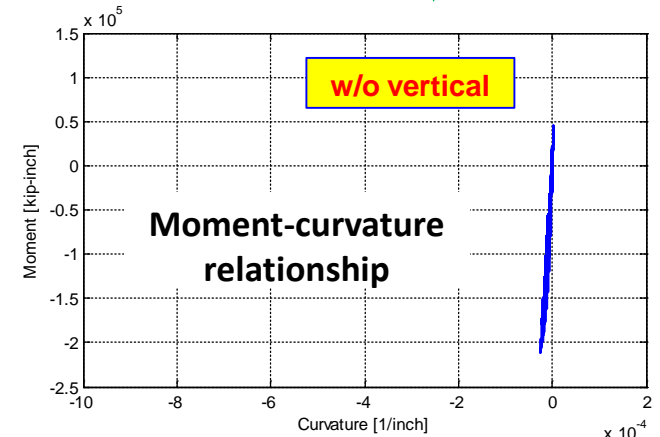
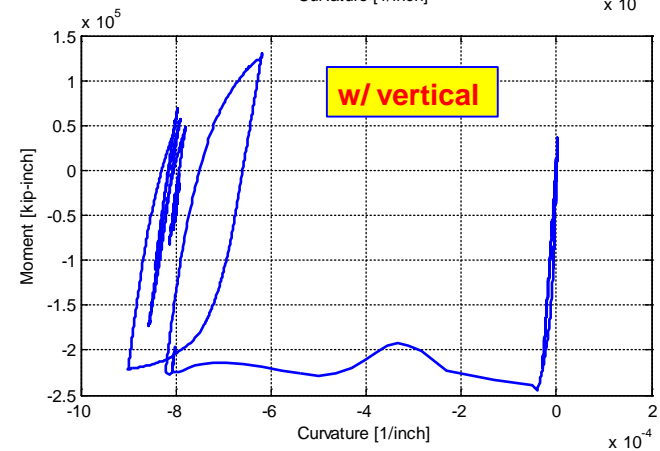
- Choose GMs with most severe effect on bent cap beam
 - Select final GMs for loading protocol
- Prelim. nonlinear time history analysis of prototype w/ & w/o vl. excitation
- > 80 ground motions (GMs) from PEER NGA database (**Criteria:** Magnitude > 6 & Distance to fault < 20 km)

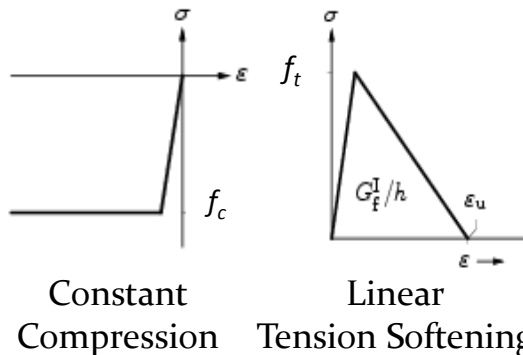
Concrete Material Model

Total Strain- Based Crack Model

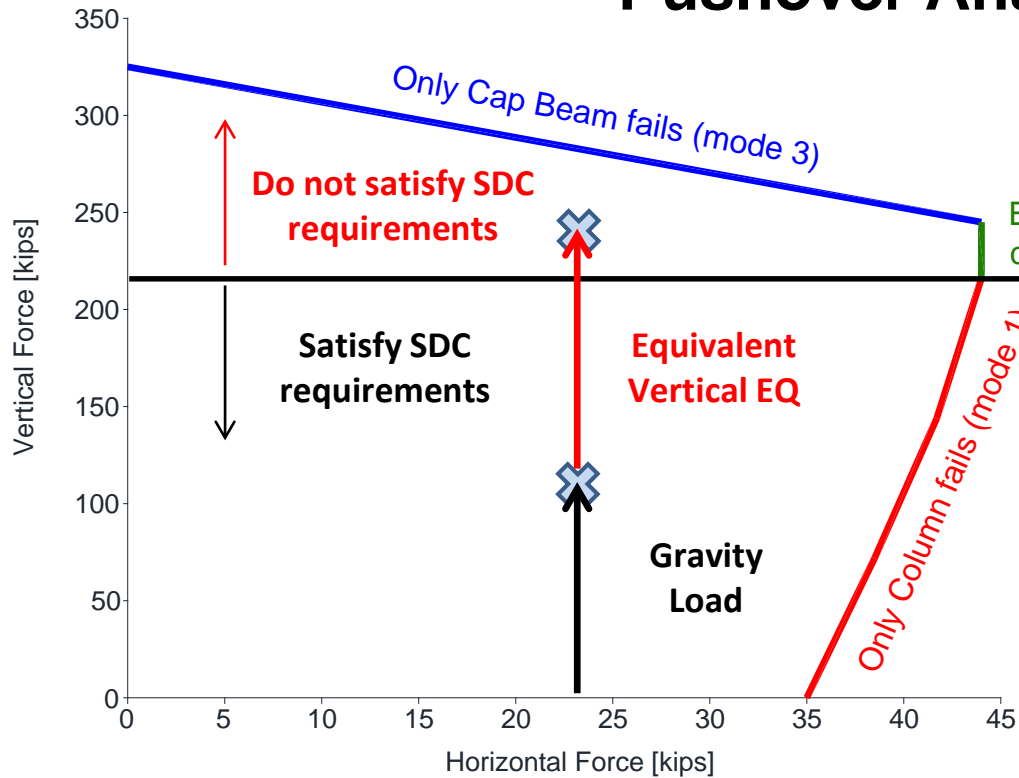
Pushover Analysis

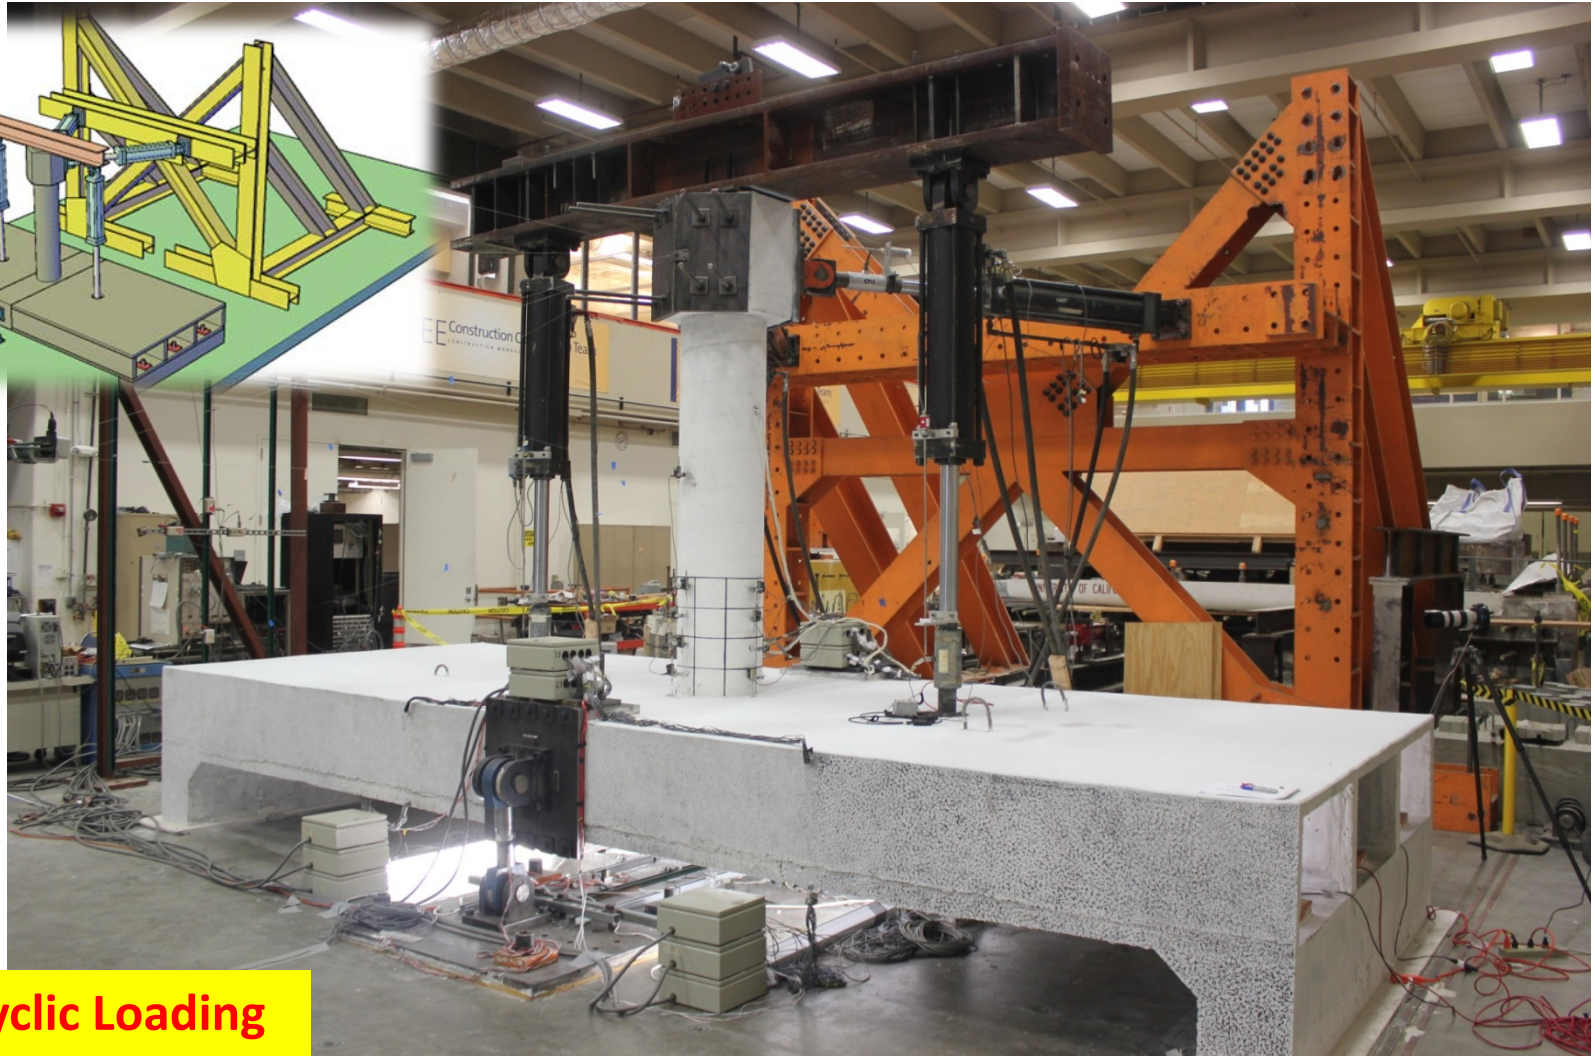
**Cyclic Loading
Test Setup**

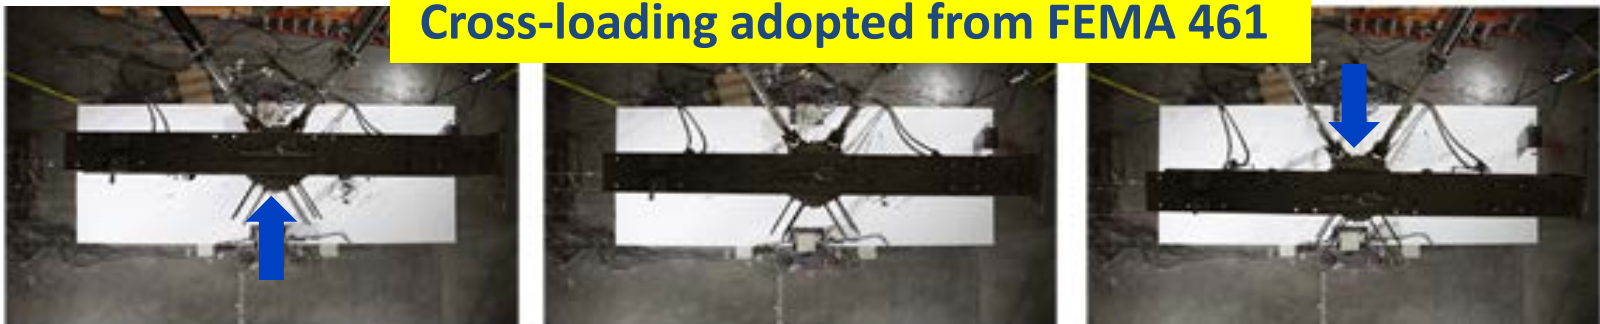
Bidirectional Cyclic Loading Protocol

Cross-loading adopted from FEMA 461

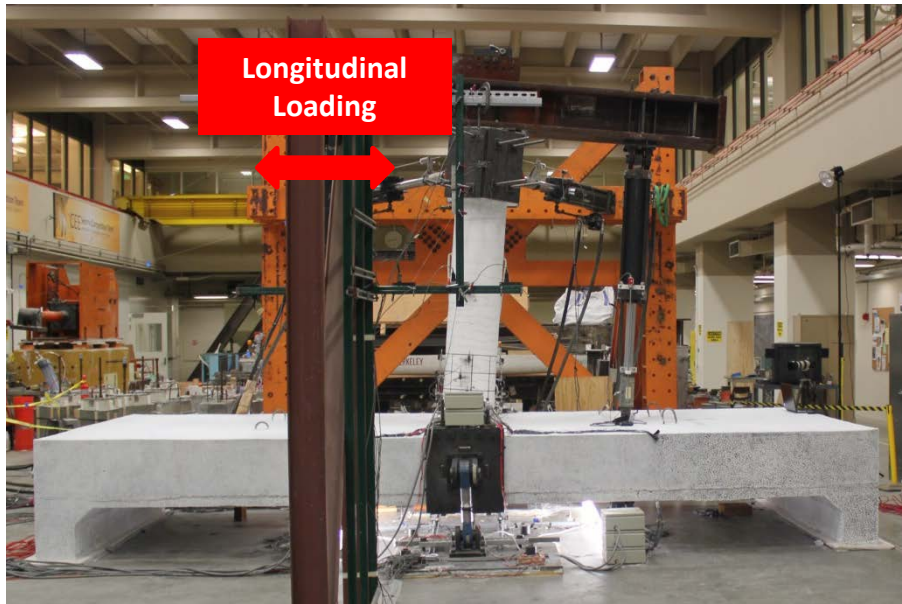
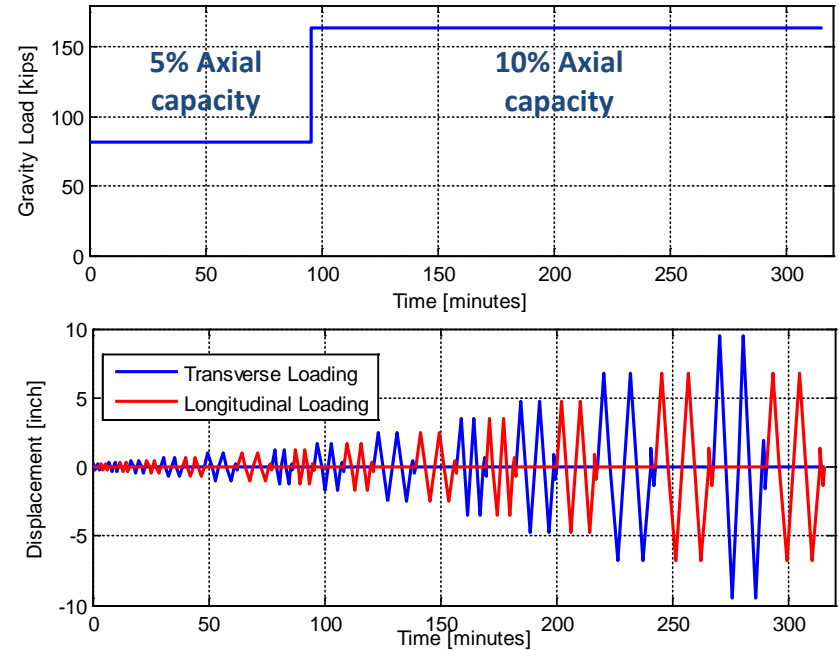
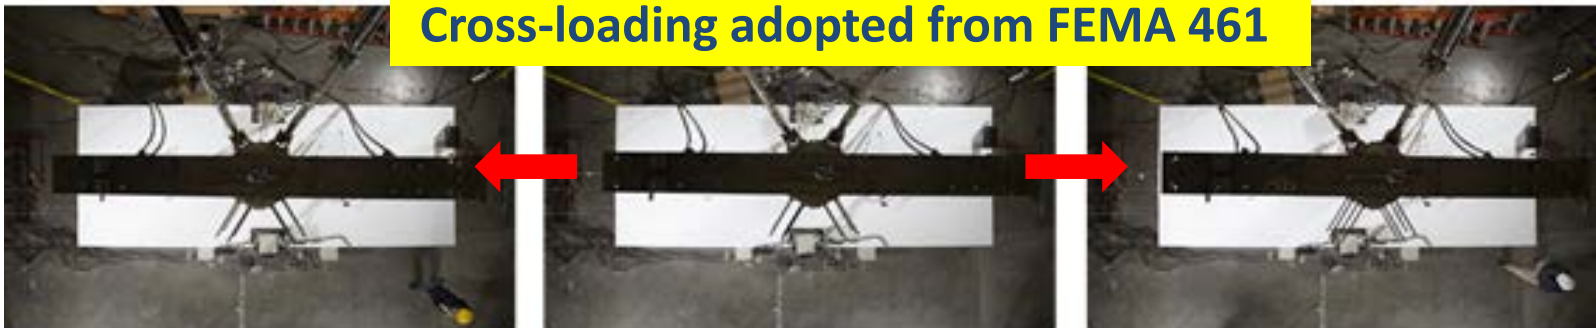
Bidirectional Cyclic Loading Protocol

Cross-loading adopted from FEMA 461

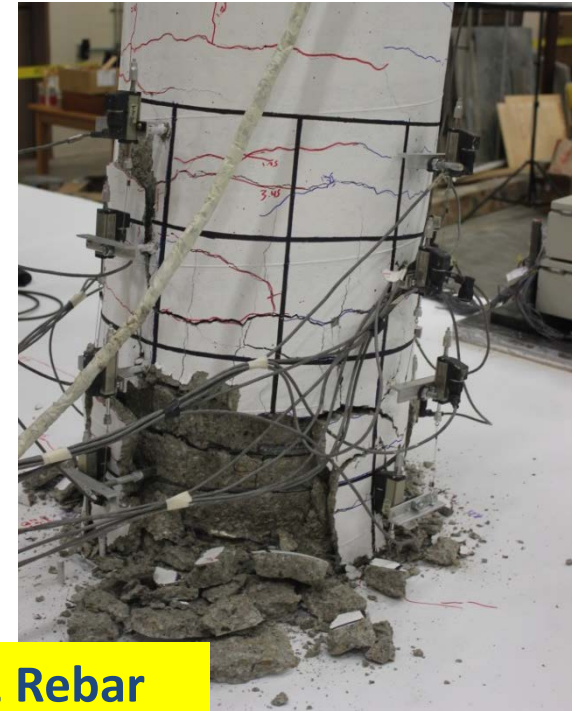
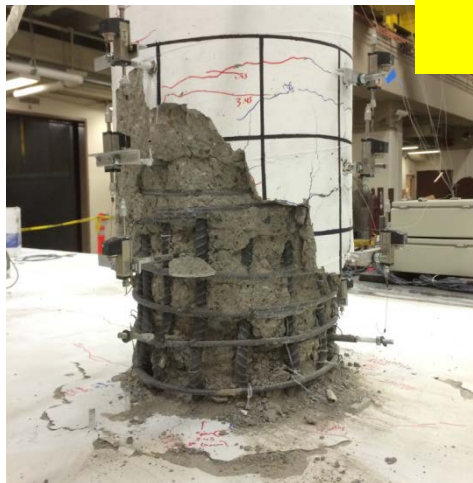
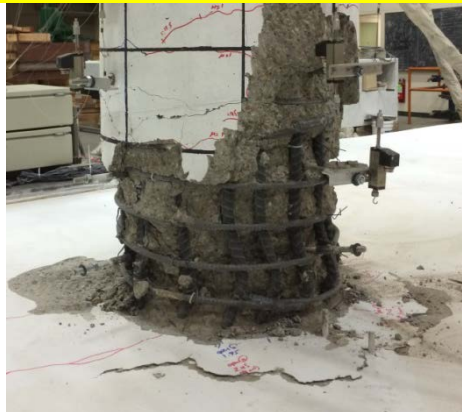
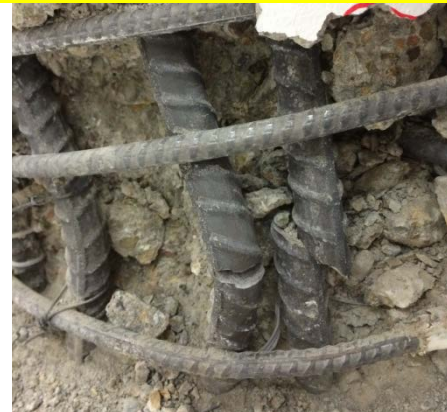
Crack Propagation, Cover Spalling & Rebar Rupture in Column Plastic Hinge Region

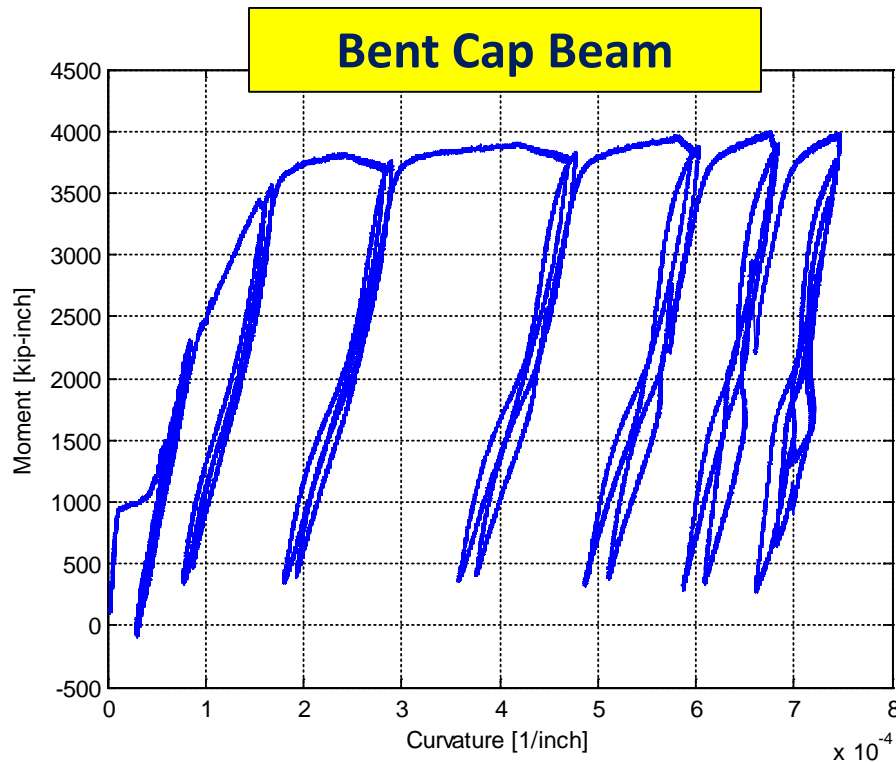
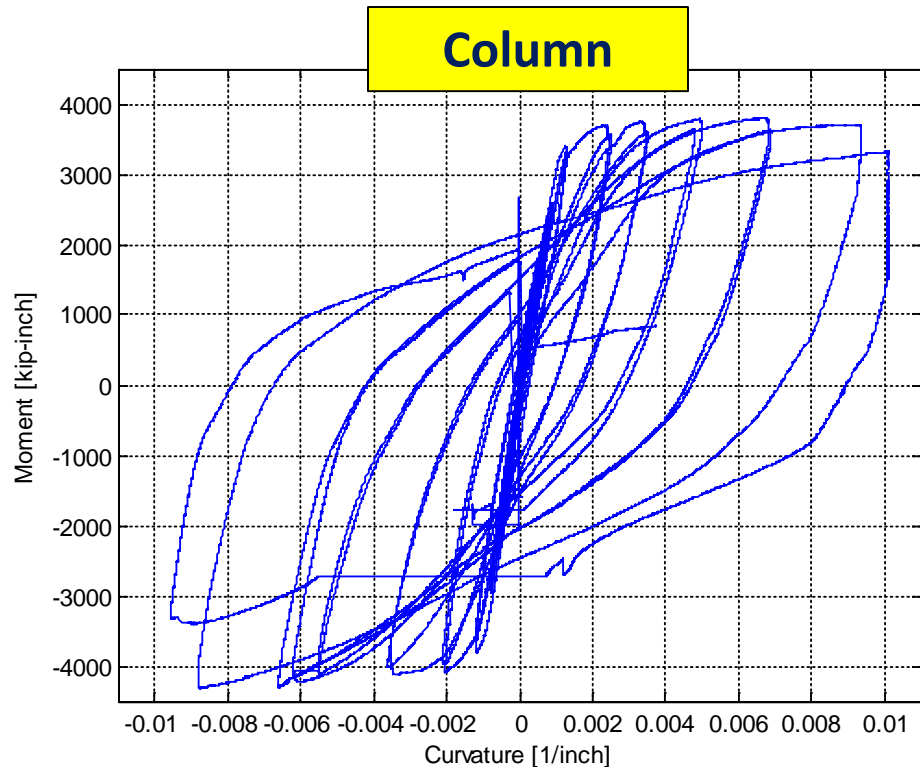
Moment-Curvature Relationship

- Yielding of rebars & hairline cracks
- NO spalling or PH formation

- Rupture of rebars
- cover spalling & PH formation

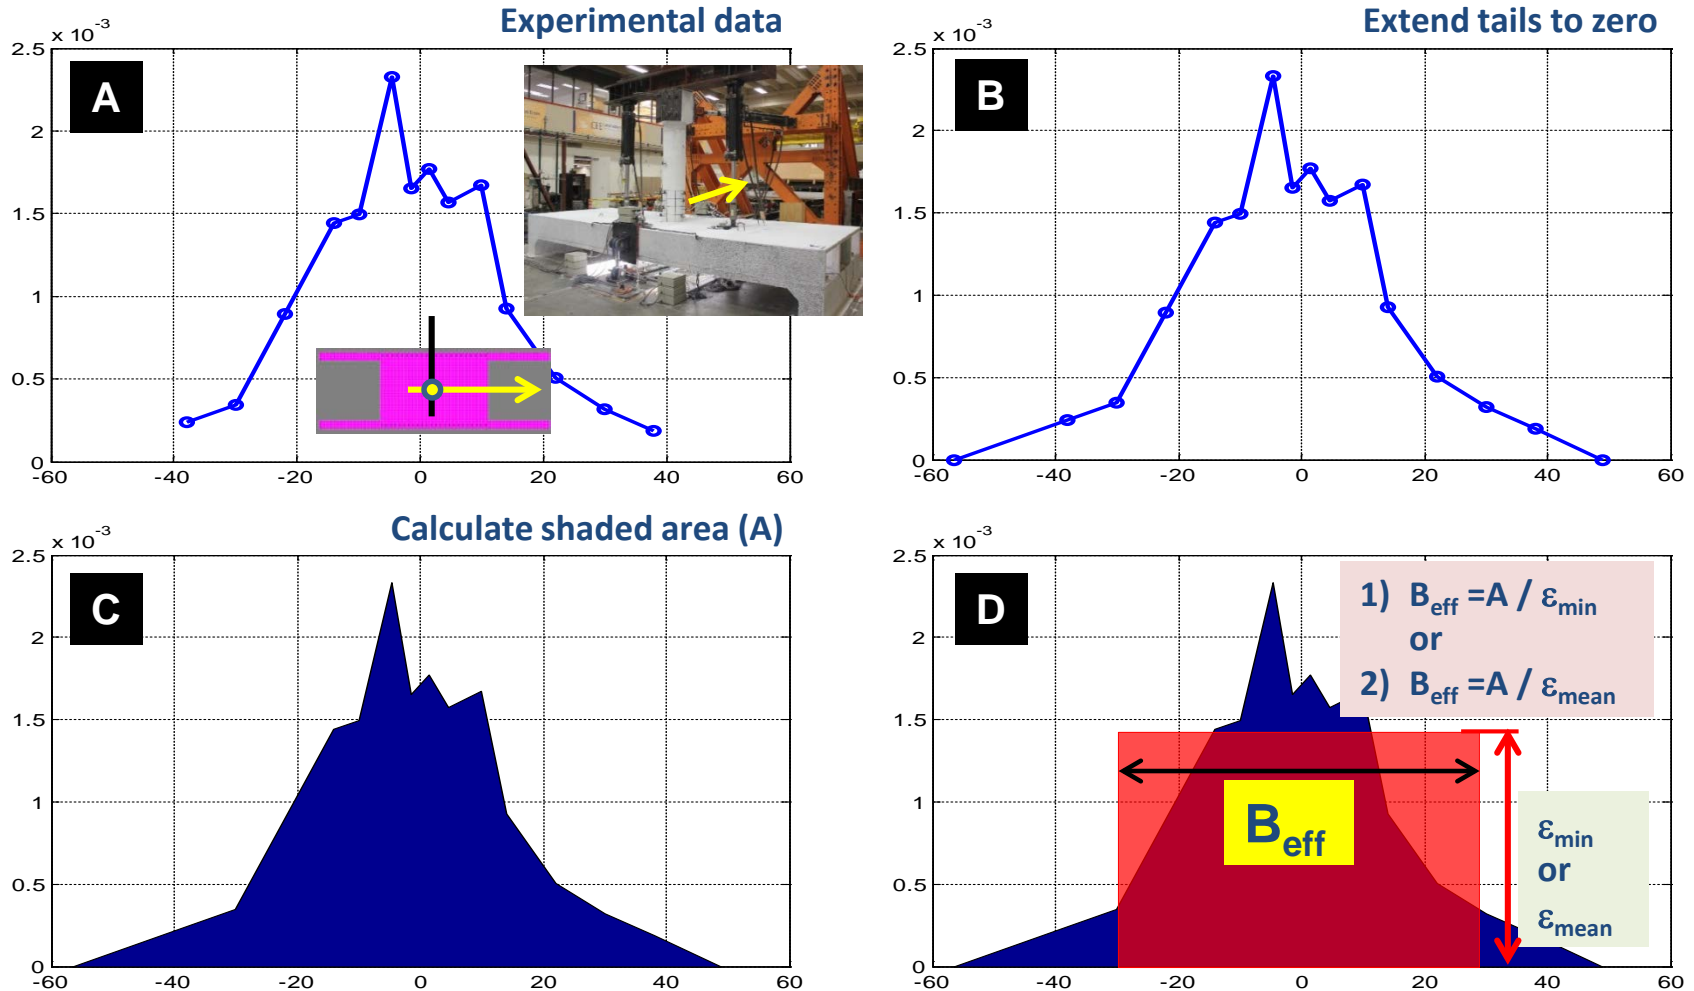
Procedure for estimating effective width from strain distribution

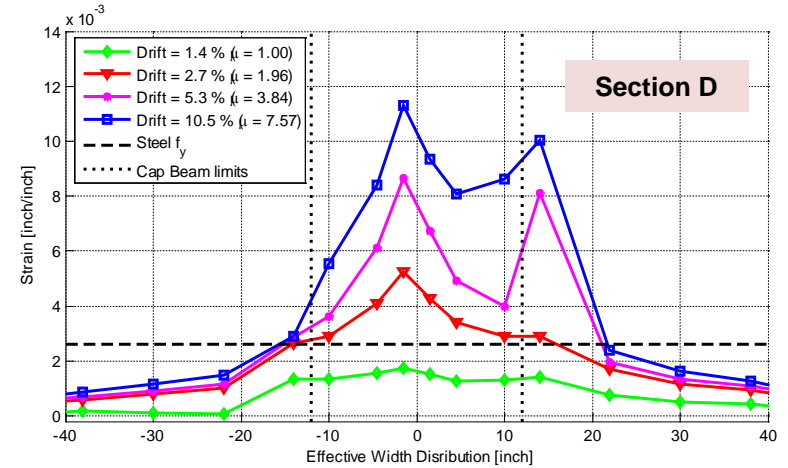
Strain Distribution & Effective Slab Width during TRANSVERSE Loading

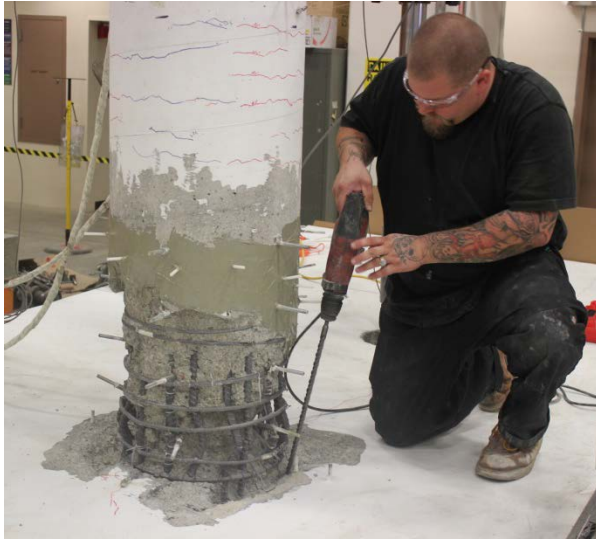
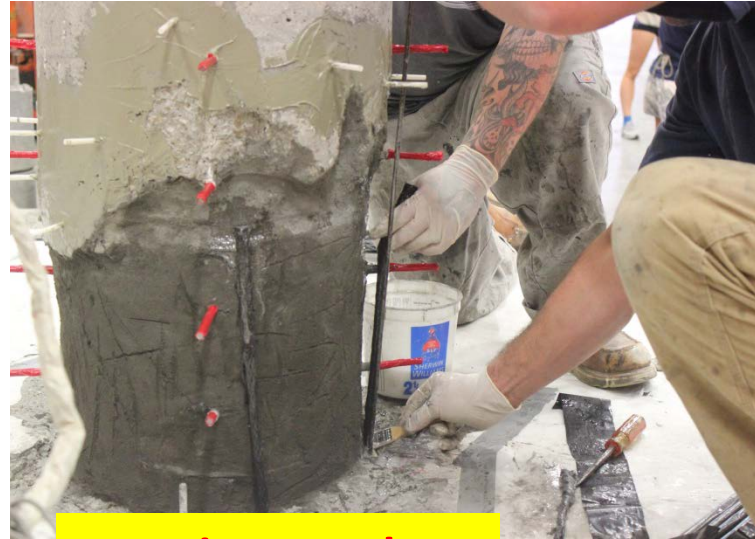
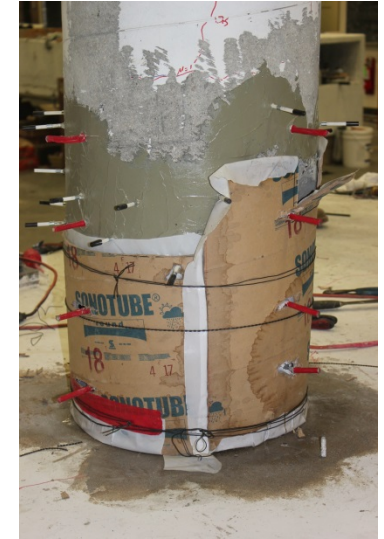
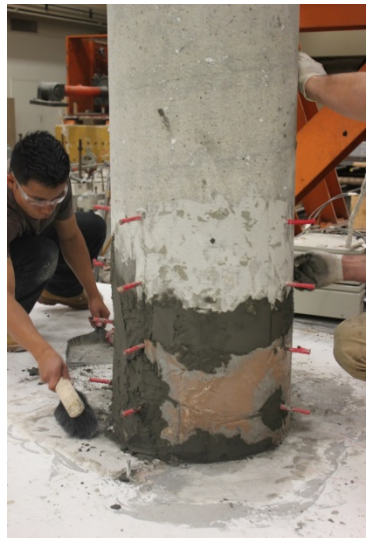
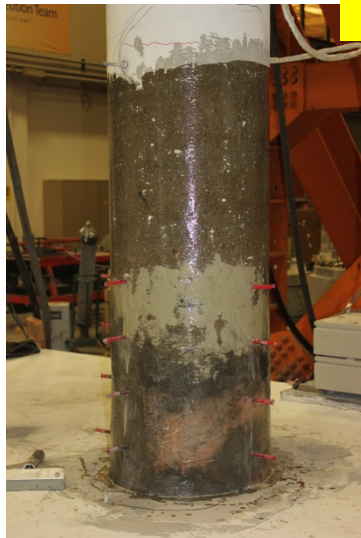
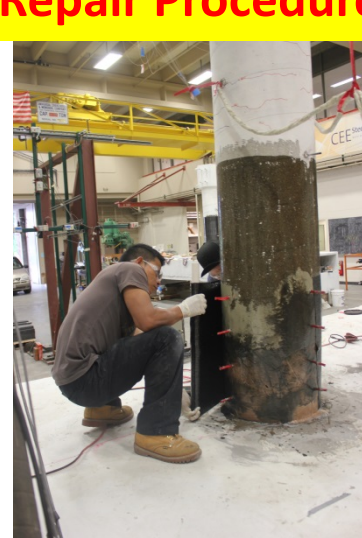
Repair Procedure

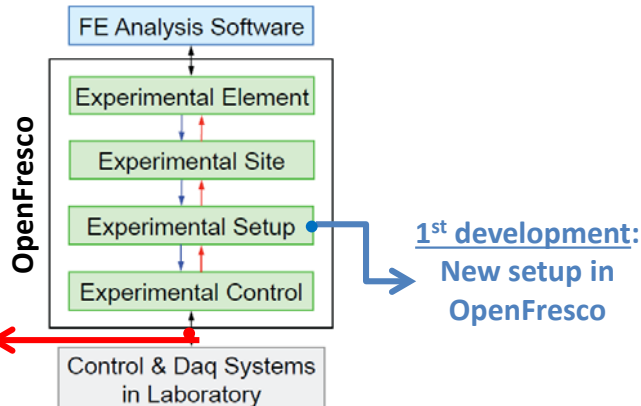
- Physical Substructure: specimen subassemblage
- Computational Substructure: MDOF mass & damping

$$\mathbf{M}\ddot{\mathbf{U}}_{i+1} + \mathbf{C}\dot{\mathbf{U}}_{i+1} + \mathbf{P}_r(\mathbf{U}_{i+1}) = \mathbf{P}_{i+1}$$

Main components of HS system

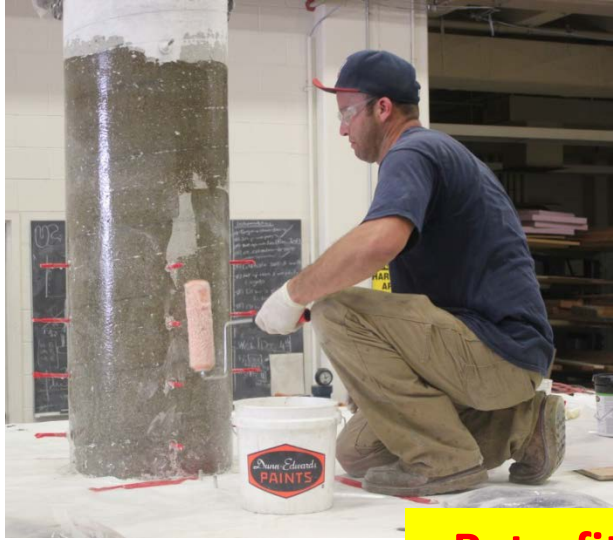
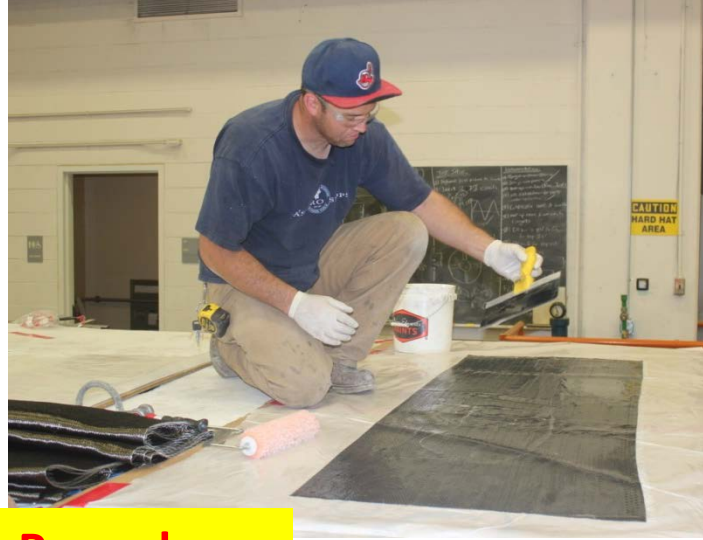
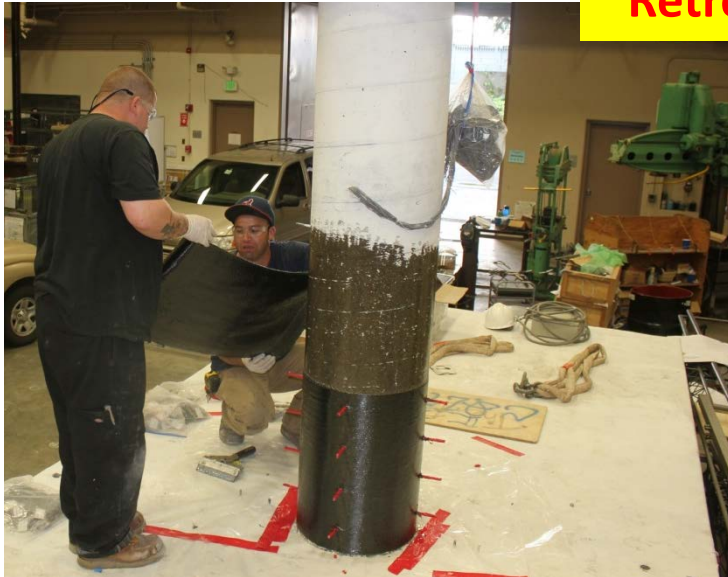
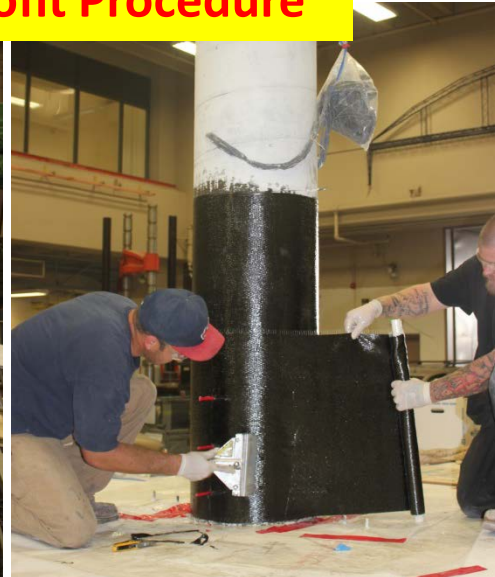
Retrofit Procedure

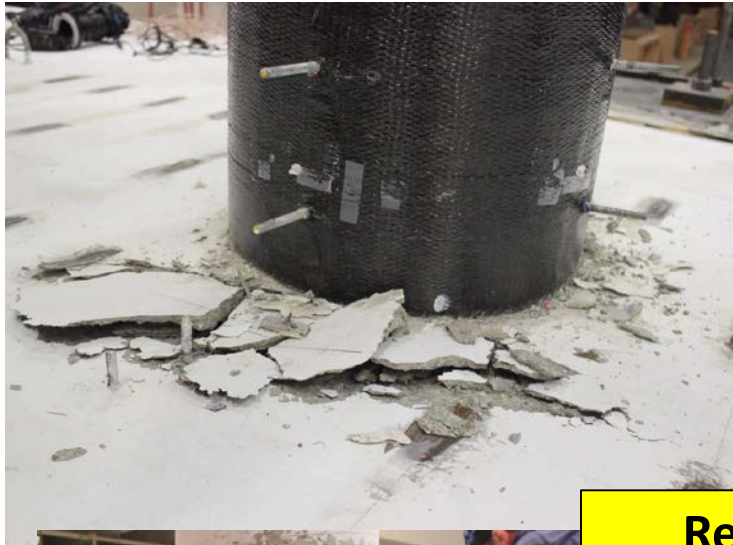
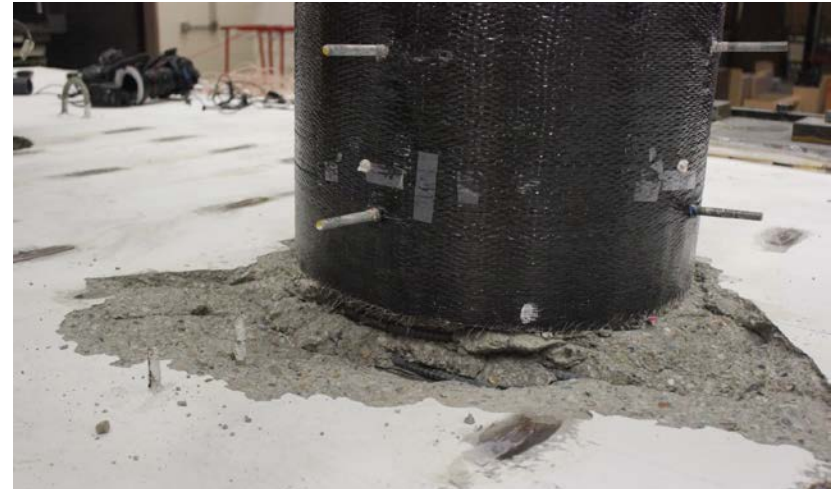
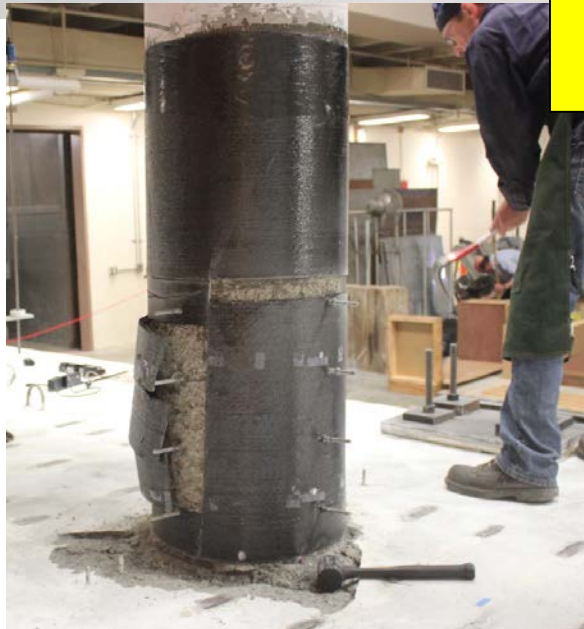
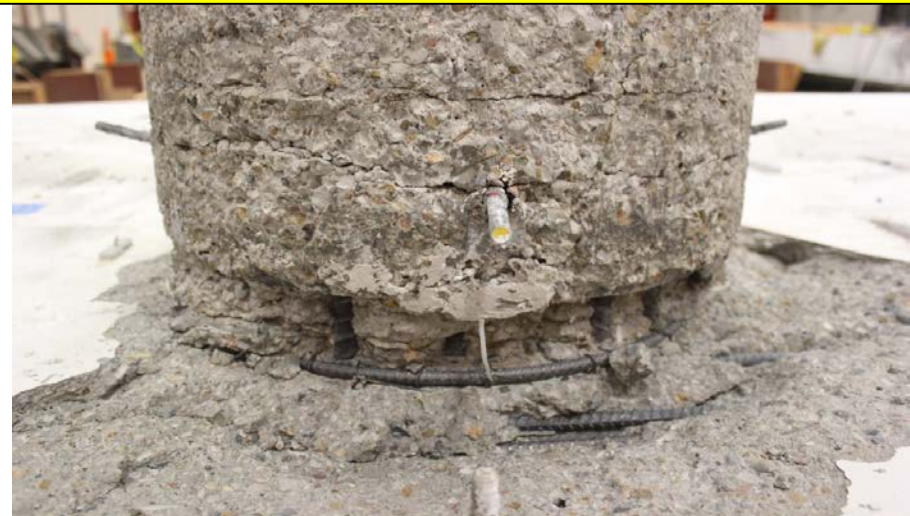
Retrofitted SP2 Damage after HS Tests
Bent cap concrete crushing in compression

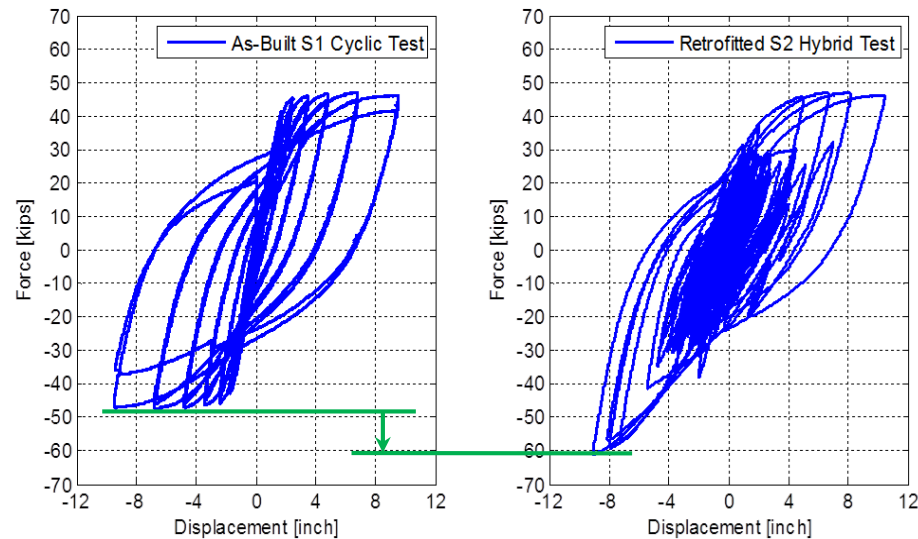
- ❑ Retrofit increased overall SYSTEM capacity by $\sim 25\%$
- ❑ Increased demand from column + higher gravity (15%) \rightarrow bent cap failure

Force-displacement relationship (transverse)
