Western Bridge Engineers' Seminar

September 10, 2015
8:30 AM

SPECIALIZED POST-TENSIONING ASSESSMENT AND REPAIR

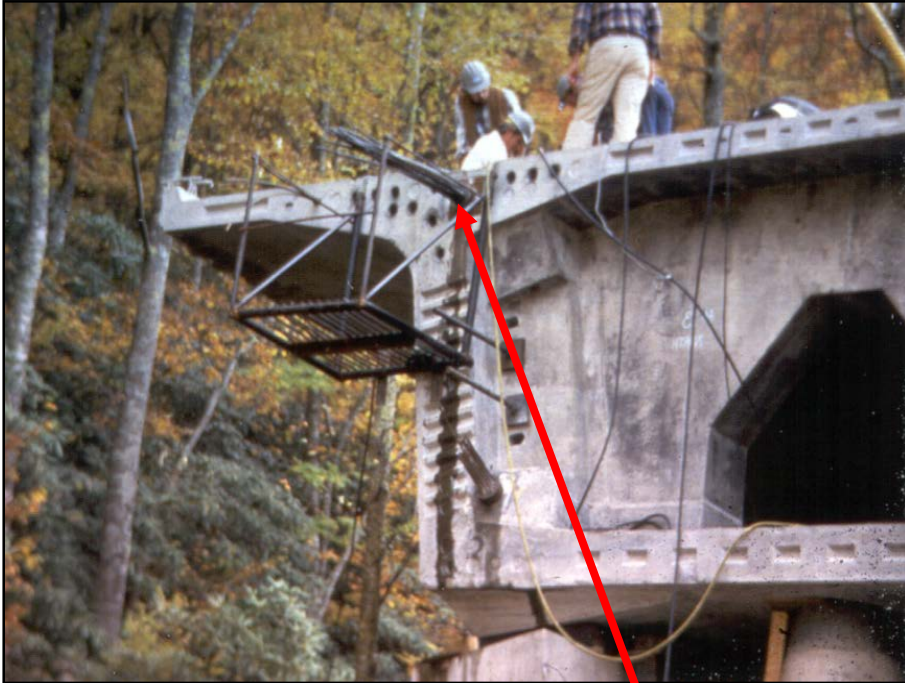
Internal vs. External Tendons

Internal PT Tendons

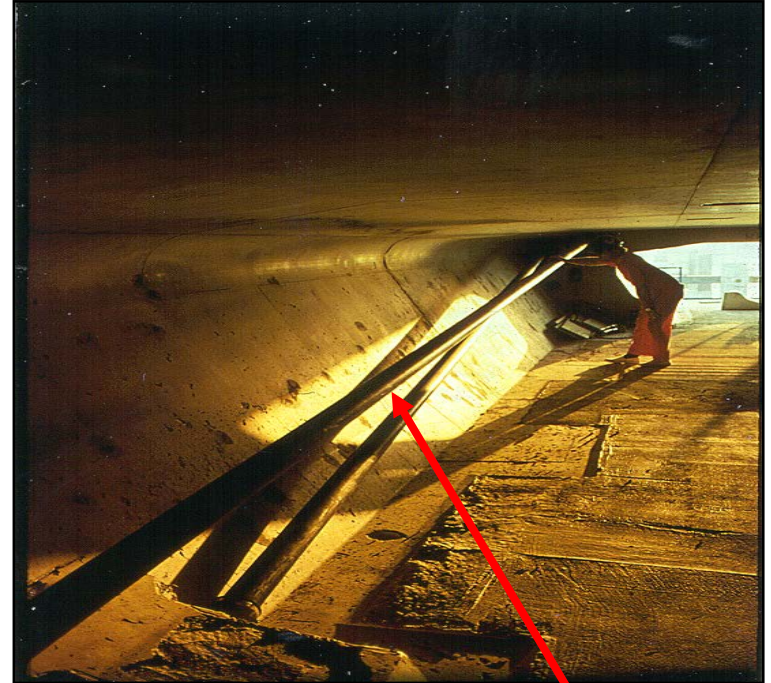
External PT Tendons

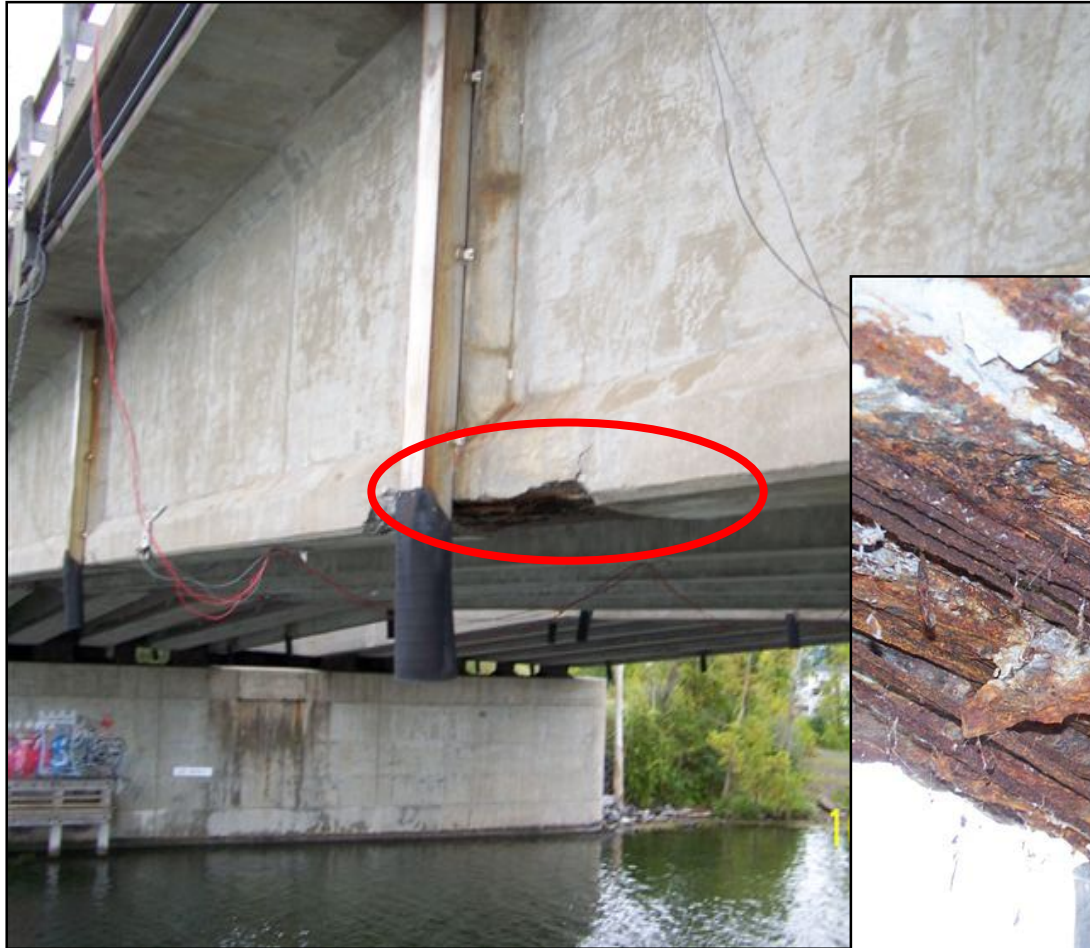
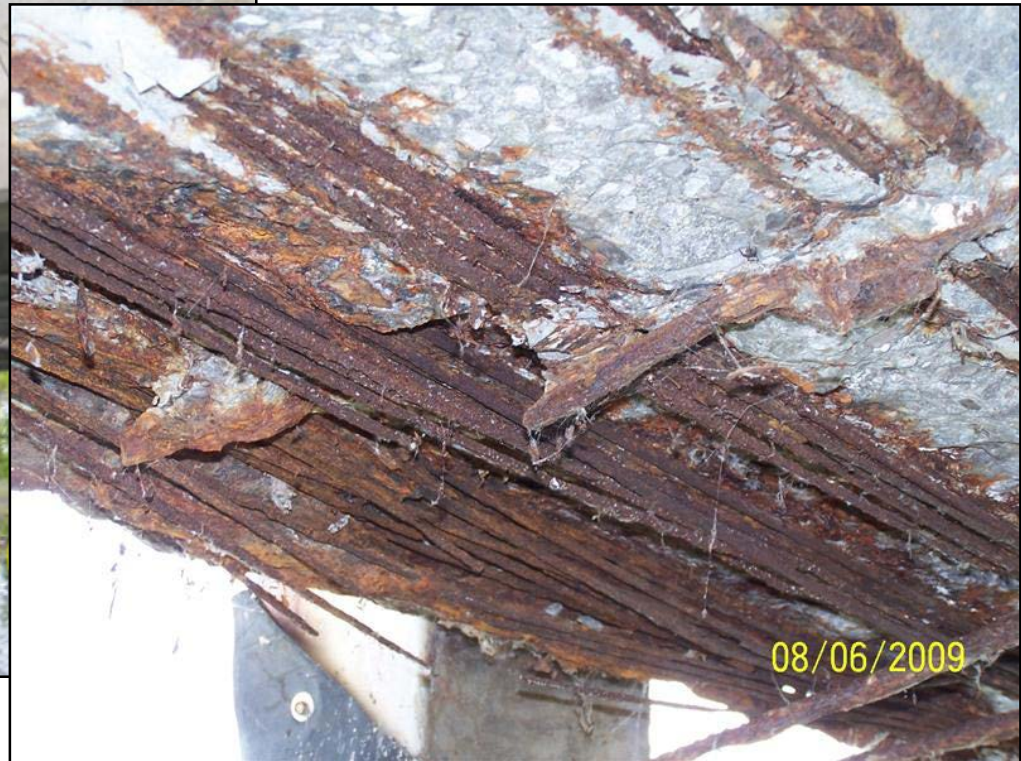
Example - Drainage Details

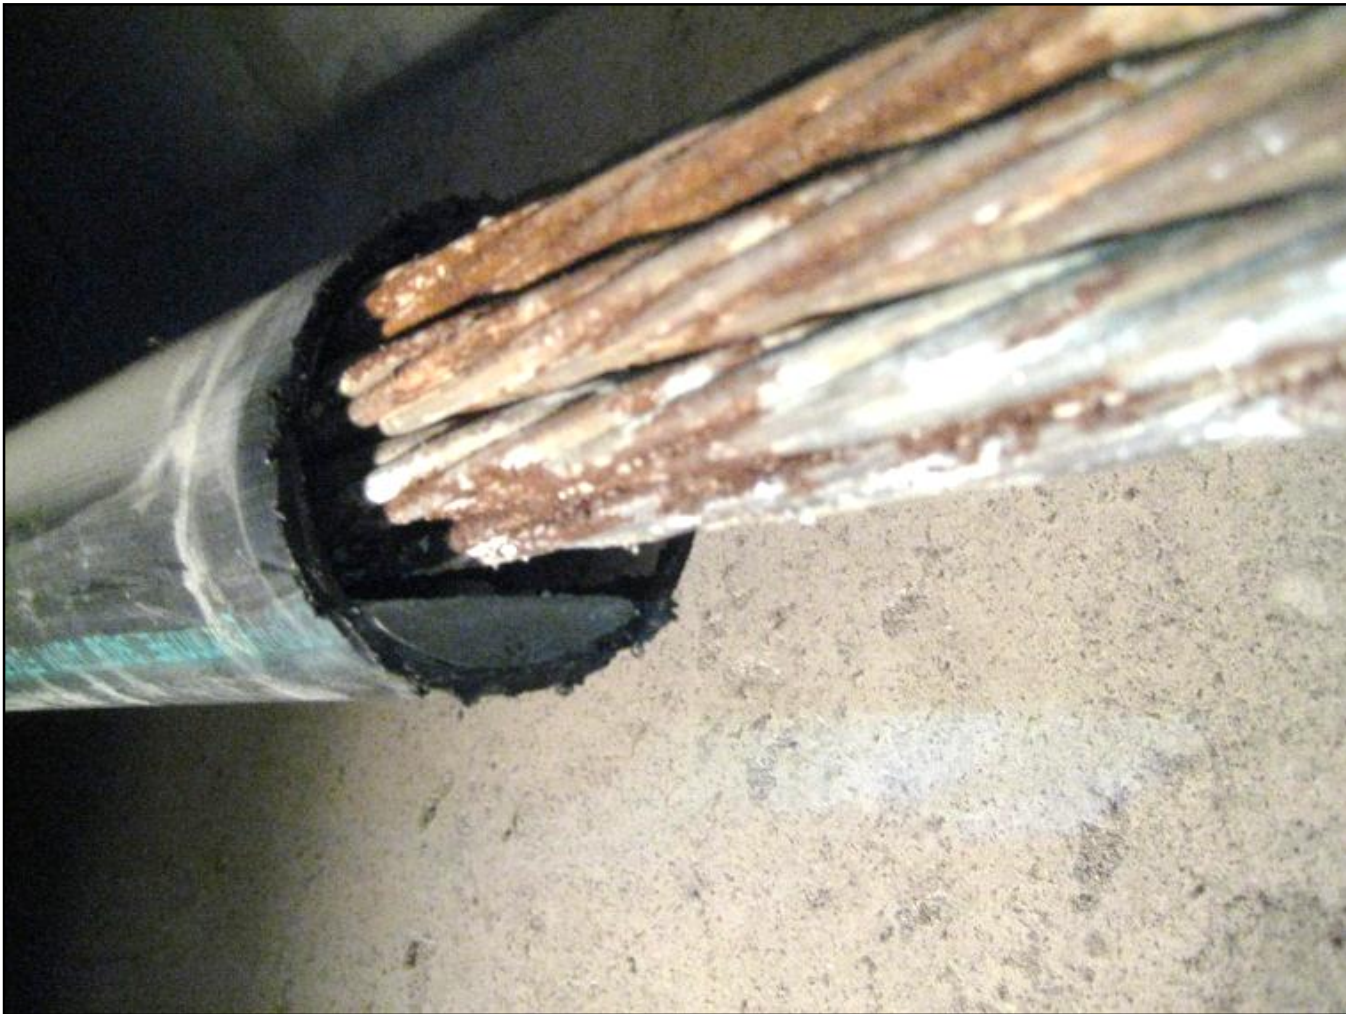
Example - Grout Voids and Corrosion

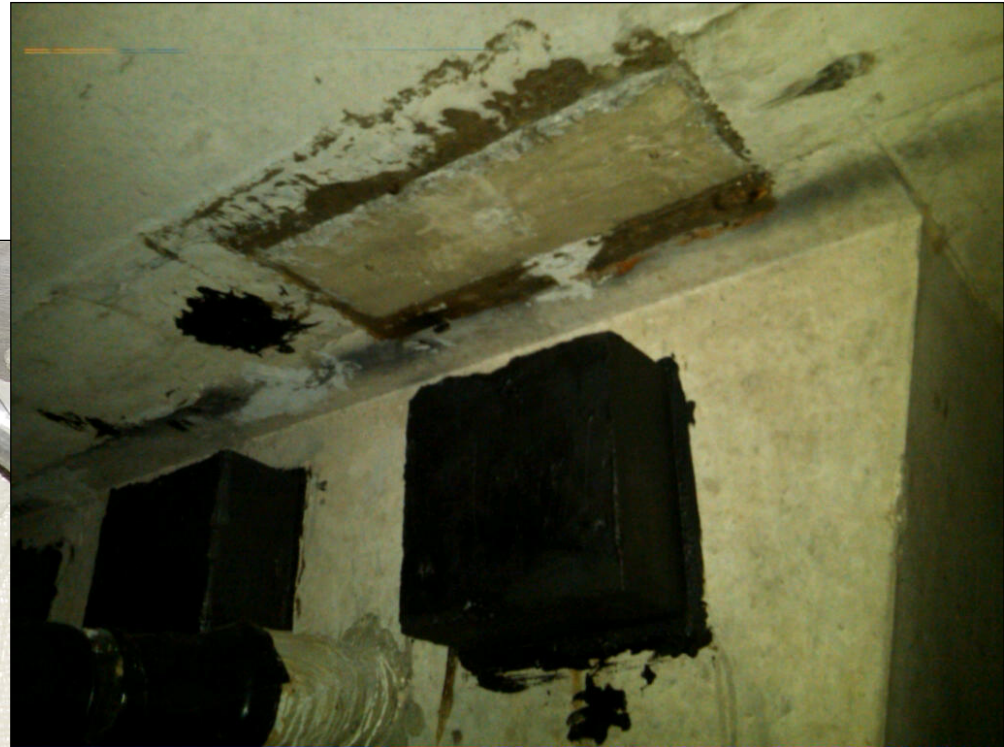
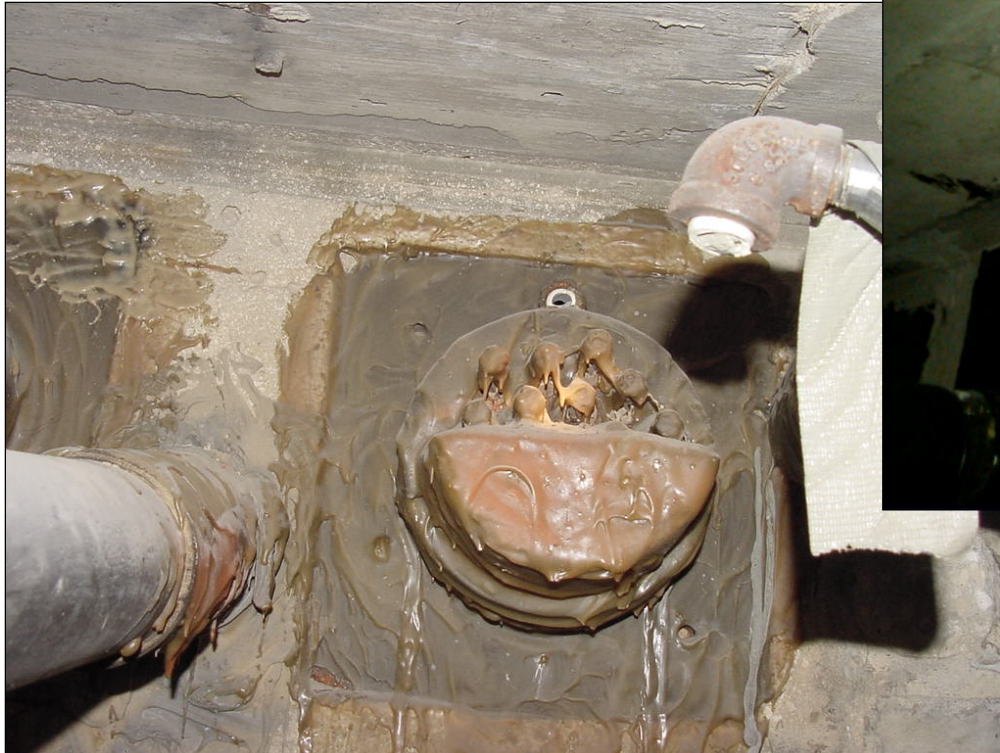
Example - Anchor Protection

- ❑ Incomplete pourbacks, spalled pourbacks
- ❑ Deck repairs over pourbacks

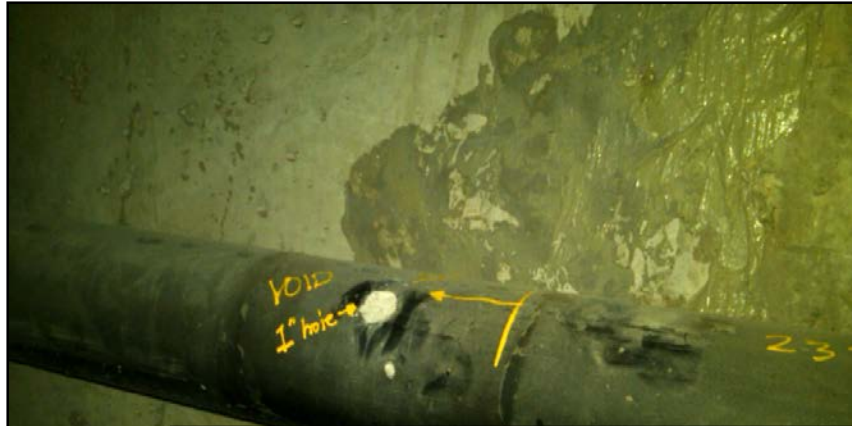
Example - External Tendon Cracking

- ❑ Over pressurized during grouting
- ❑ Physical damage during construction
- ❑ Different thermal coeff of expansion
- ❑ Mix design with expansive agents

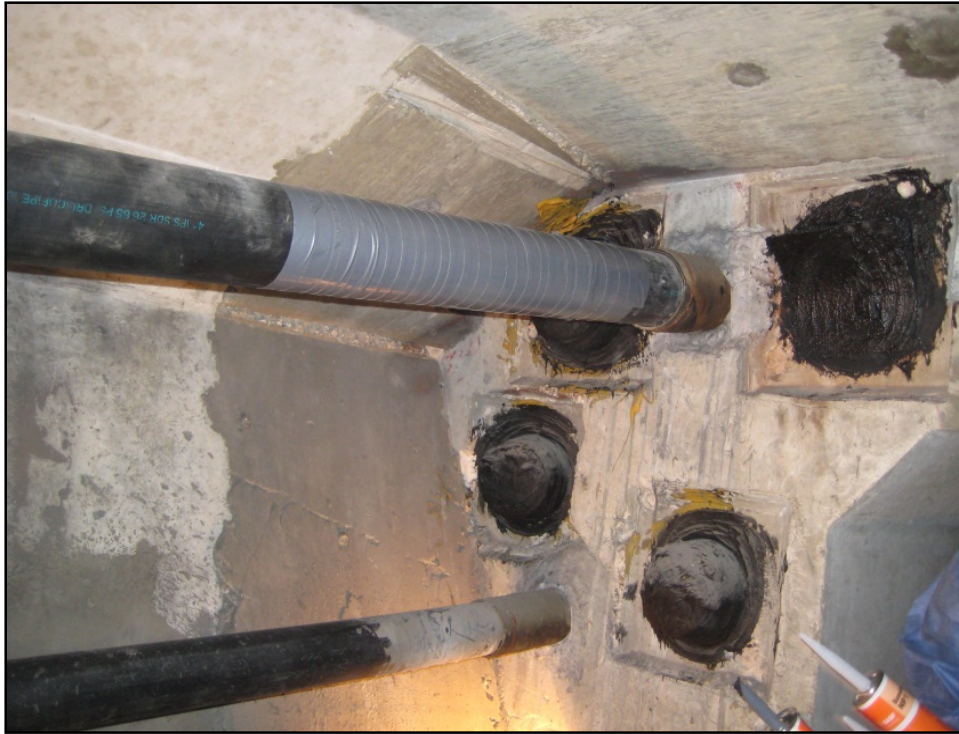
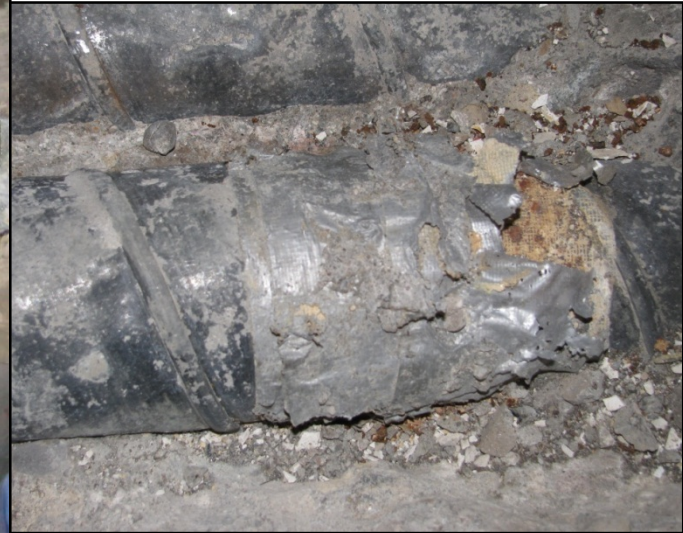
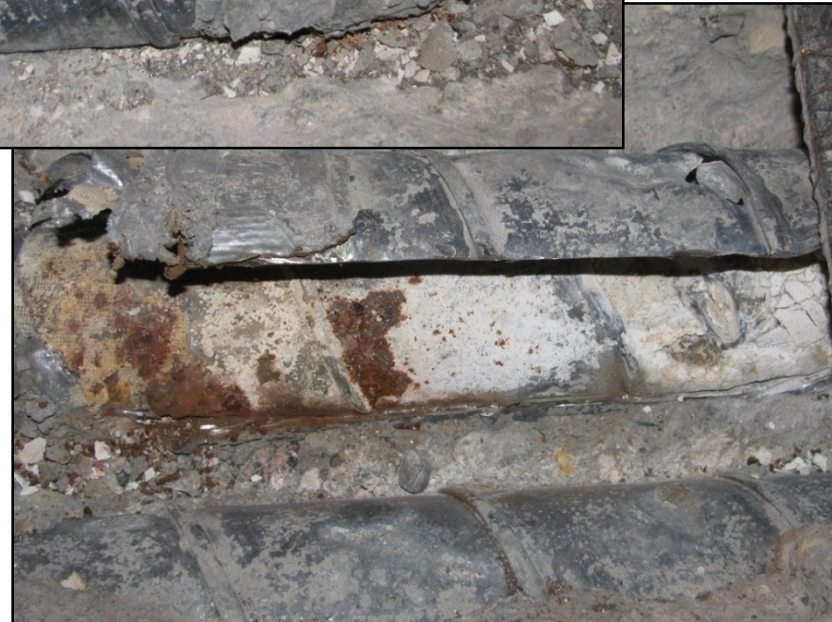
Example - Improper Use of Materials

- Duct tape is good but maybe not for permanent HDPE repairs

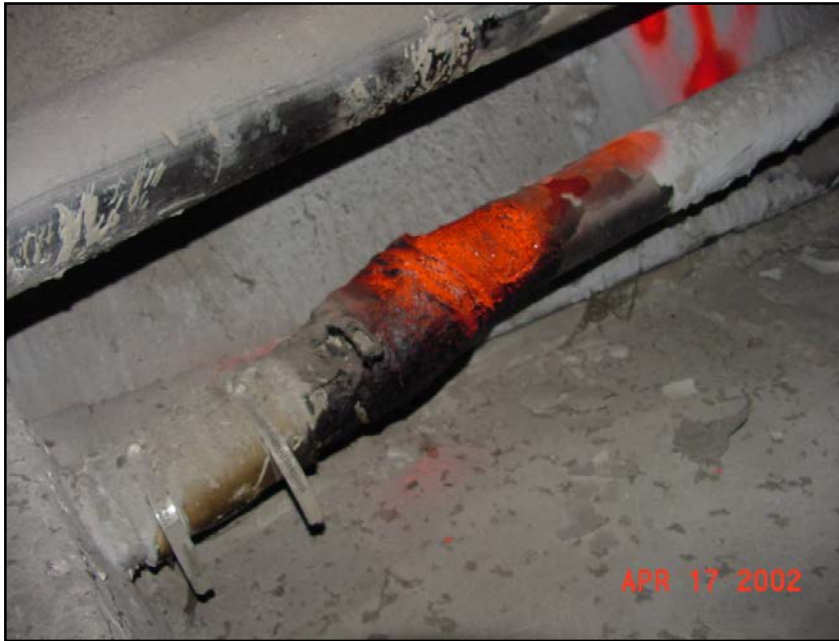
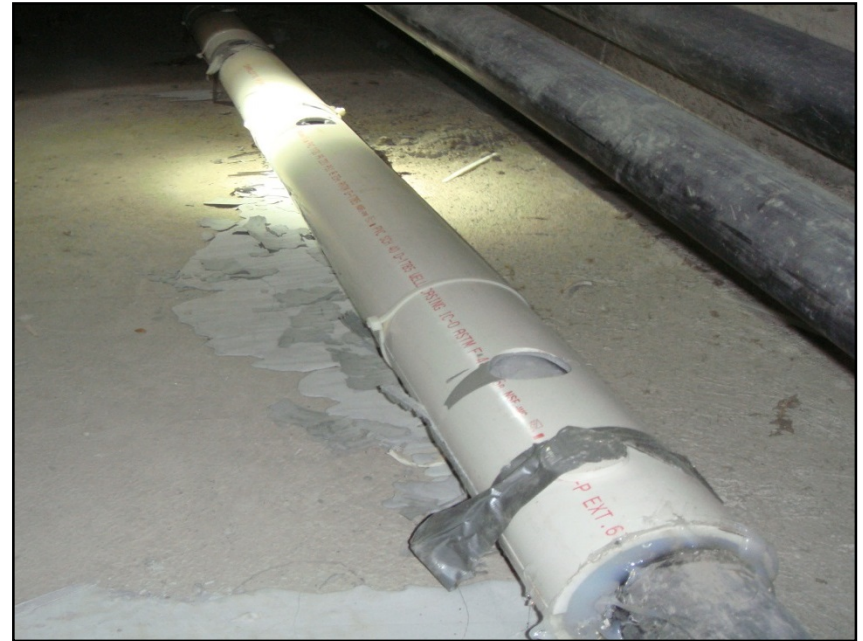
Example - Inadequate Duct Repair

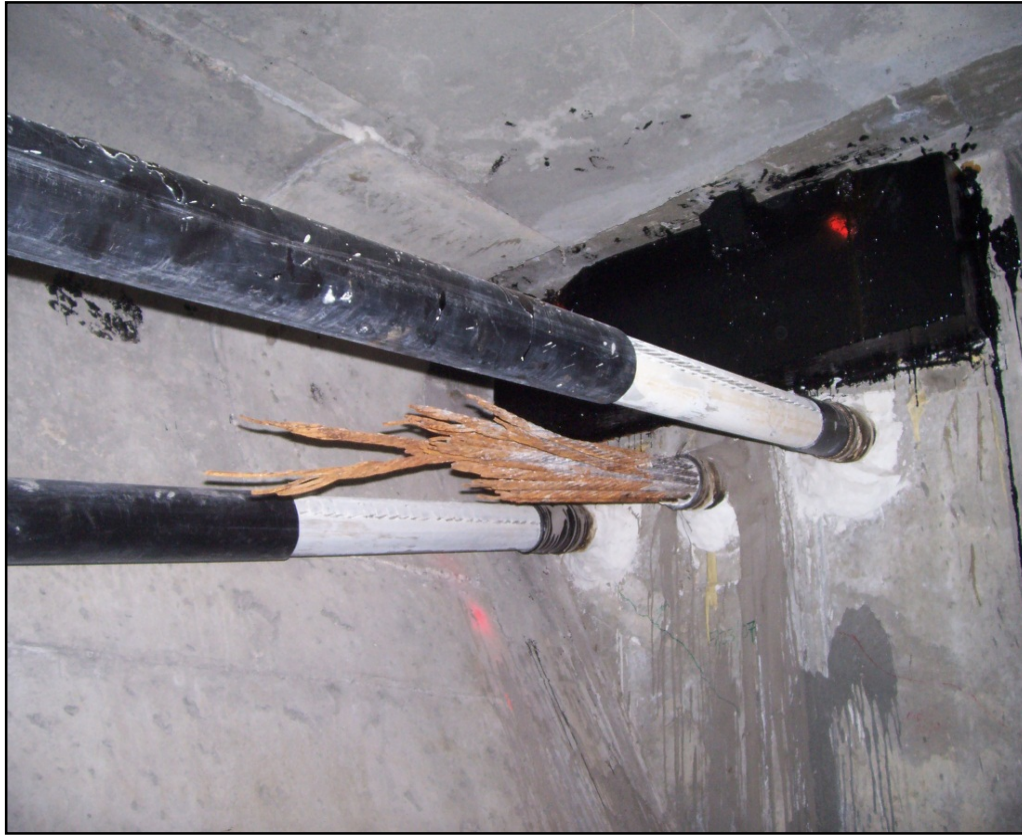
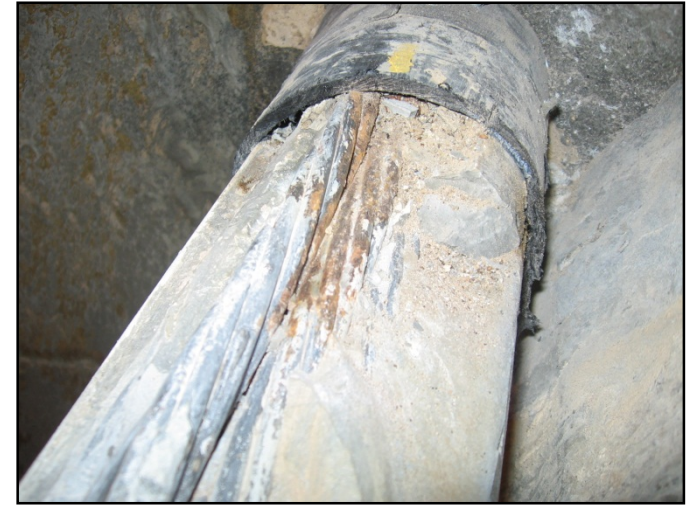
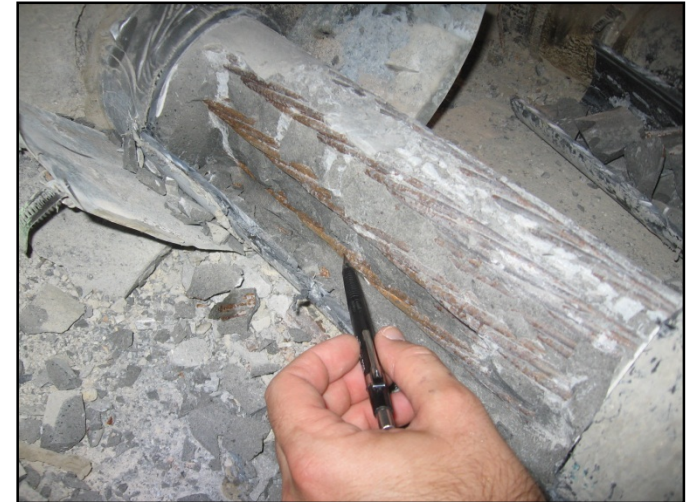
Example – Regrouting Materials

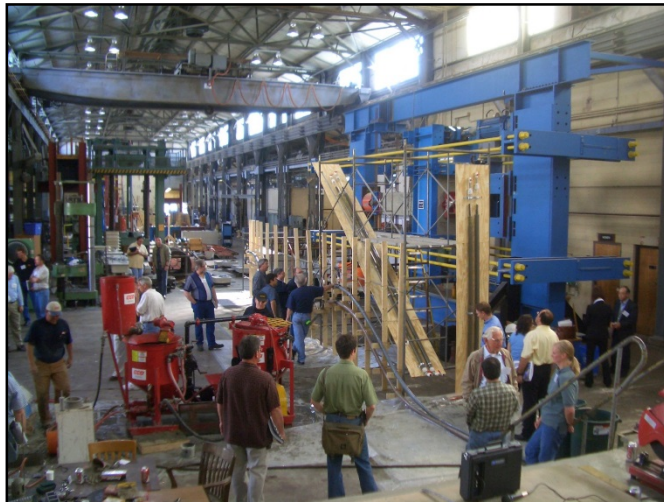
New Procedures and Grouts

ASBI Inclined Tube Example

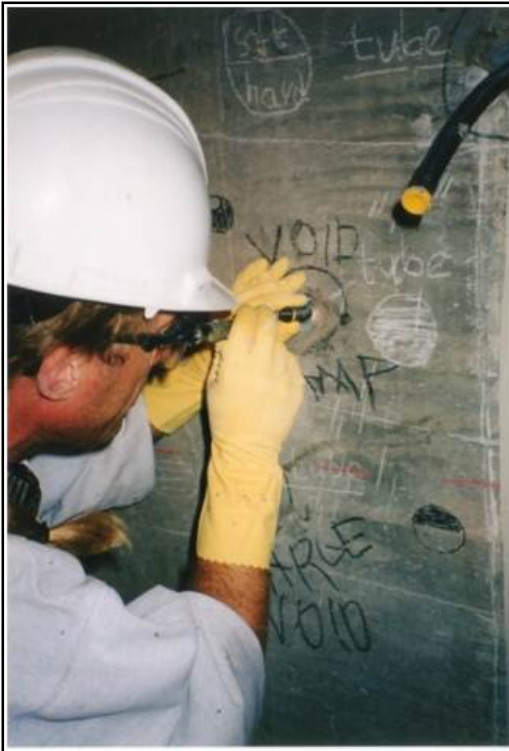
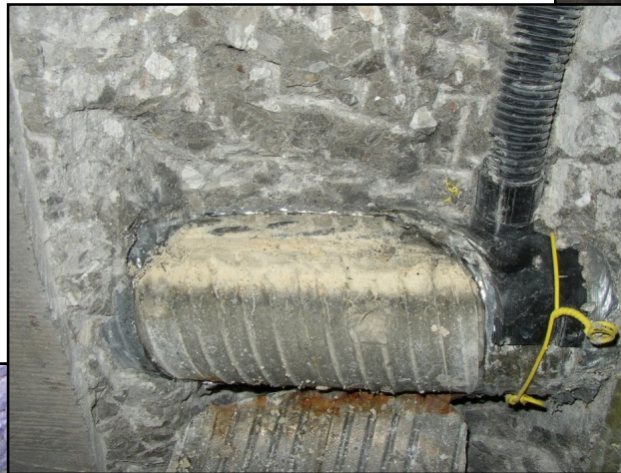
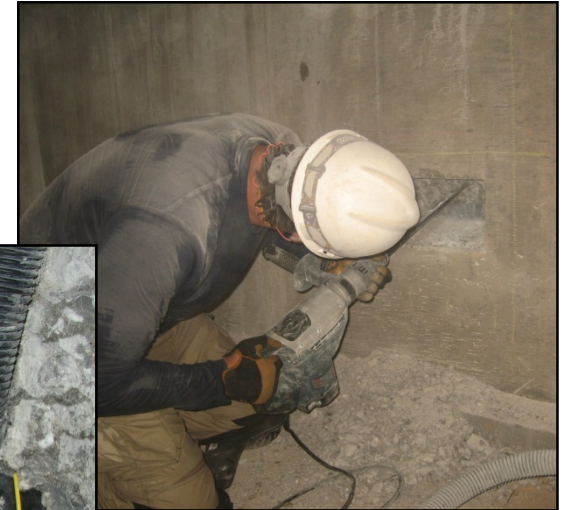
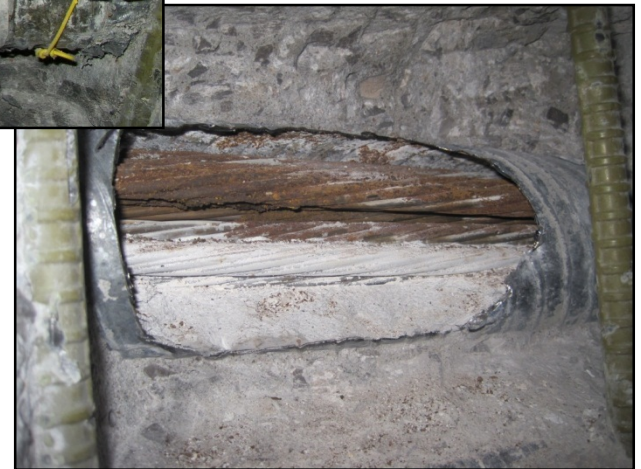
WJE PT Assessment Methods

- High Points and Anchor Inspection
 - 1" dia. drill hole openings
 - Slightly bigger duct openings

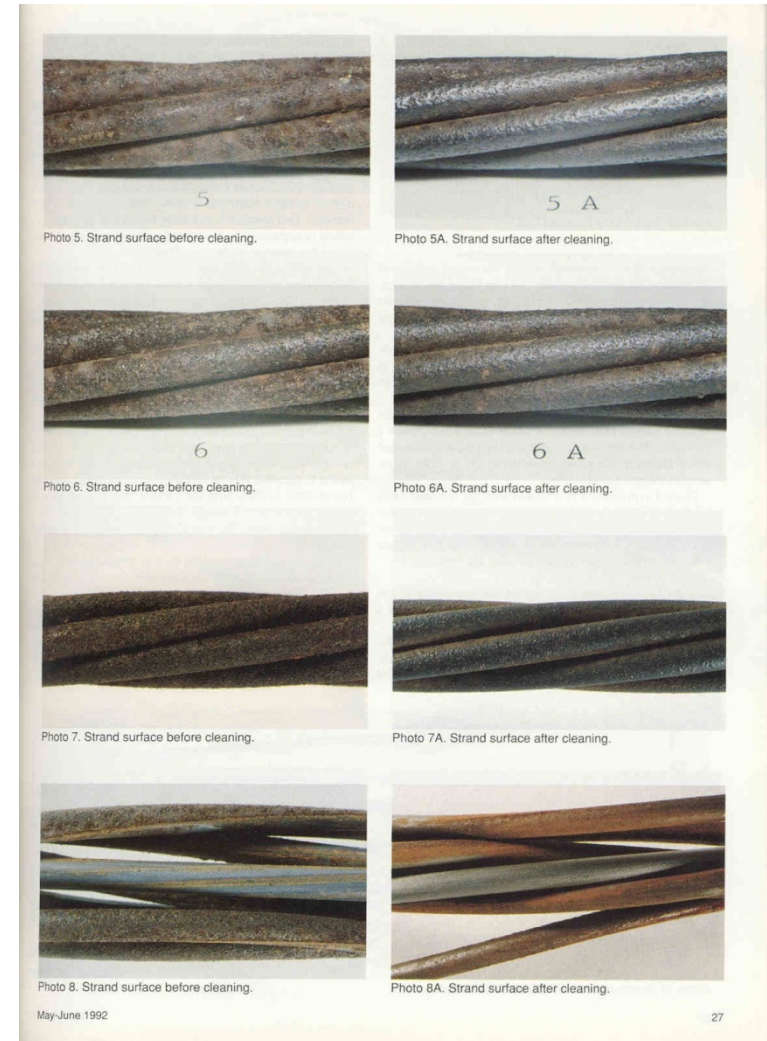
PCI Grading of Strands

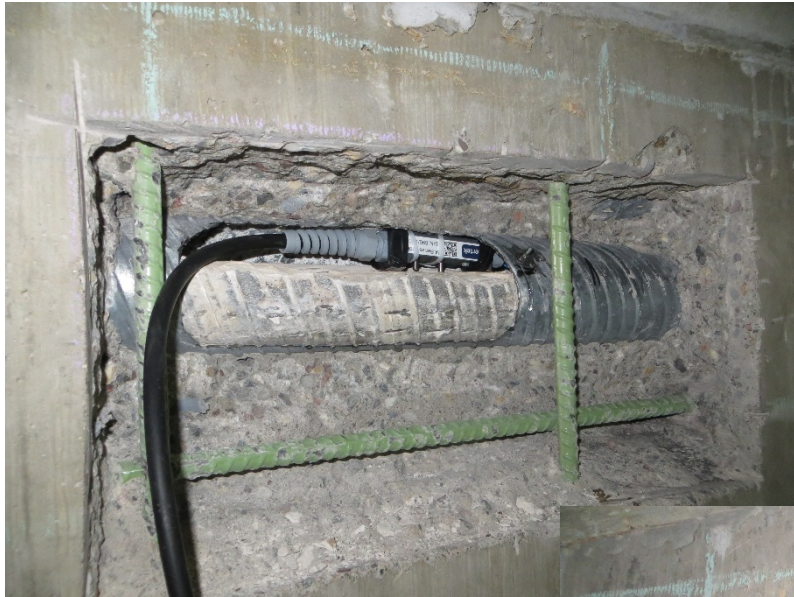
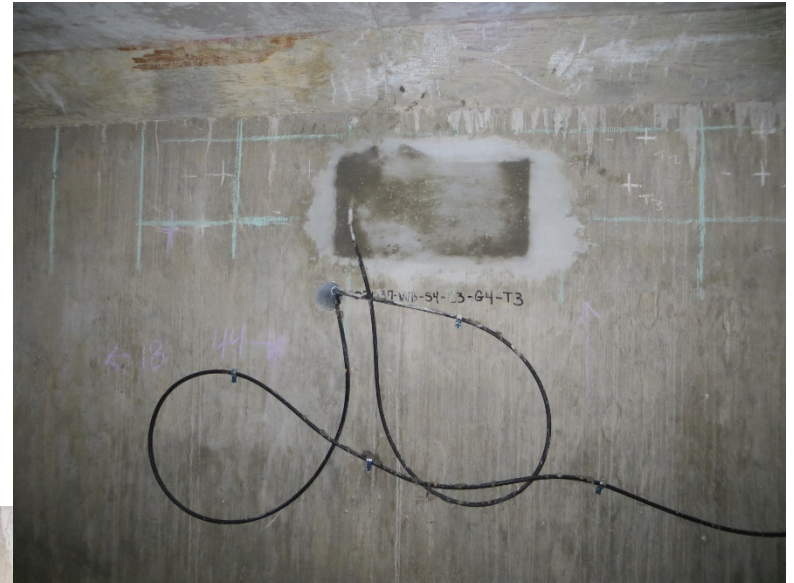
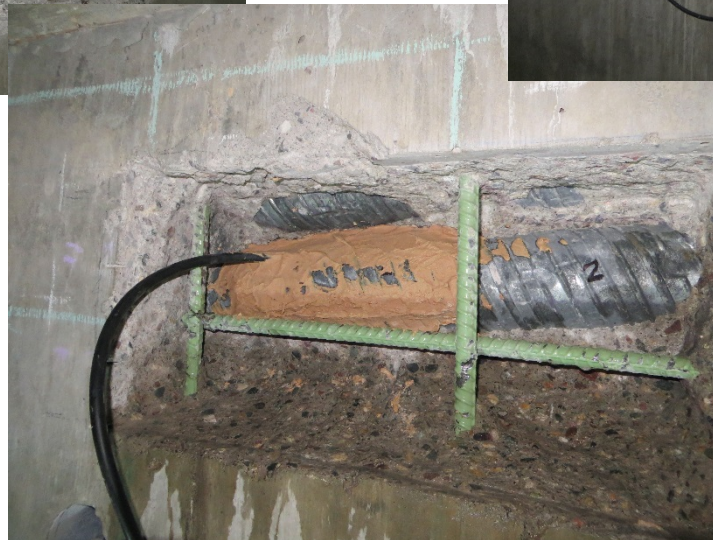
C-Probe Data

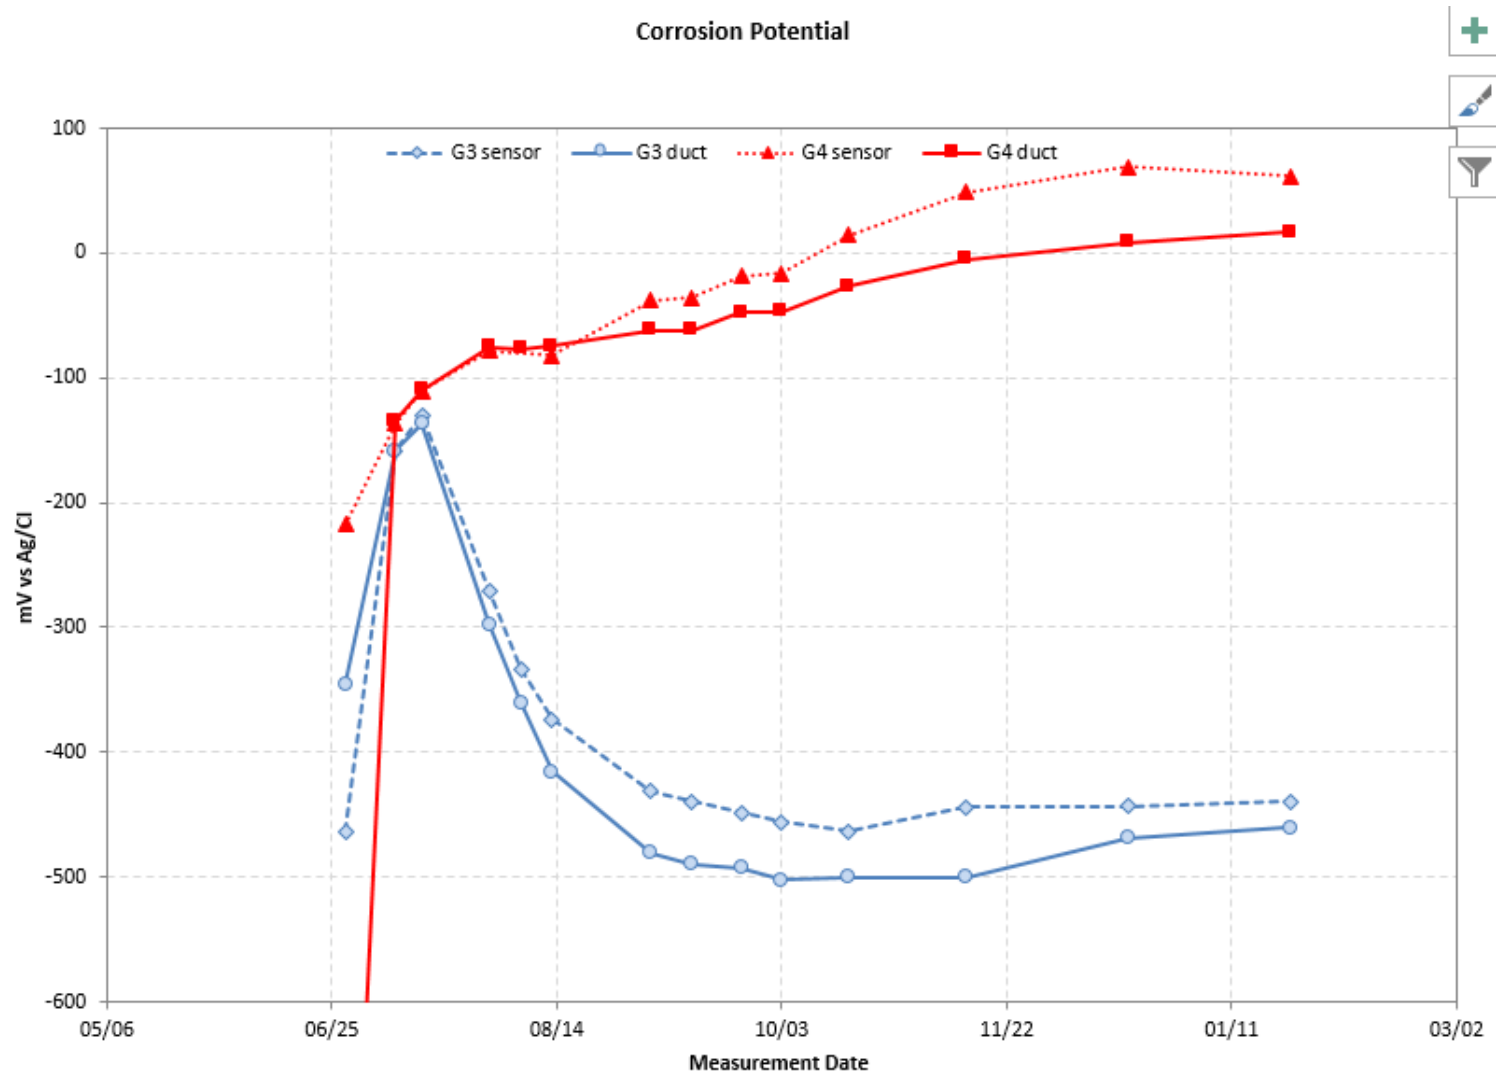
C-Probe Data

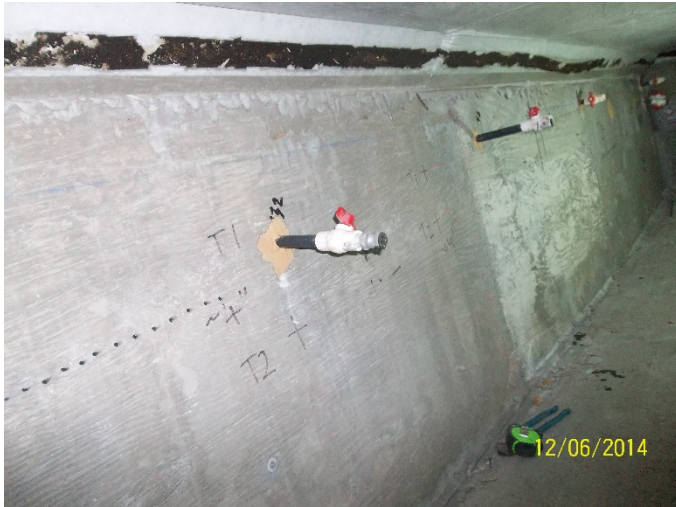
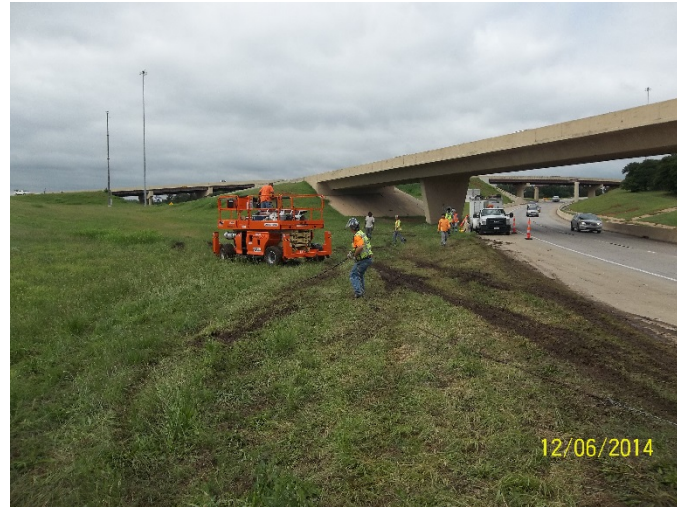
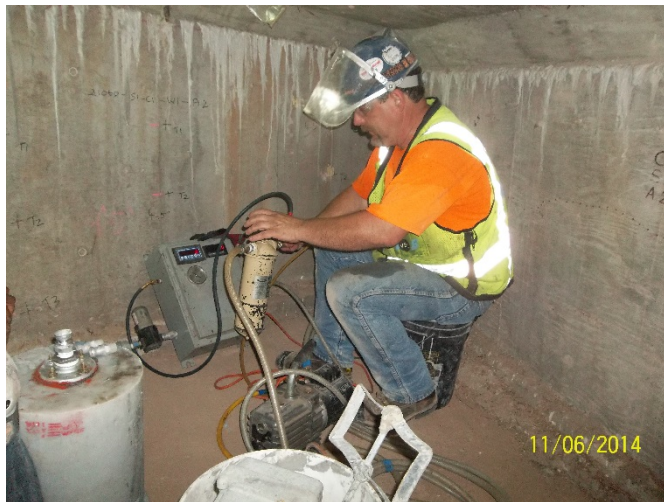
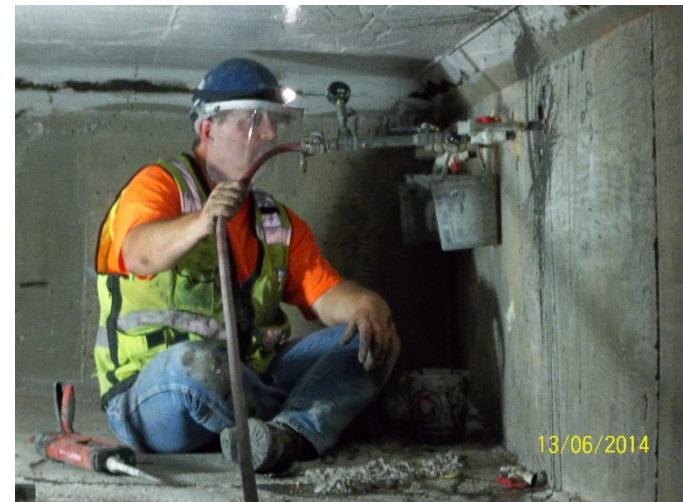
Vacuum Assisted Grouting

- May do nothing if:
 - No grout voids, corrosion, or moisture infiltration noted
 - Grout voids observed but strands are protected by grout
- If corrosion, voids, etc. are noted, perform detailed analysis to determine how many strands or tendons are needed
- If repairs are needed:
 - Remedial grouting if strands are exposed, if strands are exposed to air/moisture infiltration (potentially regardless of structural analysis results)
 - Vacuum grouting, vacuum assisted grouting, pressure grouting
 - Make sure new grout is compatible with existing grout
 - Tendon replacement or strengthening (typically external)
 - Rehabilitation of PT anchor protection systems (install permanent grout caps)
 - HDPE pipe repair (heat shrink sleeves)
- As an alternate, consider periodic assessments/monitoring
