# SEISMIC RETROFIT AND REHABILITATION OF GEORGIA STREET BRIDGE & WALLS

Nathan Johnson, PhD, PE

Western  
Bridge  
Engineers'  
Seminar

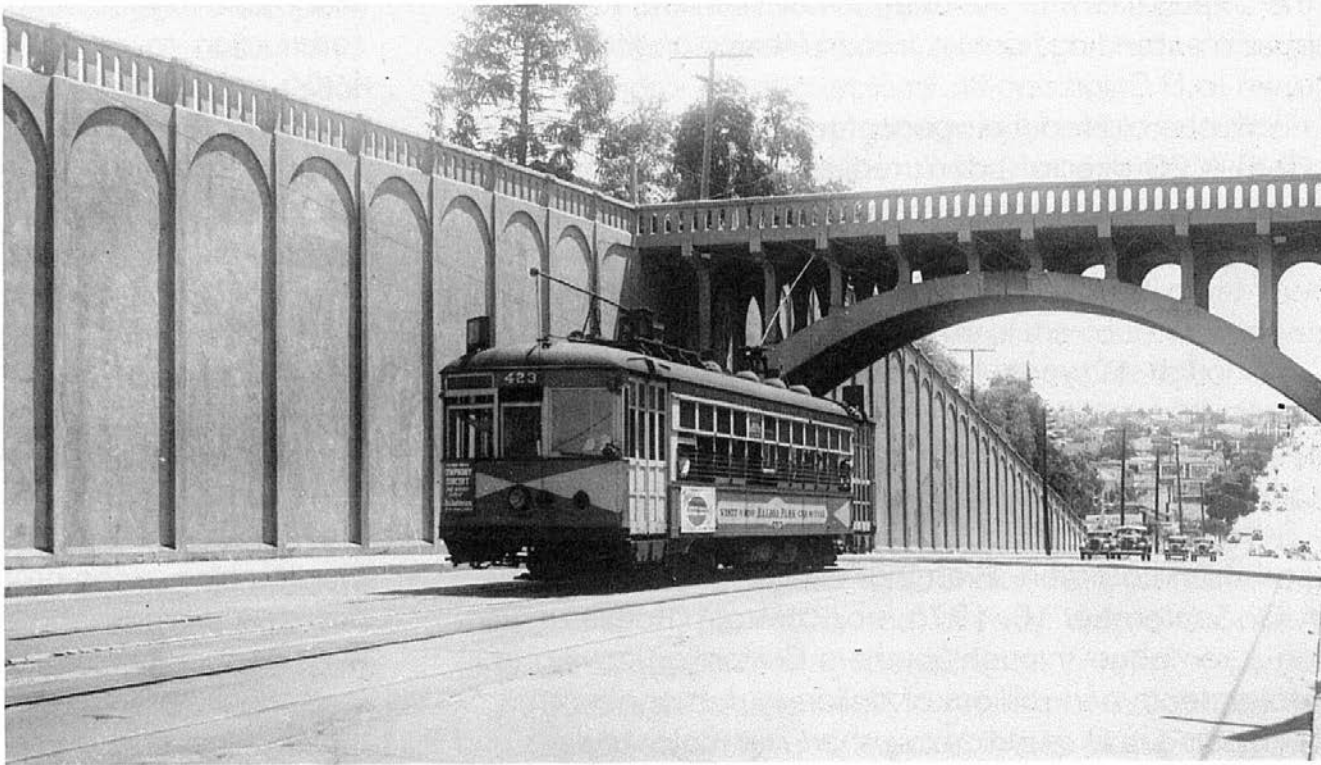
# Georgia Street Timeline

- Built in 1914 in San Diego, CA
- Two 640-Foot Long Anchor Block Retaining Walls
- 3-Hinge Concrete Arch Bridge

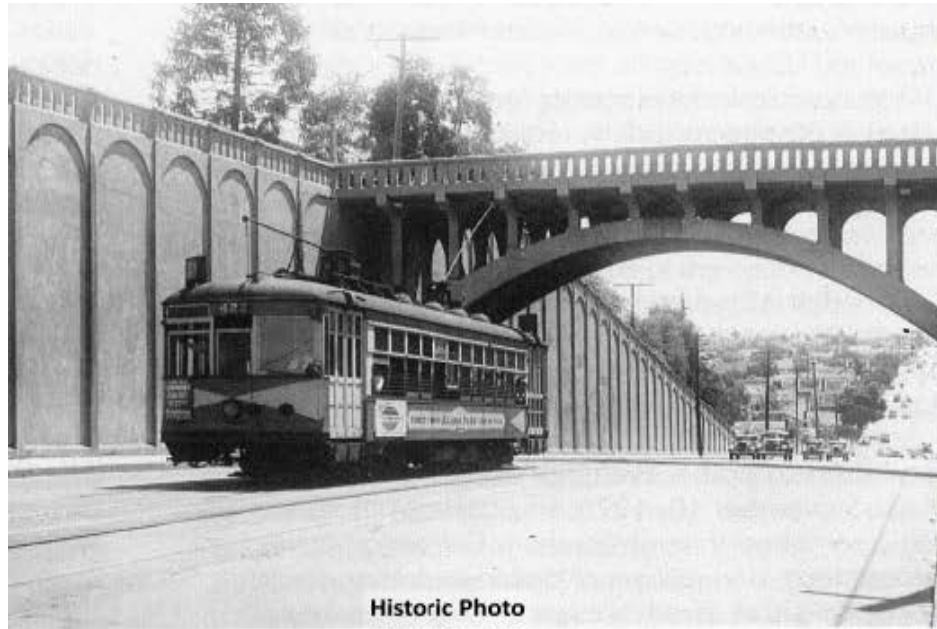
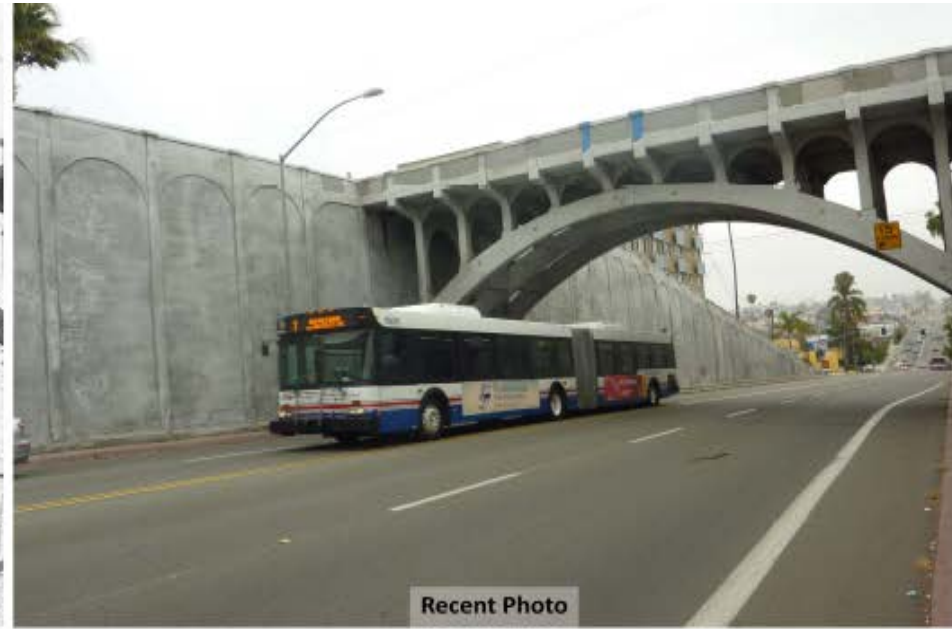
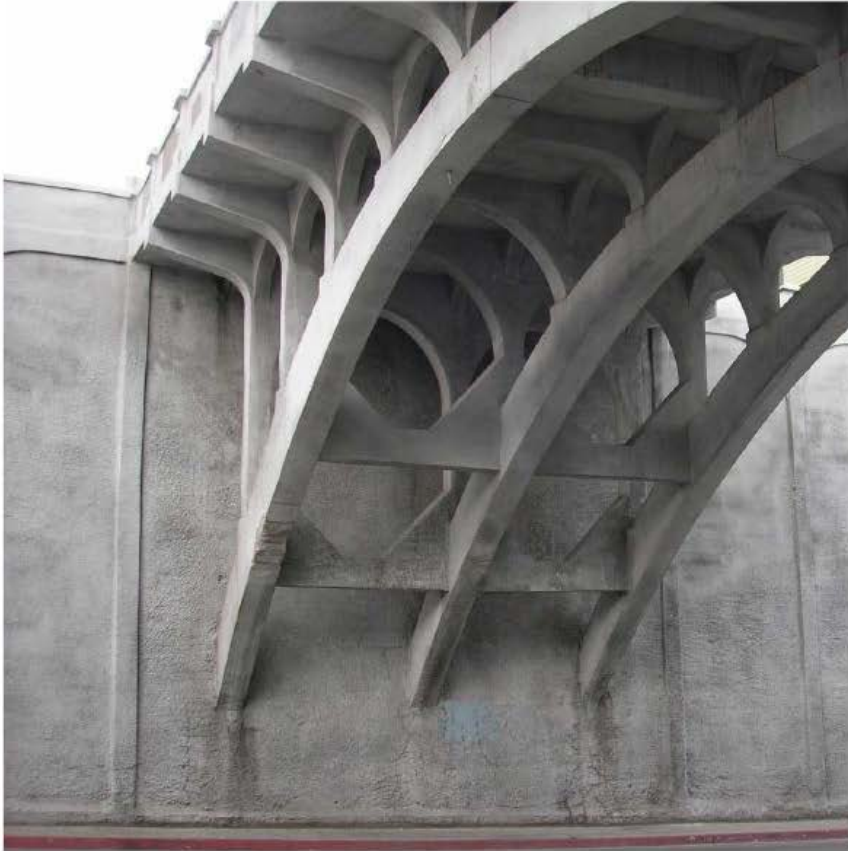
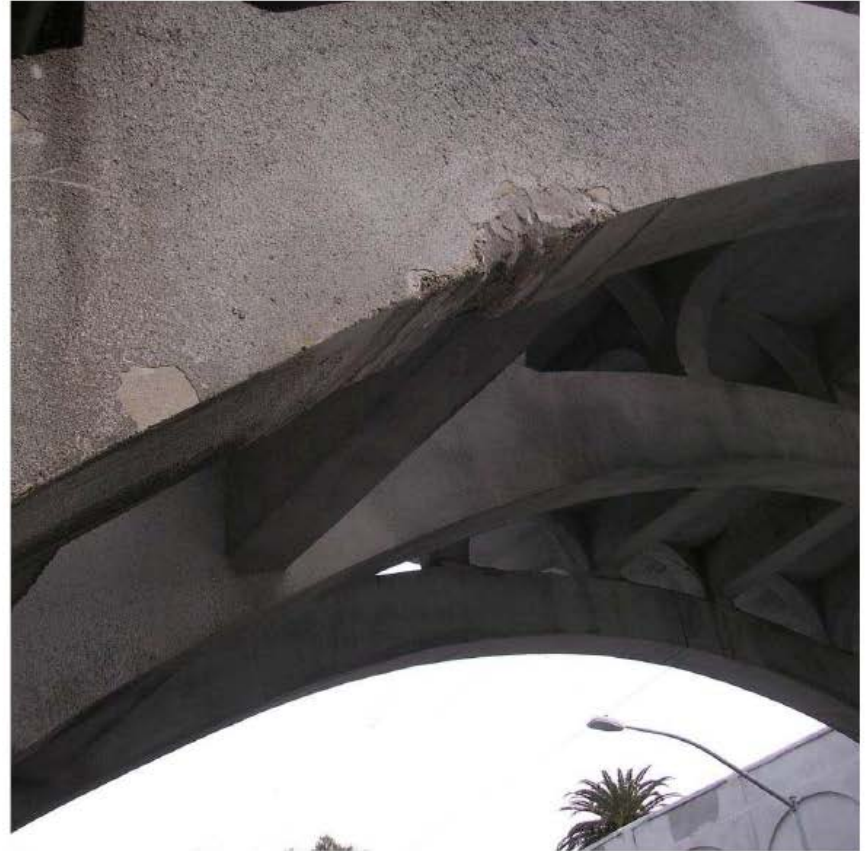
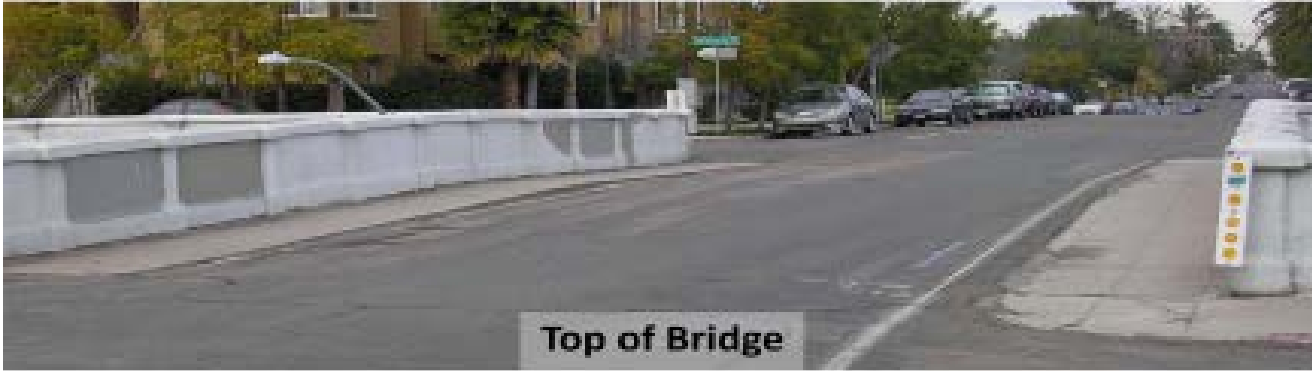
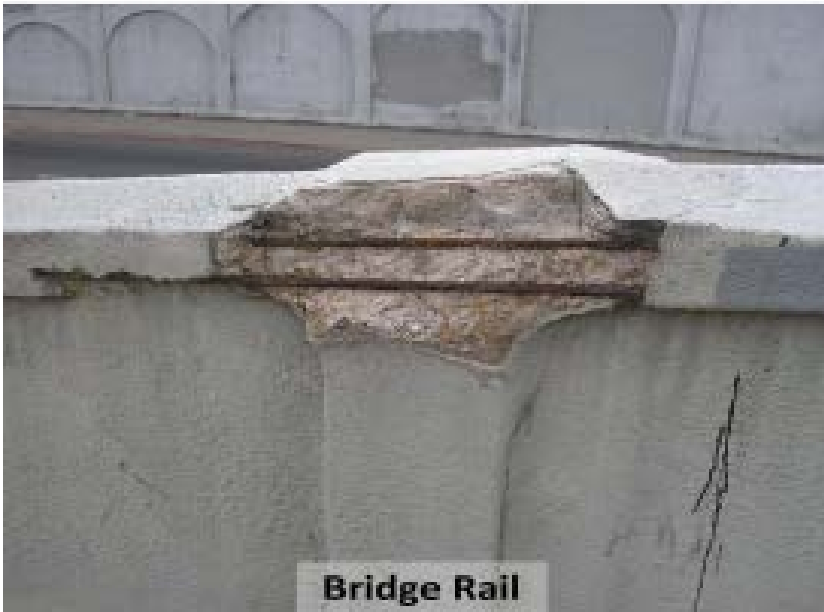
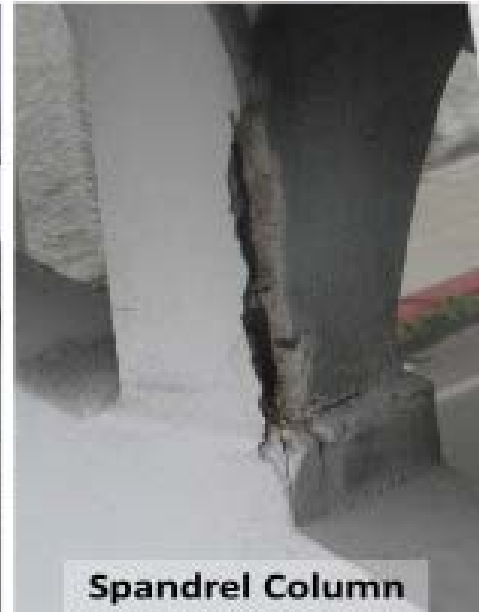
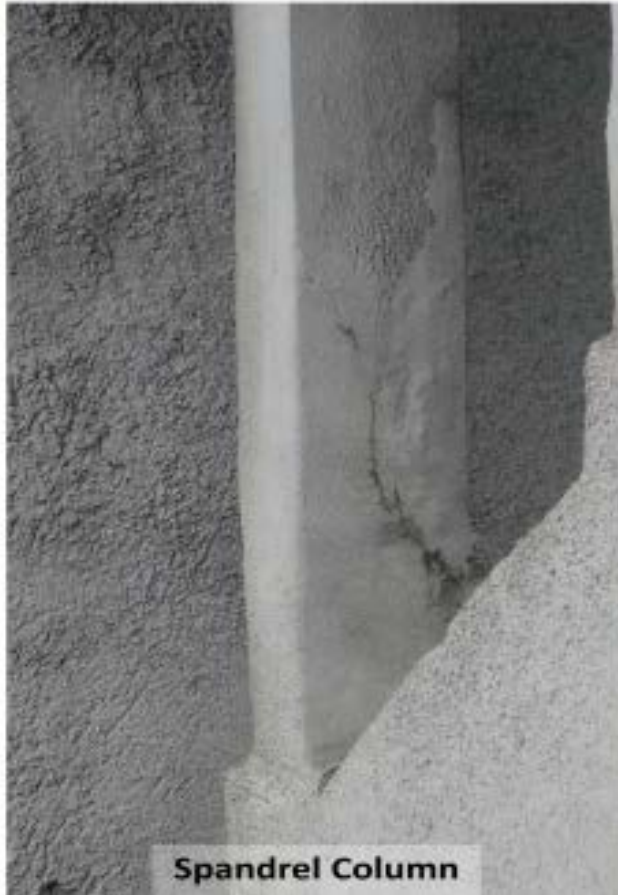
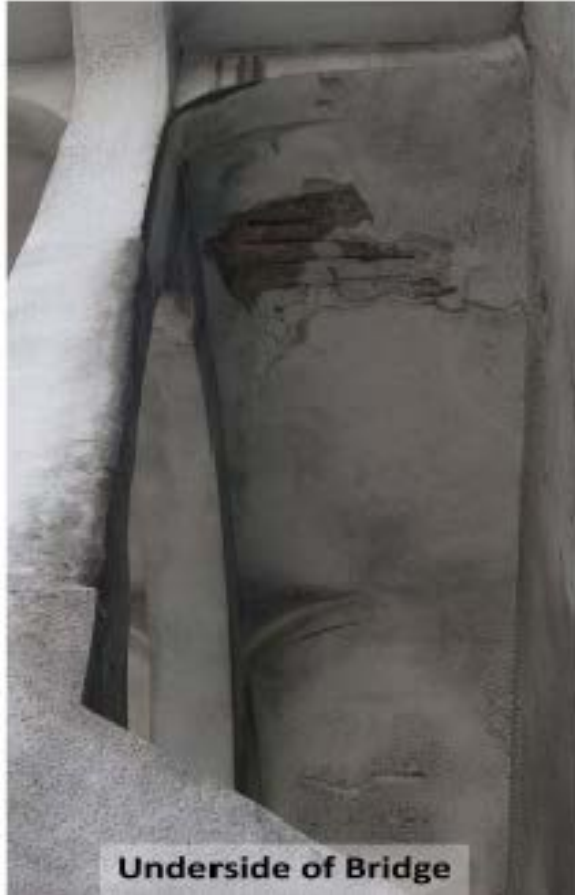
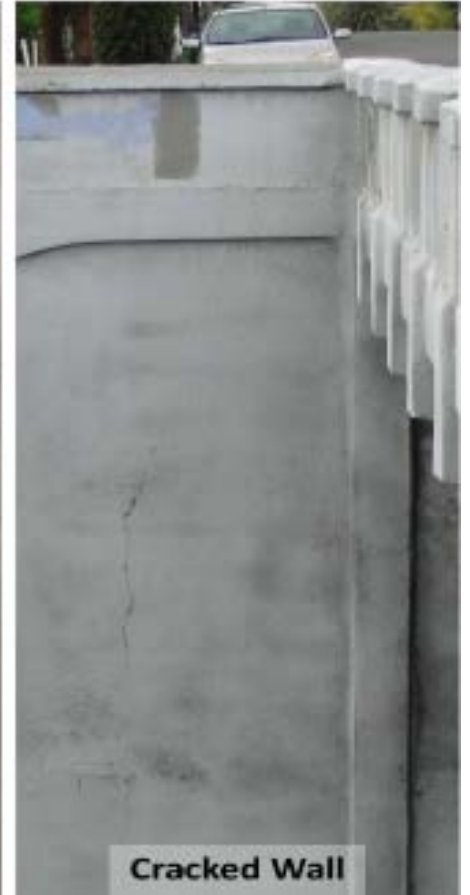
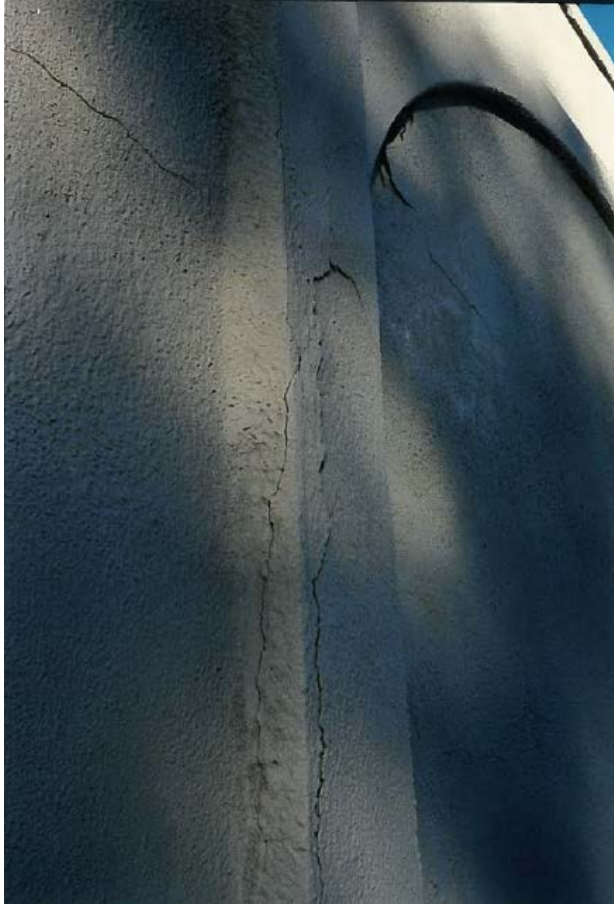
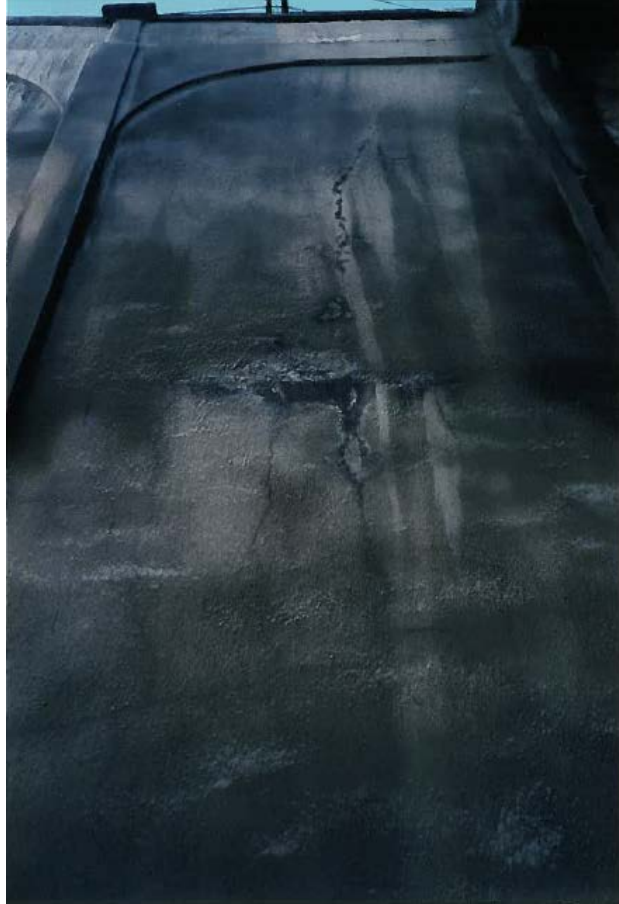
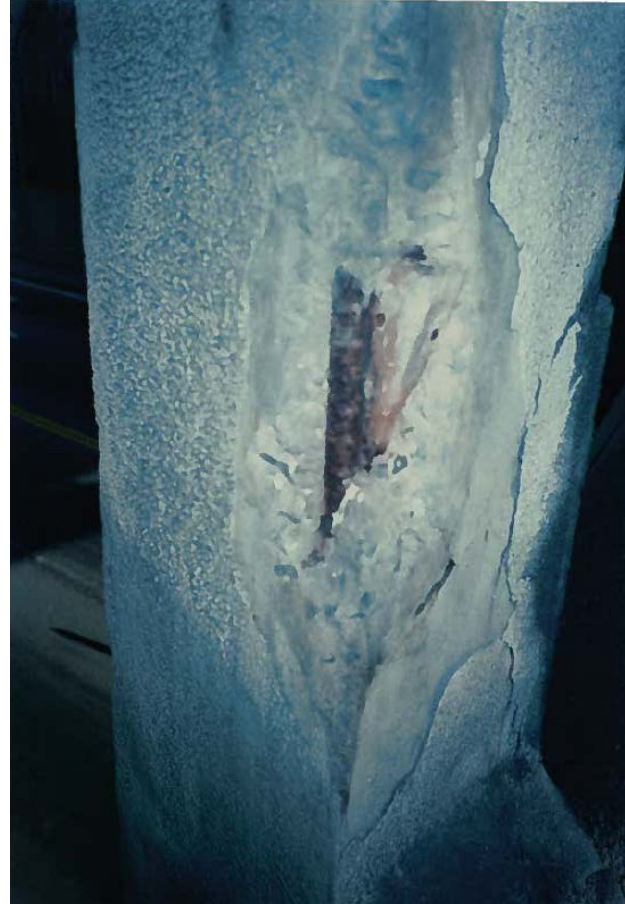
# Existing Condition

Structurally Deficient  
Sufficiency Rating = 44.9

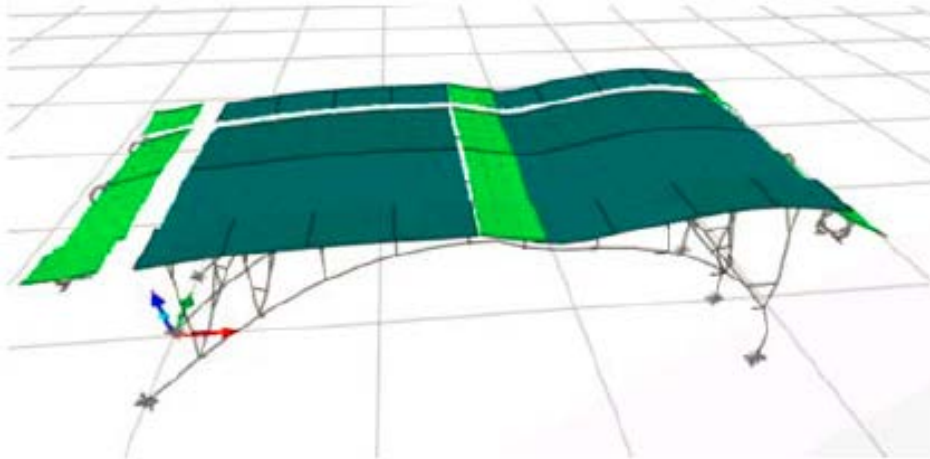
Longitudinal

- CQC frequency with secant stiffness
  - Arch, spandrel, superstructure displacement demands
  - Elastic element demands
  - Influence of foundation stiffness

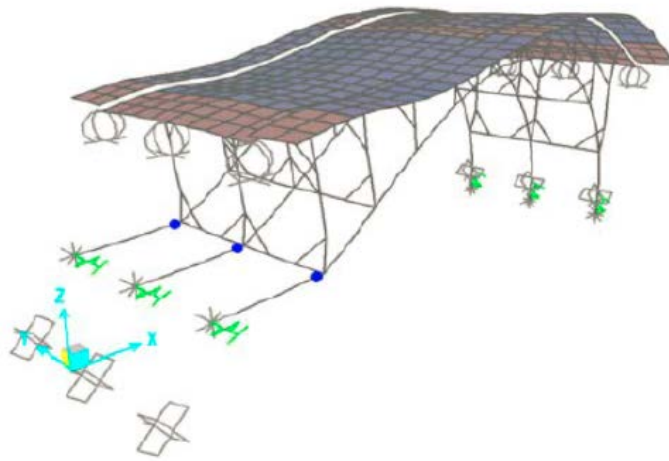
Longitudinal

- System pushover analysis
  - Arch displacement capacity and force demands
  - Bent displacement capacities and force demands

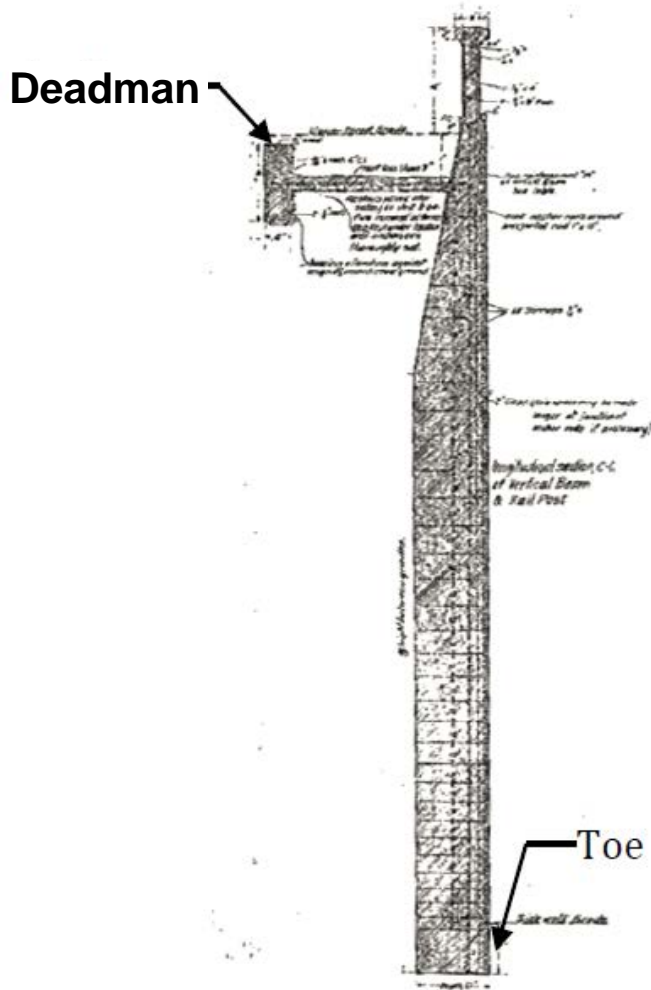
# Wall D/C Analysis

Element of Abutment or Attached Wall Beam	Unit	D/C Ratio		
		Case 1	Case 2	Case 2
		Static (added cohesion)	Static design	Seismic design
Abutment Toe Passive + Friction	(kip)	0.36	1.17	2.14
Abutment Deadman Passive	(kip)	0.26	1.17	1.55
Abutment Deadman Rod	(kip)	0.07	0.33	0.44
Abutment Deadman Shear	(kip)	0.05	0.23	0.30
Abutment Vertical Beam Moment	(kip-ft)	0.09	0.33	0.56
Abutment Vertical Beam Shear	(kip)	0.08	0.28	0.47
Lagging Bending Moment (3/8 in bar)	(kip-ft)	0.02	0.10	0.10
Lagging Bending Moment (1/2 in bar)	(kip-ft)	0.02	0.08	0.11
Lagging Bending Moment (5/8 in bar)	(kip-ft)	0.02	0.07	0.13
Wall Beam Toe Passive + Friction	(kip)	0.67	2.14	4.05
Wall Beam Deadman Passive	(kip)	1.33	5.22	7.99
Wall Beam Deadman Rod	(kip)	0.16	0.64	0.97
Wall Beam Deadman Shear	(kip)	0.69	2.68	4.11
Wall Vertical Beam Moment	(kip-ft)	0.22	0.77	1.35
Wall Vertical Beam Shear @ Top	(kip)	0.34	1.31	2.06
Wall Vertical Beam Shear @ Base	(kip)	0.19	0.61	1.14

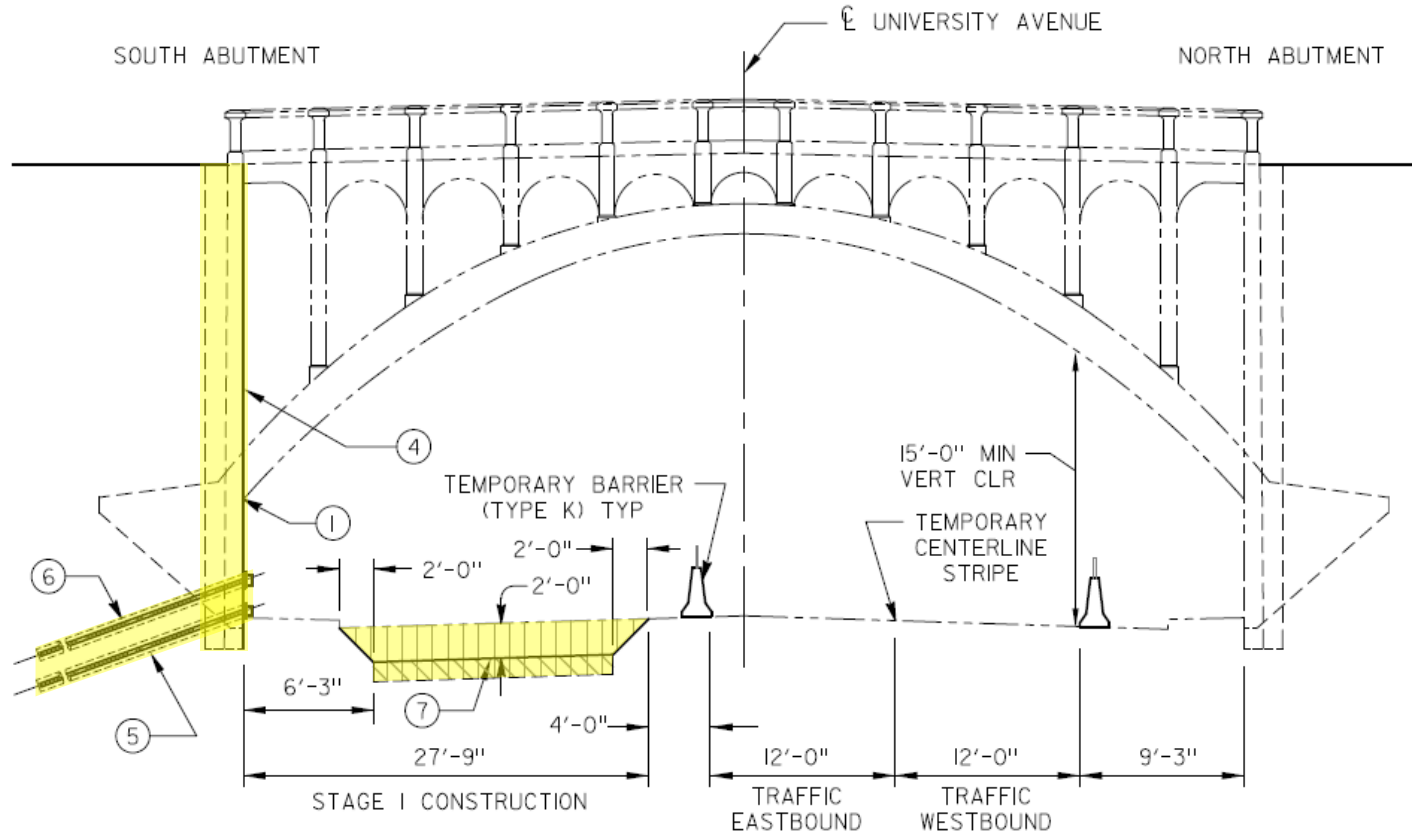
**STAGE 1  
BRIDGE ELEVATION**

- Major Construction Stages
  - Stage 1 – 3
    - Stabilize Walls
    - Partially Stabilize Abutments
    - Lower University Avenue
  - Stage 4A: Partial Demolition of Bridge
  - Stage 4B: Retrofit Abutment Walls
  - Stage 4C: Retrofit Arch-Ribs
  - Stage 4D: Partial Superstructure Reconstruction

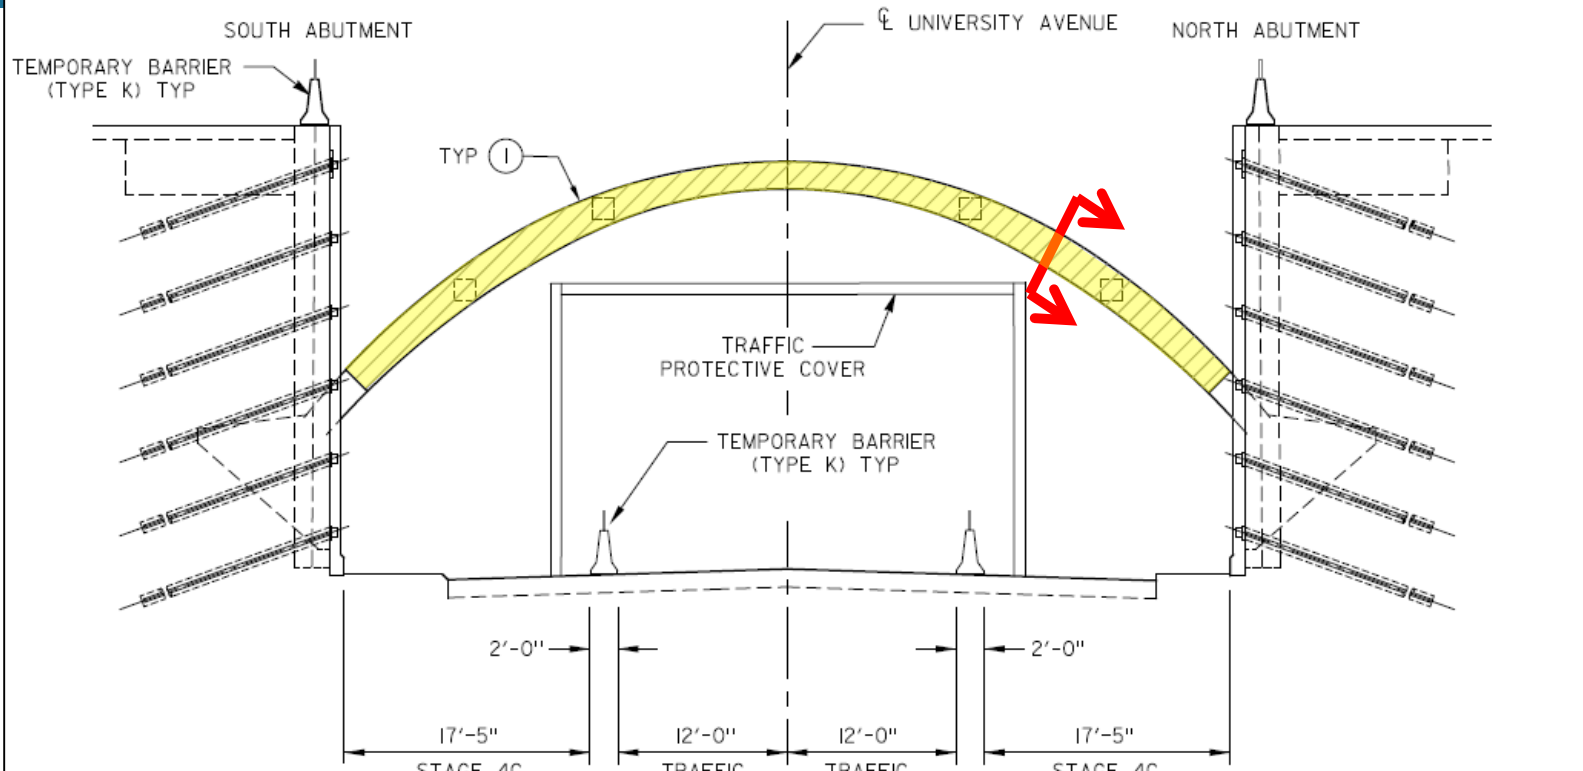
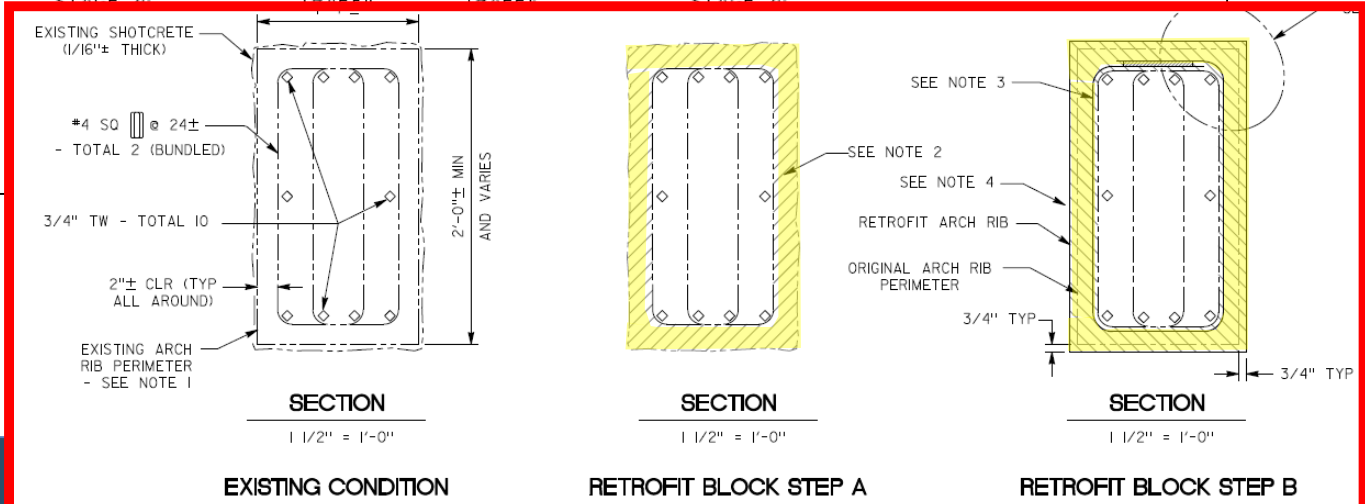
EXISTING CONDITION

RETROFIT BLOCK STEP A

RETROFIT BLOCK STEP B

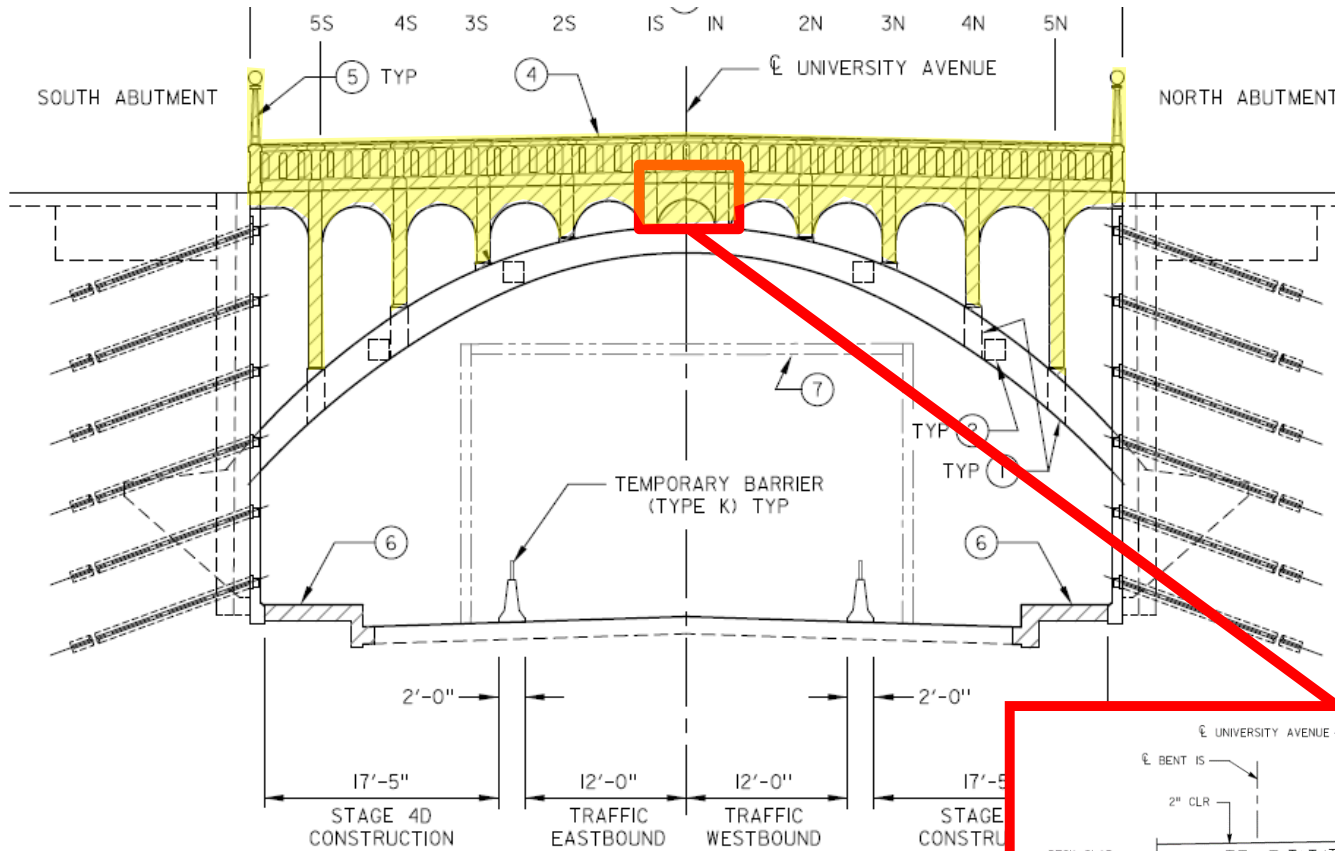
**STAGE 4D  
BRIDGE ELEVATION**

- 1. THE CONTRACTOR MUST SUBMIT DETAILS OF THE RECONSTRUCT OF THE BRIDGE DECK, BENT CAPS, AND COLUMNS TO THE ENGINEER FOR APPROVAL.
