SR-89 Hell Canyon Bridge

MP 345.70

Presentation by Mike Morrison
September 11, 2015

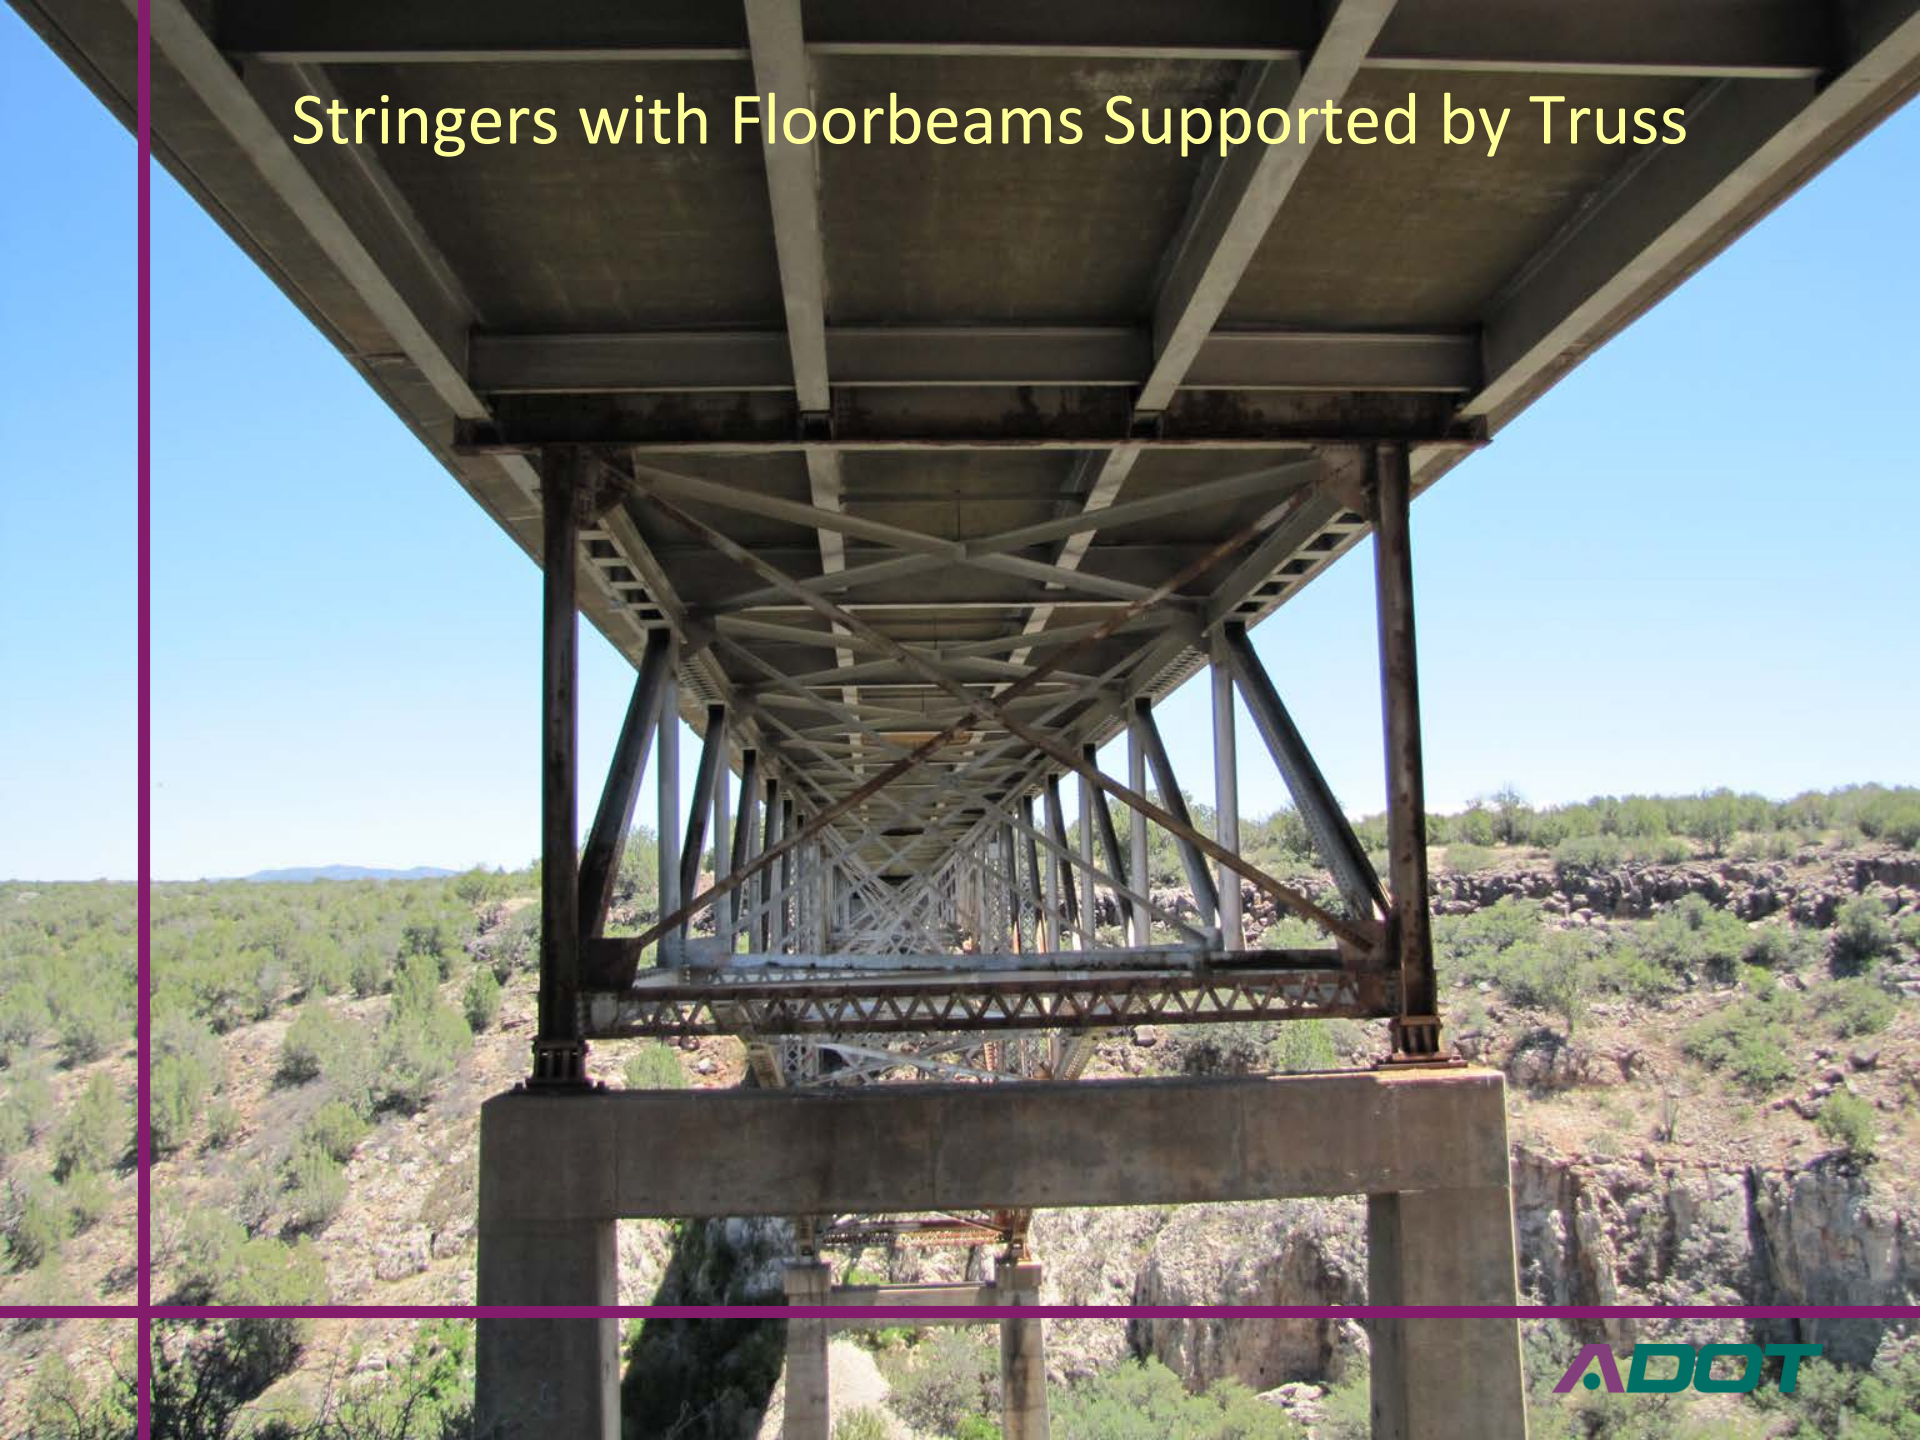
North Face

30-foot layer of volcanic Basalt capping Redwall Limestone

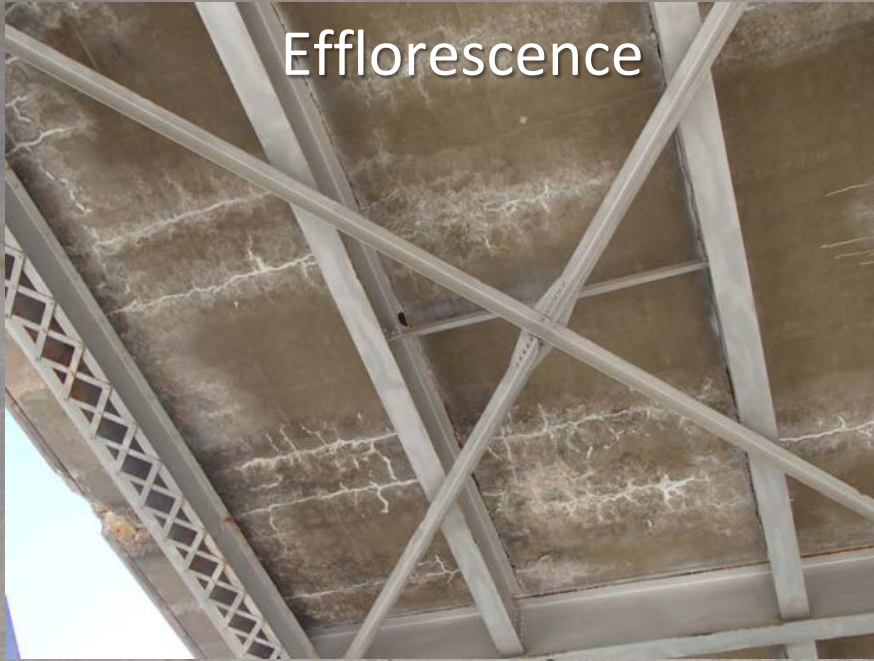
Efflorescence

- Top of Deck: Poor
- Deck Undersurface: Poor
- Deck Overall Rating: Poor

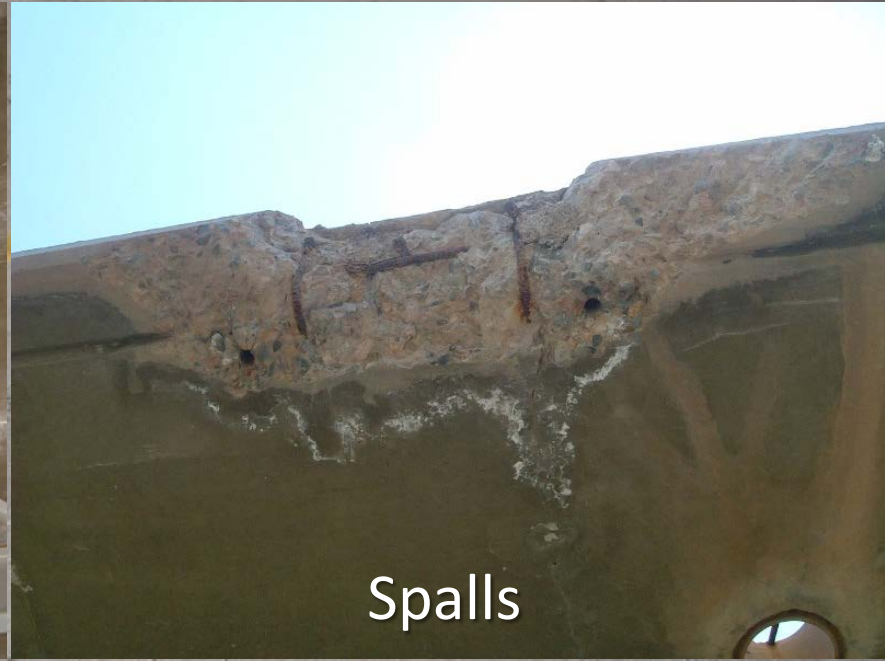
Spalls

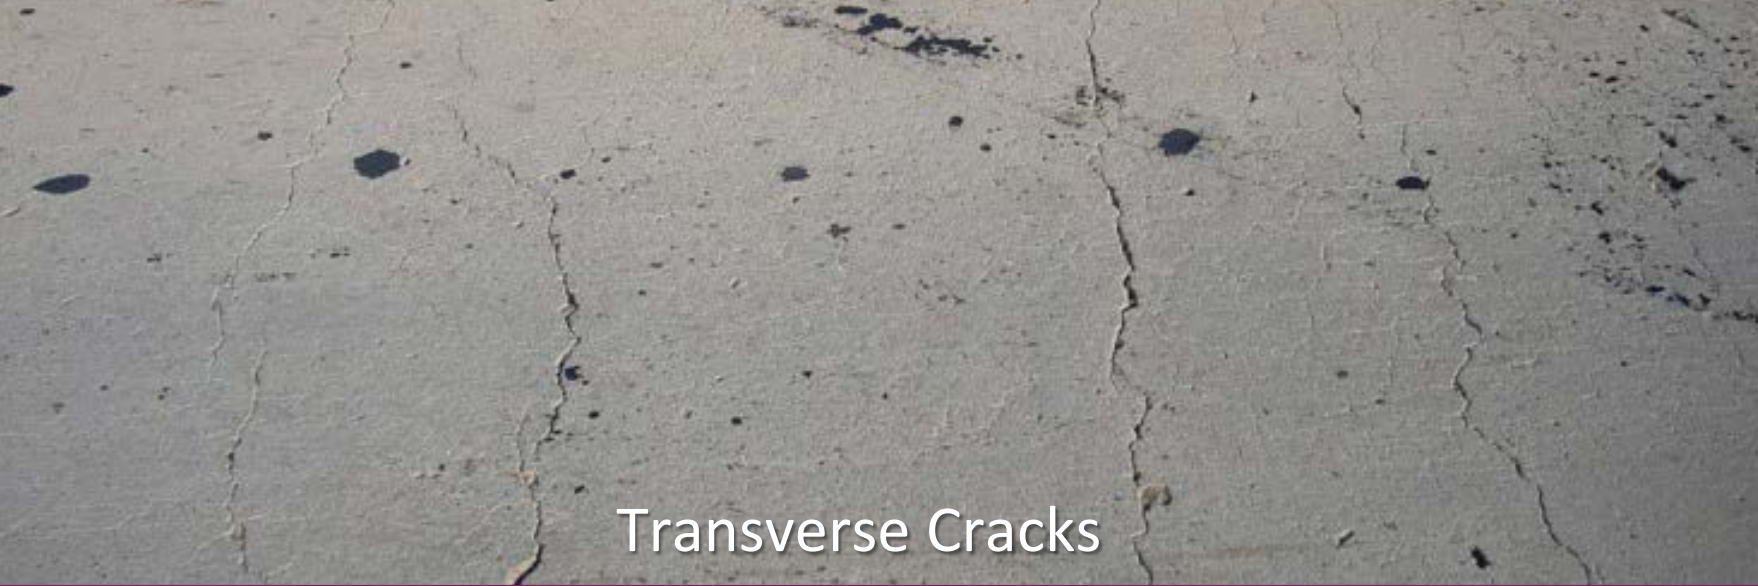
Transverse Cracks

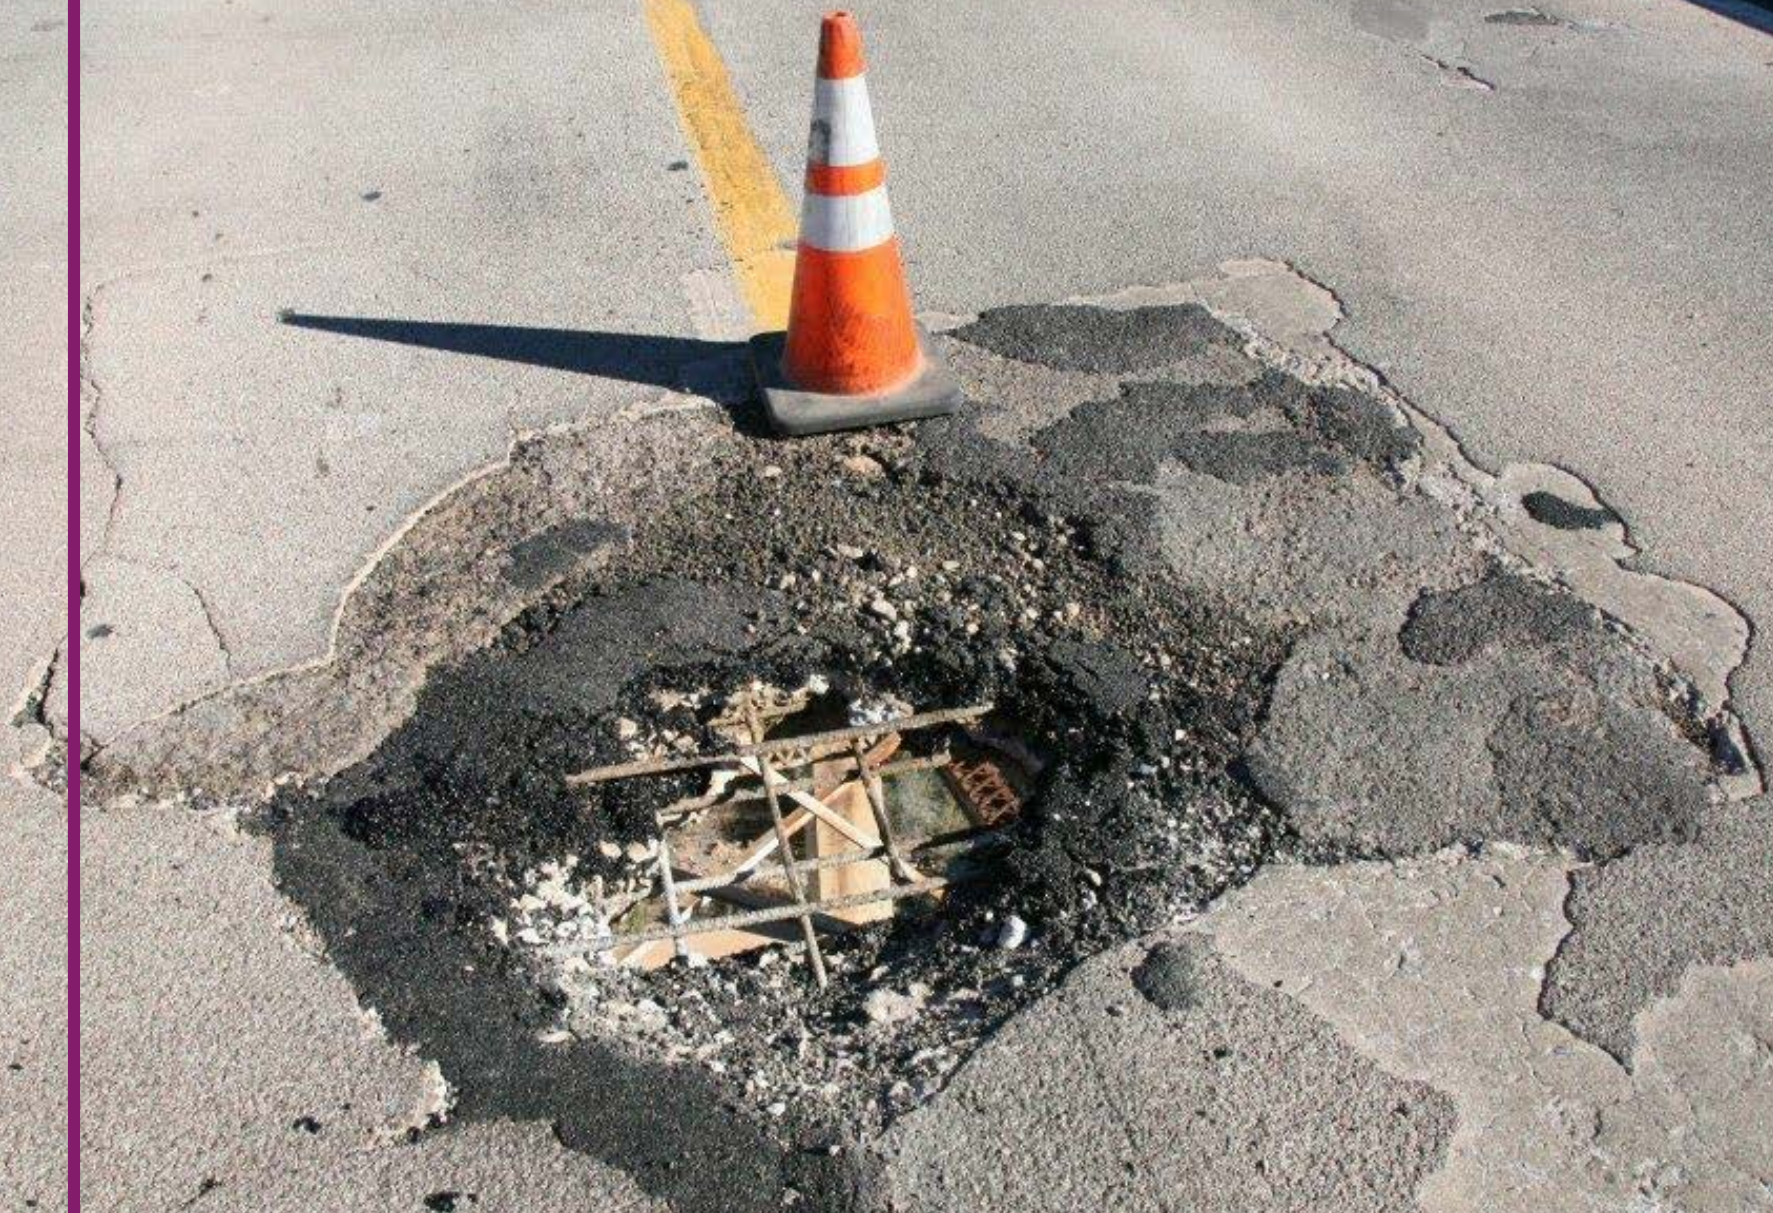
2013 Emergency Deck Repair

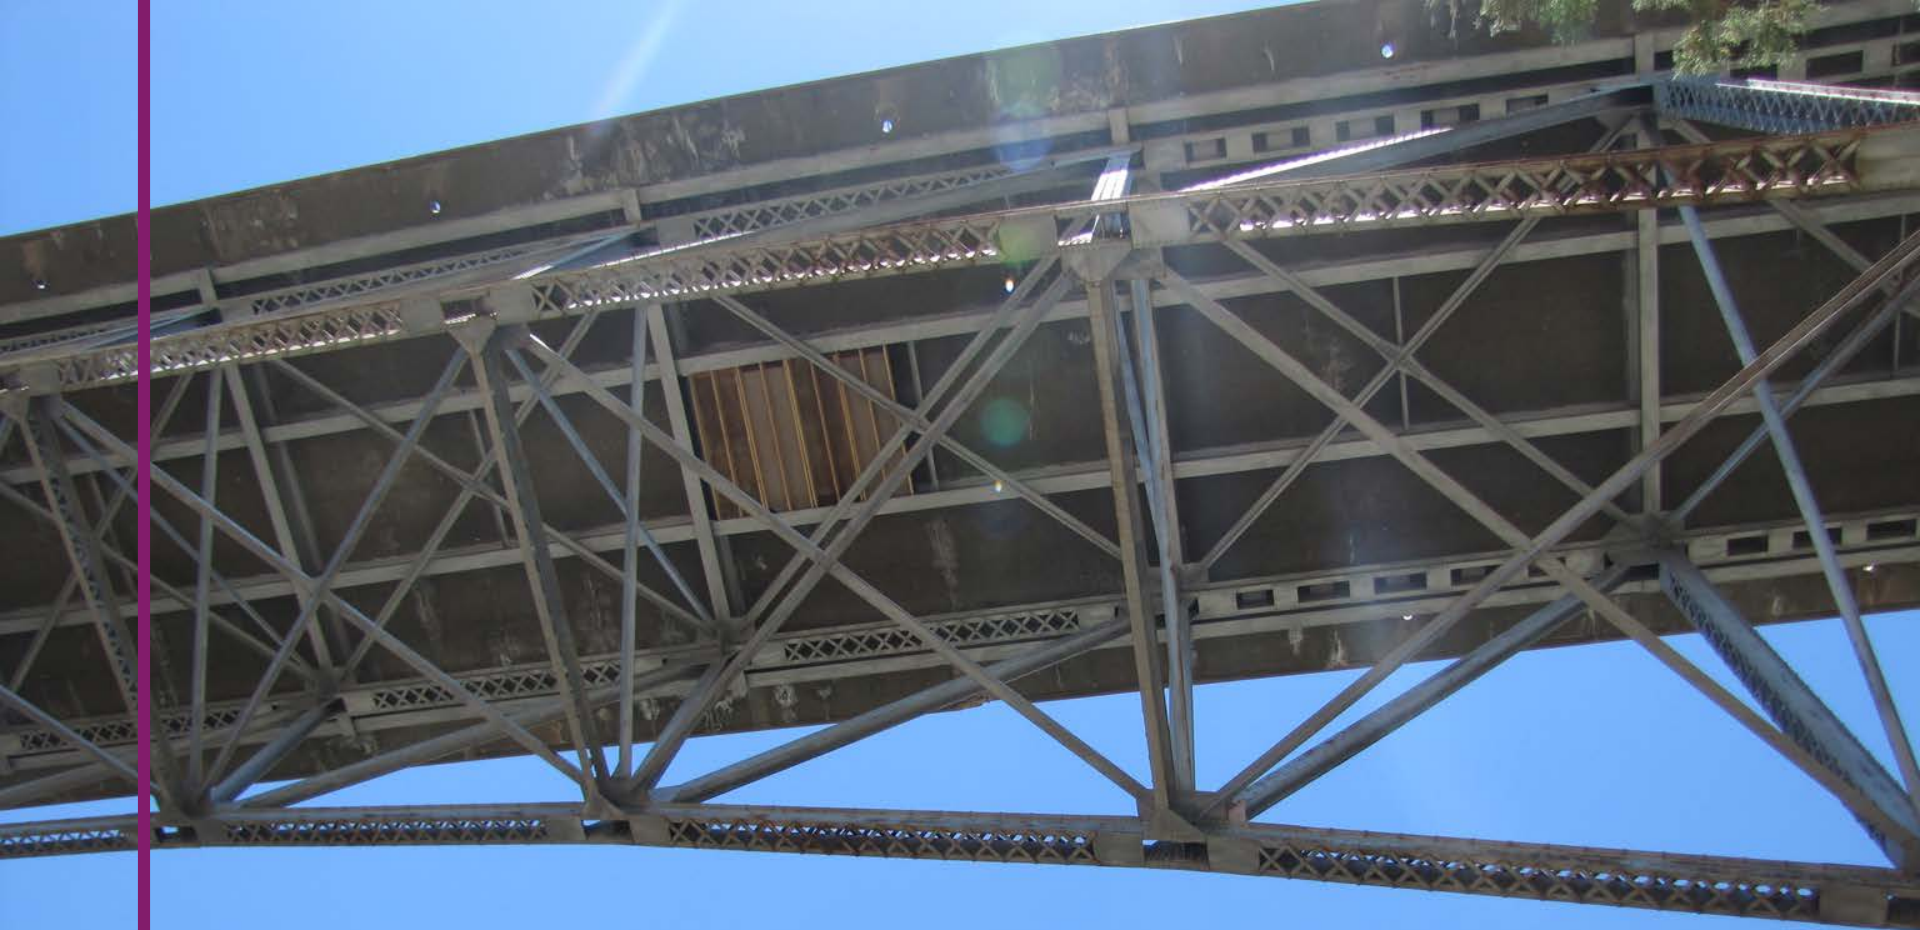
9'x12' Deck Patch

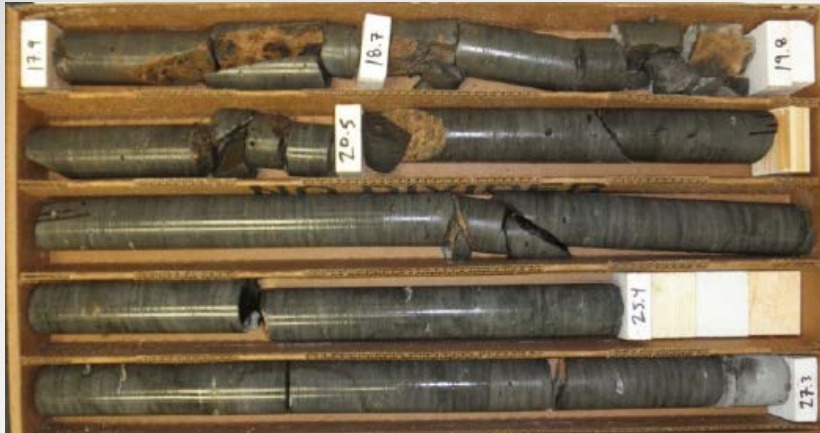
Abutments: Spread Footings
