Renewal of Aging and Deteriorated Reinforced Concrete Bridges with Titanium Alloy Bars (TiABs)

Christopher Higgins, Ph.D., P.E.

Overview

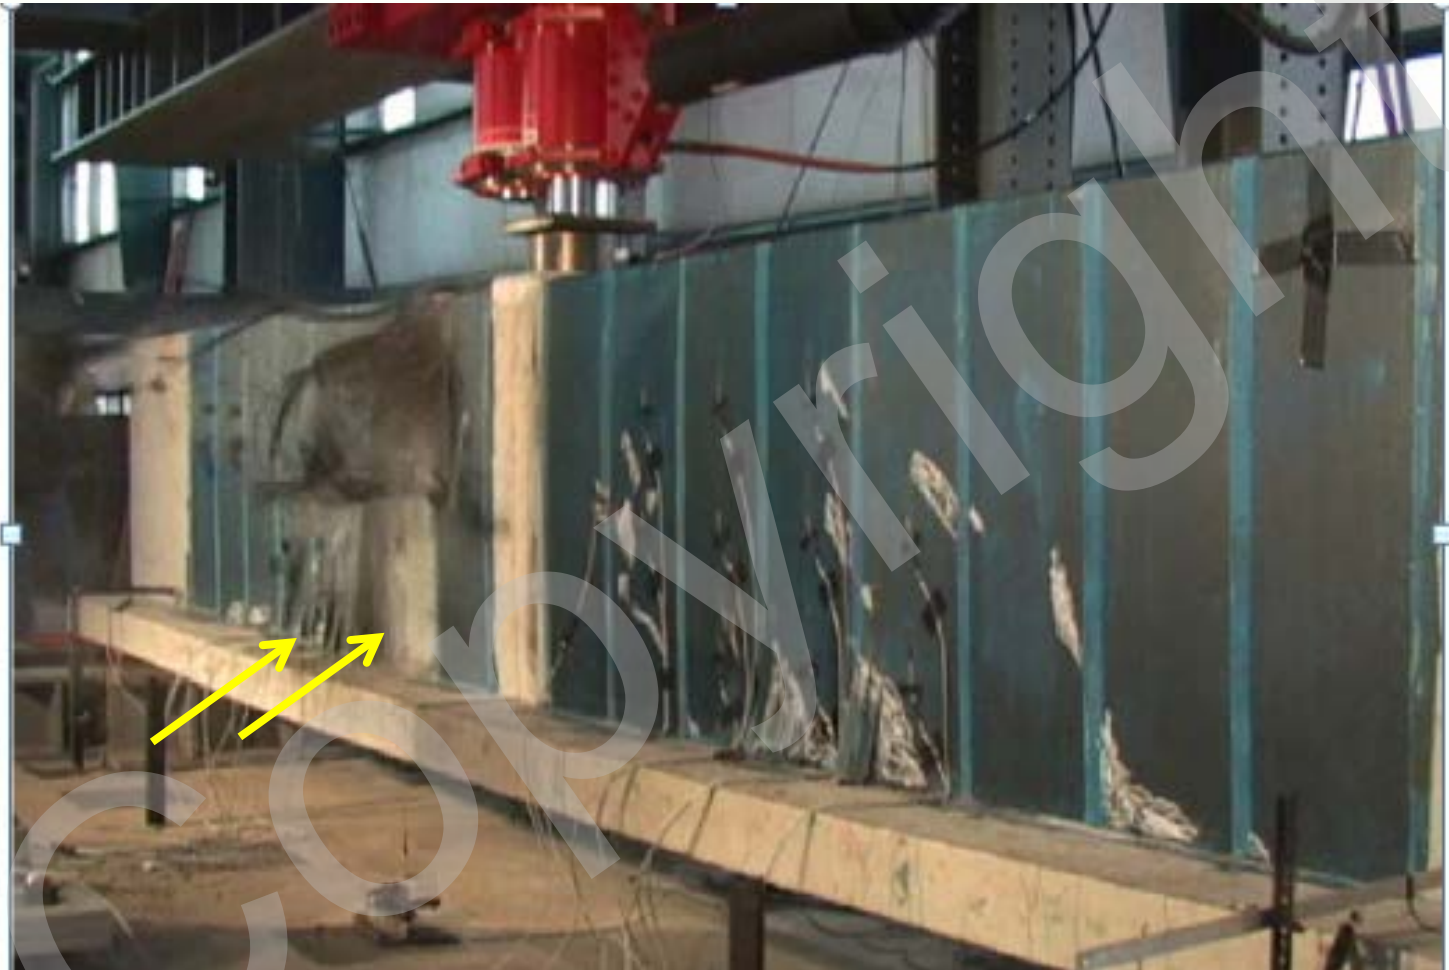
CFRP Bond Failure – Limits material strength

FRP rods and laminates fail due to bond and anchorage and materials are nonductile

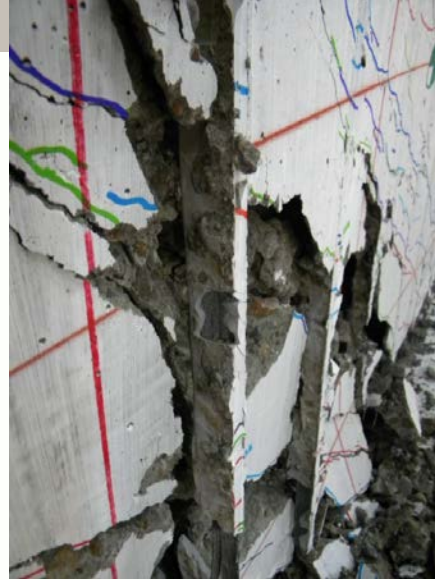
CFRP-NSM

Outer shell peeling

Inner core cracked diagonally

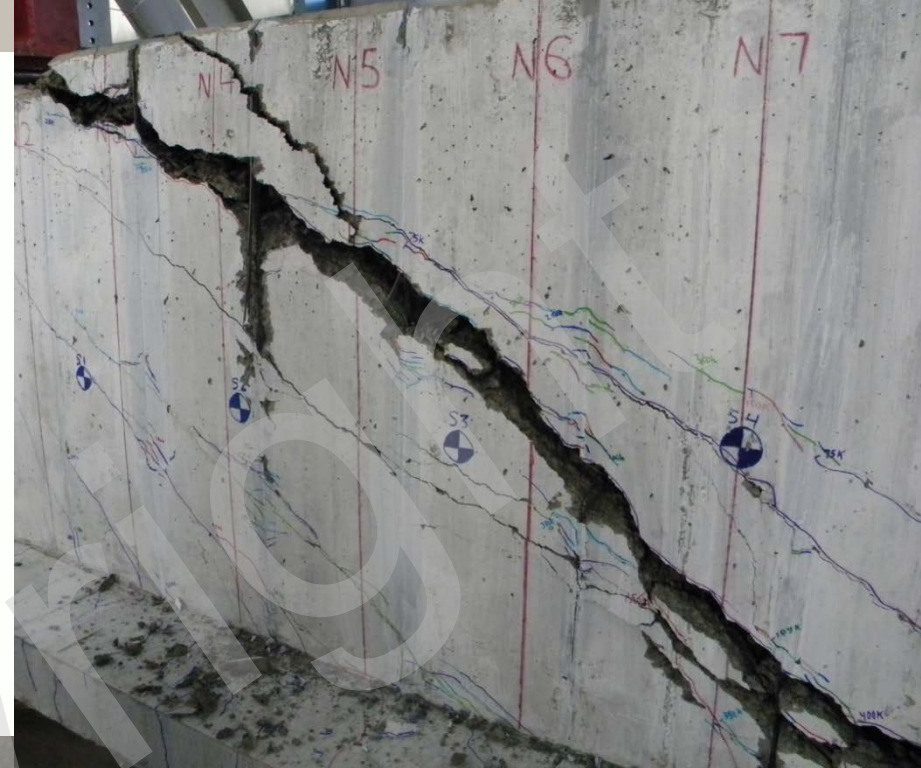
Wide CFRP-NSM

Tightly spaced CFRP-NSM

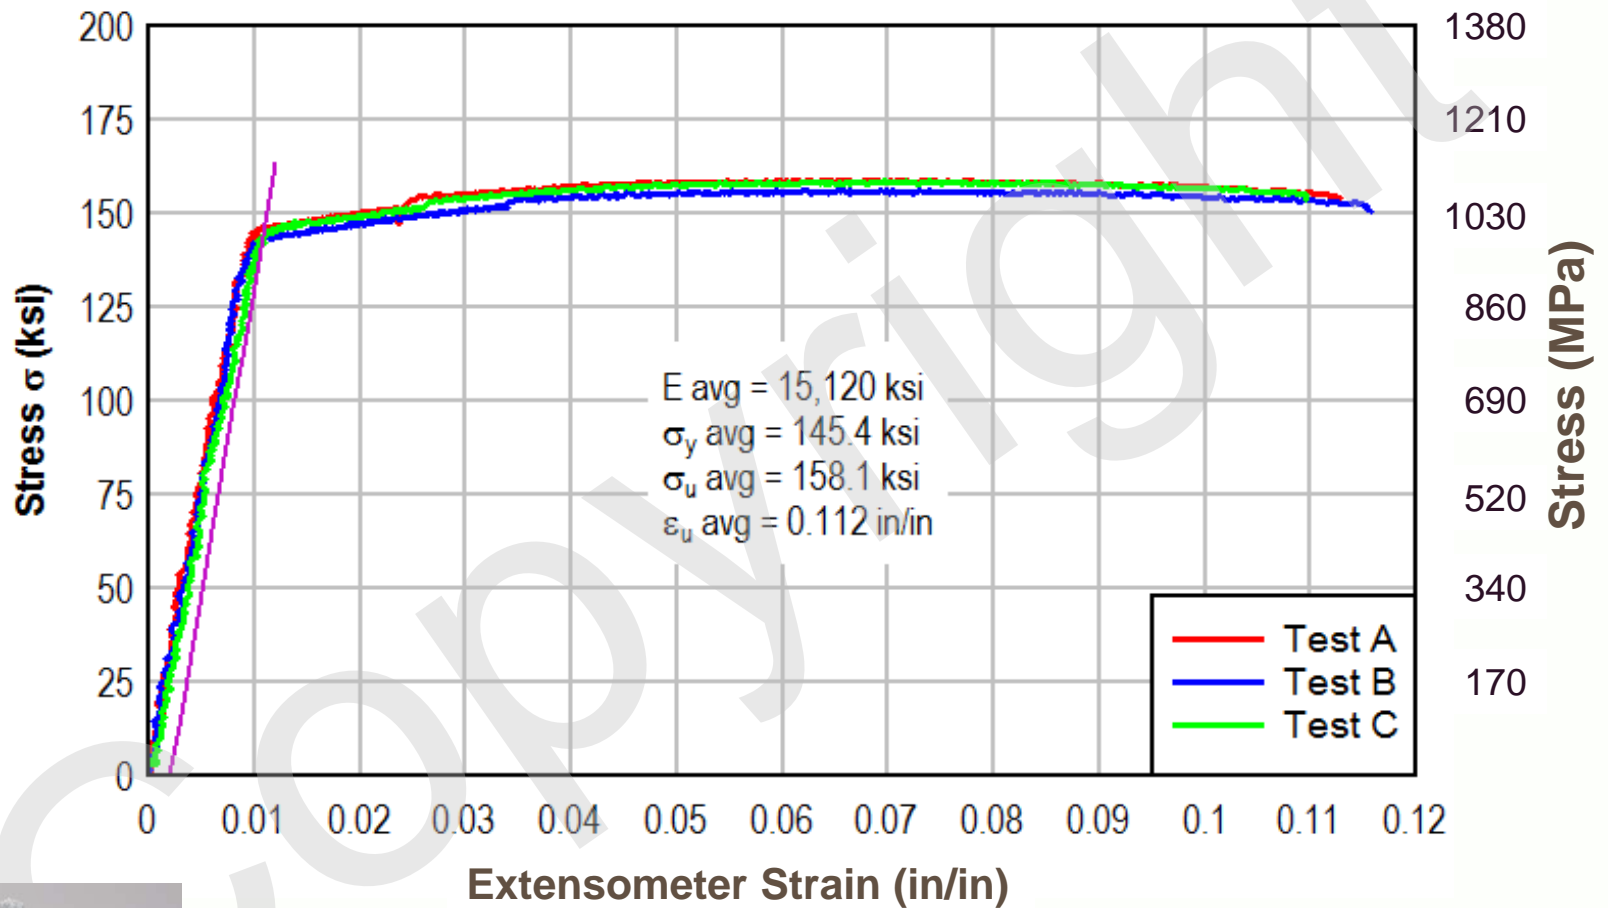
Titanium Alloy Material Properties (Ti-6Al-4V)

- **Aircraft fastener quality** (6% Aluminum 4% Vanadium)
- **Well-defined, high strength, and ductile** (limited hardening->protects bond, structural fuse)
- **High fatigue resistance** (CAFL~ 75 ksi), low notch sensitivity
- **Impervious to chlorides** due to stable oxide layer
- **Coeff. of thermal expansion** ($8.6\mu\epsilon/^\circ\text{C}$) (8-12 Con. and 12 St.)
- **Conventional fabrication** (shear, cut, and bend)
- **Relatively lightweight** of 281 lb/ft^3 (steel 1.7x)

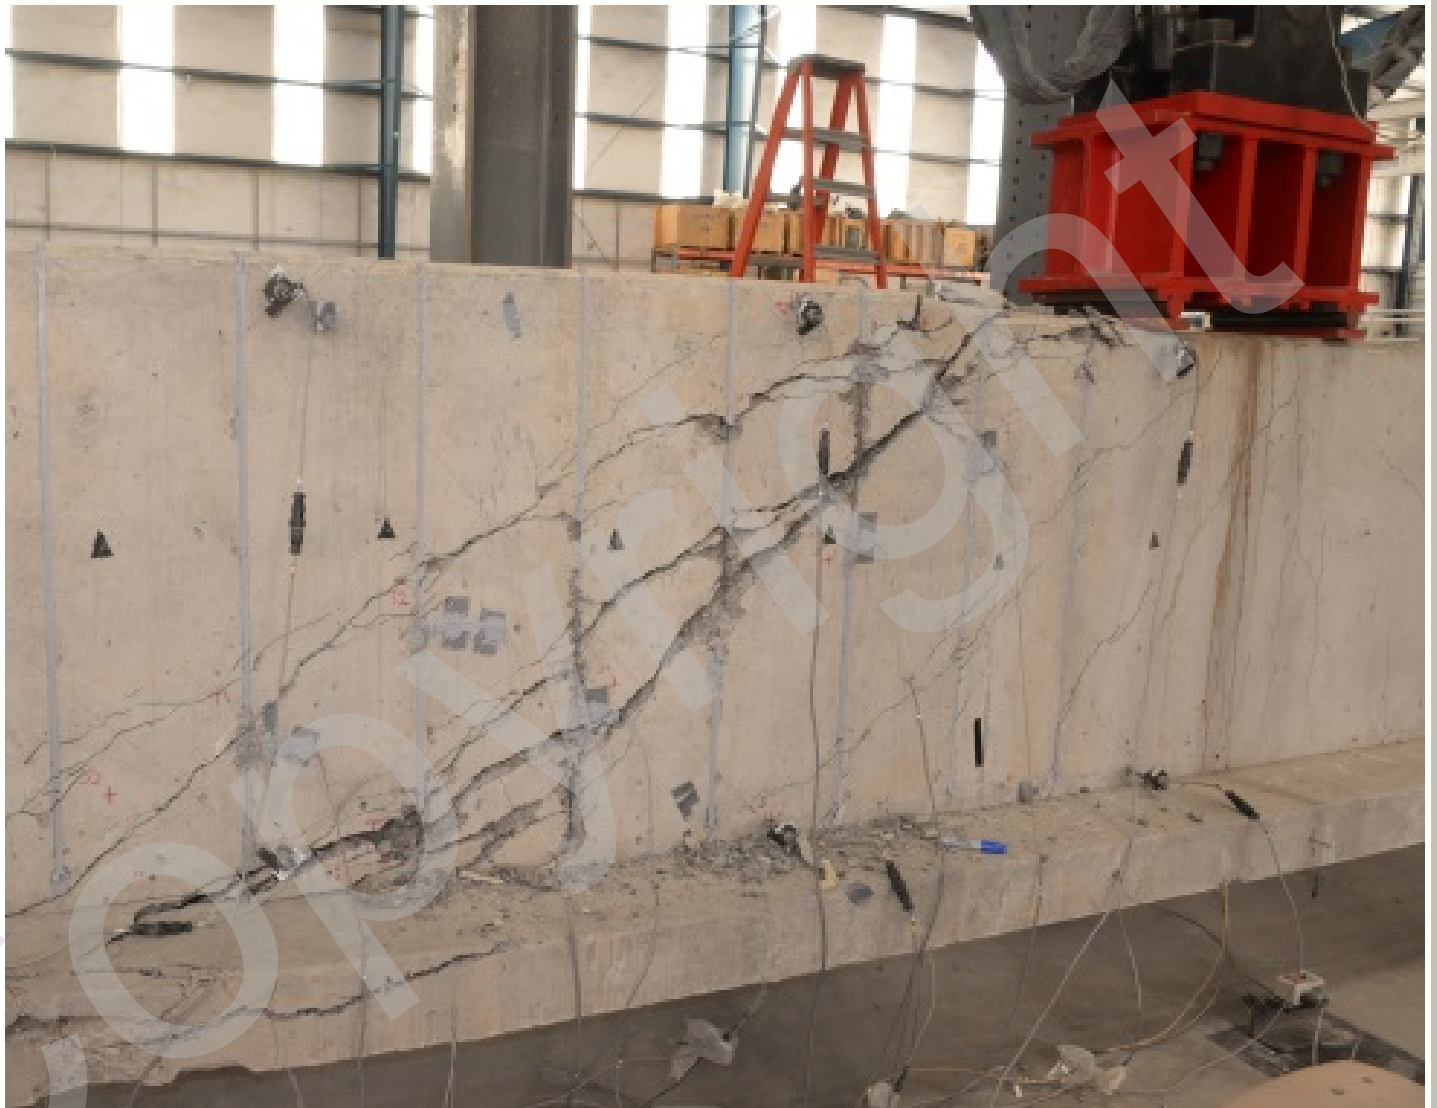
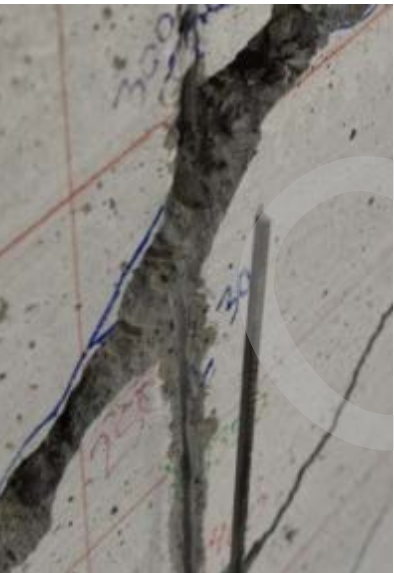
Shear : Fatigue with Freeze-Thaw

- Designed to simulate 50 years of damage based field testing
- 2,400,000 cycles
- Internal stirrup stress range of 13 ksi

- 120 cycles
- Represents 25-100 years of damage in Oregon, depending on location

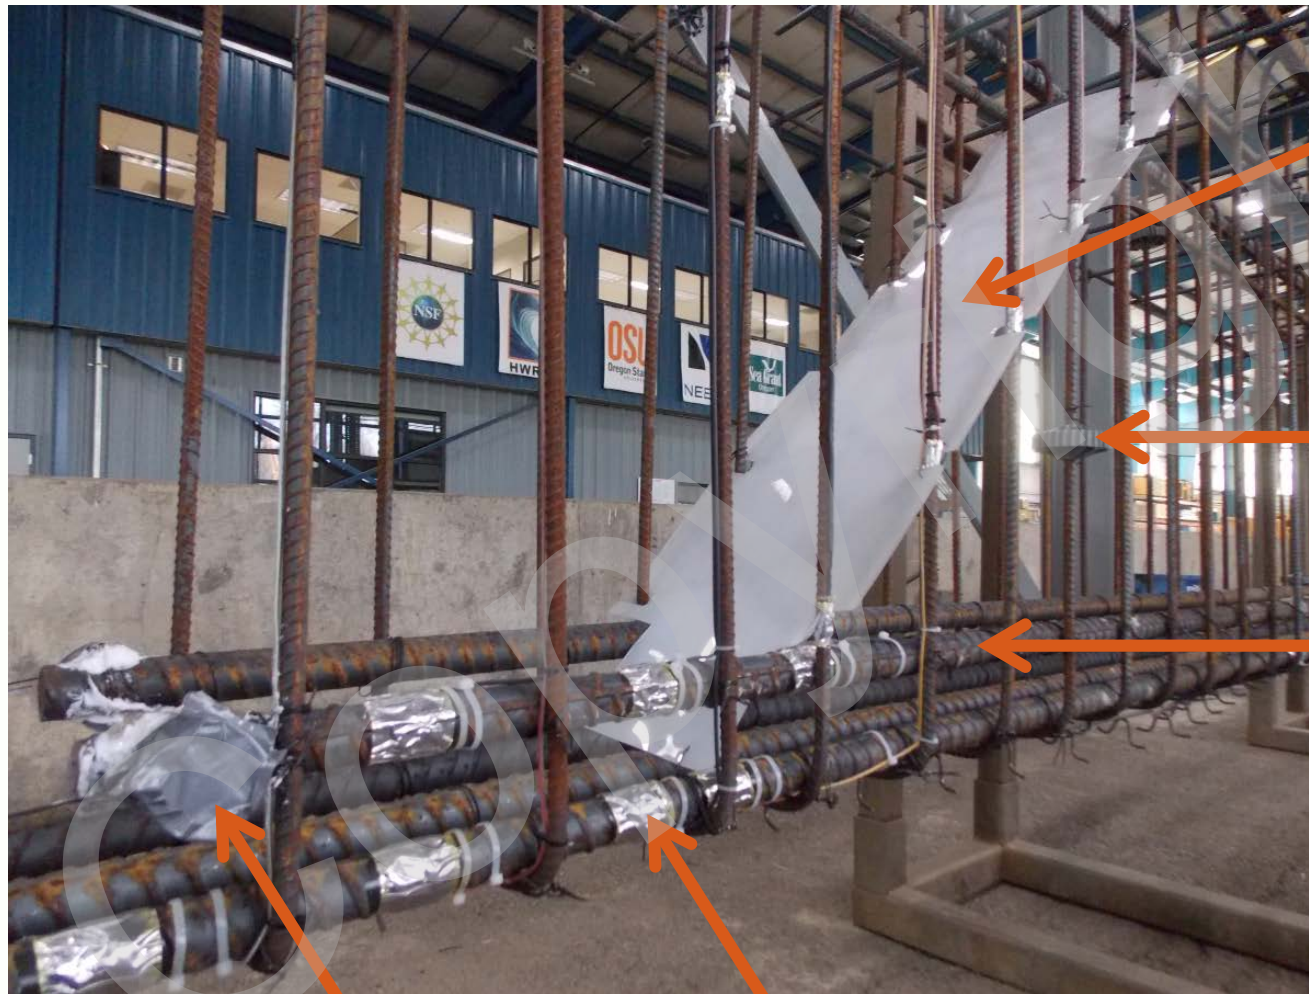
T and IT Beam Construction

45°
preformed
crack

1.5 in.
spacer

Cutoff bar

Blockout for slip sensor

Strain gage

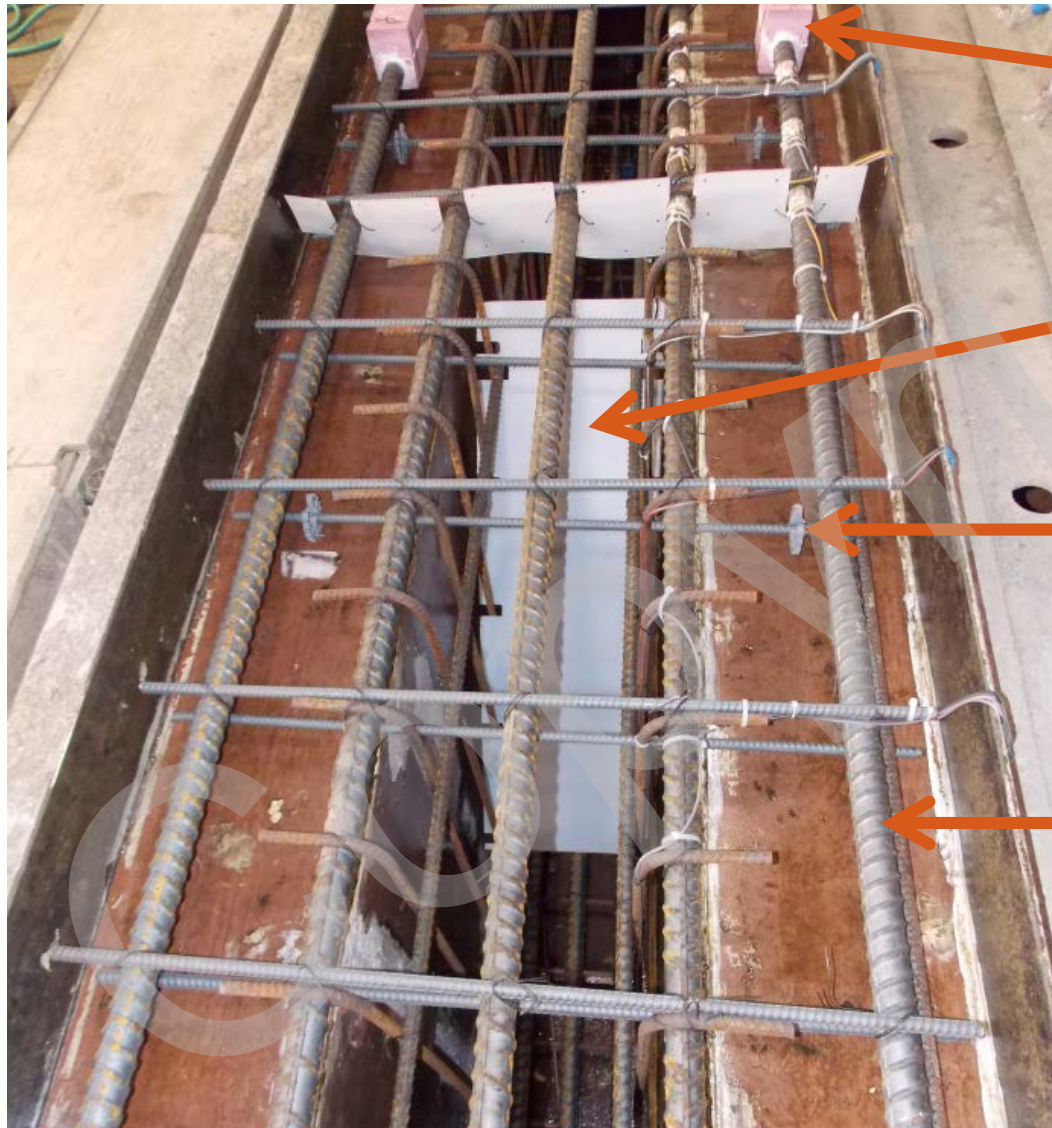
Specimen Construction

Blockout for slip sensor

45° preformed crack

1 in. spacer

Cutoff bar

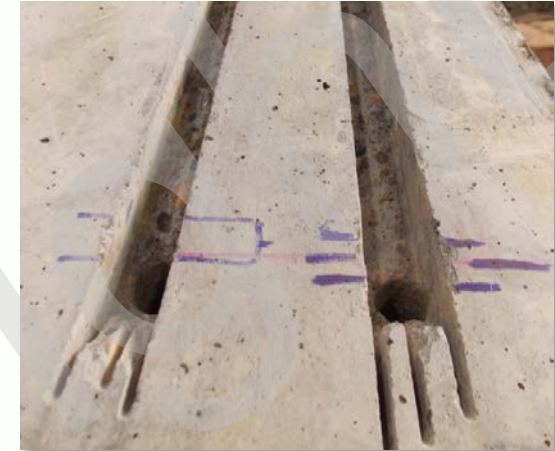
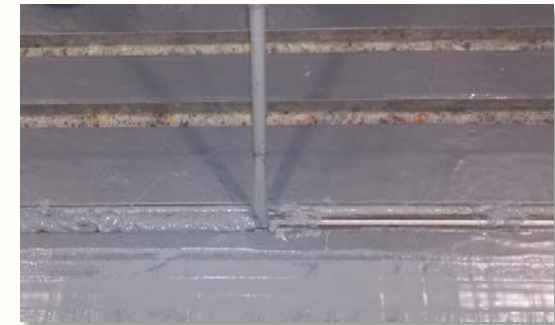
Experimental Setup: NSM Strengthening Methodology

ACI 440.2R

- Groove Spacing
- Groove dimensions

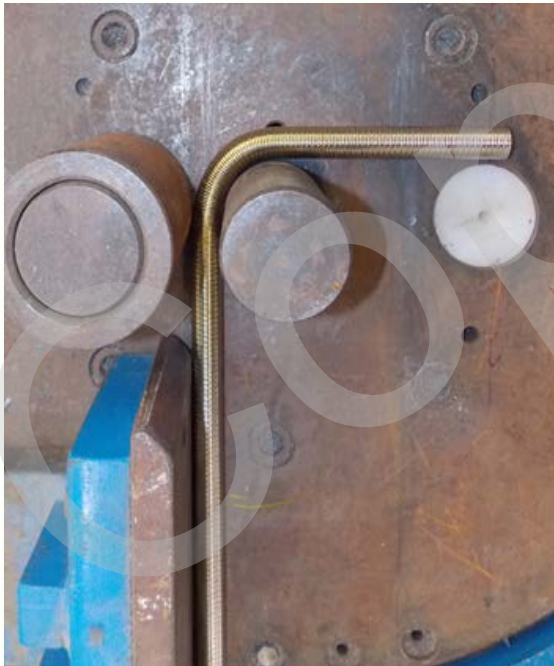
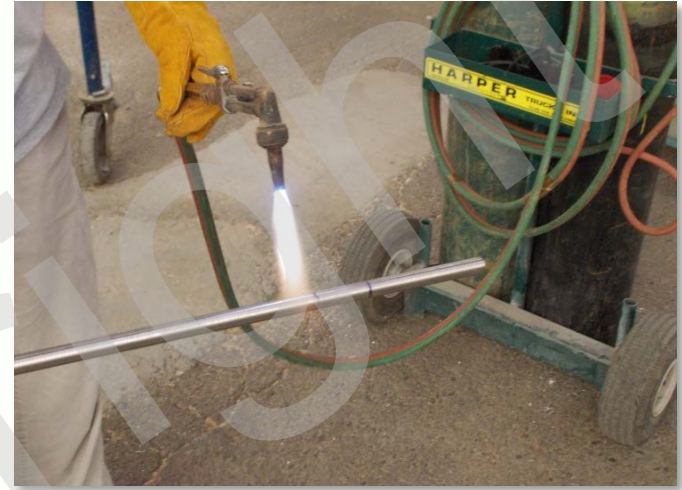
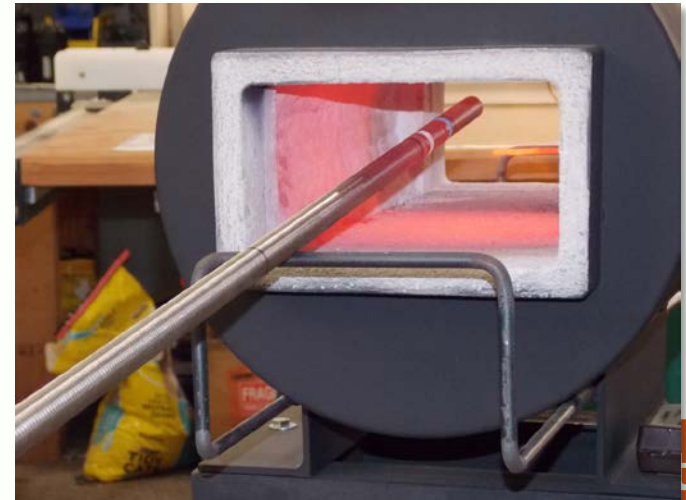
Hook Fabrication

- 2 Ti bars on each side
 - 12.5 ft length
 - 6 in. hooks
- 2 in. bend diameter
- Ti: Heat to 900 °F or 1250 °F

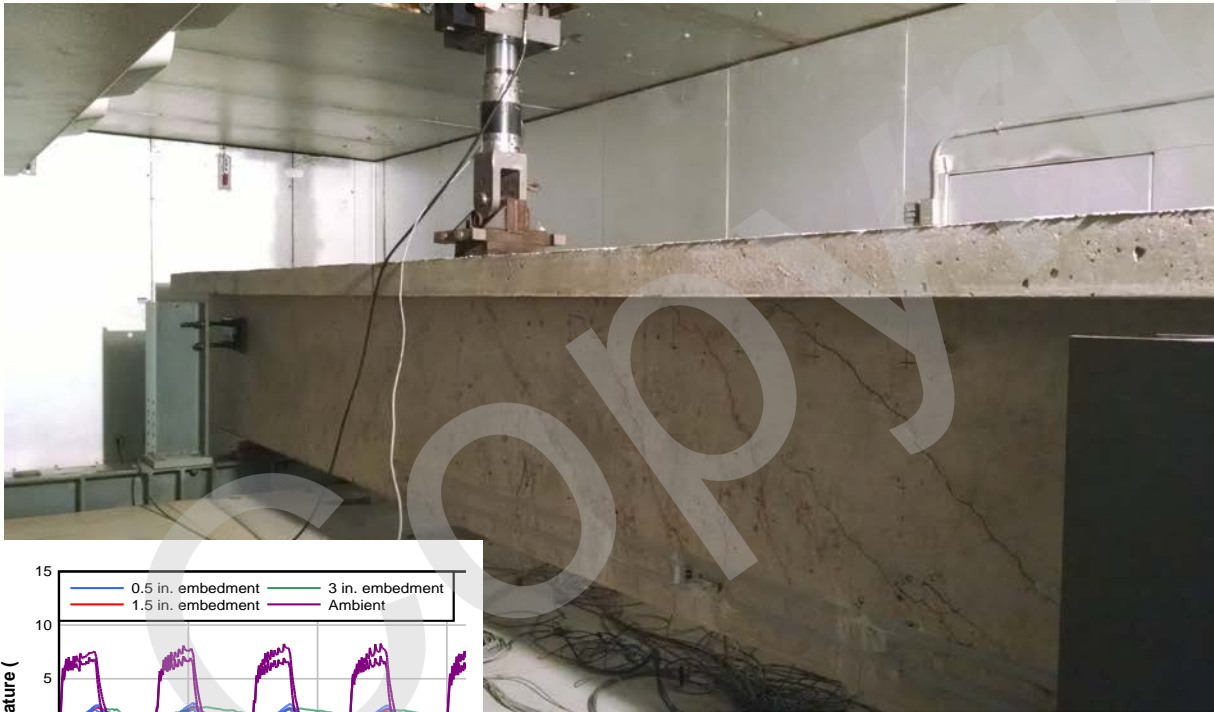
Durability High Cycle Fatigue and Freeze-Thaw Combined

- Largest combined structural-environmental chamber
- Thermocouples at 0.5, 1.5, and 3 in. ensure temperature targets
- 1.6 million cycles @ steel stress range >50 years of life.

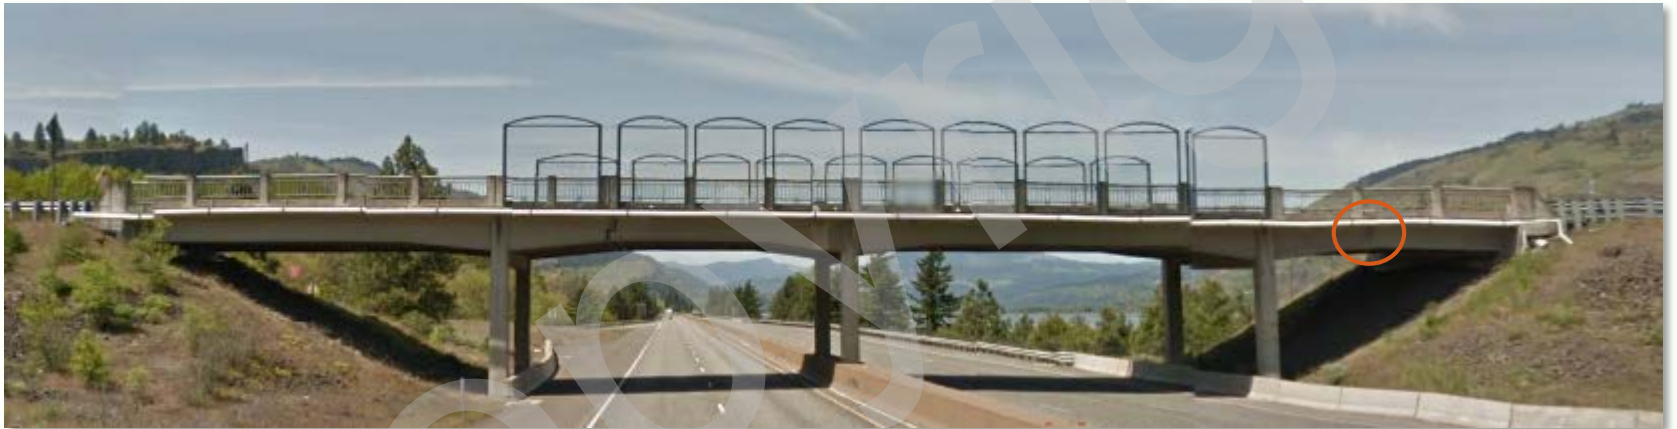
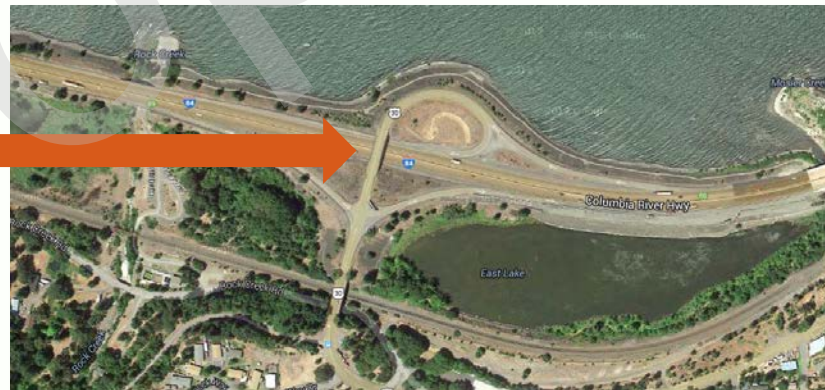
Mosier Overcrossing of Interstate 84

- Built in 1952
- Serves a nearby quarry

**Vertical offset
on crack face**

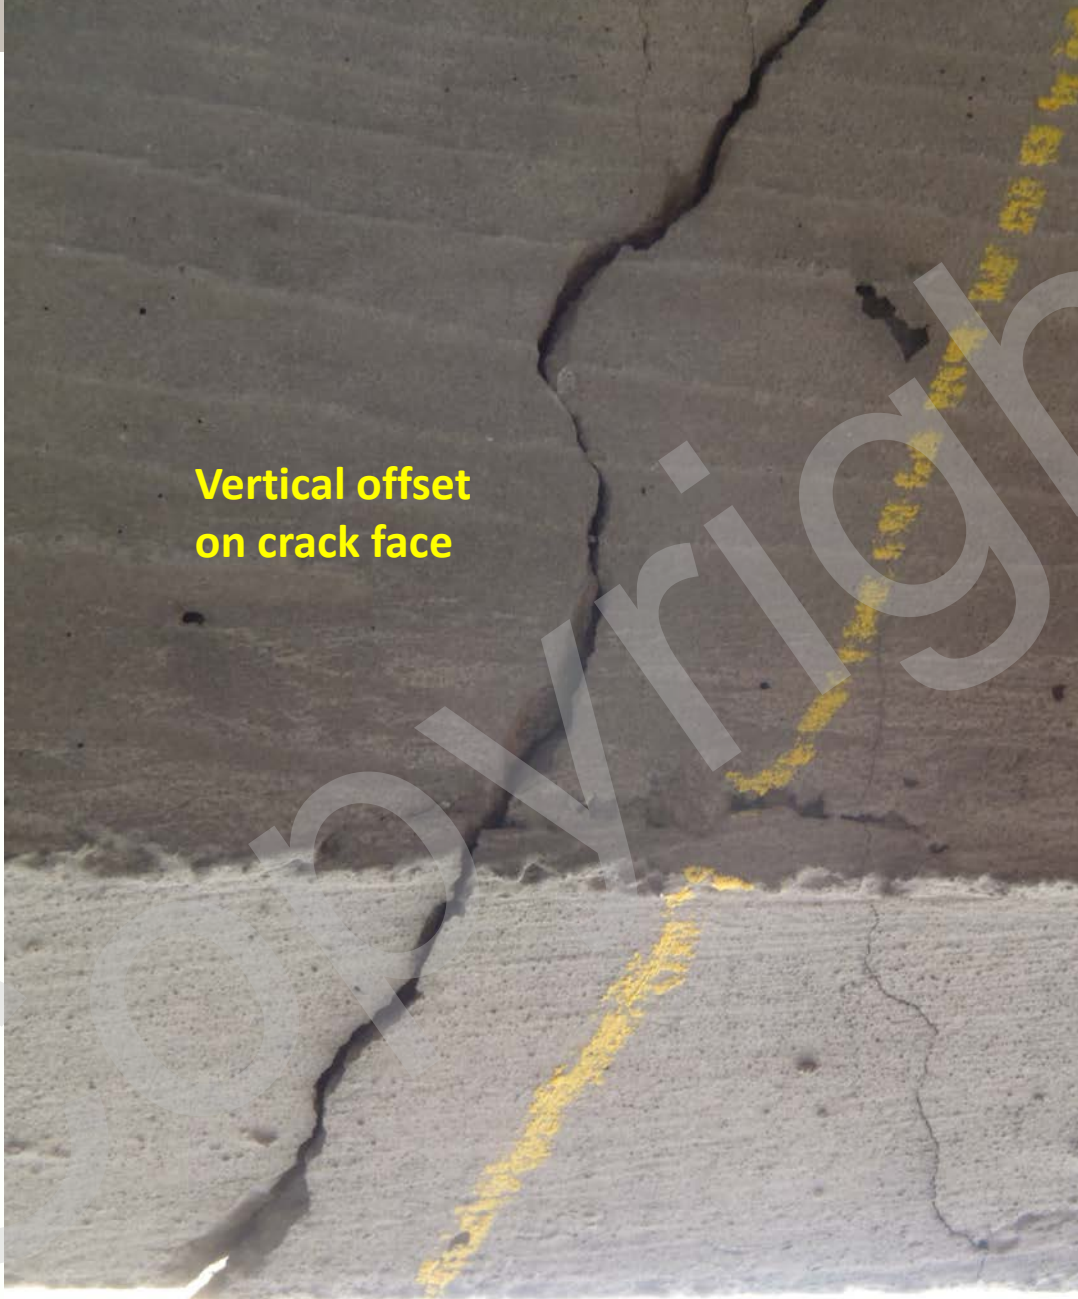
Elevation View

(2) No. 8 @ 130" o-o
(2) No. 8 @ 160" o-o
(2) No. 7 @ 212" o-o
(1) No. 8 @ 202" o-o

(2) No. 6 Gr 60 @ 138" o-o

(2) No. 8 @ 132" o-o

(2) No. 7 @ 97" o-o

(2) No. 9 @ 112" o-o

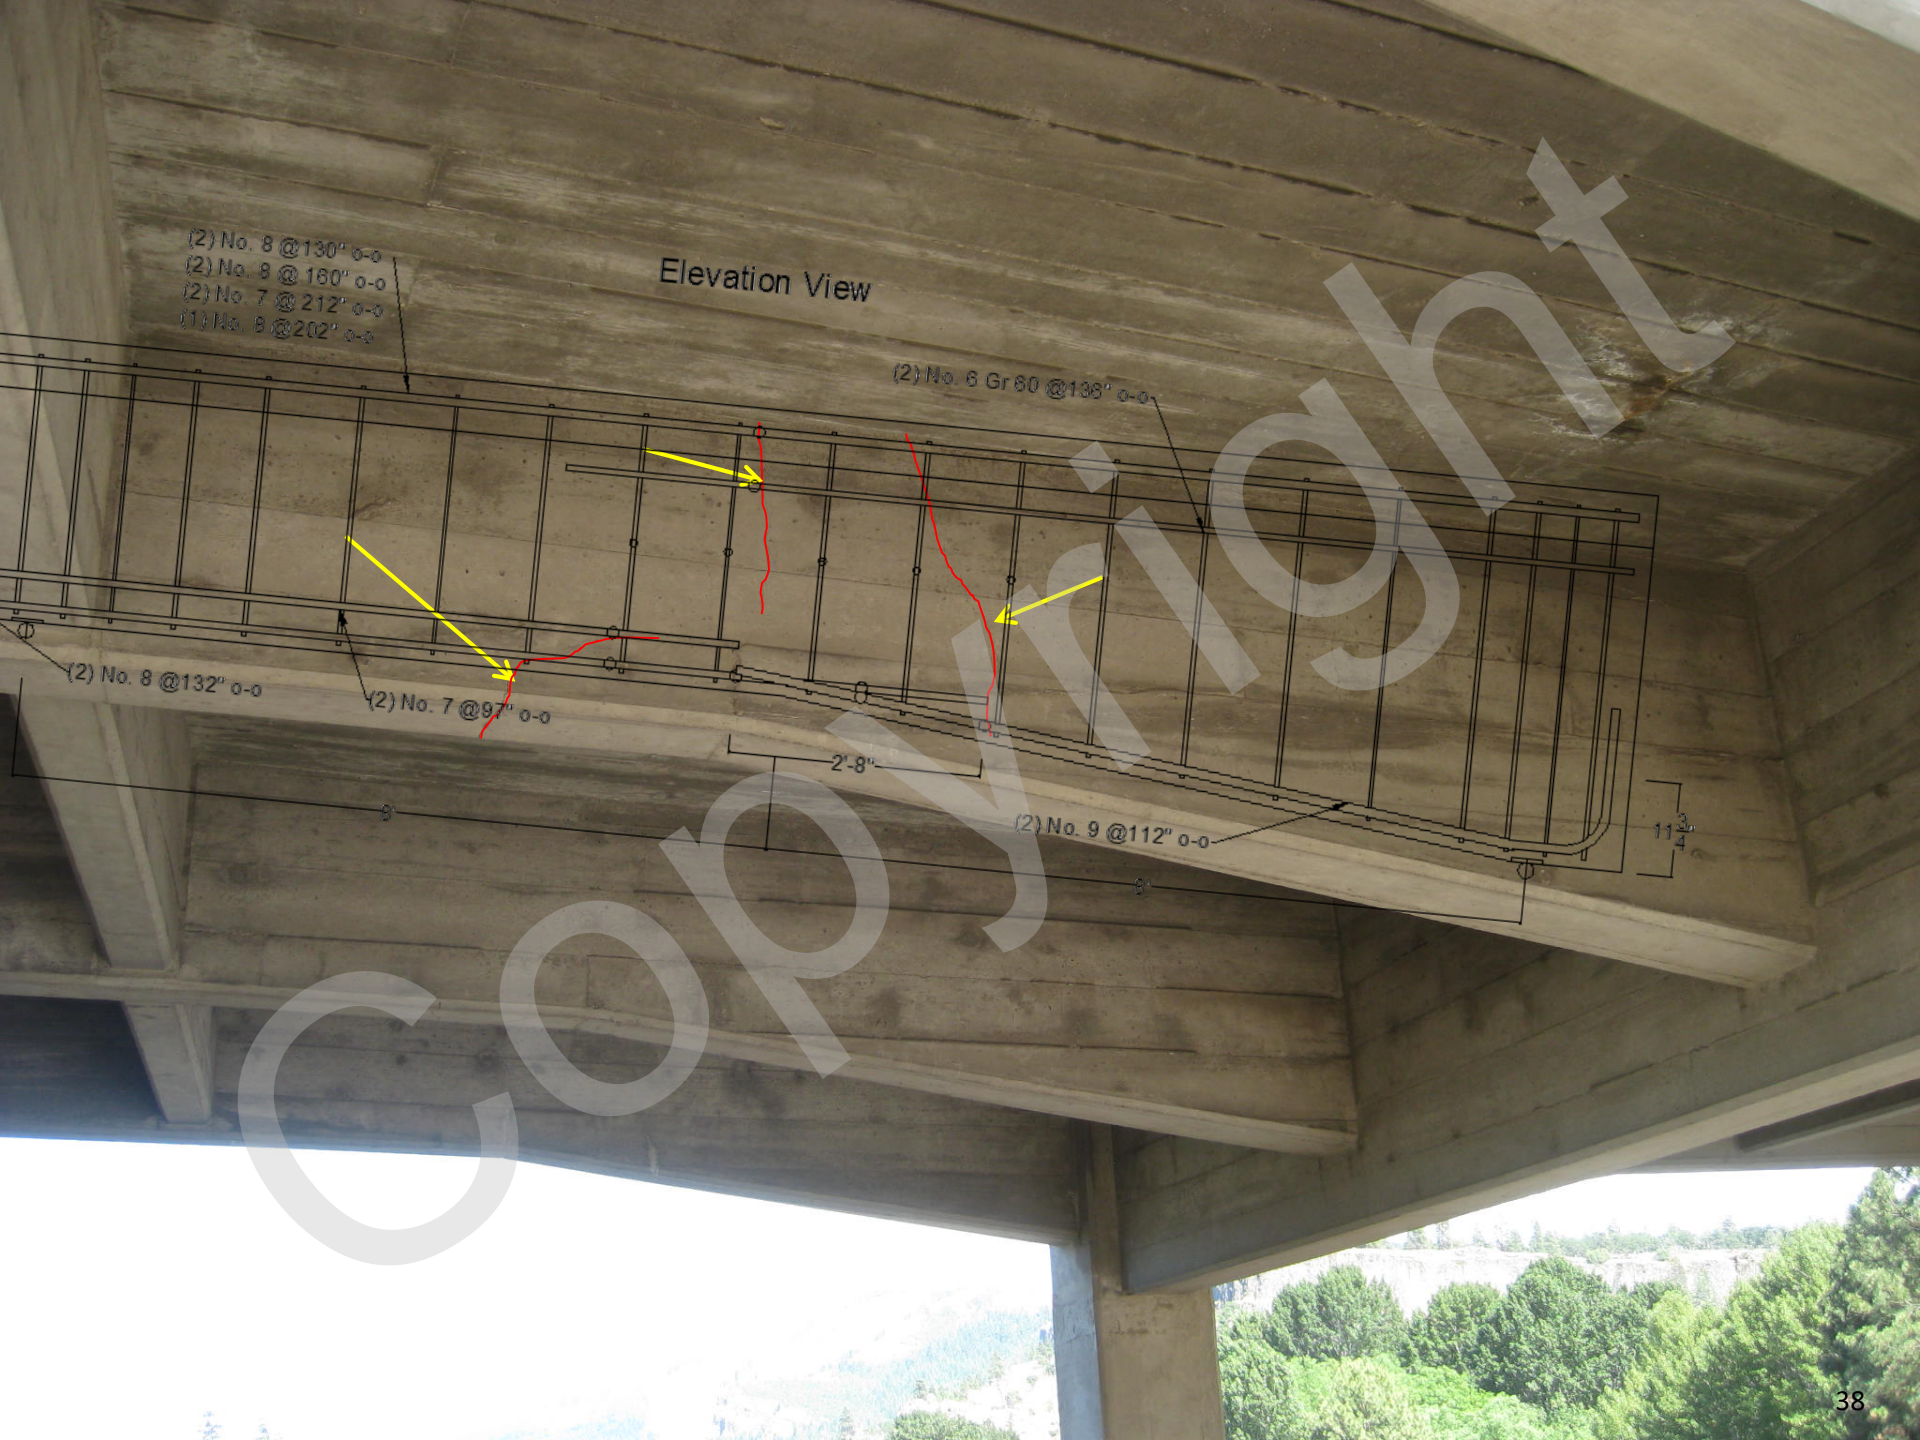
Mosier As-Built Details

BEAM A

HAUNCH AB

LONGITUDINAL BEAM SECTIONS

DL produces M-
LL produces M+

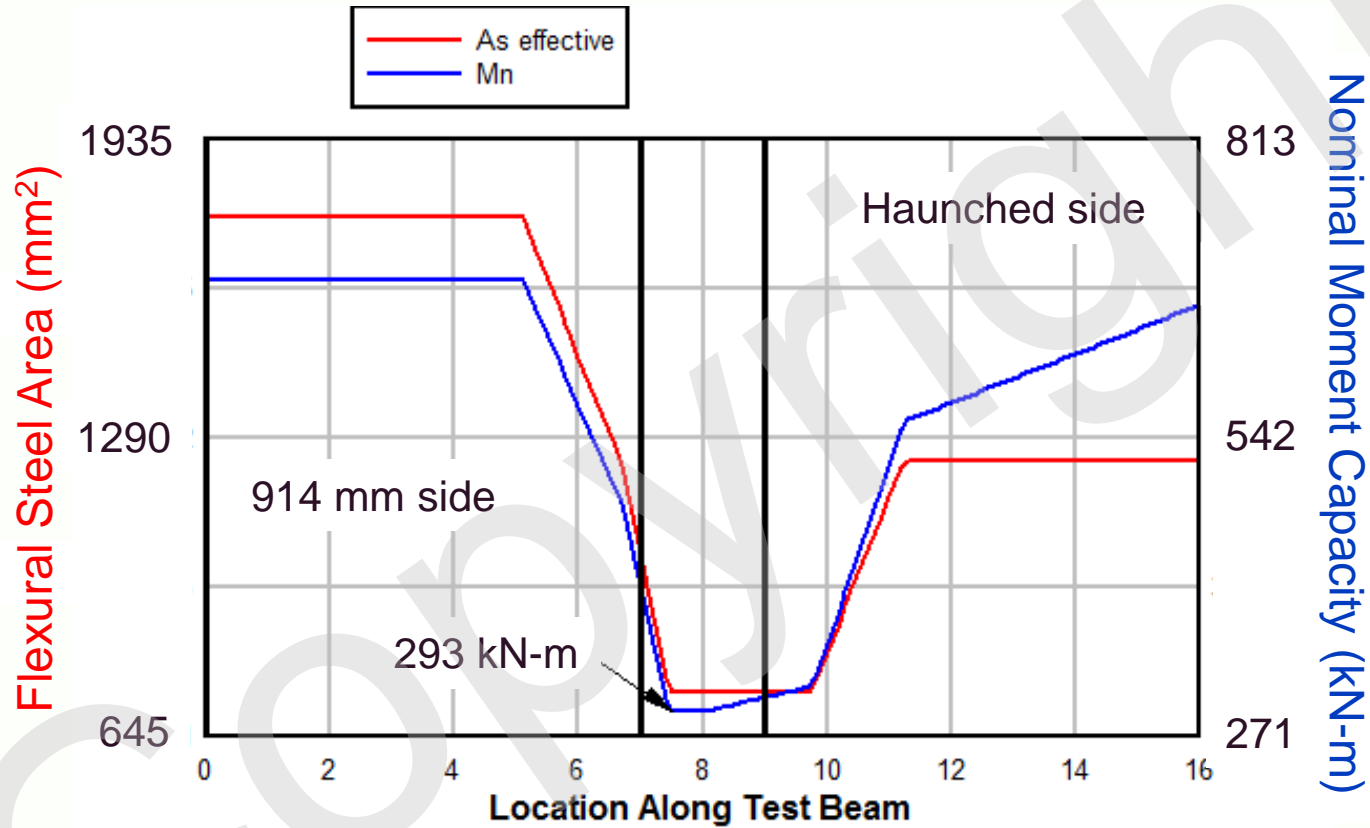
Designer assumes the steel is completely failed

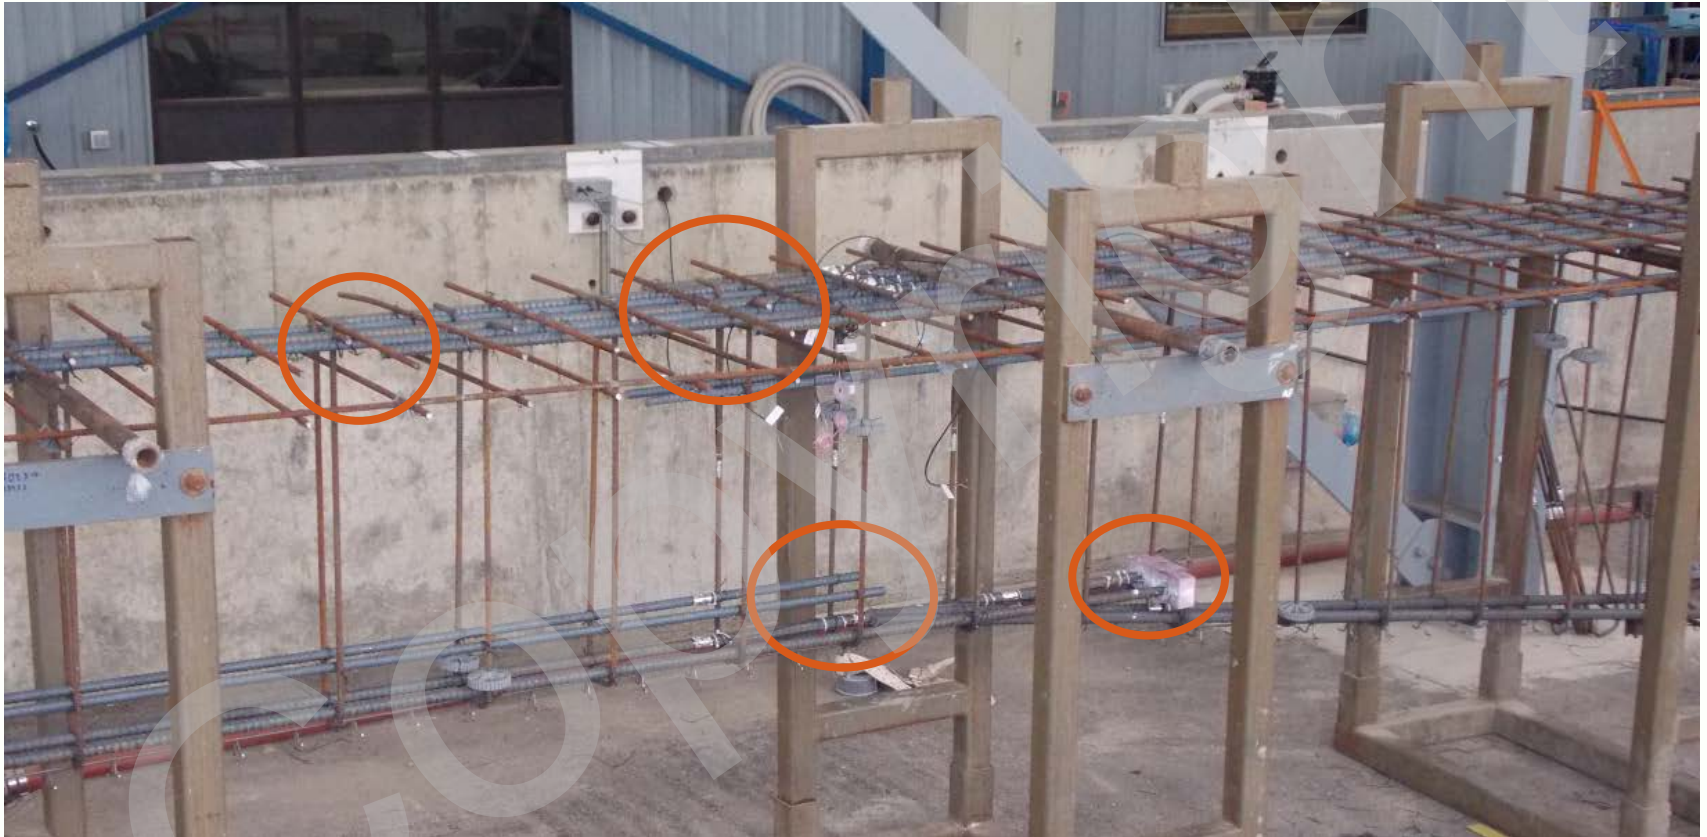
Mosier Construction

Searched mill certifications to locate bars that best matched strength curves of original design. Used smaller sized Grade 420 (60) rebar to match development length of intermediate grade steel (280 MPa (40 ksi))

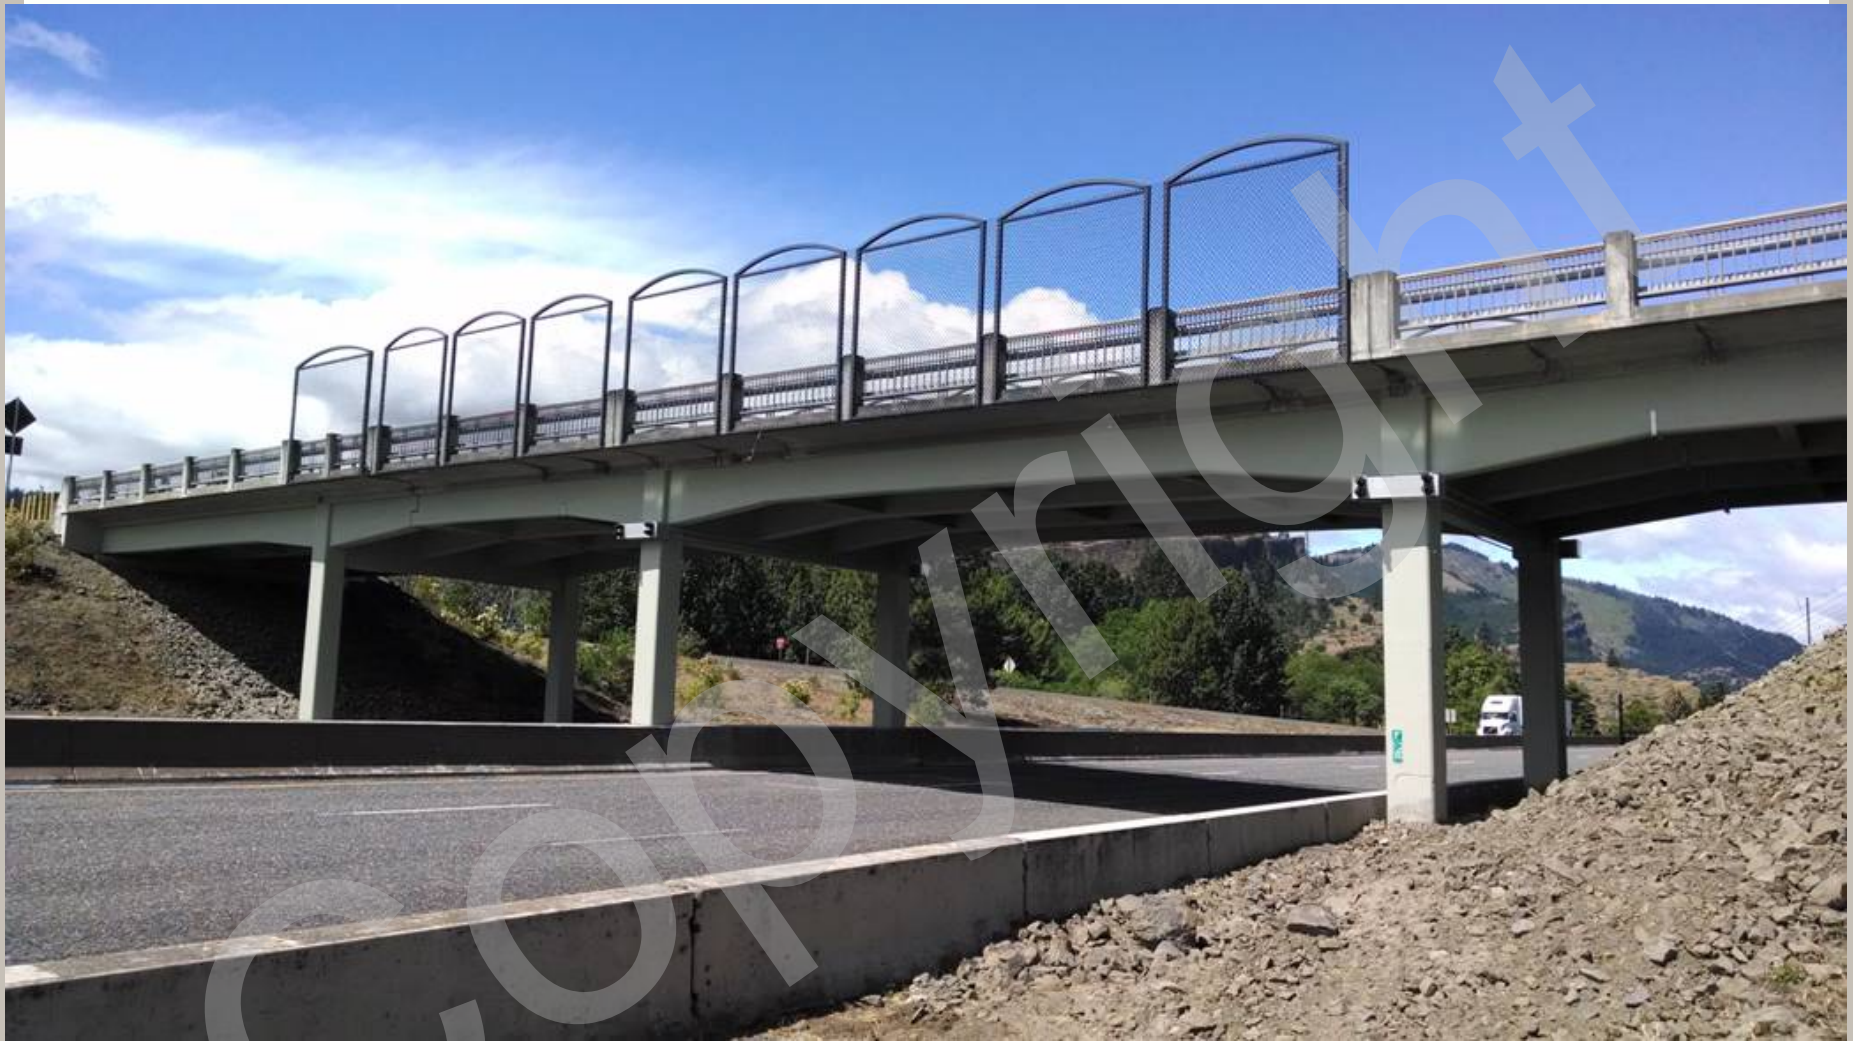
- Design strength of Ti girder exceeds factored demands even with conservative assumptions

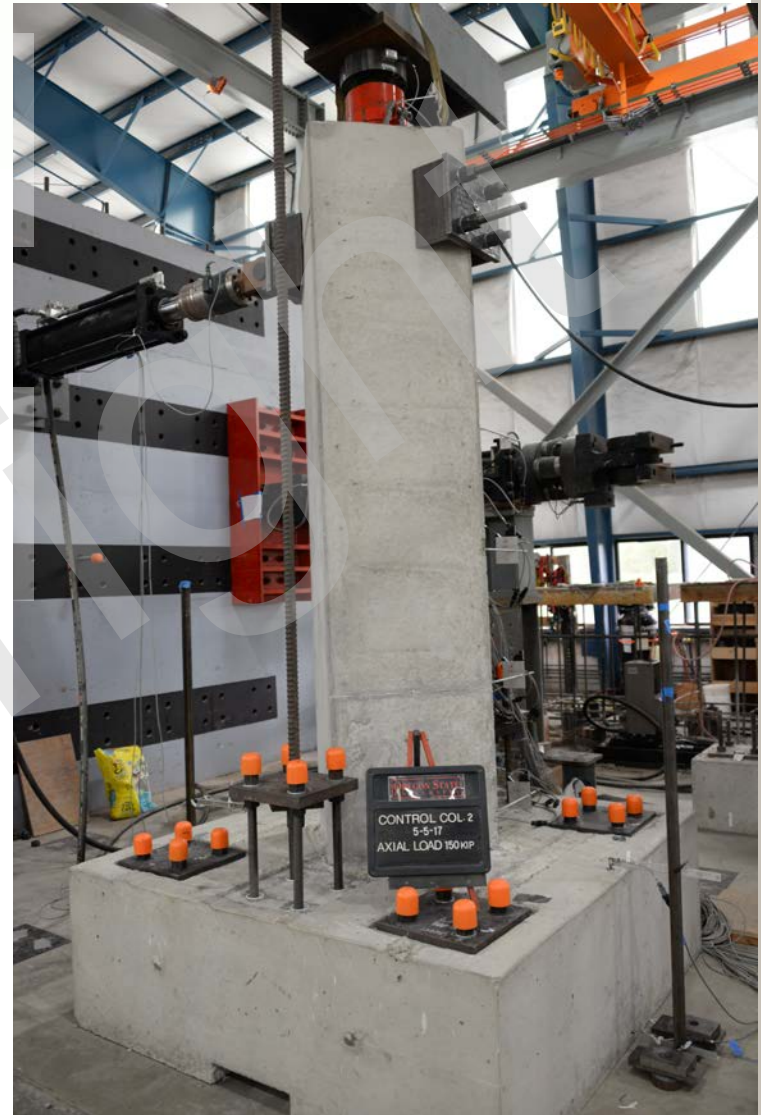
Experimental Set-Up

Axial load
200 kip
($0.10 f'cAg$)

Actuator
110 kip
+/- 10 in

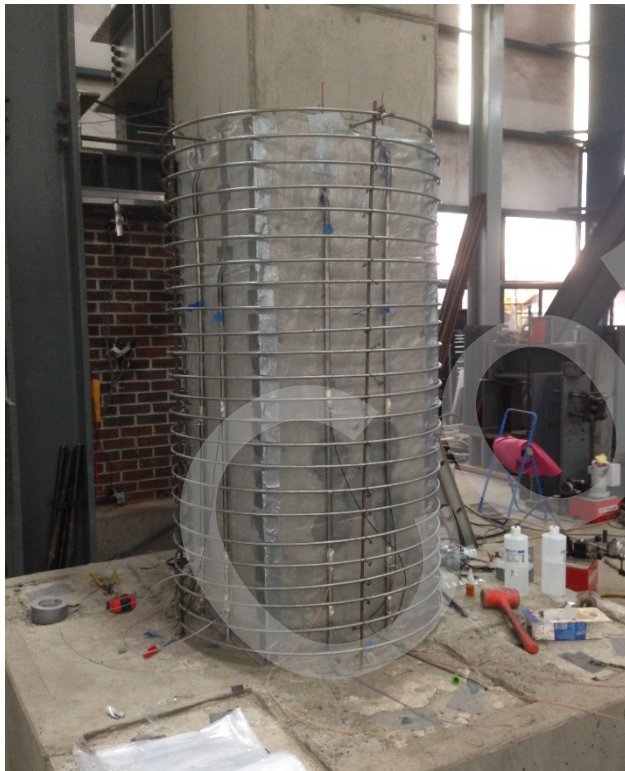
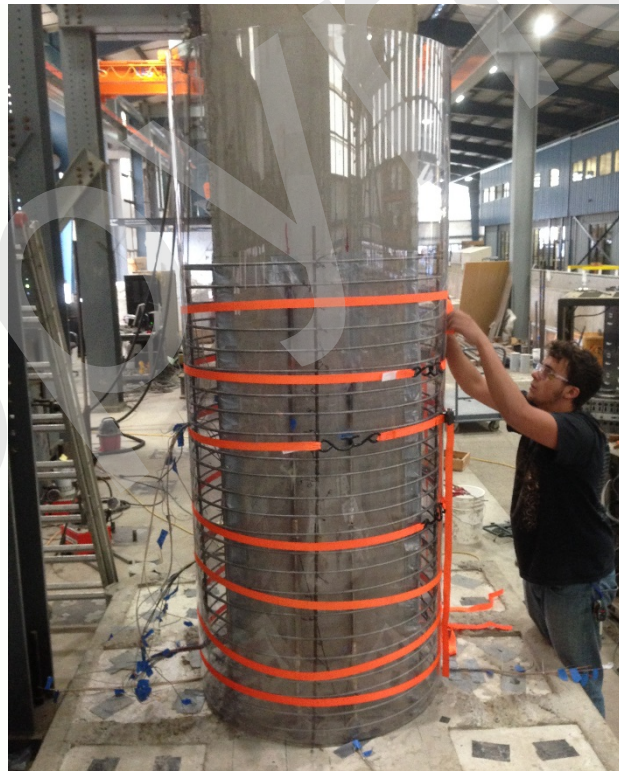
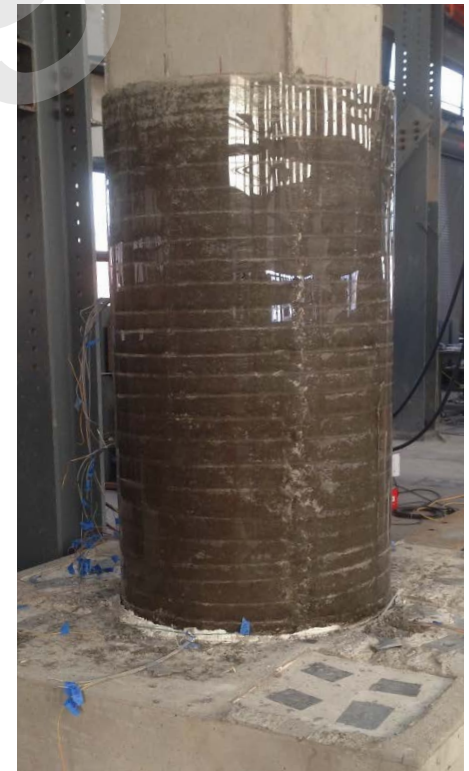
TiAB Spiral Reinforced Concrete Shell

- Continuous spiral
- Debonded shell from column with plastic sheet
- Flexible polycarbonate sheet formwork
- Ratchet strap drawn tight to TiAB spiral (no cover) and holds form
- See-through, so know completely filled
