Renewal of Aging and Deteriorated Reinforced Concrete Bridges with Titanium Alloy Bars (TiABs)

Christopher Higgins, Ph.D., P.E.

Overview

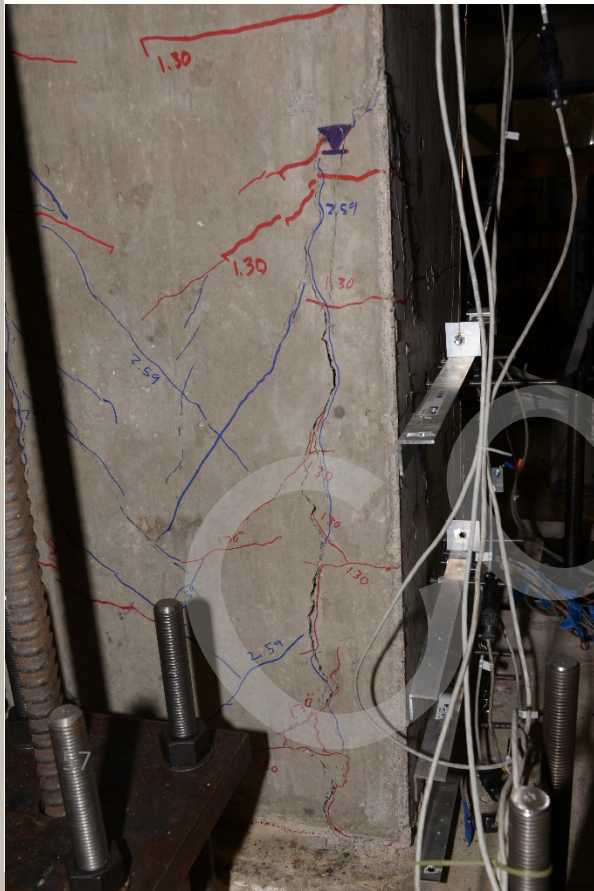
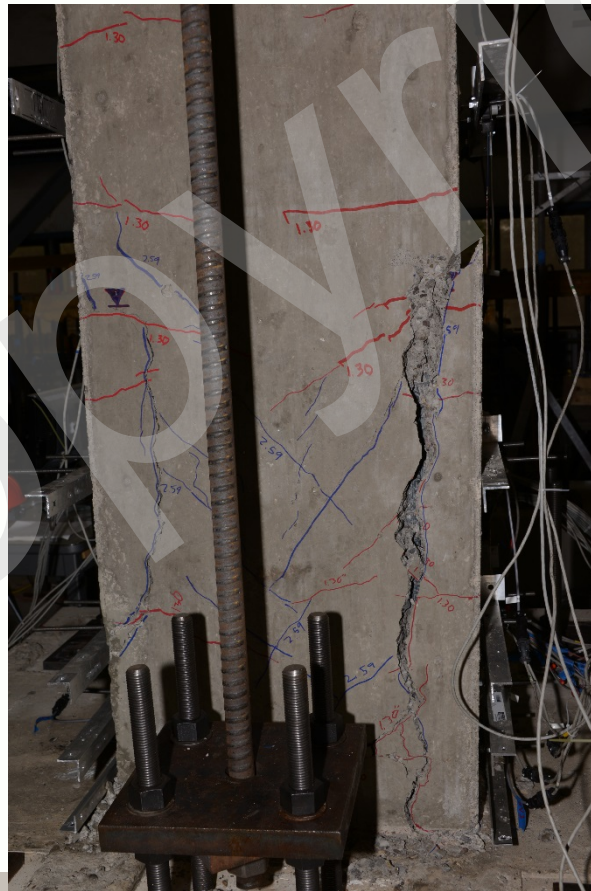
Control Specimen: Observed Performance

Progression of lap-splice exposure and bond-slip

- Lap-splice failure -> rapid flexural strength degradation
- Severe spalling
- Non-ductile

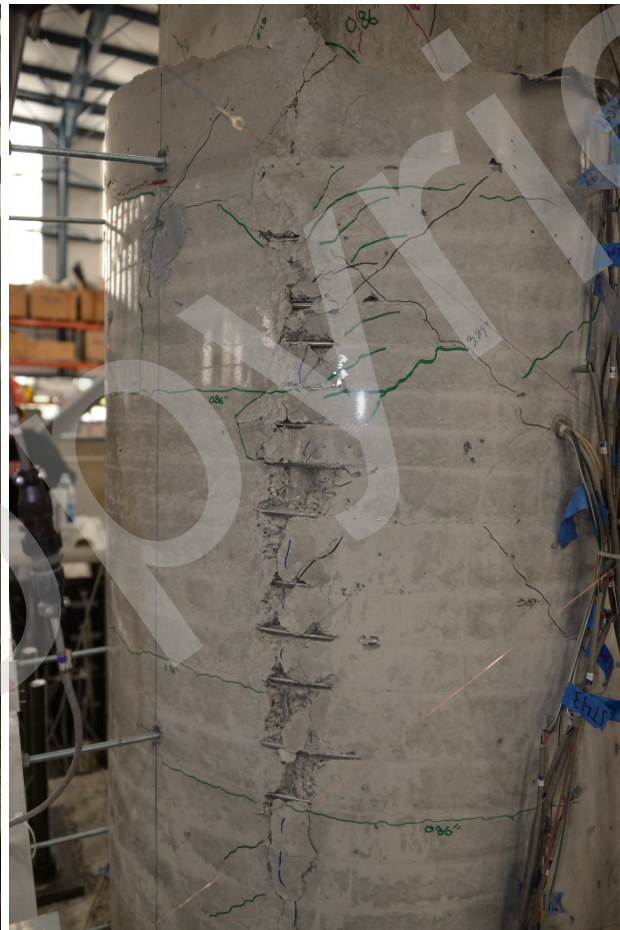
Titanium Observed Performance

Retrofitted specimens: corner spalling progression

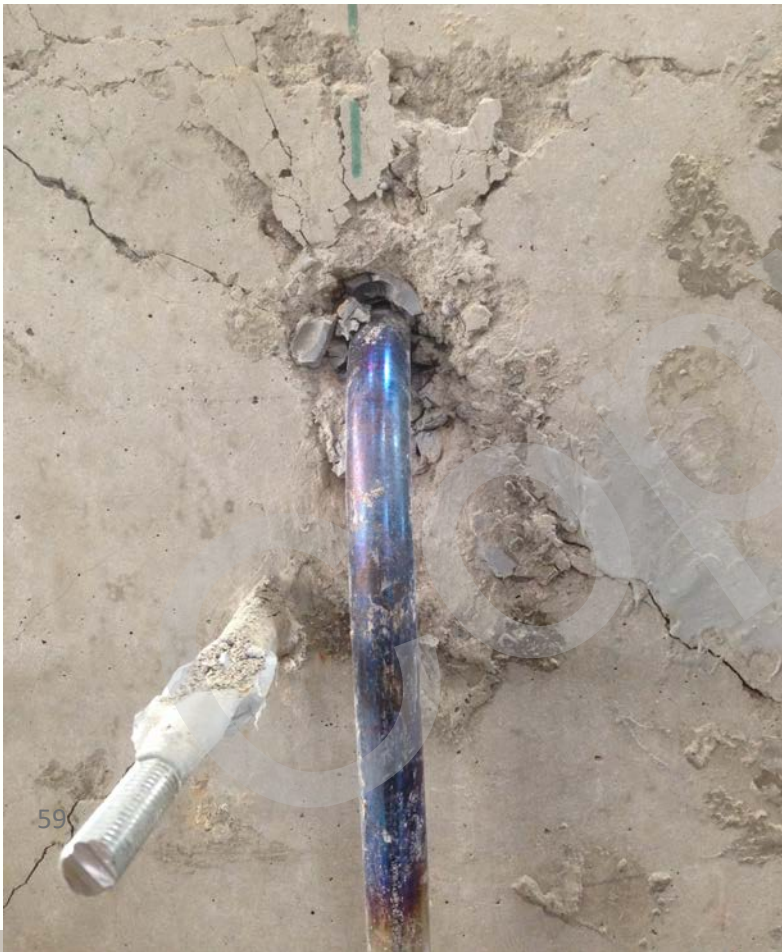
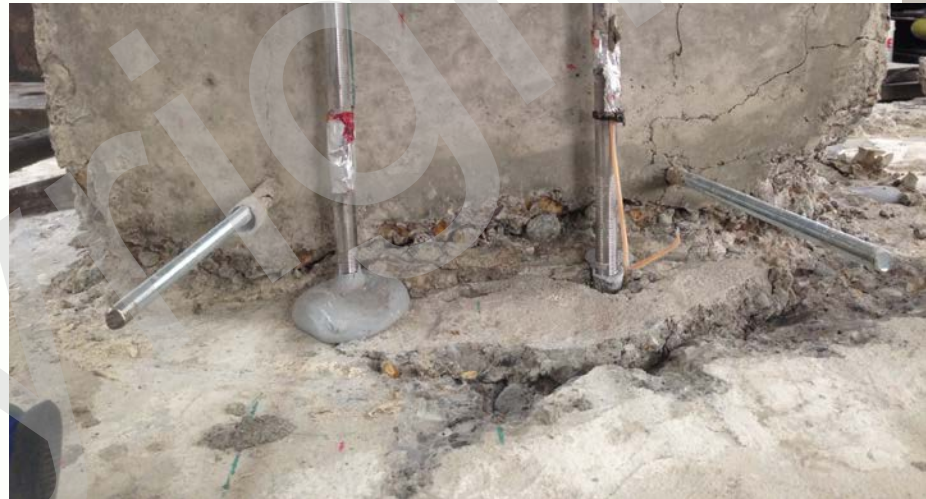
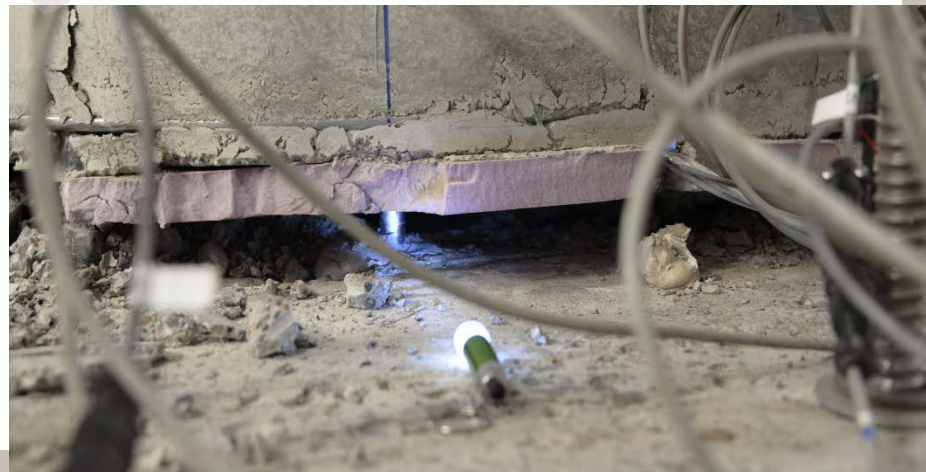
Observed Performance

Retrofitted specimens with lap splices (similar performance):

- Ductile withdrawal of hooked anchorages
- Footing concrete spall cones
- Rocking column behavior

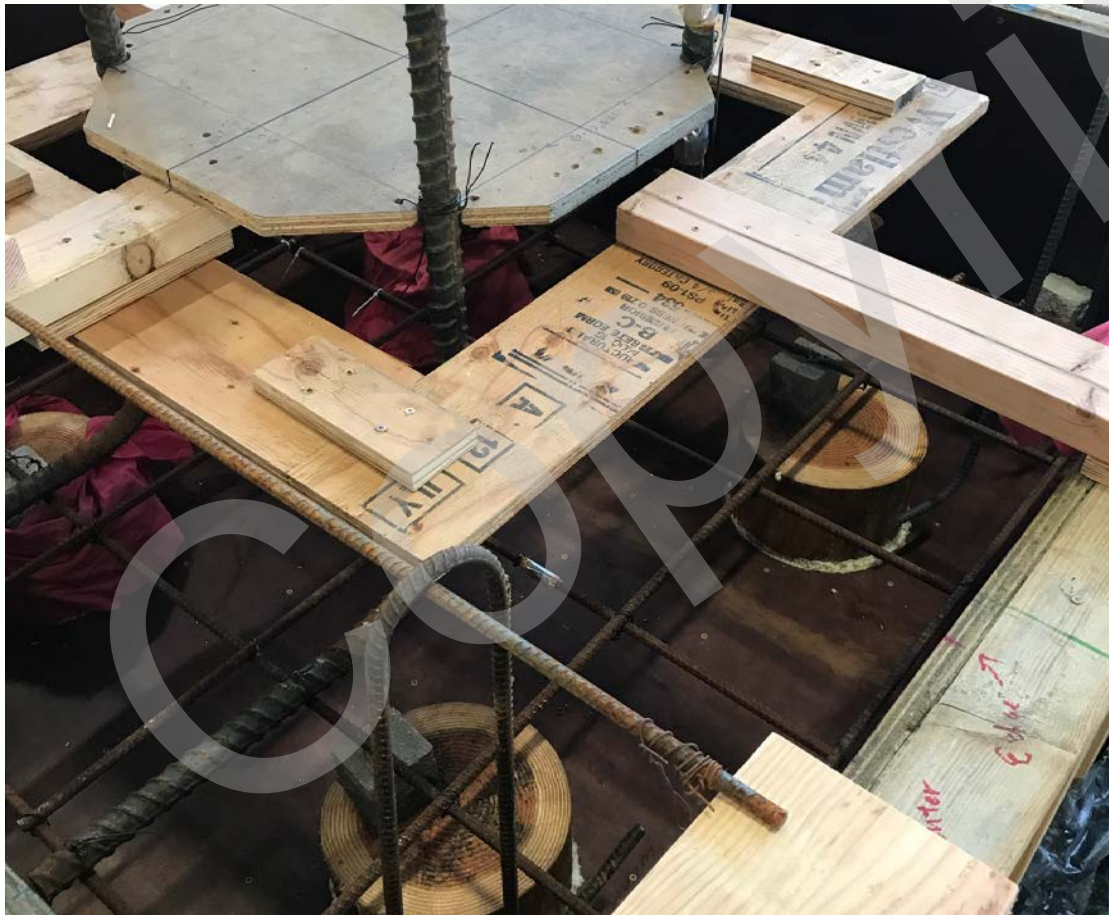
Fuse Seismic Forces Imparted on Footing

- Spread footing
- Timber pile
