# Emerging Technology for Deep Foundation Quality Control

JAMES SCHMIDT, P.E., P.ENG, D.GE.

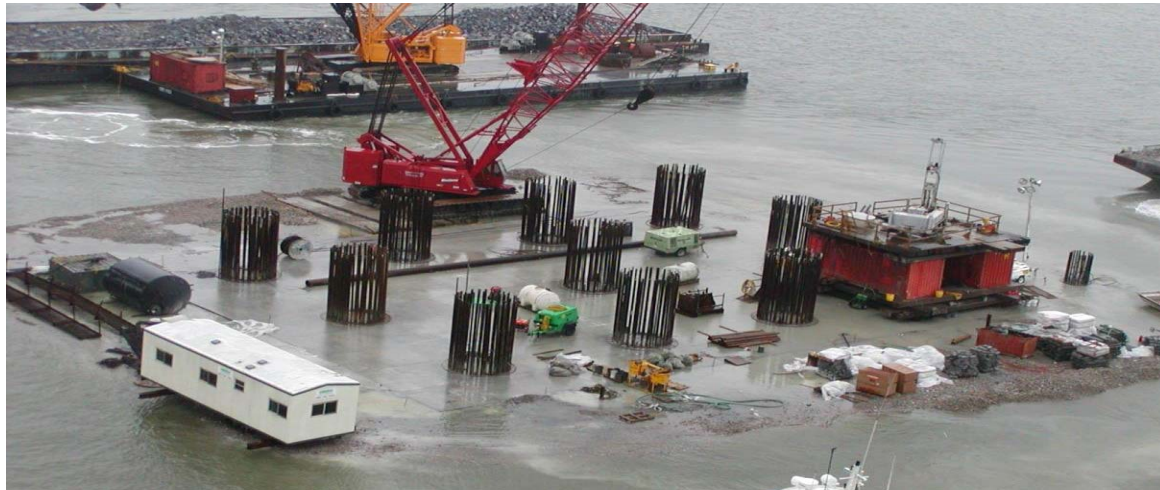
**West Tower Drilled Shaft Foundations**  
Arthur Ravenel Jr. Bridge, Charleston SC

- **Integrity Evaluation**

- Along entire Shaft length
- Size & location of anomalies

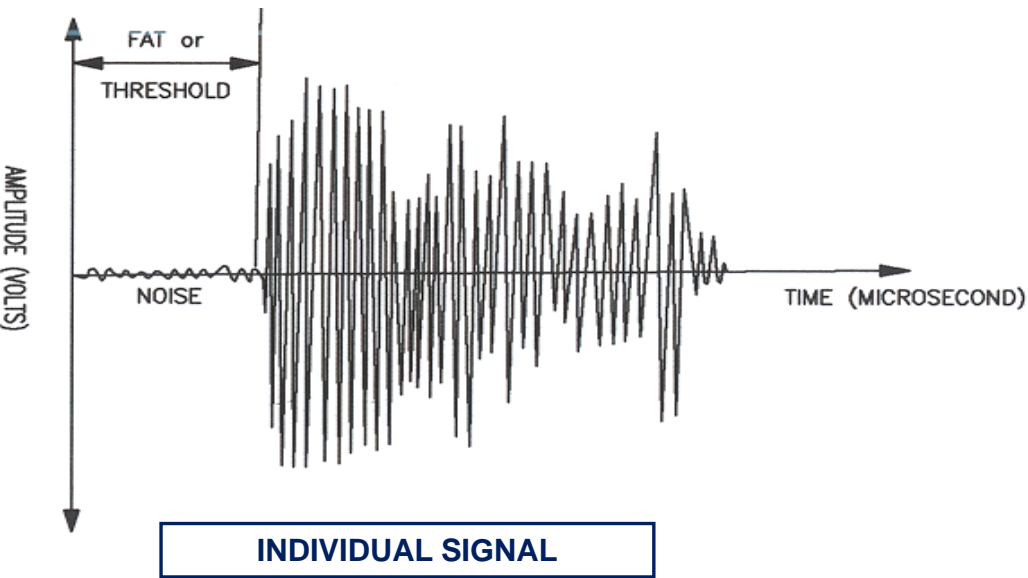
FAT = First Arrival Time

## WHAT AFFECTS SIGNAL?

- Low density concrete
- Voids
- Soil Intrusions

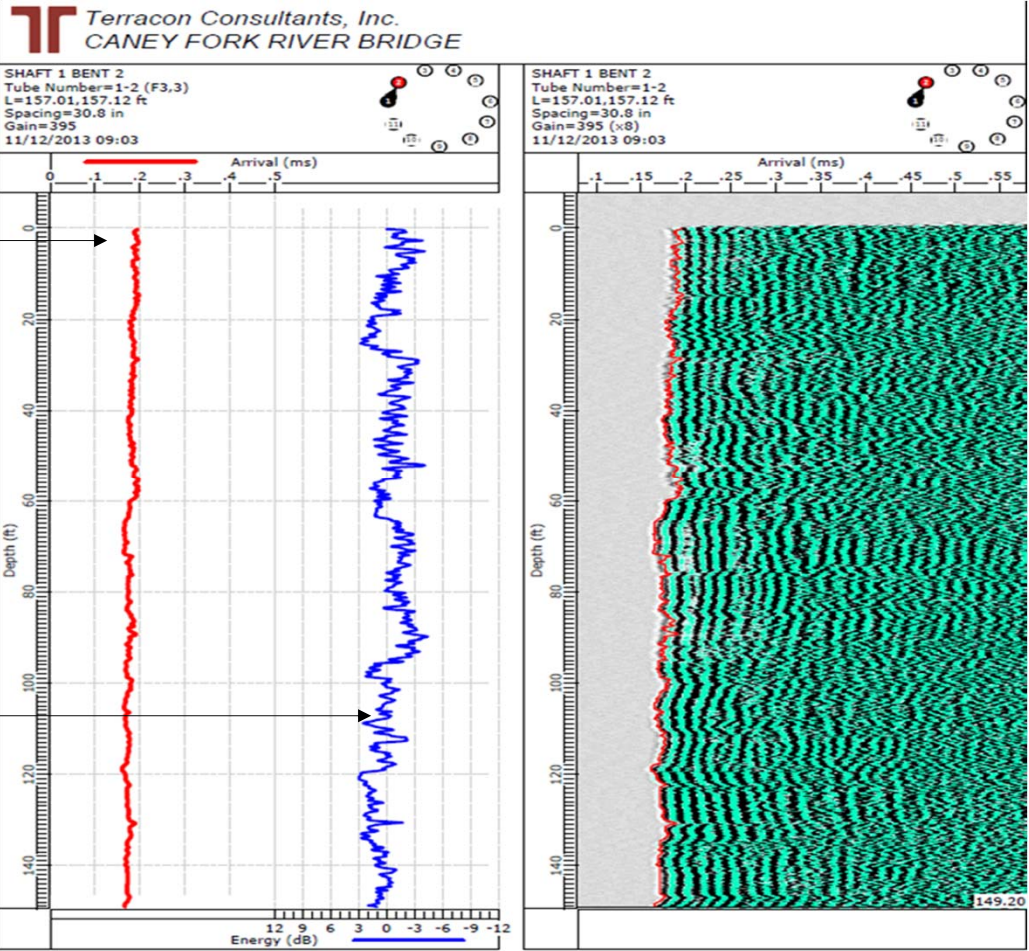
Arrival Time

Energy

Waterfall

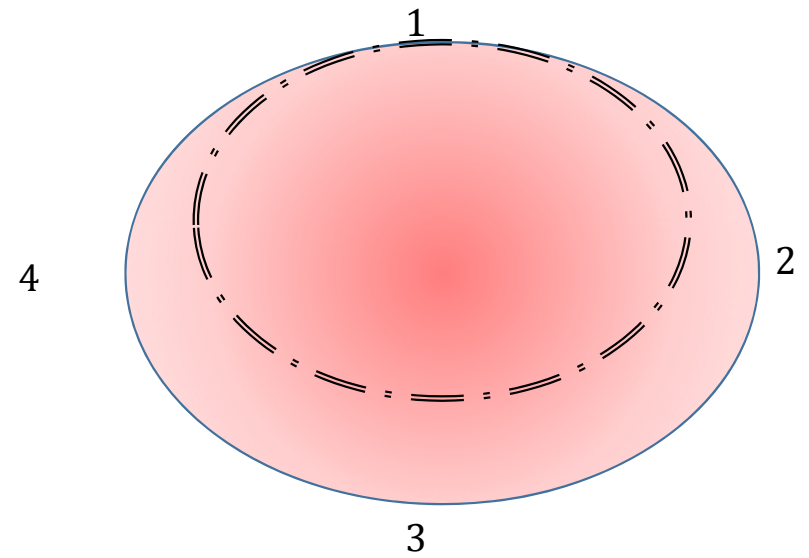
# THERMAL INTEGRITY PROFILING CAGE SHIFT

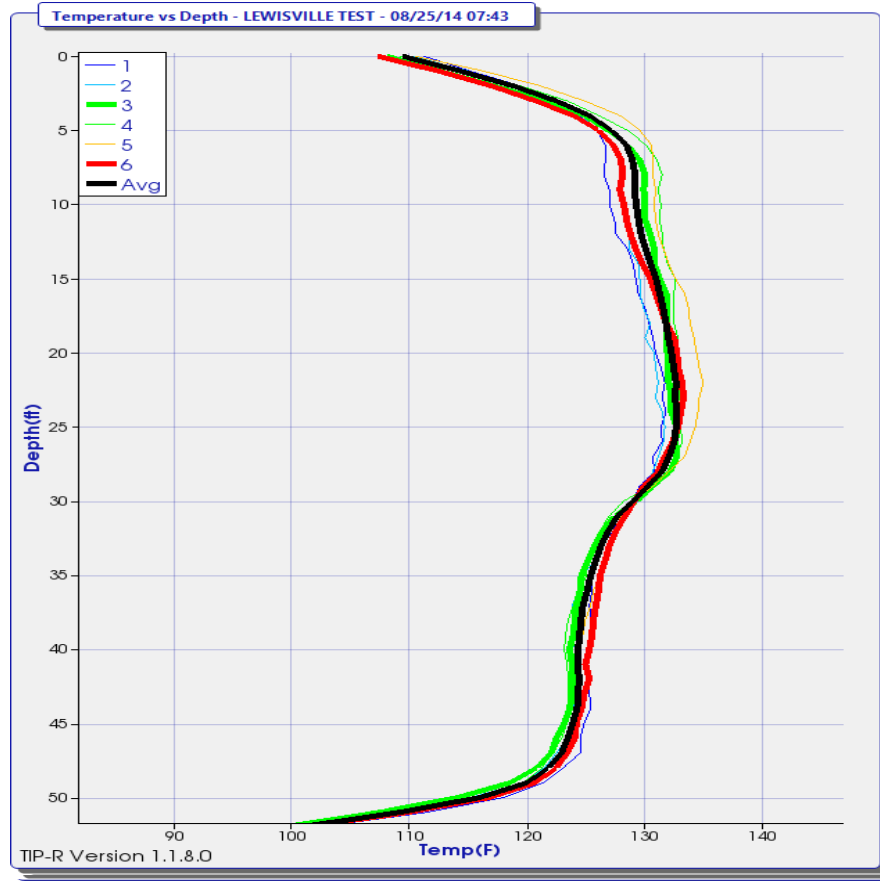
# TEMPERATURE VS TIME

30 min  
1 hr  
2½ hrs  
5 hrs  
9 hrs  
12 hrs  
1 day  
1 day 15 hrs  
2 days  
2 days 12 hrs

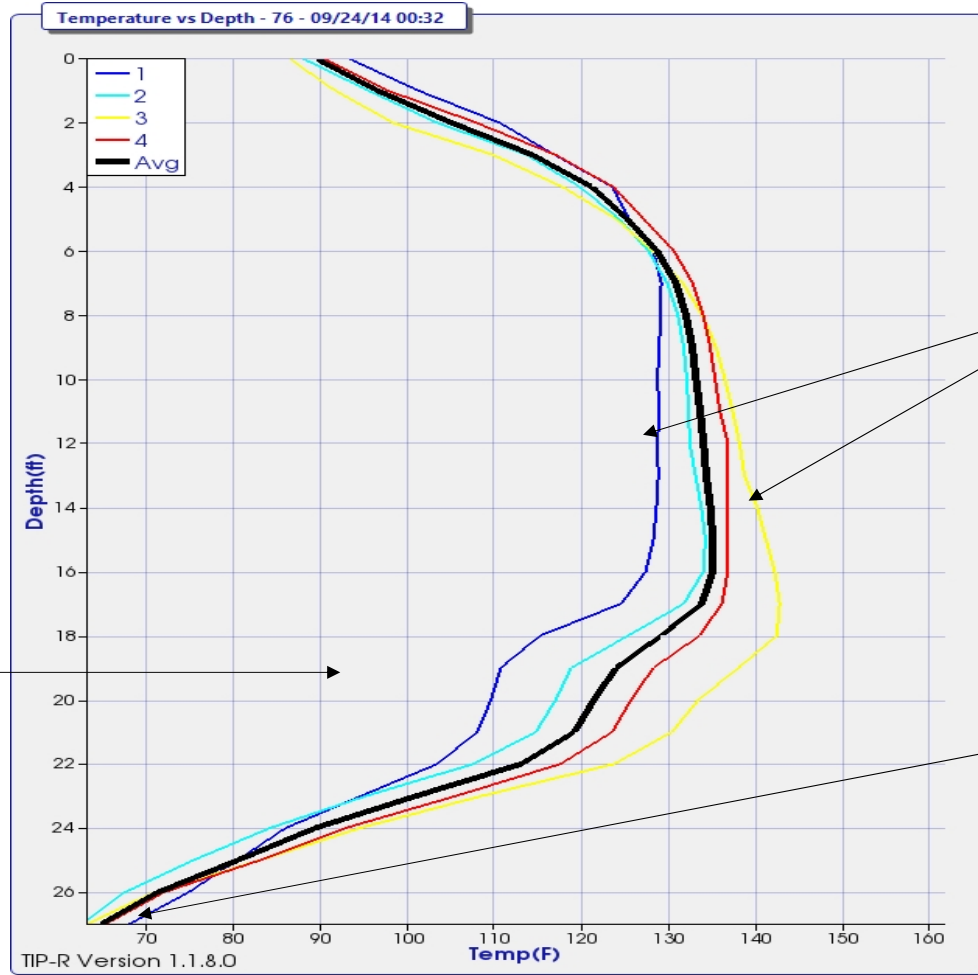
NY/NJ Pier 76

Cage Shift

Soft Bottom

Rock socket

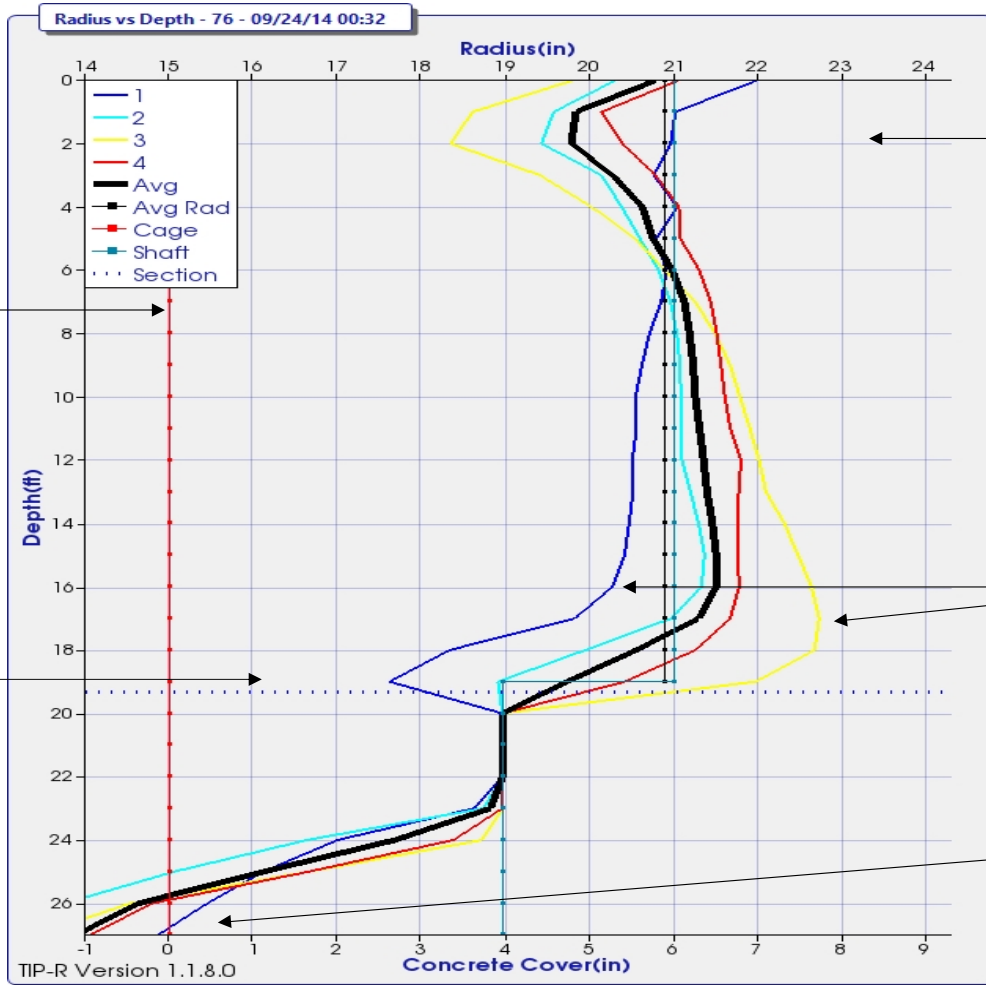
NY/NJ Pier 76

Cage

Neck

Cage Shift

Rock socket

Soft Bottom

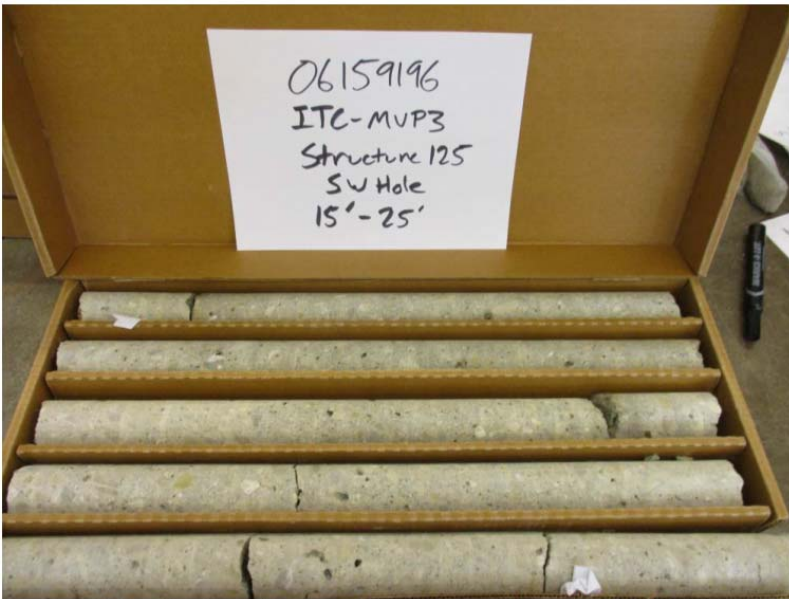
Structure 125 – Southwest Core. Concrete cores from 15 to 25 feet.

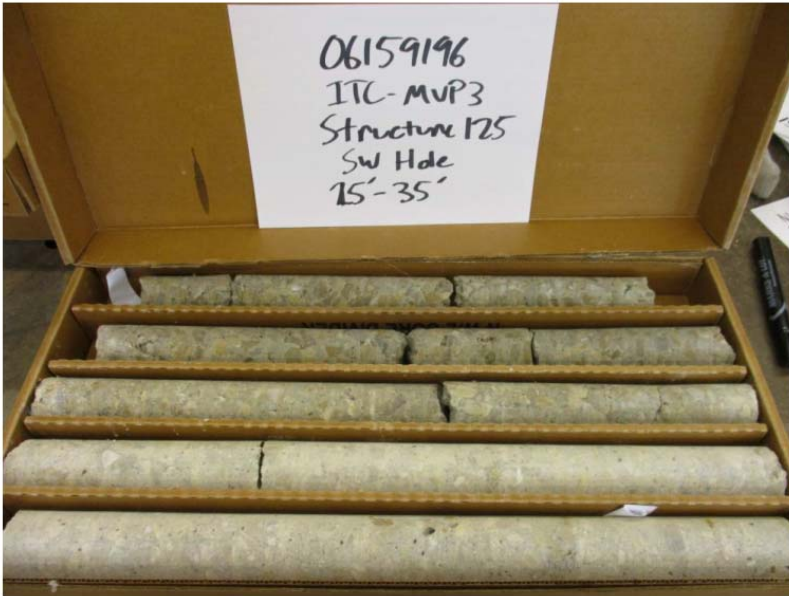
Structure 125 – Southwest Core. Concrete cores from 25 to 35 feet.

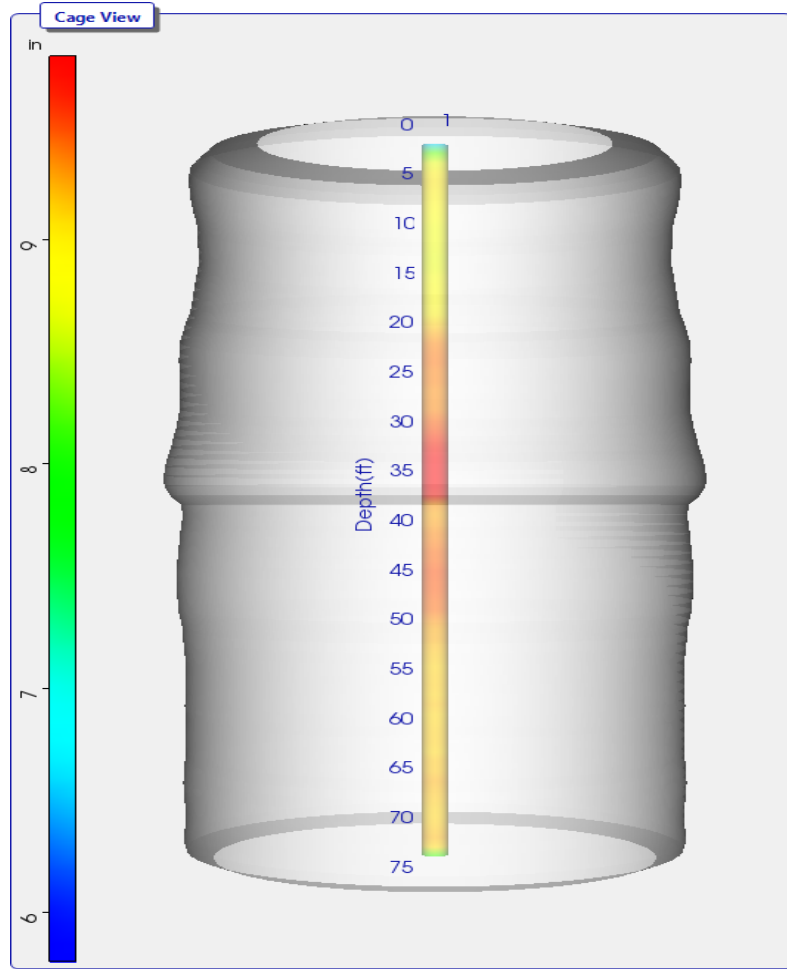
3D rendering with colors corresponding to radius
