# Reconstruction Challenges of a Nationally Historic Arch Bridge in San Diego

Ebrahim AmiriHormozaki, PhD, PE  
Nathan Johnson, PhD, PE

September 7, 2017

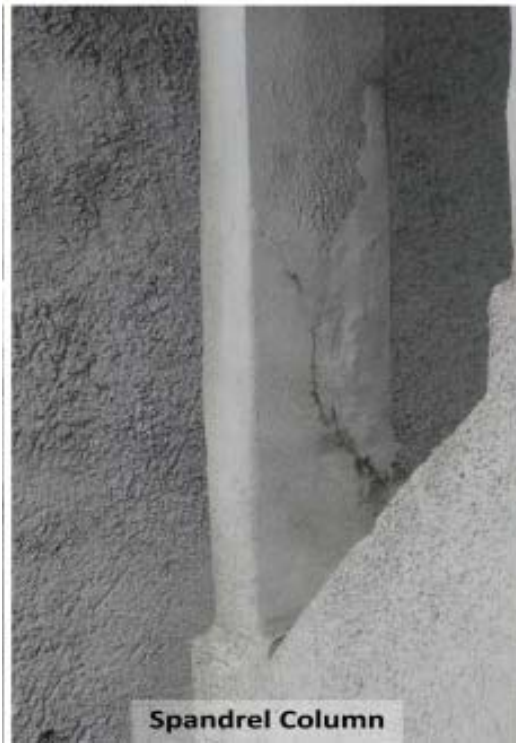
Spandrel Column

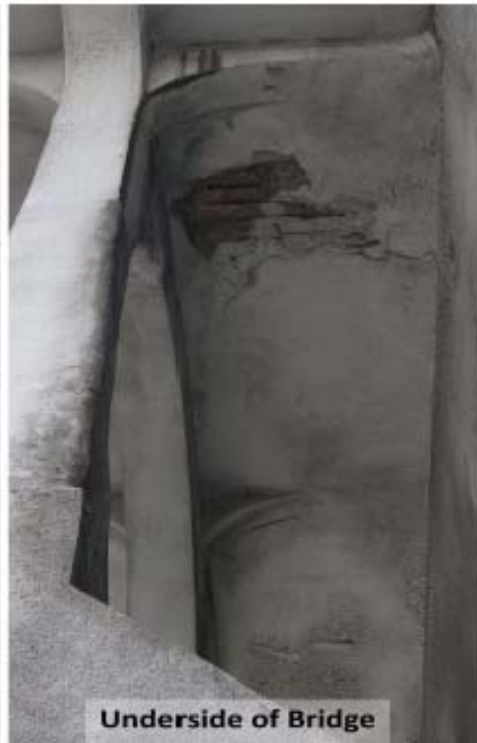
Underside of Bridge

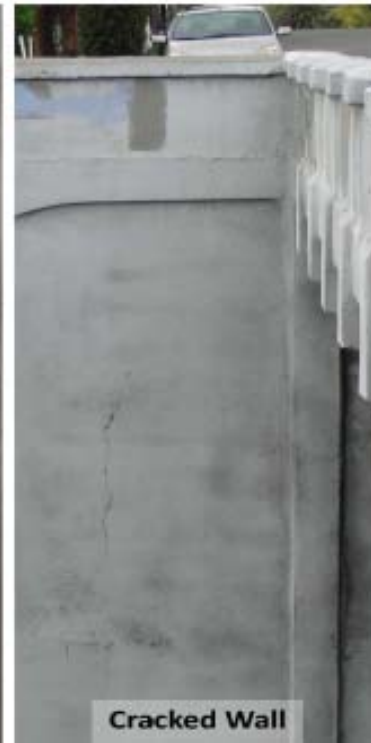
Cracked Wall

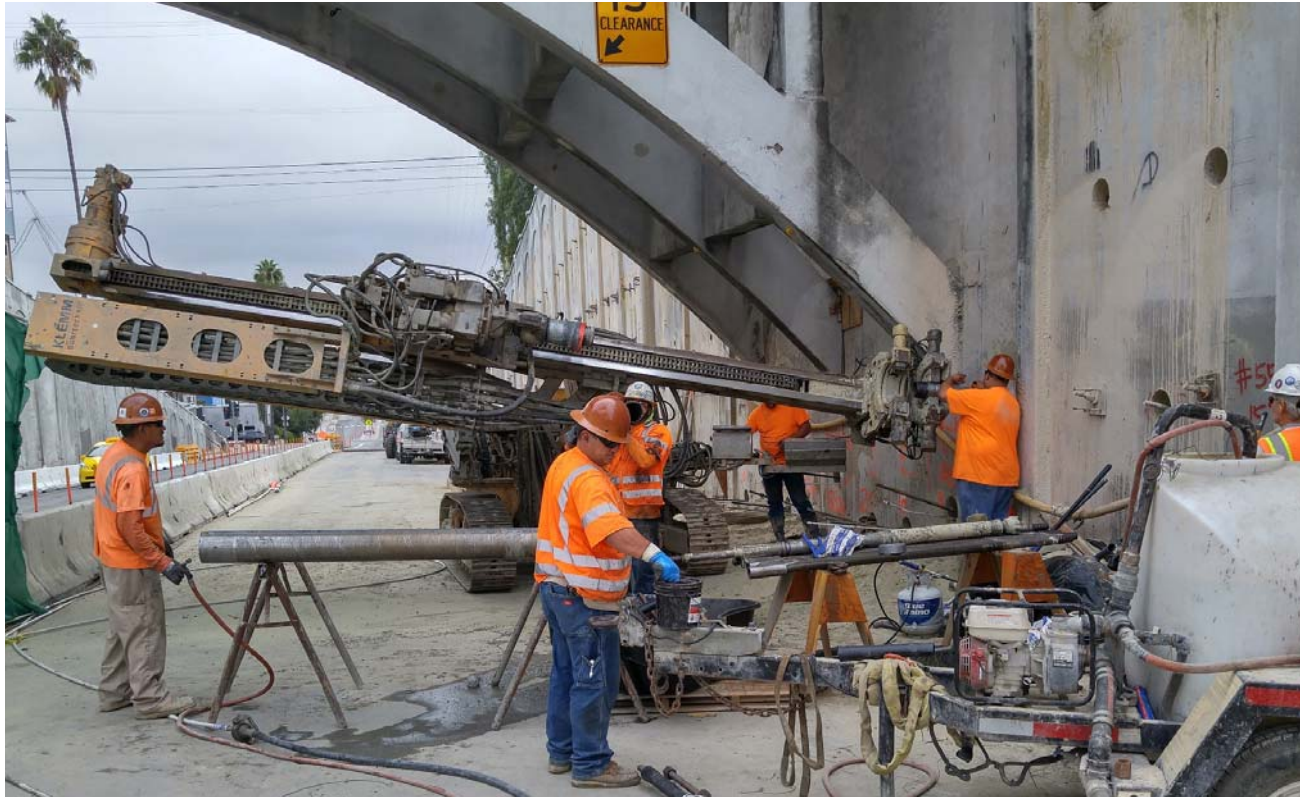
## Soil Nail Installation Using Temporary Steel Casing

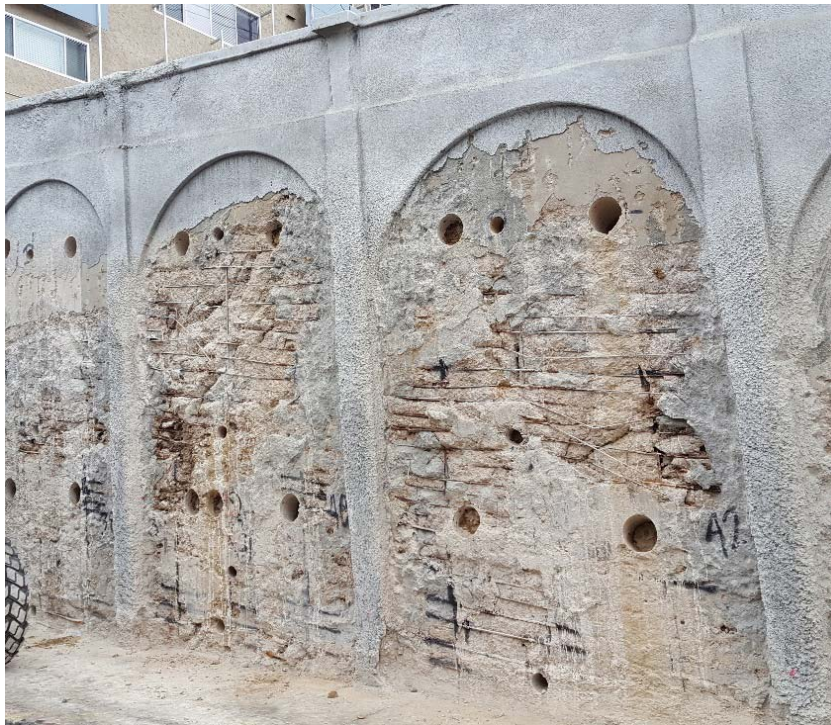
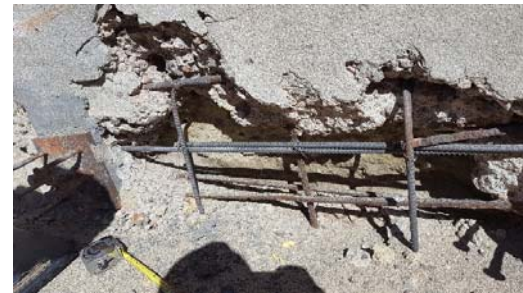
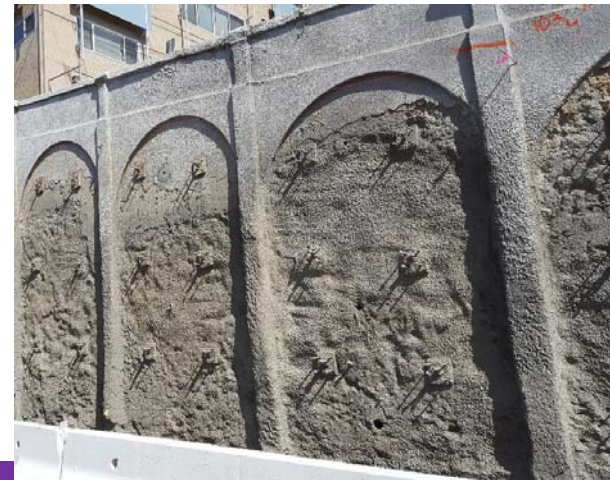
Reinforce and Shotcrete Wall Unsound Concrete

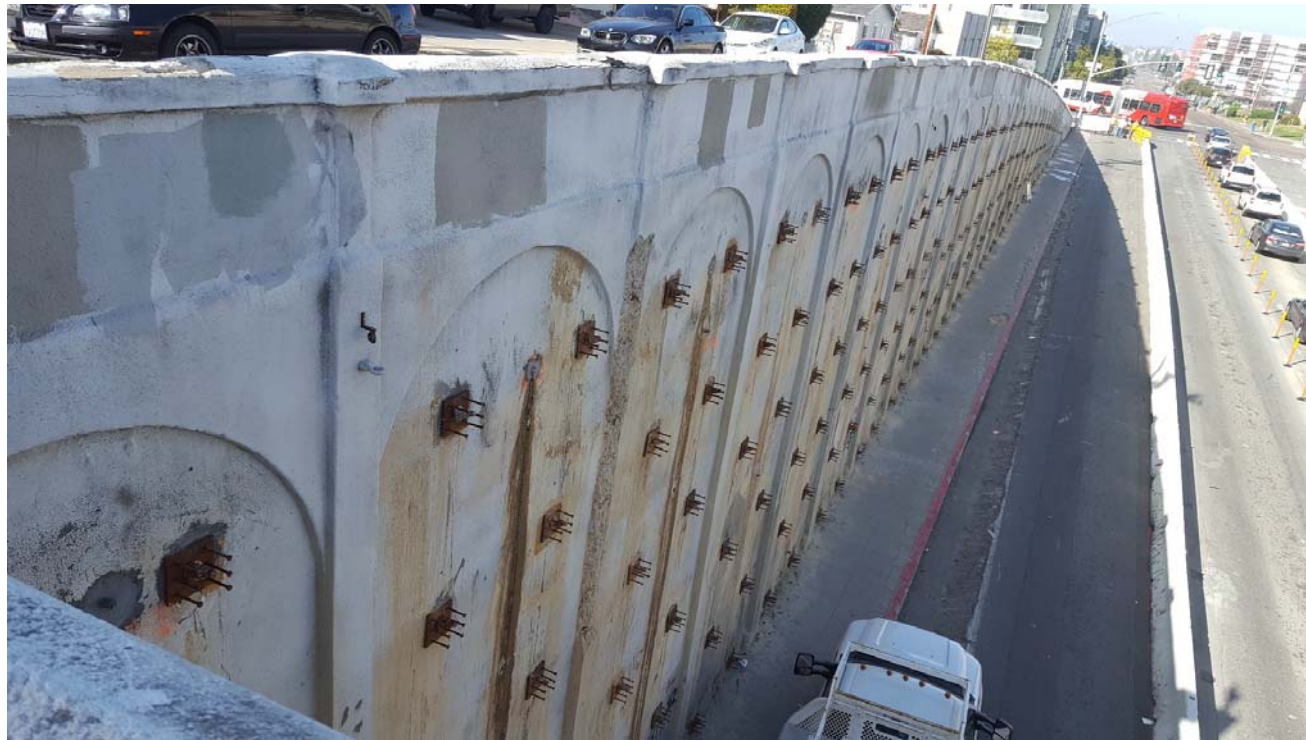
Existing Wall Curved Alignment

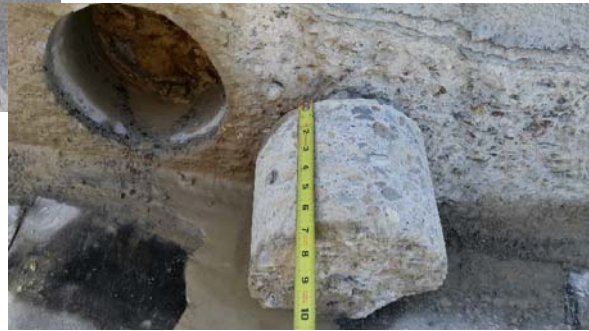
## Coring Abutment and Retaining Walls

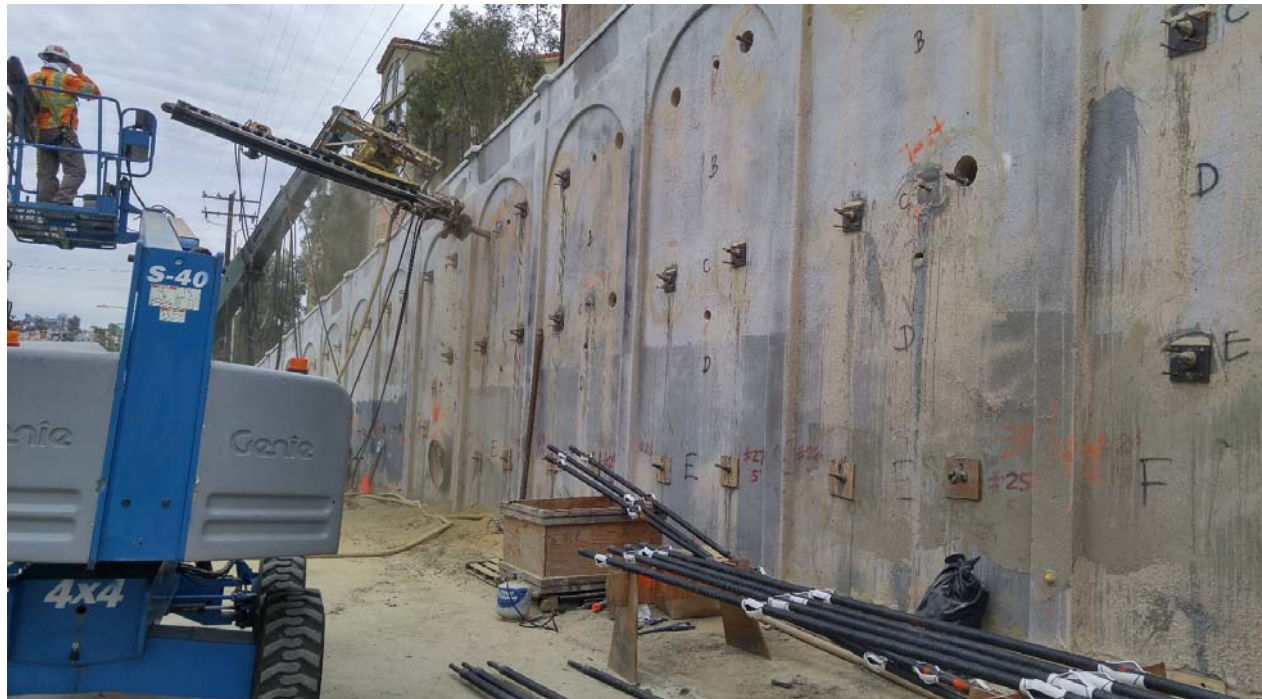
Drilling into Backfill and Formation

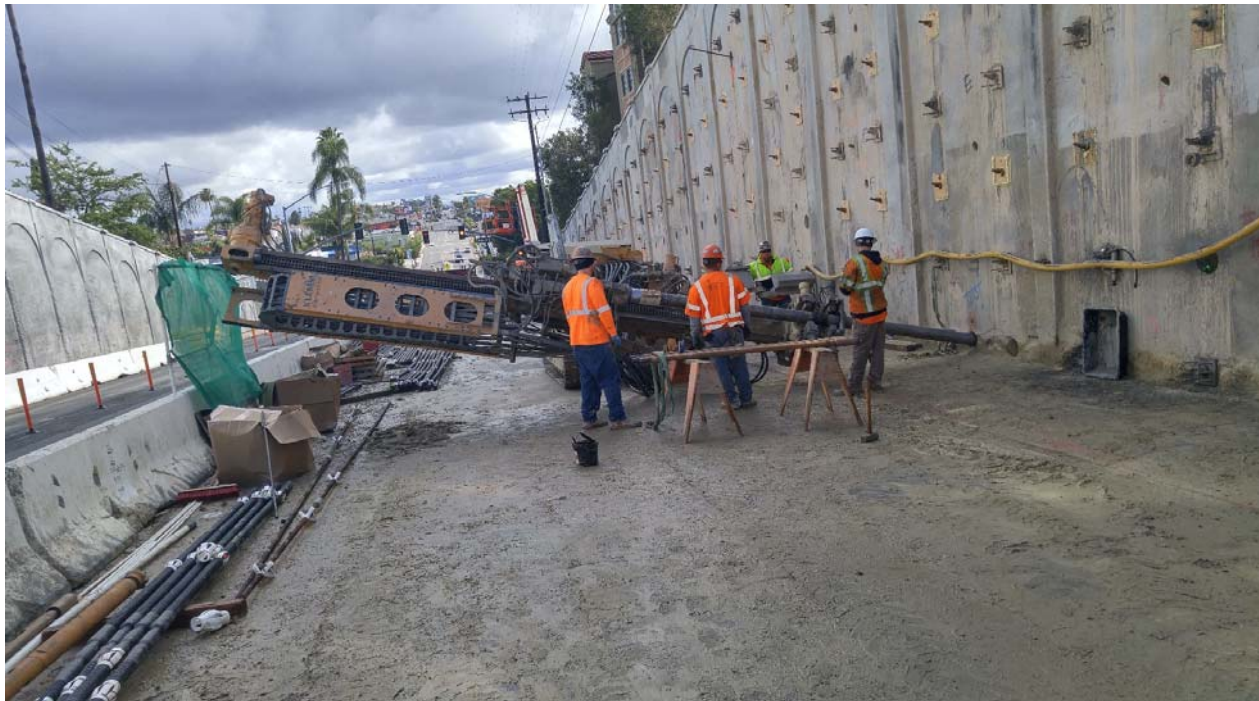
## Soil Nail Installation

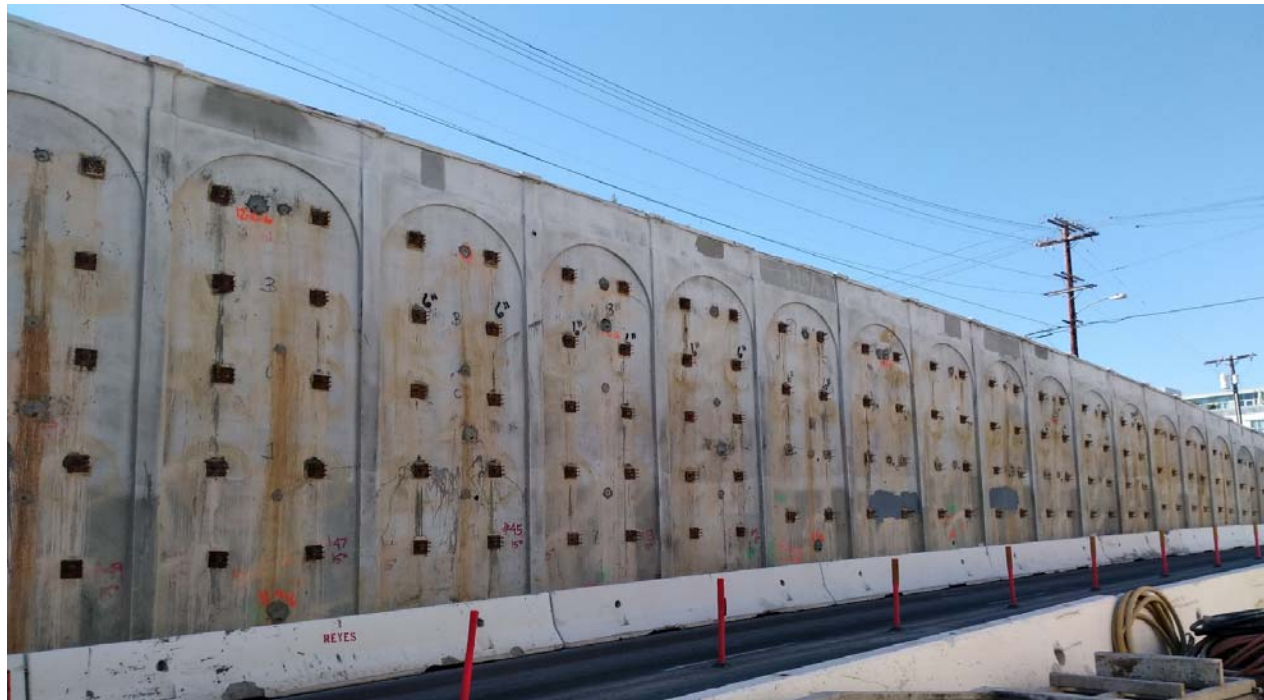
Soil Nails Installation Completed

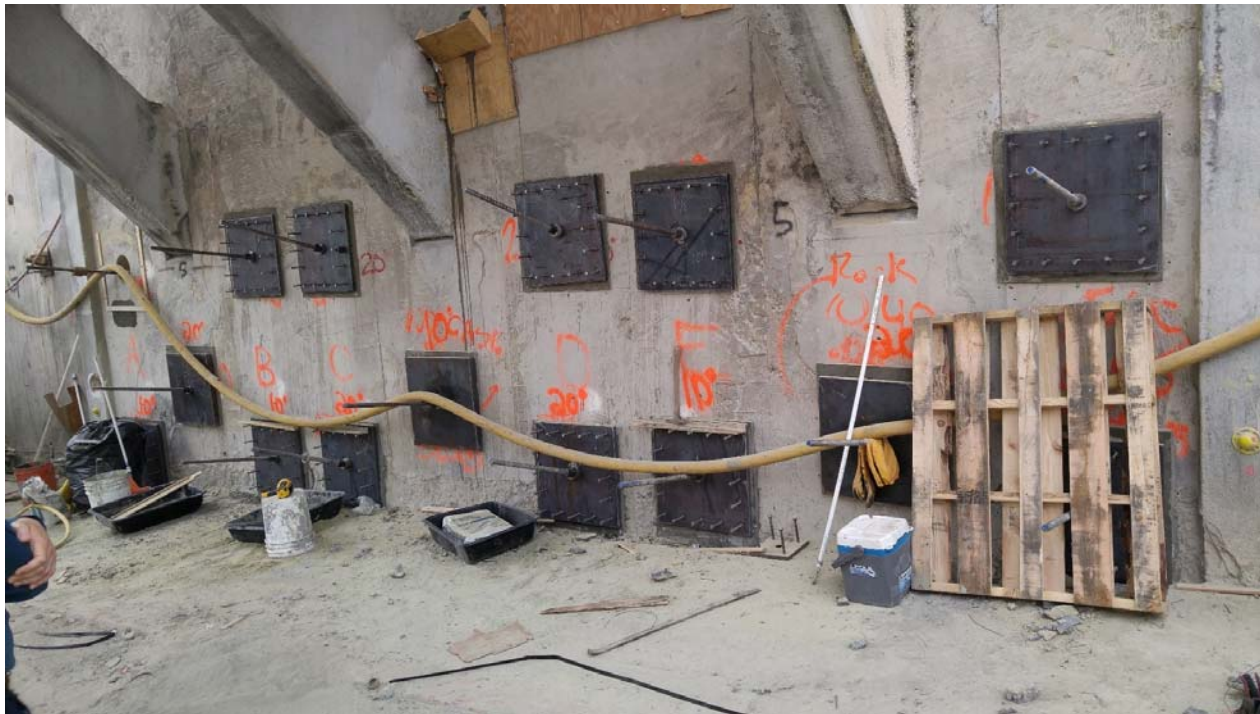
## Ground Anchor Installation

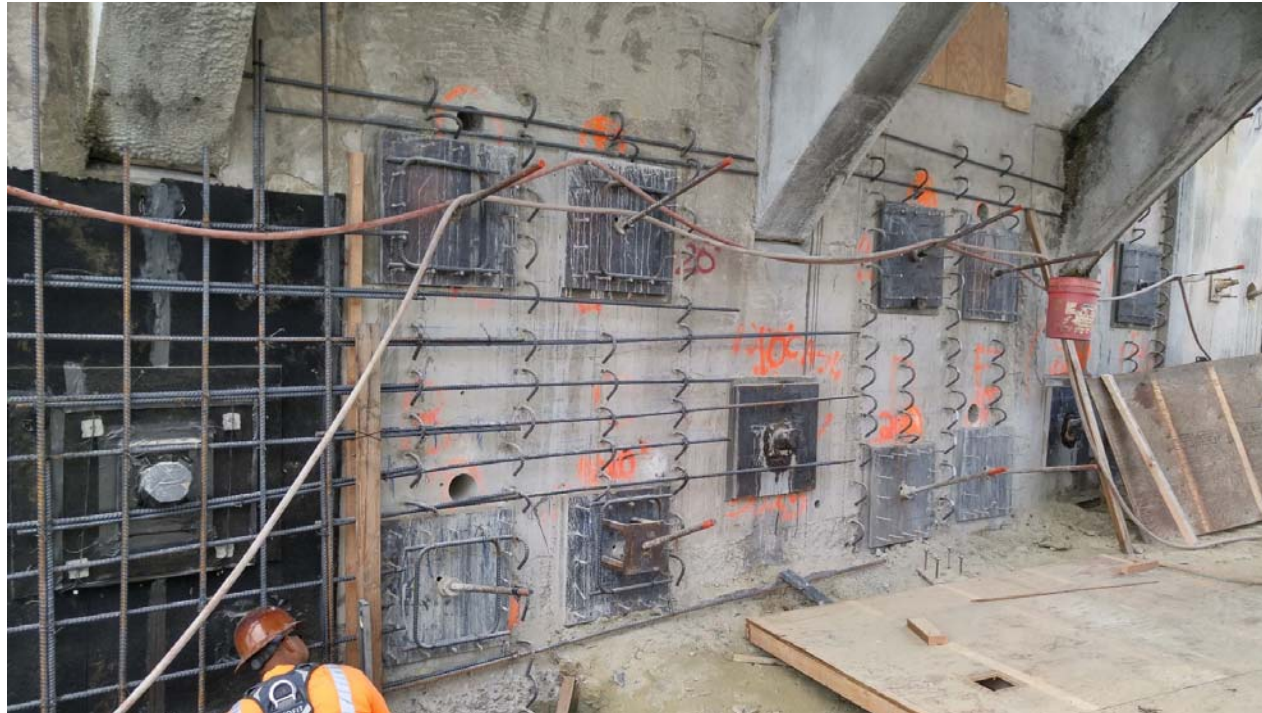
## Abutment New Facing Construction

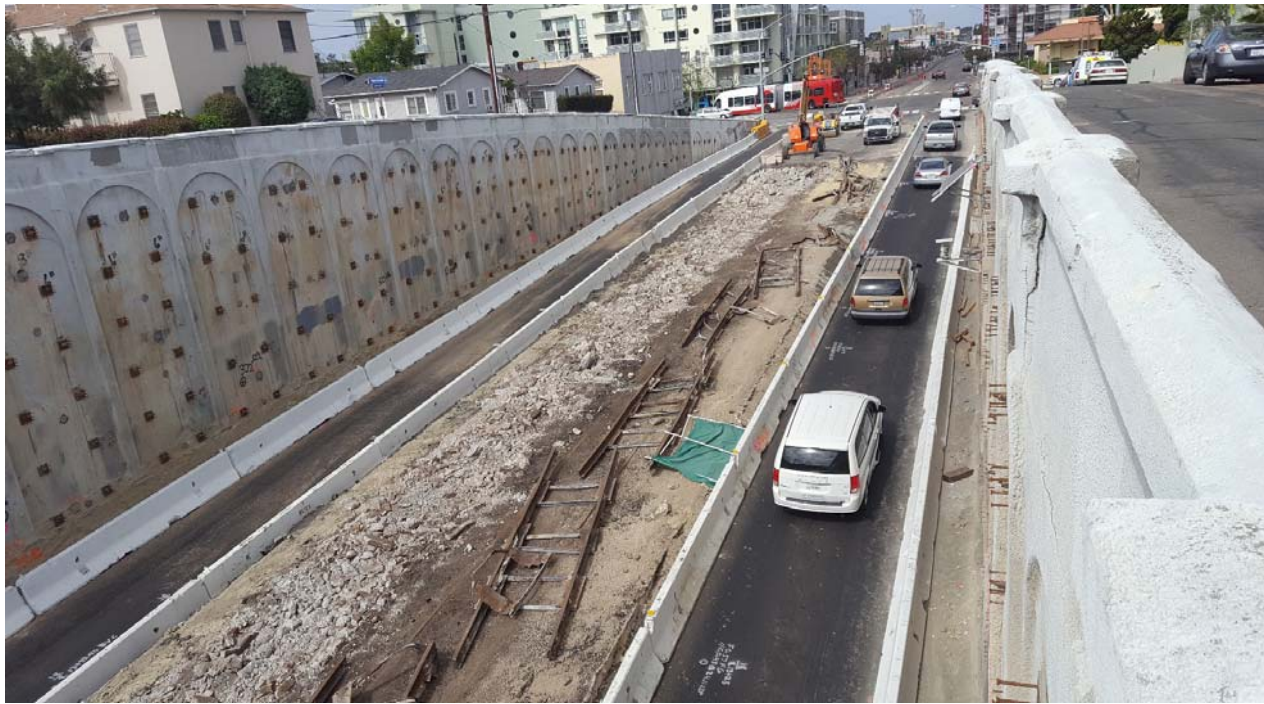
## Roadway Lowering

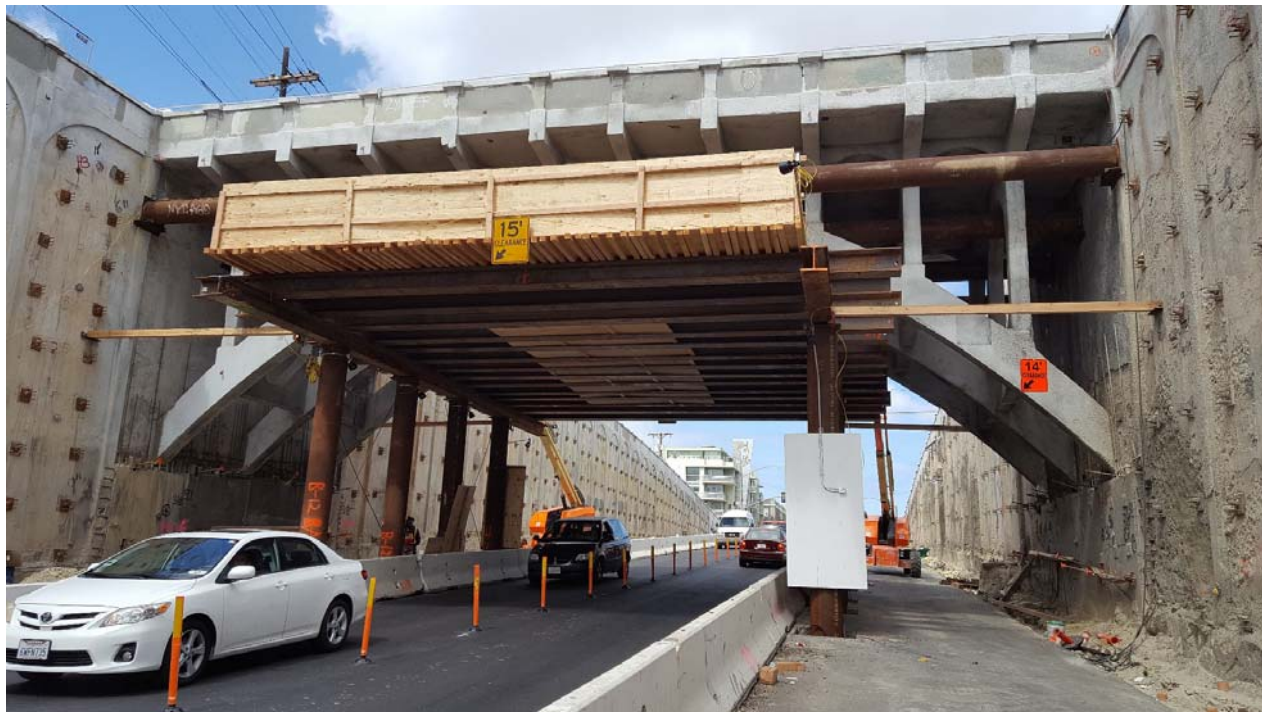
Traffic Protective Cover

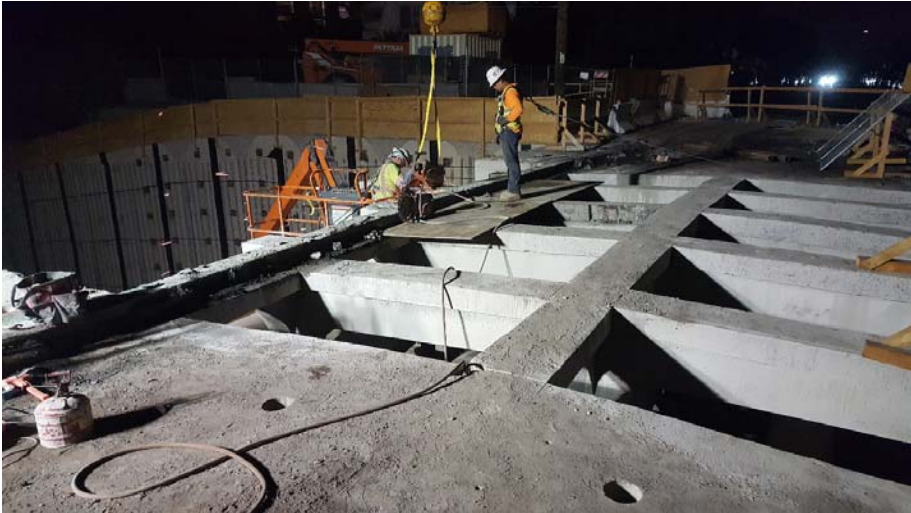
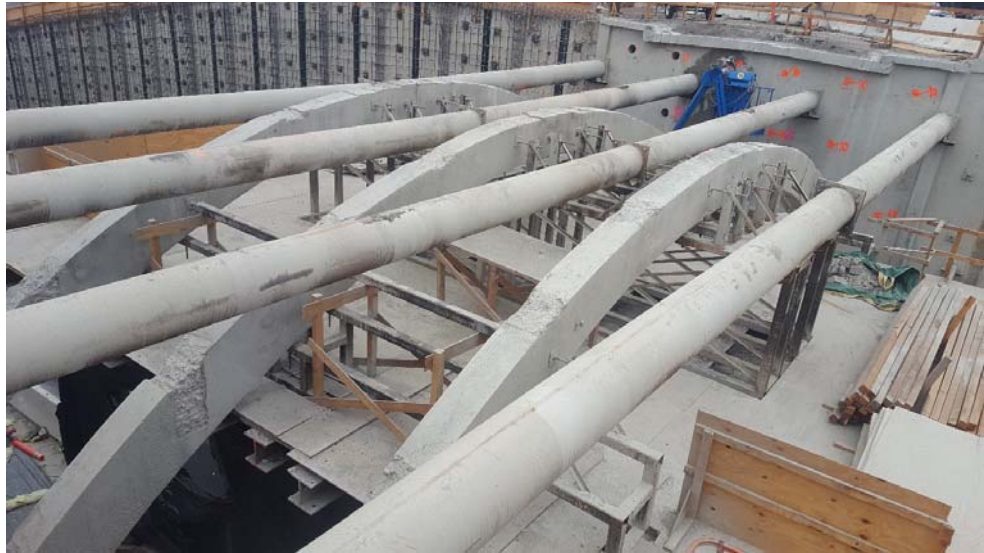
## Bridge Demolition

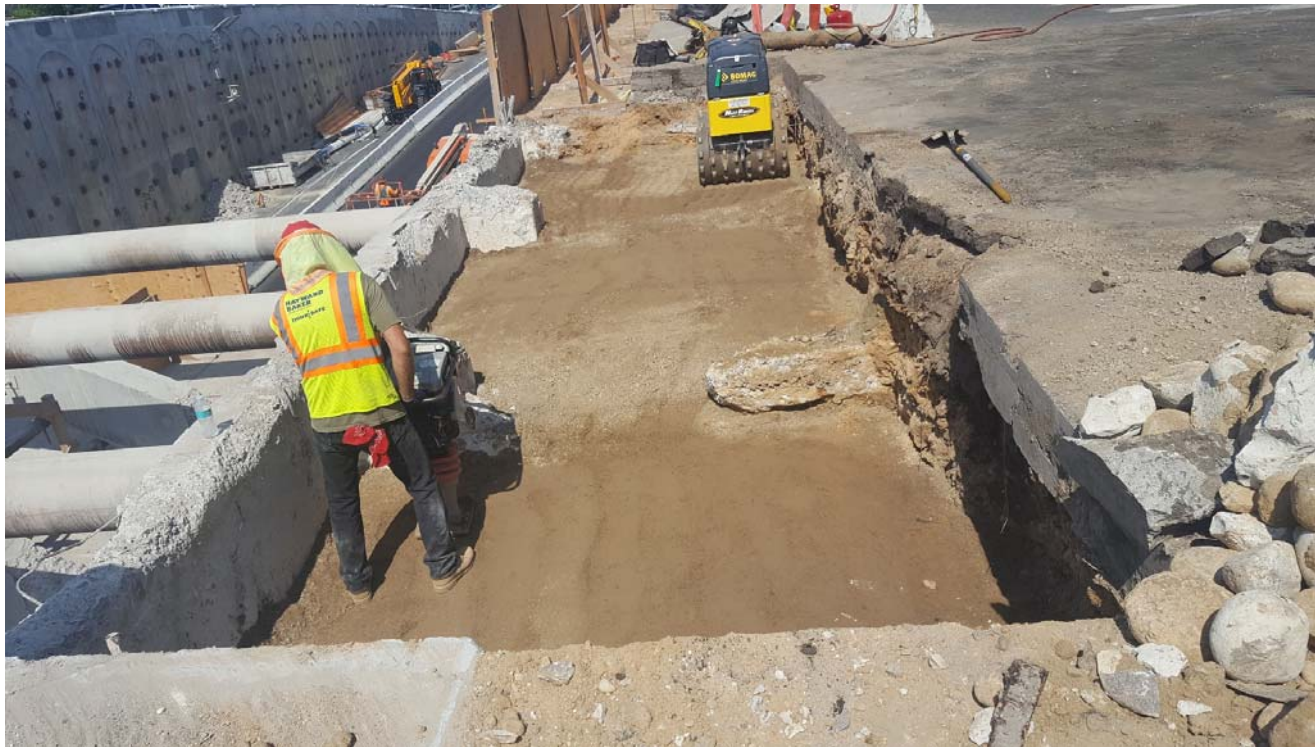
Soil Improvement

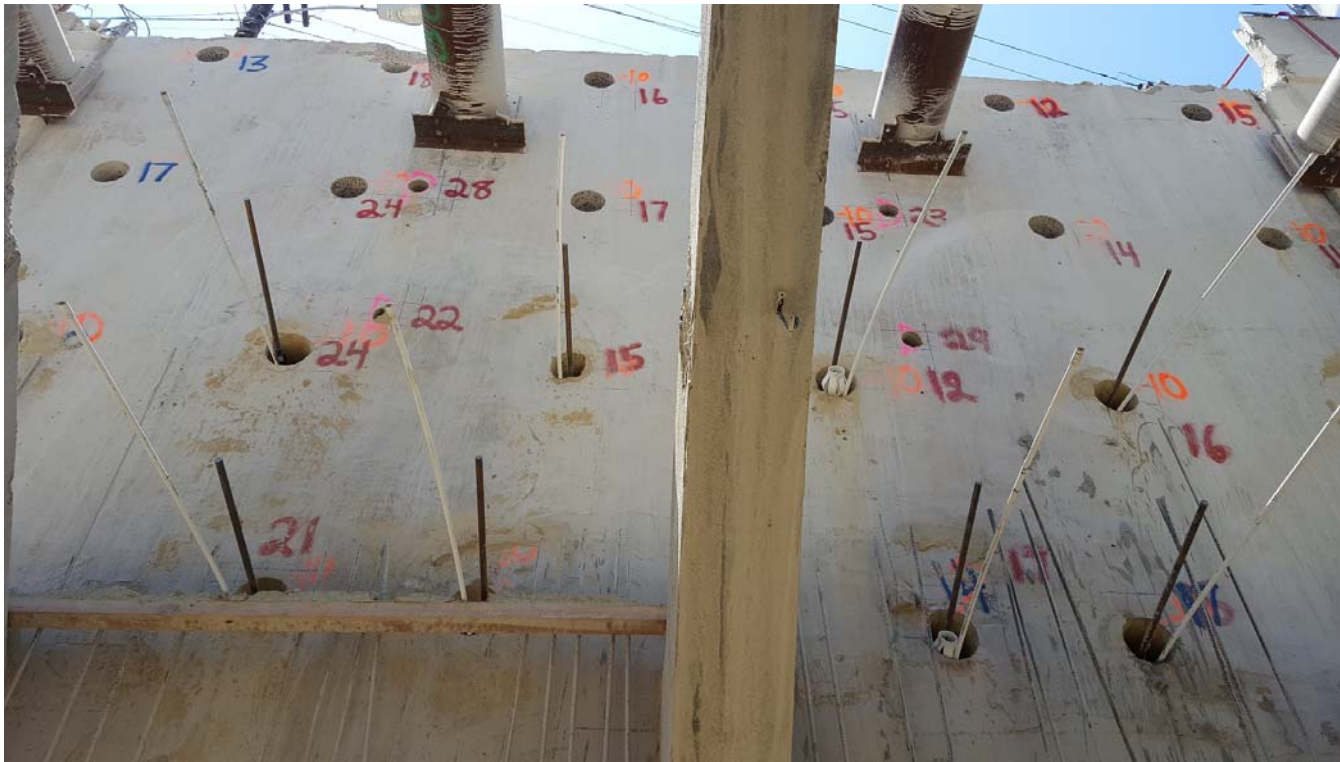
Installation of Remaining Ground Anchors

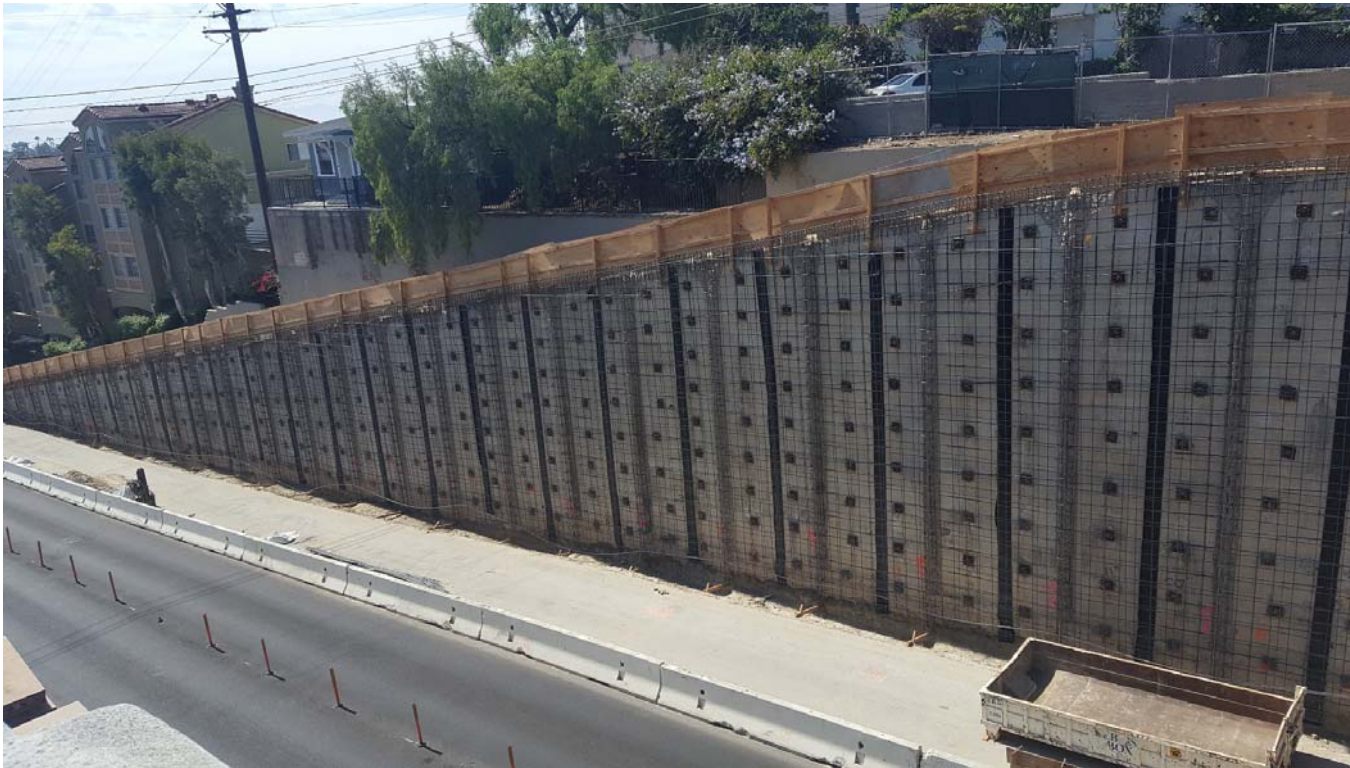
## New Facing Construction

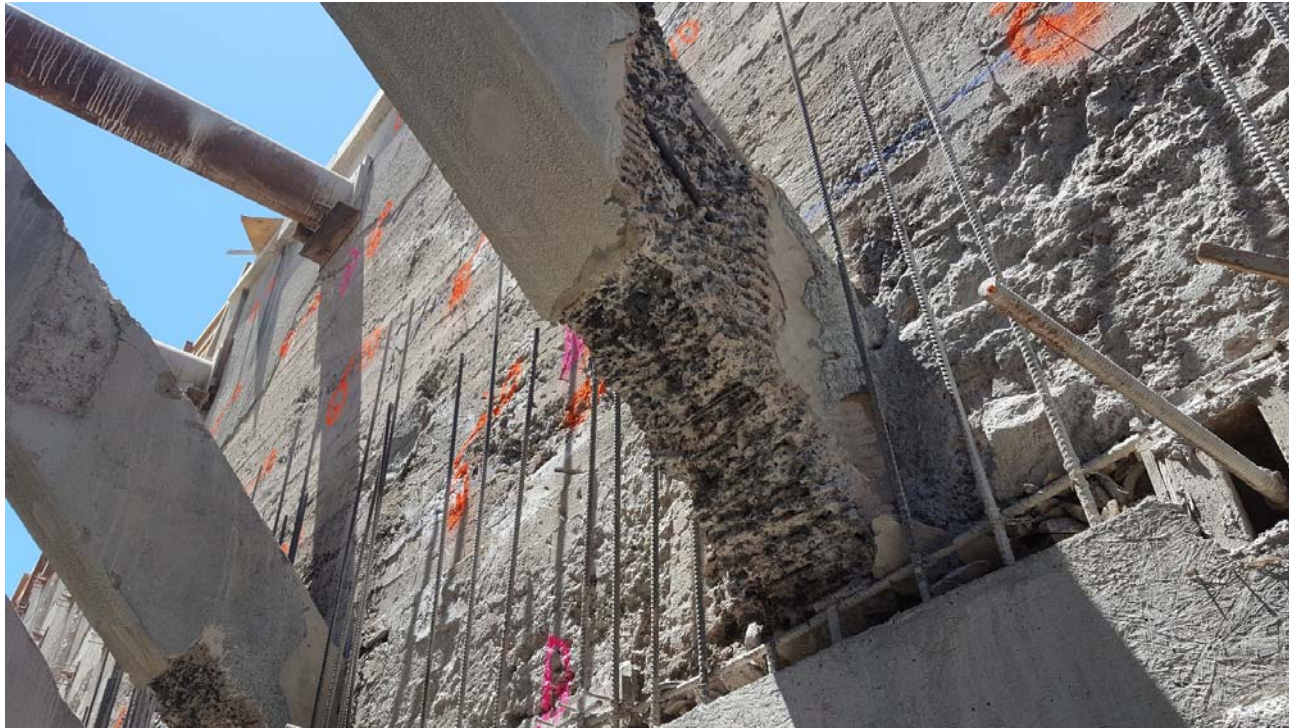
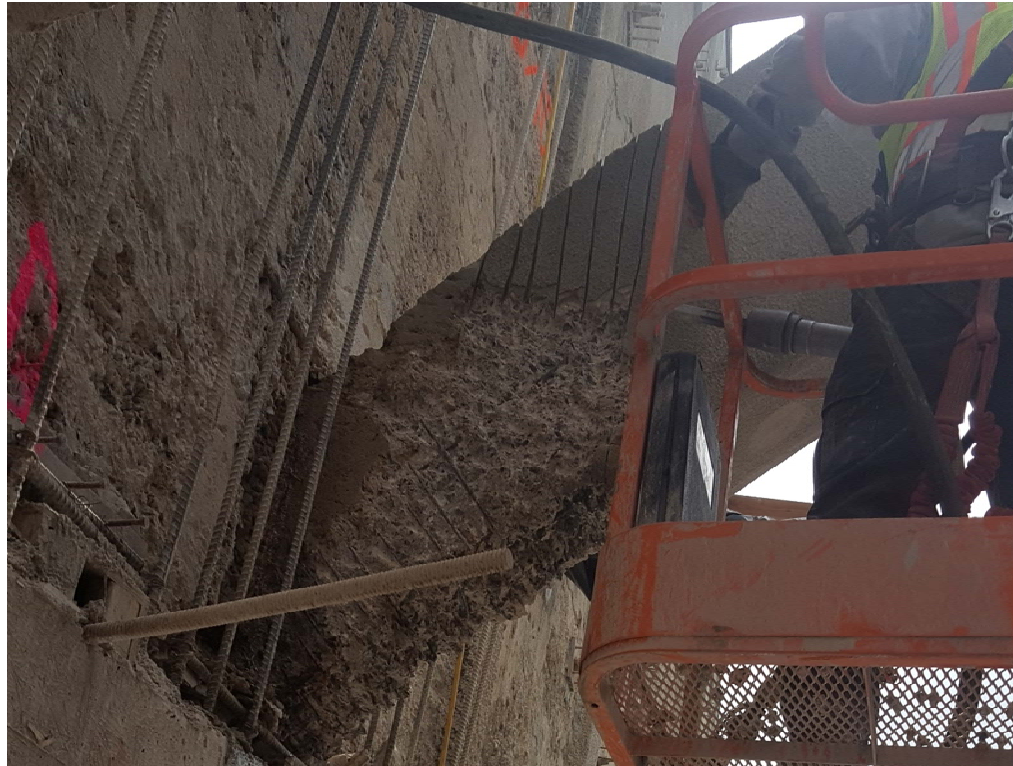
Hydrodemolition- Alternative Means and Method

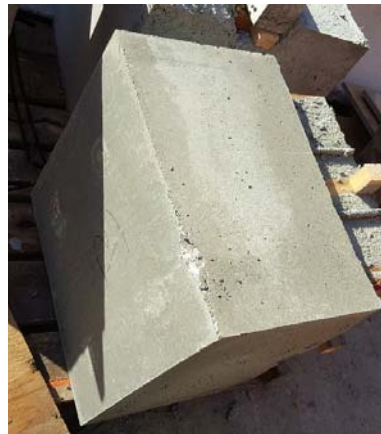
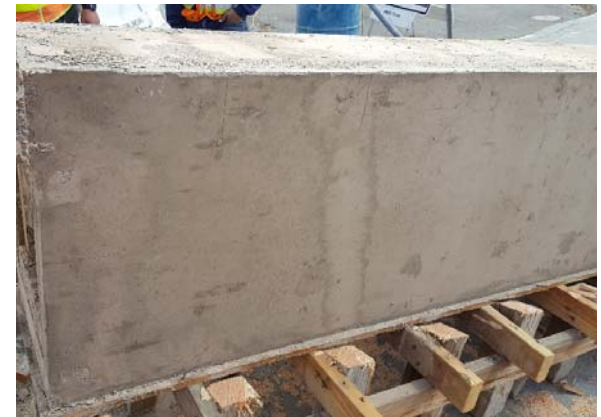
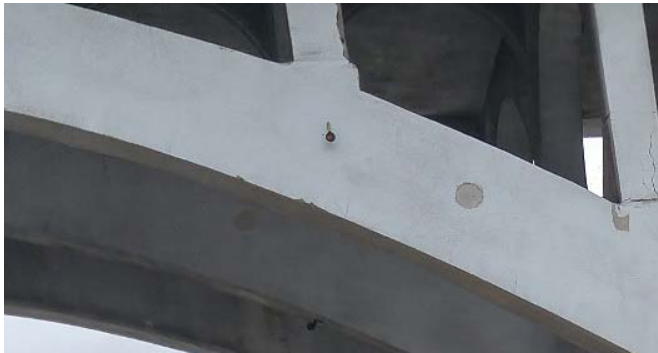
## Arch Rib Fiber Reinforced Self-Consolidating Concrete

Arch Rib Mock-ups
