# **Alternative ABC Connections Using UHPC**

**Florida International University**

**September 2017**

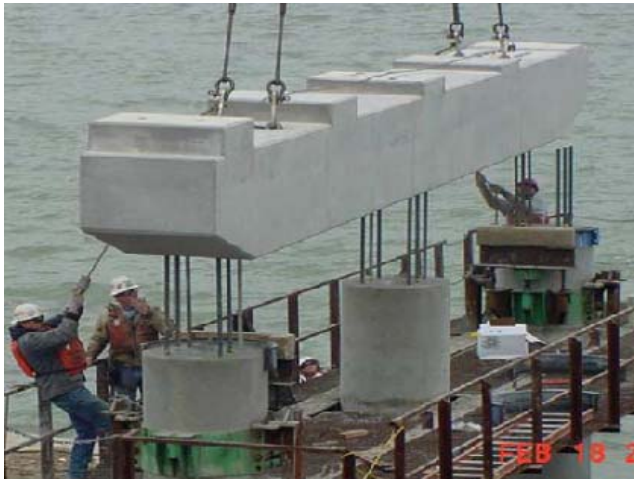
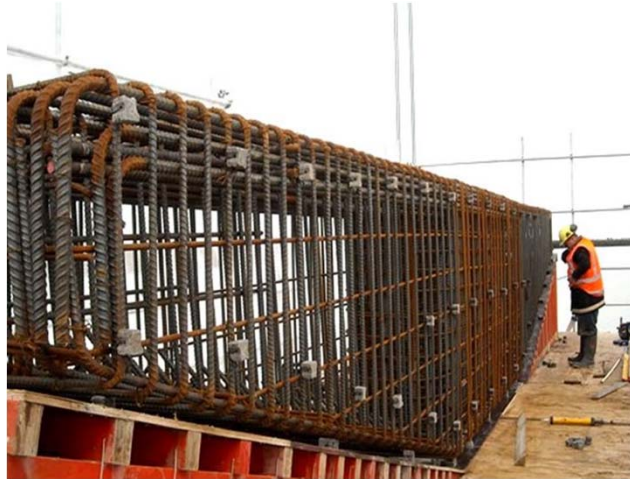
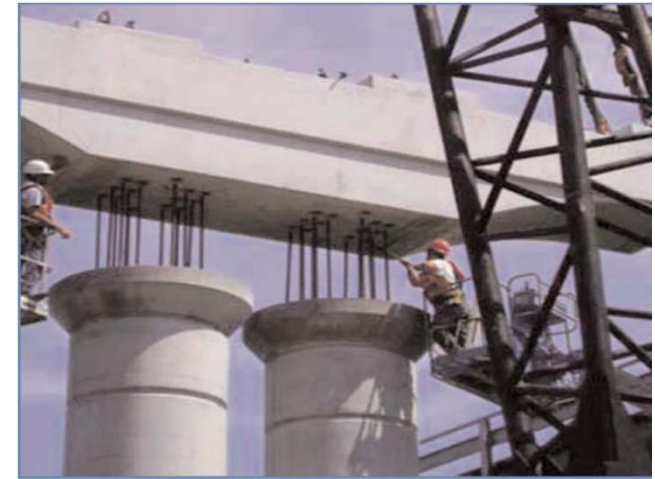
Currently all ABC Connections to connect cap beam to columns uses types of connections that penetrates into the cap beam, creating a very challenging detailing Requirements within the cap beam.

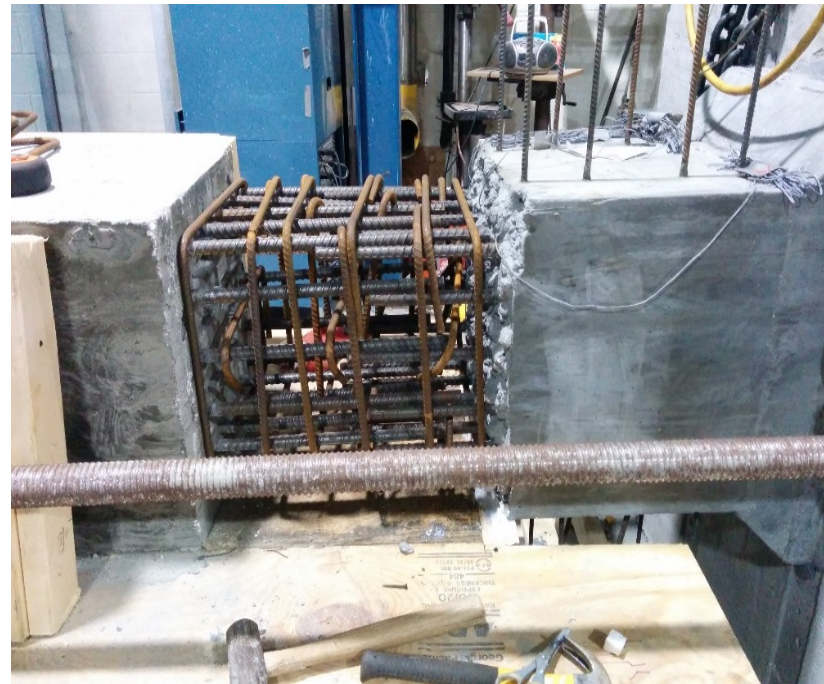
✓ Large Tolerances

Splice region  
using UHPC

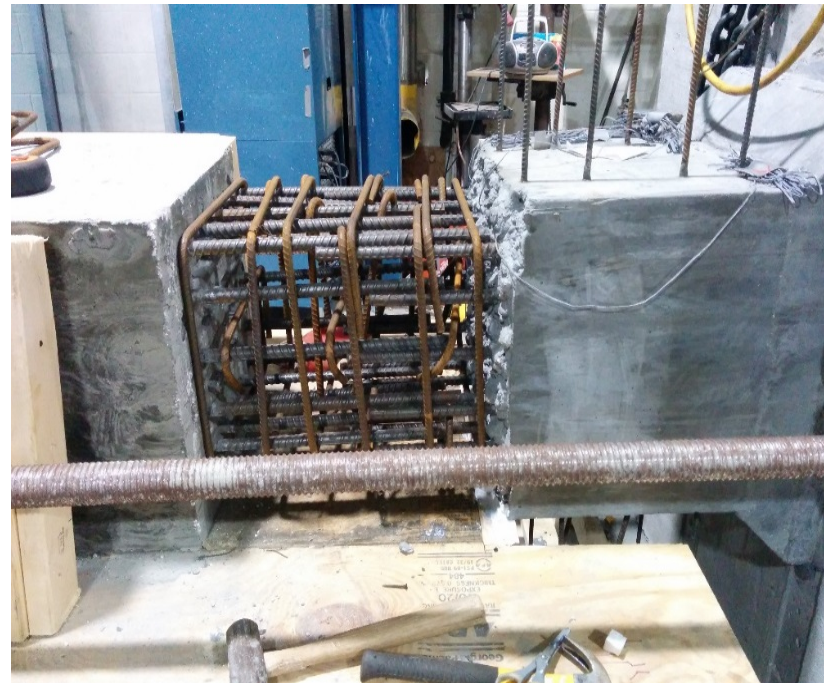
- ✓ Developing the reinforcement over short length
- ✓ Minimal volume of concrete to be casted in the field

Splice region  
using UHPC

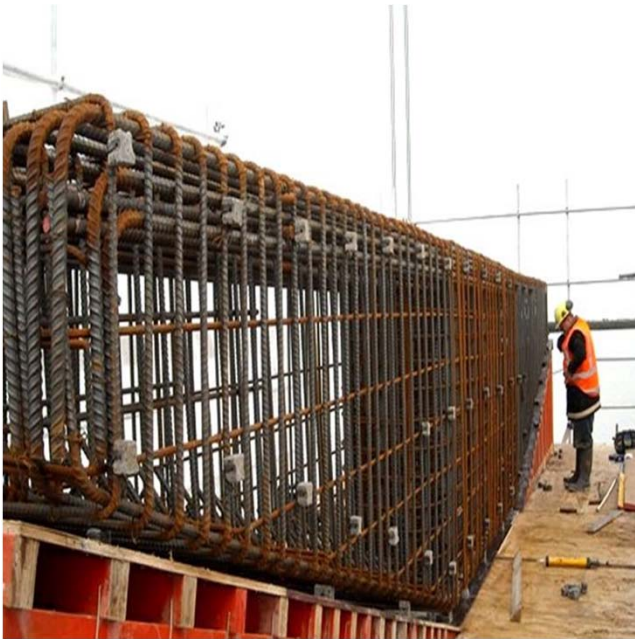
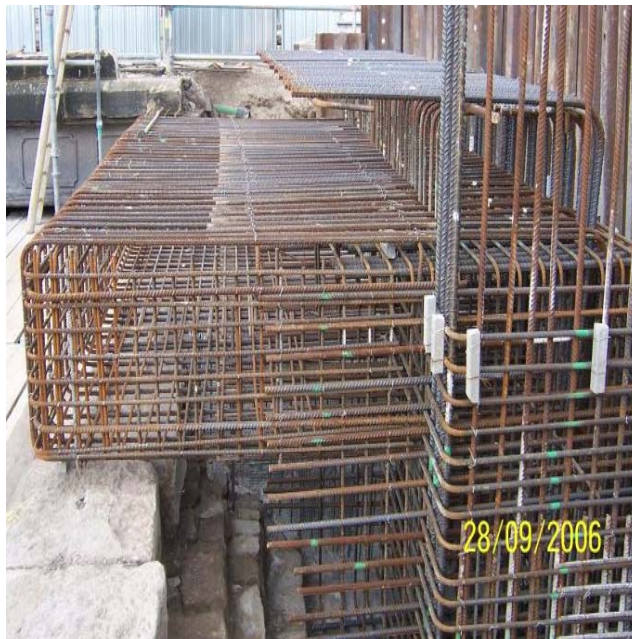
- ✓ Eliminating the potential interferences with reinforcement in the cap beam

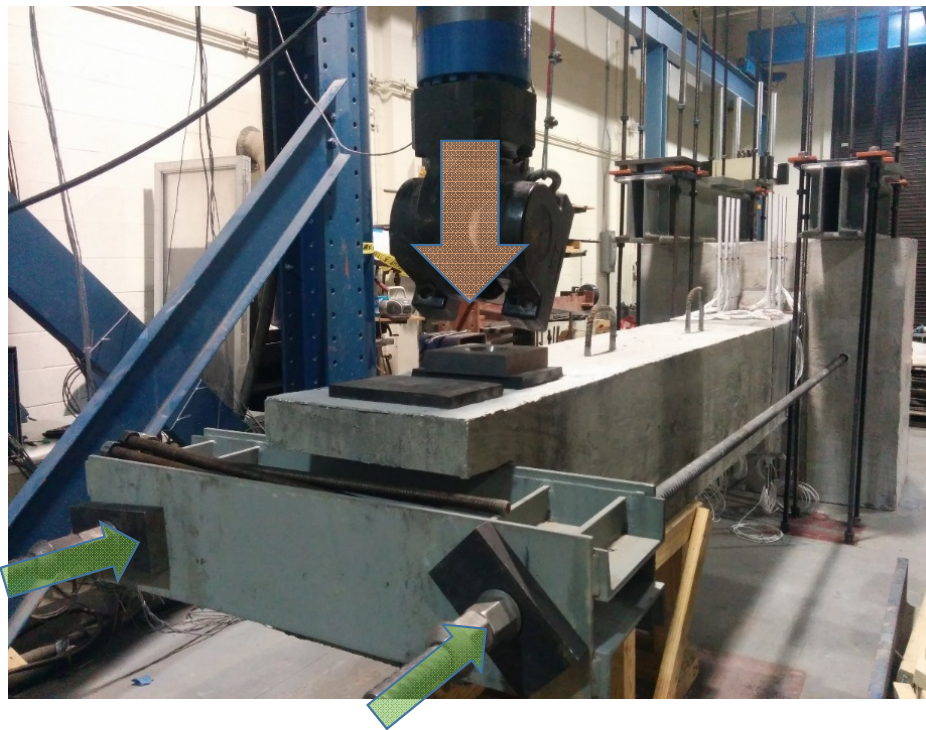
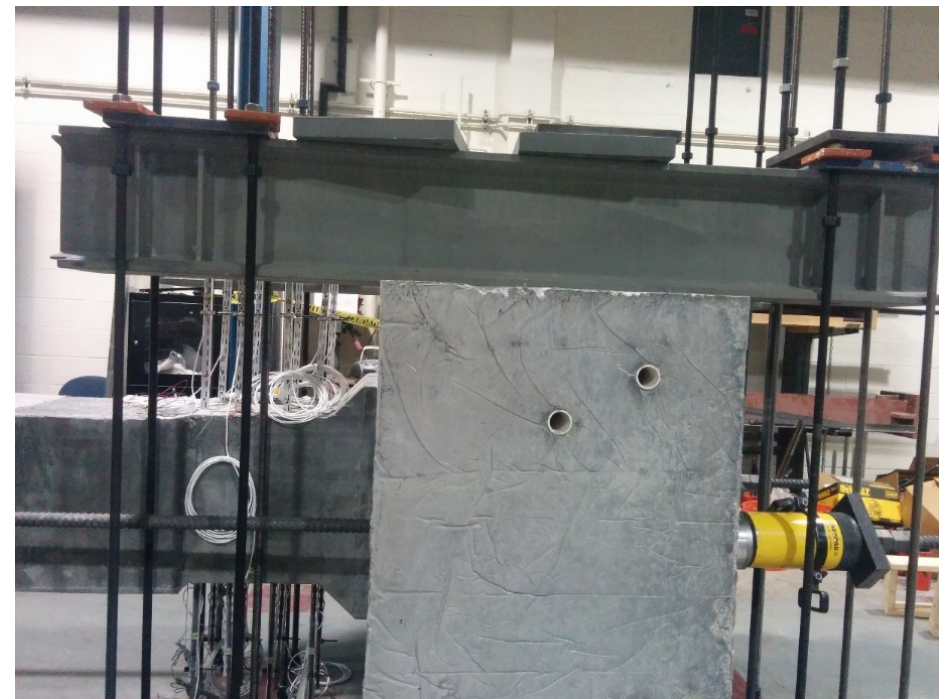
# Testing the Specimen

Loading and Supports (Axial Load=200 Kip (10%  $P_u$ ))

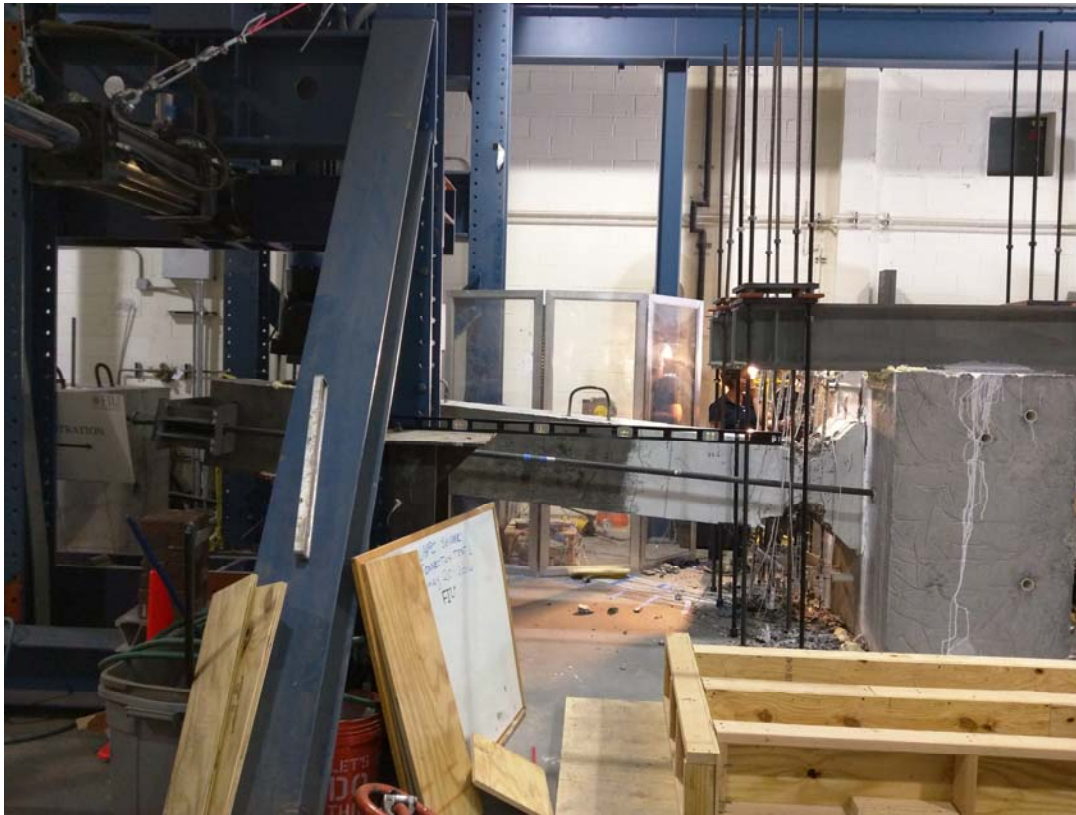
# Results

## Observations

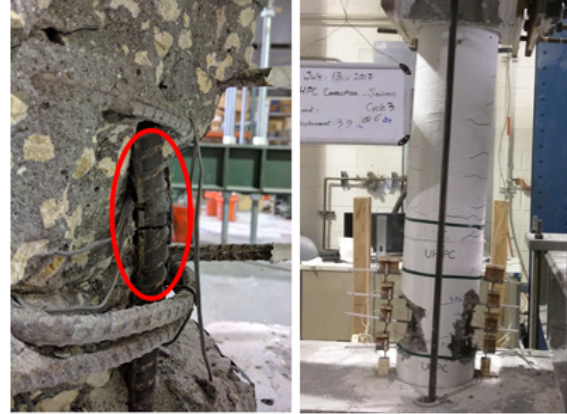
b) S-4-0-10

# Results (Mode of failure)

- All of the specimens with seismic detail showed ductile behavior and the plastic hinge formed in the desired location.
- The main characteristic of the proposed connection is influenced by transverse rebar ratio. The distance between the stirrups plays a major role in preventing longitudinal bars buckling.
- No major crack was observed in the cap beam for the proposed seismic and non-seismic details. Therefore the non-seismic detail, with a seismic design consideration can be an alternative detail even for seismic regions.
- No significant damage was found in splice region even in the absence of the transverse reinforcement in this region.
