History of Pumphouse Wash Bridge in Oak Creek Canyon

Final Design

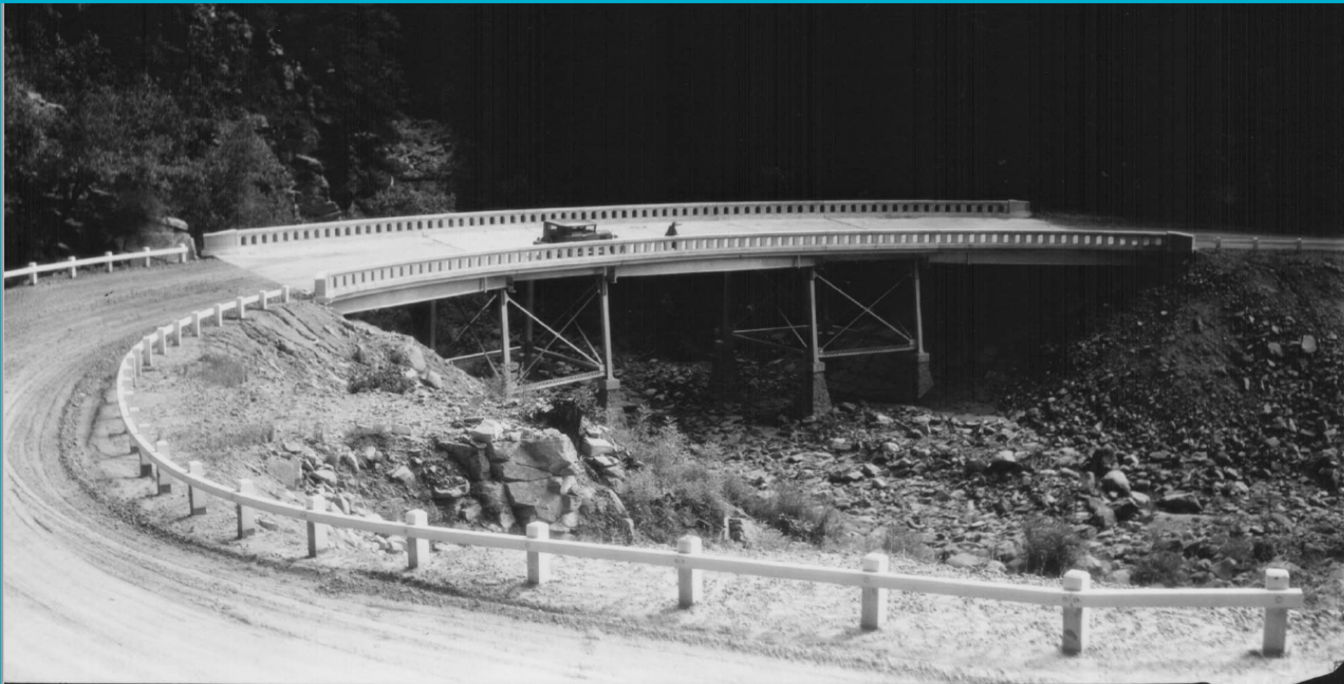
- Built in 1931 by the US Bureau of Public Roads
- Designed by BPR engineers and built by C.G. Willis and Sons for an estimated \$187,000
- Pedestals at Pier line #2 and #3 were encased in concrete in 1932 at bottom of creek
- First state highway designated as a “scenic road” by ADOT in 1984.
- 160ft total length 5 Span steel stringer bridge supported by steel four-legged piers on concrete pedestals.
- Roadway construction centerline was on a 150 ft radius.
- Designed for H15 truck loading.
- Bridge barriers and expansion joints replaced in 1986. Shotcrete scour apron installed at piers #2 and #3.

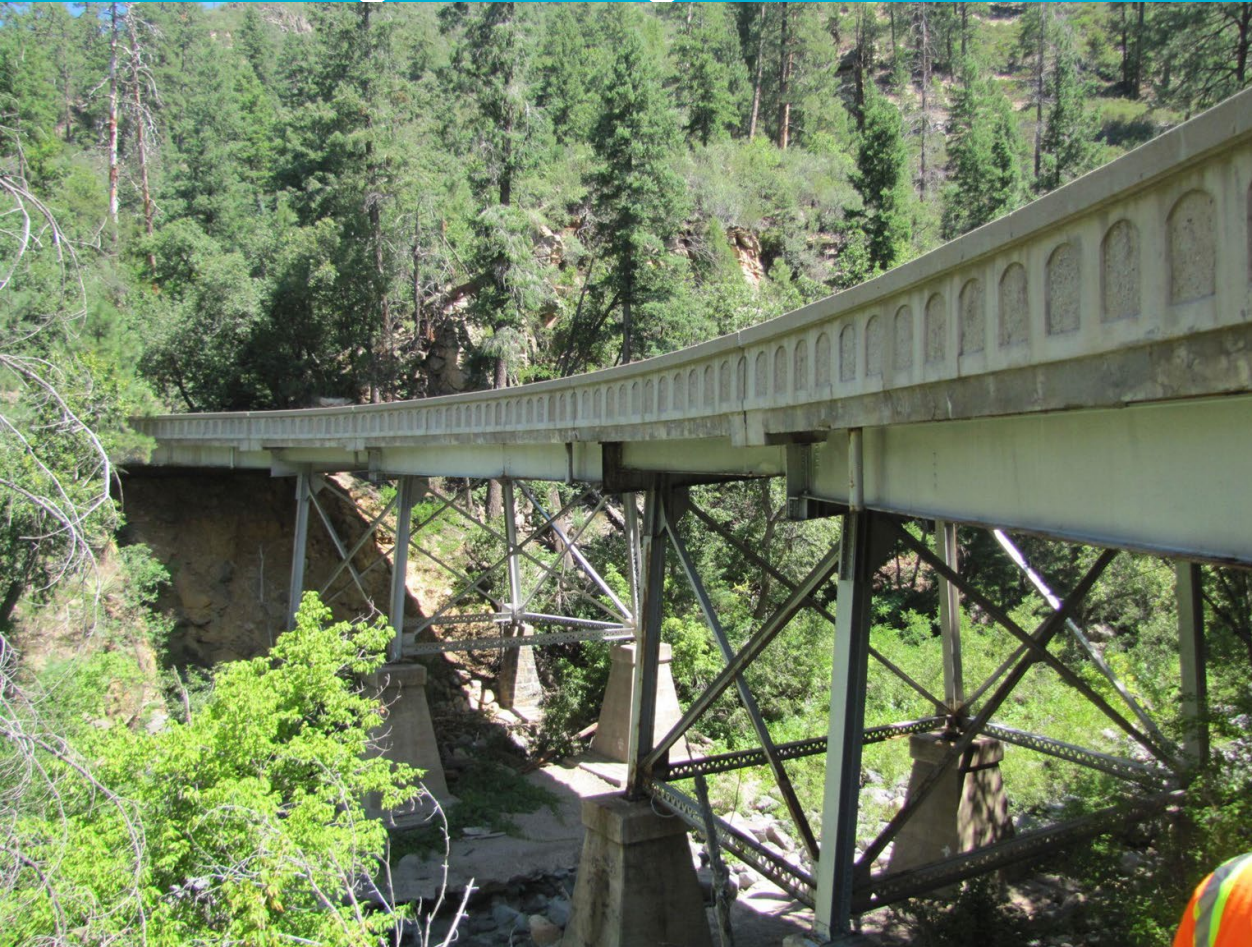
Phasing challenges

- Fracture Critical Bridge would not allow phased demolition

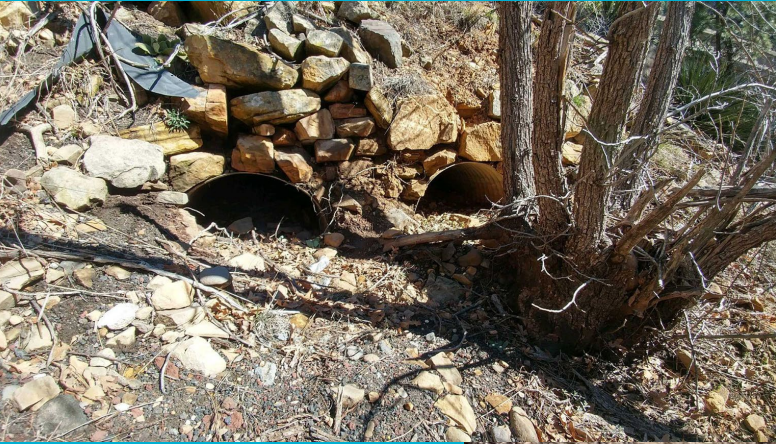
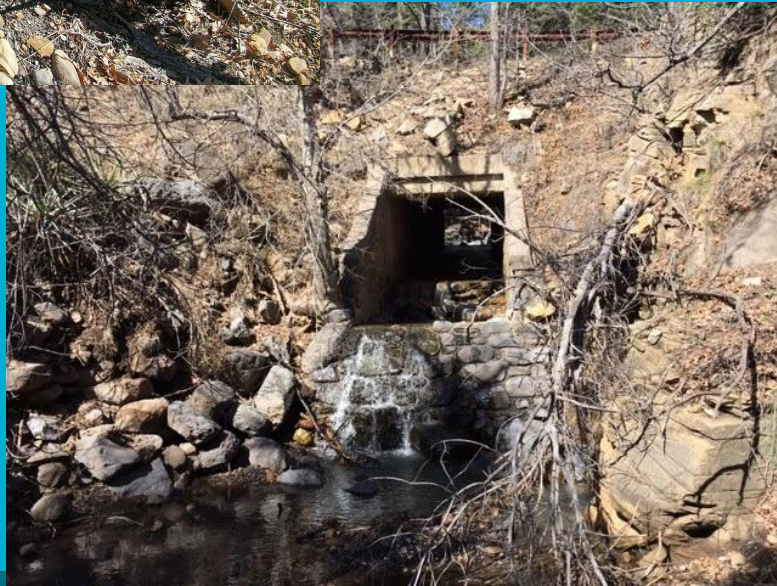
Field Visit to Pumphouse Wash Bridge project

- Project Field visit occurred Feb 2017
- Attendees included J2, HDR, FHWA, NAU biologists, City of Sedona, US Fish and Wildlife, US Forest Service, and all design disciplines.
- Discovered two substantial culverts that required extension as part of the roadway shift.
- Stone culvert was possibly 4(f)
- Proposed access road was highly discouraged due to impacts to snake habitat.

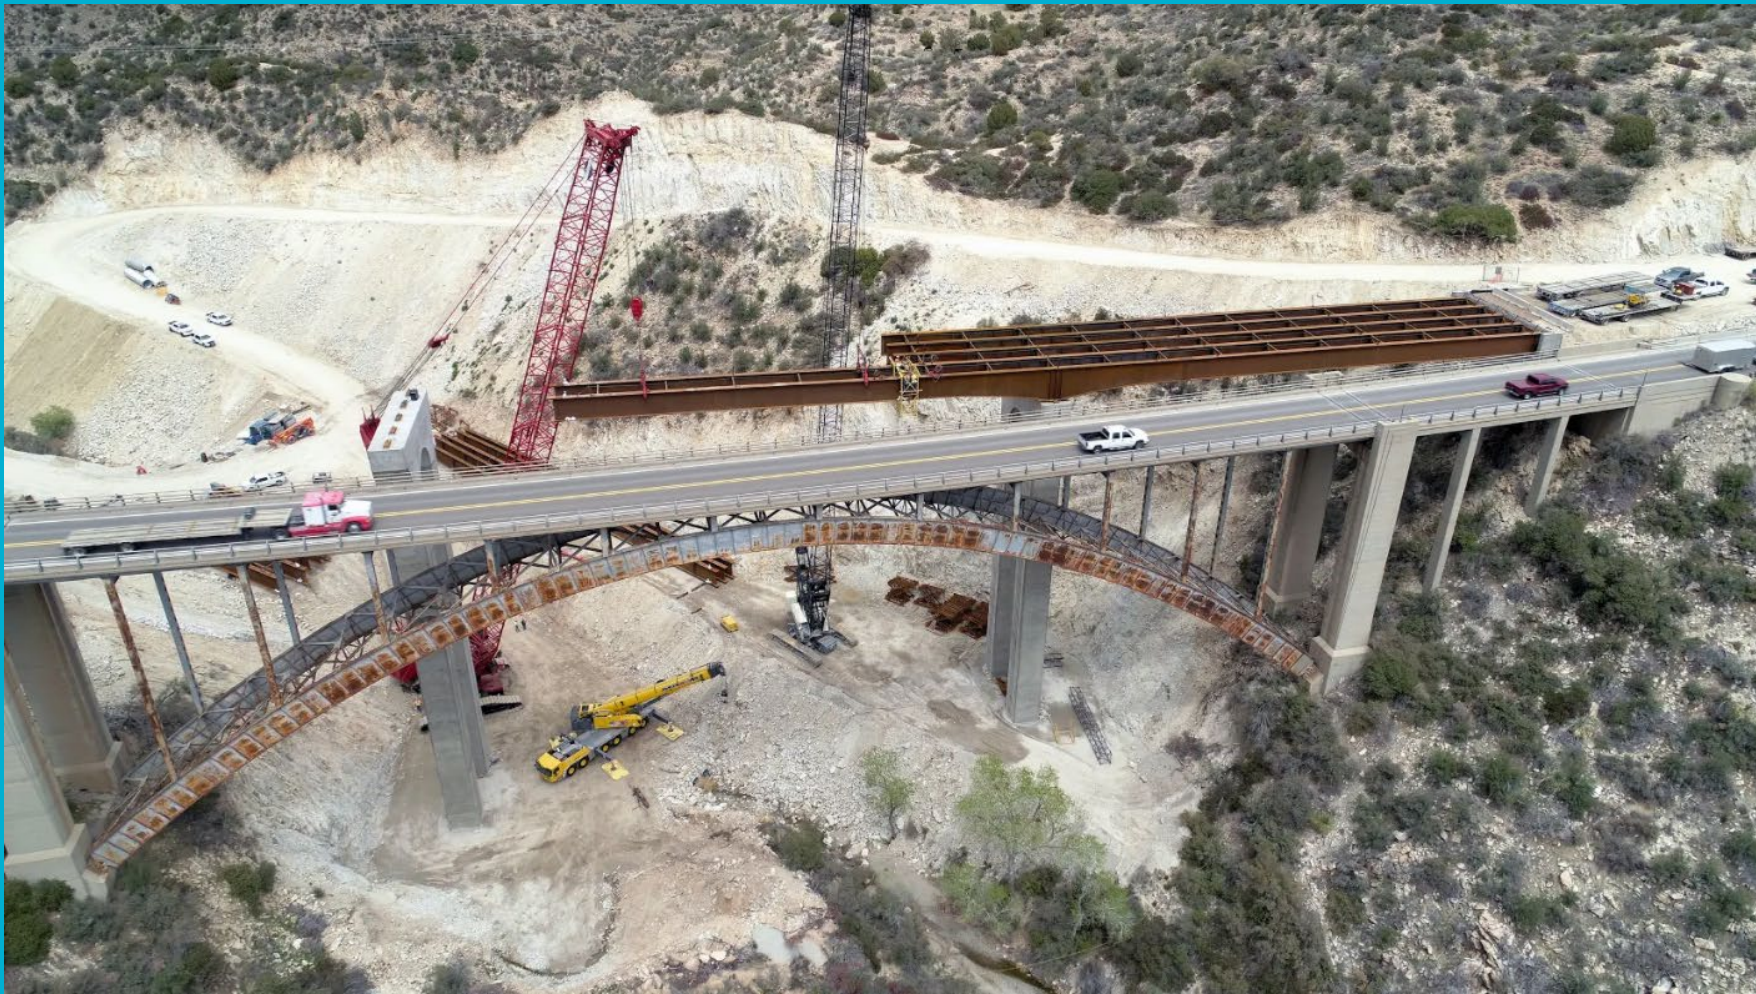
Significant construction access and equipment needed for bridge construction

- Piers in wash required large drill rigs to core thru rock which required construction access, large tanks for slurry construction, spoils piles, drill rig construction pad with radius for swings, cranes for reinforcing cages, shaft casing, cofferdam for wash flows, and substantial shoring.

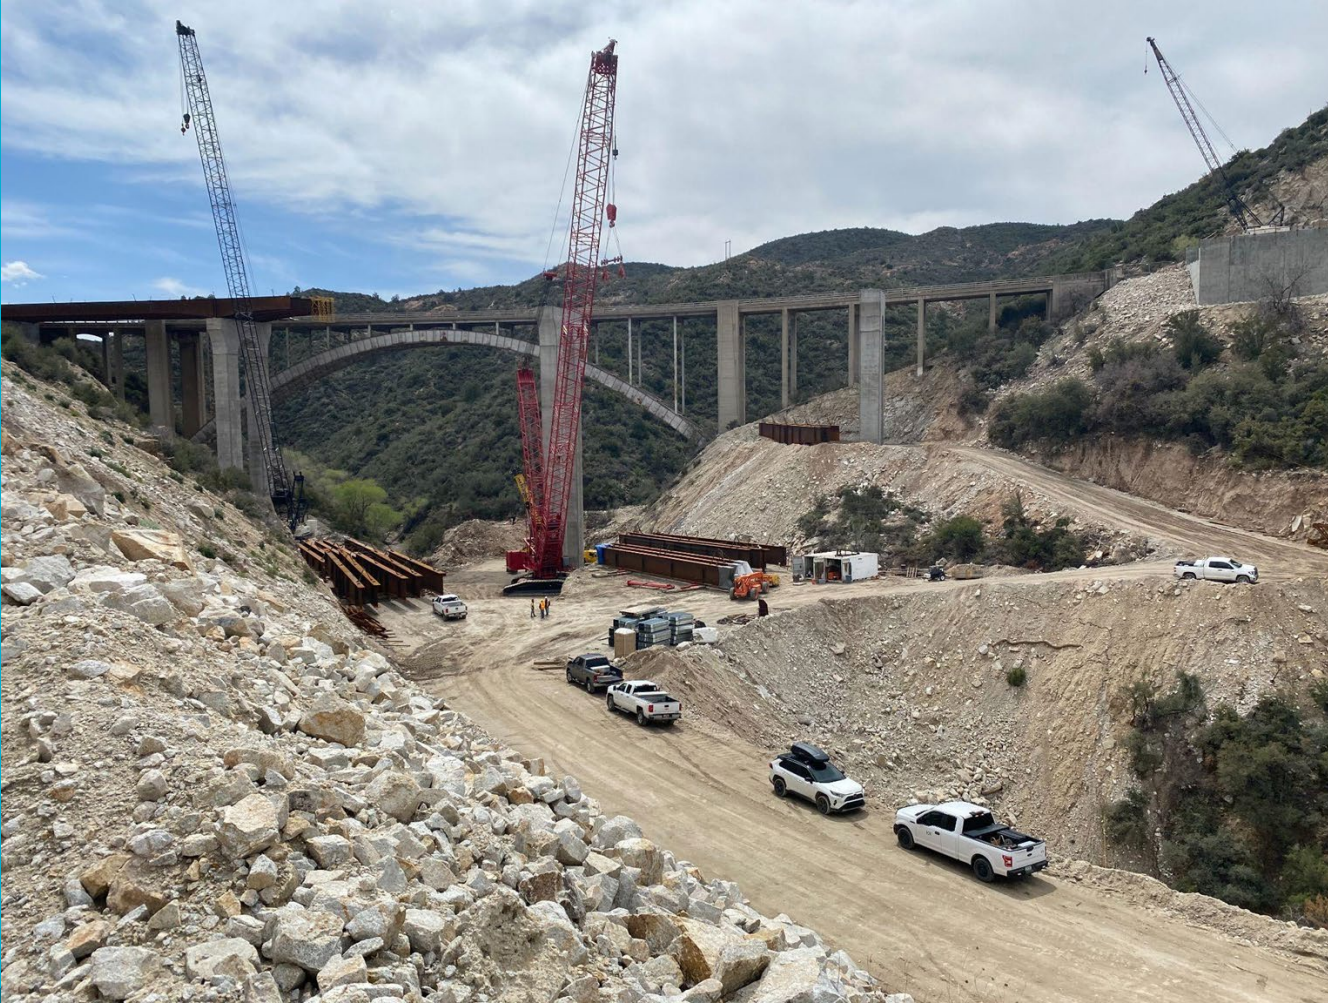
Significant construction access and equipment needed for bridge construction

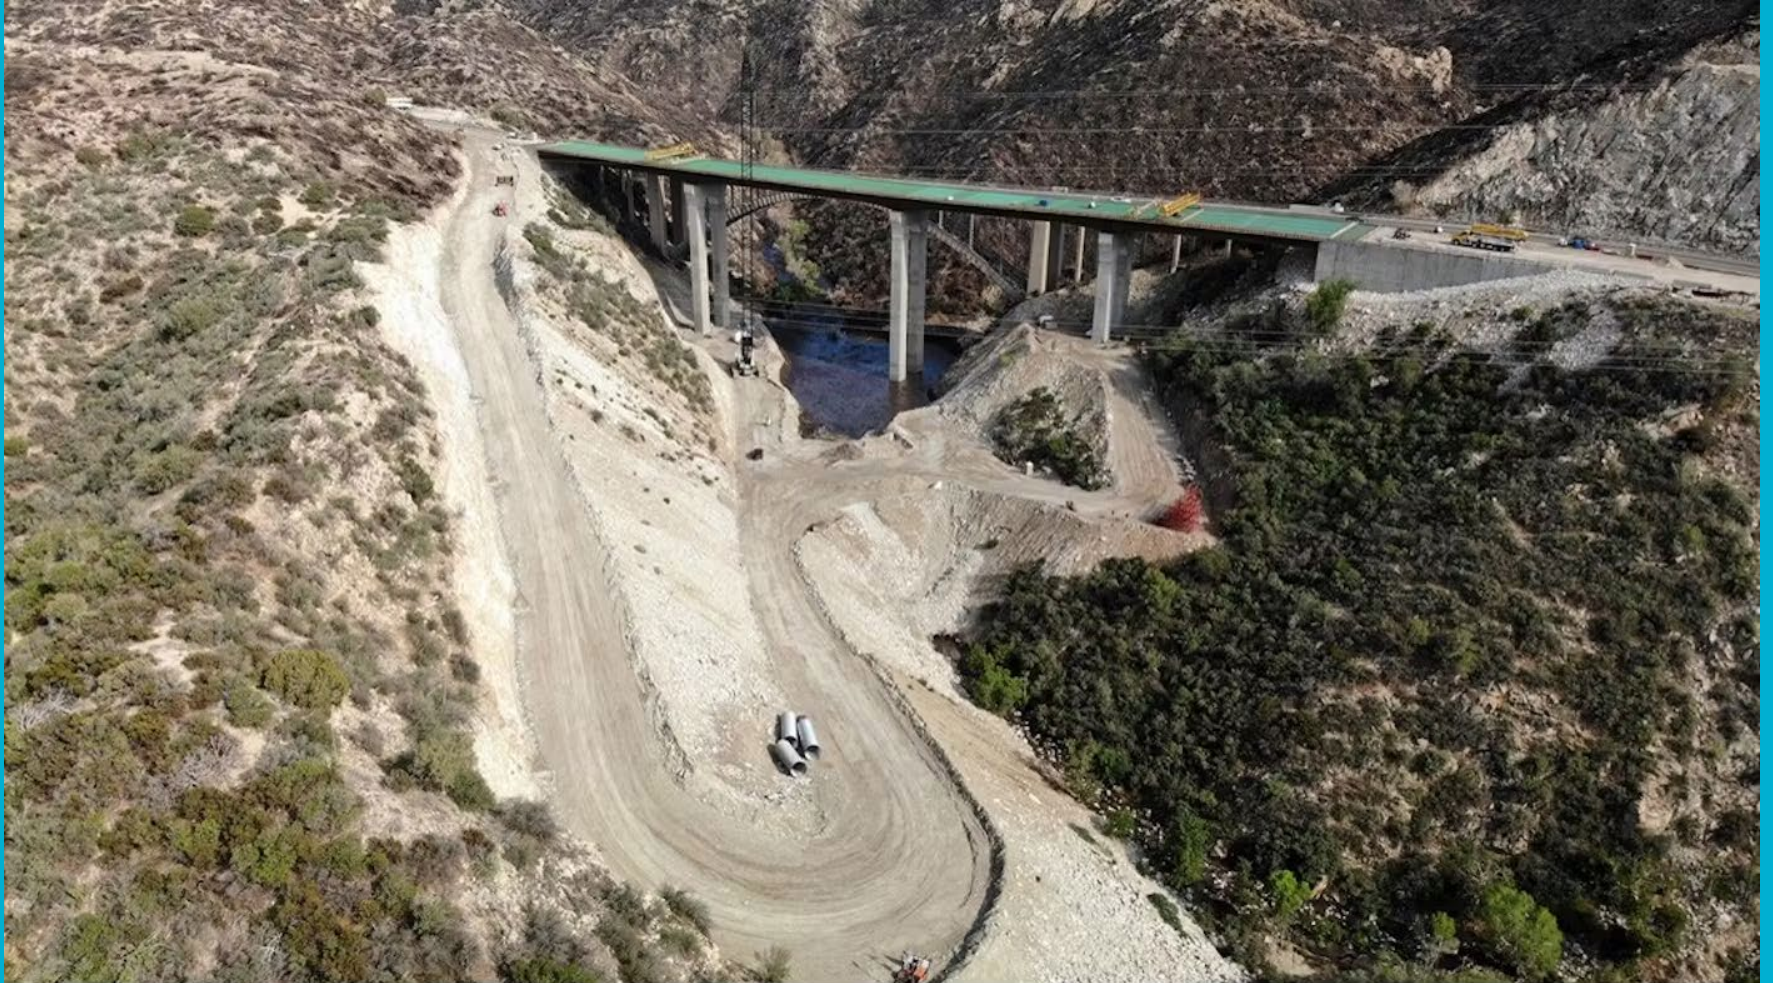
Pinto Creek Bridge construction access roads

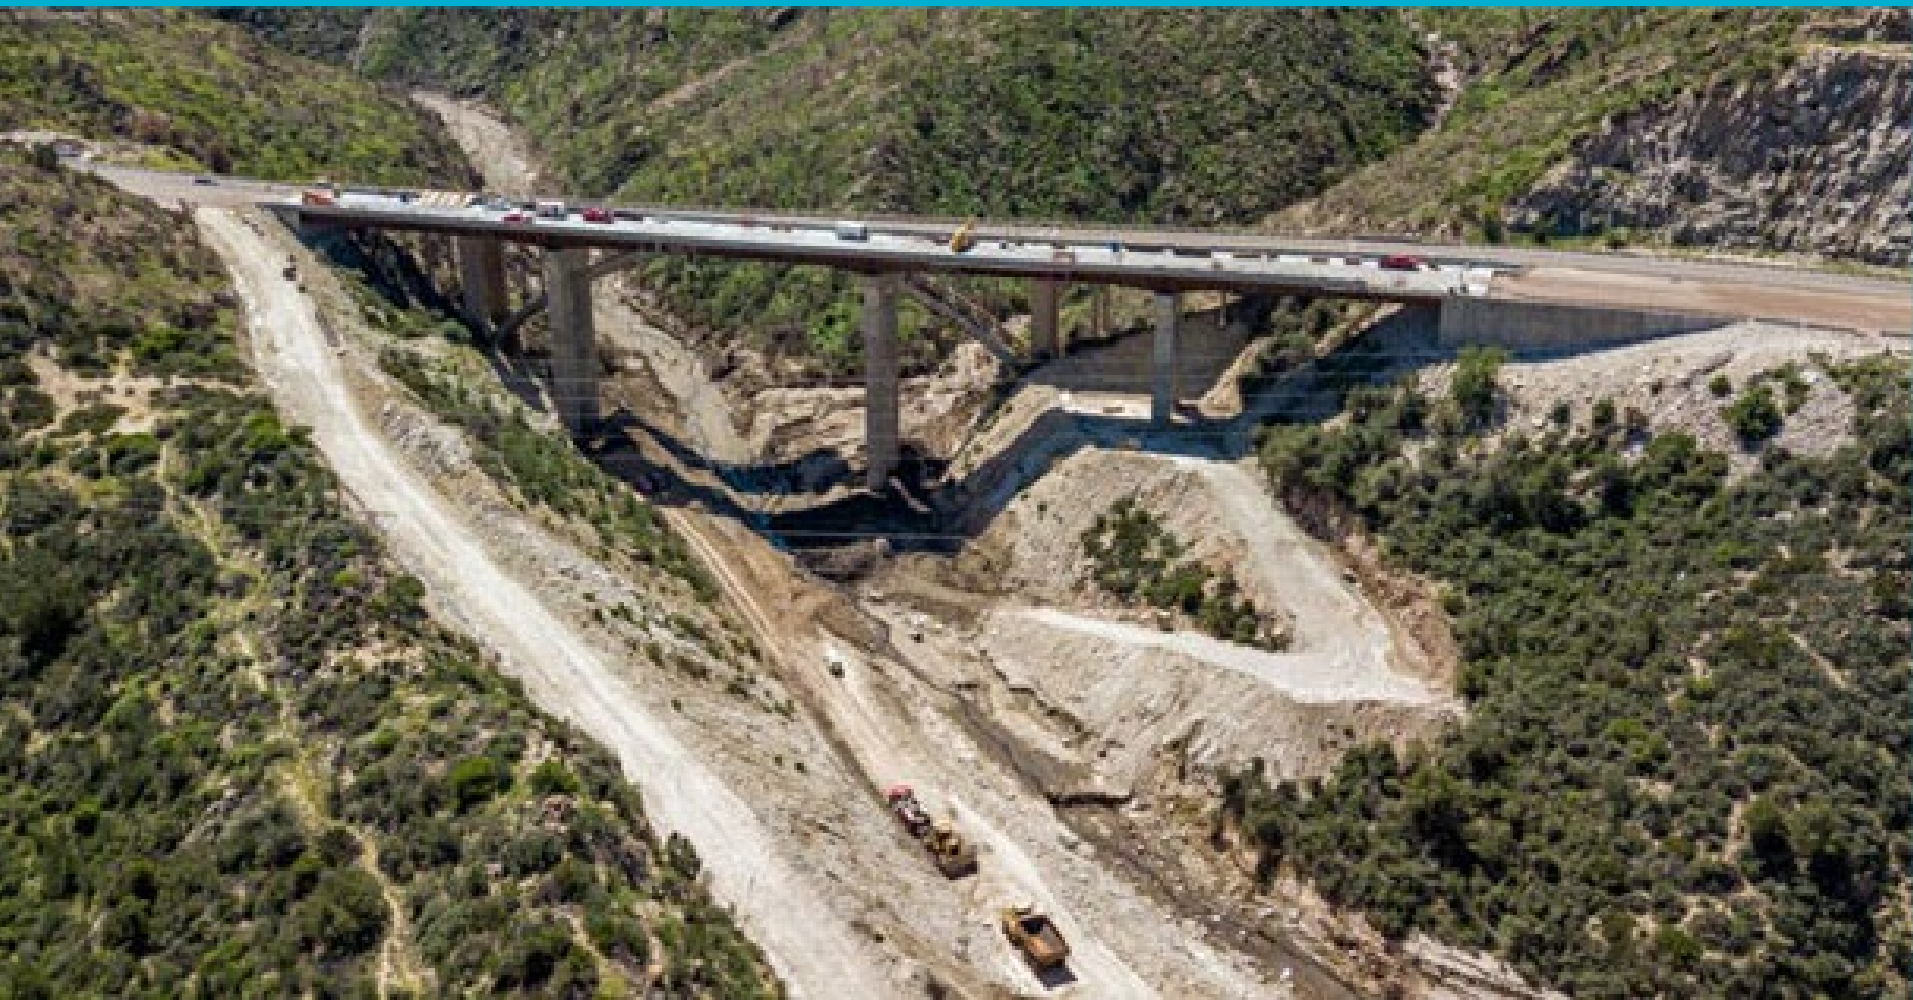
Pinto Creek Bridge blowout of construction site. Pumphouse wash had a larger watershed and faster velocities

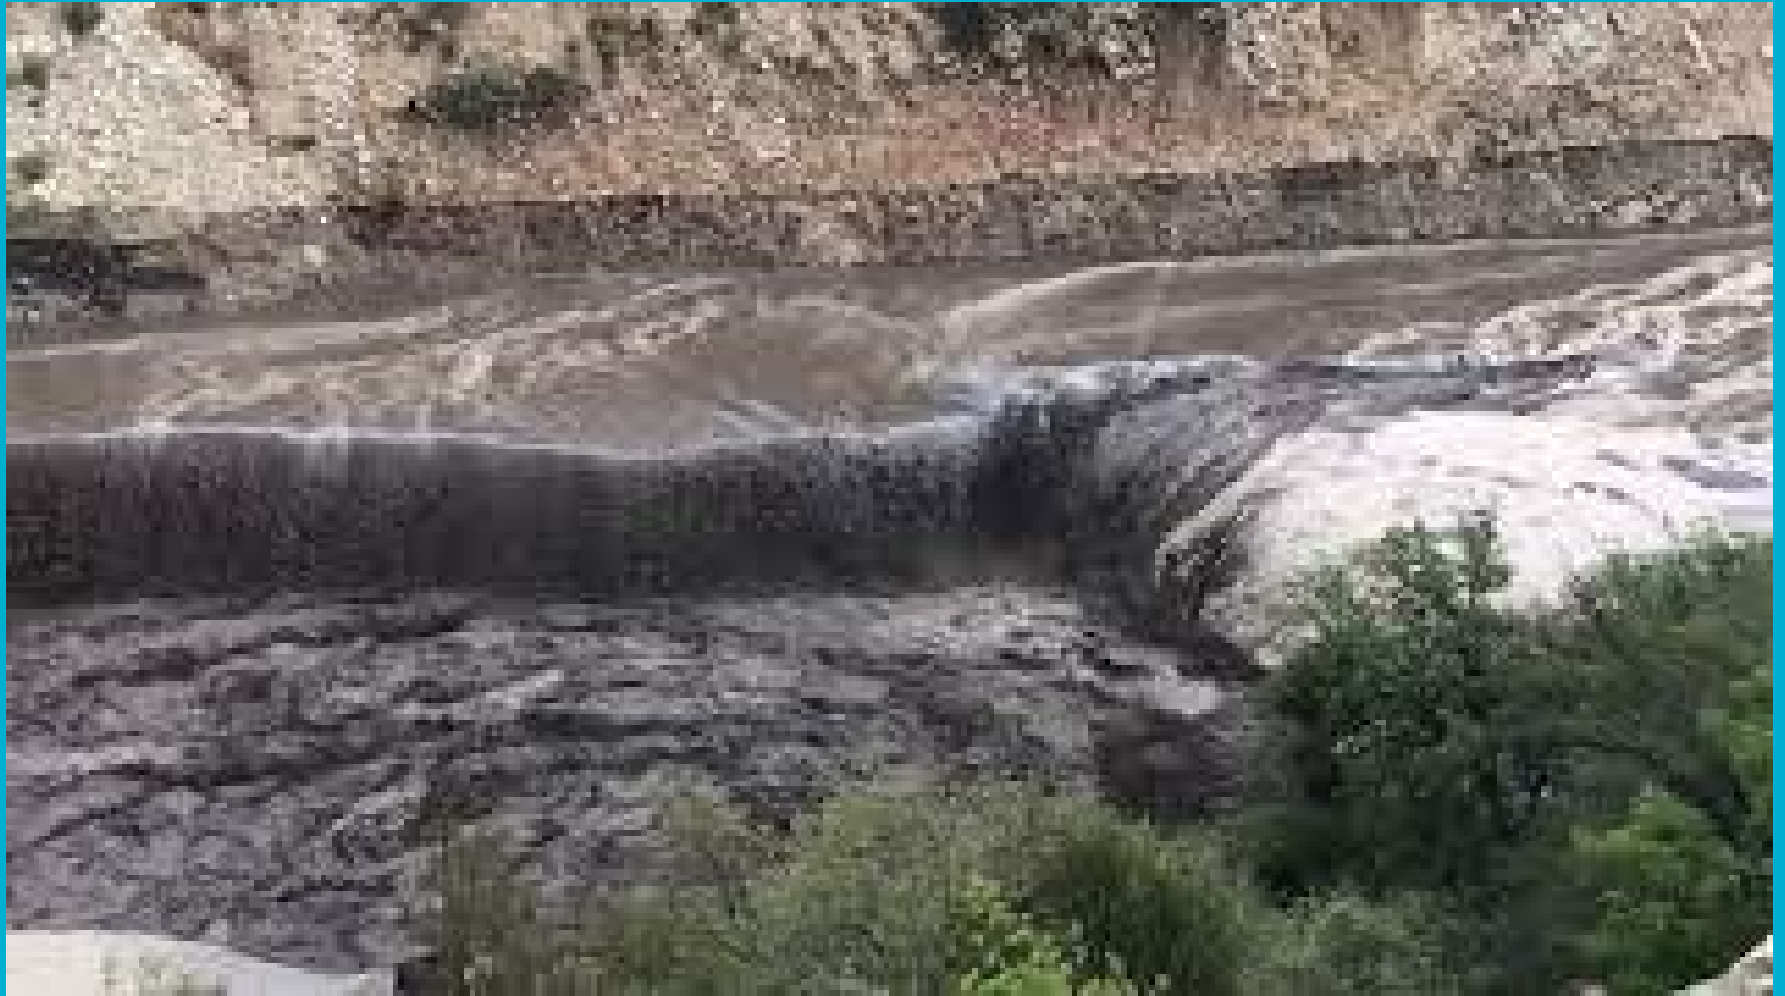
Pinto Creek Bridge blowout of construction site. Pumphouse wash had a larger watershed and faster velocities

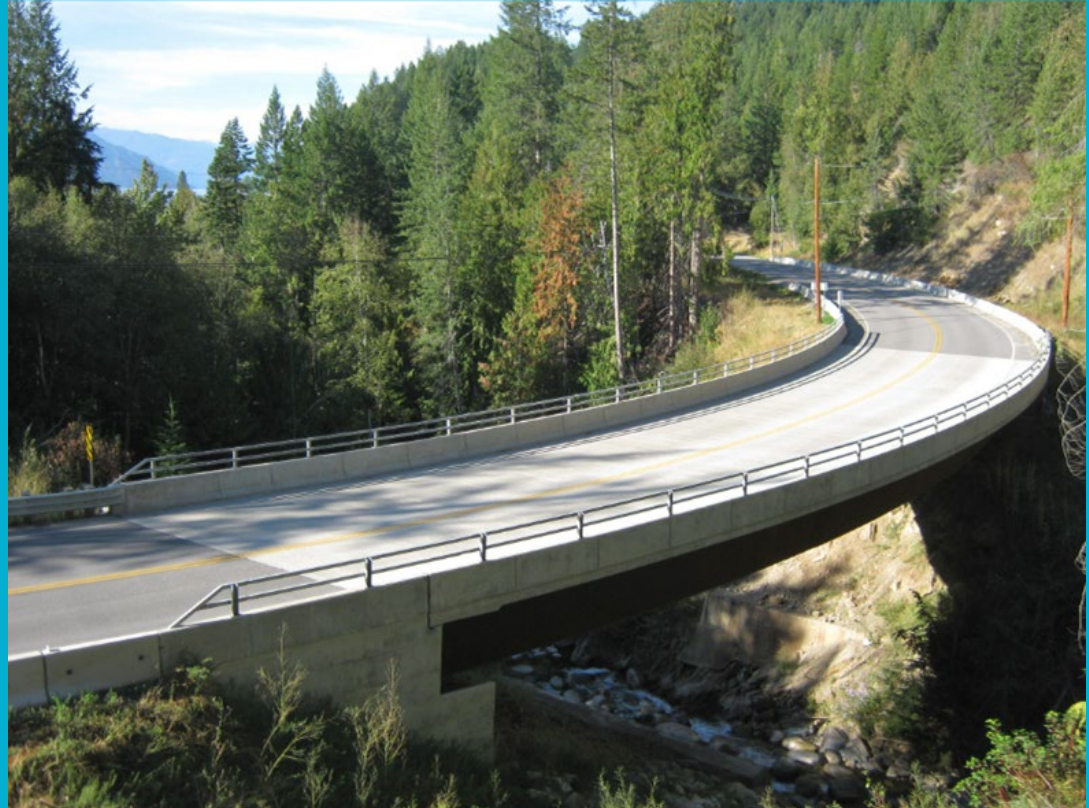
Single span steel tub girder bridge

- Significant secondary forces and deflections
- Multiple bolted splices required to transport girders to field
- Required full closure of 89A for at least 3 months
- No EV access
- Single span of wash
- Required proprietary bearings to handle torsion and uplift
- Shoring towers required to keep girders stable until everything is bolted together
- Not possible to achieve system redundancy so fracture critical designation would be given
- Akokli Creek Bridge spanned 167.45 ft with a 328 ft radius

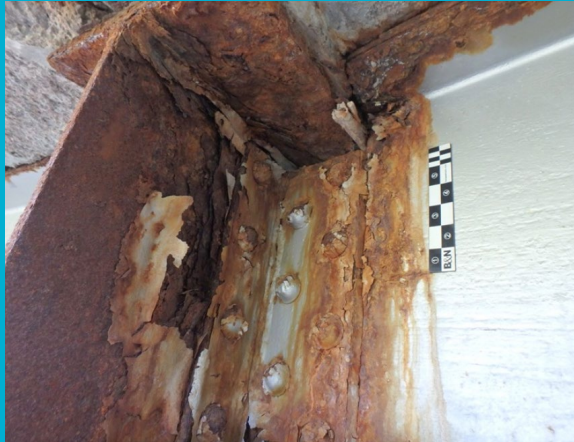
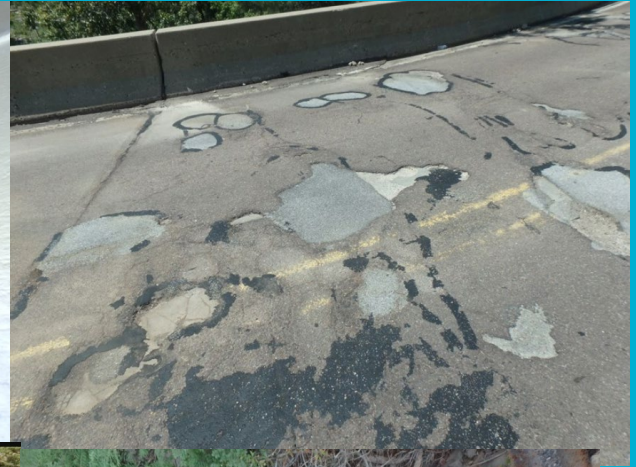
- Existing bridge was not that bad
- Substantially reduced Environmental impacts
- Substantially reduced construction risks
- Reduced construction time and scope provided best chance of biddable project
- No need for FHWA Historic American Engineering Record (HAER) documentation

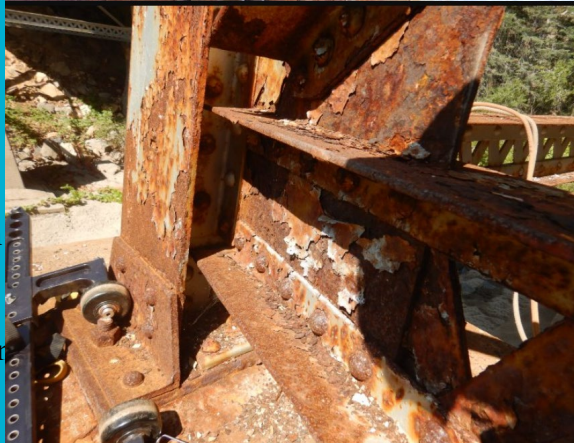
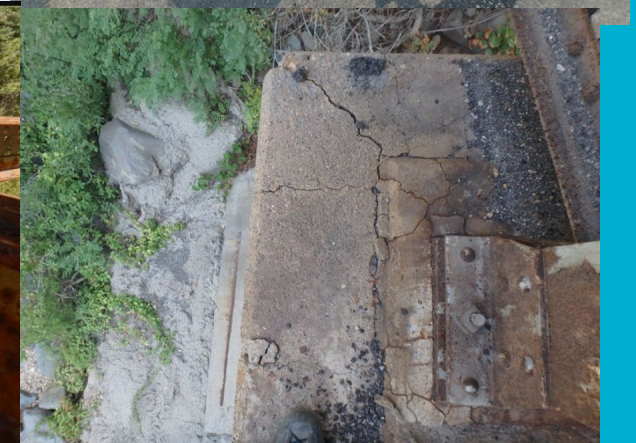
- Tight geometry restricted truck length to 30 ft based on Auto Turn Analysis
- Potentially reduced lifespan
- Continued need for Fracture Critical in depth inspection
- Lead paint substantially increased cost
- Risk of unknown knowns and unknown unknowns

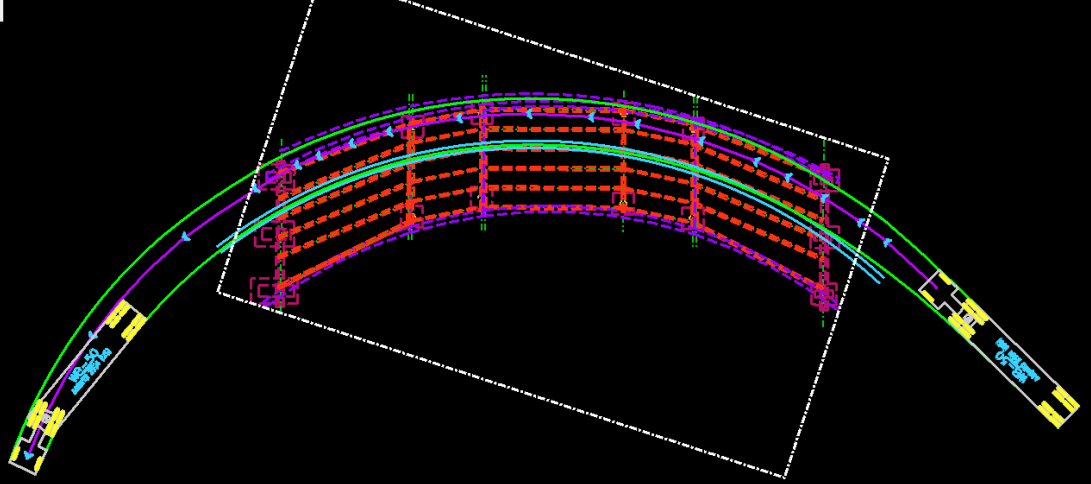
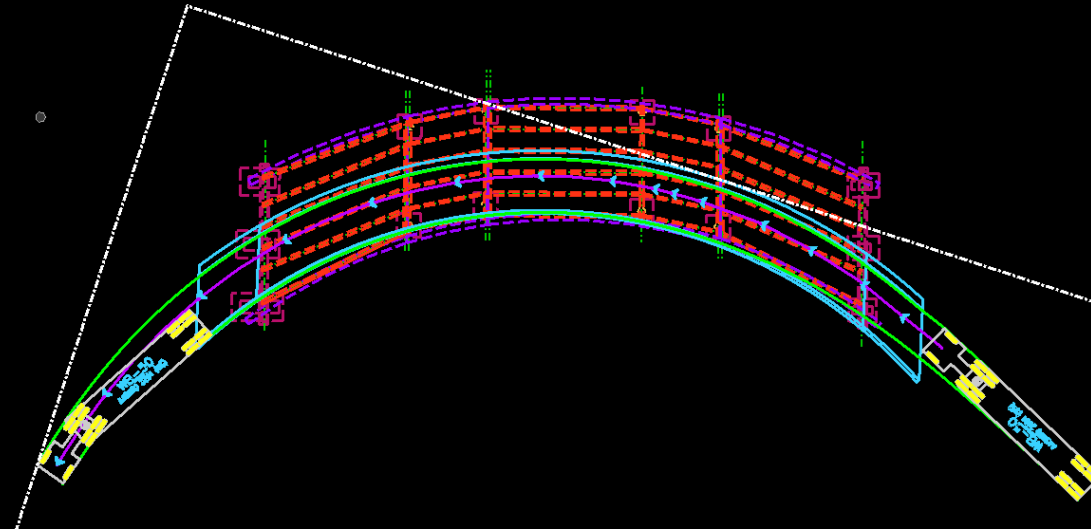
Autoturn analysis showed 40 ft trucks could sneak thru the phased condition with TCB

- 24/7 flaggers were posted at locations with turnarounds
- Signed for 30 ft max vehicle length
