Seismic Evaluation of a Historic Concrete Arch Bridge.

Depoe Bay Bridge

Sean White P.E.

Oregon DOT

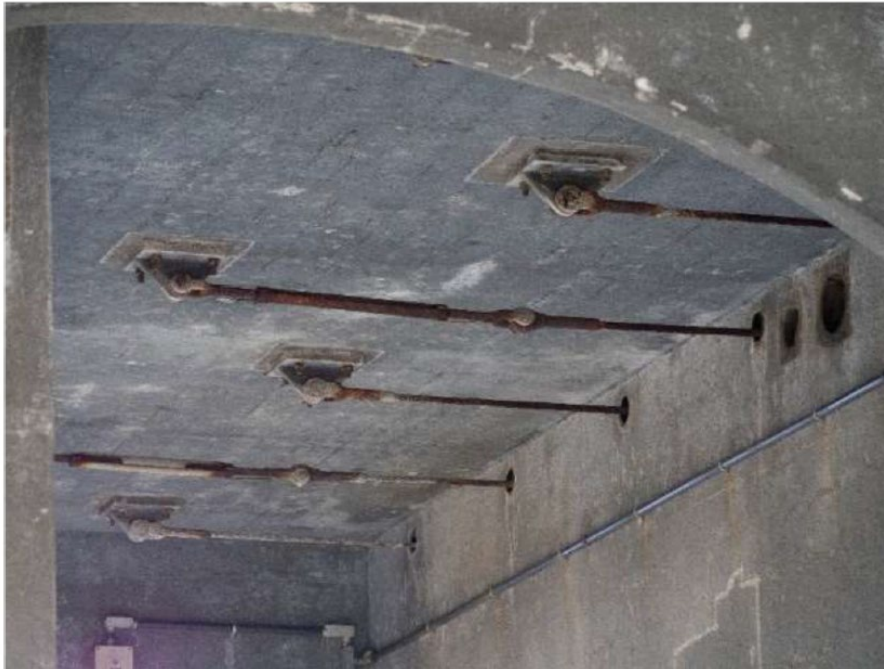
Figure 1: Example of corroded seismic restraint cables.

- The primary work on this bridge is to update of the Cathodic Protection system and repair the bridge railing.
- The need to replace existing seismic restrainers provided an opportunity to revisit the design.
- The scope of the seismic work is limited to Phase 1 life safety retrofit.

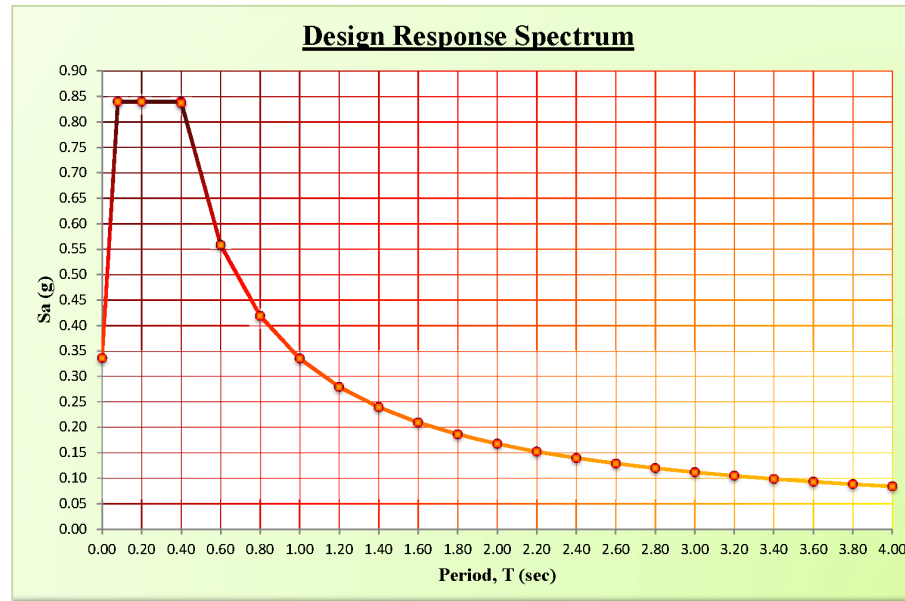
ODOT_ARS_V2014.20

1000 Years ~ (Life Safety Criteria)

2014 USGS Seismic Hazard Data

Site Class	PGA (g)	S _s (g)	S ₁ (g)	F _{pga}	F _a	F _v	A _s (F _{pga} *PGA)	S _{DS} (F _a *S _s)	S _{D1} (F _v *S ₁)	SDC
A	0.5014	1.0497	0.4186	0.8000	0.8000	0.8000	0.4012	0.8398	0.3349	III

Period, T (sec)	S _a (g)
0.00	0.3359
0.08	0.8398
0.20	0.8398
0.40	0.8398
0.40	0.8373
0.60	0.5582
0.80	0.4186
1.00	0.3349
1.20	0.2791
1.40	0.2392
1.60	0.2093
1.80	0.1861
2.00	0.1675
2.20	0.1522
2.40	0.1395
2.60	0.1288
2.80	0.1196
3.00	0.1116
3.20	0.1047
3.40	0.0985
3.60	0.0930
3.80	0.0881
4.00	0.0837

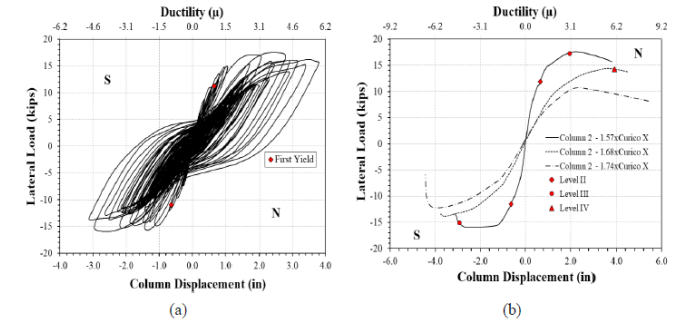
Figure 6.7 shows the lateral load vs. displacement response of the tested RC square column and Table 6.5 lists material values for specific performance parameters.

Figure 6.7: Circular RC column performance. (a) Force-displacement hysteresis curve and (b) force-displacement envelope [Dusicka & Lopez (2016)]

Level	Limit State	Steel Strains (ϵ_s)	Concrete strains* (ϵ_c)	% Drift	Ductility (μ)
I	Cracking	0.0002	0.0004	0.20	0.3
II	First Yield	0.0013	0.0008	0.68	1.0
III	Effective Yield	-	-	-	-
IV	Onset of Spalling	0.0117	0.0046	2.55	3.8
V	Buckling Rupture	0.0402	0.0099	4.08	6.0

* The extreme concrete compressive strains of the columns were obtained using the results from the strains in the reinforcing steel and a linear strain profile for a circular section. The actual values of concrete strain in the confined section are expected to be lower since these values are the maximum compressive strain and not the strain in the confined section.
