Saving a Structure

Innovations in Strengthening and Protection
Lessons from the I-10 Broadway Curve at Western Canal

Project Location and Project Need

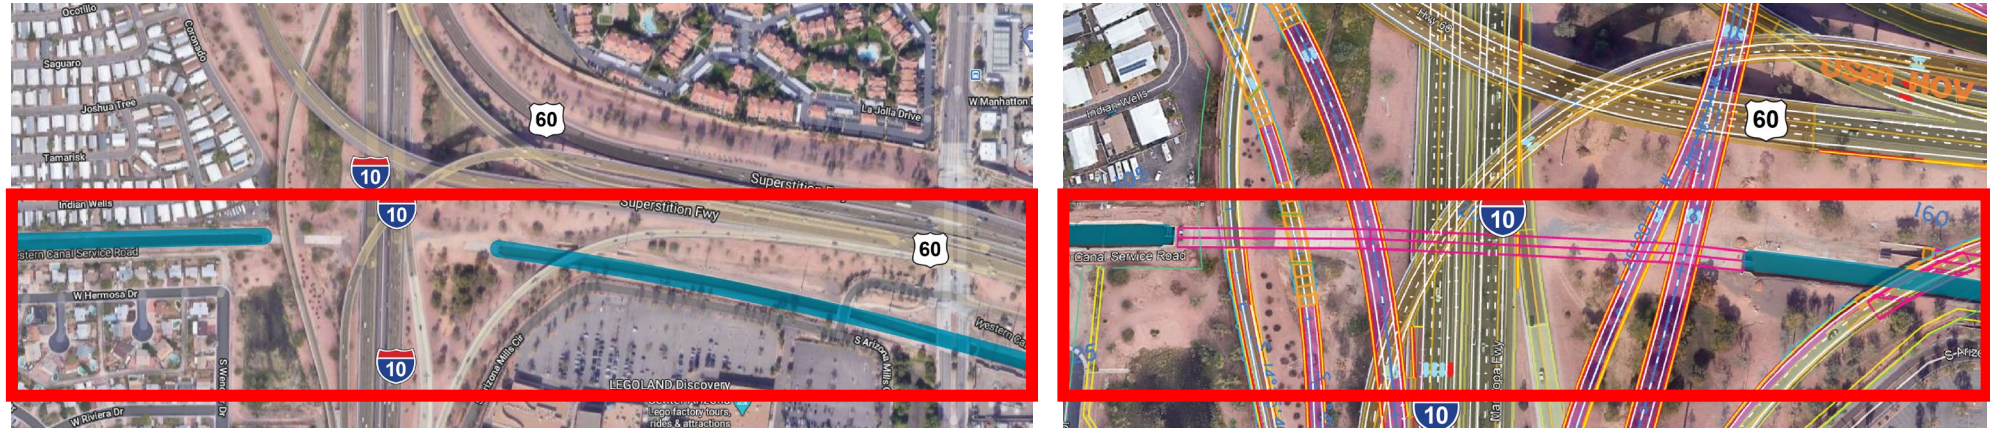
1. Located south of US-60 across I-10 in Phoenix, AZ

2. ADOT I-10 Broadway Curve Project
 - a. Existing 2-cell reinforced concrete box culvert
 - b. Active Canal managed by Salt River Project
 - c. Adding General Purpose Lanes
 - d. Adding Collector-Distributor Roads
 - e. Total of 3 new crossings, 5 lanes

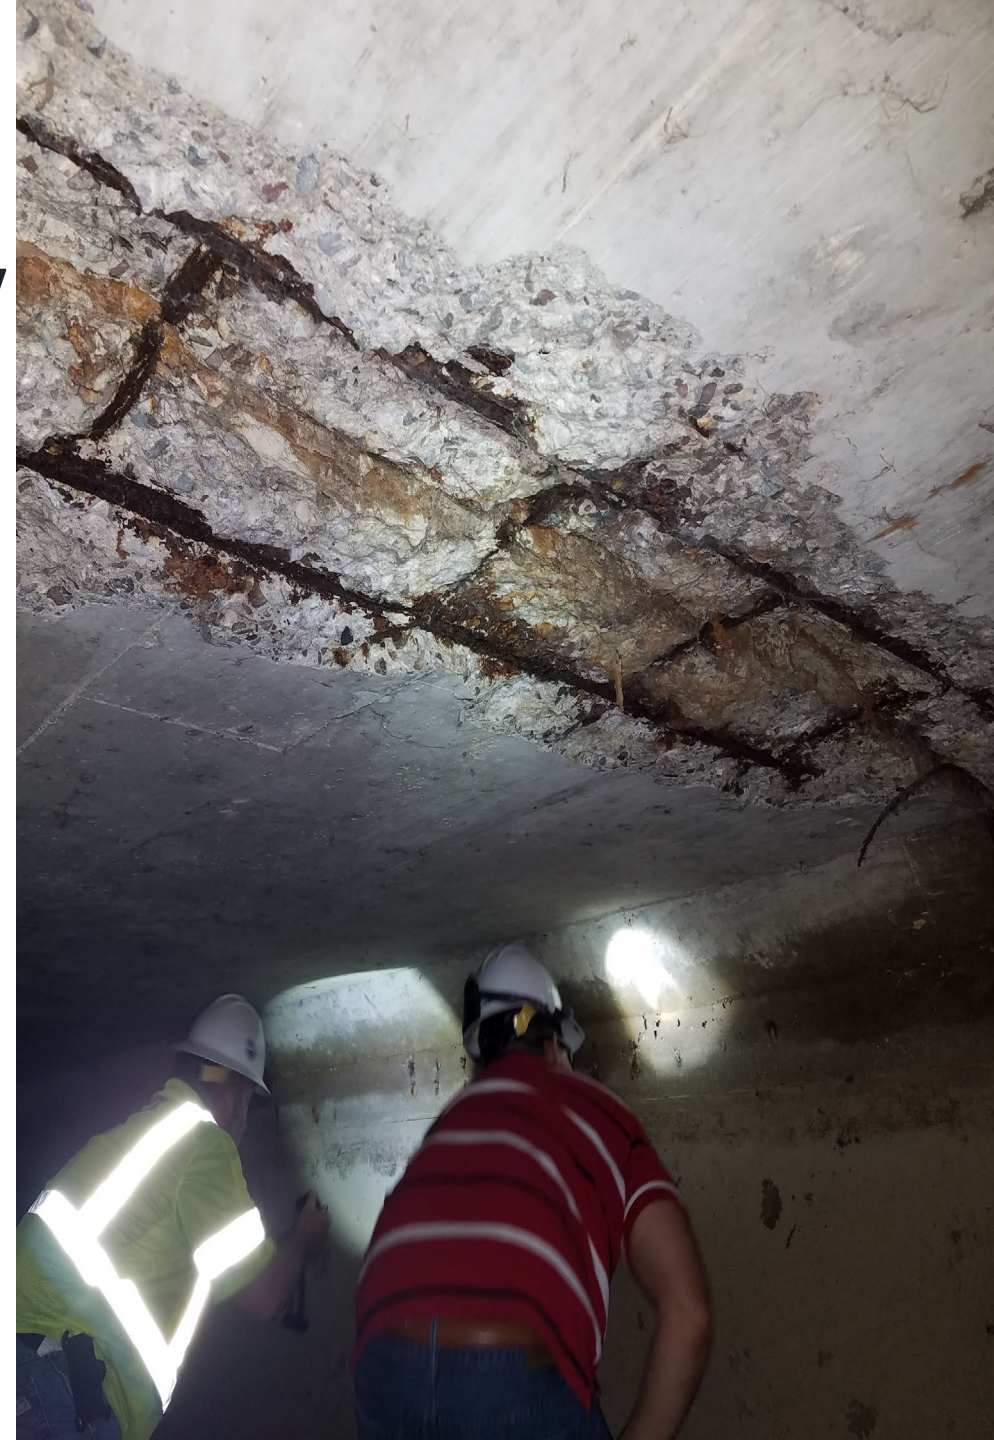
1. Signs of Corrosion identified during a routine structural inspection in 2017
 - a. Areas of Delamination
 - b. Sporadic cracking throughout
 - c. Majority of deterioration in soffit of top slab
2. ADOT worked with SRP to rehabilitate the boxes
 - a. Removed deteriorated concrete
 - b. Applied Zinc coating to exposed reinforcement
 - c. Replaced severely deteriorated reinforcement
 - d. Applied shotcrete grout to restore original section

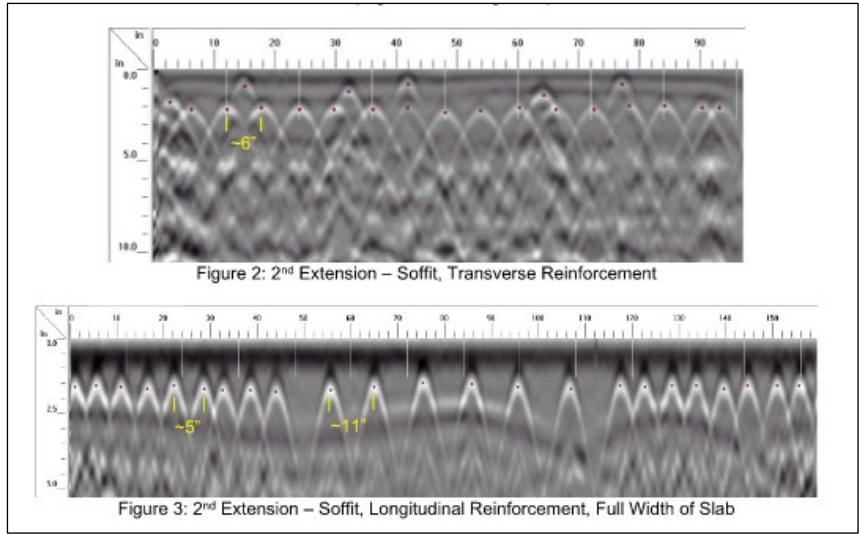
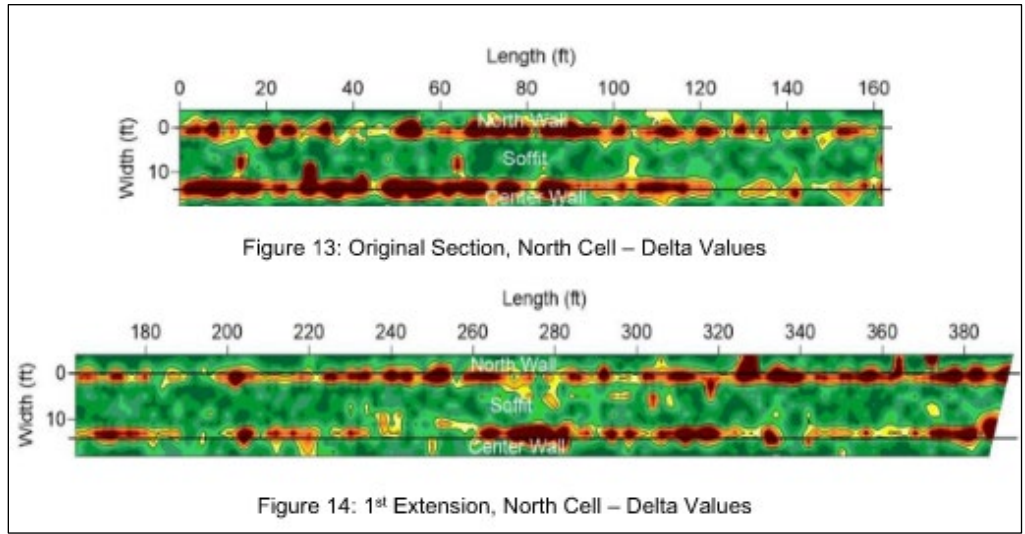
- Confirmed reinforcement spacing with Record Drawings
 - *Exception* - 2nd Extension longitudinal reinforcement above transverse layer
- Cover is within typical construction tolerances for current RCBC construction practices (ADOT SD 6 Series)

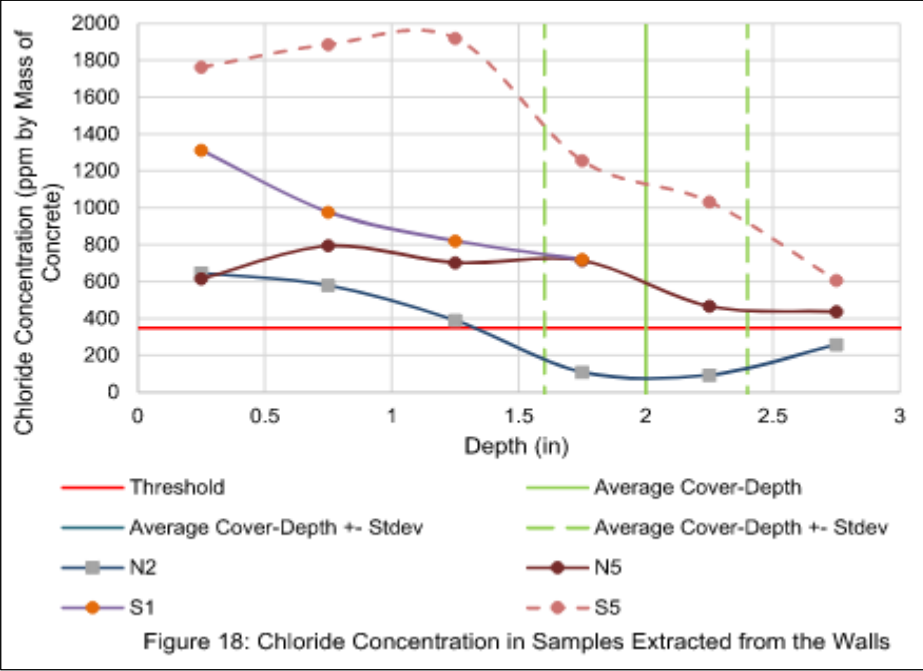
Figure 18: Chloride Concentration in Samples Extracted from the Walls

Chloride Penetration

- Chloride lowers pH increasing potential
- Soffit indicated minimal chloride penetration
- Walls indicate suitable chloride levels for corrosion
 - Likely due to chlorides in the water which leach into walls during saturation

1. Spacing and cover of reinforcement generally agreed with as-built conditions
2. Corrosion potential in walls is moderate to high
 - a. Chloride concentration is elevated in walls
 - b. 43% to 99% is likely in active corrosion
 - c. Submerged section lower likelihood of corrosion
3. Corrosion potential in soffit is generally low with some moderate to high
 - a. Low levels of chlorides

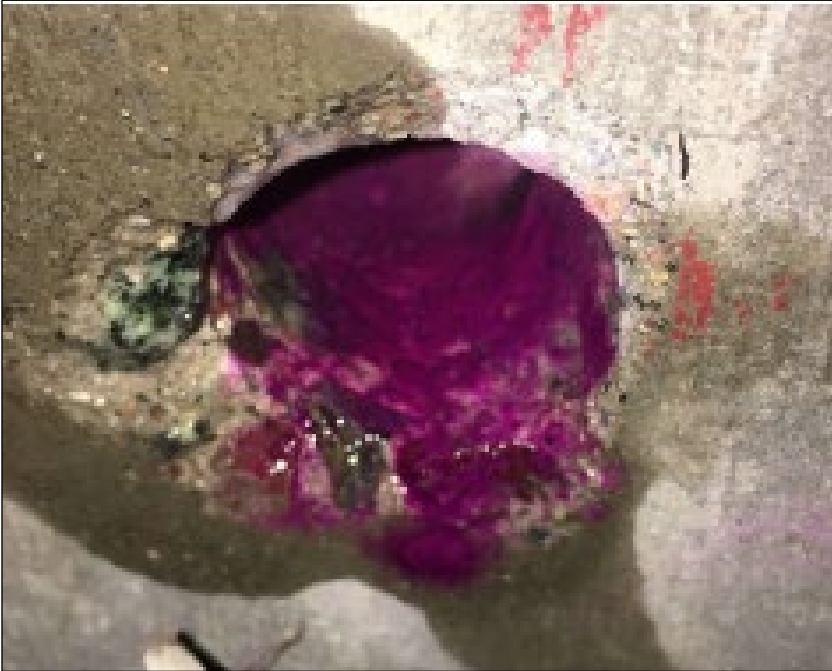
Carbonation Testing

- Dye test indicates presence of carbonation
- Carbonation lowers concrete pH
- No carbonation detected in testing

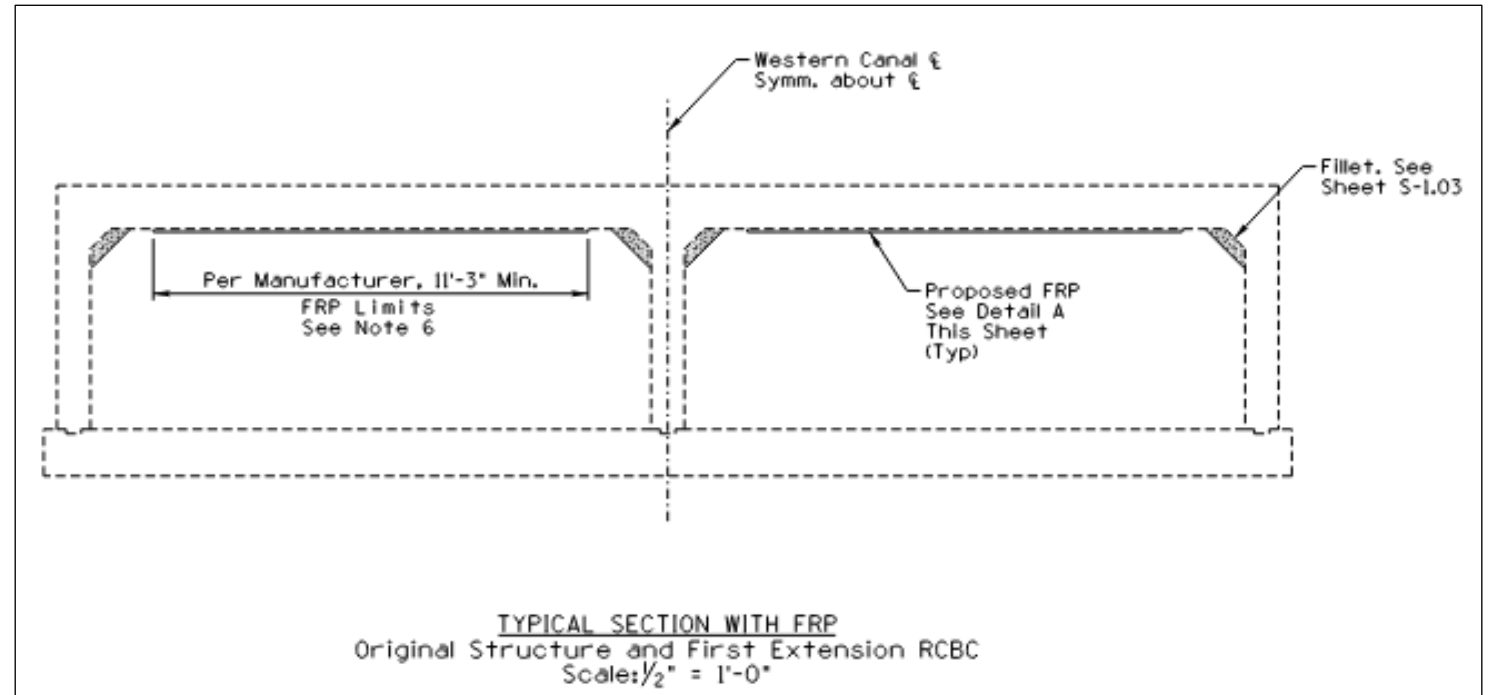
- Work needed to be accomplished from inside the box cell
- Needed to increase positive moment → FRP Systems
- Needed to increase negative moment → Deepen “beam” using fillet

Alternative approach:

Allow negative moment region to hinge, and only strengthen positive moment region.

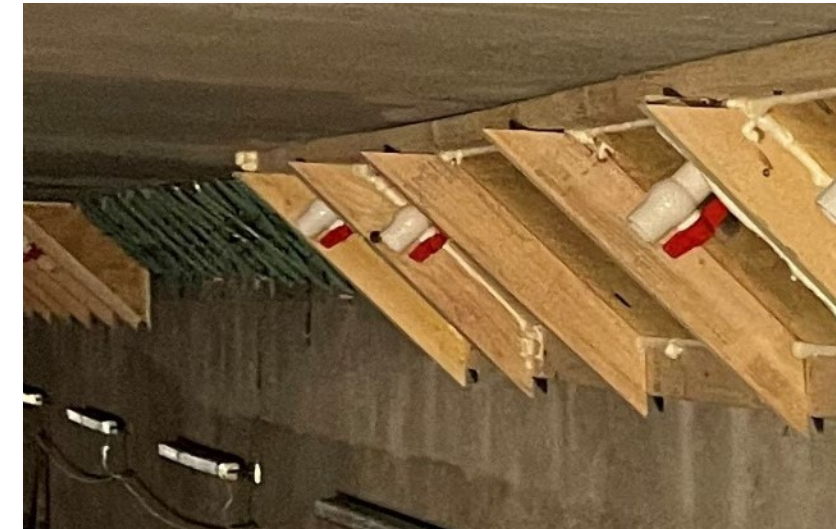
- Increase depth to reinforcement
- Requires composite action
- Improves Negative Moment Capacity
- Improves Shear Capacity

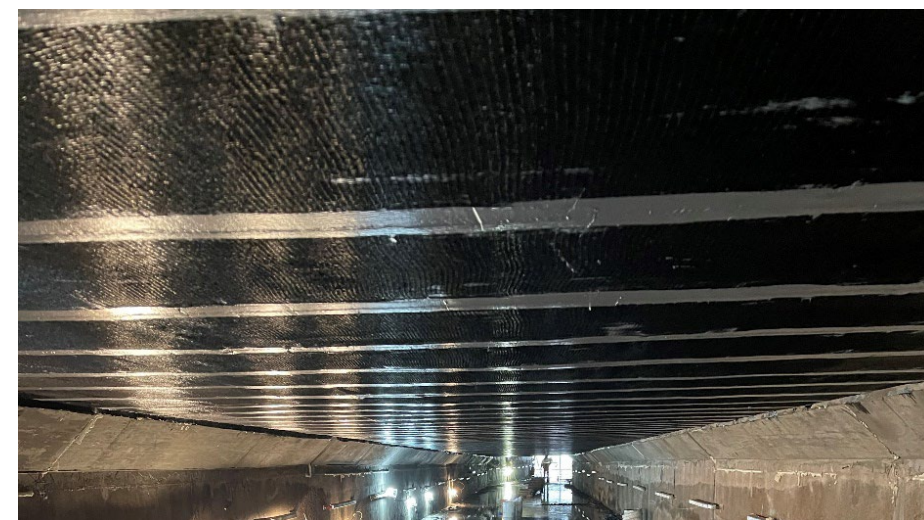
- Fiber Reinforced Polymers
- Increases “Reinforcement”
- Improves Positive Moment Capacity
- Installed from below top slab

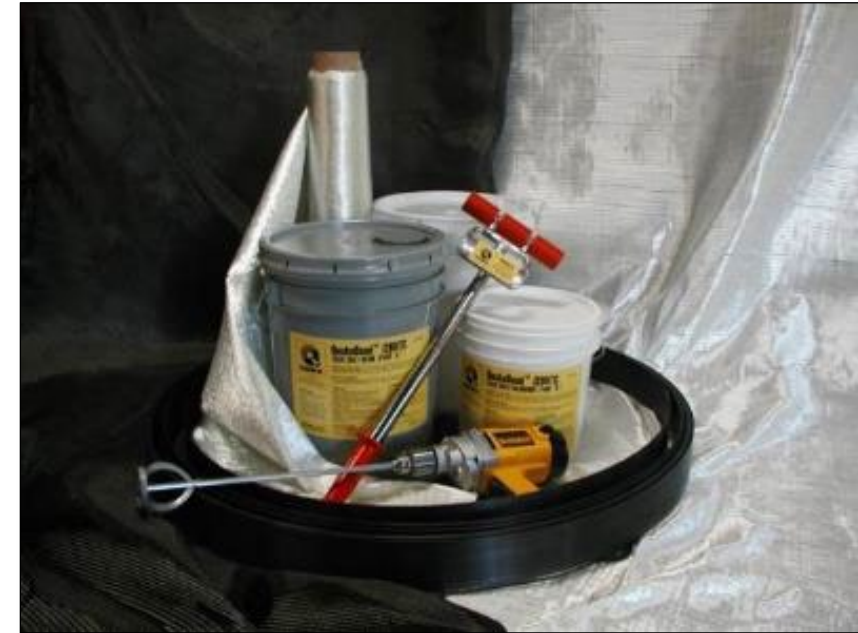
- A Polymer (i.e. epoxy, vinyl ester, etc.) that has been reinforced with a Fiber (e.g. carbon, glass, etc.)
- FRP is non-homogeneous.
- FRP does not have the same strength in all directions; these types of materials are called anisotropic.
