FHWA BRIDGE SCOUR EVALUATION

Structures in the Multiverse

ADOT I-10 Widening Gila River Bridge Study

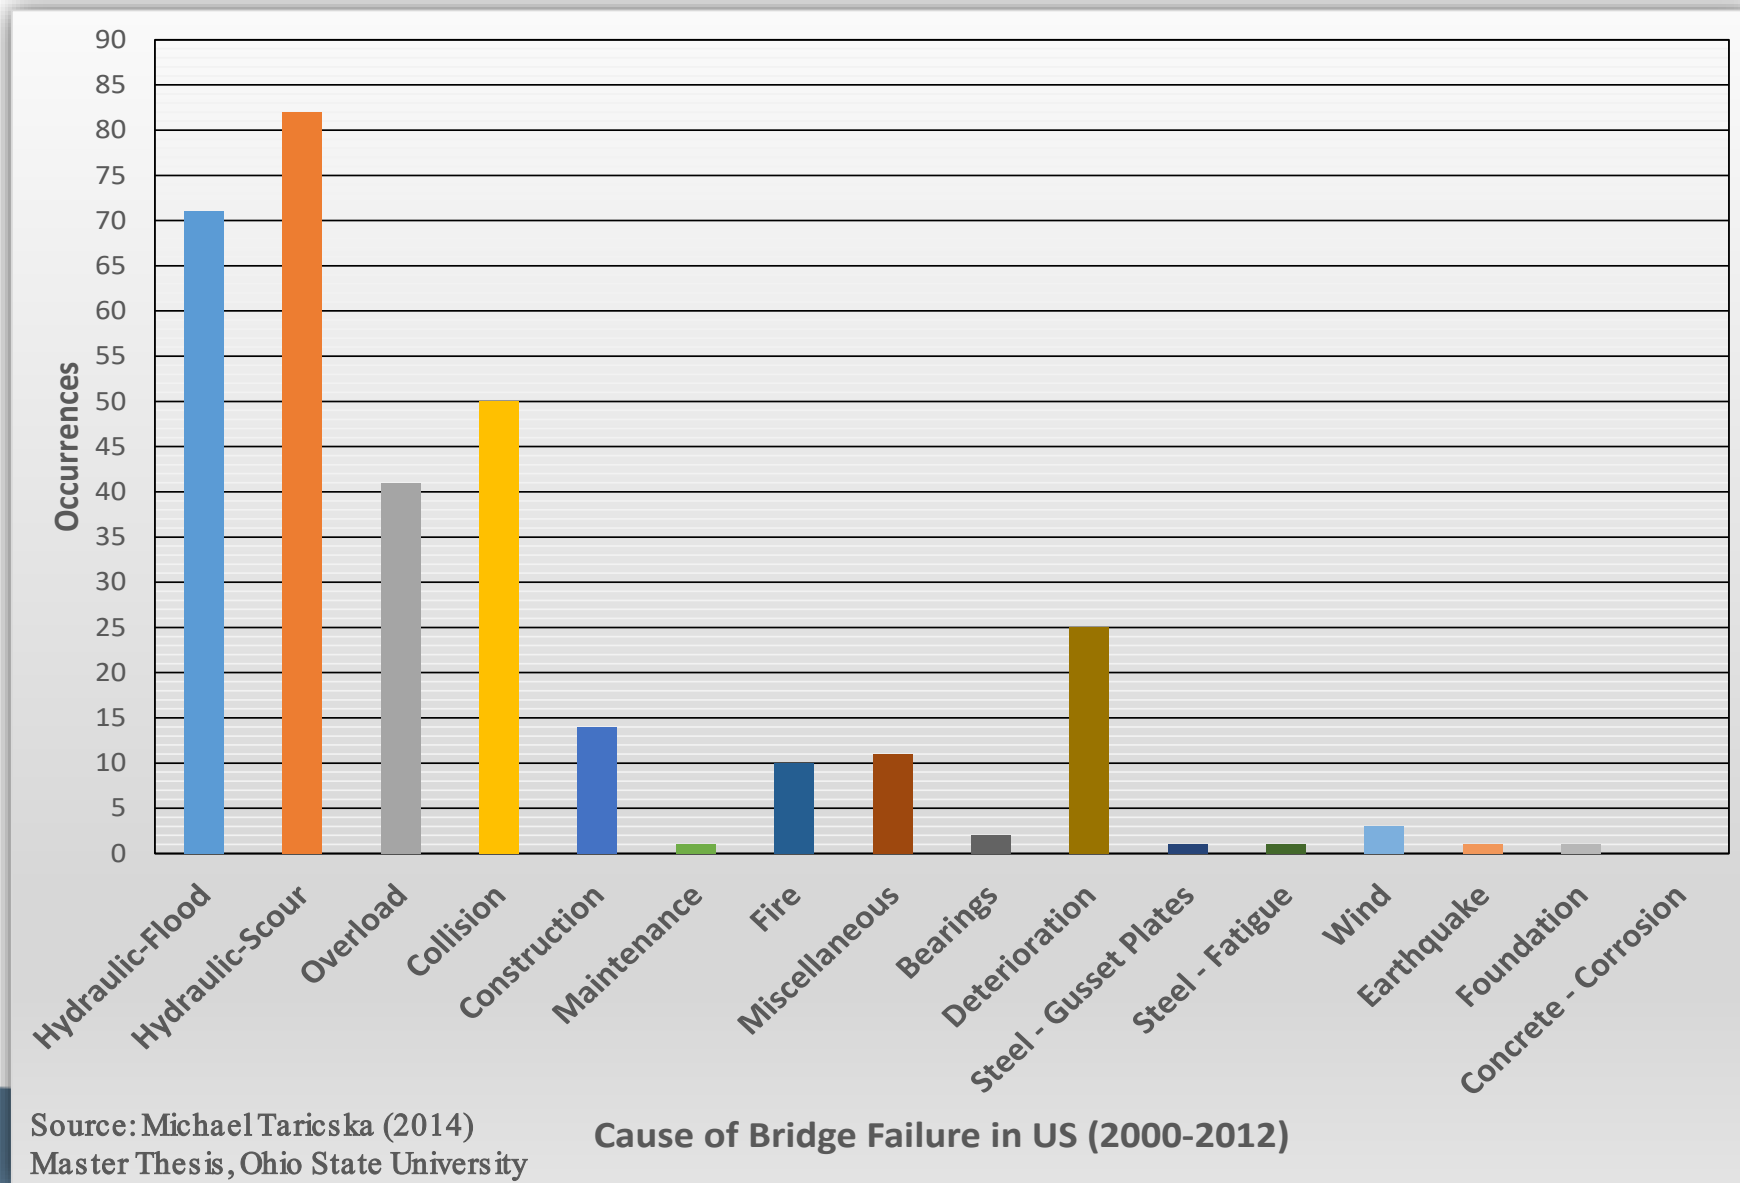
STATISTICS OF BRIDGE FAILURE

- Flooding – changing climate and extreme weather events are causing more flood-related damages to bridges
- Scour – gradually wearing away streambed material (soils) around and underneath the bridge piers and abutments
- Deterioration – bridges in US earn C+ rating for maintenance and safety. One out of every nine bridges is considered structurally deficient
- Design & Manufacturing Defects – weak structural elements, insufficient redundancy, poor quality steel/concrete, improper welding techniques
- Other – overload, earthquake, collision, fire

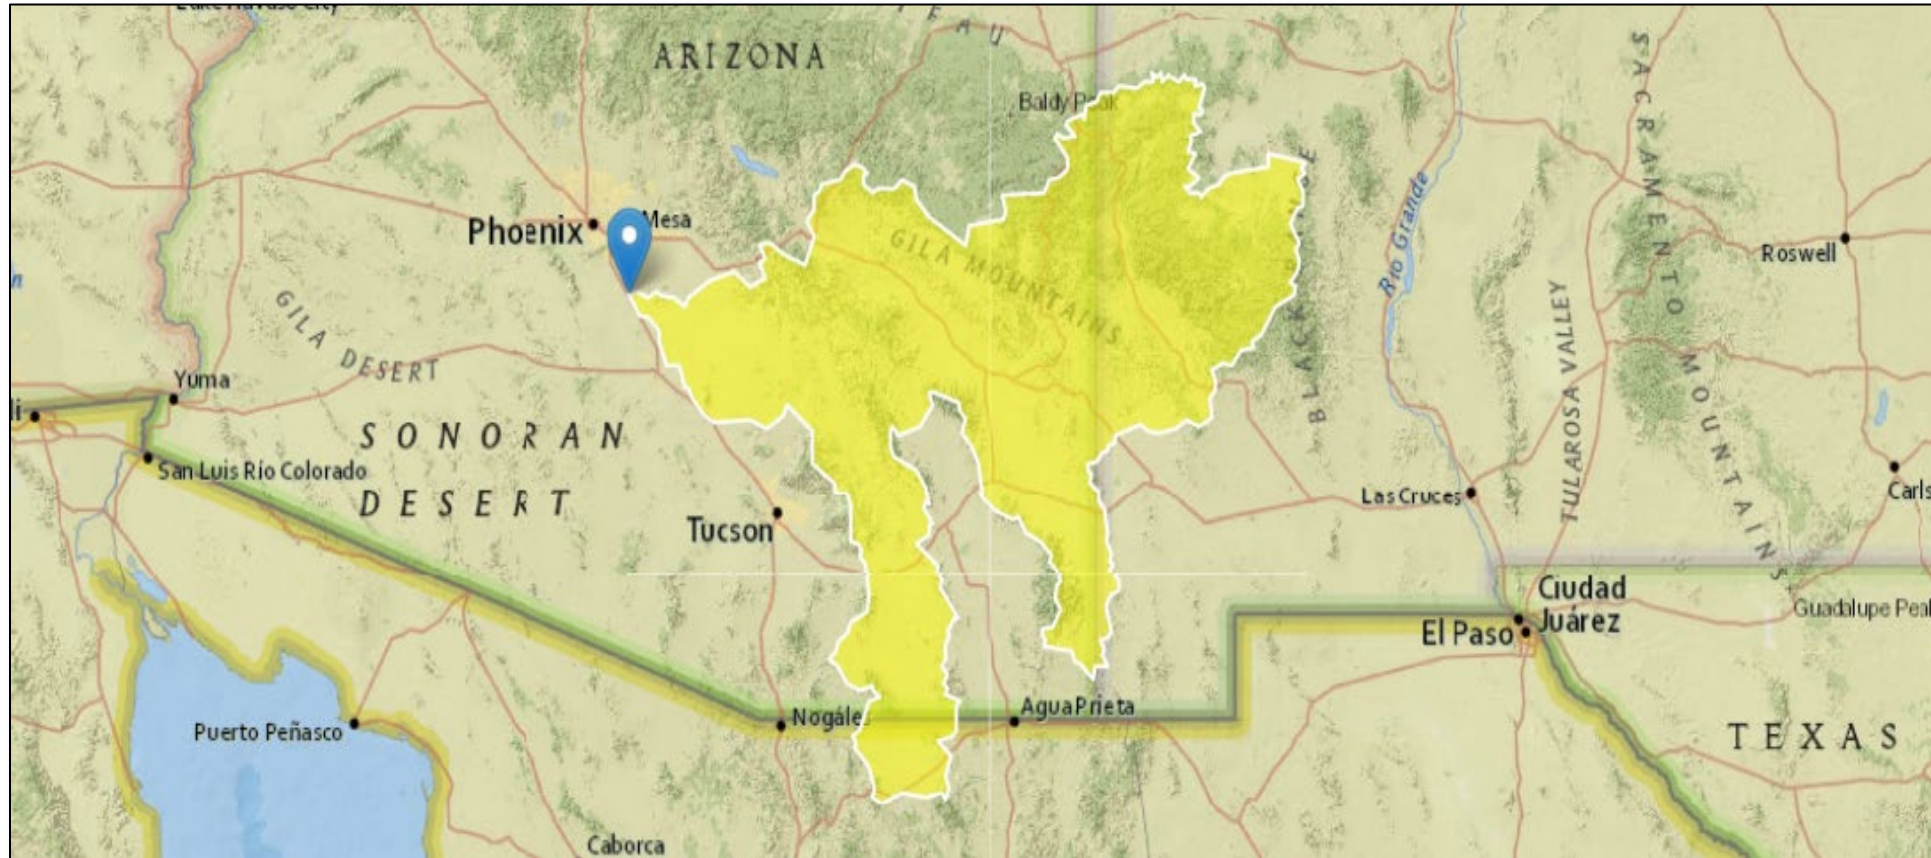
I-10 HYDROLOGY

- 19,520 Sq Mi
- Regulated Flows - Dams
- Gage Data 1912 - 2021
- Multiple 100,000cfs+ Events
- Multiple River Systems
- Stretches Into Both New and Old Mexico

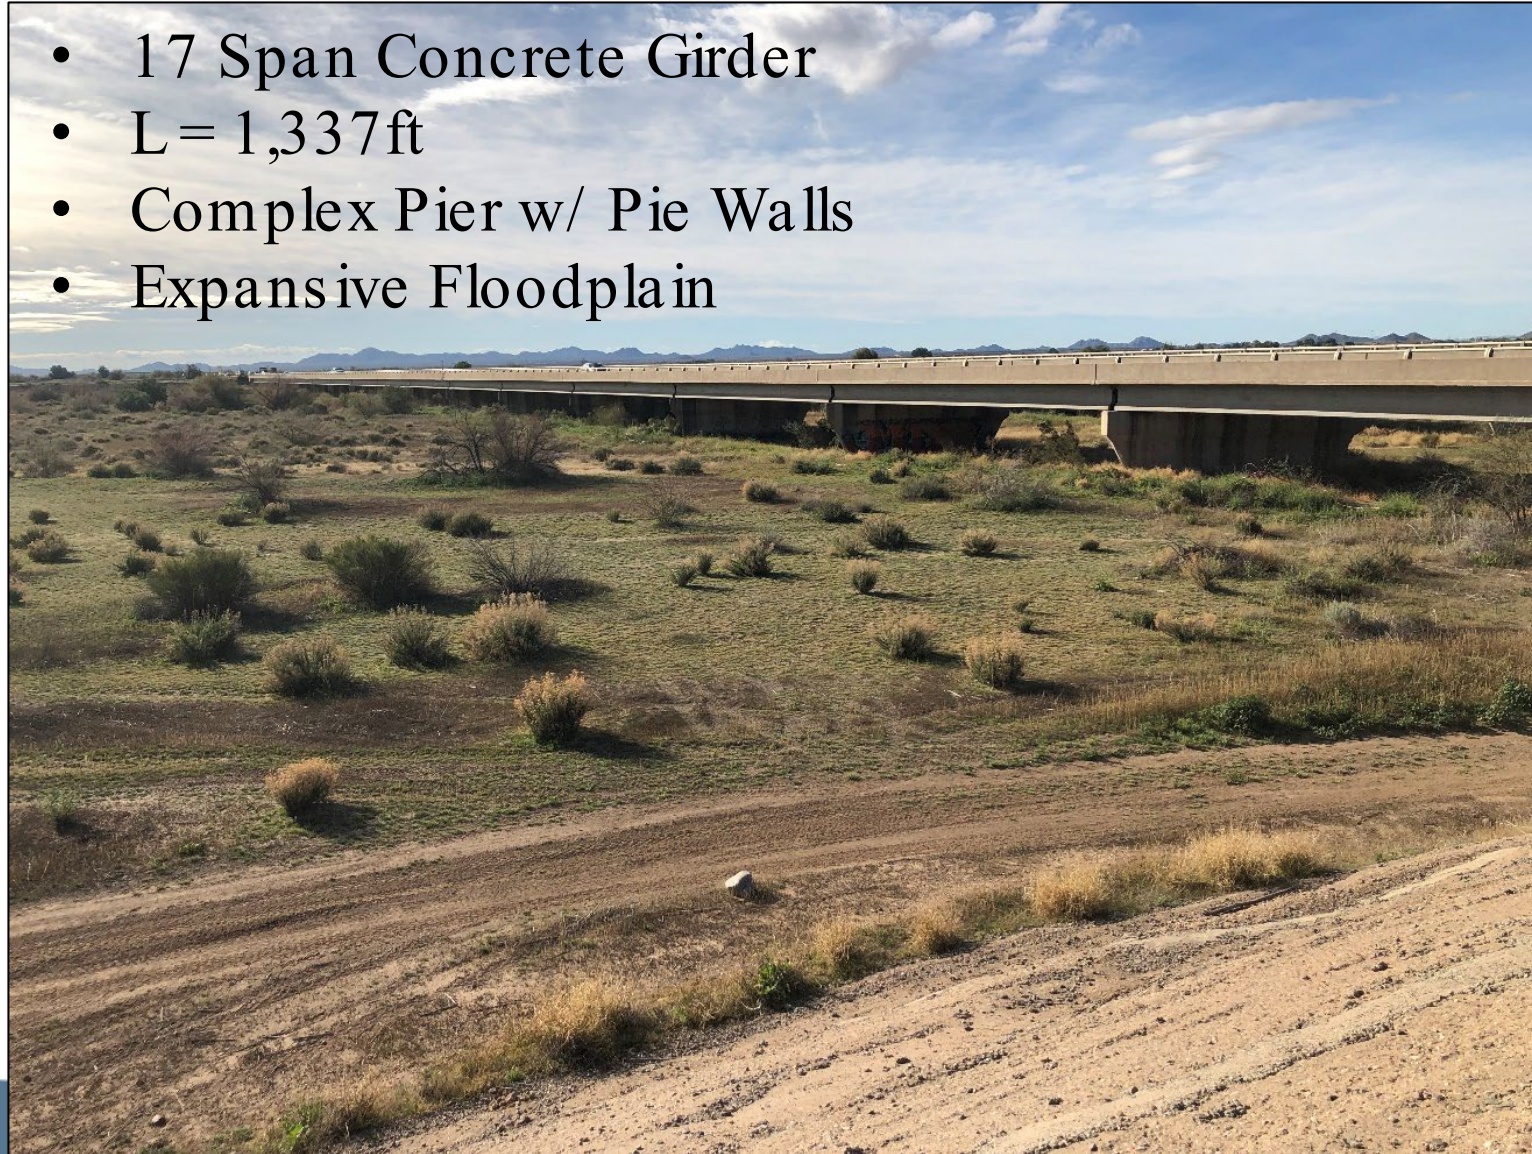
I-10 FIELD VISIT

- 17 Span Concrete Girder
- $L = 1,337$ ft
- Complex Pier w/ Pie Walls
- Expansive Floodplain

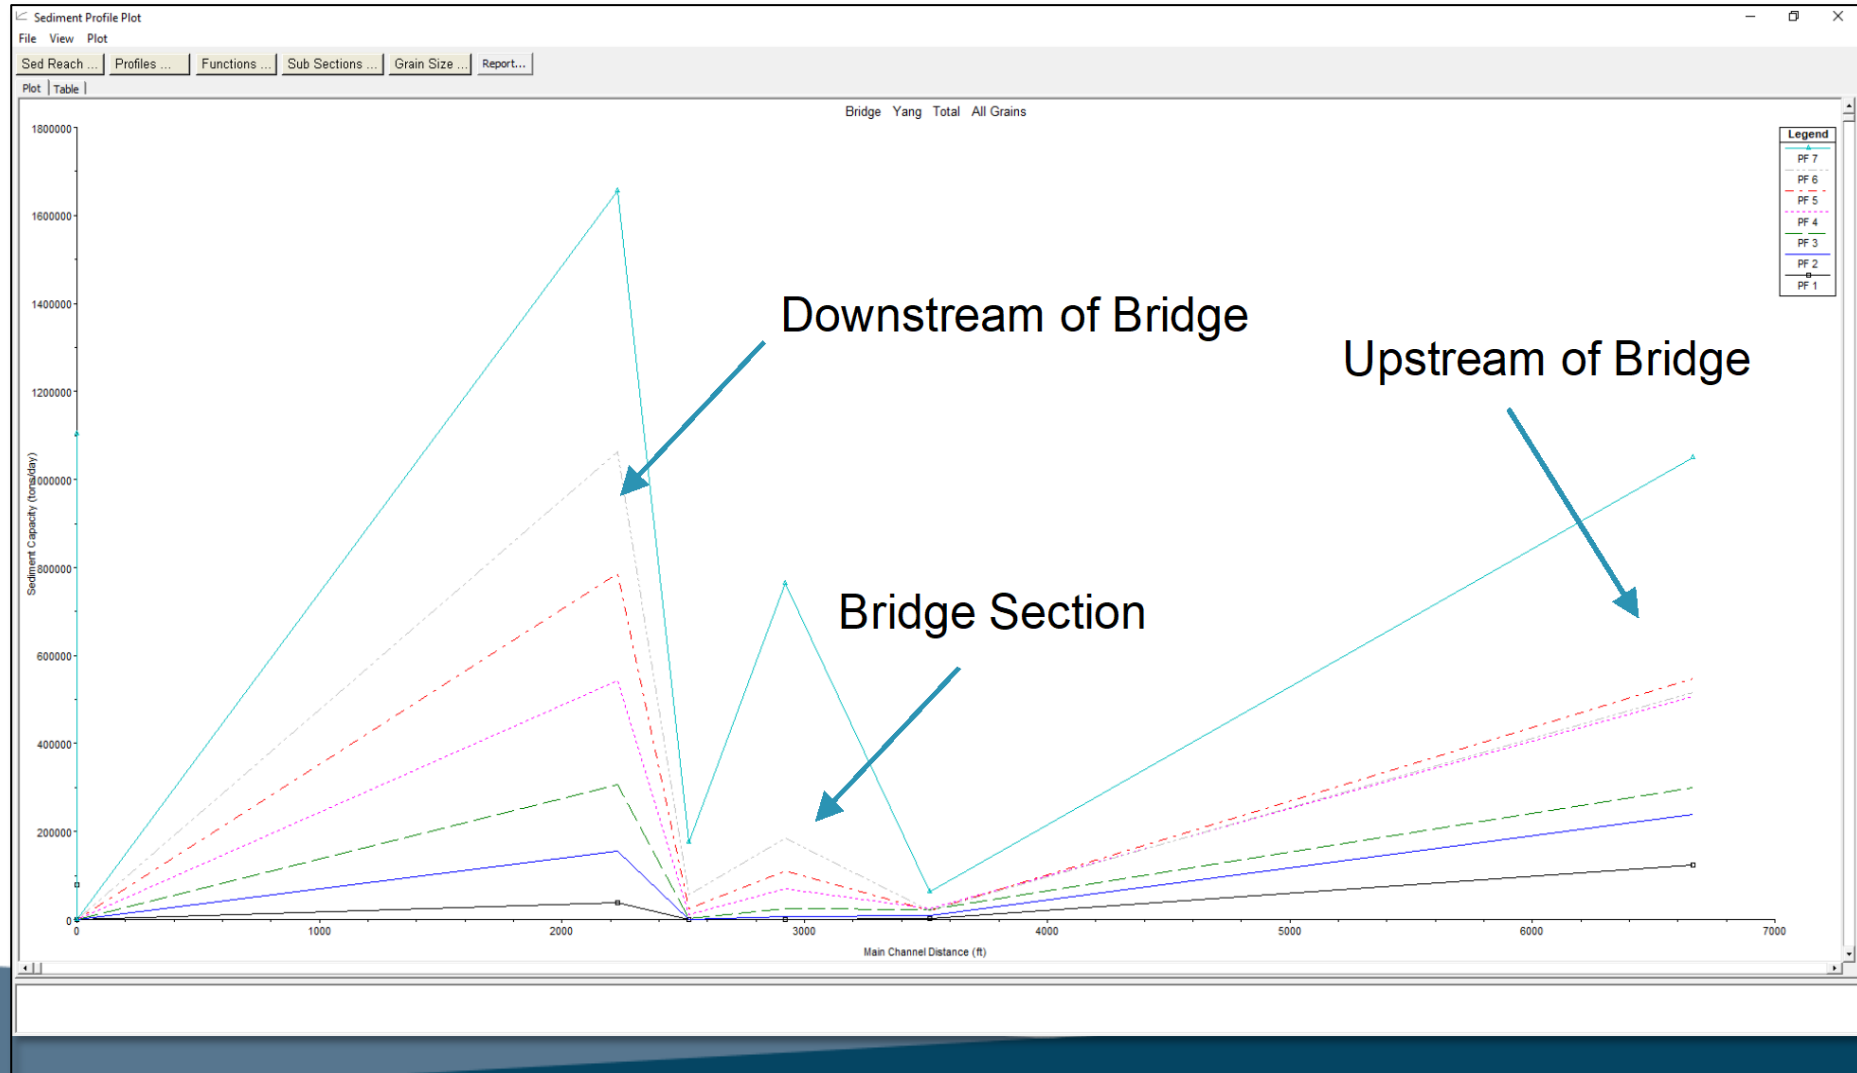
SEDIMENT TRANSPORT CAPACITY AT I-10 BRIDGE

- Average annual sediment transport capacity upstream of I-10 bridge is 111,000 tons/day
- Average annual sediment transport capacity at I-10 bridge is only 17,000 tons/day
- Average annual sediment transport capacity downstream of I-10 bridge increases to 110,000 tons/day
- *Significant decrease in sediment transport capacity through I-10 bridge crossing will cause long-term sediment deposition (~4 ft in 50 years) on channel bed, unless routine removal of sediment occurs*
- *Abrupt increase in sediment transport capacity downstream of I-10 bridge crossing will produce geomorphic headcut (channel incision) with tendency to propagate upstream if not mitigated*
