A Practical Look At Comparing Puget Sound LIDAR Consortium (PSLC) Data to Field Survey Points Within A Photogrammetric Soft Copy Stereo Model.

Report By Kurt Iverson and Jason Goldstein, WSDOT, Geographic Services. 5-20-03

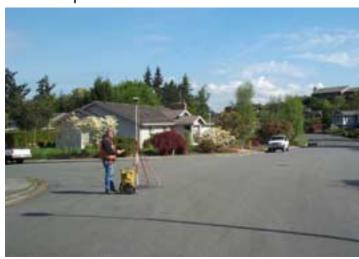
QC1-Manhole cover in paved street at intersection of SE 20th/121 Ave. SE.

LIDAR vertical differences: +0.22ft.

LIDAR horizontal point proximity to survey point: 1.76ft.

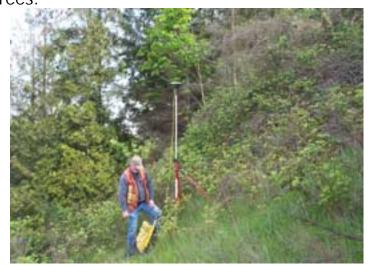
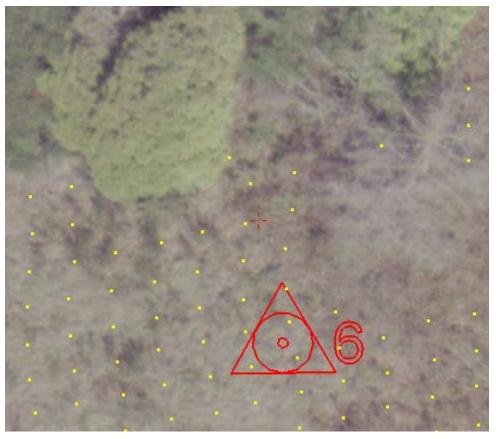
QC6-East side of SR405, halfway up the hillside in knee-high grass, surrounded by brush and trees.

LIDAR vertical differences: +0.97ft. LIDAR horizontal point proximity to survey point: 2.2ft. *QC7*-East side of SR405 on the pavement near a retaining wall. Transportation corridor landscape. Trees and obstructions to the east.

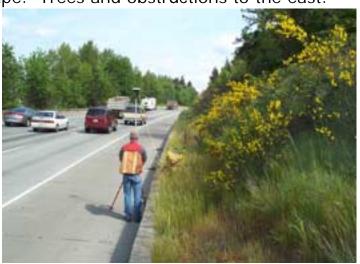
LIDAR vertical differences: +0.30ft.

LIDAR horizontal point proximity to survey point: 0.27ft.

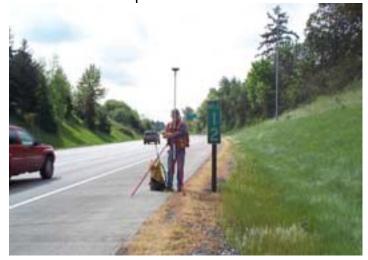
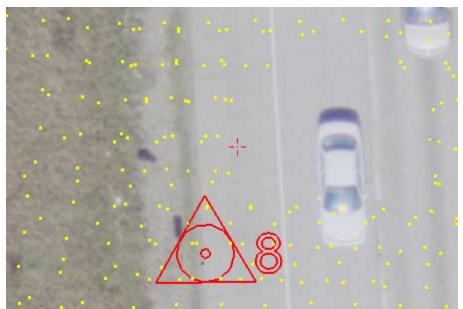
QC8-West side of SR405, southbound lanes, on the edge of pavement at MP12. Transportation corridor landscape. No obstructions.

LIDAR vertical differences: +0.31ft.

LIDAR horizontal point proximity to survey point: 1.3ft.

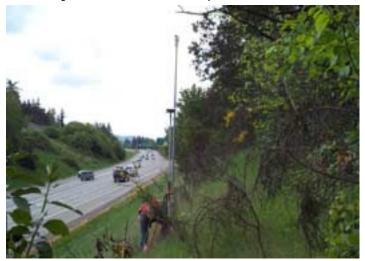
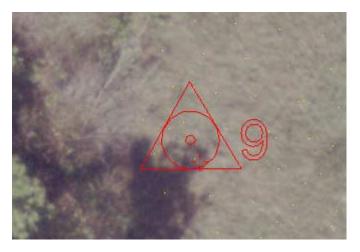
QC9-West side of SR405, southbound lanes, near the top of slope, in 12" high grass at the westerly tree line. Transportation corridor landscape.

LIDAR vertical differences: -0.51ft.

LIDAR horizontal point proximity to survey point: 2.1ft.

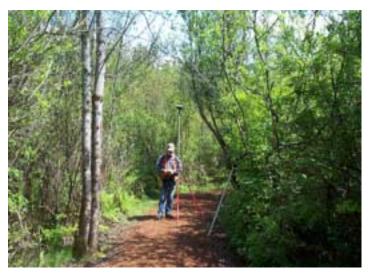
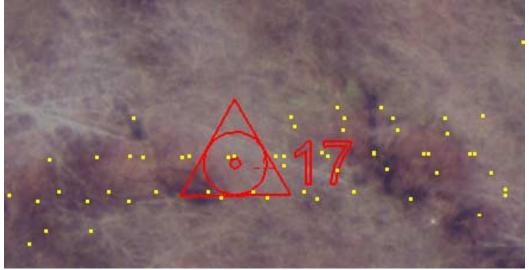
LIDAR vertical differences: +0.34ft. & -0.12ft. LIDAR horizontal point proximity to survey point: .09ft. & .09ft.

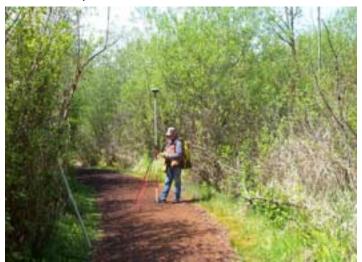
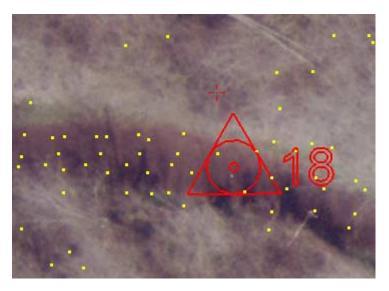
QC18-Ground surface of wood chip trail, surrounded by tall trees. Obstructed. Marshland riparian landscape.

LIDAR vertical differences: +0.45ft. & +1.79ft. LIDAR horizontal point proximity to survey point: 1.18ft. & 8.1ft.

comparison between survey field data and LIDAR demonstrates a maximum vertical difference of 1.79ft and minimum vertical difference of 0.07ft. The differences represent displacement between survey field control and nearest LIDAR points as measured within a 3.D. photogrammetric stereo model. Results show the data could be utilized for 1-2 foot or greater vertical mapping accuracy specifications (as stated by PSLC) in this study area. With some photogrammetric editing (adding data to better depict changes in grade) or cleaning, this data could be used to provide accurate elevation data for 1:12,000 scale or smaller orthophotography. It is not accurate enough for large-scale WSDOT engineering design level mapping accuracy specifications, where 3 tenths of a foot vertical accuracy is desired. Even the PSLC states: "locally, the data are of considerably poorer quality" This means this agencies large scale design projects should not utilize LIDAR data. It is a tool best used for regional research and planning purposes and has been used for geological fault analysis, forest characterization, and flood plain modeling. Our agency might best utilize LIDAR data for remote areas and applications where vertical accuracies of less than a foot are not needed.
