Research Report
Expansion Joint Noise

Modular Expansion Joint Noise Mitigation Study

Per G. Reinhall and Alexander G. Soloway

Department of Mechanical Engineering
University of Washington
Seattle, Washington 98105-6698

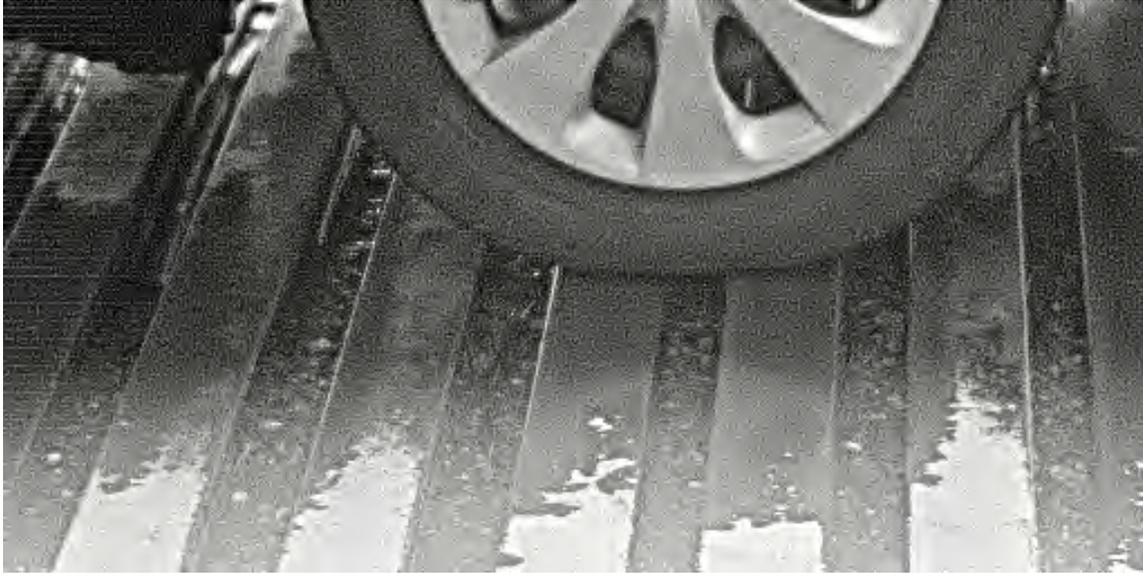
Figure 5-16 Frame from high-speed video recording of Toyota Prius front tire passing over east-side large expansion joint center beams.

Comparing the two sedans (Toyota Prius in Figure 5-16 and Scion FR-S) appear to pass over the center-beams such that a single gap is covered, and the tire is in contact with the center beams on either side. The tire on the Toyota Prius appears to deform more compared to the Scion FR-S with the tire making almost full contact with center beams so the tire contact patch is larger. The Scion FR-S, however exhibits a smaller tire contact patch with little contact with the center beams as the tire passes over the gap.

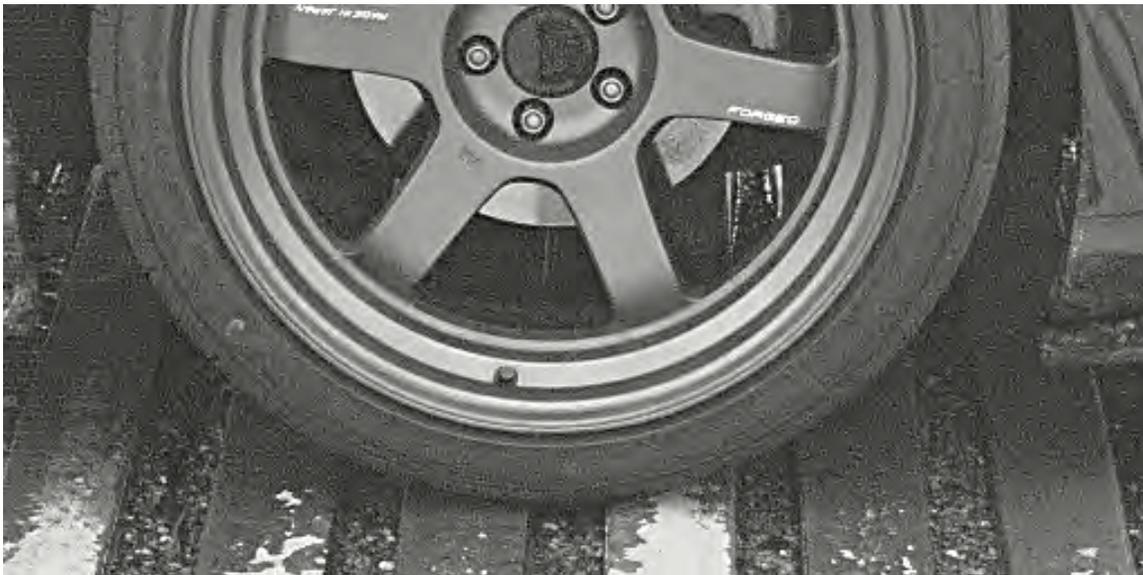
Figure 5-17 Frame from high-speed video recording of a Scion sports car front tire passing over east-side large expansion joint center beams.

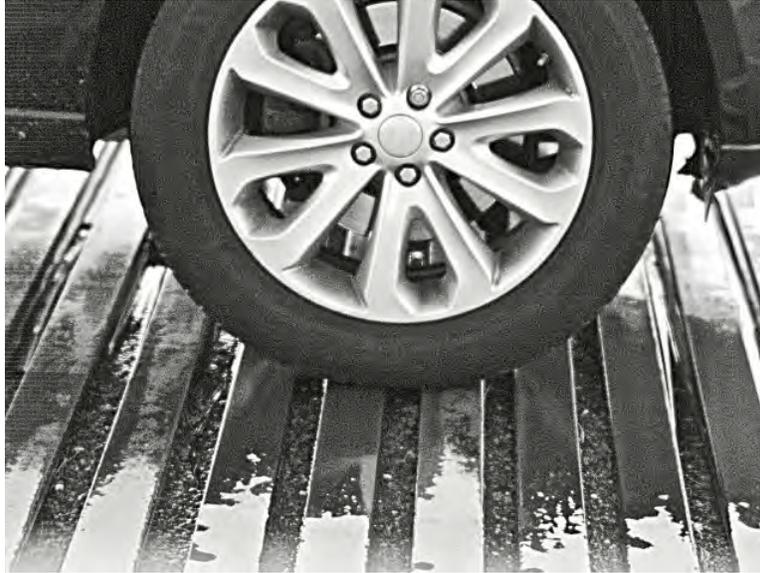
Figure 5-18 Frame from high-speed video recording of an SUV tire passing over east-side large expansion joint center beams.

Moving on to the SUV video recordings (unidentified SUV in Figure 5-18 and a Toyota Tundra Figure 5-19). The two recordings show similar results with the tire contact patch covering the gap and part of each center beam on each side of the gap. The contact with the center beams is less than the Toyota Prius (Figure 5-16) but more than the Scion FR-S(Figure 5-17).

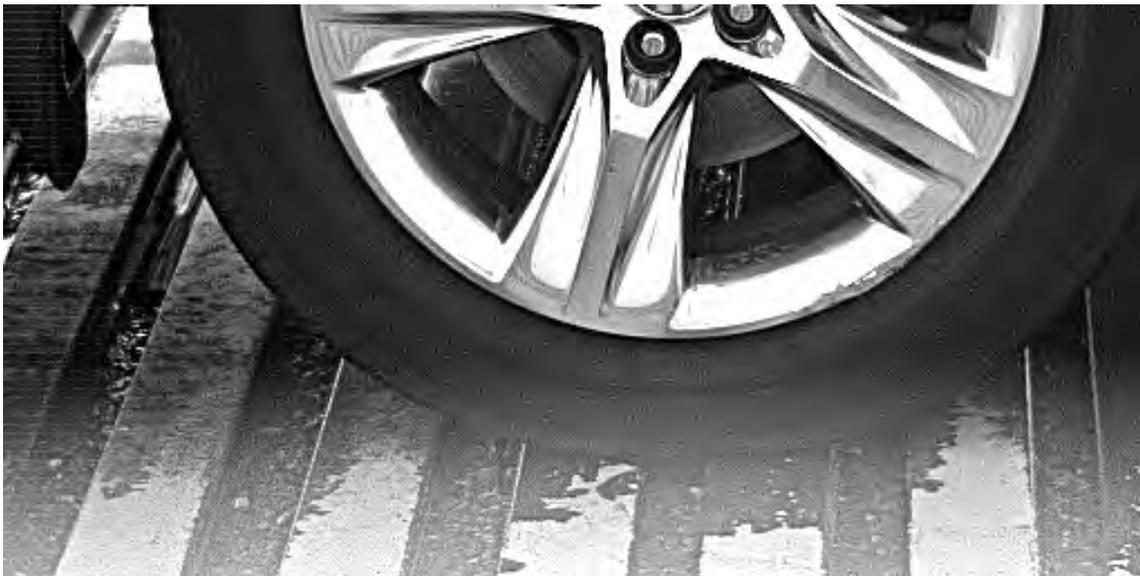
Figure 5-19 Frame from high-speed video recording of a Toyota Tundra front tire passing over east-side large expansion joint center beams.

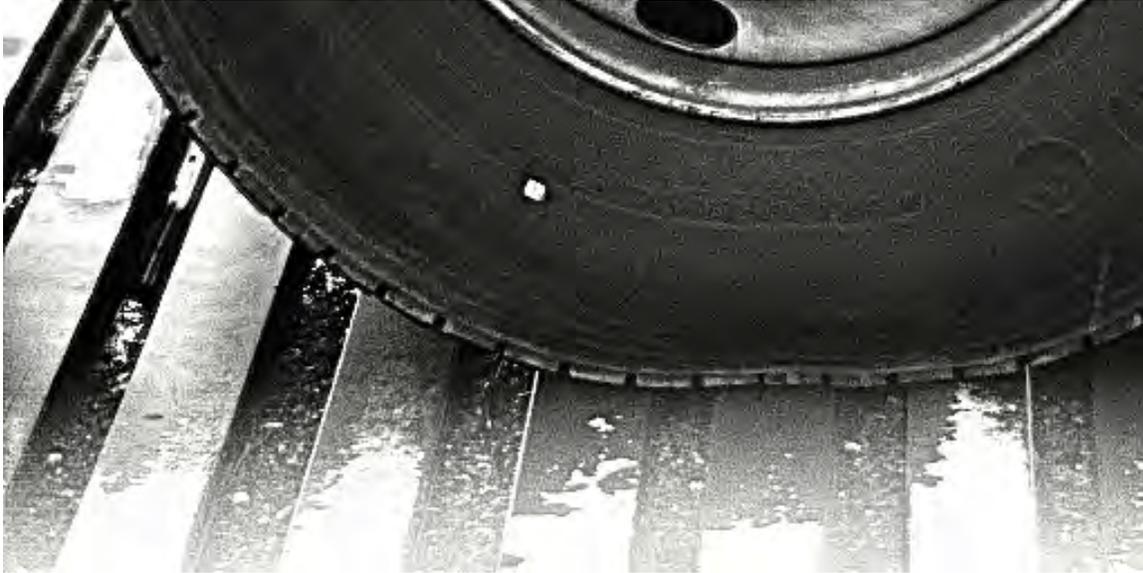
Figure 5-20 Frame from high-speed video recording of a car-carrier truck front tire passing over east-side large expansion joint center beams.

Comparing the car-carrier truck (Figure 5-20) and a bus (Figure 5-21), the tire contact patch of both vehicles is large enough that two gaps are covered and contact is made with three center beams. Both tires are deformed at the point where they run over the middle center beam that they are in contact with. The bus tires appear to sink into the gaps whereas the car-carrier truck tires do not appear to deform such that they sink down into the gaps. This could impact the pressure changes within the gaps.

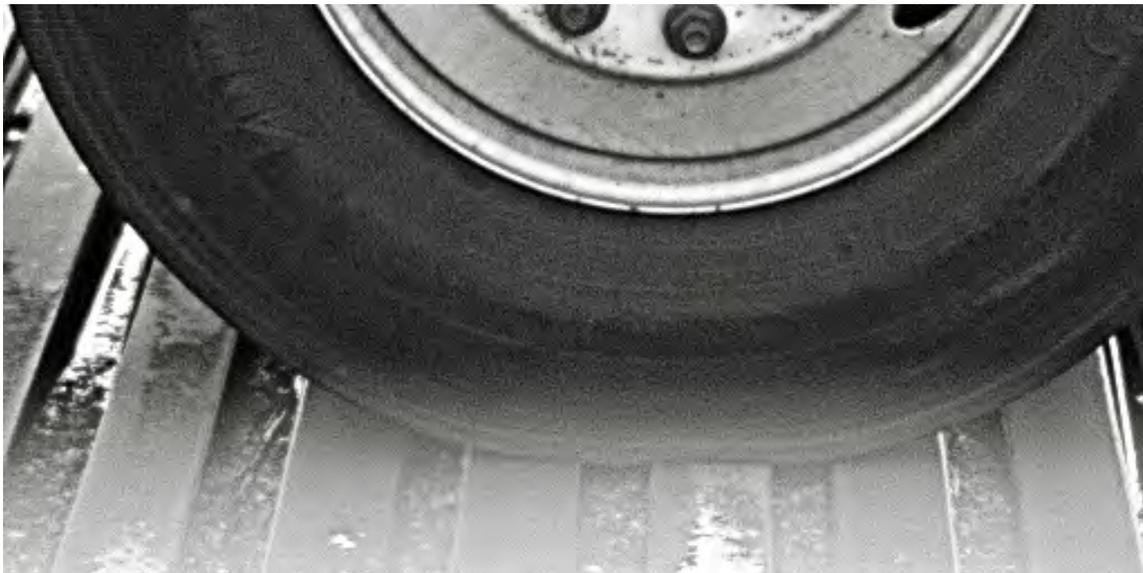
Figure 5-21 Frame from high-speed video recording of a bus front tire passing over east-side large expansion joint center beams.
