4 TERMINAL SPECIFIC INFORMATION

ANACORTES

4.1 Anacortes

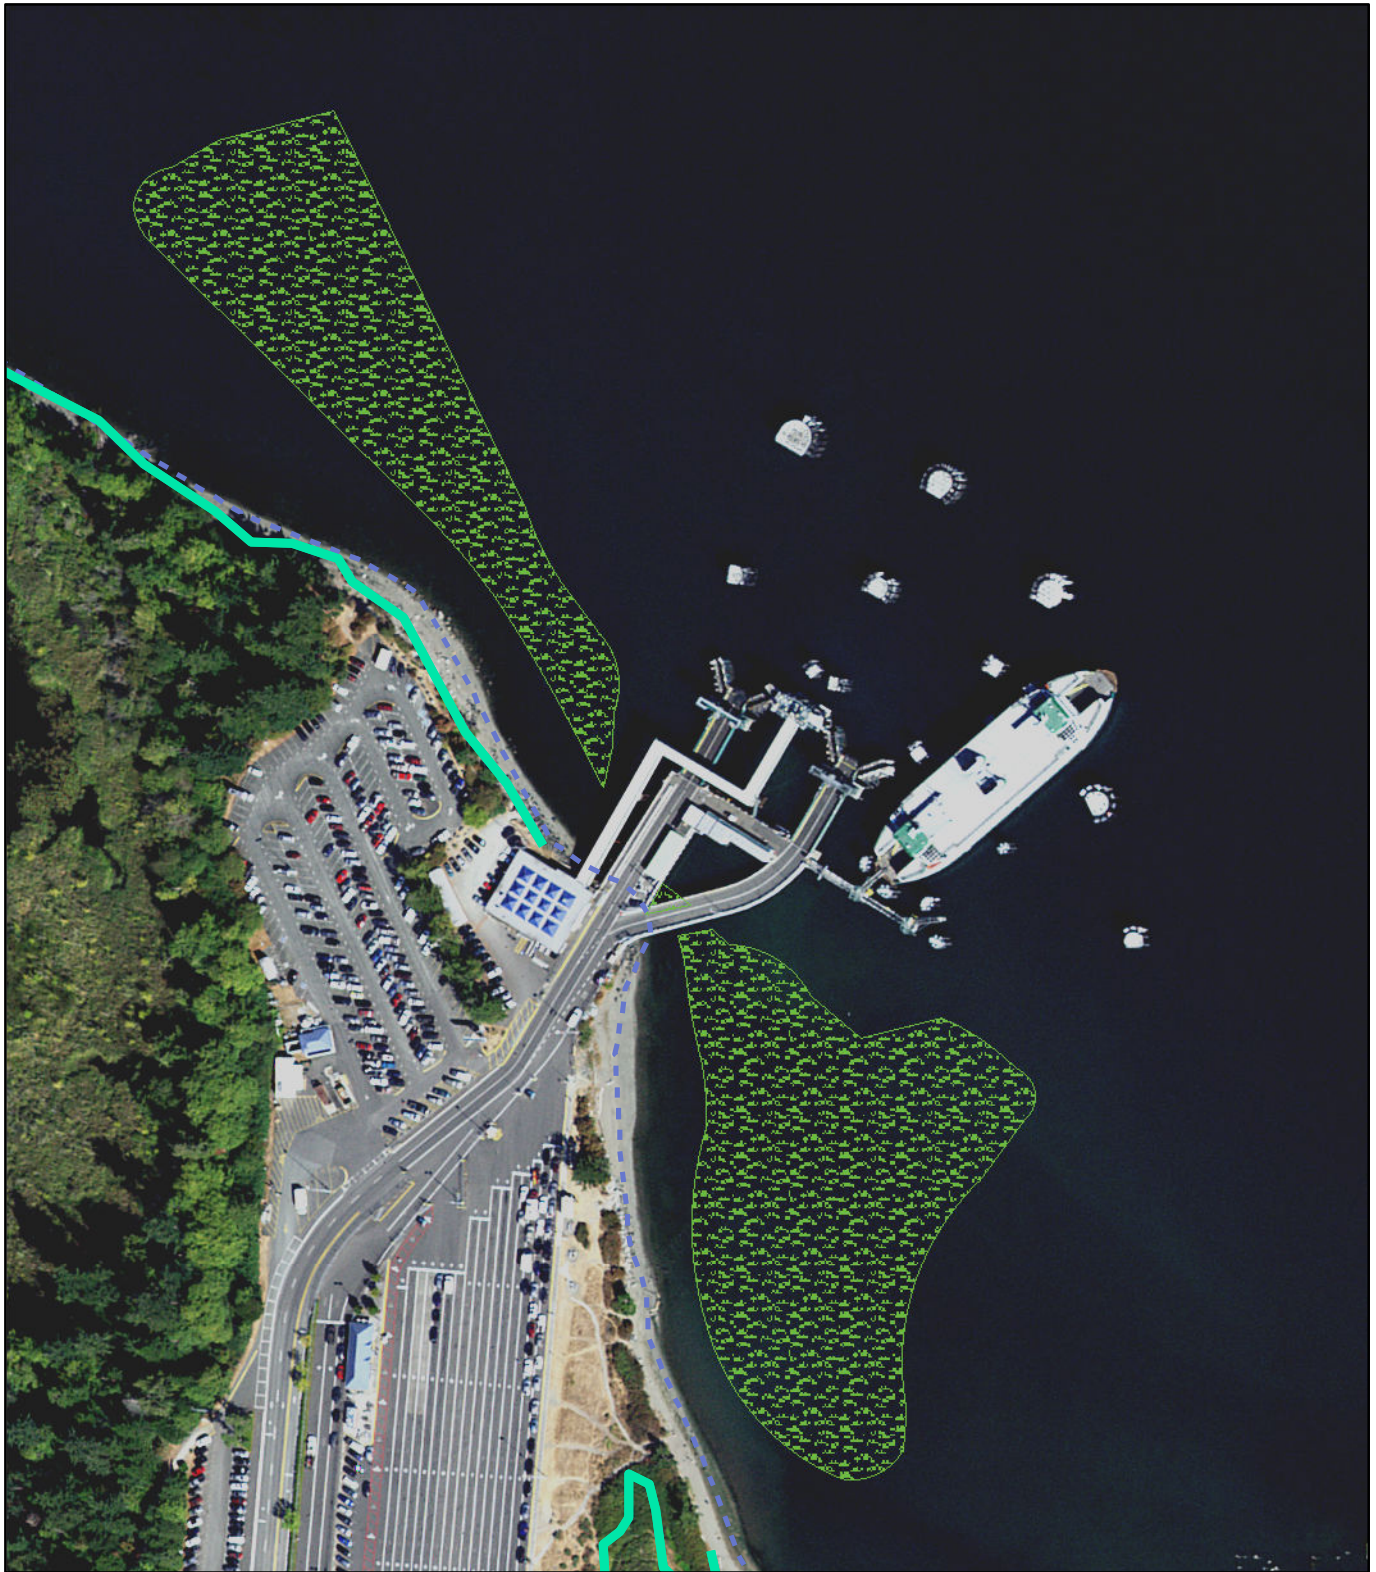
Figure AN-2
Aerial Photo of Anacortes Ferry Terminal
WSF Biological Assessment Reference
Anacortes, Washington

- Smelt Spawning
- Approximate Mean High Water (MHW)
- Eel Grass

The Anacortes Ferry Terminal is located in the city of Anacortes, on Fidalgo Island, adjacent to Guemes Channel (see Figures AN-1 and AN-2).

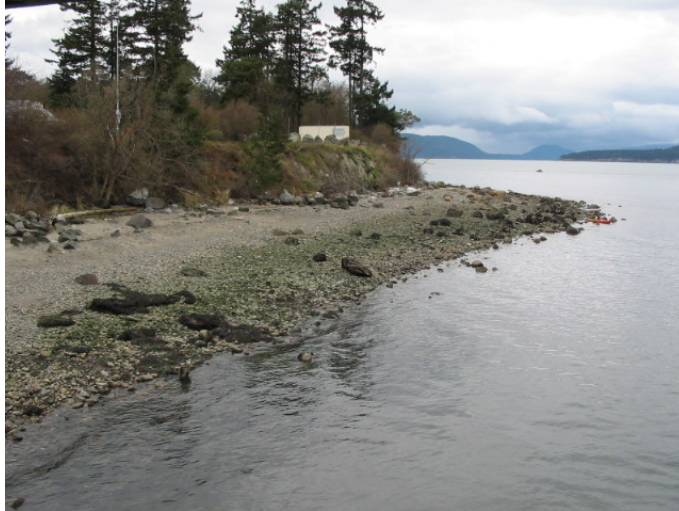
Figure AN-3
Shoreline Area to the West of the Anacortes Ferry Terminal

At the ferry terminal, substrates below MLLW are primarily sand and silt, with larger areas of shell fragments in offshore areas. Substrates above MLLW are a mix of gravel, cobble, and sand. Some riprap and hardened shoreline occurs at the bulkhead under the trestle and adjacent to the terminal.

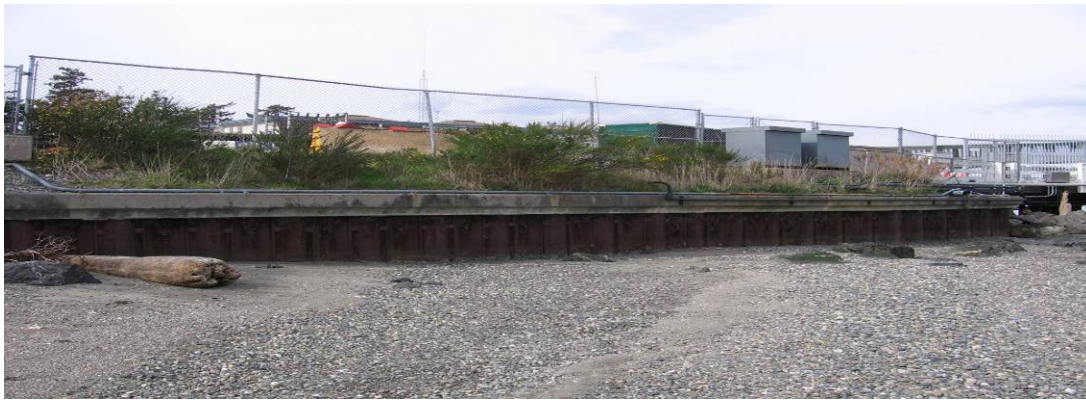
Figure AN-5
Marine Riparian Vegetation

Shoreline vegetation at the ferry terminal is generally absent. Existing vegetation consists predominately of shrubs and herbaceous vegetation. Much of this vegetation consists of invasive or non-native vegetation such as Himalayan blackberry (*Rubus discolor*) and Scotch broom (*Cytisus scoparius*) (see Figures AN-5 and AN-6).

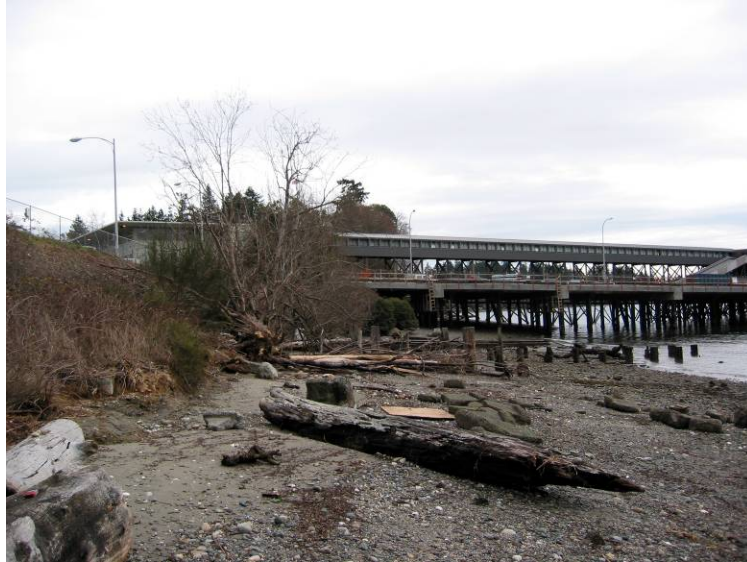
Figure BA-3
Beach Area on South Side of Bainbridge Island Ferry Terminal

Substrate in the area is gently sloping sand, gravel, and shell in the intertidal areas, and drops off steeply toward the end of the terminal entrance. The high intertidal zones are characterized by cobble and gravel-sized sediment, and the mid- to low-intertidal areas are characterized by silt and sand (EPA 1989). Offshore depths of terminal structures are: head of main slip (-29.9 feet MLLW), auxiliary slip (-31.6 feet MLLW), and tie-up slip (-28.8 feet MLLW). Maximum depth for fixed dolphins is -40.4 feet MLLW, and the floating dolphin is -40.0 feet MLLW.

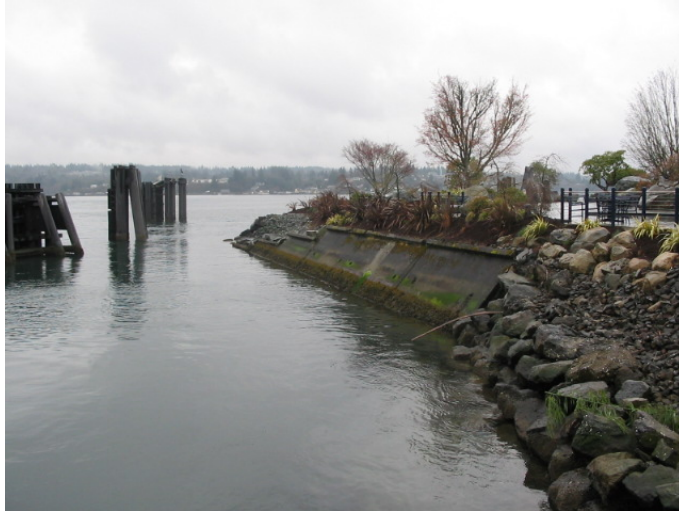
Figure BR-3
Shoreline Area to the West of the Bremerton Ferry Terminal

Substrates in Sinclair Inlet are comprised of gravel, sand, mud/clay, and shell hash. Some woody debris and garbage (i.e., bottles, tires, and cable) are present. The shoreline is heavily armored with riprap (see Figures BR-3 and BR-4). Offshore depths of terminal structures are: head of main slip (-29.9 feet MLLW), auxiliary slip (-31.6 feet MLLW), and tie-up slip (-28.8 feet MLLW). Maximum depth for fixed dolphins is -40.4 feet MLLW.

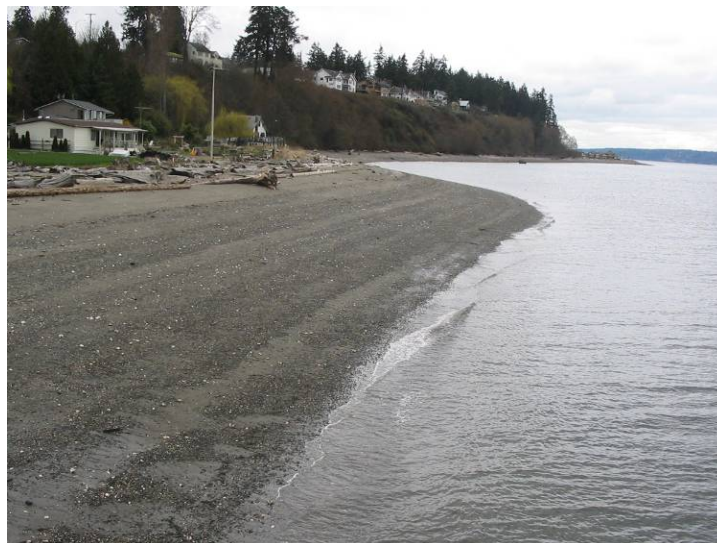
Figure CL-3
Shoreline Area to the North of the Clinton Ferry Terminal

A small sandy beach with low bank waterfront exists north of the terminal. South of the terminal, the beach is moderately sloping coarse sand to approximately MLLW. See Figures CL-3 and CL-4. The terminal exists in a portion of beach that is somewhat steeper than areas within 0.5 mile north and 0.5 mile south of the terminal.

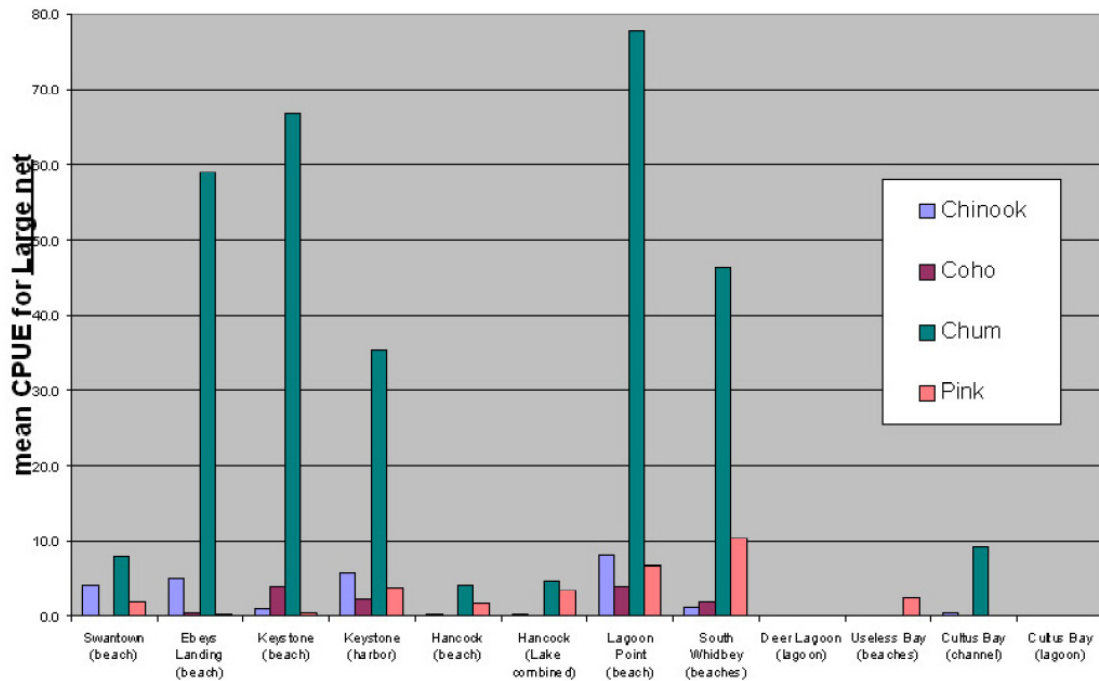
Figure CL-6
Total Catch per Unit Effort for all Juvenile Salmon at all Sites, Across the Sampling Season (February to August) Using the Large Beach Seine

Figure CL-6 shows the catch per unit of effort for juvenile salmon at all sites, across the entire field season using the large net, while Figure CL-7 shows the catch per unit effort for juvenile salmon at all sites, across the entire field season using the small net. Overall, chum salmon were the most common juvenile salmon caught, while coho salmon were the least common. The Cultus Bay sampling sites are nearest to the Clinton Ferry Terminal. One Chinook salmon was caught in the Cultus Bay Channel with the large beach seine (see Figure CL-6).

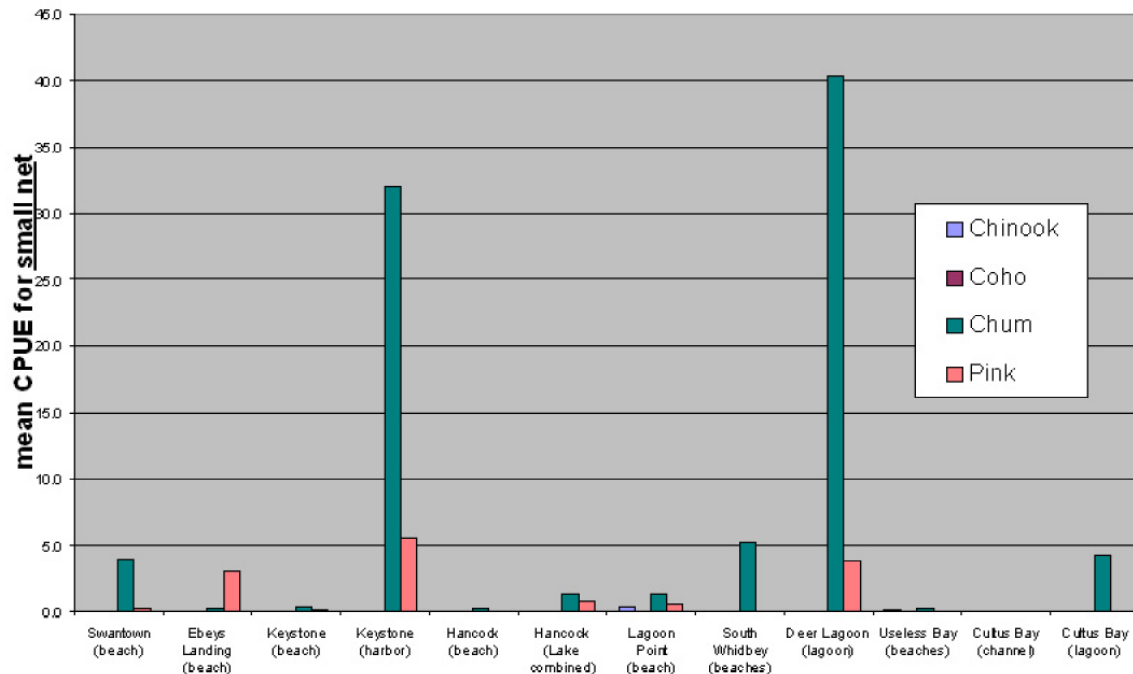
Figure CL-7
Total Catch per Unit Effort for all Juvenile Salmon at all Sites, Across the Sampling Season (February to August) Using the Small Beach Seine

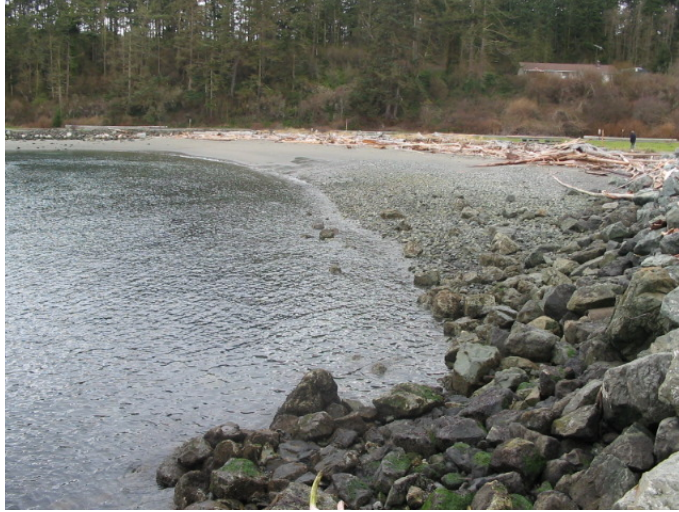
Figure CO-3
Shoreline Area to the West of the Coupeville Ferry Terminal

There are three distinct areas within Keystone Harbor with respect to substrate composition. The center of the harbor, ferry lane, and terminal area are mostly cobble and gravel with a few patches of sand/shell debris. The side slopes of the harbor are composed of mostly gravel, with some cobble. The areas outside of propeller wash influence and not on a slope are composed of sand, mud, and mud with wood debris. Outside of the harbor mouth, substrate is either gravel or cobble. The jetty that forms the east side of the harbor is composed of large, angular riprap boulders. There are other areas of riprap, most notably the area around the terminal where riprap is used to armor the shoreline from propeller wash scour. The intertidal zone areas that are not riprap are either gravel or mixed sand and gravel. The intertidal and shallow subtidal area on the east side of the harbor is clean homogeneous large gravel, indicative of high energy and regular movement.

See Figures CO-3 and CO-4 for pictures of the shoreline areas west and east of the ferry terminal.

The shoreline within Keystone Harbor is characterized by a nearly level surface with a gentle slope down toward the water of about 4 percent. The seafloor surface slopes from the shoreline down to the south, with an overall gradient of about 12 percent, with the steepest portion closest to the beach at about 20 percent. Offshore depths of terminal structures are: head of slip (-22.7 feet MLLW). Maximum depth for fixed dolphins is -28.0 feet MLLW. A steep slope, located west of the terminal, is a near-vertical bluff on Keystone Harbor.

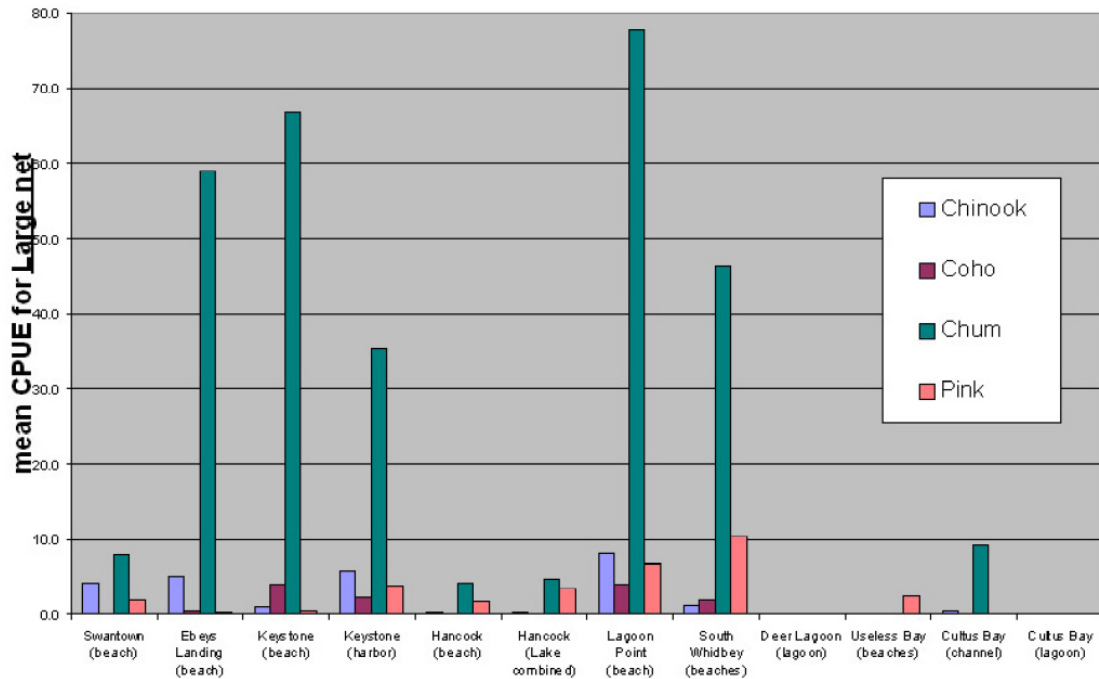
Figure CO-6
Total Catch per Unit Effort for all Juvenile Salmon at all Sites, Across the Sampling Season (February to August) Using the Large Beach Seine

Figure CO-6 shows the catch per unit of effort for juvenile salmon at all sites, across the entire field season using the large net, while Figure CO-7 shows the catch per unit effort for juvenile salmon at all sites, across the entire field season using the small net. Overall, chum salmon were the most common juvenile salmon caught, while coho salmon were the least common.

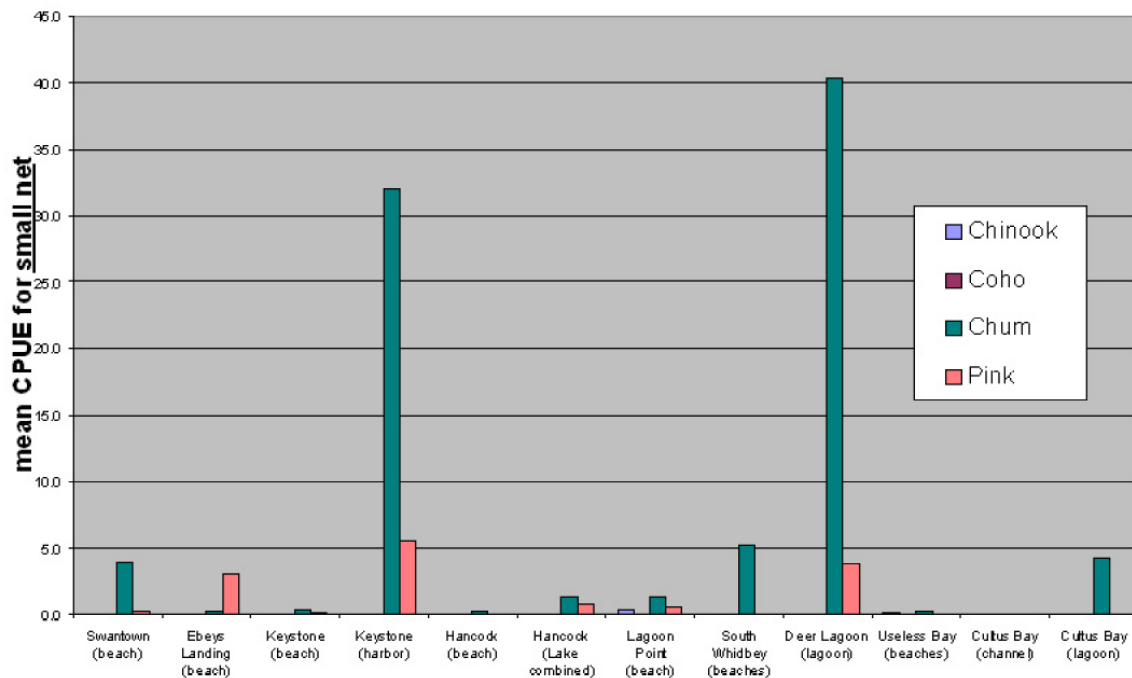
Figure CO-7
Total Catch per Unit Effort for all Juvenile Salmon at all Sites, Across the Sampling Season (February to August) Using the Small Beach Seine

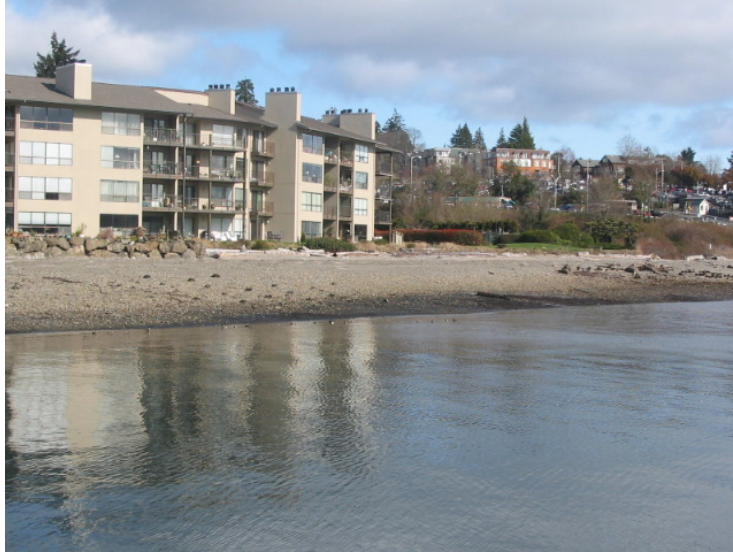
Figure EH-3
Shoreline Area East of the Eagle Harbor Maintenance Facility

Substrate conditions adjacent to the maintenance facility are highly variable. Substrate beneath the facility is sandy silt, gravel, and shell. Propeller scour has removed most fine material leaving coarse sand, gravel, and shell debris. The depth/slope in the area is relatively flat with shallow depths (especially in the western portion of the harbor) and shoaling near the outlet to Puget Sound on the east side of the harbor. Offshore depths of maintenance facility structures are: head of Pier 1 (-35.8 feet MLLW), Pier 2 (-30.0 feet MLLW), and Slip E (-25.4 feet MLLW). Maximum depth for fixed dolphins is -37.0 feet MLLW.

See Figures EH-3 and EH-4 for pictures of the shoreline areas east and west of the maintenance facility.

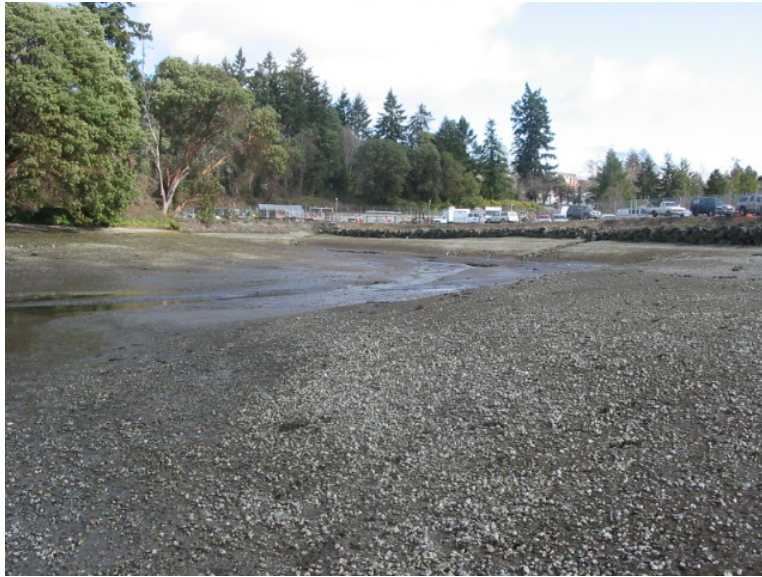
Figure EH-5
The Ravine Adjacent to the Eagle Harbor Maintenance Facility (photo is looking upstream)

There are three year-round streams and six seasonal streams that discharge into Eagle Harbor. A narrow, approximately 0.5-mile-long ravine drains into the harbor adjacent to the maintenance facility (see Figure EH-5).

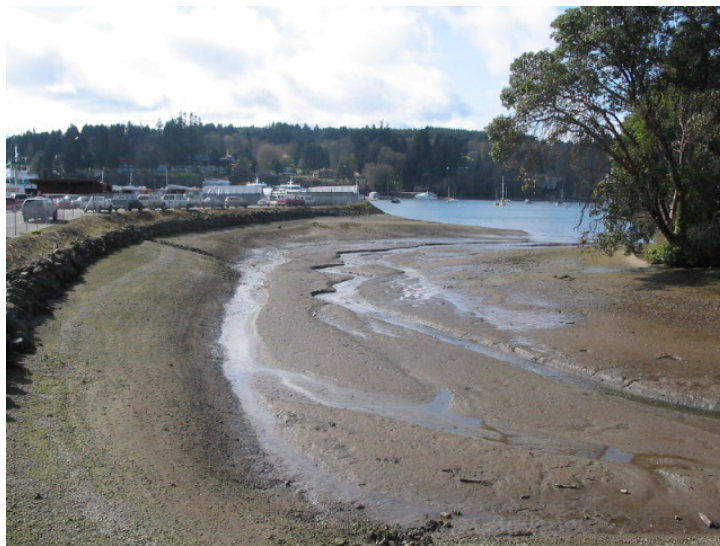
Figure EH-6
The Mouth of Ravine Creek as it Empties into Eagle Harbor

Ravine Creek (aka Canyon/Winslow) flows into Eagle Harbor at the northwest corner of the maintenance facility property into an inlet that is lined with large overhanging wood vegetation on the west (see Figure EH-6). There is little to no shoreline vegetation in the remaining area of the maintenance facility. The east side of the inlet adjacent to the maintenance facility property is lined with riprap and gravel, covered with a habitat mix along much of the bank. Shoreline vegetation east of the maintenance facility is characterized by grass above a bulkhead. Shoreline vegetation within the area is variable ranging from undeveloped areas with mature trees overhanging the upper intertidal zone to grass lawns behind a vertical bulkhead.

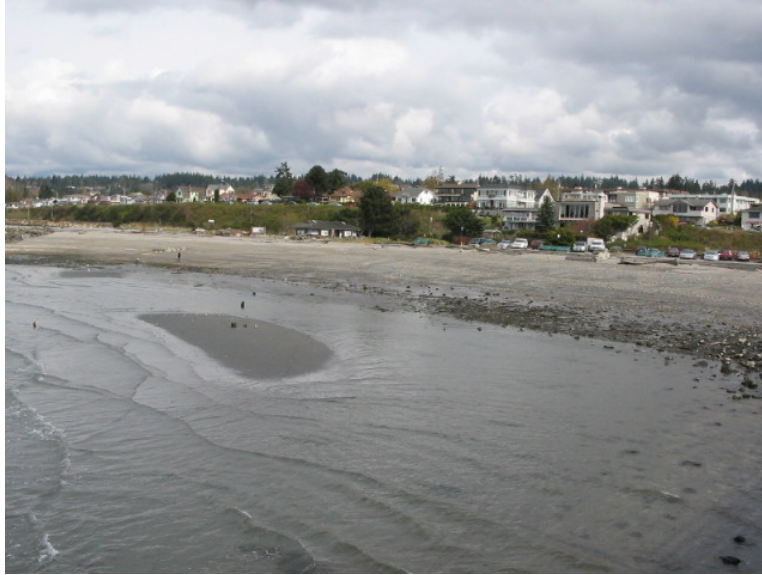
Figure ED-3
Shoreline Area East of the Edmonds Ferry Terminal

The shoreline is gently sloping low-bank beachfront (see Figures ED-3 and ED-4). Between -7 feet and -15 feet MLLW, substrate consists of 95 percent sand, 4 percent fines, and 0.4 percent gravel. At -25 feet MLLW, the substrate changes to 61 percent sand, 27.4 percent fines, and 11.6 percent gravel, with sand composition increasing to 91 percent at -40 feet MLLW. Offshore depths of terminal structures are: head of main slip (-36.5 feet MLLW). Maximum depth for fixed dolphins is -39.2 feet MLLW.

East of the terminal is an underwater park that contains large rock, cobble, and sand, as well as sunken material (boats, etc.) to provide habitat structure. West of the terminal, substrates are mostly sand above -15 feet MLLW with underwater rock reefs scattered between -15 and -90 feet MLLW.

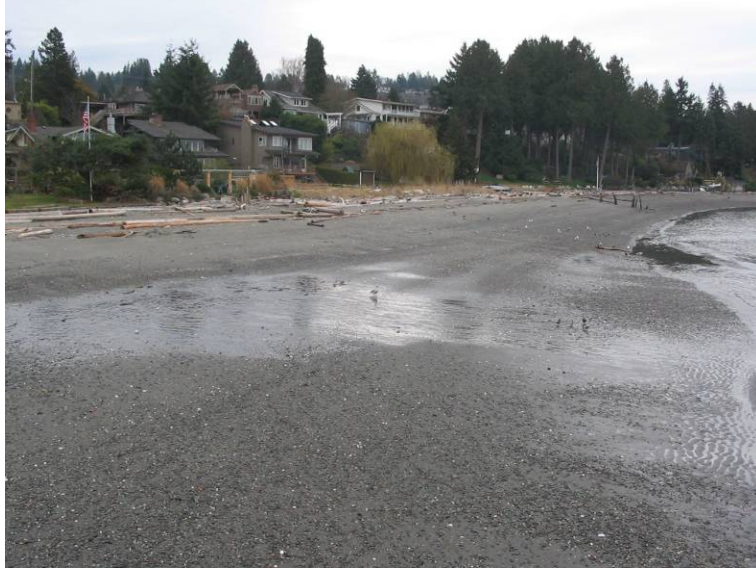
Figure FA-3
Shoreline Area South of the Fauntleroy Ferry Terminal

Aerial photographs indicate the presence of large woody debris along the shoreline in the area near the terminal. The high intertidal zone is characterized by fine-grained sand, whereas the mid to low intertidal areas are predominantly coarse sand and gravel. Bathymetry gently slopes seaward out to about -15 to -20 feet MLLW at the end of the trestle, and then drops off steeply (about 15 percent) at the end of the trestle. Offshore depths of terminal structures are: head of main slip (-33.6 feet MLLW). Maximum depth for fixed dolphins is -47.4 feet MLLW. The substrate is comprised predominately of sand and gravel. See Figures FA-3 and FA-4 for pictures of the shoreline areas south and north of the ferry terminal.

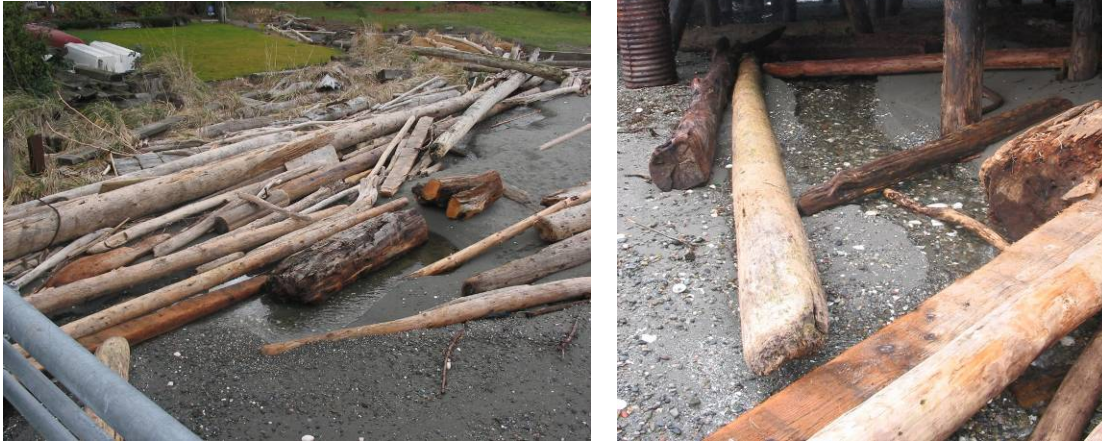
Figure FA-5
The Mouth of Fauntleroy Creek at the South End of the Ferry Terminal

Fauntleroy Creek discharges into Fauntleroy Cove just south of the ferry terminal (see Figures FA-2 and FA-5) and contributes a small volume of freshwater to the cove.

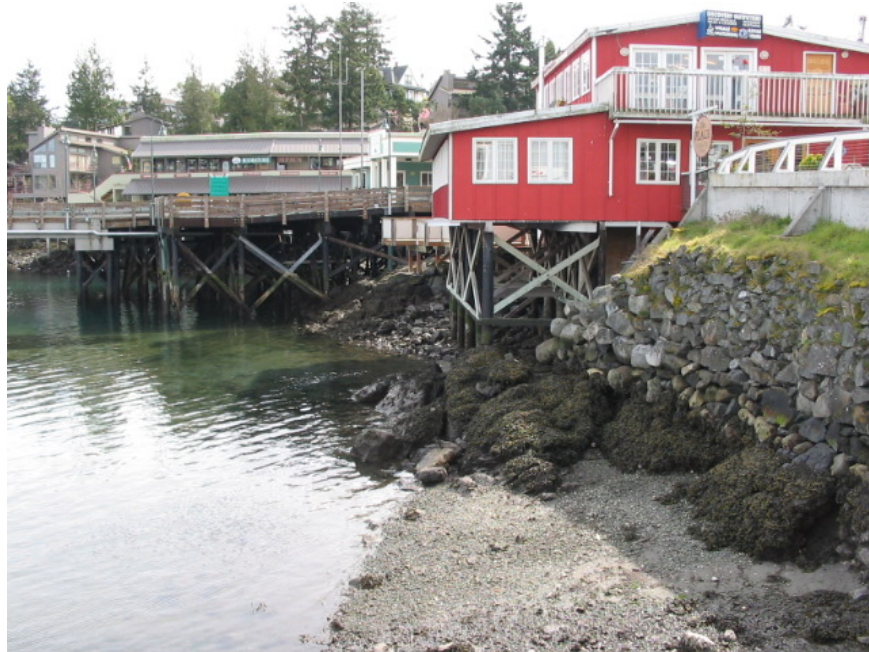
Figure FH-3
Shoreline Area on the Northwest Side of the Friday Harbor Ferry Terminal

Substrate conditions adjacent to the terminal are highly variable. Coarser grained sediments and gravel are more prevalent along the offshore areas of the facility and within the areas subject to operations. The shoreline is predominantly bedrock with some coarse sand and cobble (see Figures FH-3 and FH-4). Offshore depths of terminal structures are: head of main slip (-35.4 feet MLLW) and tie-up slip (-30.5 feet MLLW). Maximum depth for fixed dolphins is -46.5 feet MLLW.

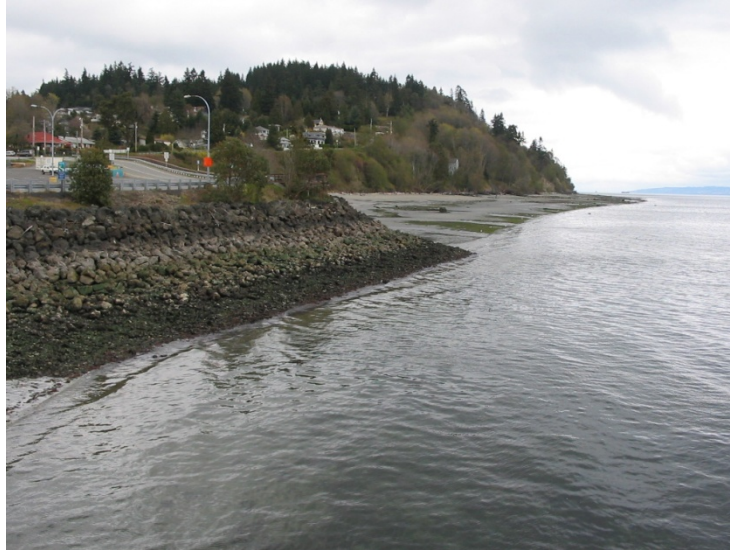
Figure KI-3
Shoreline Area North of the Kingston Ferry Terminal

The shoreline is heavily armored in the vicinity of the terminal (see Figures KI-3 and KI-4). Steep (2 horizontal to 1 vertical [2H:1V]) riprap slopes dominate from MHHW to about -8 feet MLLW. Beyond about -8 feet MLLW, there is a gentle slope to about -20 or -30 feet MLLW. Deeper intertidal and shallow subtidal substrates consist of gravel and sand, with occasional boulders. Offshore depths of terminal structures are: head of Slip 1 (-42.2 feet MLLW), Slip 2 (-33.5 feet MLLW), and tie-up slip (-26.0 feet MLLW). Maximum depth for fixed dolphins is -36.9 feet MLLW and for floating dolphins -35.7 feet MLLW.
