Lopez Island Ferry Terminal: WSF Biological Assessment Reference

4.11 Lopez Island Ferry Terminal

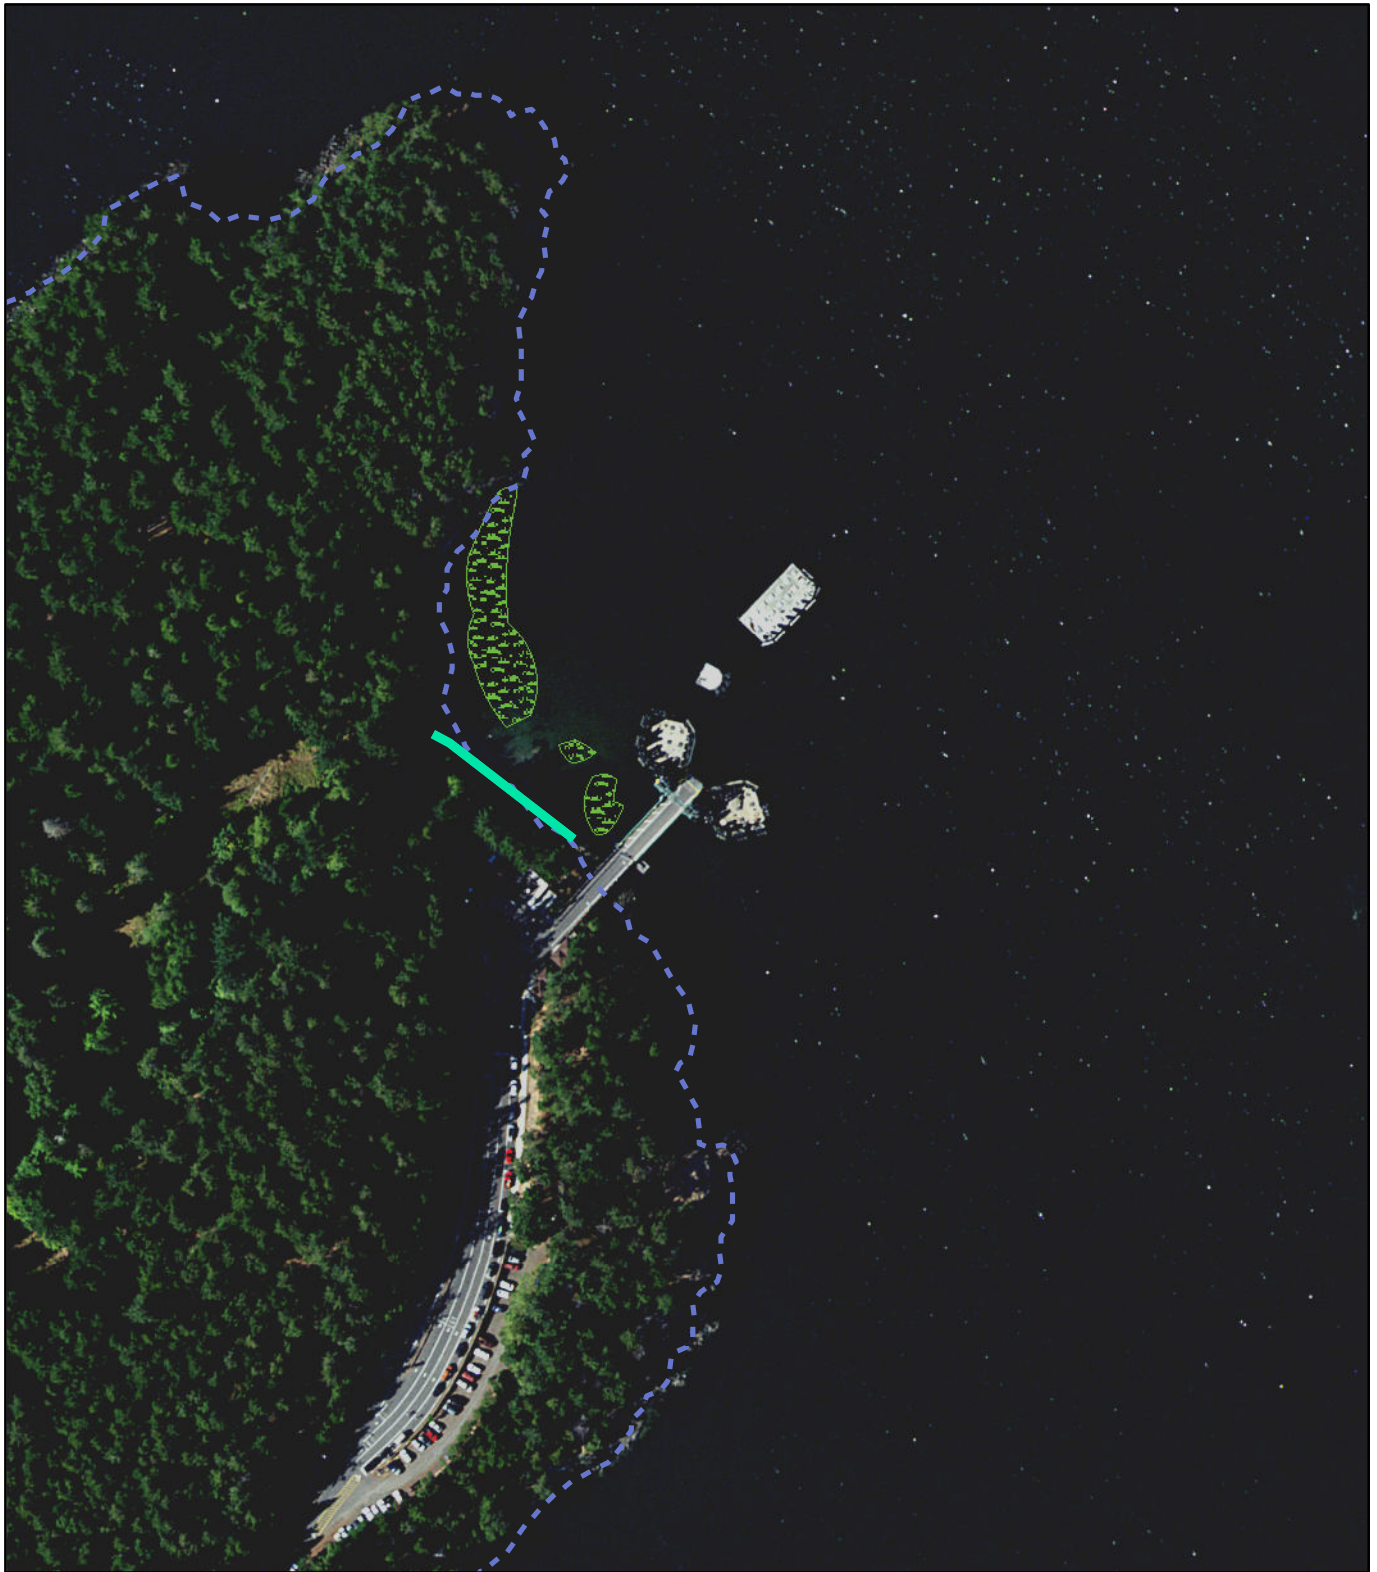
Figure LO-2
Aerial Photo of Lopez Ferry Terminal
WSF Biological Assessment Reference
Lopez Island, Washington

- Smelt Spawning
- ▨ Eel Grass
- Approximate Mean High Water (MHW)

Documented surf smelt spawning is present (see Figure LO-2), extending approximately 110 feet to the northwest (WSDOT 2018a). A large herring holding area exists about 0.25 mile northeast of the ferry terminal in open water.

The Lopez Island Ferry Terminal is located near the northern tip of Lopez Island, at the confluence of Upright and Harney Channels (see Figures LO-1 and LO-2).

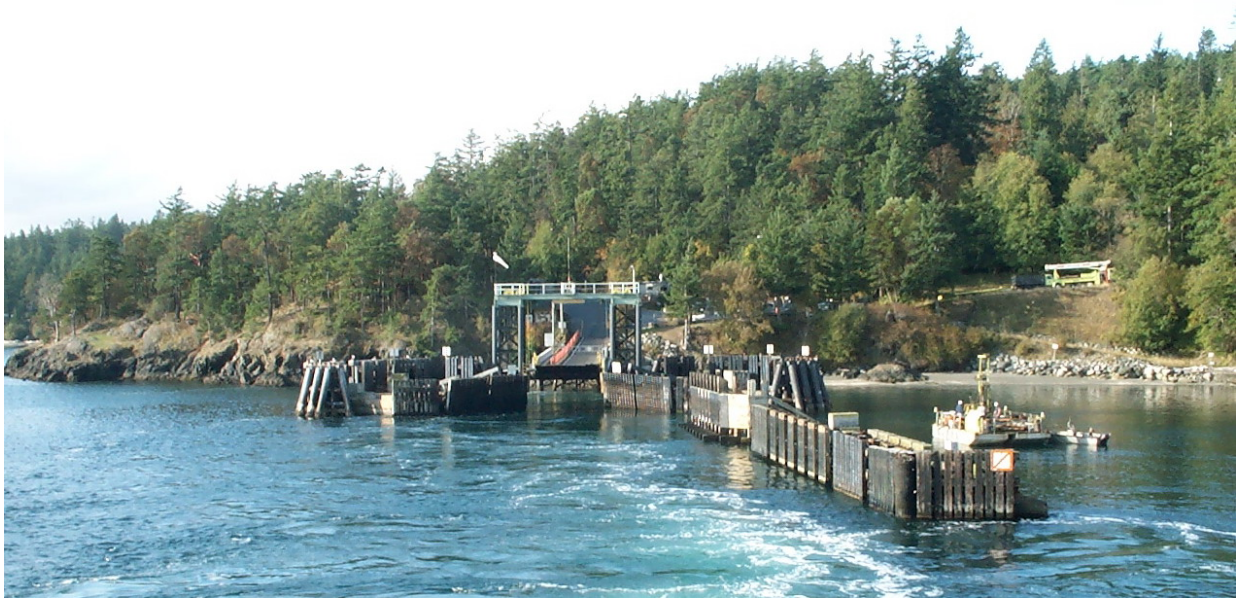
Figure LO-3
Shoreline Area at the Lopez Island Ferry Terminal

The substrate layer is thin and overlays a foundation of bedrock. Substrate consists of fine to coarse sand close to shore, giving way to mud overlying bare bedrock and boulders within the ferry slip. The bottom drops off quickly to deep water, with depths up to 90 feet at the outer dolphins. Offshore depths (feet MLLW) of terminal structures are: head of slip (-35.5). Maximum depth (feet MLLW) for fixed dolphins is -46.5 and for the floating dolphin -77.0. See Figure LO-3 for a picture of the shoreline area at the ferry terminal.

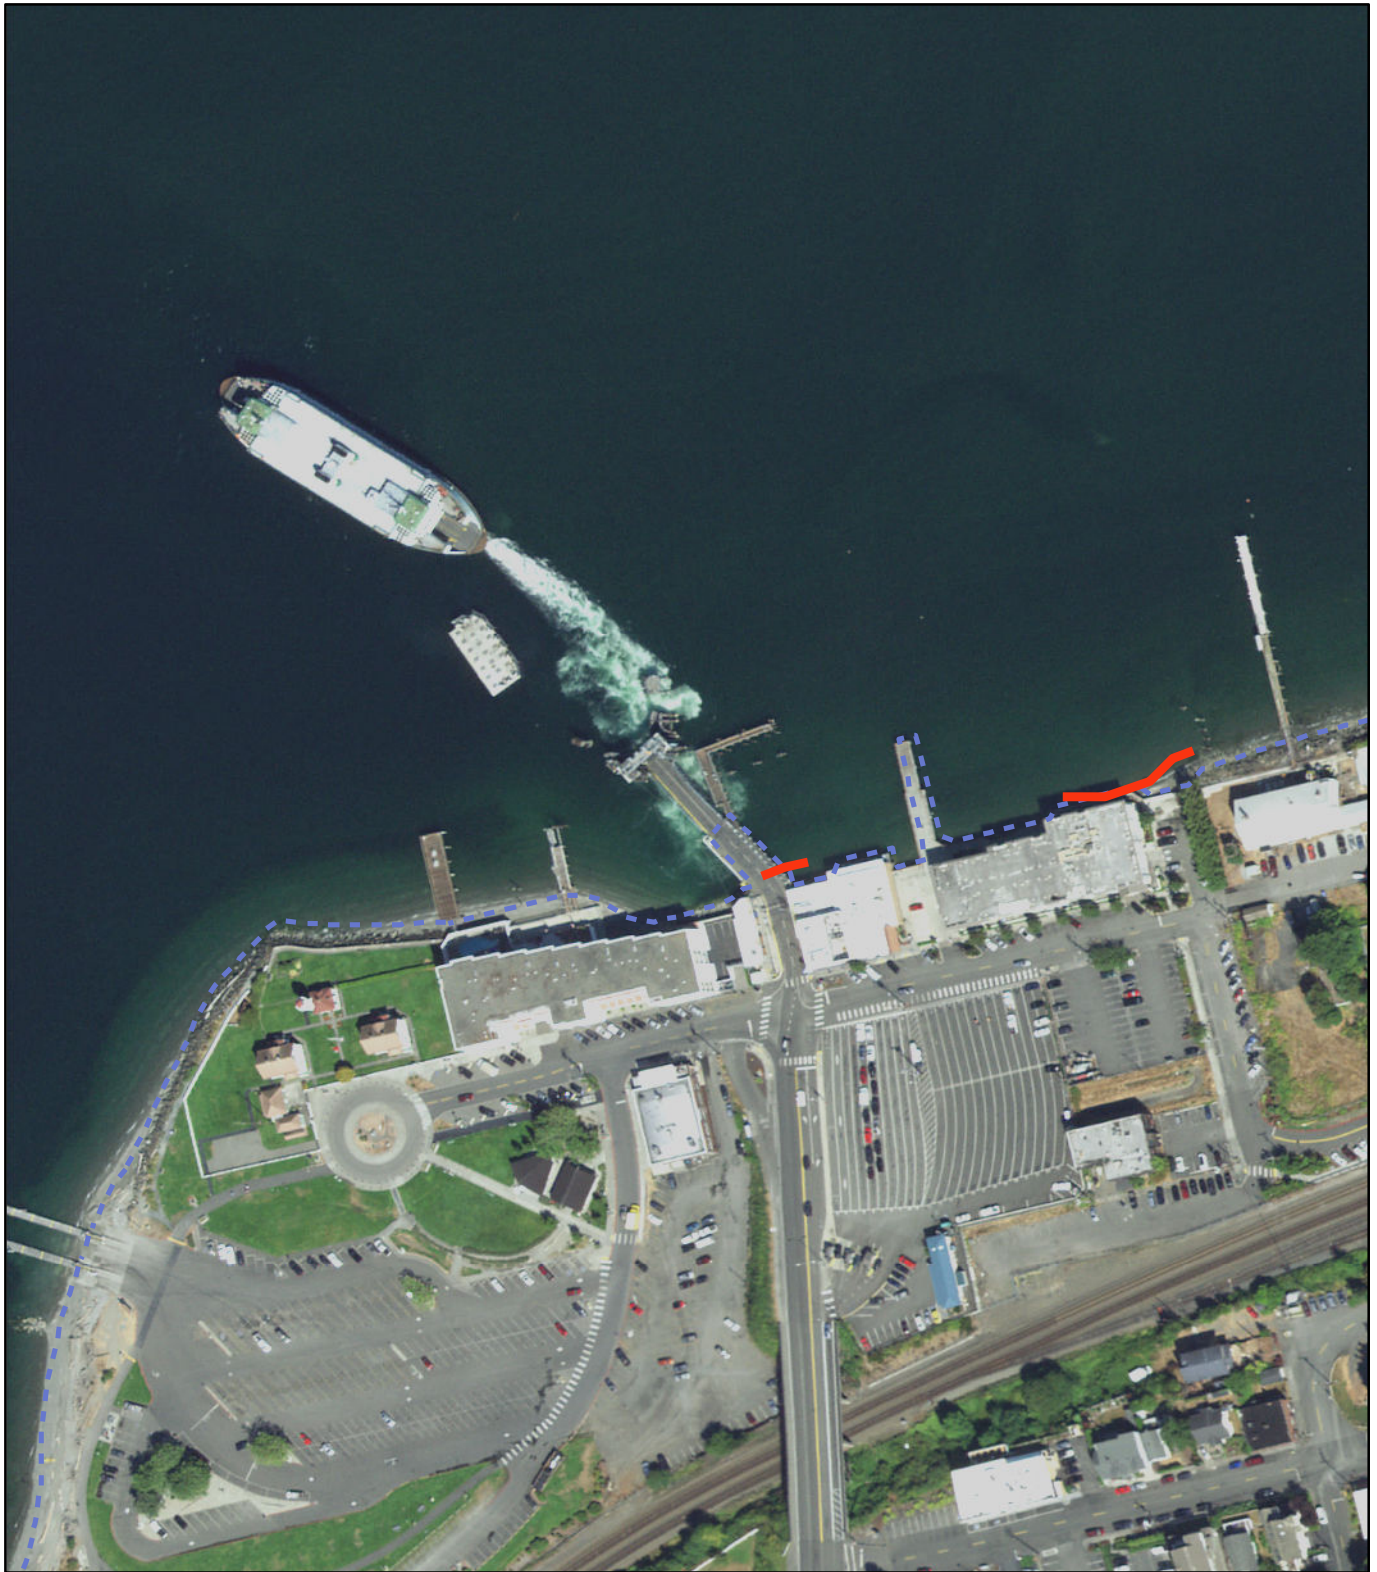
Mukilteo Ferry Terminal: WSF Biological Assessment Reference

- SandLance
- - - Approximate Mean High Water (MHW)

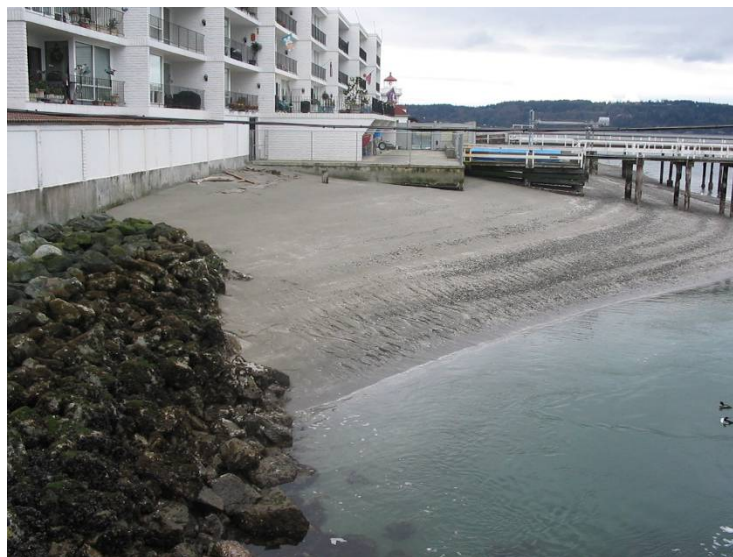
Figure MU-3
Shoreline Area to the West of the Mukilteo Ferry Terminal

Substrates generally consist of coarse grained sand to cobble. Riprap occurs in the high intertidal area. The beach is gently sloped. See Figures MU-3 and MU-4 for pictures of the shoreline areas west and east of the ferry terminal. Offshore depths of terminal structures are: head of slip (-32.3 feet MLLW). Maximum depth for fixed dolphins is -46.8 feet MLLW and the floating dolphin is -91.7 feet MLLW.

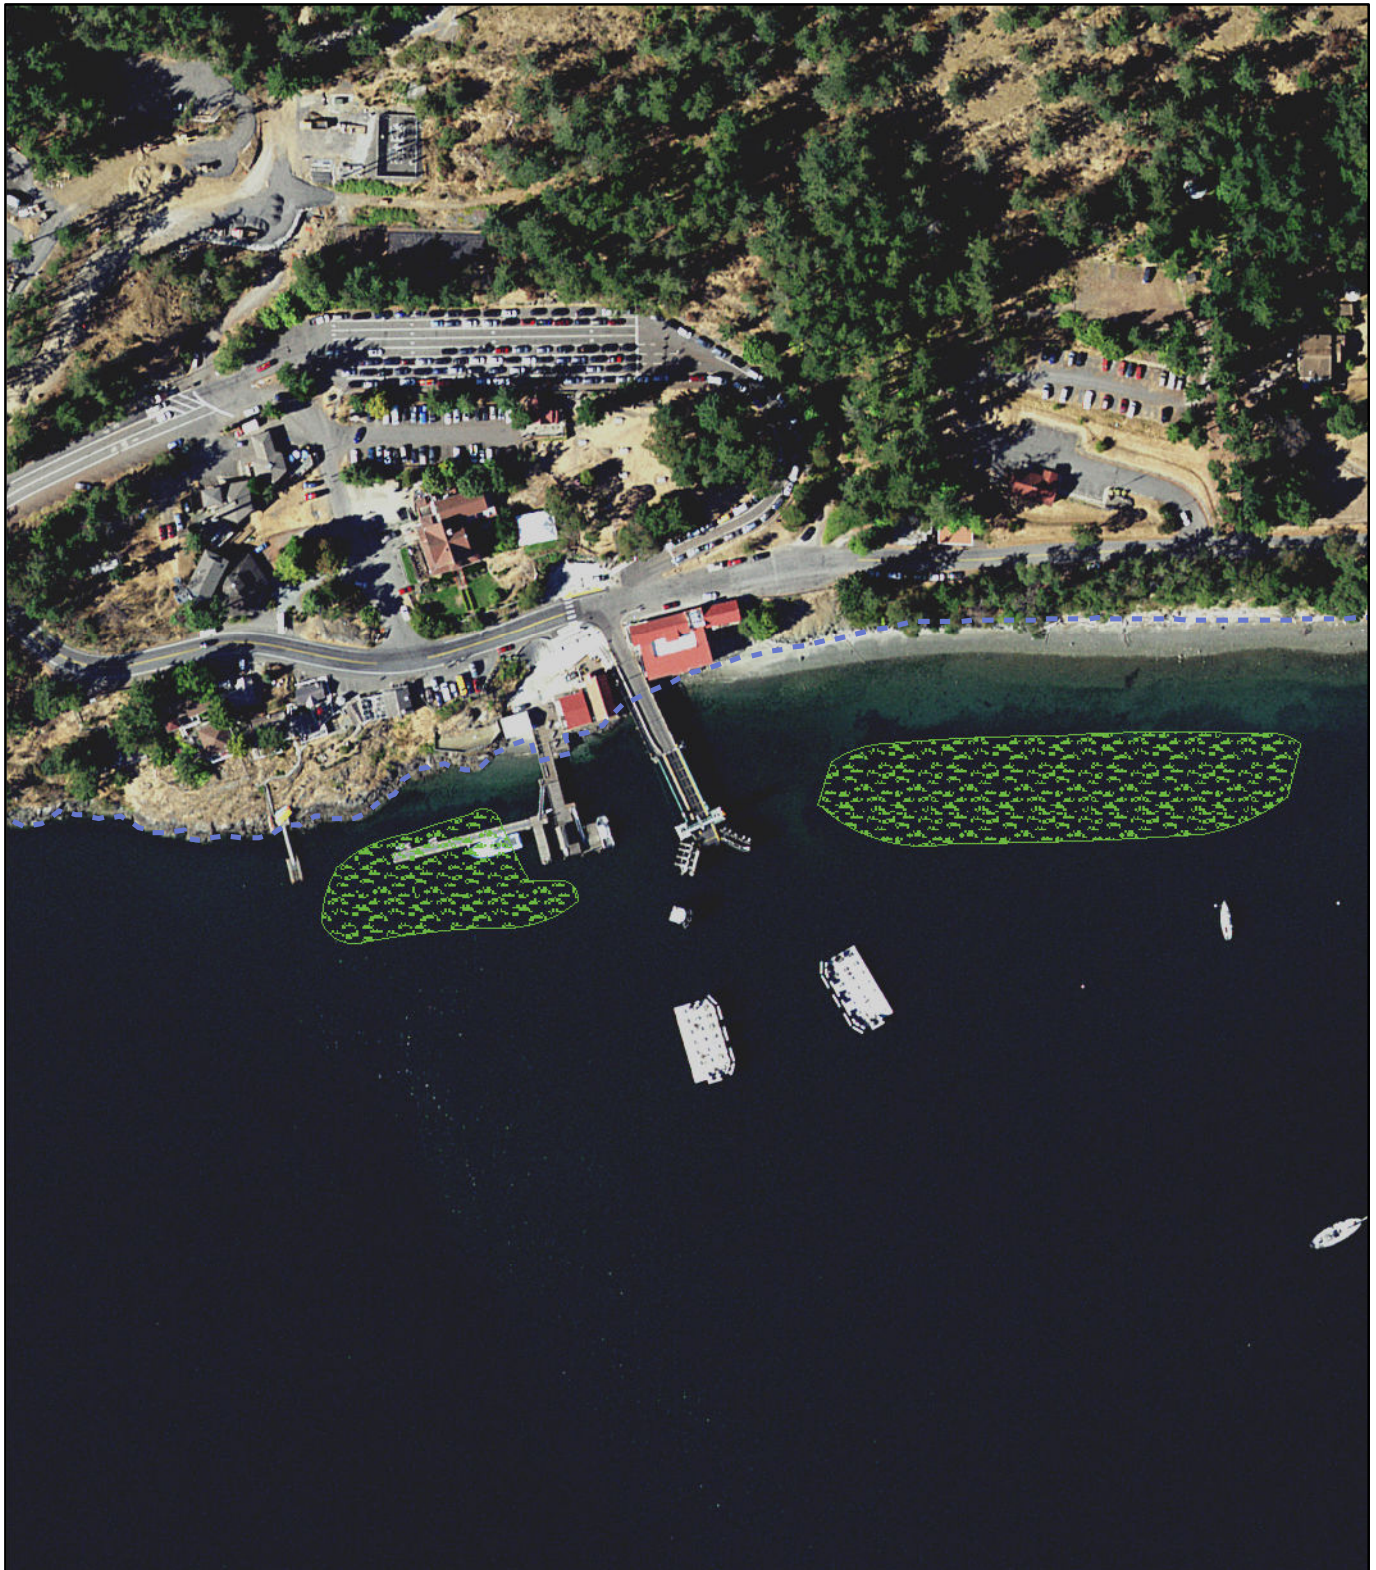
Orcas Island Ferry Terminal: WSF Biological Assessment Reference

— — — — — Approximate Mean High Water (MHW)

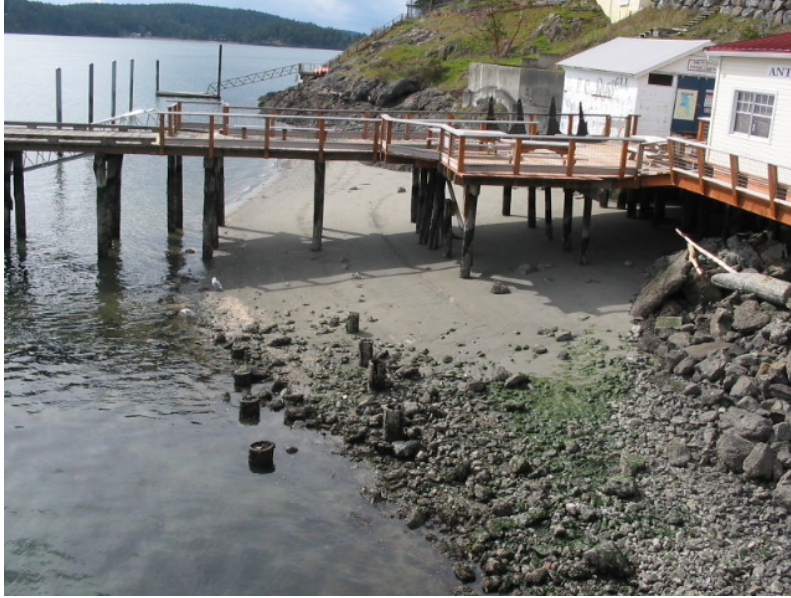
Figure OR-3
Shoreline Area to the West of the Orcas Ferry Terminal

Substrates are composed primarily of sand with gravel and shell. Beach slopes appear to be gradual. See Figures OR-3 and OR-4 for pictures of the shoreline areas west and east of the ferry terminal. Offshore depths of terminal structures are: head of slip (-30.5 feet MLLW). Maximum depth for the floating dolphins is -46.5 feet MLLW.

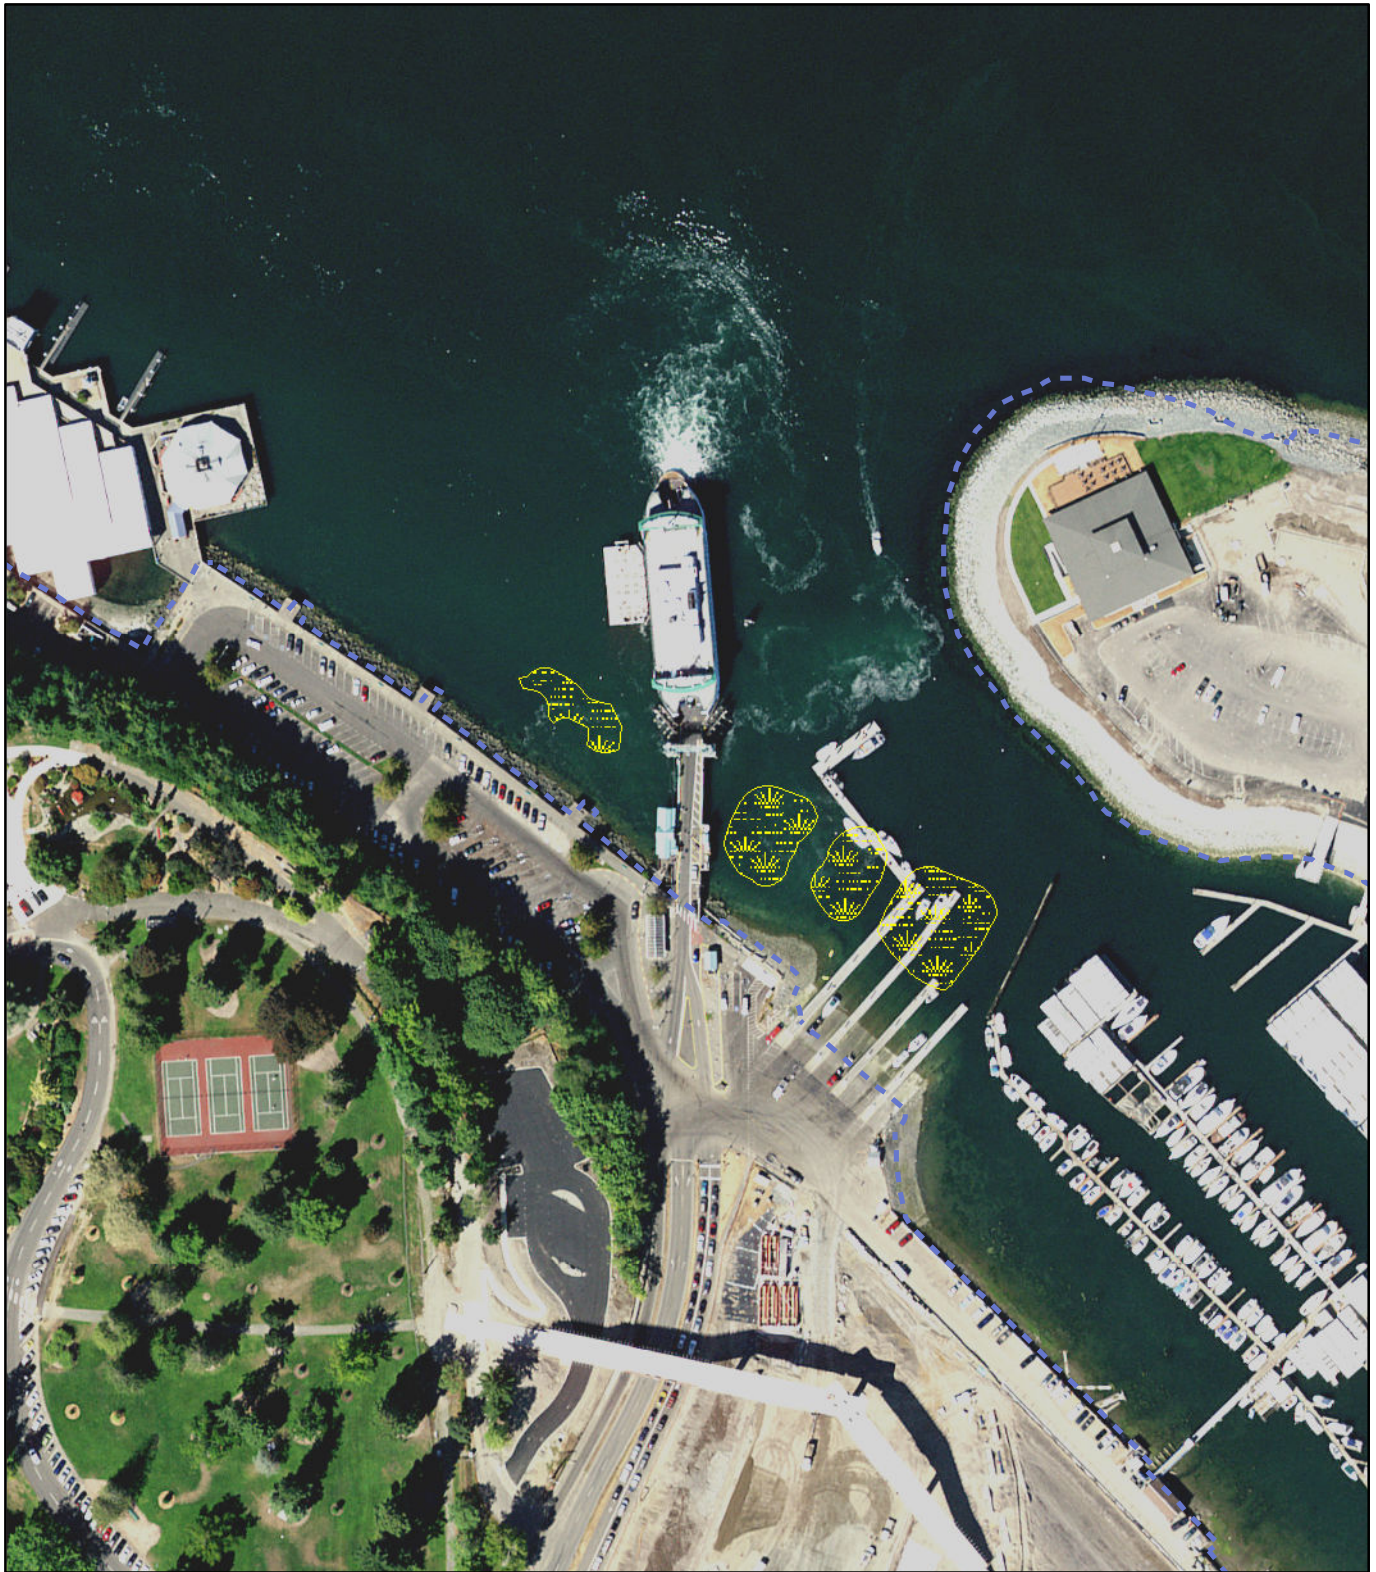
Point Defiance Ferry Terminal: WSF Biological Assessment Reference

- - - Approximate Mean High Water (MHW)
 - - - Macroalgae

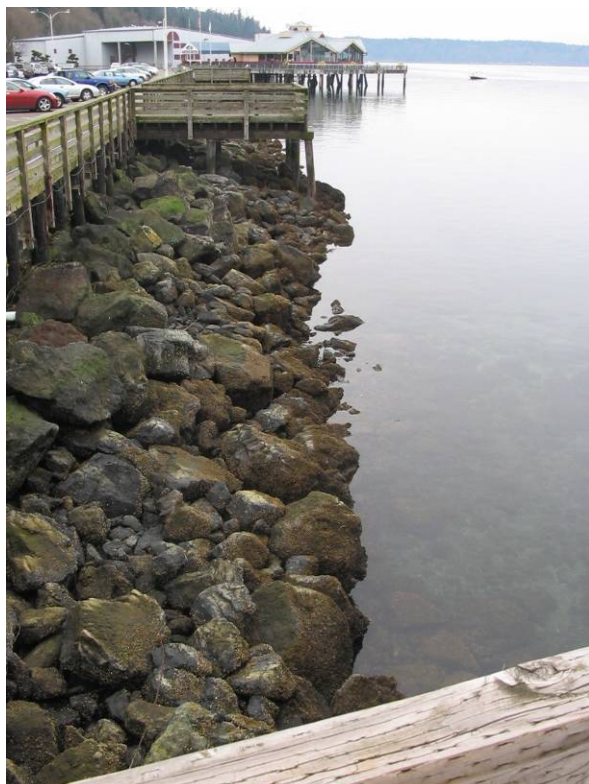
Figure PD-3
Shoreline South of the Point Defiance Ferry Terminal

The substrate is composed of medium dense silty fines to sand and gravel with riprap and bulkheads in the high intertidal. Based on aerial photographs, it appears that the aquatic bed slopes off steeply a short distance from the riprap bulkhead. Offshore depths of terminal structures are: head of slip (-18.5 feet MLLW). Maximum depth for fixed dolphin is -32.7 feet MLLW and for the floating dolphin -30.2 feet MLLW. See Figures PD-3 and PD-4 for pictures of the shoreline areas south and north of the ferry terminal.

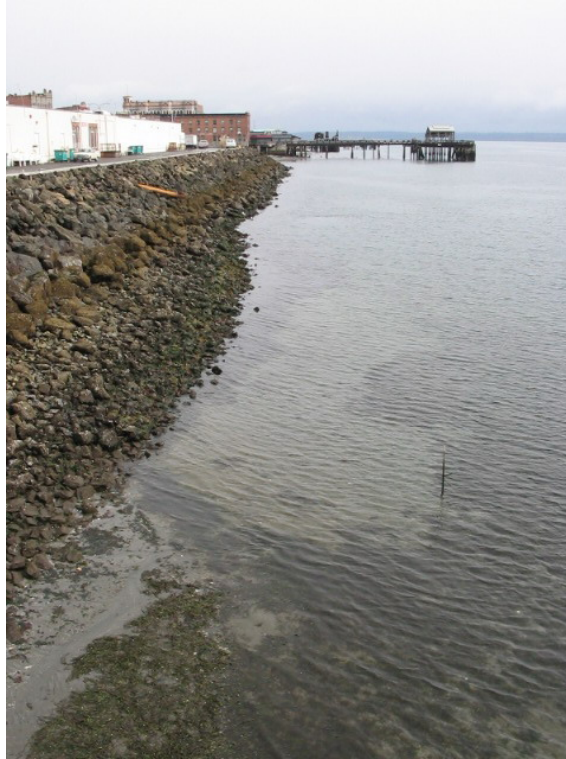
Figure PT-3
Shoreline Area North of the Port Townsend
Ferry Terminal

adjacent to the ferry terminal have been cut off from shoreline erosional processes due to fill and seawalls associated with the construction of SR 20 and other shoreline development. See Figures PT-3 and PT-4 for pictures of the shoreline areas north and south of the ferry terminal.

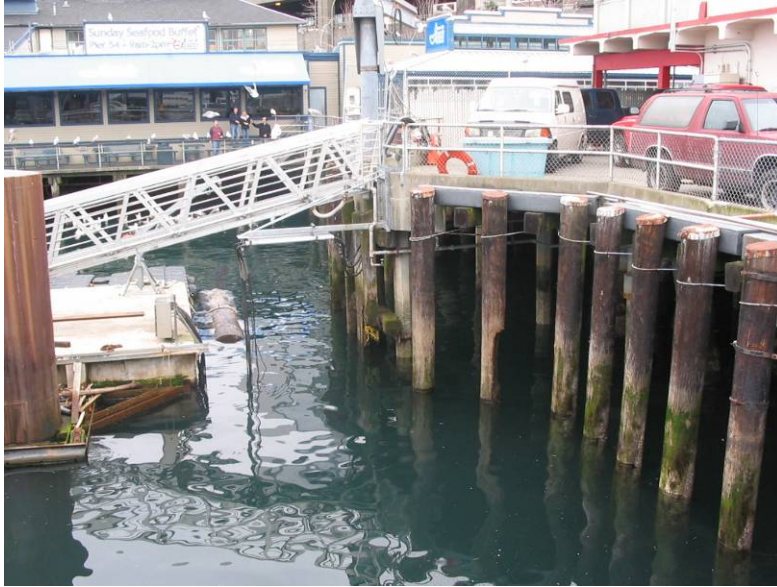
Figure SE-3
Shoreline Area North of the Seattle Ferry Terminal

Much of the shoreline along the Seattle waterfront contains riprap and seawalls. Common shoreline features within the area include constructed bulkheads, with manmade structures such as piers, wharves, and buildings extending over the water, and steeply sloped banks armored with riprap or other fill materials (e.g., concrete slabs and miscellaneous debris). See Figures SE-3 and SE-4 for pictures of the shoreline areas north and south of the ferry terminal. There are very few intertidal habitats within the area (e.g., near Pier 48 south of the Seattle Ferry Terminal, and these are less than 0.5 acre in size).

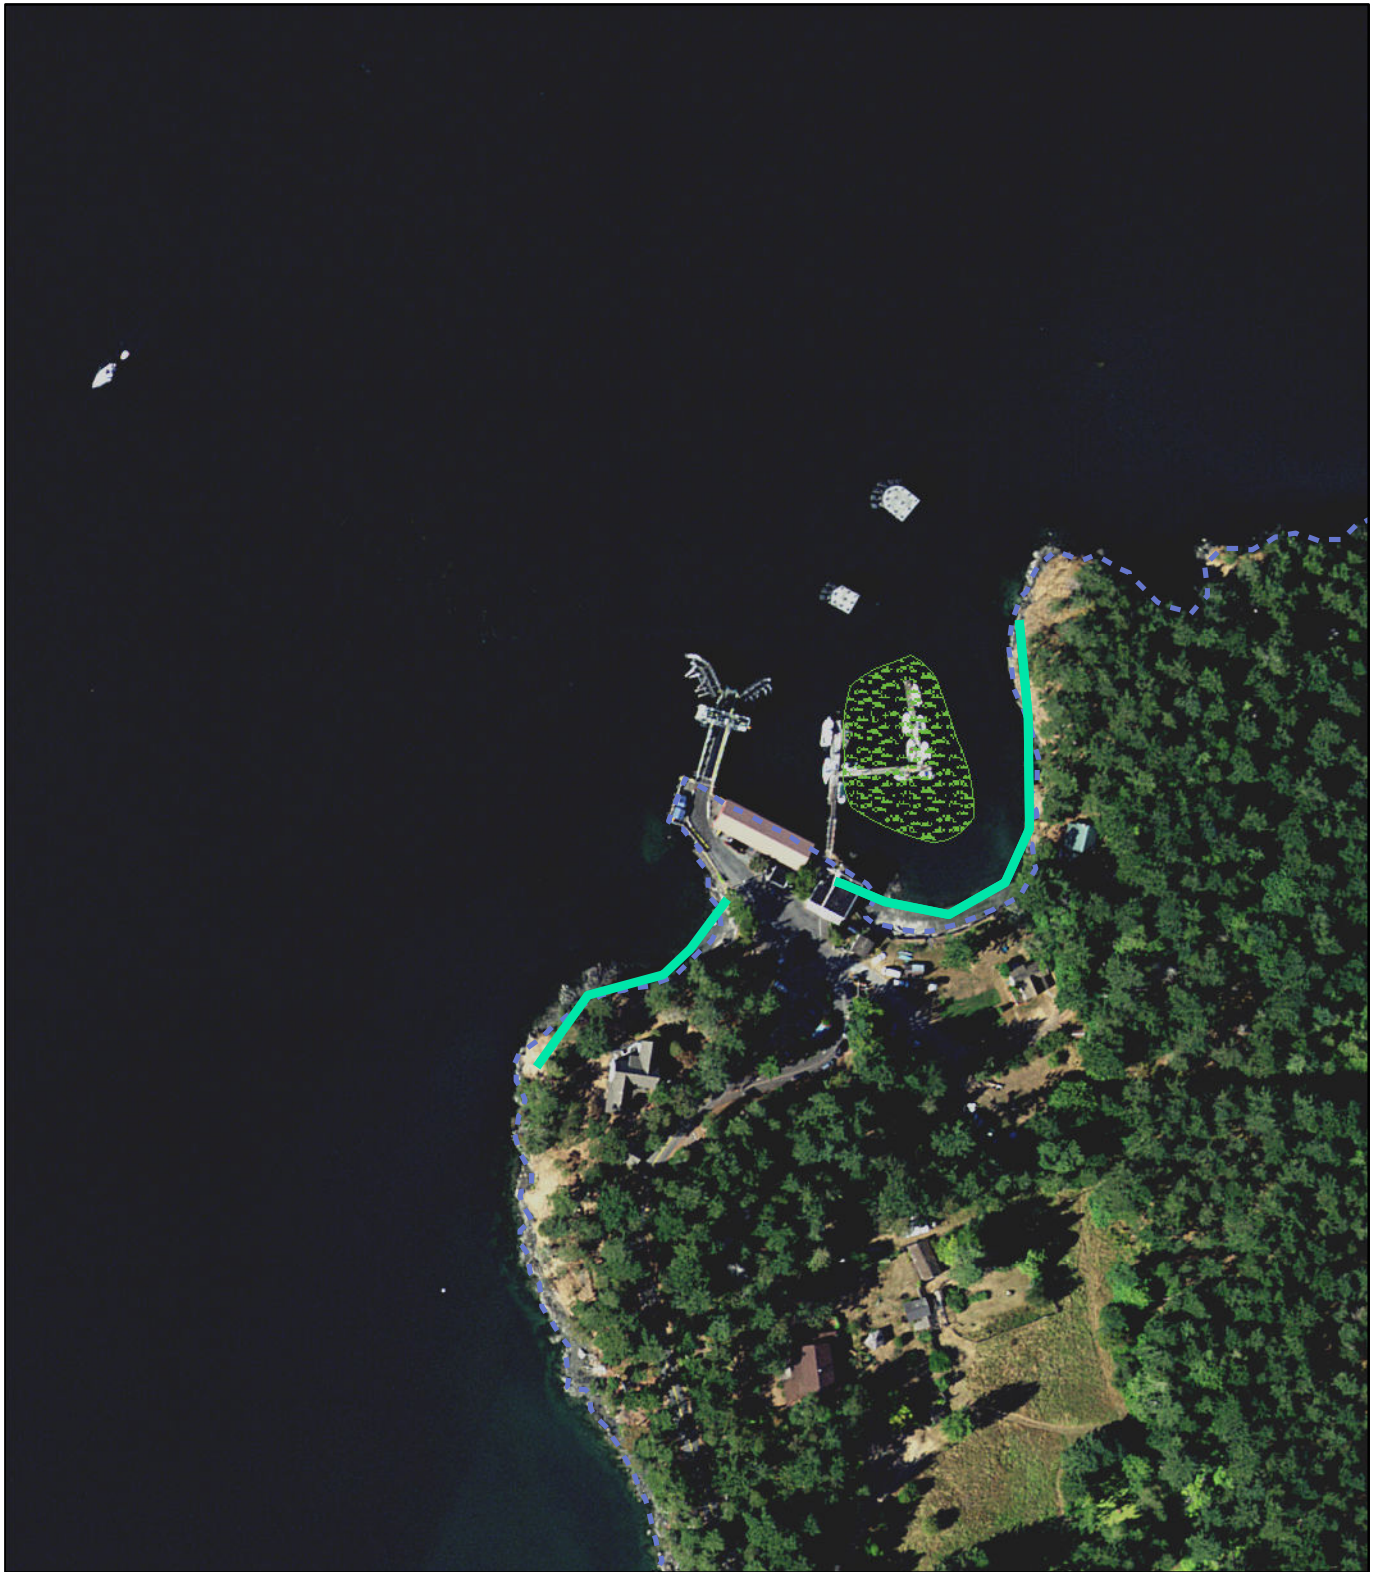
Shaw Island Ferry Terminal: WSF Biological Assessment Reference

- Smelt Spawning
- - - Approximate Mean High Water (MHW)
- Eel Grass

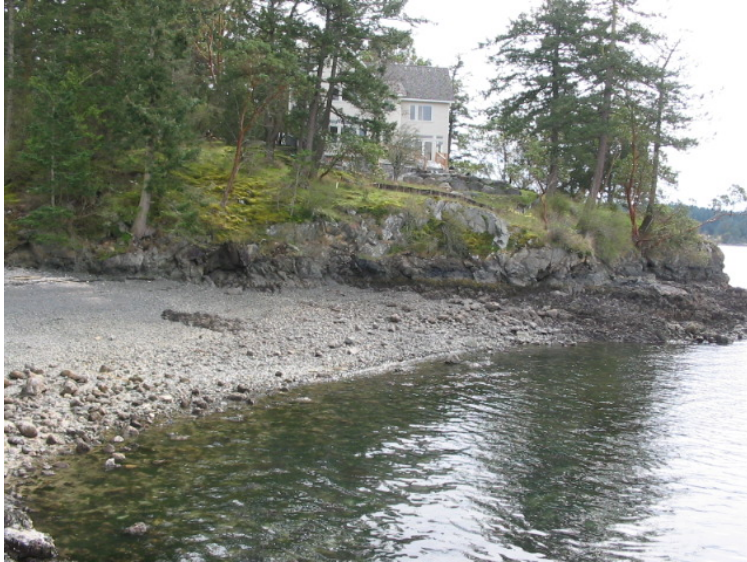
Figure SH-3
Shoreline Area West of the Shaw Ferry Terminal

With the exception of the Shaw Island Ferry Terminal, general store, chapel, music studio, and a private marina, the shoreline in the area is generally undeveloped. A small, gently sloping sandy beach exists to the southeast of the terminal, and another to the southwest. However, much of the shoreline area is steep and rocky (see Figures SH-3 and SH-4).

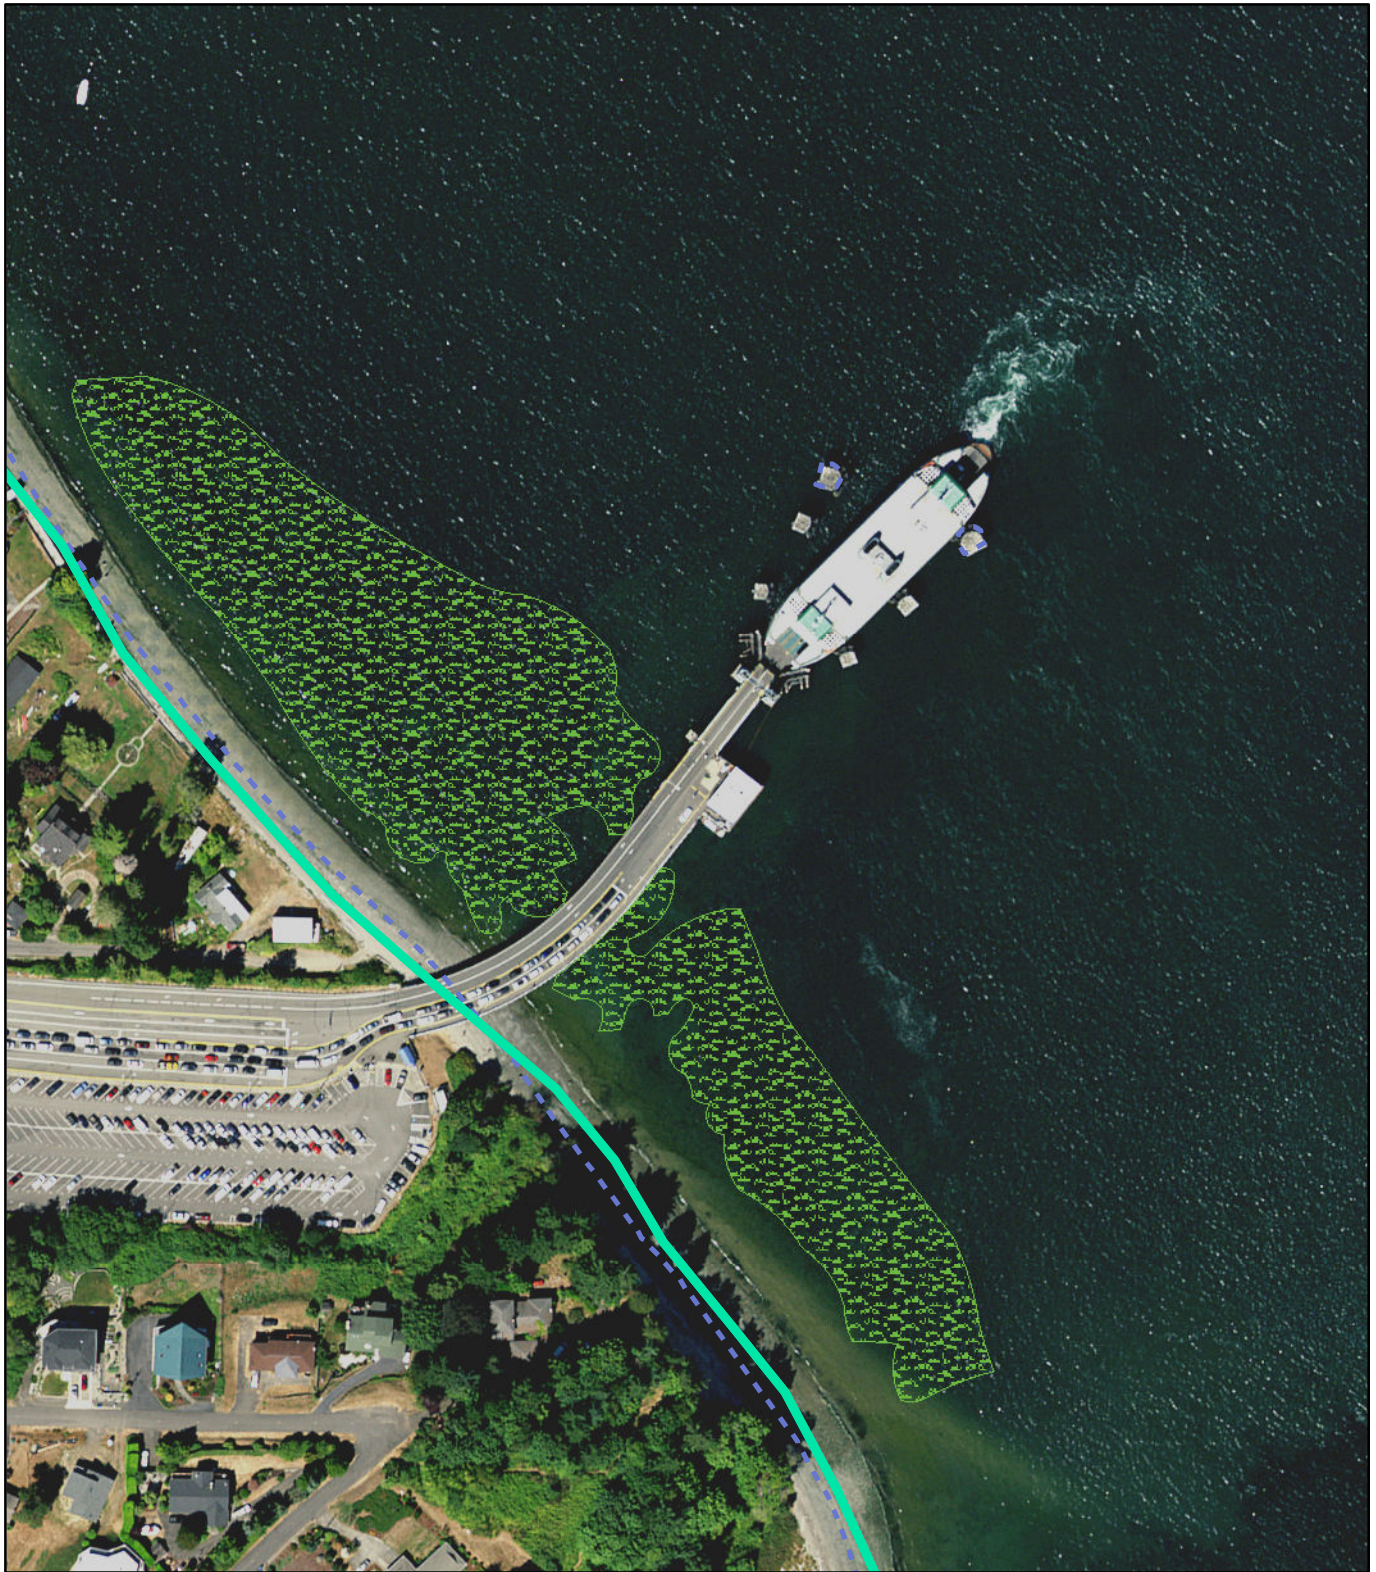
Southworth Ferry Terminal: WSF Biological Assessment Reference

- Smelt Spawning
- - - Approximate Mean High Water (MHW)
- ▨ Eel Grass

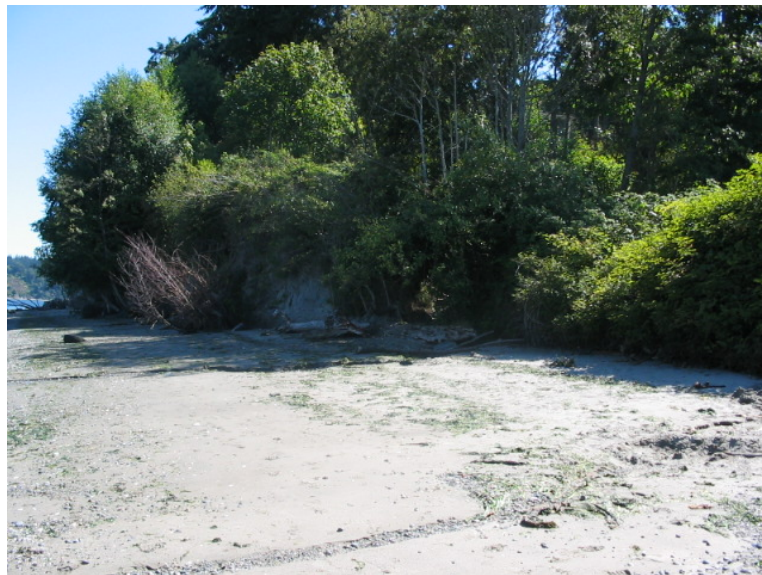
Figure SO-4
Beach and Bluff South of the Southworth Ferry Terminal

On the south side of the ferry terminal, there is a very steep bluff composed of clay and sands where sloughing is common (Figure SO-4). Erosion from the bluff ranges between 2 and 5 feet per year and is a significant source of sediments to the beach.

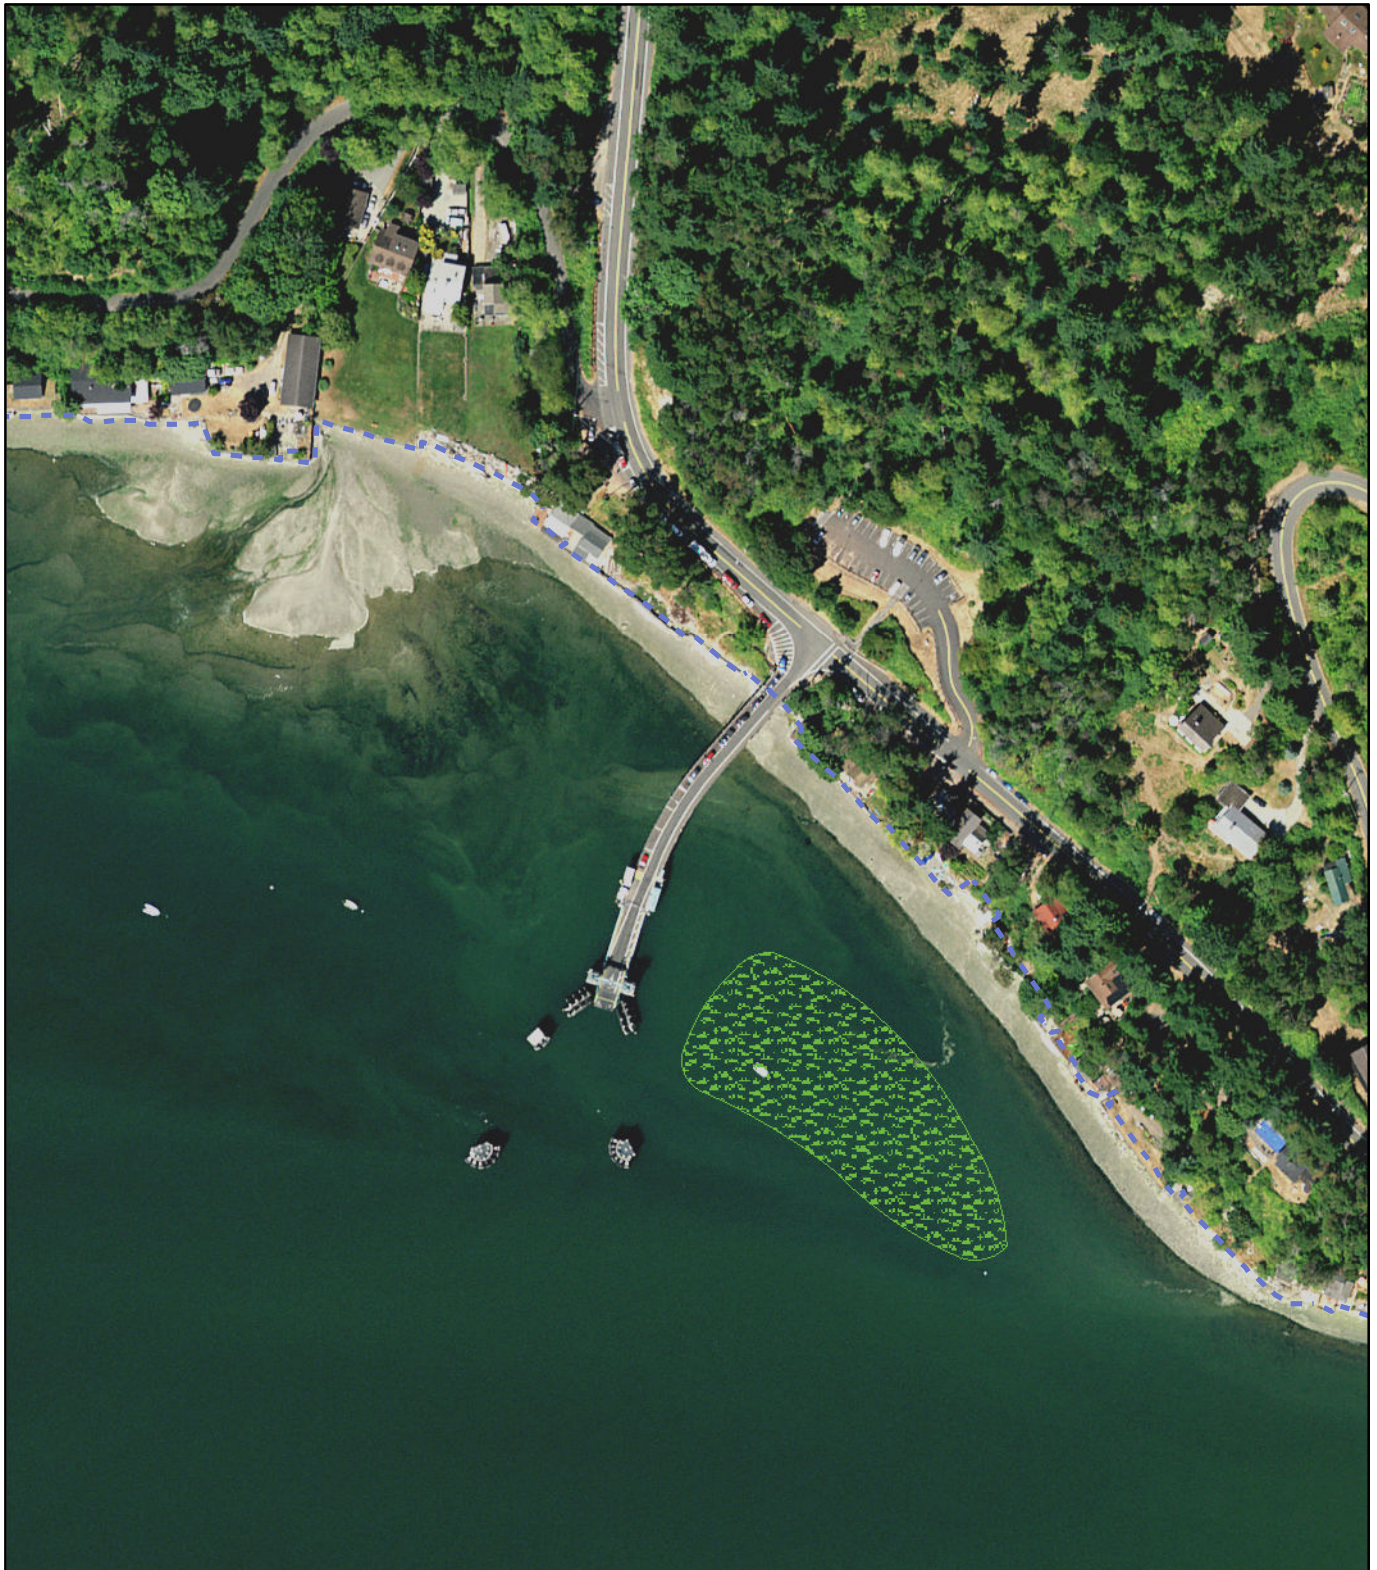
Tahlequah Ferry Terminal: WSF Biological Assessment Reference

----- Approximate Mean High Water (MHW)
 Eel Grass

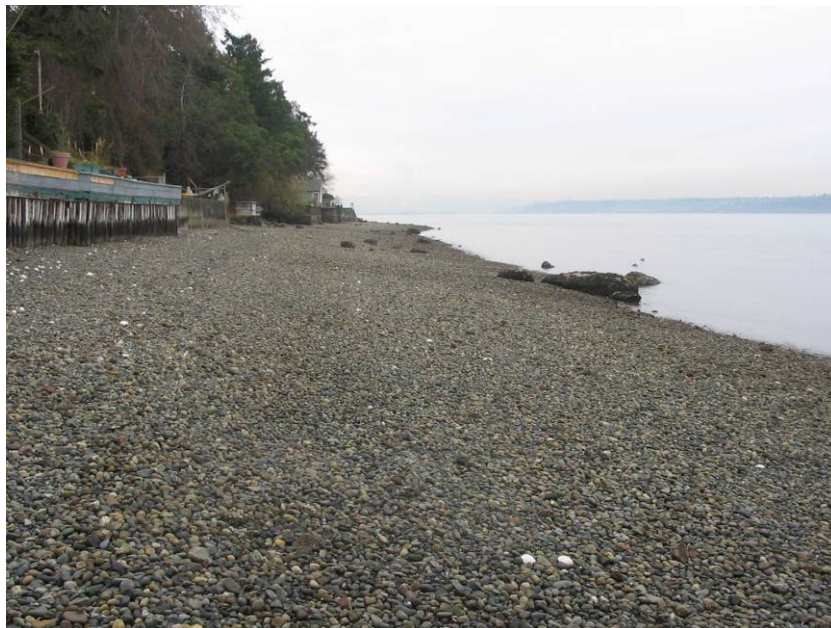
Figure TA-3
Shoreline East of the Tahlequah Ferry Terminal

Beach substrate between MHHW and +2 feet MLLW is primarily gravel. A sand-gravel mix exists between +2 feet MLLW and MLLW, and from MLLW to -4 feet MLLW, the substrate is predominantly sand with some shell hash. On either side of the ferry terminal, there is extensive hardening of the shoreline to protect single-family homes. See Figures TA-3 and TA-4 for pictures of the shoreline areas east and west of the ferry terminal.

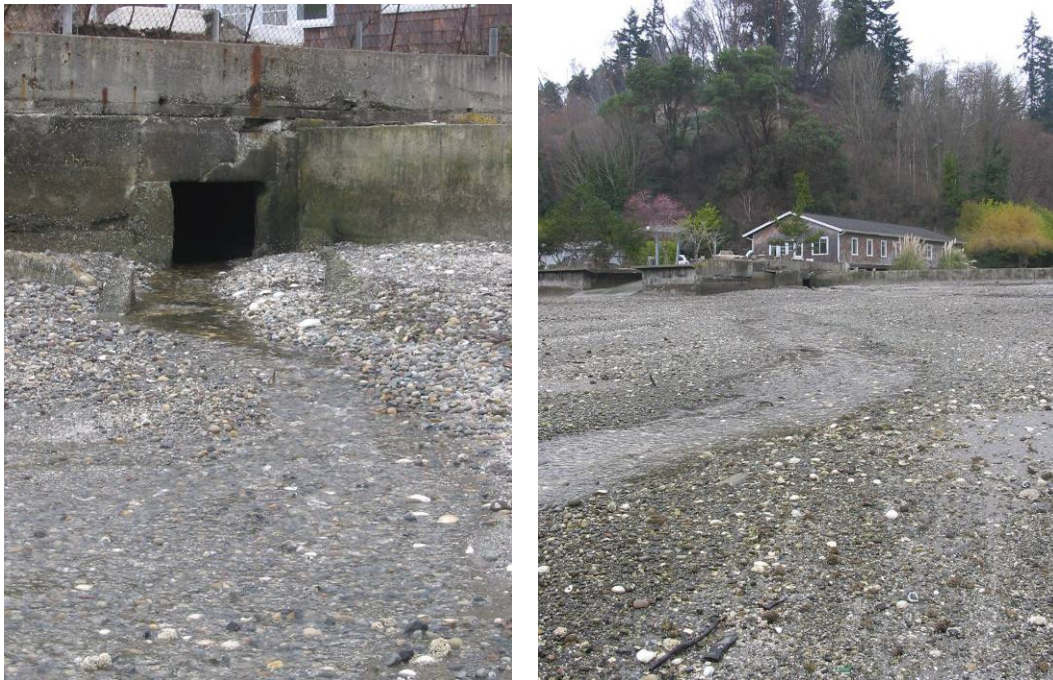
Figure TA-5
Concrete Culvert Carrying Talequah Creek and the Creek as it Flows onto the Beach

Tahlequah Creek and stormwater runoff from the surrounding area are the most significant sources of freshwater into the ferry terminal area. Tahlequah Creek enters Puget Sound about 500 feet west of the ferry terminal (see Figure TA-2). Approximately the last 300 feet of the creek is directed through private property via a concrete culvert (see Figure TA-5).
