Lopez Island Ferry Terminal: WSF Biological Assessment Reference

4.11 Lopez Island Ferry Terminal

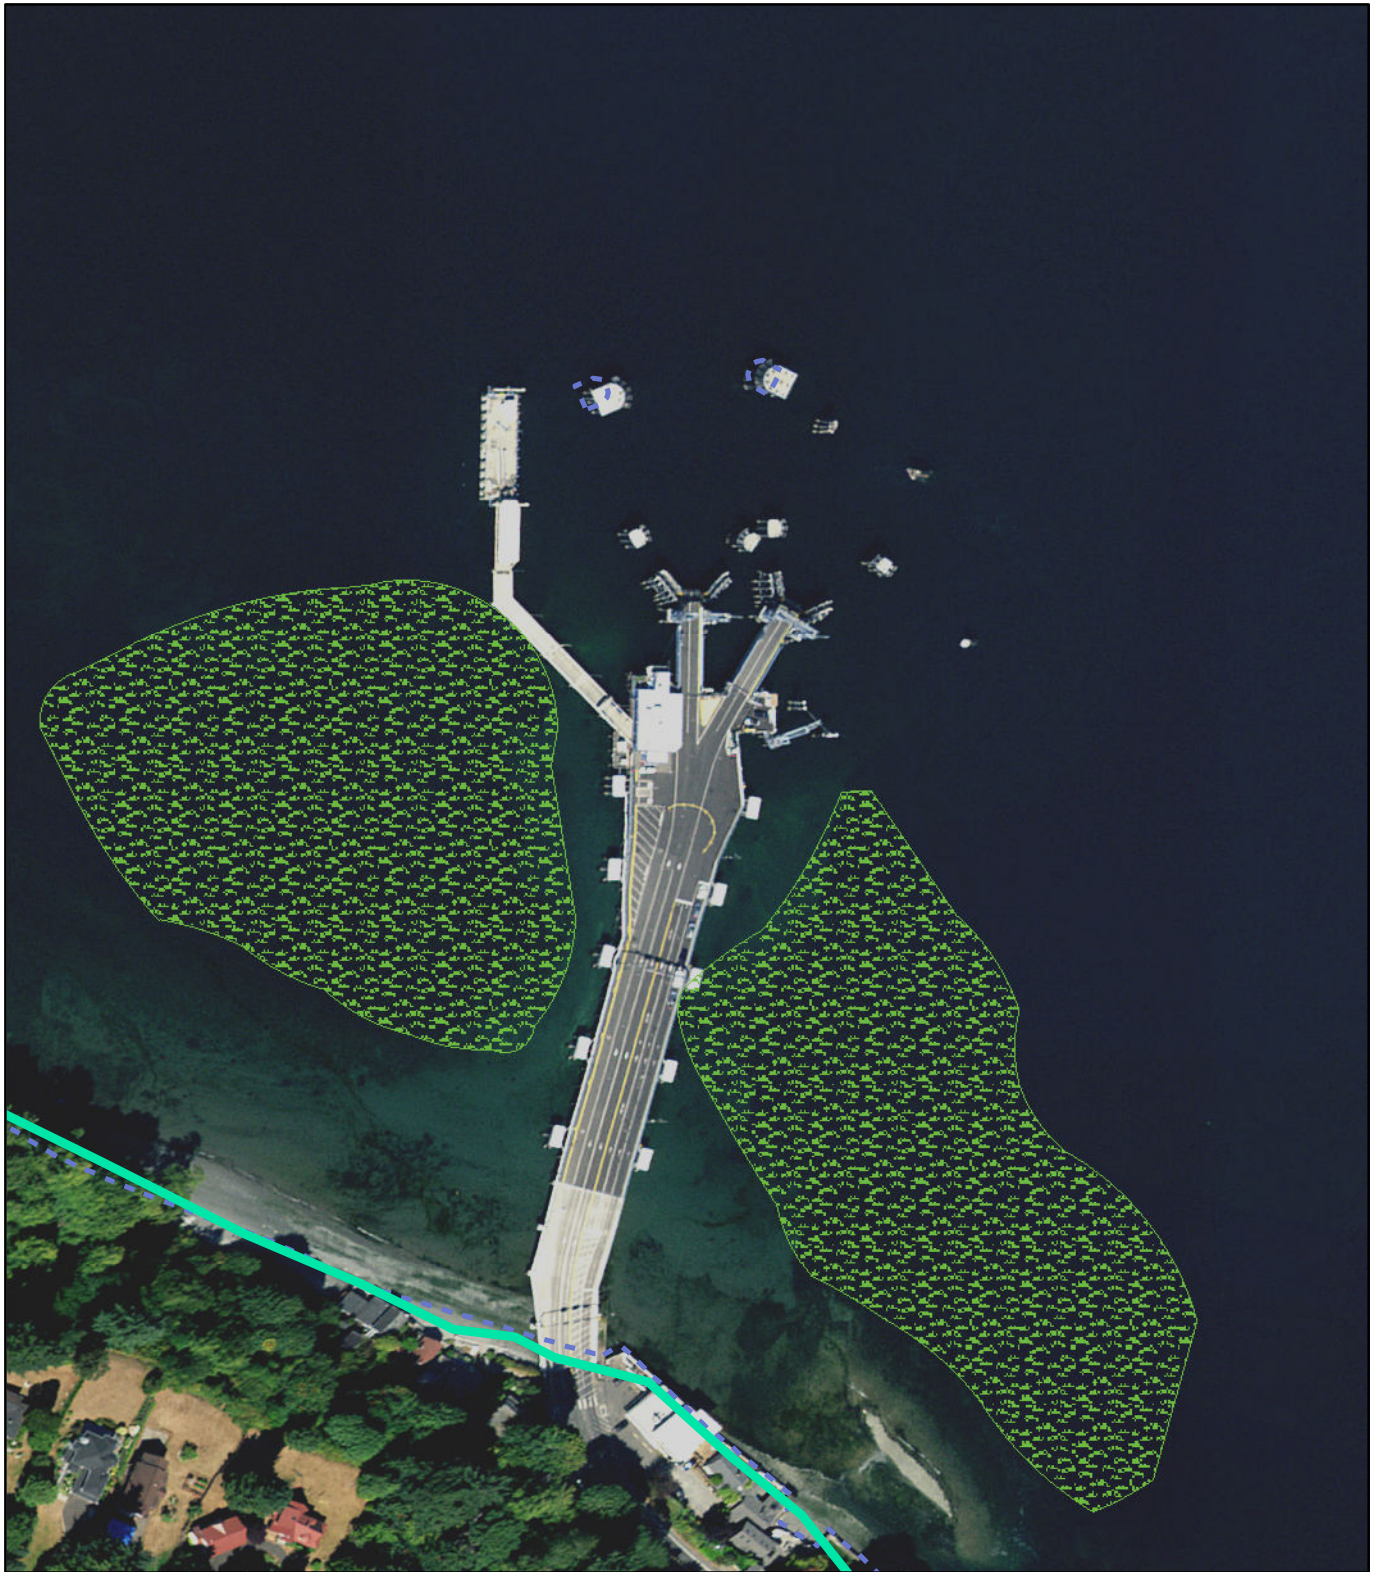
Vashon Island Ferry Terminal: WSF Biological Assessment Reference

- Smelt Spawning
- - - Approximate Mean High Water (MHW)
- Eel Grass
