*SR 24, I-82 TO KEYS ROAD PROJECT*

**UNDERWATER SOUND LEVELS  
ASSOCIATED WITH PILE DRIVING ON  
THE SR 24, I-82 TO KEYS ROAD  
PROJECT – YAKIMA RIVER**

*Prepared by:  
Jim Laughlin  
Washington State Department of Transportation  
Office of Air Quality and Noise  
15700 Dayton Avenue North, P.O. Box 330310  
Seattle, WA 98133-9710*

**July 2005**

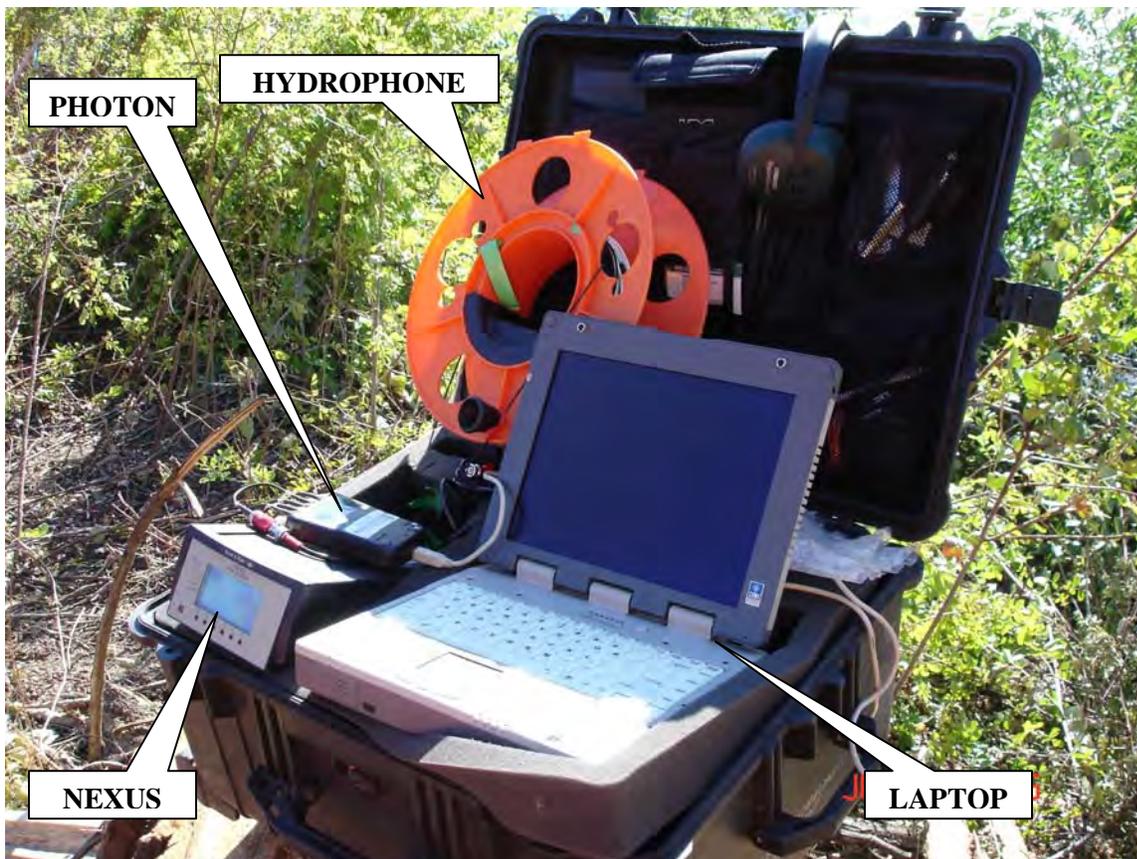
**Figure 4: Underwater Sound Level Measurement Equipment**

Underwater sound levels were measured using one Reson TC 4013 hydrophone. One hydrophone was positioned approximately at mid-water level. The hydrophone was located at a distance of 33 feet from the pile and downstream of the pile being monitored. The measurement system includes a Brüel and Kjær Nexus type 2692 4-channel signal conditioner, which kept the high underwater sound levels within the dynamic range of the signal analyzer (Figure 4). The output of the Nexus signal conditioner is received by a Dactron Photon 4-channel signal spectrum analyzer that is attached to an Itronix GoBook II laptop computer. The waveform of the pile strikes along with the number of strikes, overpressure minimum and maximum, absolute peak values, and RMS sound levels, integrated over 90% of the duration of the pulse, were captured and stored on the laptop hard drive for subsequent signal analysis. The system and software calibration is checked annually against a NIST traceable standard. The operation of the hydrophone was checked in the field using a GRAS type 42AC high-level pistonphone with a hydrophone adaptor. The pistonphone signal was 146 dB re: 1  $\mu$ Pa. The pistonphone signal levels produced by the pistonphone and measured by the measurement system were within 1 dB and the operation of the system was judged to be acceptable over the study period. A photograph of the system and its components are shown in Figure 4.

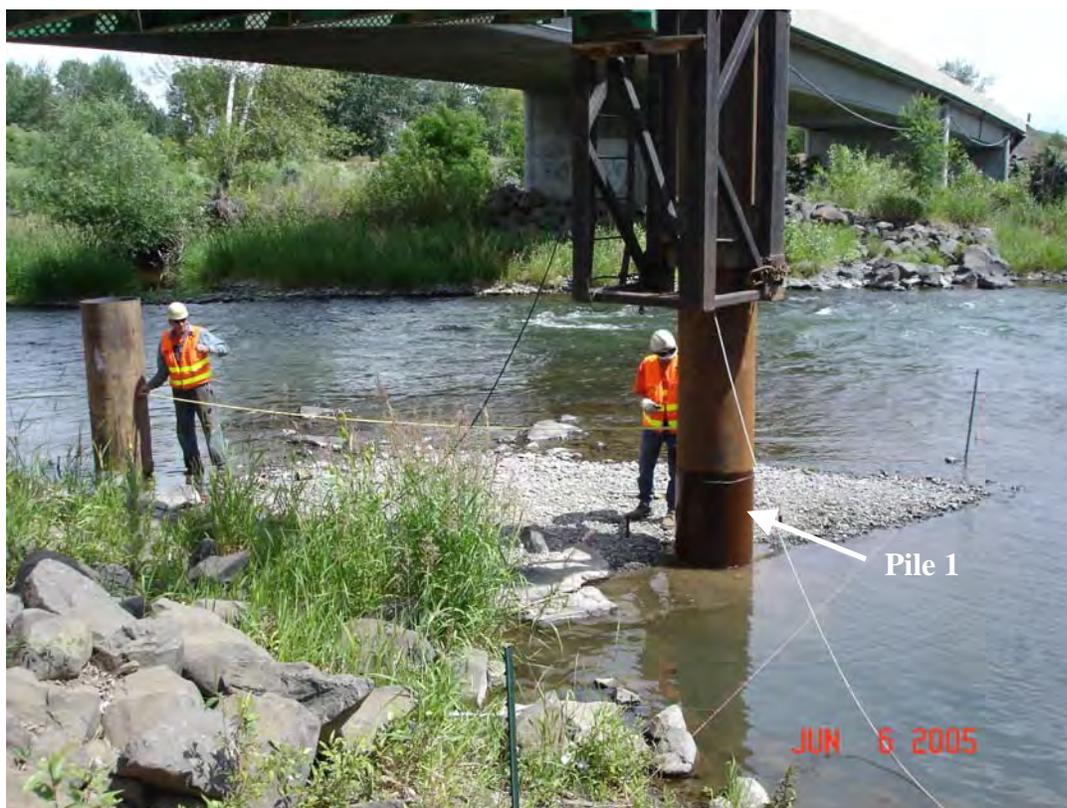
**Figure 6: Location of Pile 1 at waters edge.**

The first in-water 24-inch steel pile was monitored for underwater sound levels. The pile was driven with a diesel hammer in a water depth of six inches (Figure 6). The pile was only driven to a depth of 2.5 feet, but proper blow count of 17 blows per inch was achieved at that depth. The confined bubble curtain was not used on this pile, in part, because it was necessary to determine if sound levels exceeded the thresholds of 180 dB<sub>peak</sub> or 150 dB<sub>RMS</sub>, and because the water depth was not sufficient to submerge the bubble ring and thus it could provide no mitigation.

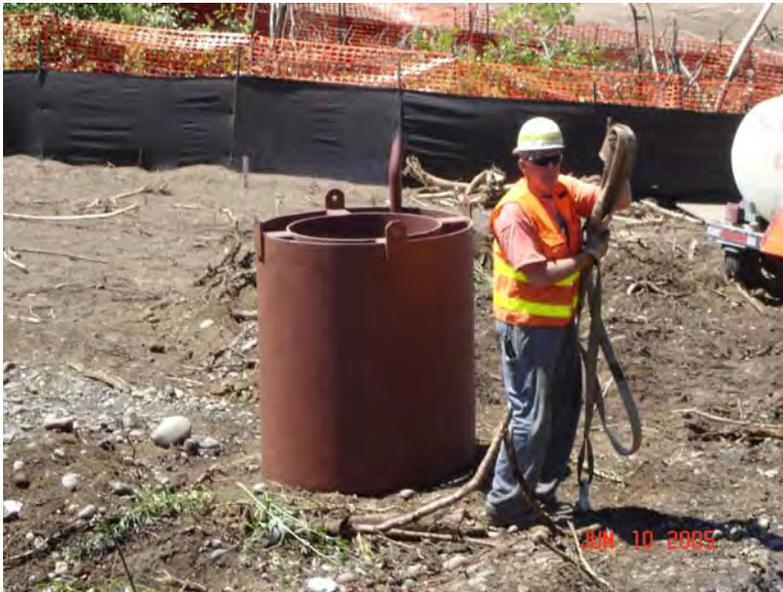
**Figure 7: Confined bubble curtain for use in shallow waters with swift currents.**

The first of two piles driven at a depth of one foot was Pile 2, driven with a diesel hammer. The confined bubble curtain (Figure 7) was deployed for this pile but the bubbles were not turned on because the contractor wanted to see if they could drive the pile and stay under the thresholds set by NMFS. The contractor would start the impact hammer, and as the blows approached and eventually exceeded set thresholds, the contractor was instructed to temporarily cease pile-driving operations. This start-stop process continued until the pile was almost completely driven to depth.

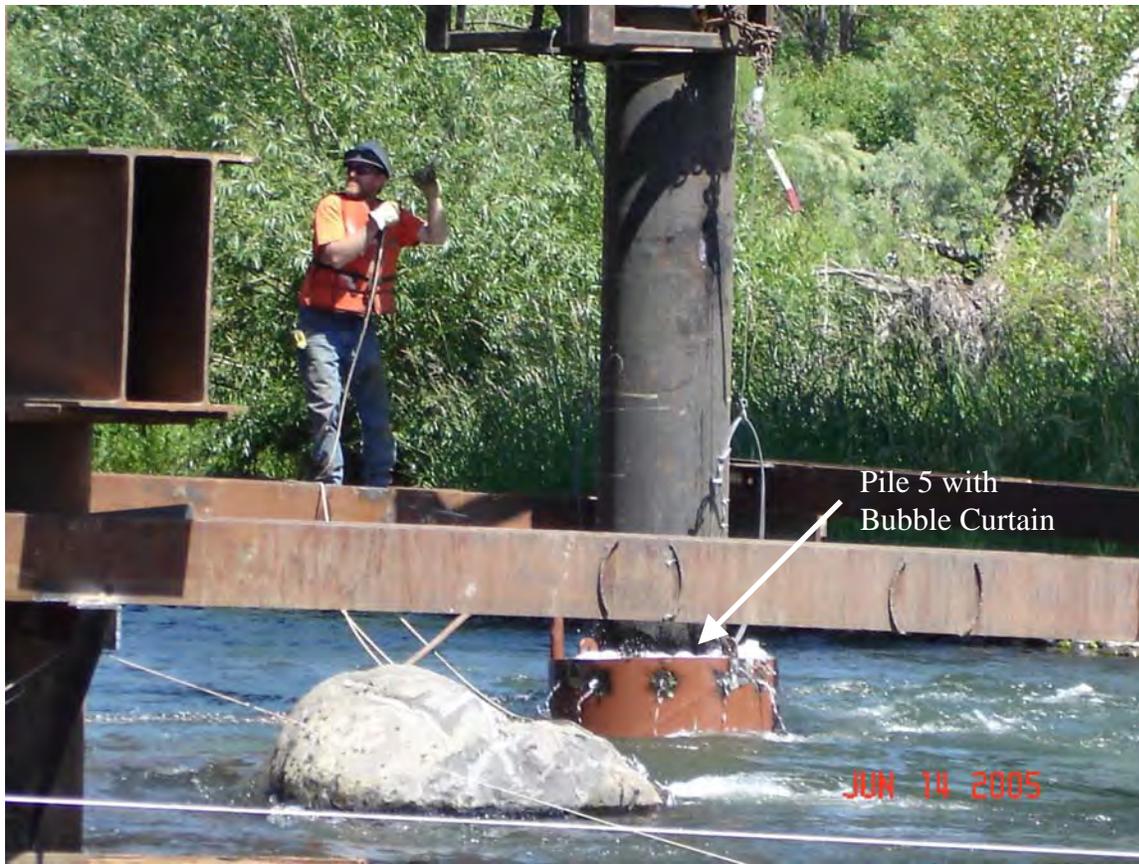
**Figure 10: Pile 5 with Bubble Curtain in Operation.**

The second of two piles driven at this depth was Pile 5 driven with a diesel hammer in a water depth of two feet. A large grab was used to pluck the larger boulders ranging from four to five feet across from the site where Pile 5 was to be driven. This would also have the additional benefit of allowing the casing on the bubble curtain to seat properly. The confined bubble curtain was deployed for this pile and bubbles were on during the entire driving event (Figure 10).
