**WSDOT NPDES Municipal Stormwater Permit
Compost-Amended Biofiltration Swale Monitoring Final
Report**

October 2020

Stormwater Monitoring and Research Program
Environmental Services Office
Washington State Department of Transportation

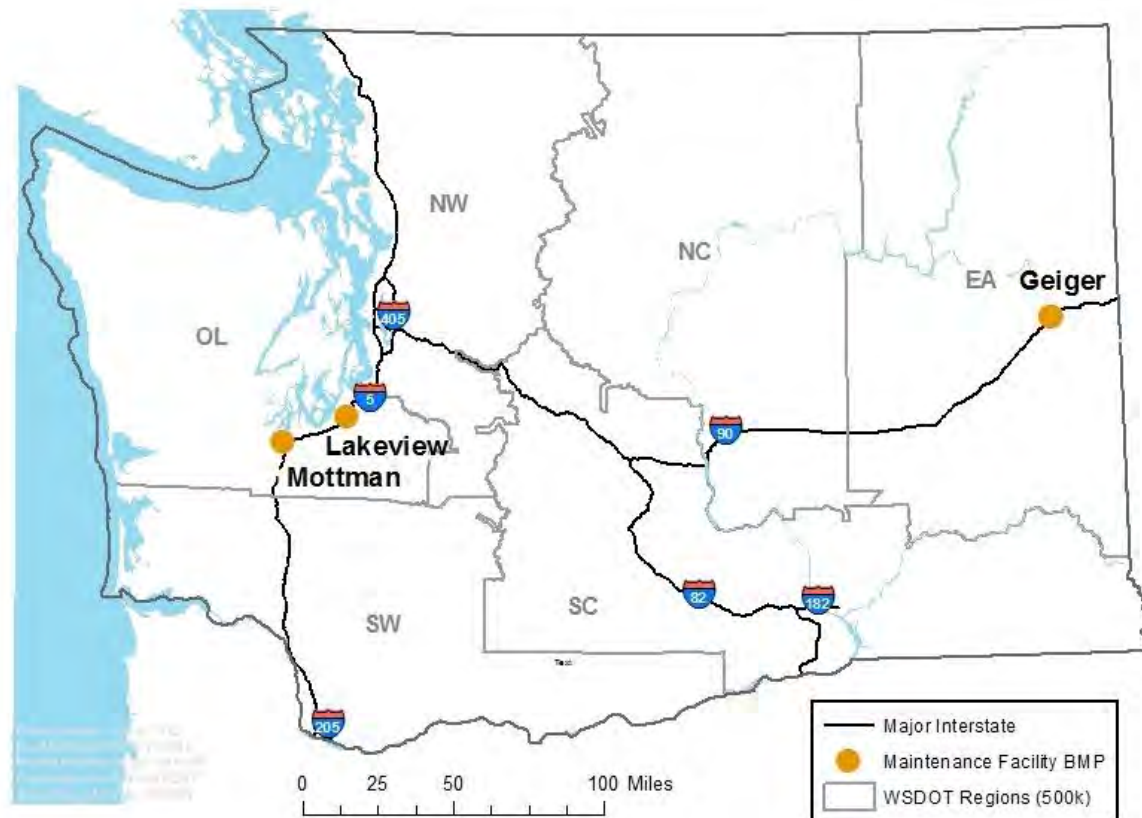
Figure 1. WSDOT CABS study sites.

Staff identified two western WA sampling locations within 30 miles of the monitoring program headquarters. These site locations reduced staff travel time, providing quick access to sites for station maintenance and sampling. For the eastern WA location, WSDOT utilized a region staff member to perform sampling duties, though headquarters monitoring staff still visited the site for station maintenance.

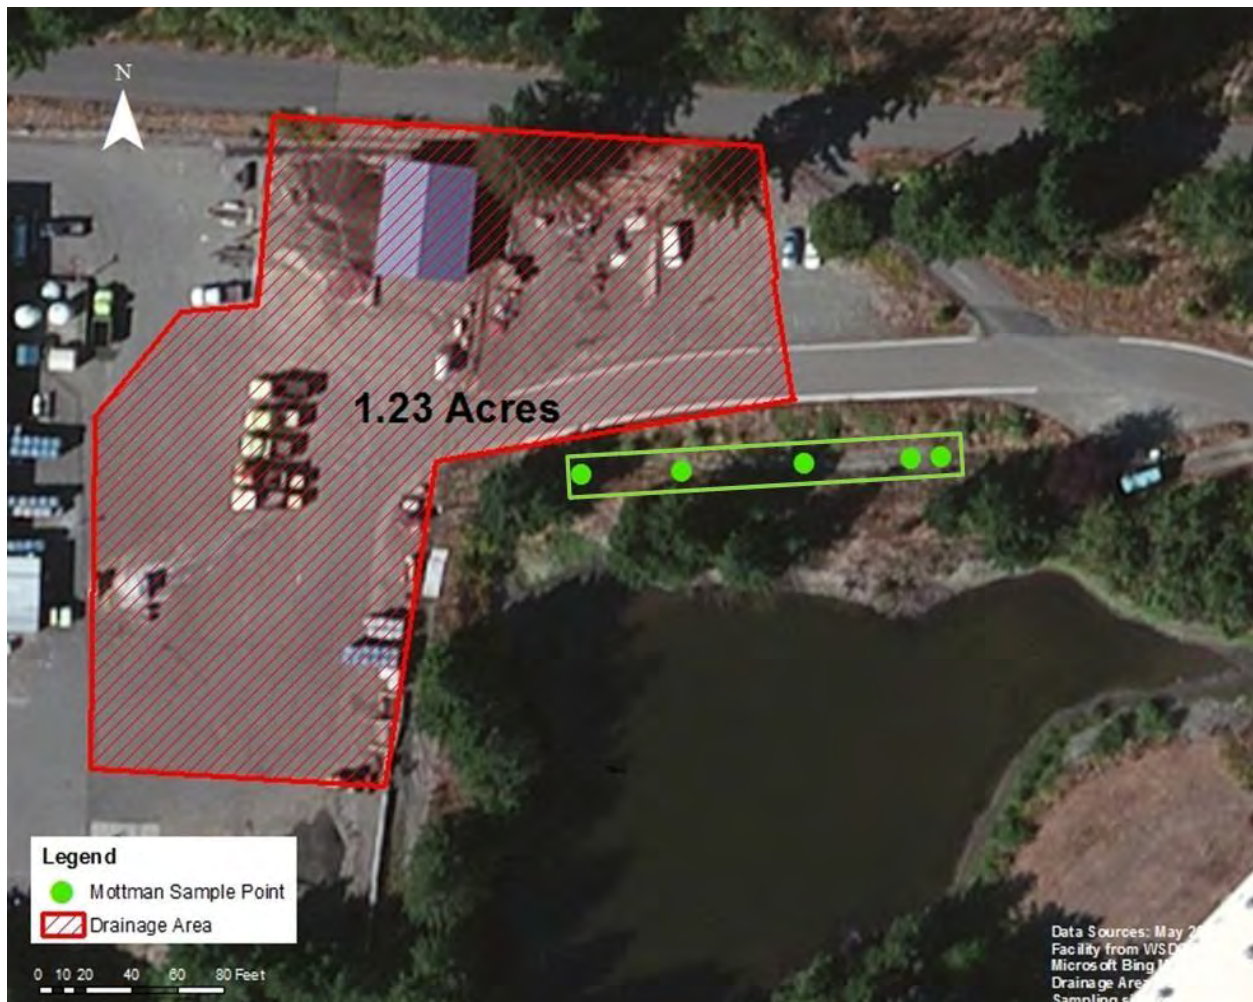
Figure 2. Mottman CABS monitoring points and associated drainage area.

The Mottman CABS is located east of the site's primary maintenance activities, and receives runoff from a 1.23-acre drainage area highlighted in Figure 2. Site observations during multiple storm events confirmed the delineated drainage area. Since stormwater flows to multiple discharge points, the CABS does not receive all of the runoff from the maintenance facility. This report only addresses pollutants generated in the drainage area that discharges to the CABS.

Potential pollutant sources in the drainage area include: trucks and heavy equipment parking, uncovered galvanized metal, a large sand pile, and a salt shed.

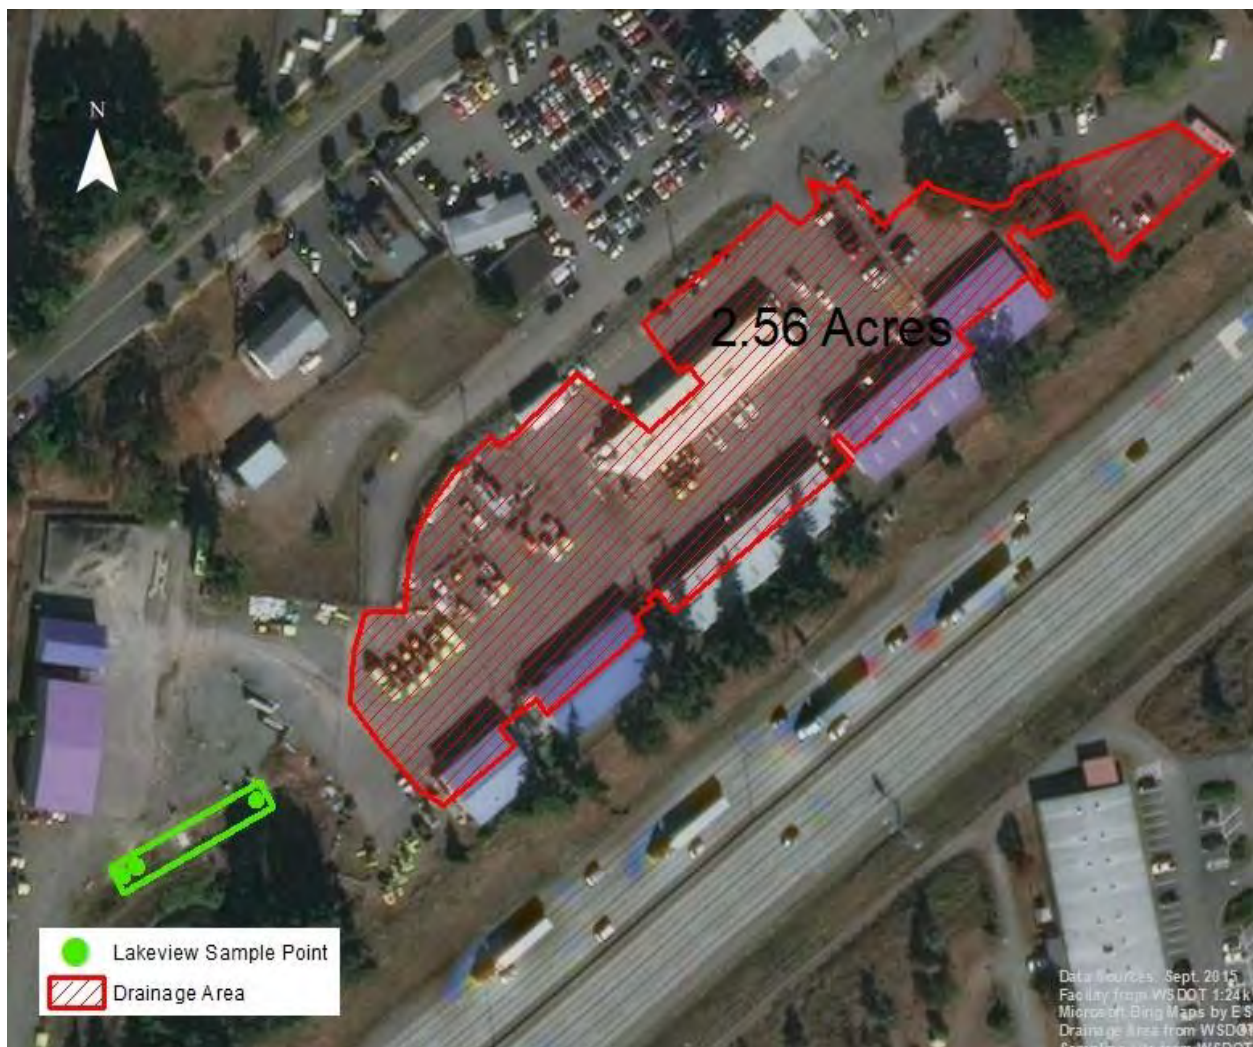
Figure 4. Lakeview CABS and associated drainage area.

Lakeview is a maintenance facility with a stormwater system that collects runoff from nearly the entire facility into a large Type-2 catch basin with an integrated oil-water separator. This catch basin discharges to the Lakeview CABS. Figure 4 shows the drainage area of 2.56 acres.

Sources of potential pollutants in the drainage area included uncovered galvanized metal, treated lumber, a prewash pad, deicer tanks, landscaping equipment, truck parking, maintenance buildings, and herbicide and fertilizer storage.
