2020 WETLAND MONITORING REPORT

SR 900 78th Vicinity to Newport Way Widening Lake Sammamish State Park (LSSP) Compensatory Mitigation Site

USACE IP NWS-2007-29-SOD

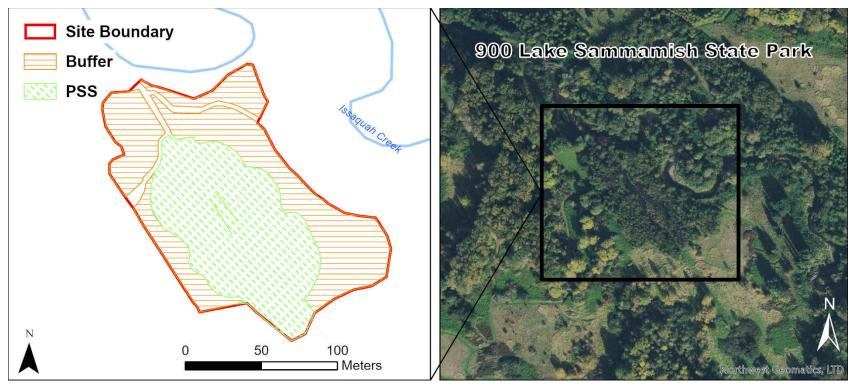
Figure 1. Site Sketch

The 900 Lake Sammamish State Park Compensatory Mitigation Site comprises 1.74 acres of wetland establishment, 0.11 acre of wetland enhancement, 1.98 acres of wetland buffer enhancement, and 0.25 acre of riparian buffer enhancement within existing state park property (Figure 1).

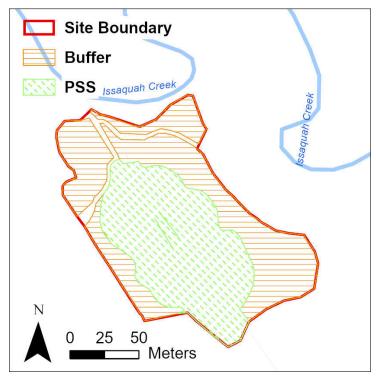
Figure 2. Sample Design

PS 2, 3	PS 4	PS 5
Attribute	Cover	Cover	Presence/Absence
Target population	Native woody species	Invasive species	Noxious weeds
Zone	Entire site	Entire site	Entire site
Sample method	Qualitative	Qualitative	Qualitative

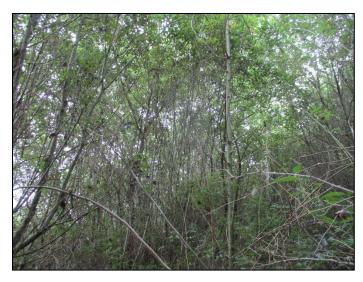
Cover of facultative or wetter woody species in the scrubshrub wetland is qualitatively estimated at 75%-80% (Photo 1). This exceeds the final year performance standard threshold.

Dominant species include Pacific willow (*Salix lasiandra*), Scouler's willow (*Salix scouleriana*), black cottonwood (*Populus balsamifera*), redosier dogwood (*Cornus alba*), and Nootka rose (*Rosa nutkana*).

Photo 1. Woody cover in the wetland (August 2020)

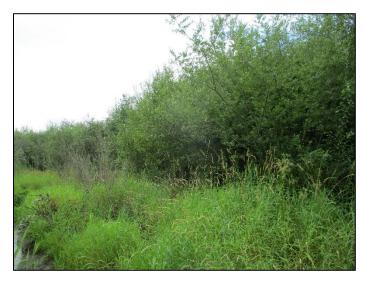
Reed canarygrass (*Phalaris arundinacea*) cover has increased over the last two years, perhaps due to changes in hydrologic regime near the stream from beaver activity. Reed canarygrass lines the stream for the entire length of the site, and has now encroached on the adjacent wetland community that had begun to develop as an emergent community. This area comprises approximately 10% of the total scrub-shrub wetland area. Since most of the site exhibits high cover with low light penetration, reed canarygrass is not expected to spread much more than it already has, unless beaver activity continues to change the site's water regime.

Approximately 10% of the scrub-shrub wetland near the stream that was originally planted with willow species has developed as an emergent community dominated by reed canarygrass (*Phalaris arundinacea*) (Photo 2). Woody cover in this area is estimated at 15%.

Photo 2. Reed canarygrass cover along the stream (August 2020)

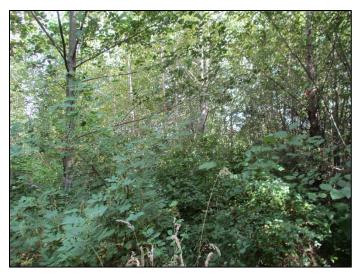
Woody cover in the buffer is qualitatively estimated at 90% (Photo 3). This exceeds the final year performance standard threshold.

Dominant species include western red cedar (*Thuja plicata*), black cottonwood (*Populus balsamifera*), Pacific crabapple (*Malus fusca*), snowberry (*Symphoricarpos albus*), and thimbleberry (*Rubus parviflorus*).

Photo 3. Woody cover in the buffer (August 2020)

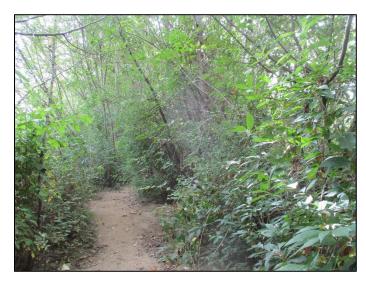
The mapped buffer area from the original as-built plans was impacted by erosion from Issaquah Creek, but there did not appear to be any new significant erosion along the creek bank since the pedestrian trail was relocated through the buffer in 2017.

A portion of the buffer on the north east side of the site was eroded by Issaquah Creek in 2016, resulting in the relocation of the pedestrian trail through the buffer (Photo 4). No evidence of new erosion was observed, and the trail has not significantly reduced cover in the buffer.

Photo 4. Relocated trail through the buffer (August 2020)

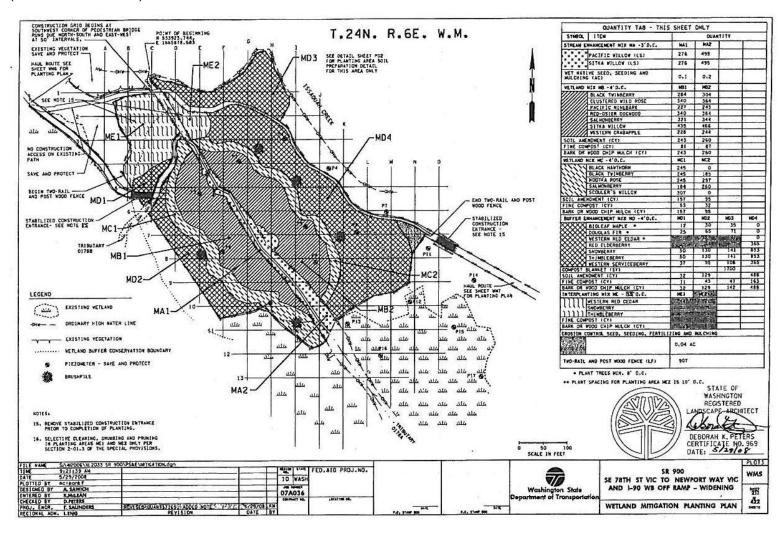
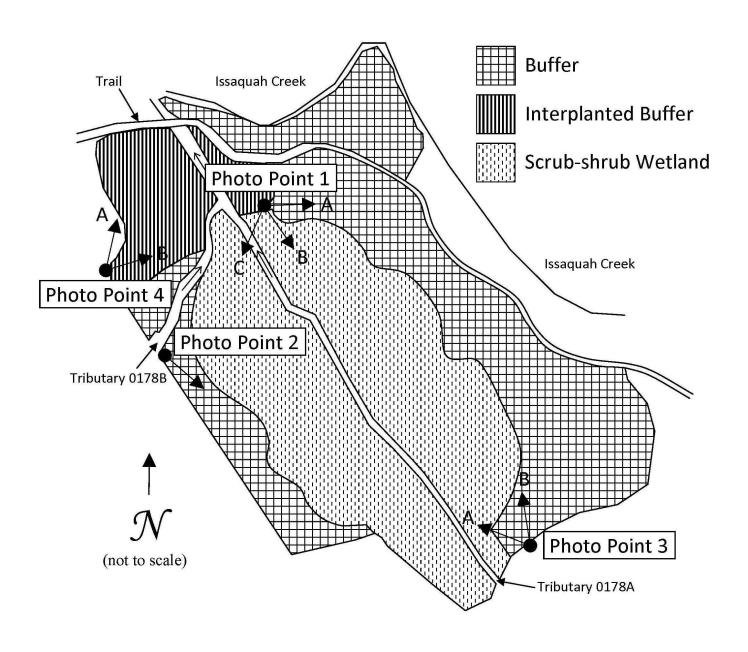
Appendix A. Planting Plan and Photo Point Locations

Appendix A shows the As Built Planting Plan (WSDOT 2010).

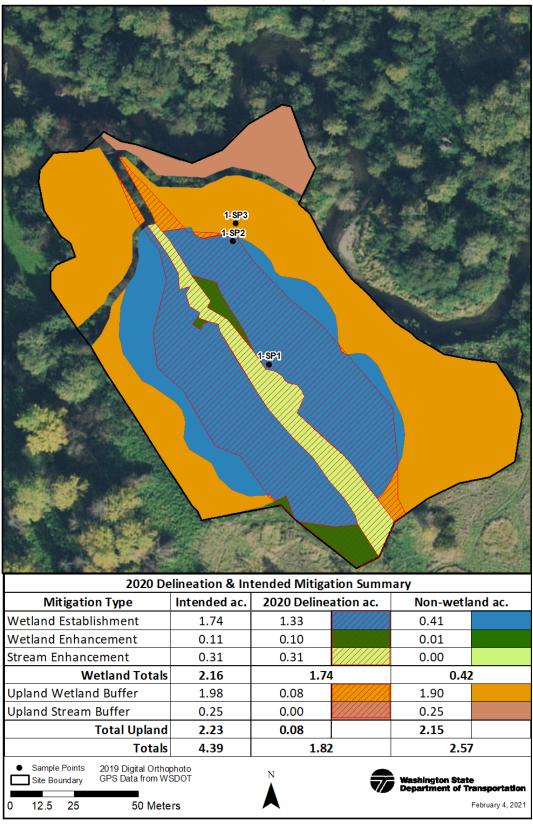
Figure 2. 2020 Delineation and Mitigation Types Map.

The SR 900 Lake Sammamish State Park compensation site remains in similar condition as documented in 2015. Wetland area within the site boundary has increased from 1.53 acres in 2015 to 1.82 acres in 2020.

The 2020 delineation verification determined 1.74 acres of wetland were present within the wetland establishment and enhancement areas, with an additional 0.08 acre present in the adjacent upland buffer area, totaling 1.82 acres present on the site. Moderate wetland boundary amendments were made in 2020 from conditions documented in 2015, and an entirely new wetland boundary was collected to document the 2020 wetland boundary.
