I-405, Downtown Bellevue Vicinity Express Toll Lanes Project (MP 11.9 to 14.6)

Attachment I: Cultural Resources Survey Discipline Report

**Cultural Resources Survey for the
Washington State Department of Transportation's
I-405: I-90 to Northeast 6th Street Improvements Project,
King County, Washington**

Short Report DOT2016-05
Archaeological and Historical Services
Eastern Washington University

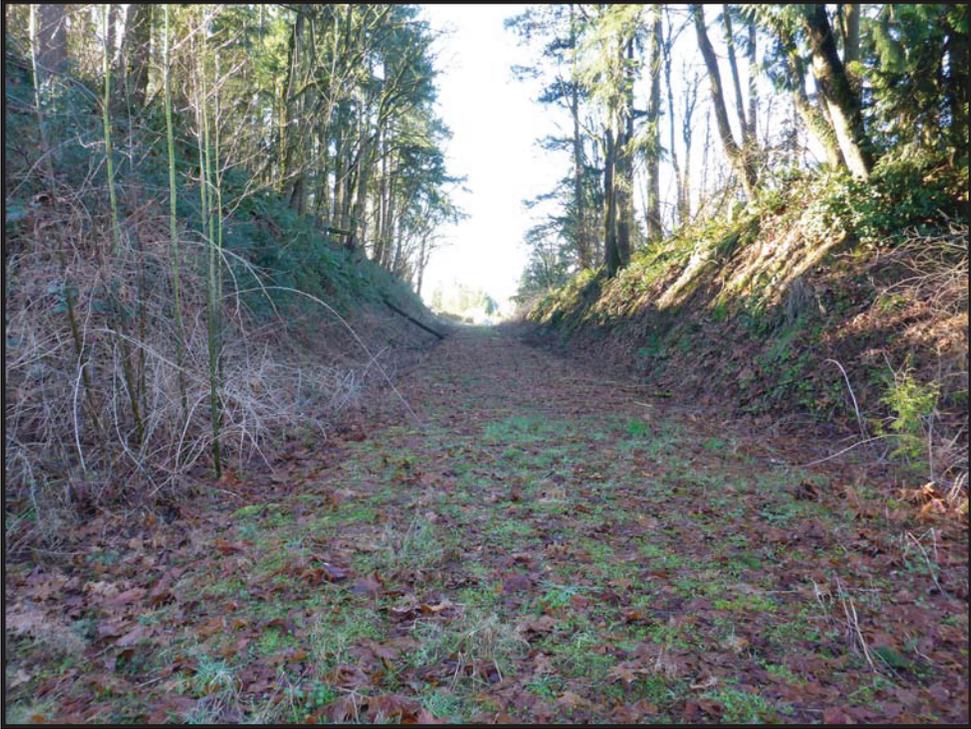
Figure 3. View of the now abandoned Burlington Northern Santa Fe Railroad bed (site 45K11274), view to the south-southwest.

Ground surfaces within the resource evaluation area have been subject to extensive disturbances, primarily due to previous road construction, as well as construction of the now abandoned Burlington Northern Santa Fe Railroad bed, which crosses the corridor in the southern end of the resource evaluation area where it is now a graveled road (Figure 3). Both I-405 and the railroad bed are deeply cut into the steep slope of a large hill, and several water retention ponds have been constructed along the western edge of I-405 (Figures 4 and 5). Further disturbance has been caused by buried utility installation. Most of the resource evaluation area is paved or occupied by thick, often impenetrable, vegetation (Figure 6).

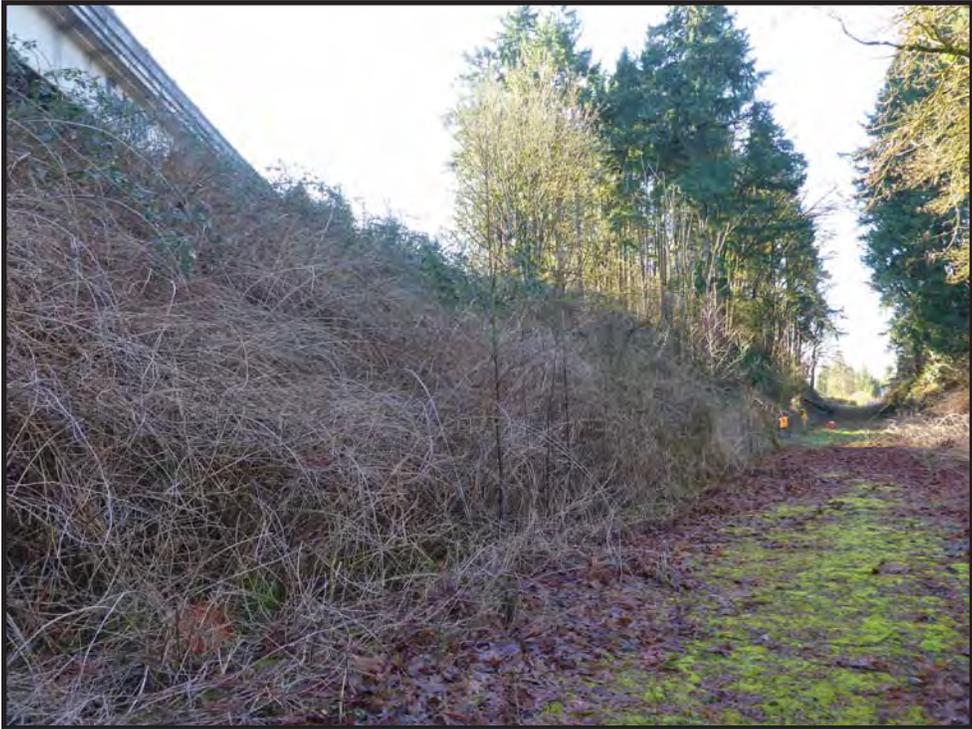
Figure 6. Photograph showing a cut slope covered by impenetrable blackberry bushes, view to the south-southeast.

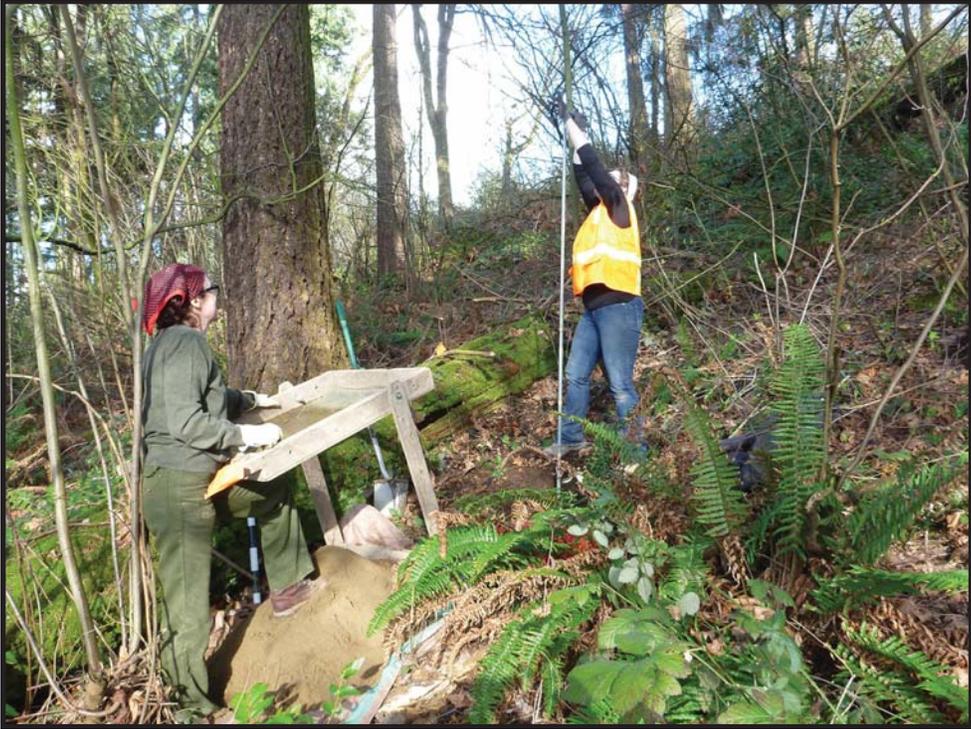
Figure 9. Shovel test excavation in Zone 69 A1, view to the northeast. Note the steep slope.

Area 1: Area 1 consists of the majority of the median between north- and south-bound I-405 lanes. Area 1 is on the steep, west-facing slope of a large glacial drift remnant of Puget Lowland fill (Booth 1994) (Figure 9). Both north and south I-405 corridors, as well as an abandoned segment of BNSF Railroad bed (Figure 10) are cut into the side of this hill. Kelsey Creek and Hixson/Trail Creek also traverse this zone. Steep cuts in the slope and impenetrable vegetation prevented shovel testing in many areas. Twenty-four shovel tests were excavated in Area 1 (see Figures 7 and 8). Five of these were excavated into road prism fill and terminated when dense gravels prevented further excavation. Excavations of the remaining 19 shovel tests exposed relatively undisturbed glacial drift sediments. Most shovel tests were terminated when dense cobbles prevented further excavation. Shovel test 613E 1870N reached a depth of 300 cmbs and revealed pebbly loamy sands with pockets of silty clay.

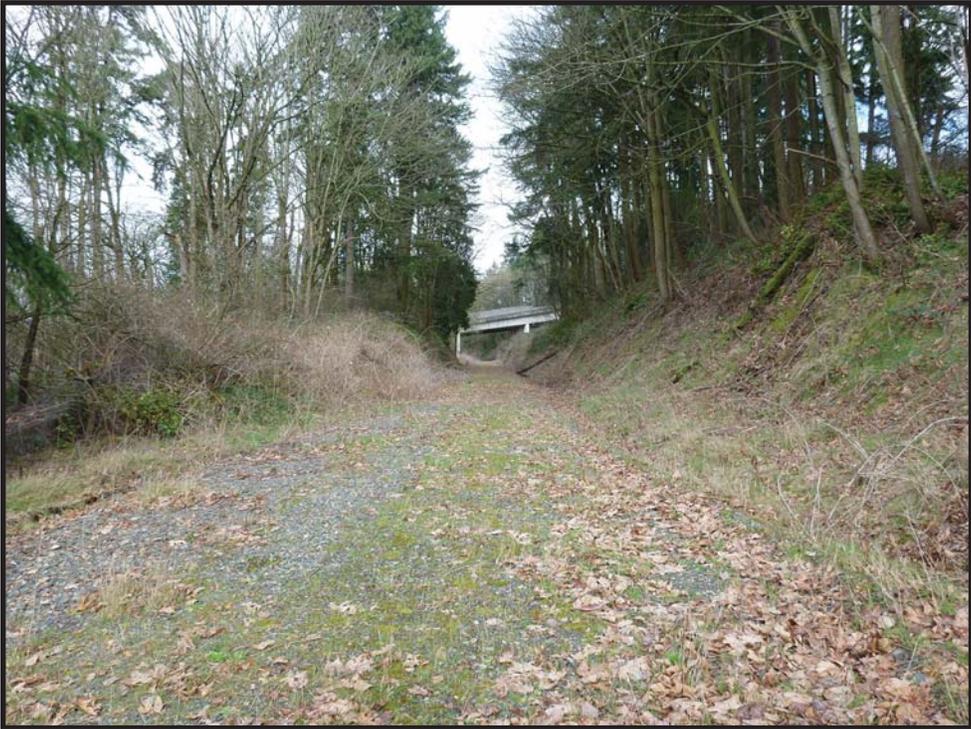
Figure 10. Abandoned BNSF railroad bed (site 45K11274) in Zone 69 A1, view to the northeast. Note the deep cuts in the hillside.

A short segment of the historic Northern Pacific (now BNSF) Railway railroad bed crosses Zone 69. The line was constructed in 1891 as a spur line connecting the Bellevue area to the major Northern Pacific line in Renton and initially served as a means of transporting coal and iron from mines east of Puget Sound to industrial plants, most importantly, to the steel mill at Kirkland (Allen and O'Brien 2007). The railroad and its associated features were determined eligible for listing in the NRHP by DAHP in 2007. The segment of the railroad within the I-405 corridor was subsequently abandoned and the rails and ties removed, leaving nothing but the ballast. The Wilburton Tunnel, part of the railroad line which once crossed the south-bound I-405 corridor, has also been removed (Figure 12). This abandoned segment was recorded on a Washington State Archaeological Inventory form (see Appendix D) and assigned the number 45KI1274.

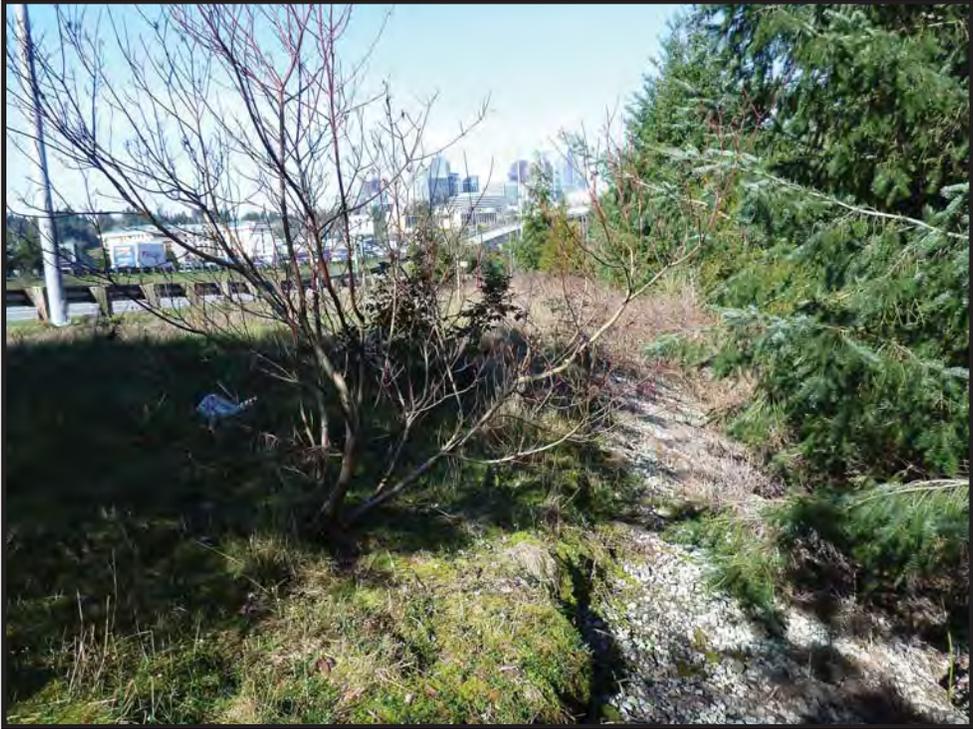
Figure 11. Zone 69 A2, view to the northwest. Note gravel layer on slope under grass mat.

Area 2: This area is located immediately east of the north-bound exit ramp to SE 8th Street and overlooks the confluence of Hixson and Kelsey Creek to the northeast (see Figure 8). A layer of fill gravels was observed beneath the topsoil (Figure 11). Four shovel tests were excavated into road prism fill; all were terminated when dense gravels prevented further excavation.

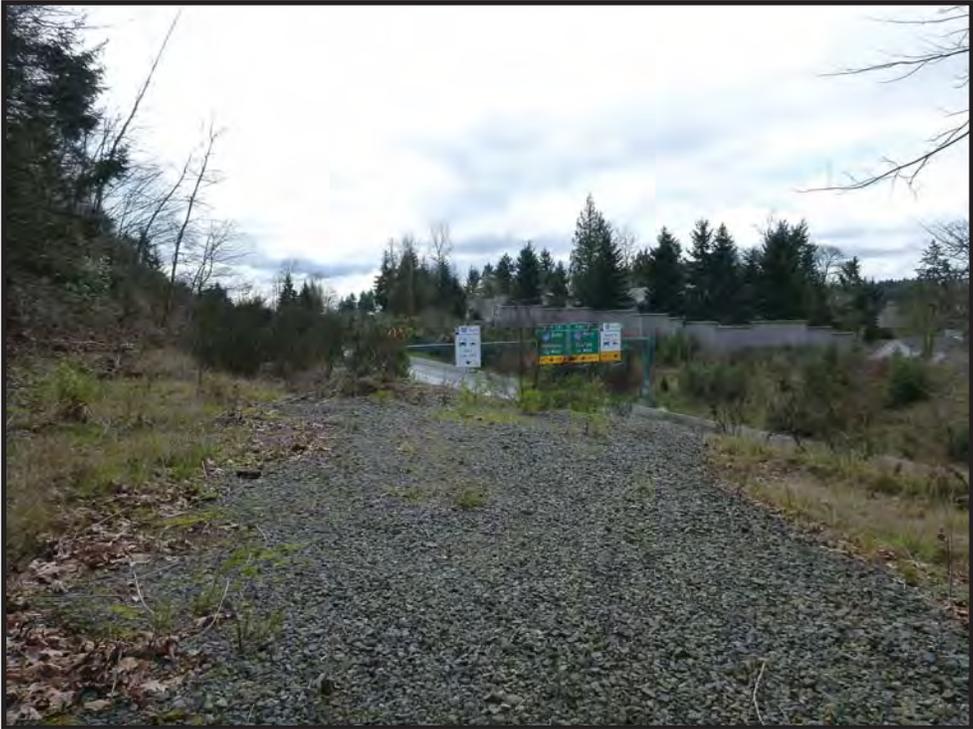
Figure 12. Photograph showing a segment of the abandoned railroad bed overlooking the former location of the Wilburton Tunnel, view to the southwest.

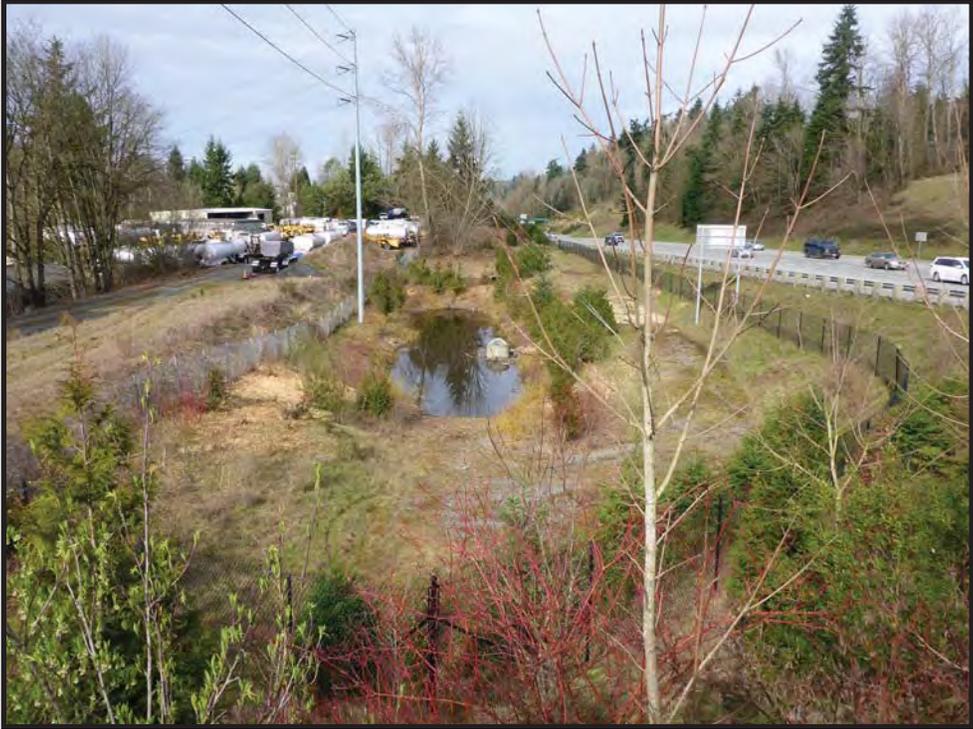
Figure 13. Zone 72 A1 fenced water retention area, view to the north. Note gravel on surface.

evidence of significant cultural materials. Zone 72 is on a hillslope likely terraced during road construction. There is no evidence for intact Holocene-age sediments and archaeological potential is low.

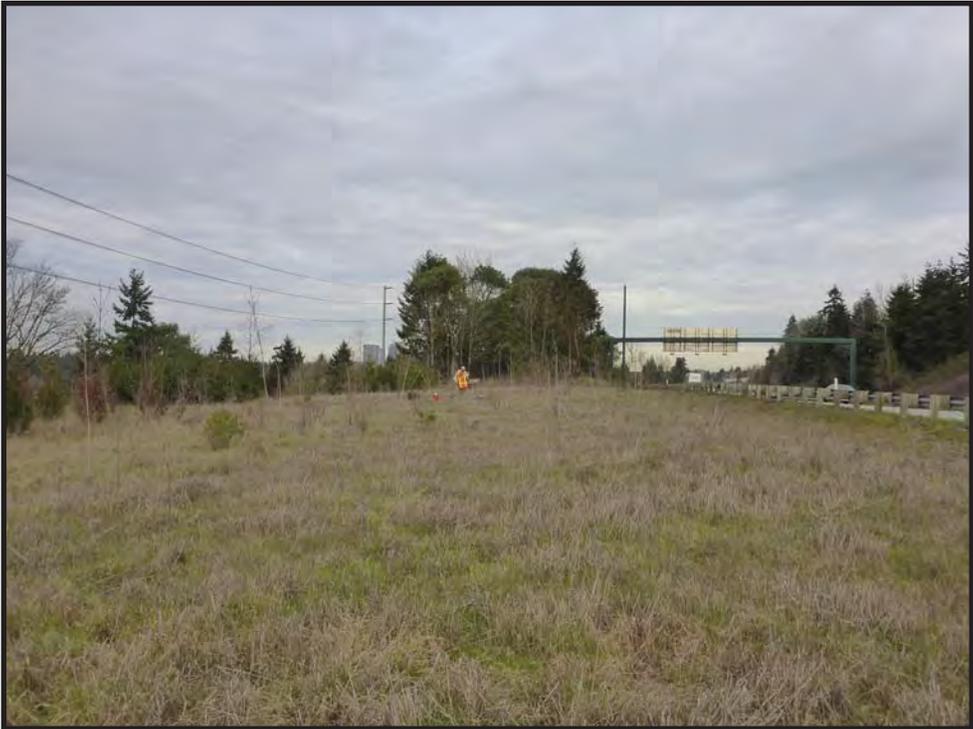
Figure 14. Zone 72 A2 terraced landscape, view is to the north.

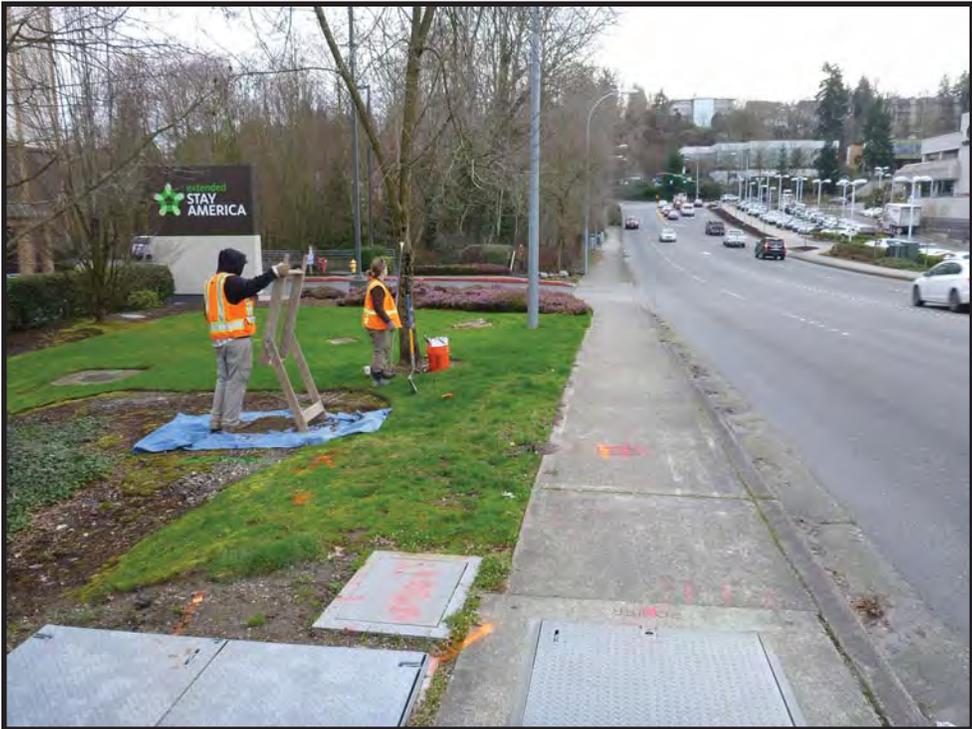
Figure 23. Shovel test excavations on NE Main Street in Zone 81 A3, view to the east. Note locations of buried utility lines denoted with orange spray paint.

Area 3: This area is located along Main Street on either side of I-405 (see Figures 20 and 21). It comprises small landscaped areas adjacent to parking lots (Figure 23). This is a Fill zone that was not included in the zone potential mapping. Buried utility and sprinkler lines determined shovel test placement. Four shovel tests were excavated through fill along Main Street and terminated on dense cobbles. Modern trash was observed in three of the shovel tests, indicating disturbance.

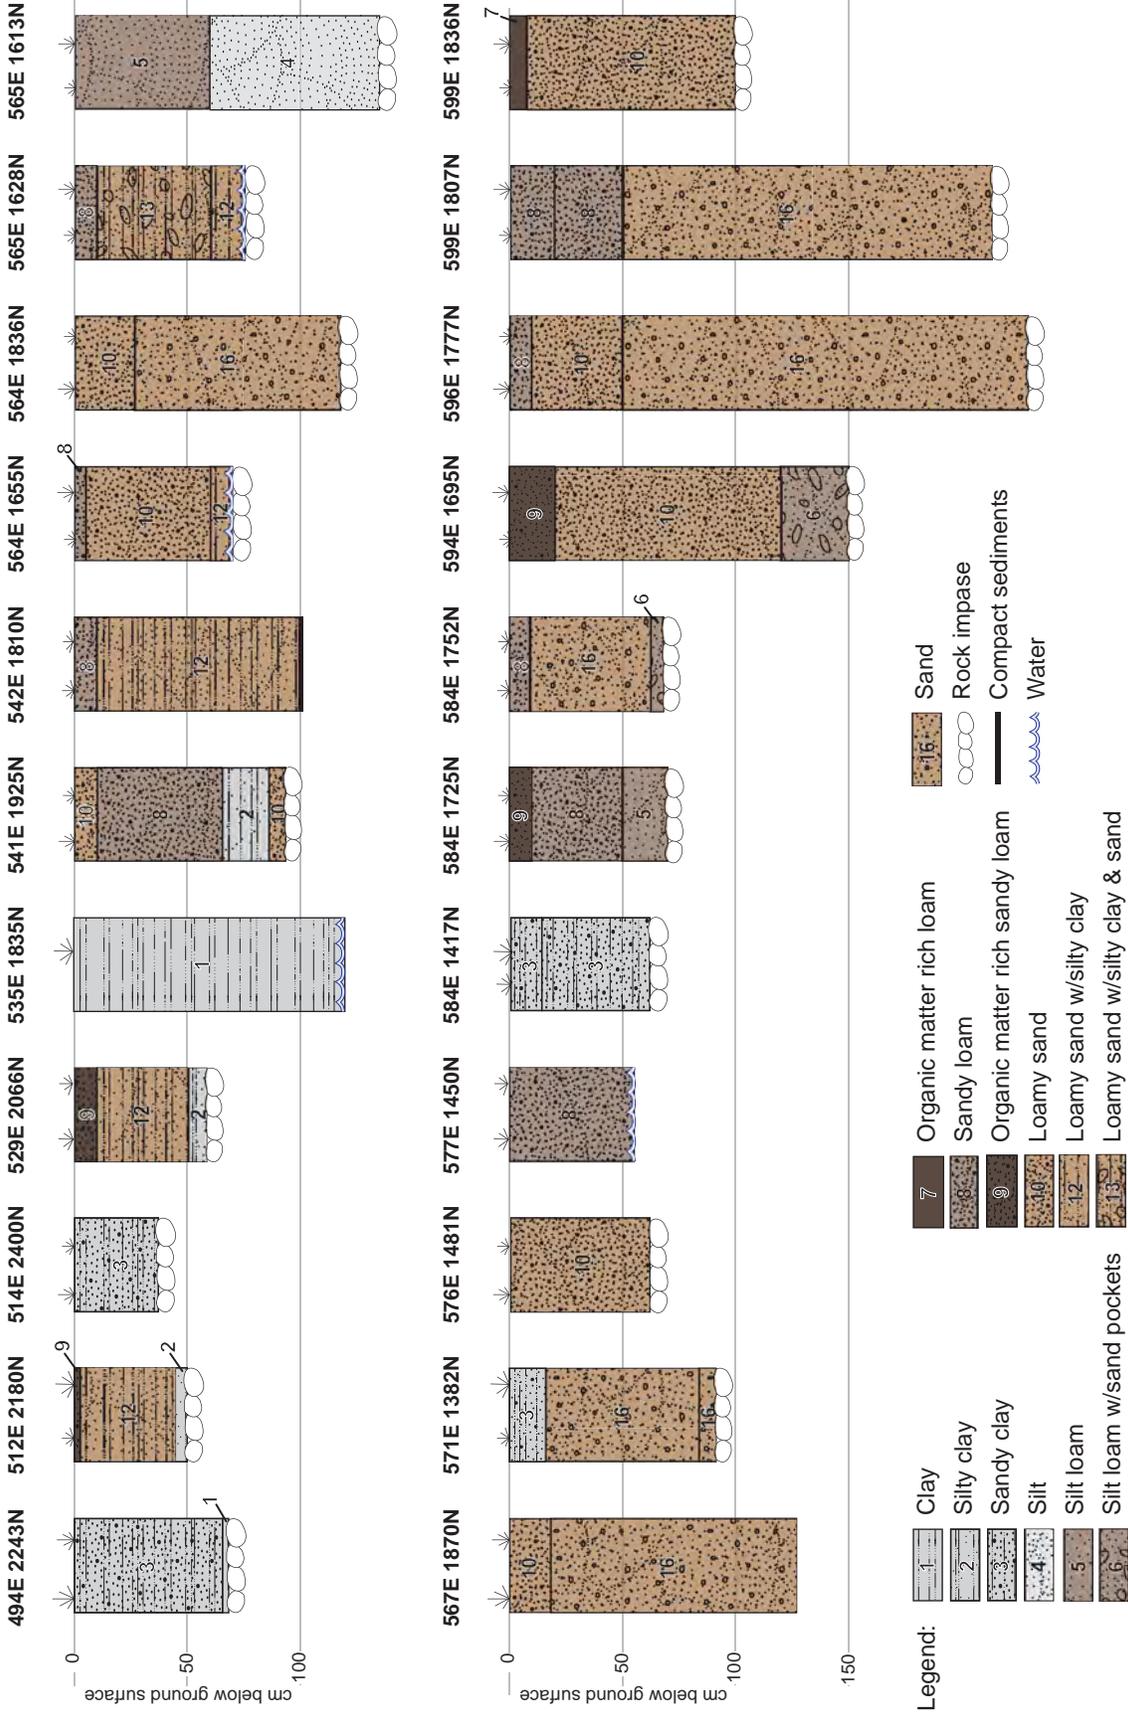
Figure B.1. Profile drawings of shovel tests excavated in Zone 69 A1.

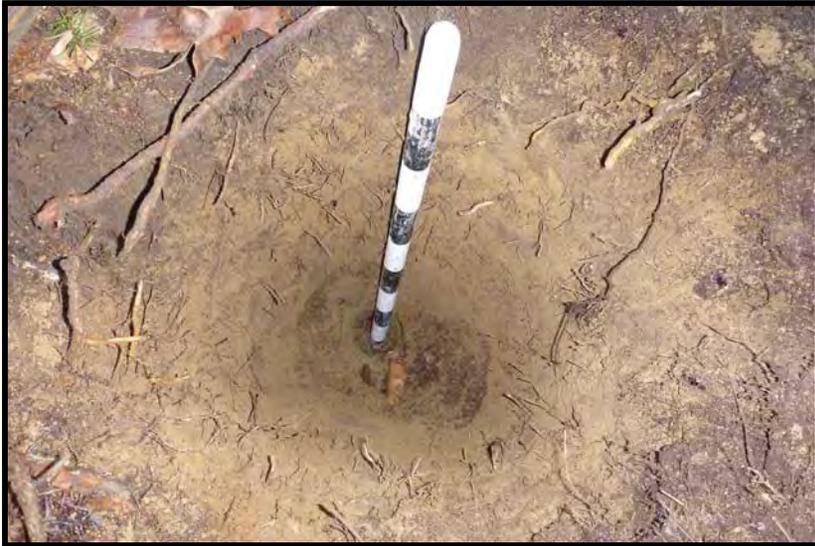
Figure C.1. Shovel test 599E 1836N in Zone 69 A1. The scale is divided into 10 cm intervals

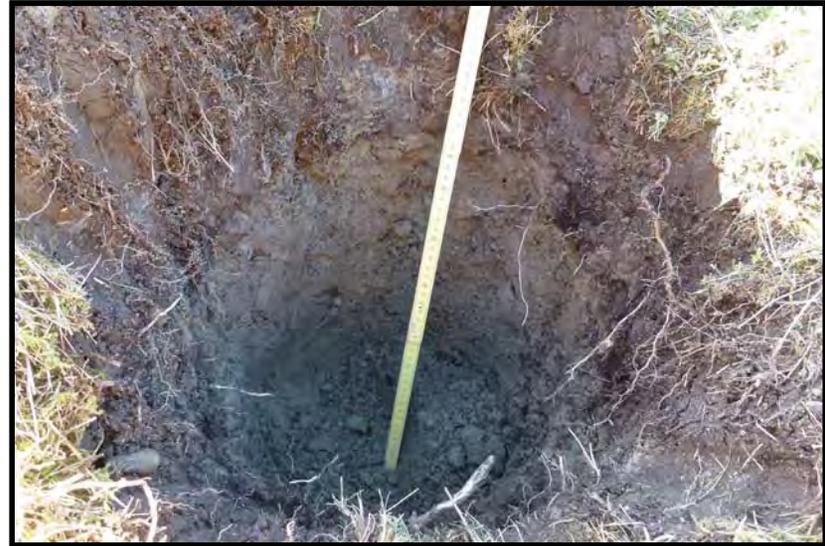
Figure C.2. Shovel test 497E 2372N in Zone 69 A2. The scale is divided into 10 cm intervals
